# Asbestos-Containing Material Inspection Report

## **NJ013 SIEVERS-SANDBERG UNITED STATES ARMY RESERVE CENTER**

U.S. Route 130  
Pedricktown, NJ 08067-3621

Final – Revision 01; 25 April 2013

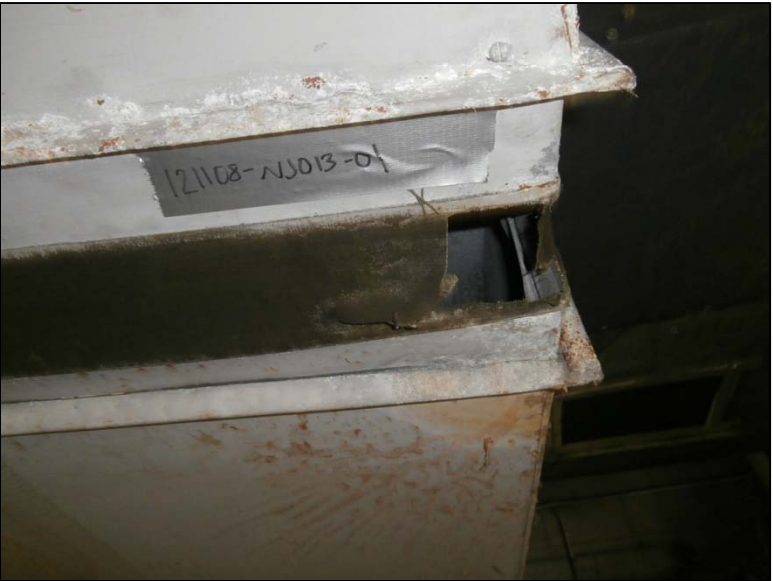
**Building:** 173  
**Photograph:** 14  
**Date:** 11/08/2012

**Description:**  
HA-NJ013-002  
Dry Wall in Boiler/Mechanical Room  
(Falling to floor from ceiling)

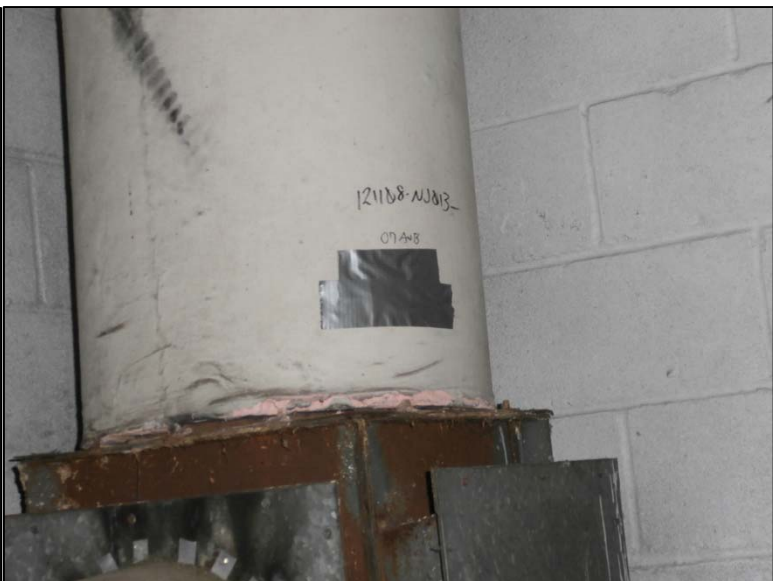
**Building:** 173  
**Photograph:** 19  
**Date:** 11/08/2012

**Description:**  
HA-NJ013-006B  
Boiler Stack TSI (Insulation)  
in Boiler/Mechanical Room

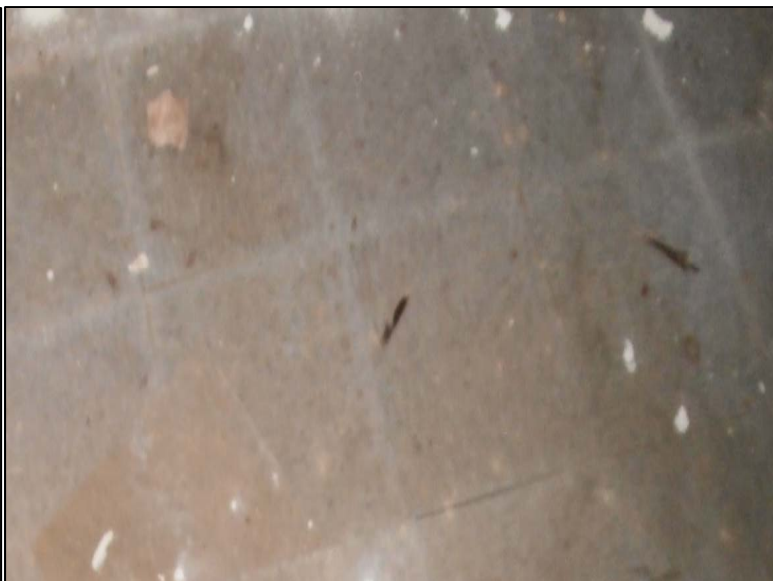
**Building:** 173  
**Photograph:** 21  
**Date:** 11/08/2012

**Description:**  
HA-NJ013-007B  
Black Mastic Under 12" x 12" Tan  
Floor Tile with Brown Flakes in Dining/  
Mess Hall

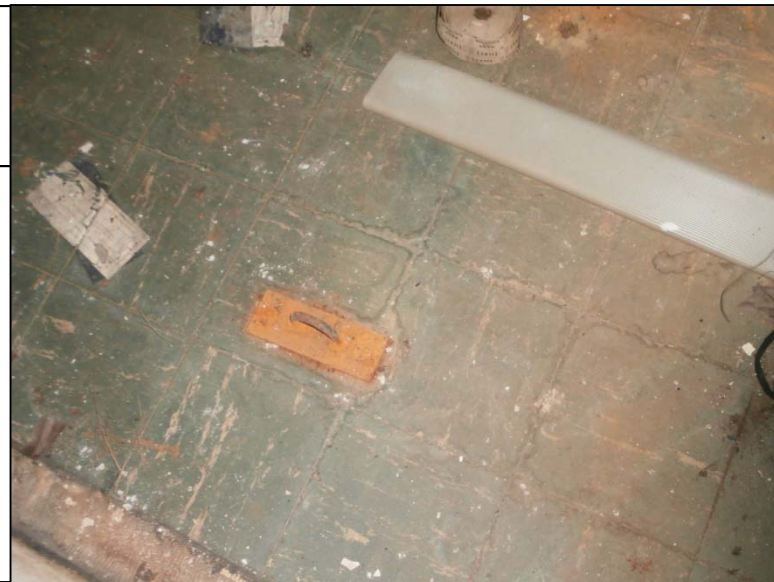
**Building:** 274  
**Photograph:** 47  
**Date:** 11/09/2012

**Description:**  
HA-NJ013-027B  
Mastic under 9" x 9" Green Floor Tile with Tan Streaks in Supply Storage Vault in Basement (ASSUMED)
