# Thornton Tomasetti

Building Solutions

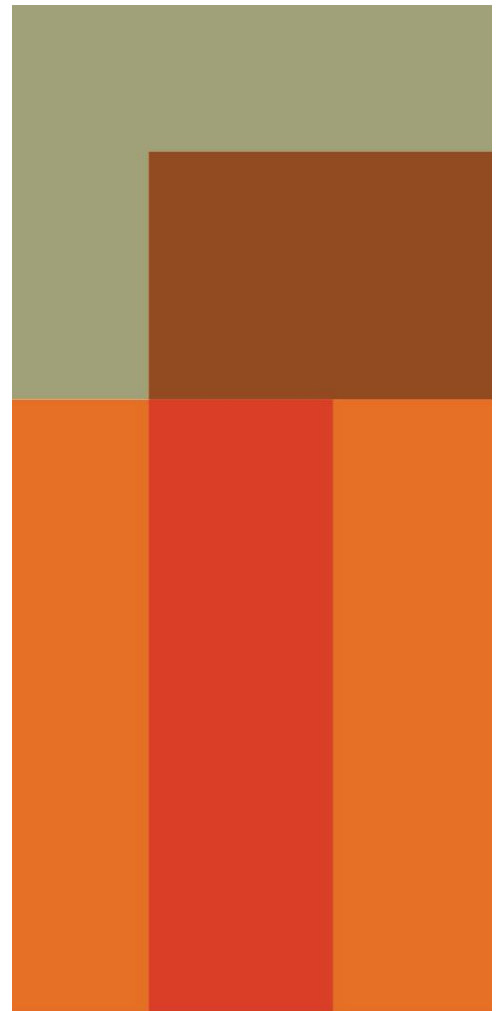
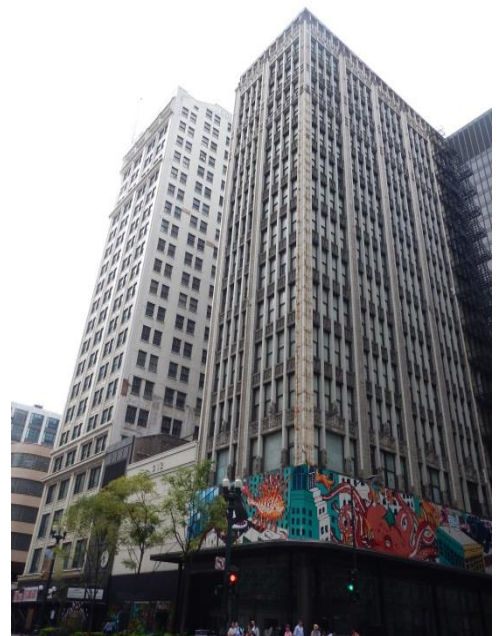
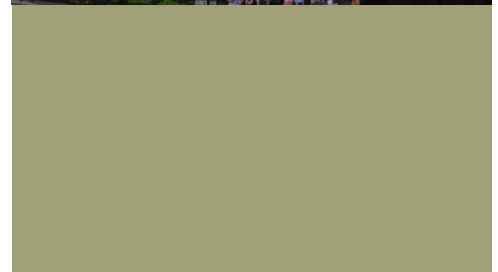
## TABLE OF CONTENTS

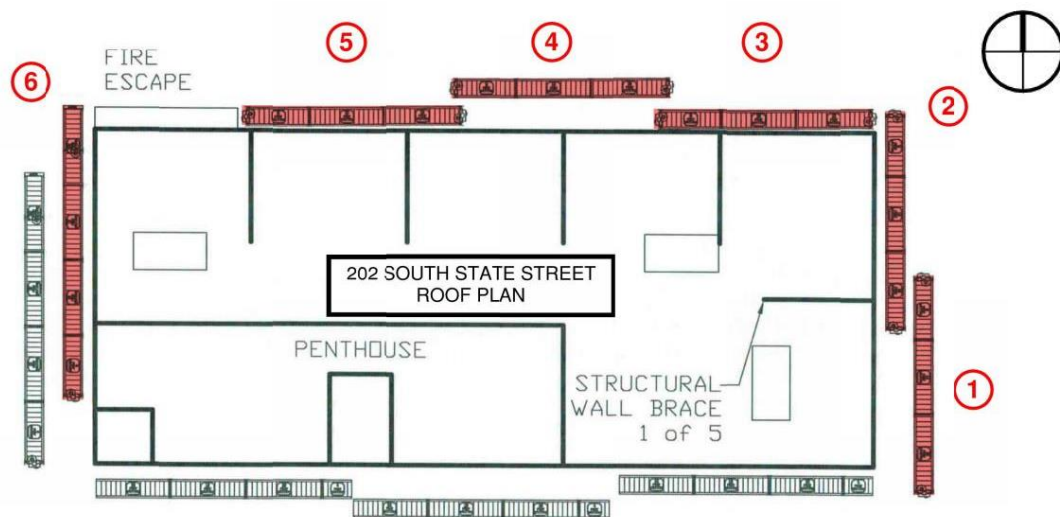
Thornton Tomasetti's observations were limited to up-close visual inspections performed at arm's length with the aid of hammer or mallet devices utilized for sounding terra cotta. No destructive material testing was performed.

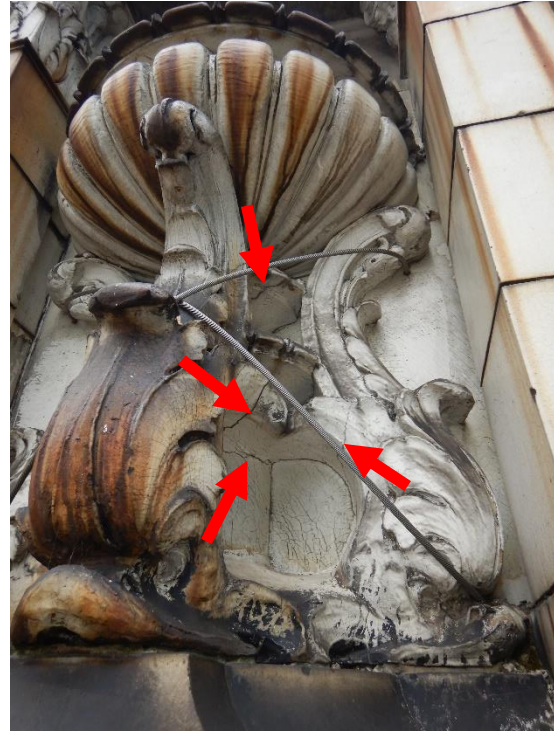
**Photo 6.** Terra cotta urn previously strapped (by others), new cracks noted by red arrows.

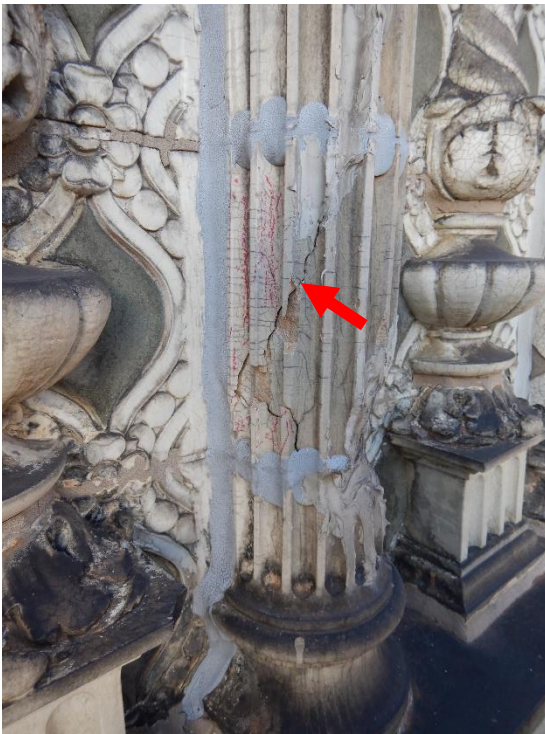
**Photo 7.** New cracks and loose material observed at terra cotta units.

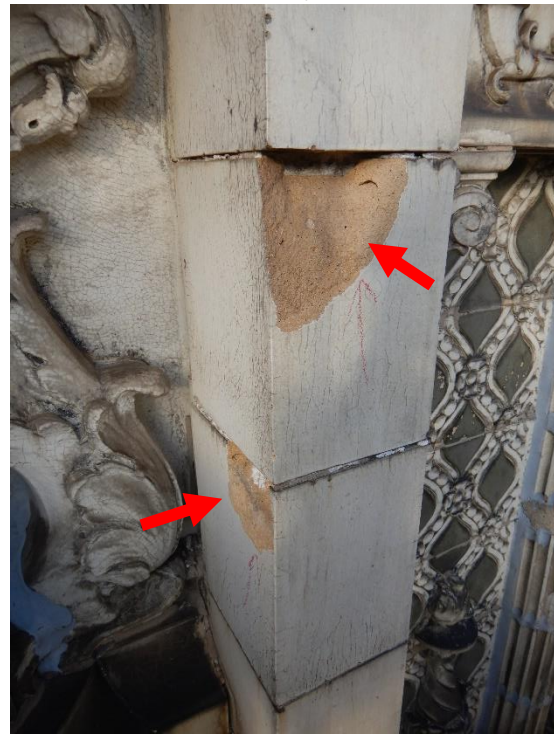
**Photo 8.** Typical spalls observed at terra cotta units.

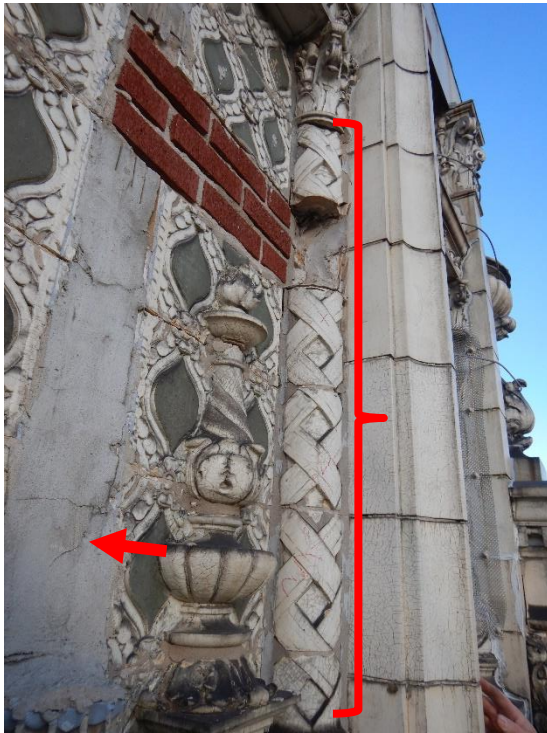
**Photo 9.** Unsound terra cotta units marked to be removed. Failed patch material noted by red arrow

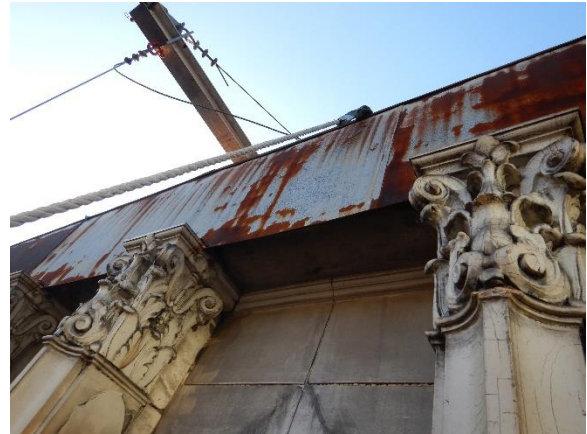
**Photo 10.** Typical condition of metal coping units.

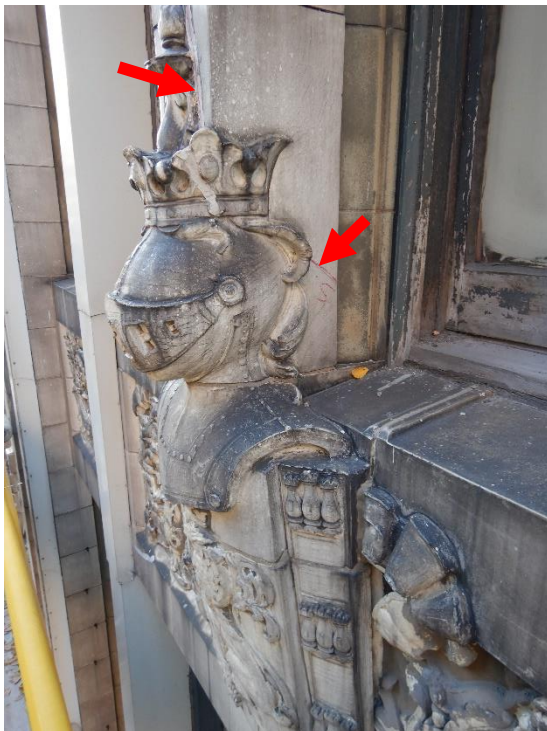
**Photo 11.** Ornamental spandrel at 4th floor (new cracks noted by red arrows).

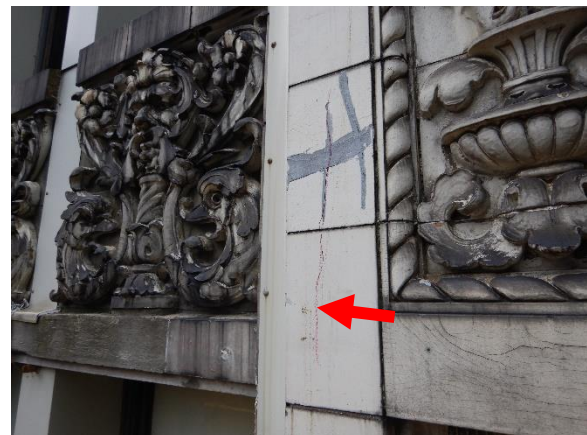
**Photo 12.** Ornamental spandrel at 14th floor (crack noted on mullion units).

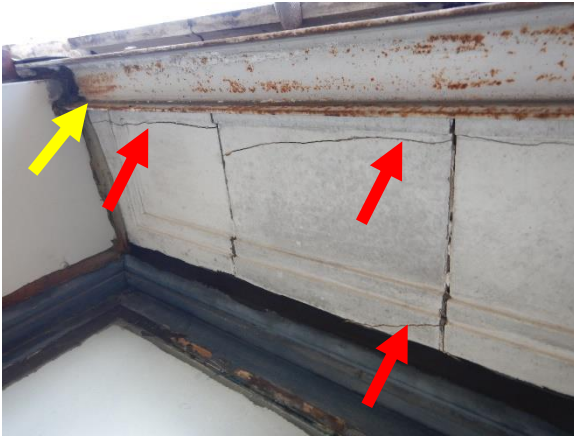
**Photo 13.** New underside cracks (red arrows) at terra cotta window head units (metal channel noted by yellow arrow).

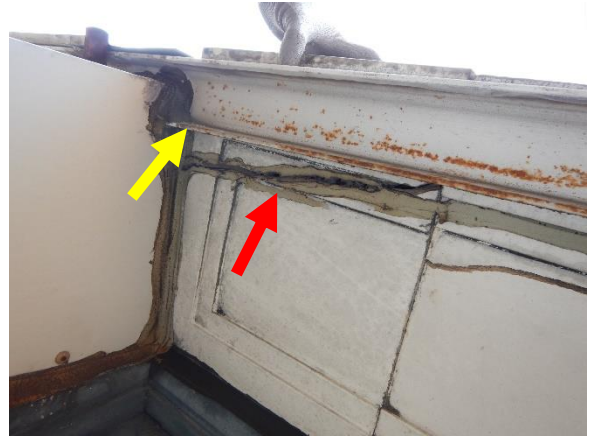
**Photo 14.** Previous underside crack repair (red arrow) in poor condition at terra cotta window head unit (metal channel noted by yellow arrow).

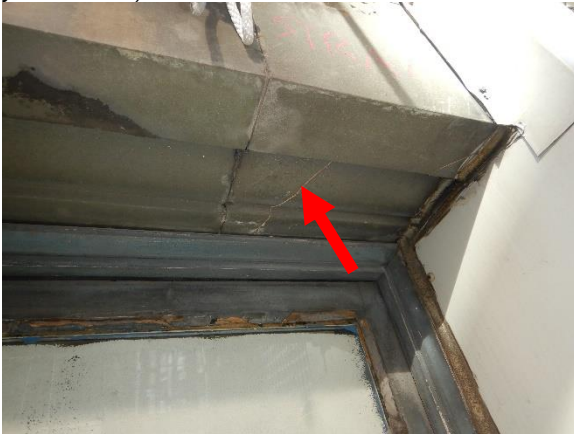
**Photo 15.** Underside crack at terra cotta window head unit (red arrow).

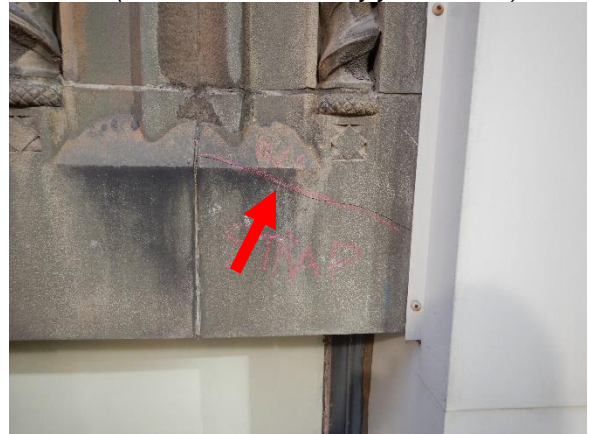
**Photo 16.** Typical diagonal crack observed on most terra cotta window head units (red arrow).

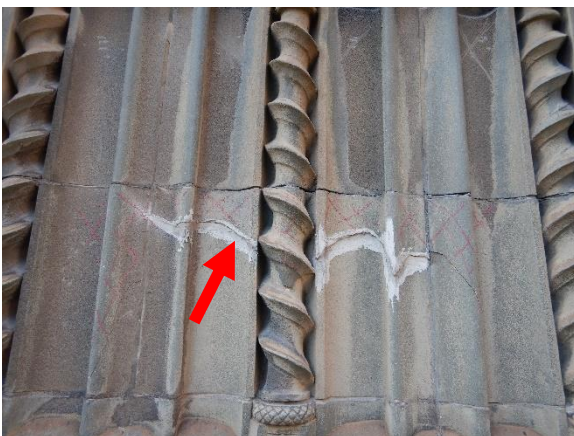
**Photo 17.** Large spall observed on terra cotta spandrel units.

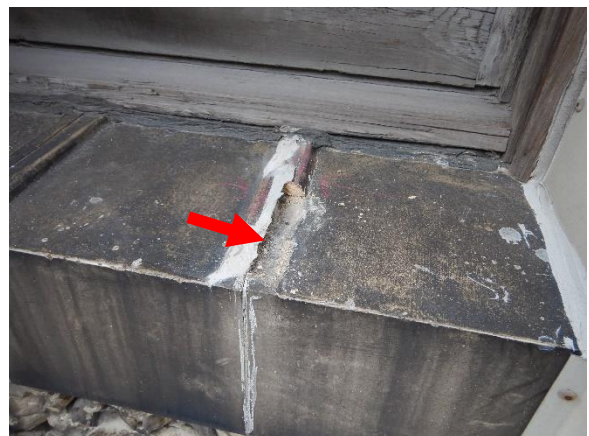
**Photo 18.** Typical spall on spandrel window sill terra cotta unit.

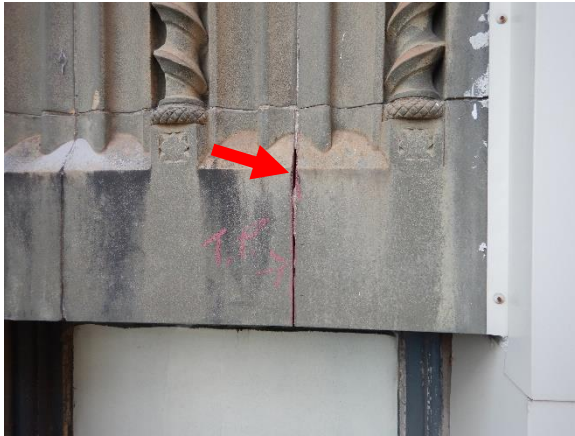
**Photo 19.** Typical open joint observed at most terra cotta window units.

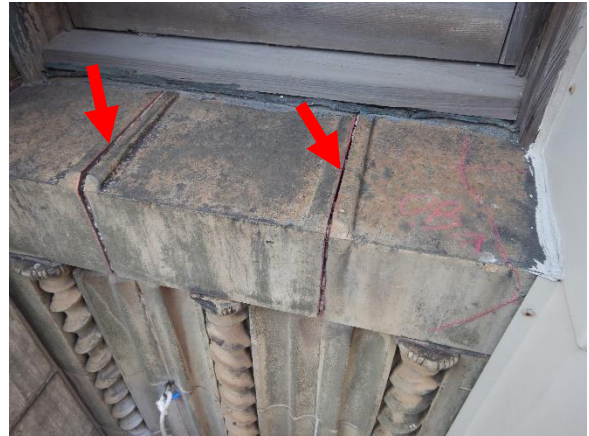
**Photo 20.** Typical open skyward facing joints observed at most window sill terra cotta units.

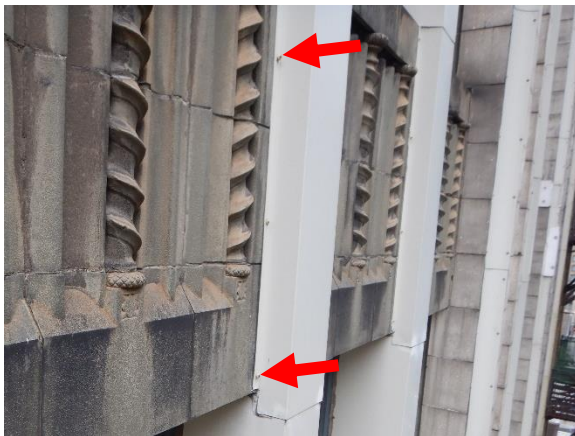
**Photo 21.** Typical loose anchors observed on aluminum sheeting at mullions.

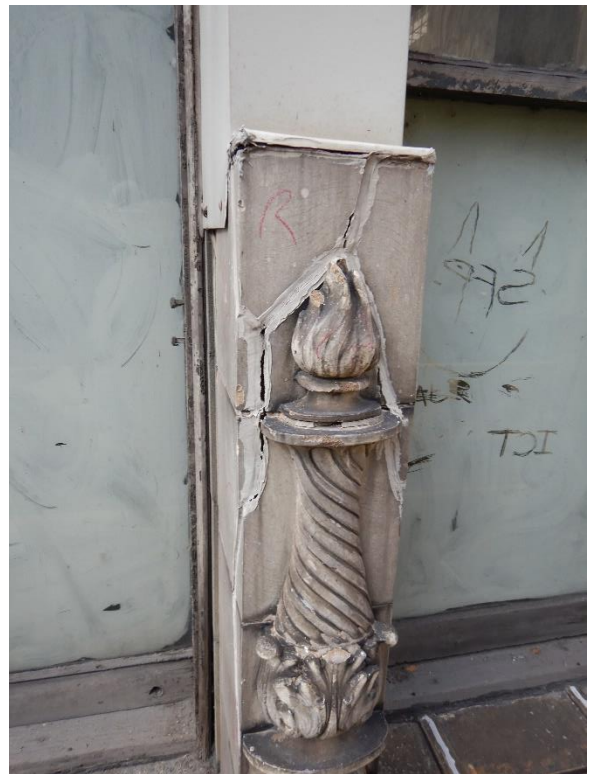
**Photo 22.** Mullion units at 3rd floor in extremely poor condition, marked for removal.

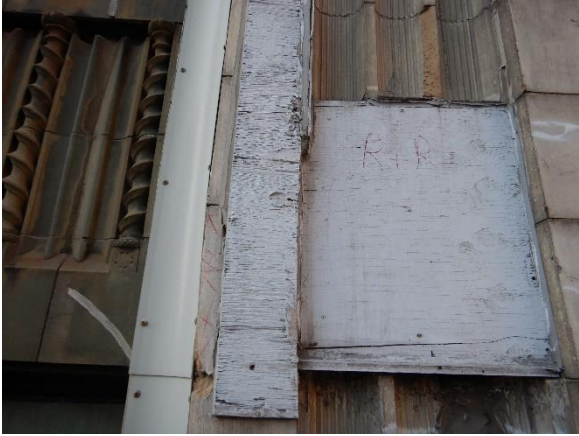
**Photo 23.** Typical weathered/deteriorated plywood coverings at previously removed terra cotta units.

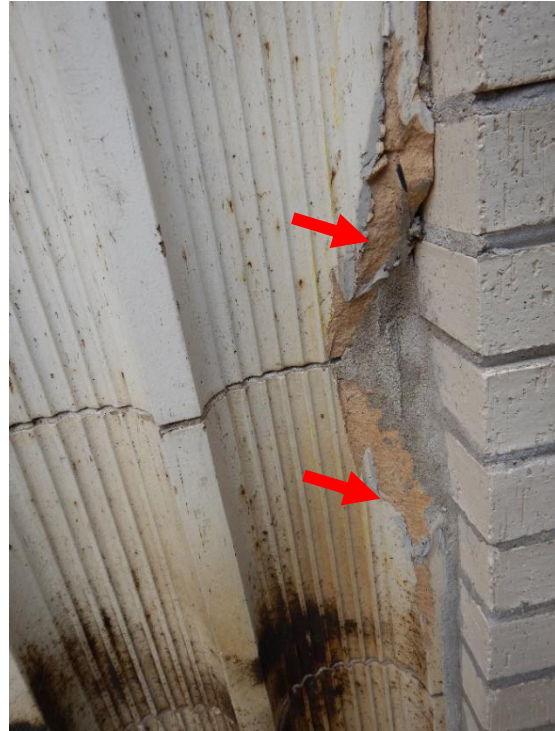
**Photo 24.** Spalled terra cotta units at column.

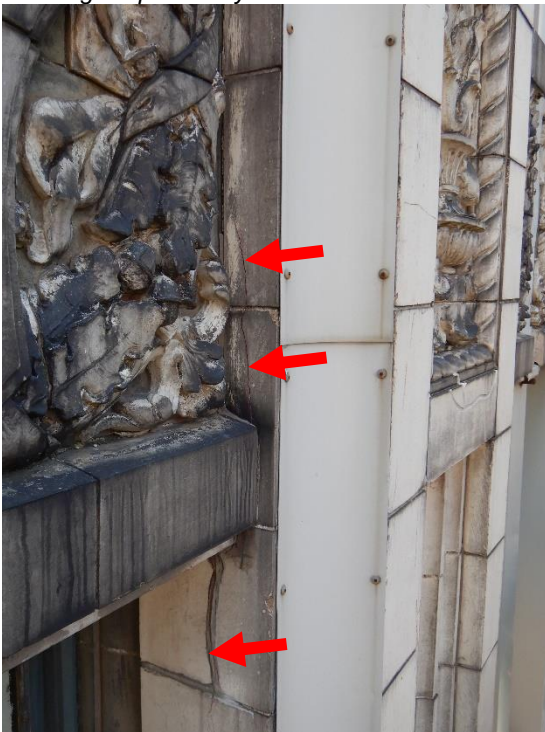
**Photo 25.** Cracked terra cotta units at jamb return.

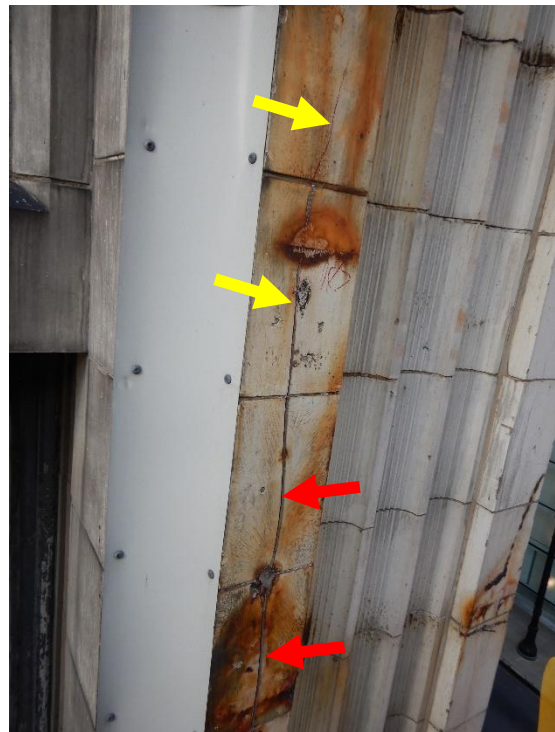
**Photo 26.** Previous crack repair in poor condition (red arrow) with new crack (yellow arrow).

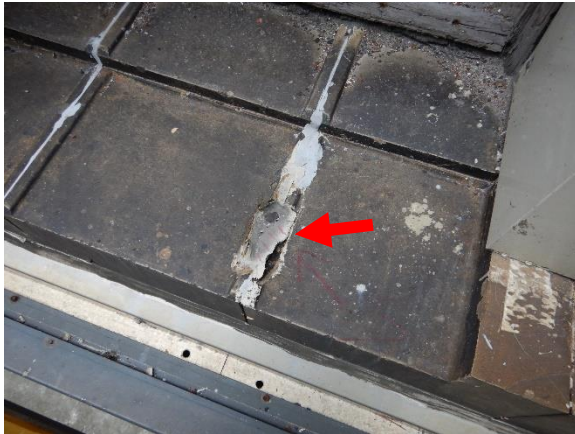
**Photo 27.** Failed sealant at skyward facing joint.

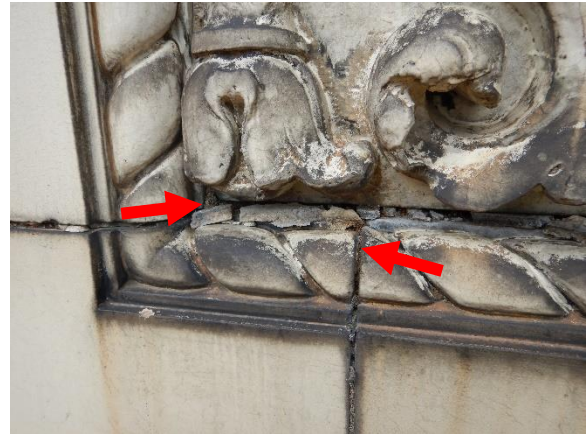
**Photo 28.** Cracked and deteriorated mortar joint with organic growth (red arrow).

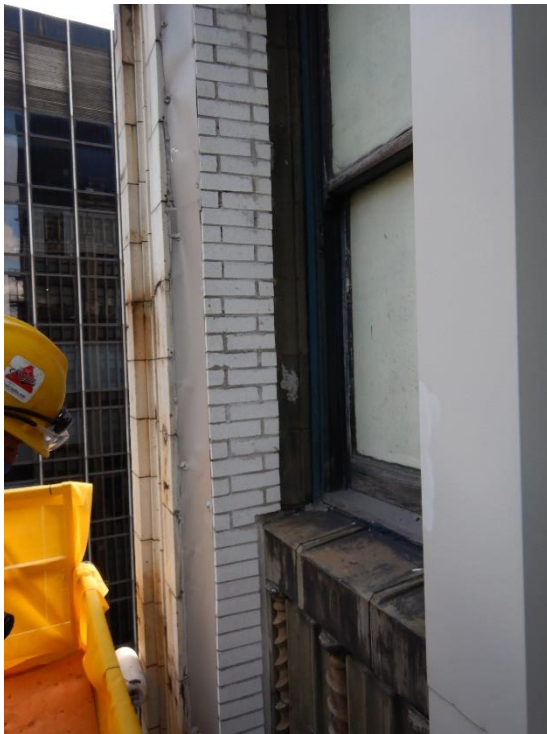
**Photo 29.** Replacement of terra cotta units with brick masonry.

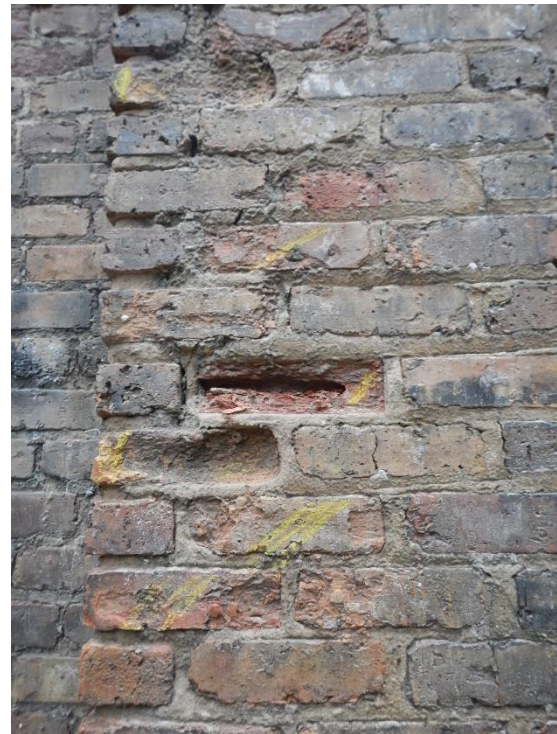
**Photo 30.** Typical deteriorated condition of brick masonry throughout west elevation.

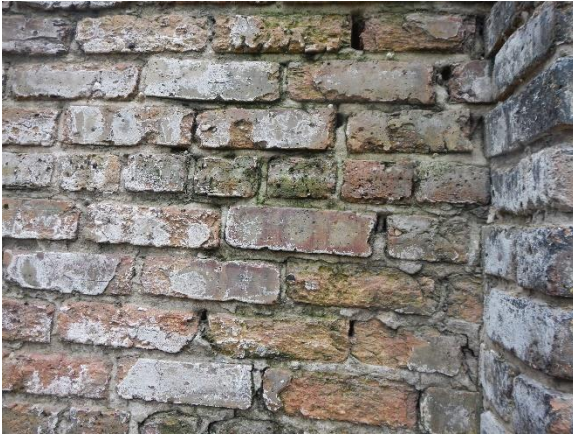
**Photo 31.** Typical brick deterioration at the west elevation included: cracked brick, spalled brick, organic growth, and efflorescence staining.

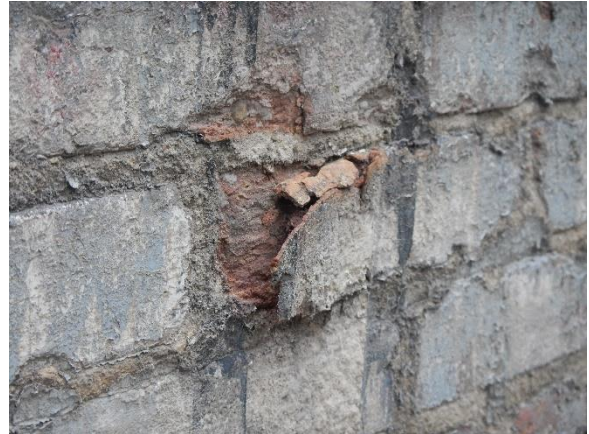
**Photo 32.** Surface spall observed, indicating excessive moisture within masonry wall.

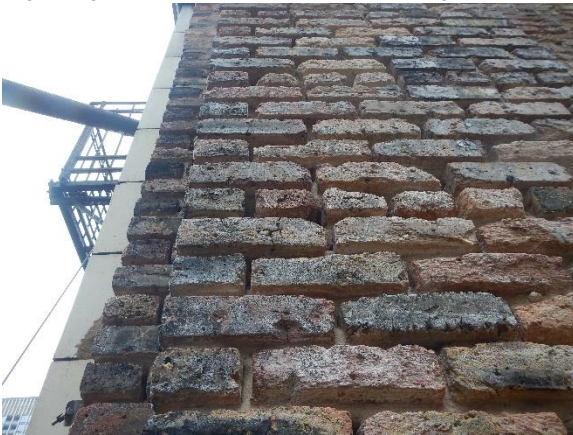
**Photo 33.** Severely eroded mortar joints observed at the west elevation.

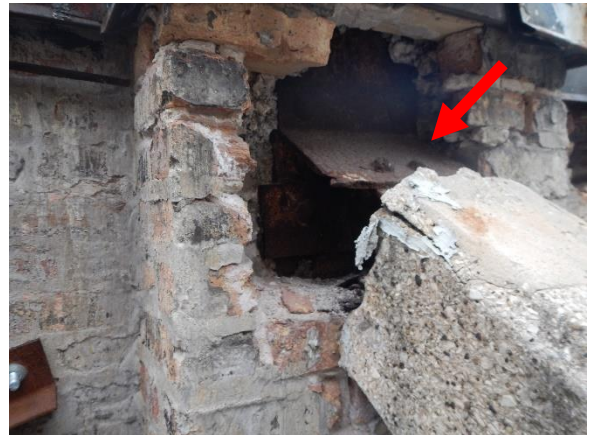
**Photo 34.** Exposed steel column at north elevation parapet. Exposure has led to extensive section loss due to corrosion.

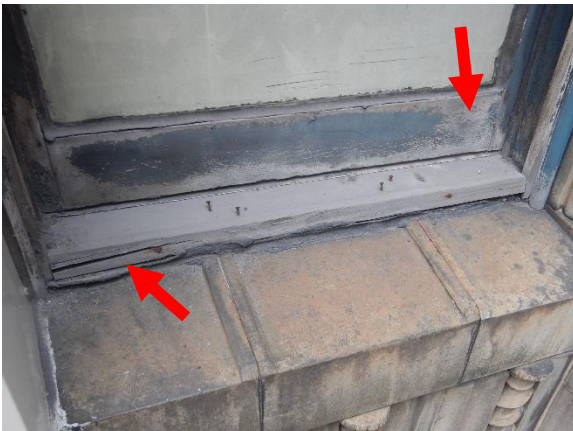
**Photo 35.** Deteriorated wooden window frame elements.

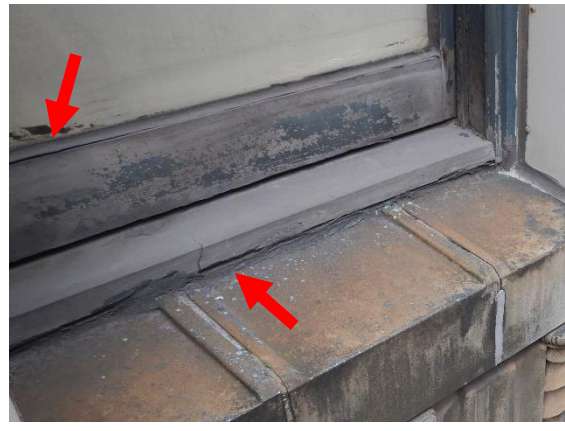
**Photo 36.** Failed sealant around window frame elements.

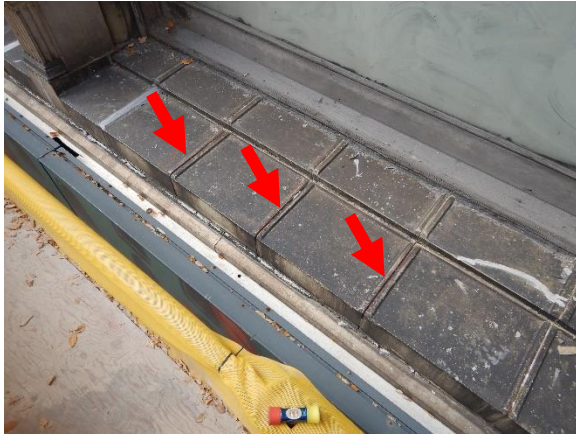
**Photo 37.** Deteriorated mortar joints at 3rd floor window sill.

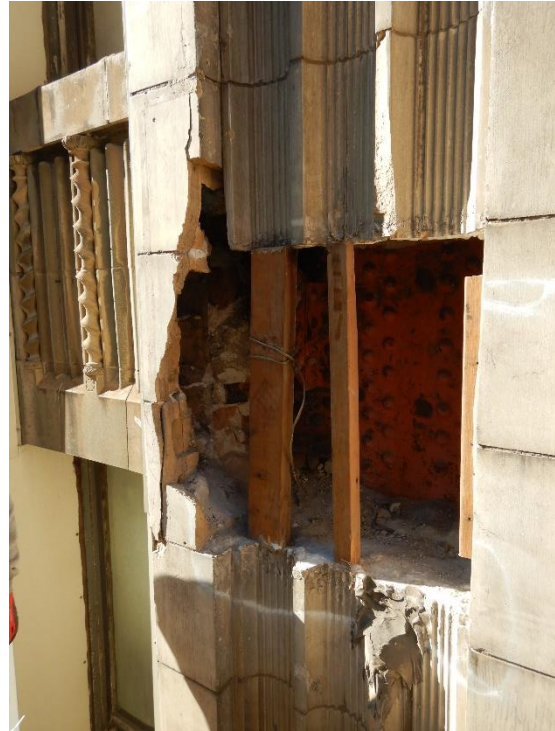
**Photo 38.** Exploratory opening at 7th floor column, east elevation.

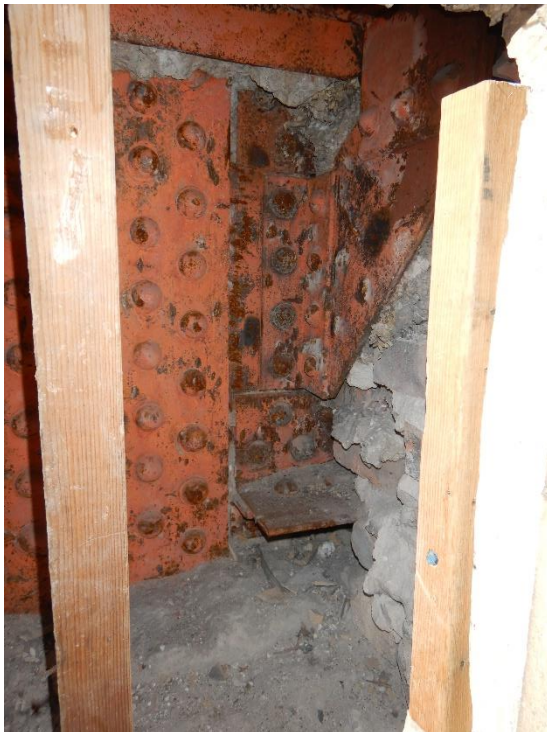
**Photo 39.** Steel column and connection in good to fair condition with minor surface corrosion.

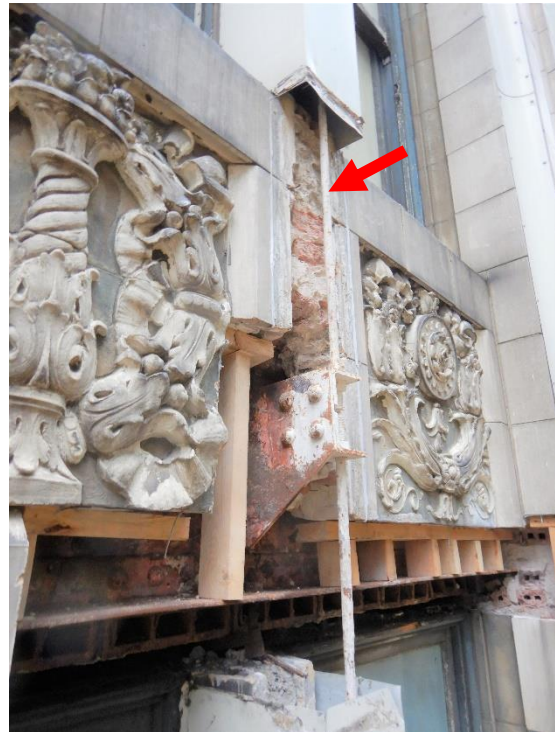
**Photo 40.** Exploratory opening at 4th floor mullion, north elevation (hanger rod noted in red).

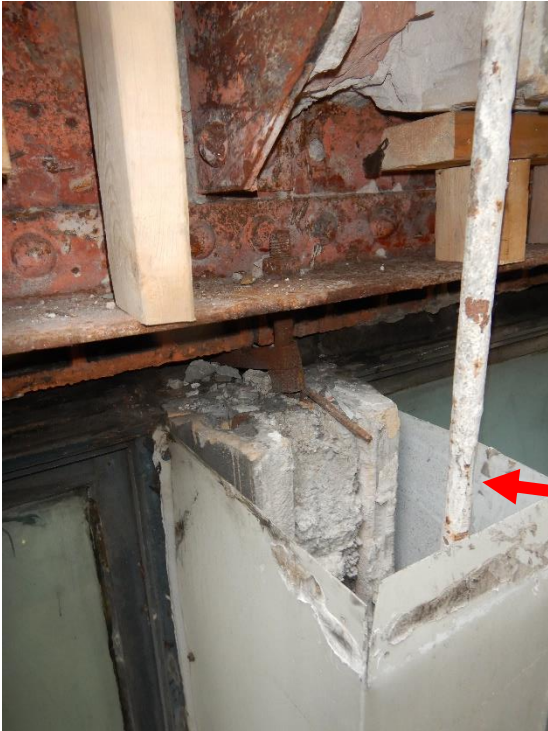
**Photo 41.** Section loss due to corrosion noted on steel hanger rod (red arrow).

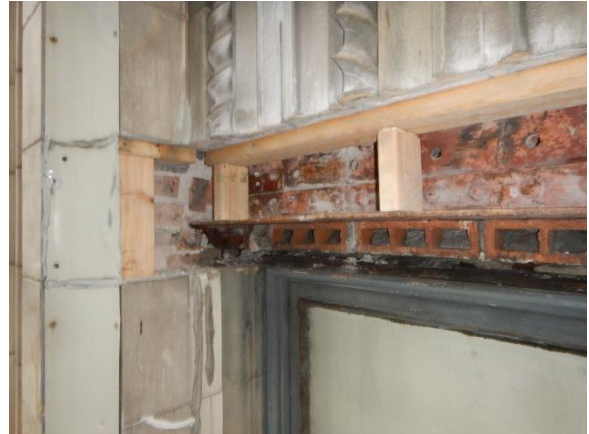
**Photo 42.** Exploratory opening #1 at 5th floor spandrel, north elevation. Moderate surface corrosion observed at bottom flange of steel built-up spandrel.

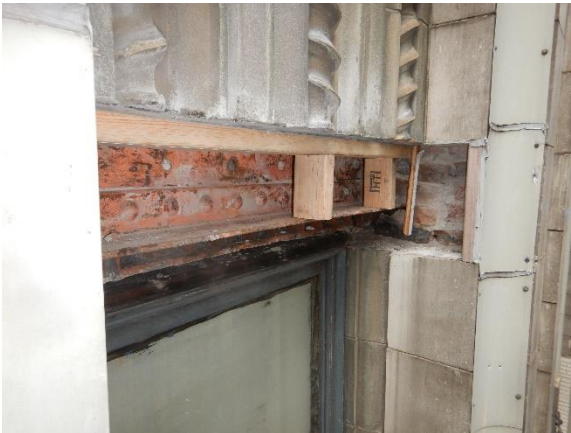
**Photo 43.** Exploratory opening #2 at 5th floor spandrel, north elevation. Moderate surface corrosion observed at bottom flange of steel built-up spandrel.

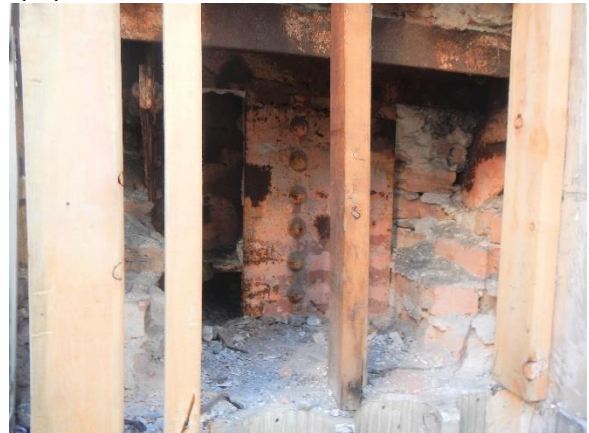
**Photo 44.** Exploratory opening at 8th floor column, north elevation. Minor surface corrosion and rust staining observed on steel.

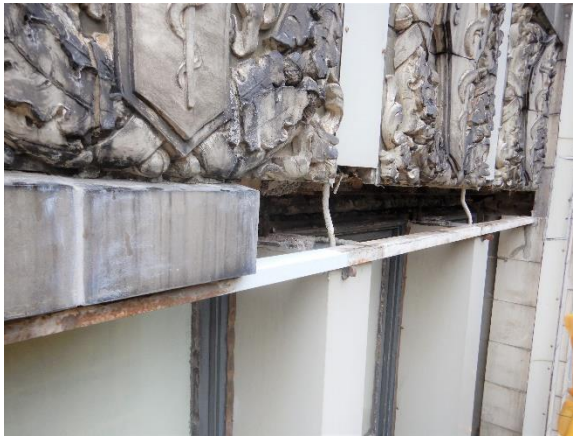
**Photo 45.** Exploratory opening at 13th floor window headers, north elevation.

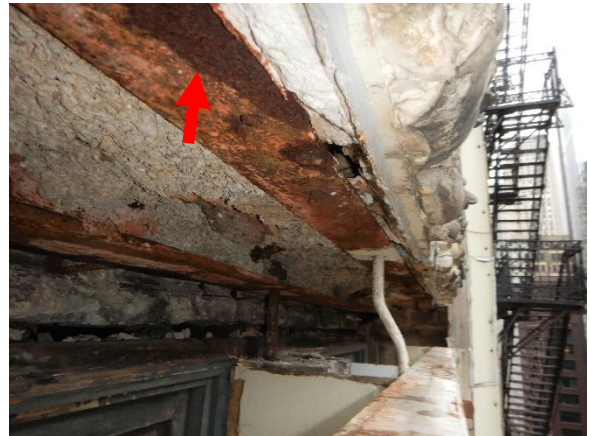
**Photo 46.** Corroded steel shelf angle with water staining (red arrow), evidence of water infiltration.

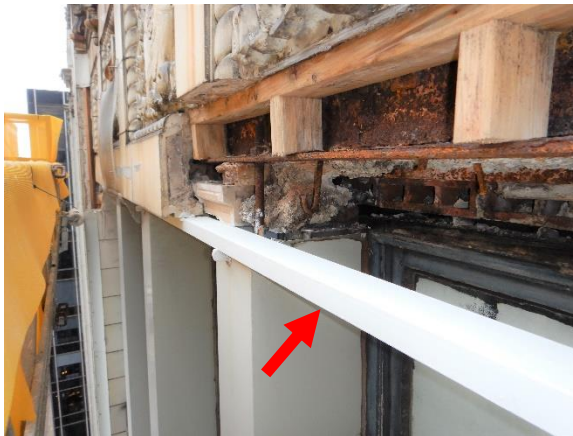
**Photo 47.** Exploratory opening #1 at attic floor window headers, north elevation (painted metal channel noted by red arrow).

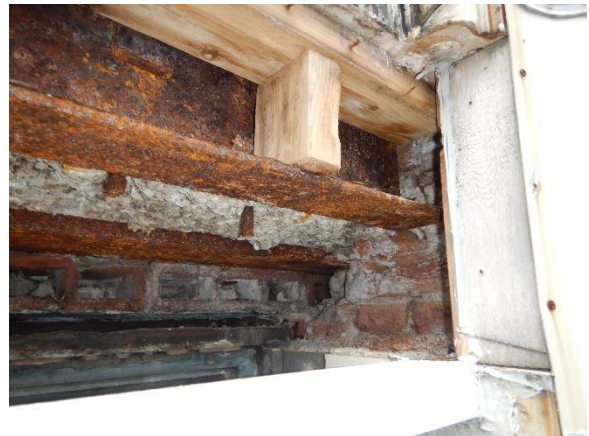
**Photo 48.** Extensive surface corrosion and rust jacking observed on existing steel elements.

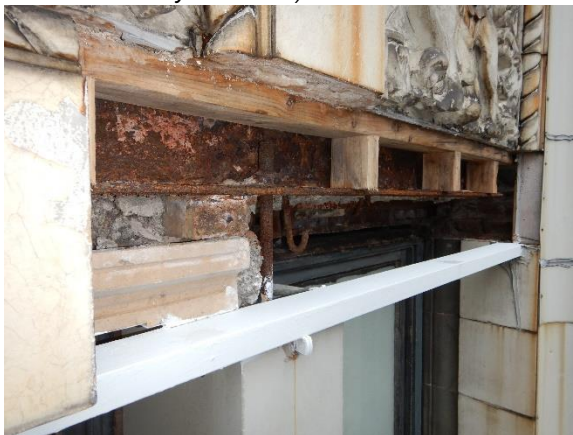
**Photo 49.** Exploratory opening #2 at attic floor window headers, north elevation.

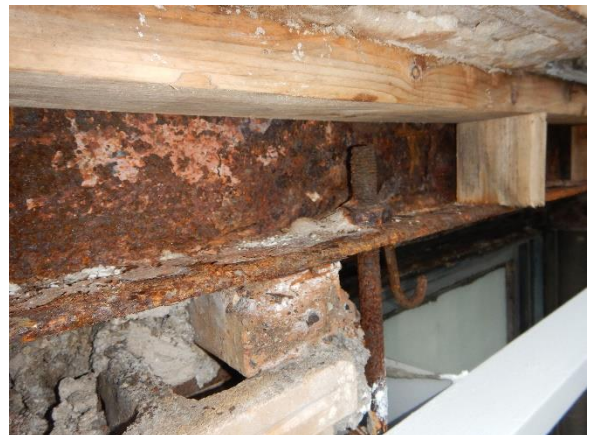
**Photo 50.** Extensive surface corrosion and rust jacking observed on existing steel elements.

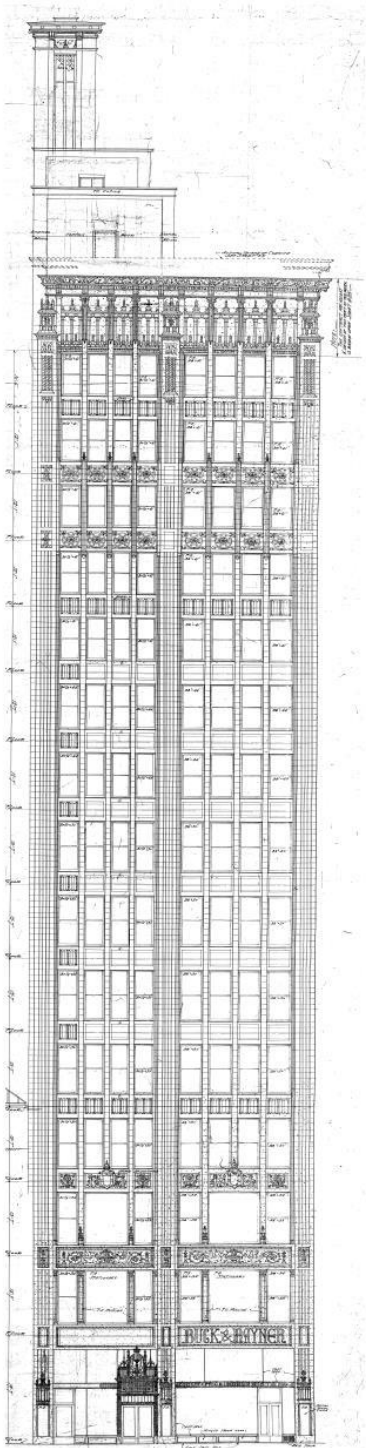
*Figure 1: East Elevation*
