**RE: Pre-Alteration Assessment for Lead-Based Paint Report  
Electrical Vaults in Bldgs. #103, 103F, 105, and 107  
OCCU-TEC Project Number: 918005**

**Lead-Based Paint Testing Report  
GFC Bldg. #103F**

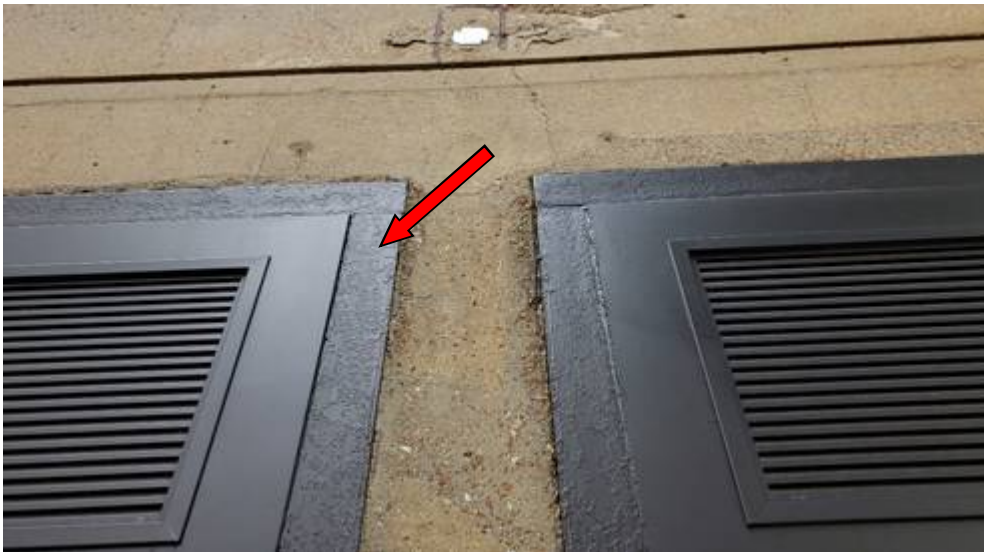
Photograph Number: 01

Description: GFC Bldg. 103D Elec. Vault - Door Frame with Lead-Based Paint

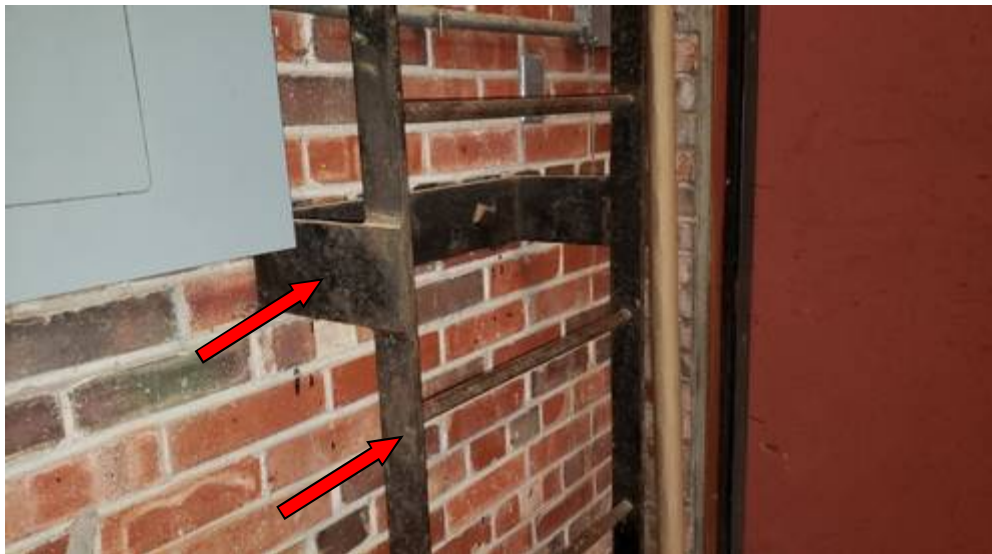
Photograph Number: 02

Description: GFC Bldg. 105 Elec. Vault #1 - Ladder and Ladder Bracket with Lead-Based Paint

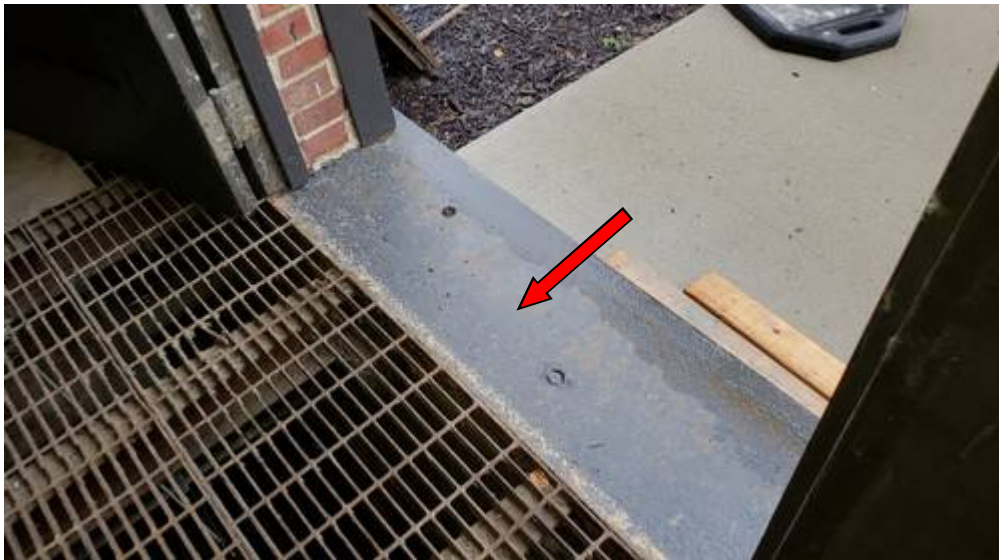
Photograph Number: 03

Description: GFC Bldg. 105 Elec. Vault #1 - Door Threshold with Lead-Based Paint

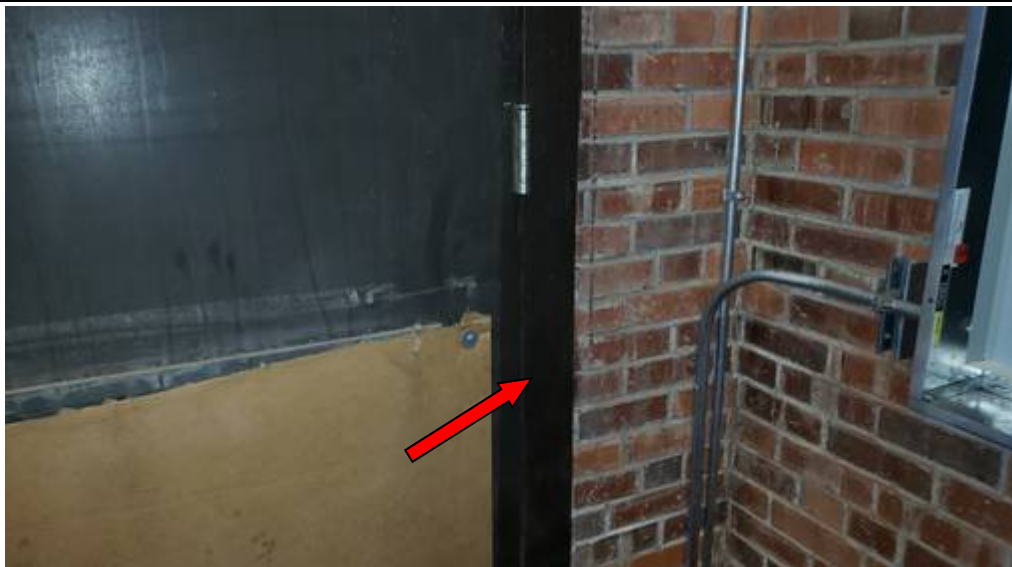
Photograph Number: 04

Description: GFC Bldg. 105 Elec. Vault #5 - Door Frame with Lead-Based Paint

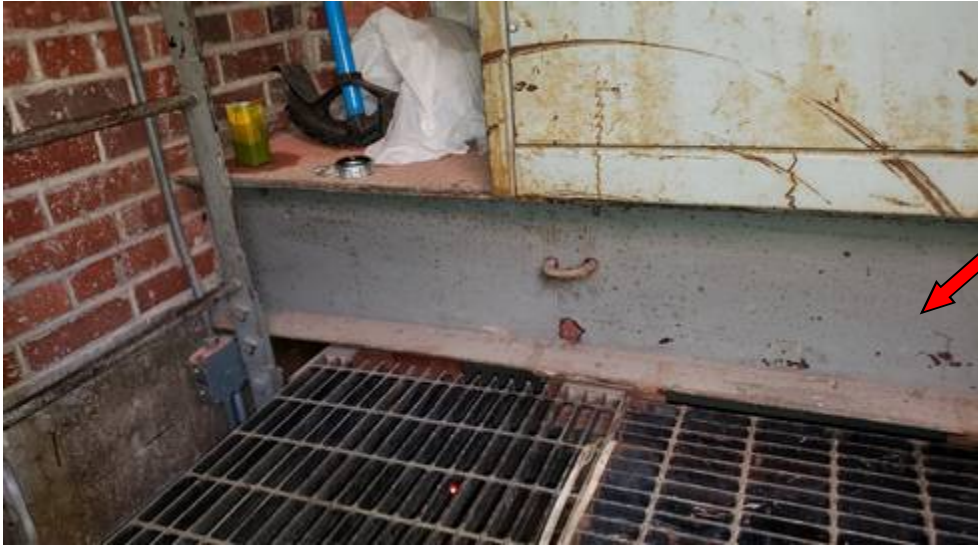
Photograph Number: 05

Description: GFC Bldg. 103 Elec. Vault #3 -I-Beam with Lead-Based Paint

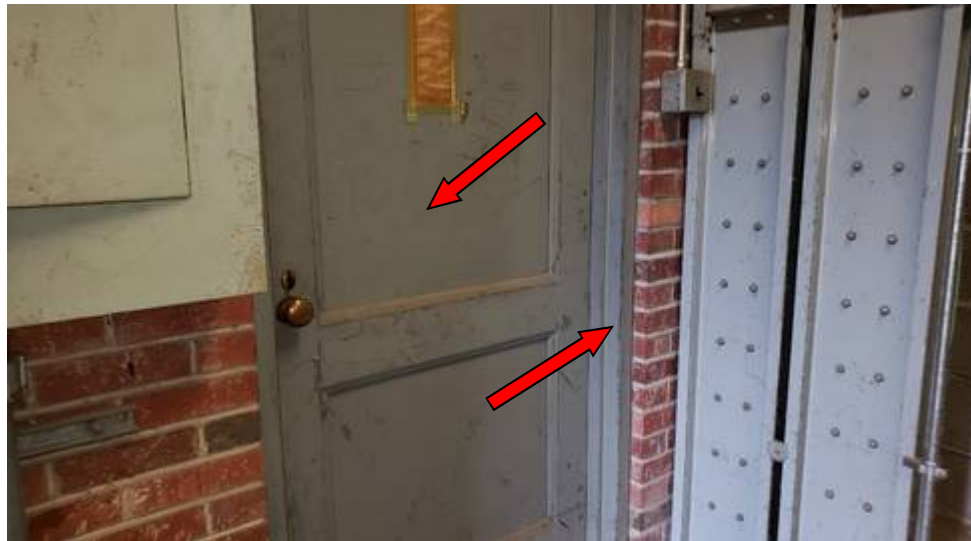
Photograph Number: 06

Description: GFC Bldg. 103 Elec. Vault #2 - Door and Door Frame with Lead-Based Paint

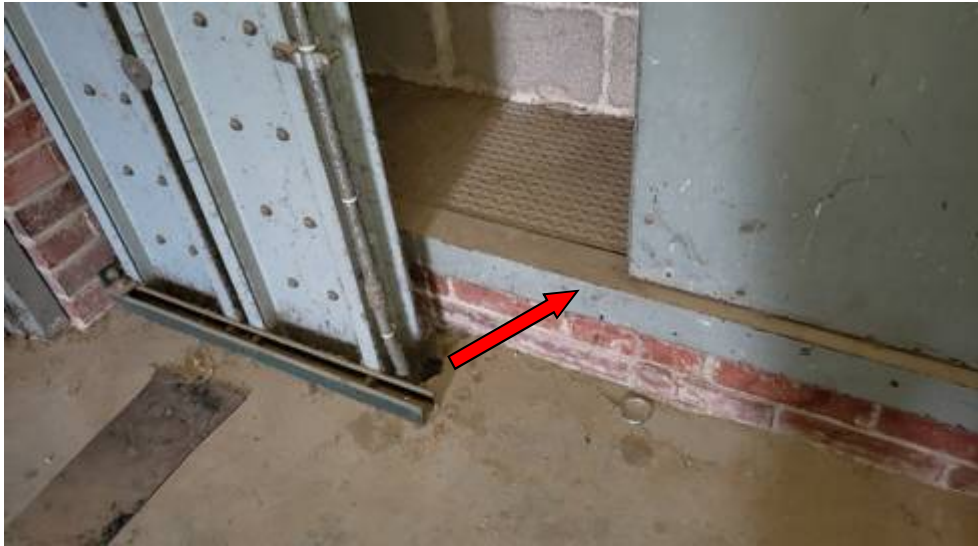
Photograph Number: 07

Description: GFC Bldg. 103 Elec. Vault #4 -Angle Iron with Lead-Based Paint

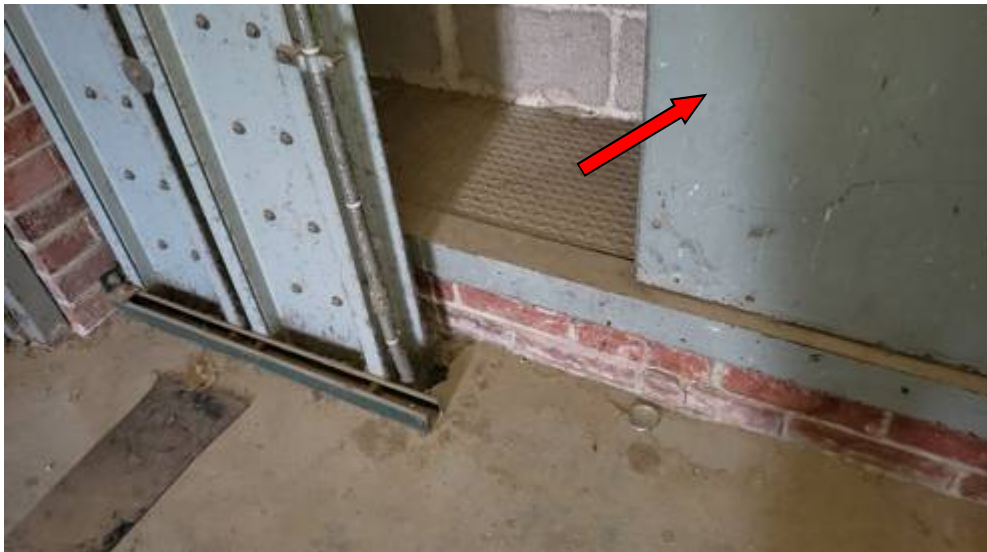
Photograph Number: 08

Description: GFC Bldg. 103 Elec. Vault #4 -Electrical Panel with Lead-Based Paint
