**APPENDIX C:
KIT CARSON MONUMENT CONDITION ASSESSMENT REPORT**

Christopher “Kit” Carson Monument, S. Federal Place, Santa Fe, NM.

Condition Assessment

Prepared by Crocker Ltd
11 November 2024

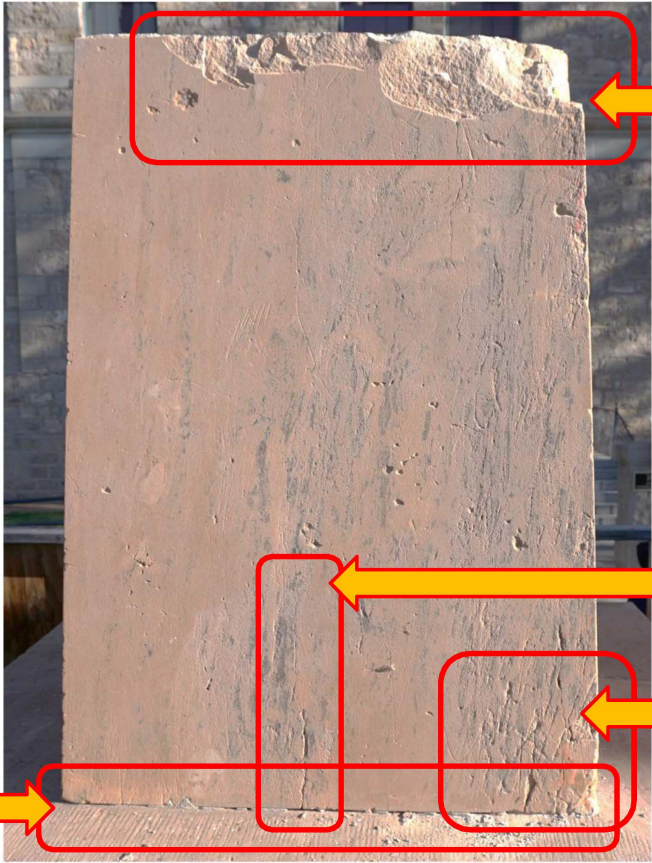
**Obelisk
Stone A4 south**

A4 shows signs of deterioration both from age and intended use, as well as deliberate destruction. Age-related issues tend to show themselves in linear cracking and mortar loss. The south face of A4 has a structural crack at the base near the midpoint along the bottom edge. The crack extends upward approximately five inches. There appears to be another similar crack near the same location on the north face, but it is impossible to determine if this is the same crack extending through the entirety of the stone. However, this corresponding crack on the north face extends the full height of the element.

Large fragmentation from rotational forces as A1, A2, & A3 were toppled.

Vertical cracking, potentially integral through the entirety of the material

Crushing at corner from rotation. Vandalism gouging with object harder than the stone.

Deteriorated mortar joint.

Given the considerable degradation of A4 it is our opinion that it cannot be used in restoration/reconstruction.

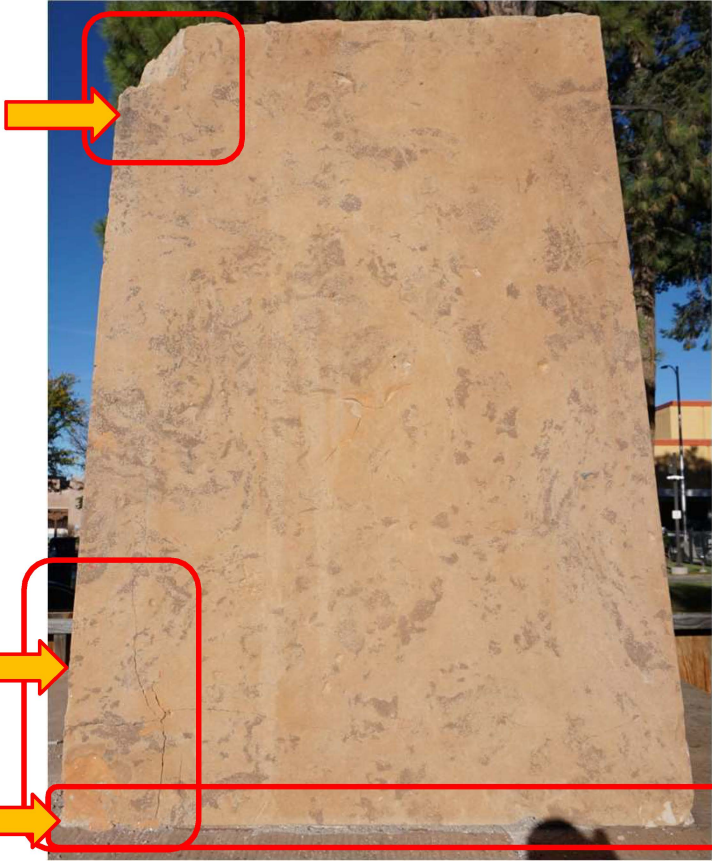
**Obelisk
Stone A4 - east**

There is structural cracking on the lower left (NE) corner of the north face. Several interlocking cracks, corresponding to cracks in the same area of the east elevation suggest that a portion of the A4 in the bottom NE corner may be in jeopardy of spalling off. Exacerbating this is the condition of the mortar bed. The original lime-based mortar was repointed in 2001. That repointing has flaked away under part of the cracked section.

Large fragmentation from rotational forces as A1, A2, & A3 were toppled.

Crushing at corner. Large structural cracking.

Deteriorated mortar joint.

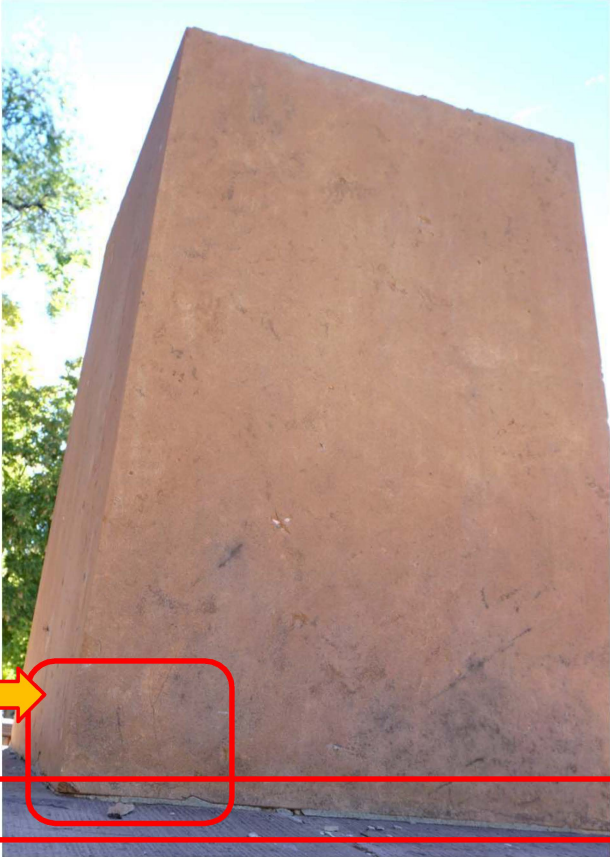
**Obelisk
Stone A4 - west**

The west face shows the least cracking, with a small crack in the NW corner, approximately four inches from the north edge, but is limited to approximately five inches in length.

Material cracking from tension stresses.

Deteriorated mortar joint.

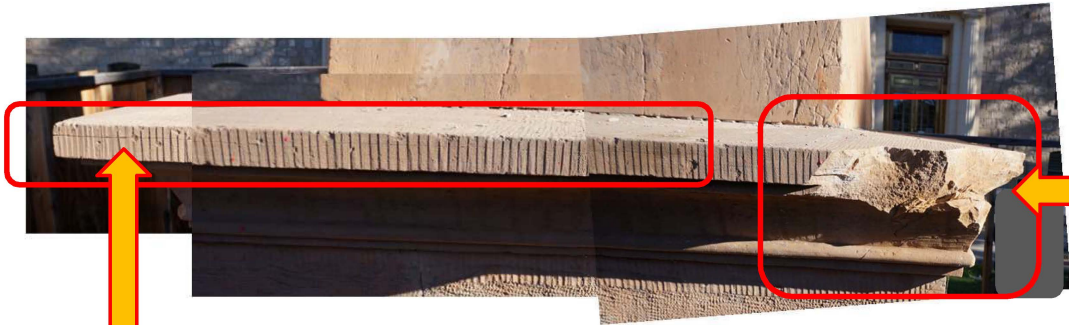
**Cornice
Stone B1S – south**

There is delamination along the bedding planes approximately midway through the top 1½-inches of the vertical face of B1S. This delamination appears to continue through all three exposed edges. There are signs of chipping across B1S. The worst damage is found at the SE corner where the combination of A1, A2, and A3 struck as it was rotated from A4. Diagonal cracking from the impact extends down through the remaining thickness of the stone. The remaining stone bounded by this cracking is subject to failure.

Stratification
separation

Material fragmentation
from falling A1, A2, A3
impacting this corner.

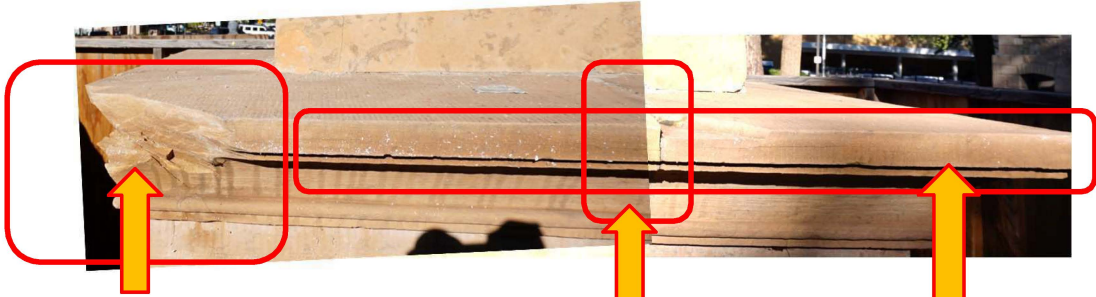
Cornice
Stone B1S/B1N - east

Material fragmentation
from falling A1, A2, A3
impacting this corner.

Mortar deterioration

Stratification separation

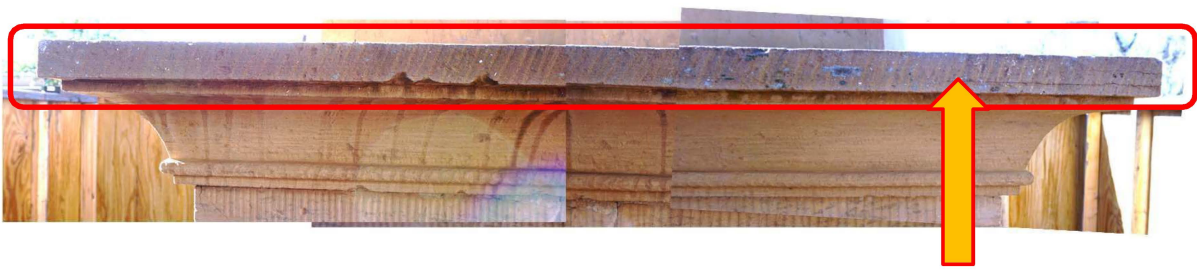
**Cornice
Stone B1N/B1S – west**

Stratification separation

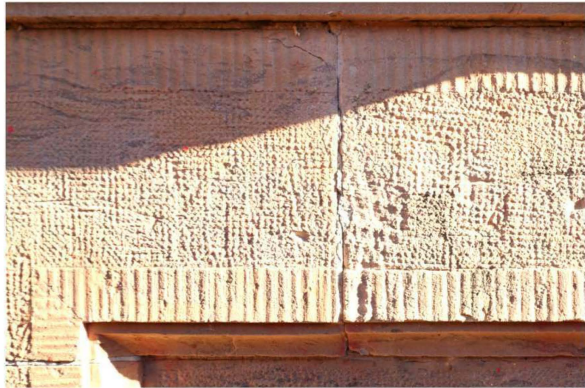
Center Course
Stone B2E – east

Material cracking, shows signs of
previous consolidation repairs.

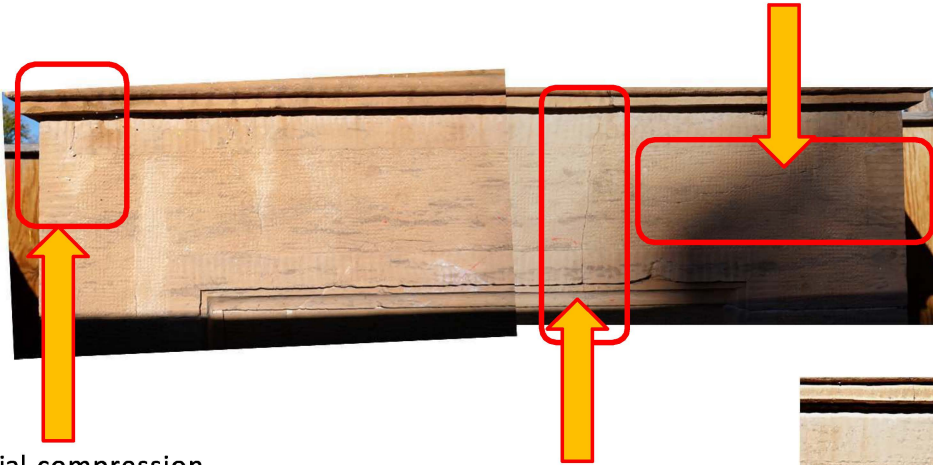
Material compression
cracking, consistent with
cornice above, caused by
A1, A2, A3 collision.

Material cracking, depth
unknown

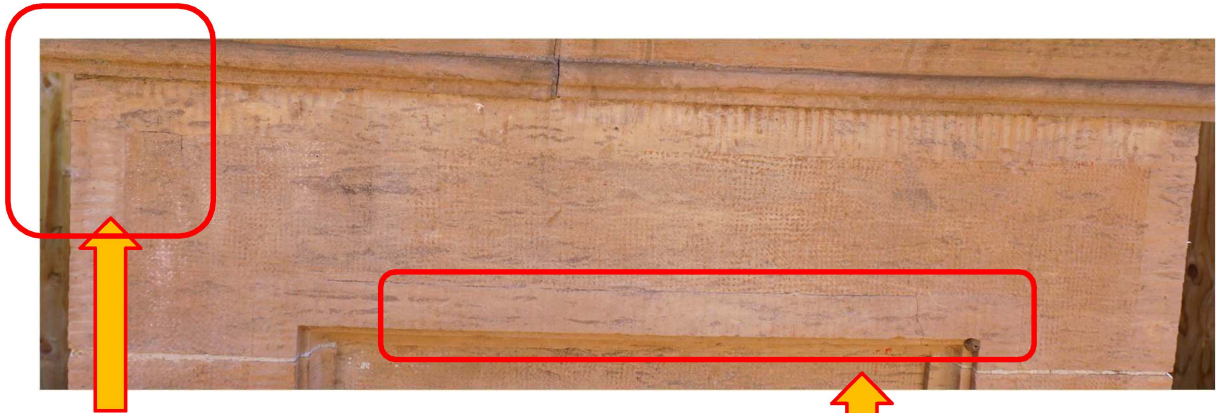
**Center Course
Stone B2W – west**

Material cracking, depth unknown, potentially continuation with cracks at adjacent face of stone.

Material cracking at textured transition, depth unknown.

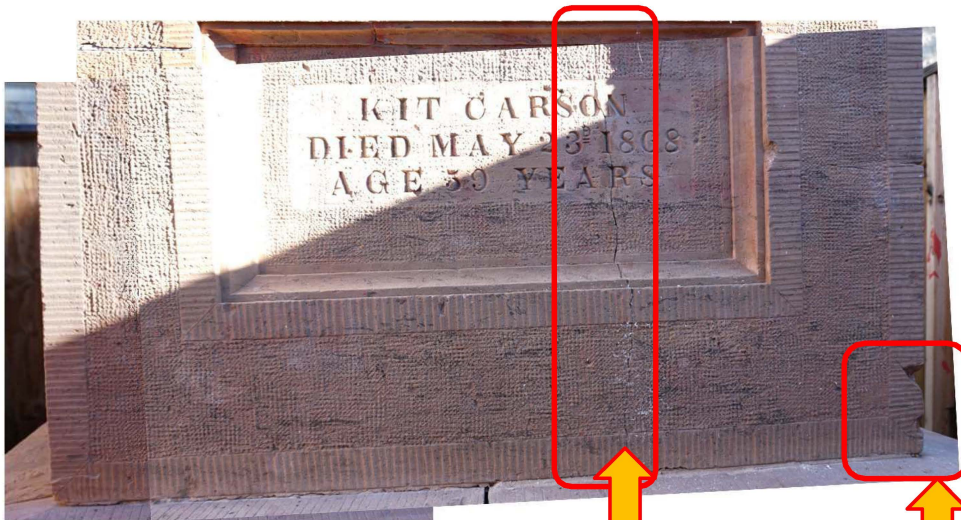
Inscription Stone
B3 – south

Material cracking, depth unknown.

Material cracking, depth unknown, may correspond with adjacent face which will eventually lead to fragmentation. Some natural chipping.

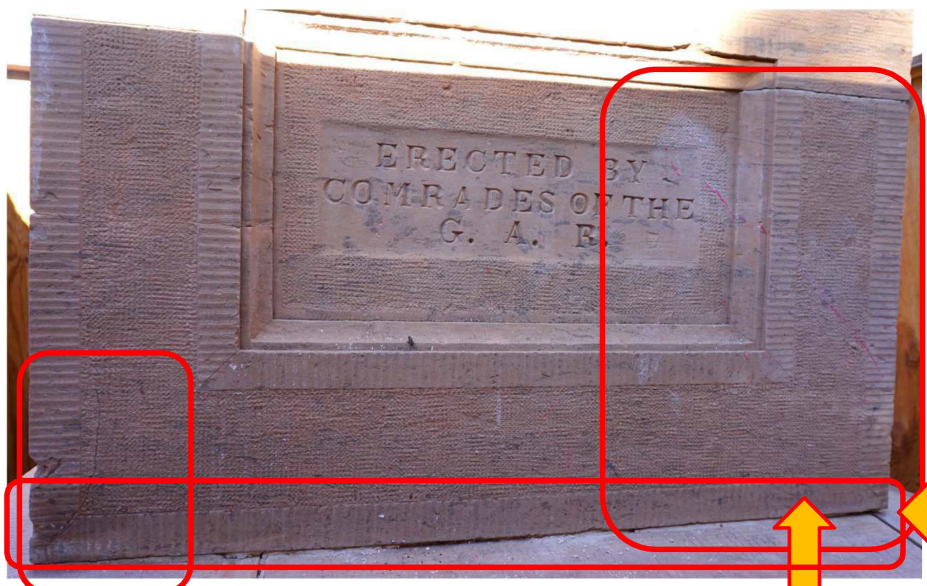
**Inscription Stone
B3 – east**

Mortar deterioration.

Evidence of vandalistic graffiti removal.

Material cracking, depth unknown.

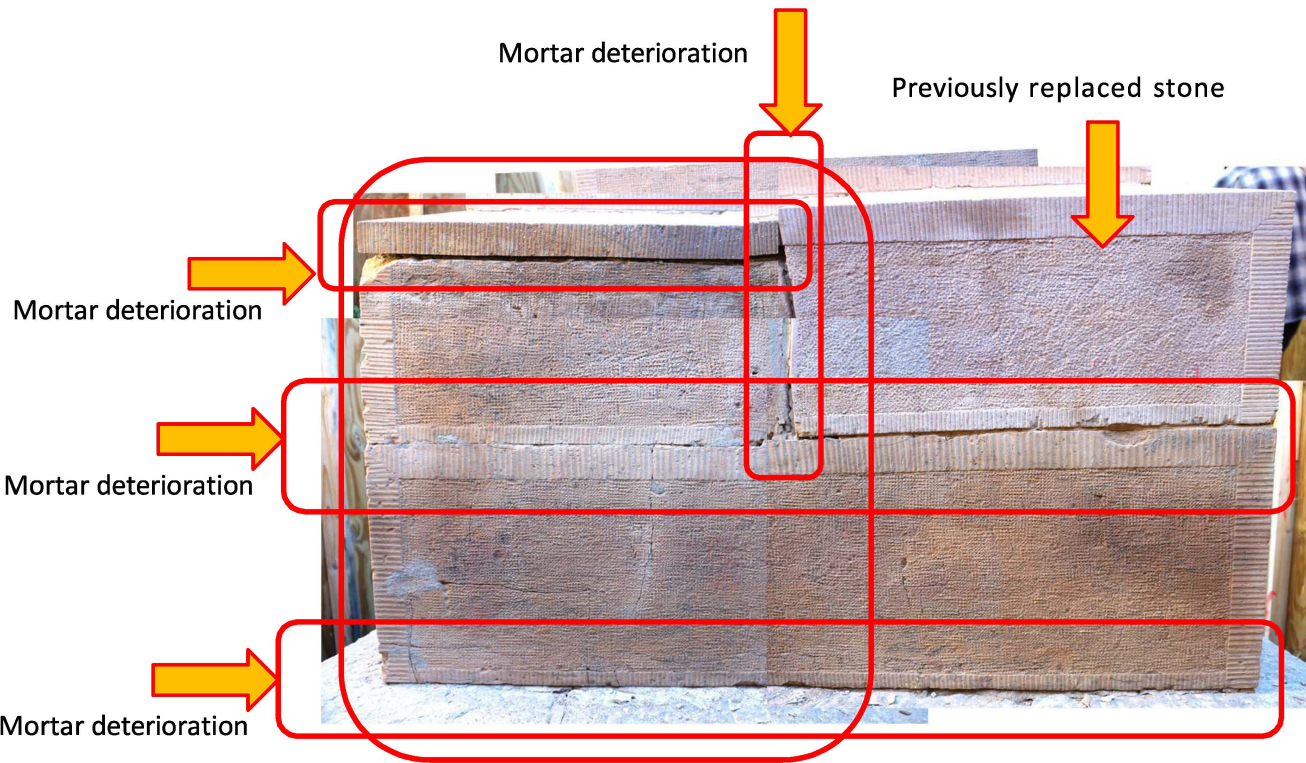
**Pedestal
Section C – south**

This region has severe cracking and chipping in both stones. There have been previous repairs attempted.

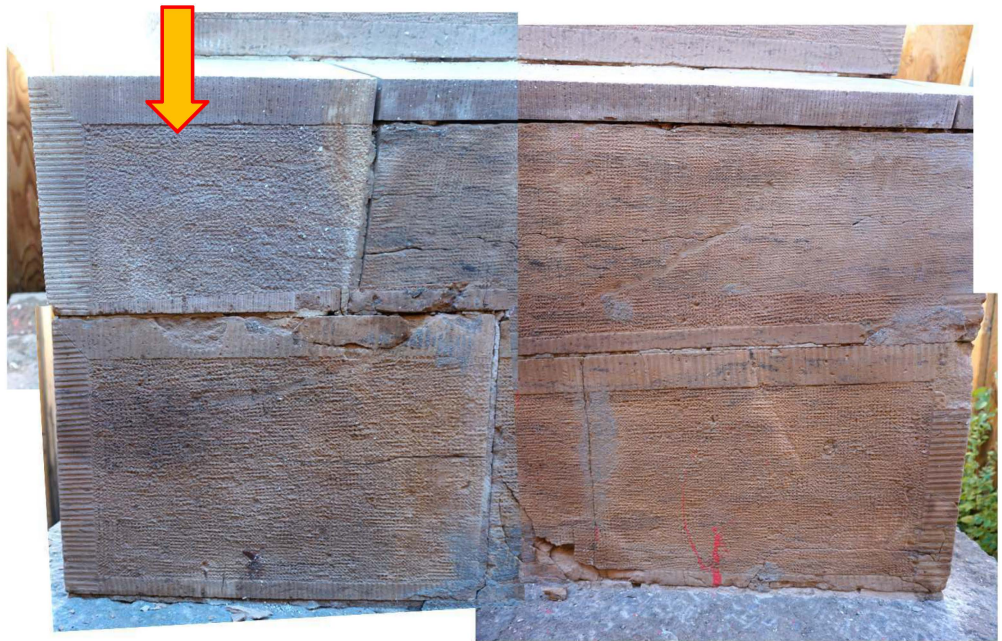
**Pedestal
Section C – east**

Previously replaced stone

Aside from the replaced portion of C1, the extents of C is in poor condition. Mortar joints are failing or are fully removed. Previous attempts at repairs have since fully removed. New spalling, cracking, and fragmentation is rampant.

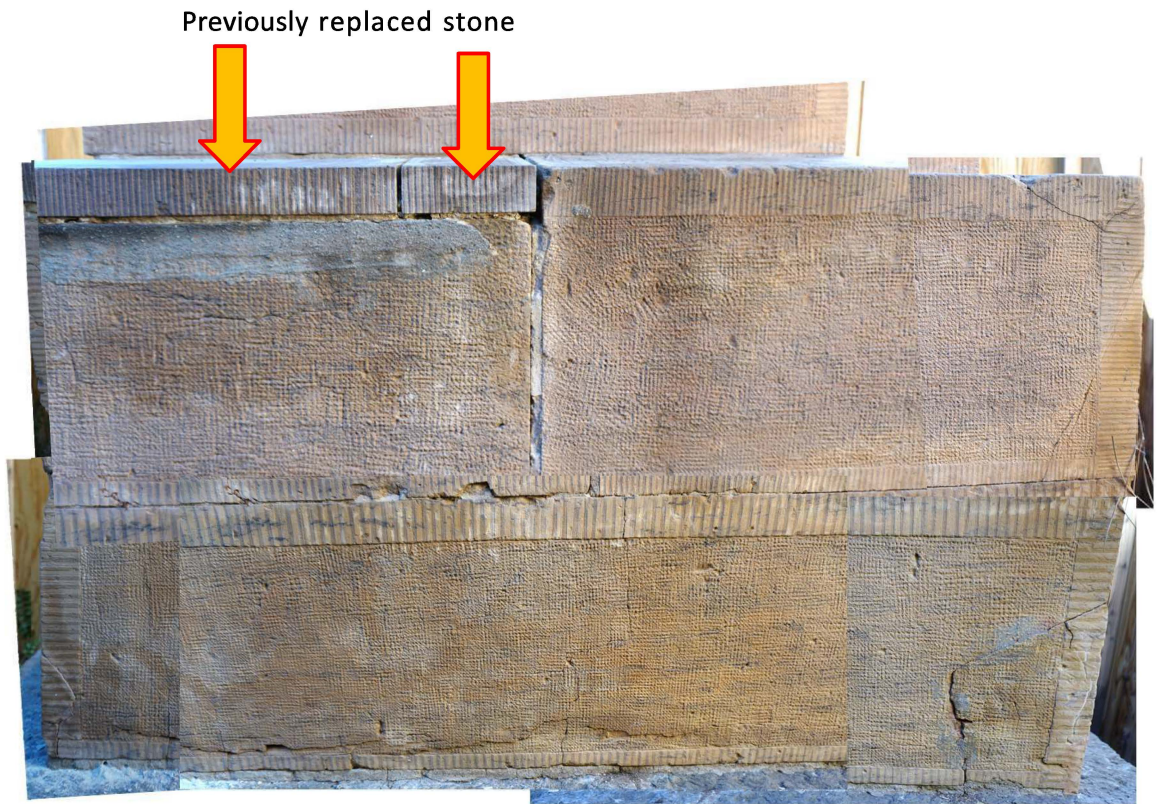
**Pedestal
Section C – north**

Aside from the replaced portion of C1, the extents of C is in poor condition. Mortar joints are failing or are fully removed. Previous attempts at repairs have either failed or have since fully removed. New spalling, cracking, and fragmentation is rampant.

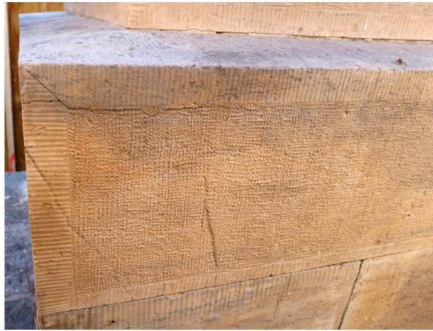
**Pedestal
Section C – west**

Aside from the replaced portion of C1, the extents of C is in poor condition. Mortar joints are failing or are fully removed. Previous attempts at repairs have either failed or have since fully removed. New spalling, cracking, and fragmentation is rampant.
