Potomac Annex: Buildings 1 & 3-7

Historic Structures Report, Corrected Final Submission
General Services Administration Project Control Number: 44007

September 9, 1997

BUILDING 1: EXTERIOR EXISTING CONDITIONS

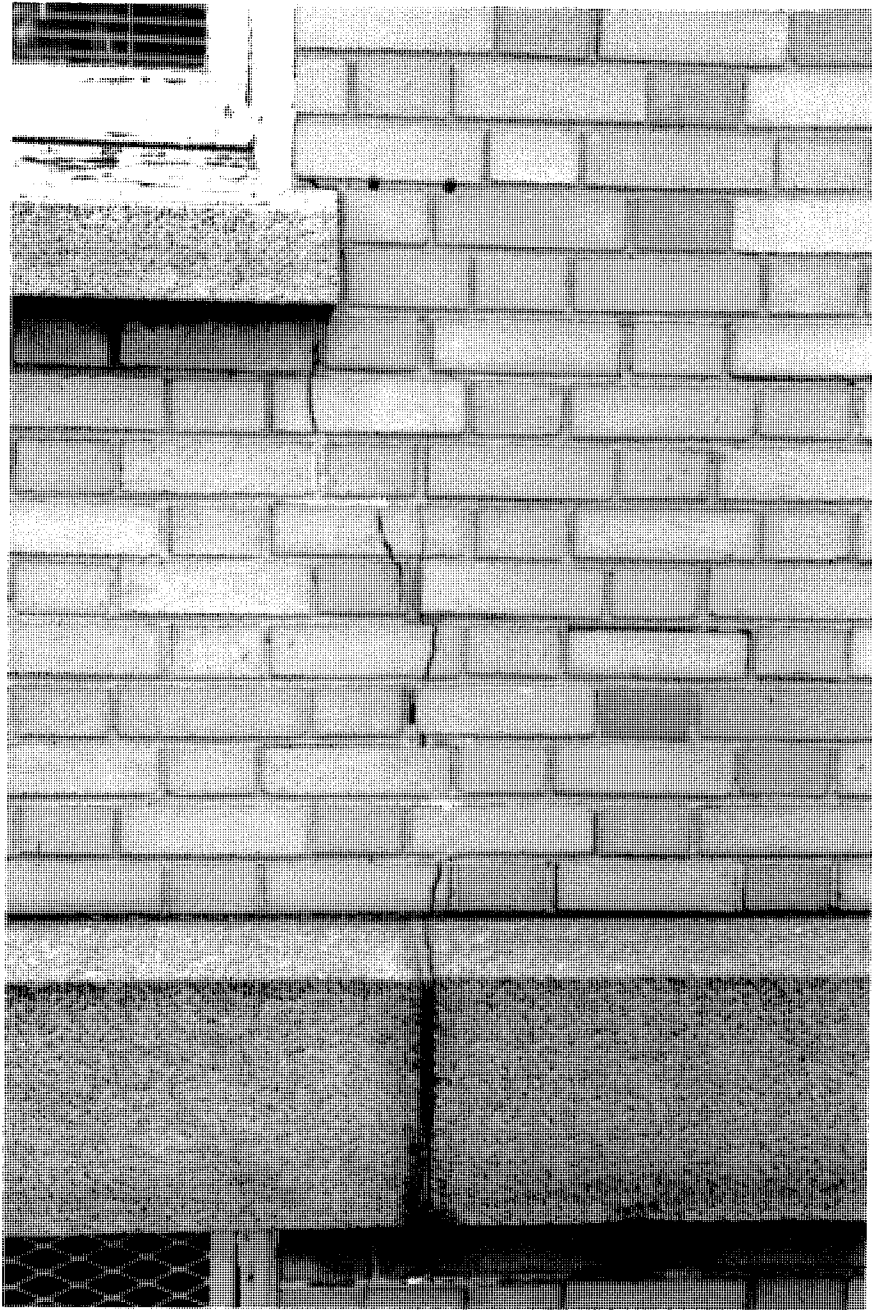
Figure 1-1

Location: North Elevation of Building 1 at West End

Suggested Remedy: Remove brickwork and assess for rusting iron anchors. If anchors are rusted they should be replaced with stainless steel anchors; brick should then be replaced to match existing texture, color and size and reset in mortar to match surrounding pointing in color, texture, and profile.

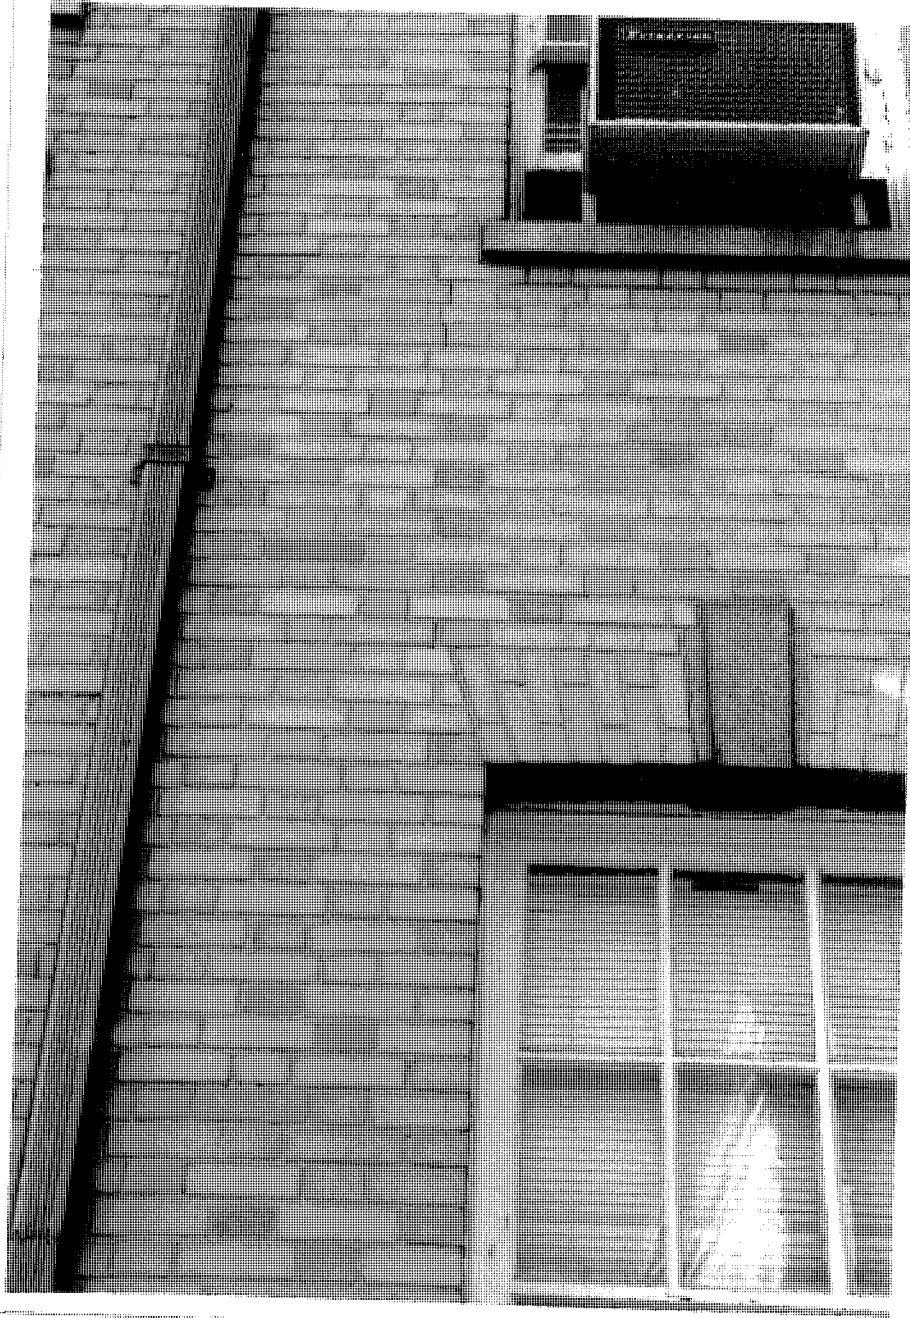
Figure 1-2

Location: East Elevation of Building 1 at North End

Suggested Remedy: Remove brickwork and assess for rusting iron anchors. If anchors are rusted they should be replaced with stainless steel anchors; brick should then be replaced to match existing texture, color and size and reset in mortar to match surrounding pointing in color, texture, and profile.

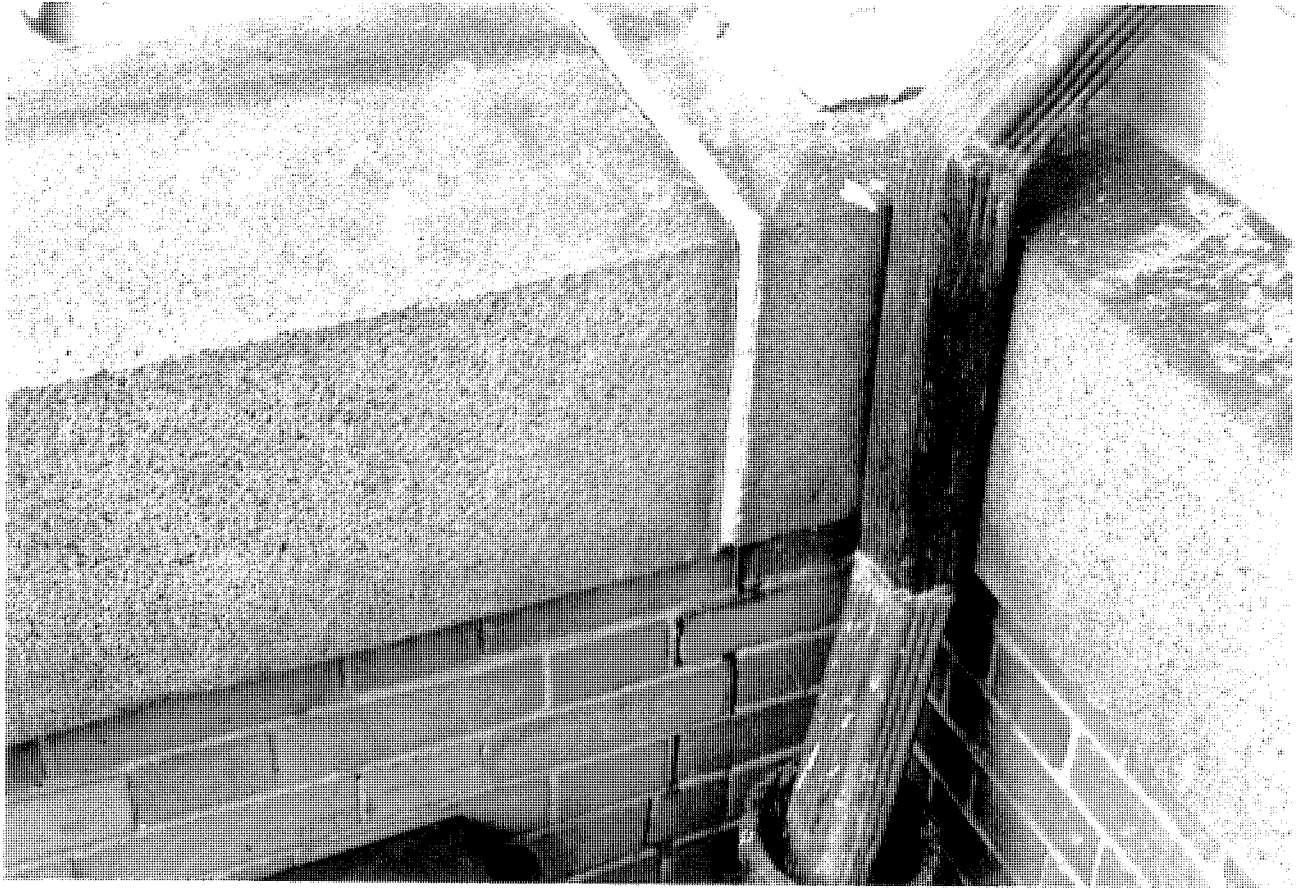
Figure 1-3

Stress cracks and open joints are found on Building 1 in association with the vertical or head joints of the granite water table. The stresses associated with the open joints transfer up and through the brick above, following the mortar joint pattern. Frequently they continue up to the first floor granite window sills (Figure 1-1). In some cases these cracks extend up the wall to the second floor windows (Figure 1-2). These conditions are pervasive on all elevations of Building 1. Stress cracks and open joints are also associated with the two areaways on the front of Building 1 (Figures 1-3, 1-4, 1-5).

Location: East Elevation of Building 1 in South Areaway

Suggested Remedy: Existing mortar should be raked from the joints to a minimum depth of 3/4 inches. Repoint joints with fresh mortar that matches existing pointing mortar in color, texture and profile.

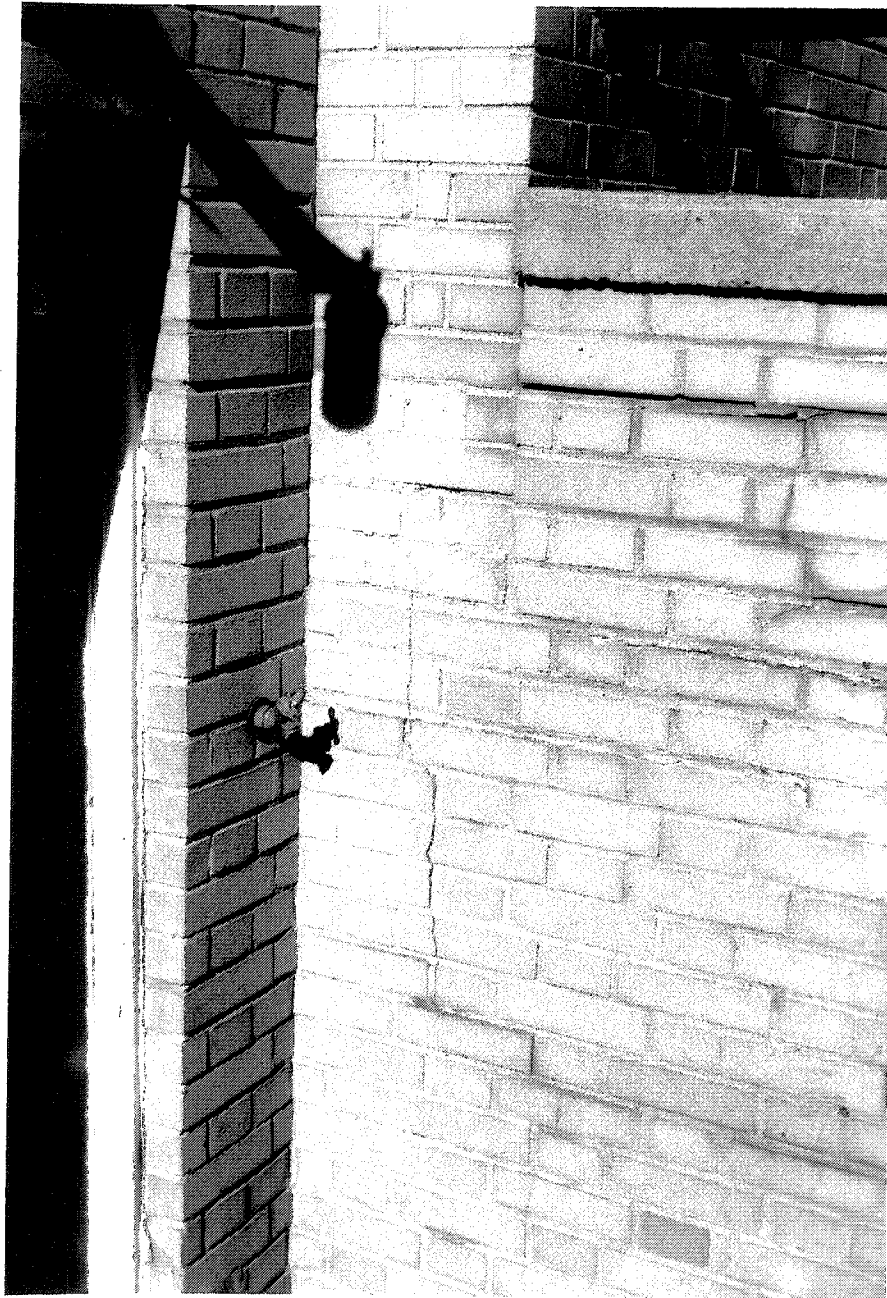
Figure 1-4

Location: East Elevation of Building 1 in Central Areaway

Suggested Remedy: Existing mortar should be raked from the joints to a minimum depth of $3/4$ inches. Repoint joints with fresh mortar that matches existing pointing mortar in color, texture and profile. Crack brick should be removed and then replaced to match existing texture, color and size and reset in mortar to match surrounding pointing in color, texture, and profile.

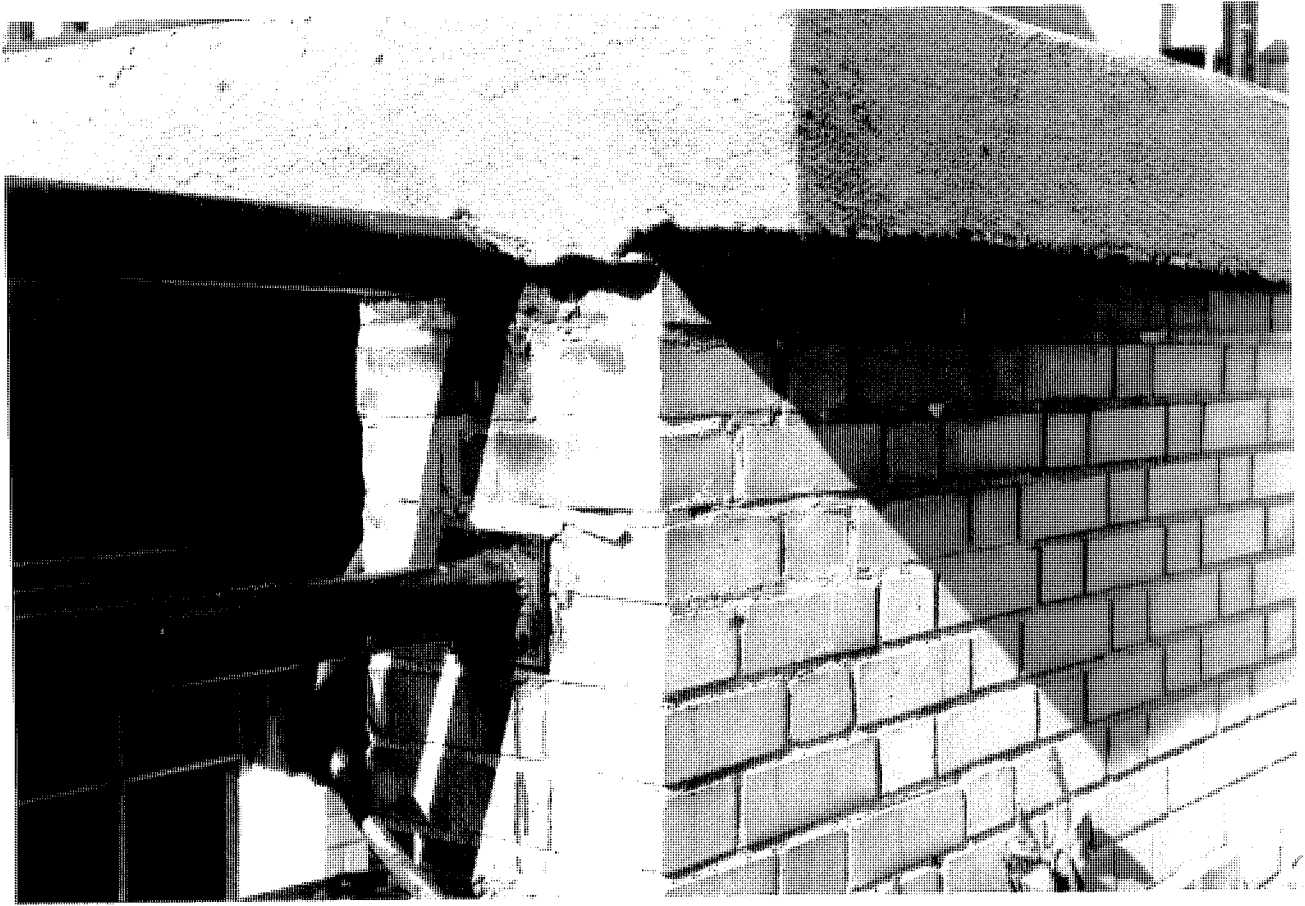
Figure 1-5

Iron railings are found in the areaways and on the two main entrances to Building 1. These railings are generally in good condition, requiring periodic scraping and painting. Water entry at their bases has rusted some of the railings causing damage to the concrete (Figures 1-5 and 1-14).

Location: East Elevation of Building 1 in South Areaway

Suggested Remedy: Existing mortar should be raked from the joints to a minimum depth of 3/4 inches. Repoint joints with fresh mortar that matches existing pointing mortar in color, texture and profile.

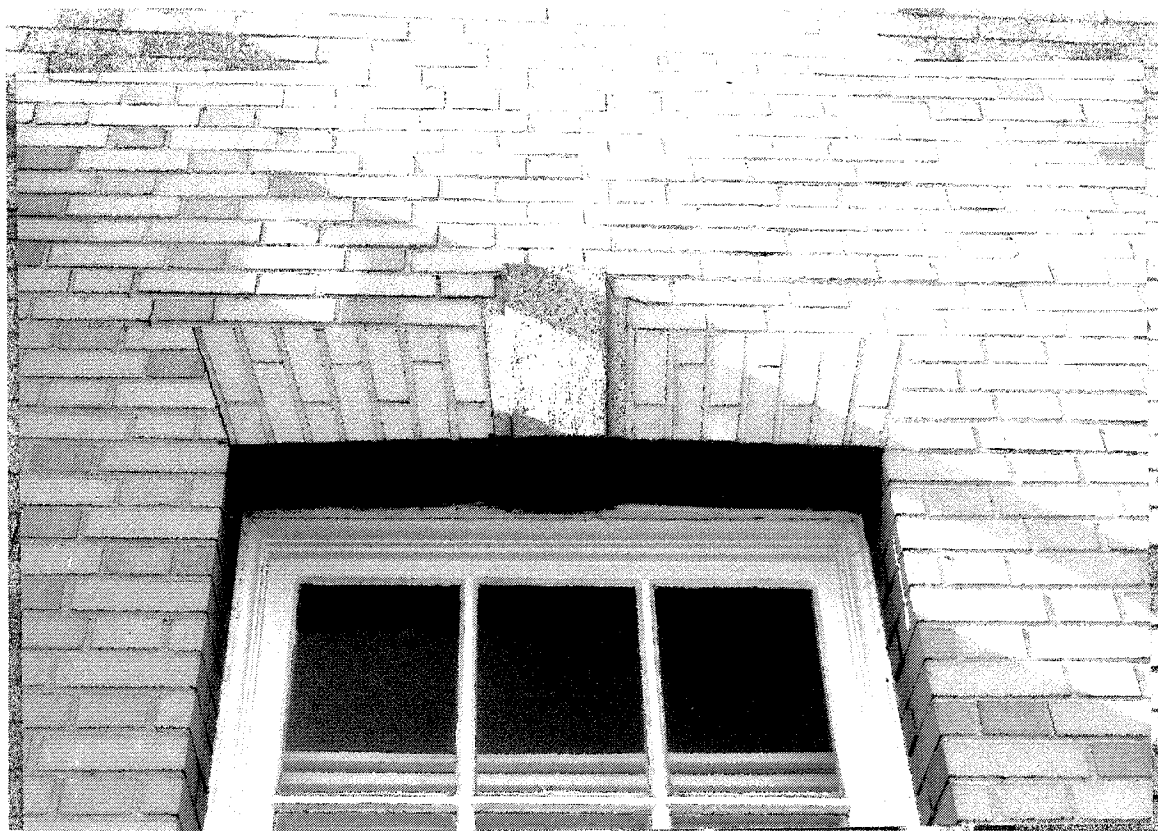
Figure 1-6

Location: East Elevation of Building 1 at North End

Suggested Remedy: Existing mortar should be raked from the joints to a minimum depth of 3/4 inches. Repoint joints with fresh mortar that matches existing pointing mortar in color, texture and profile.

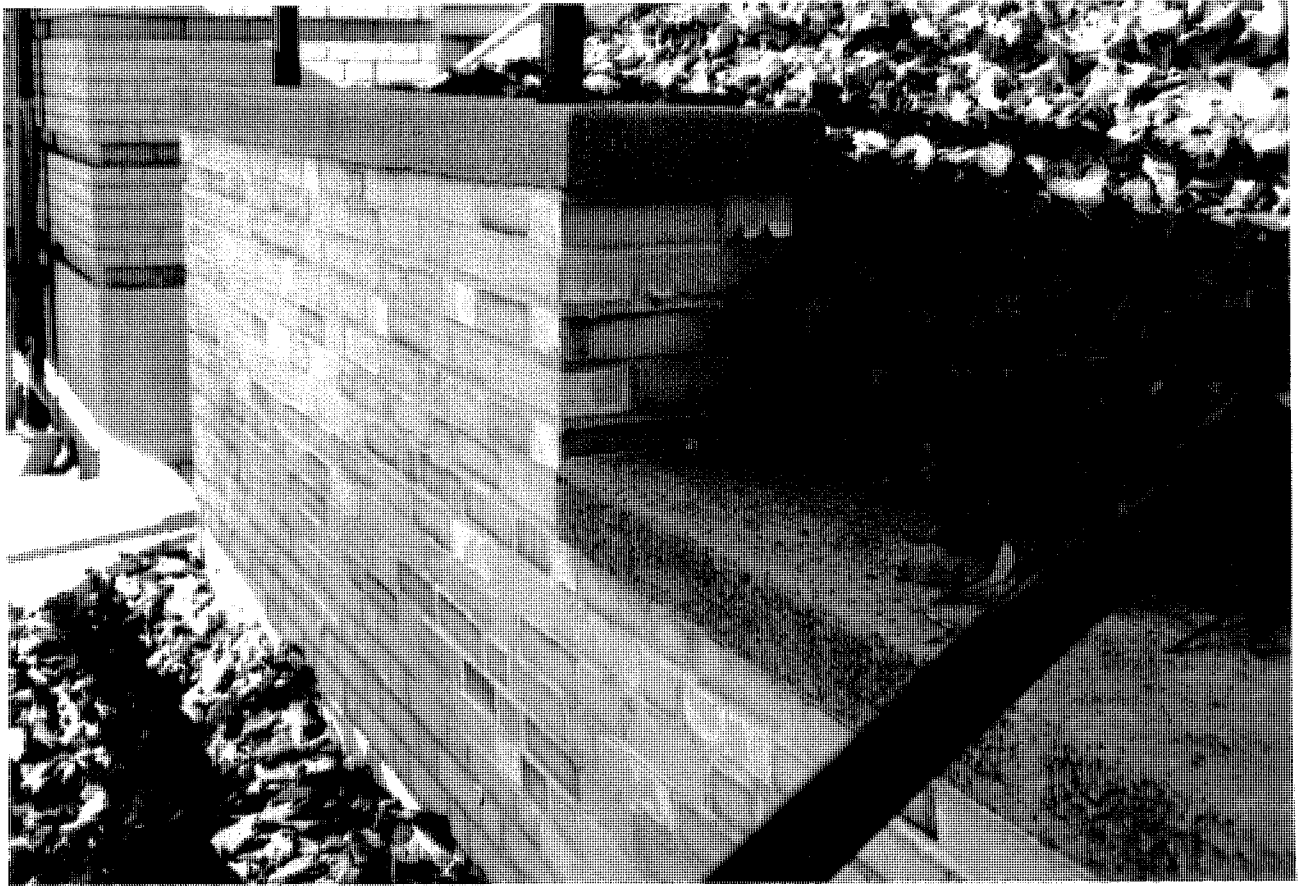
Figure 1-7

Location: South Elevation of Building 1 near South Areaway

Suggested Remedy: Earth should be excavated from next to the wall, the waterproofing skin renewed. The opposite side of the wall is cut and repointed.

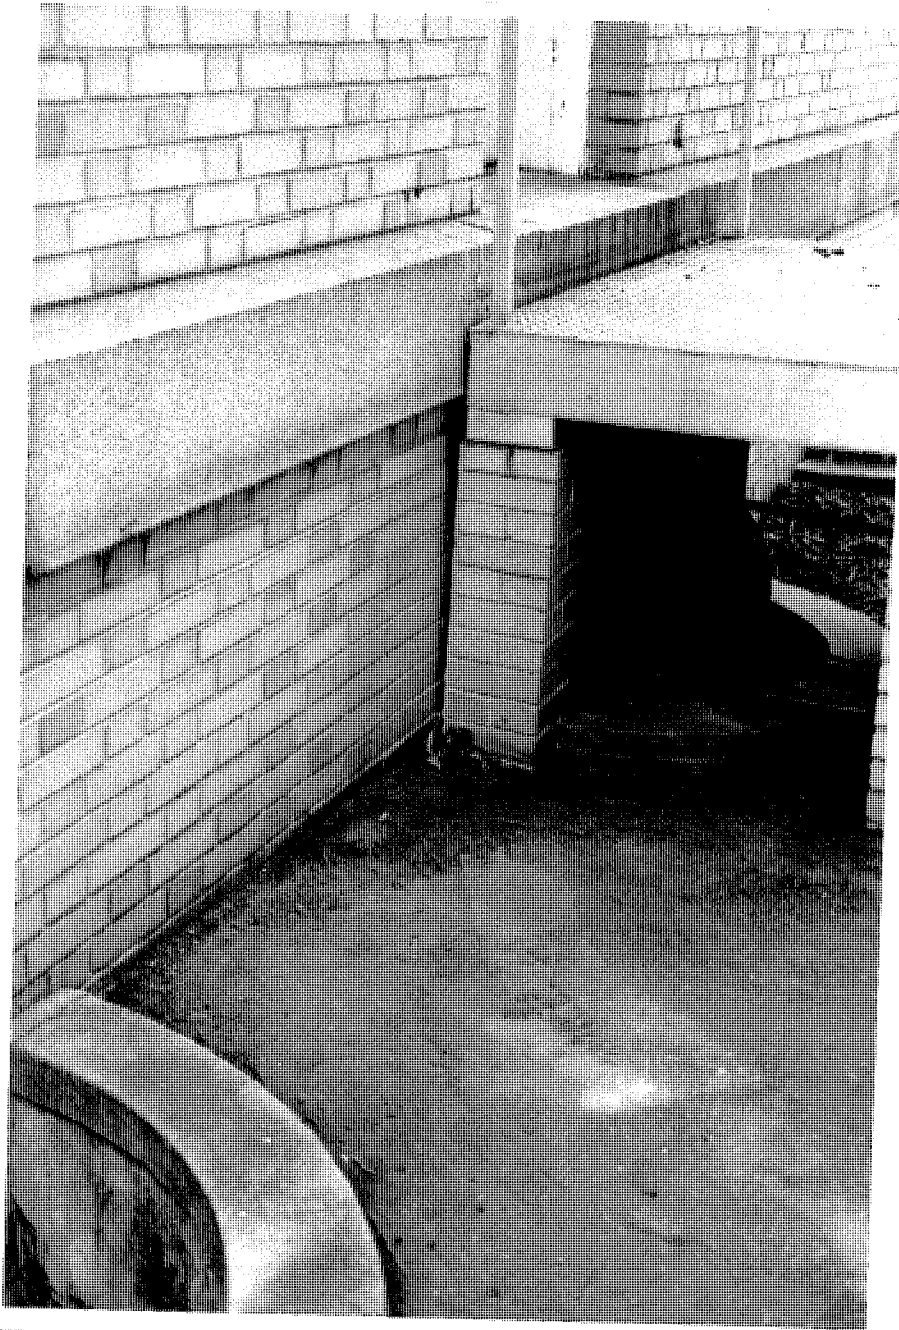
Figure 1-8

Location: North Elevation of Building 1 at Central Steps

Suggested Remedy: Rebuild piers anchoring rear ones to the wall

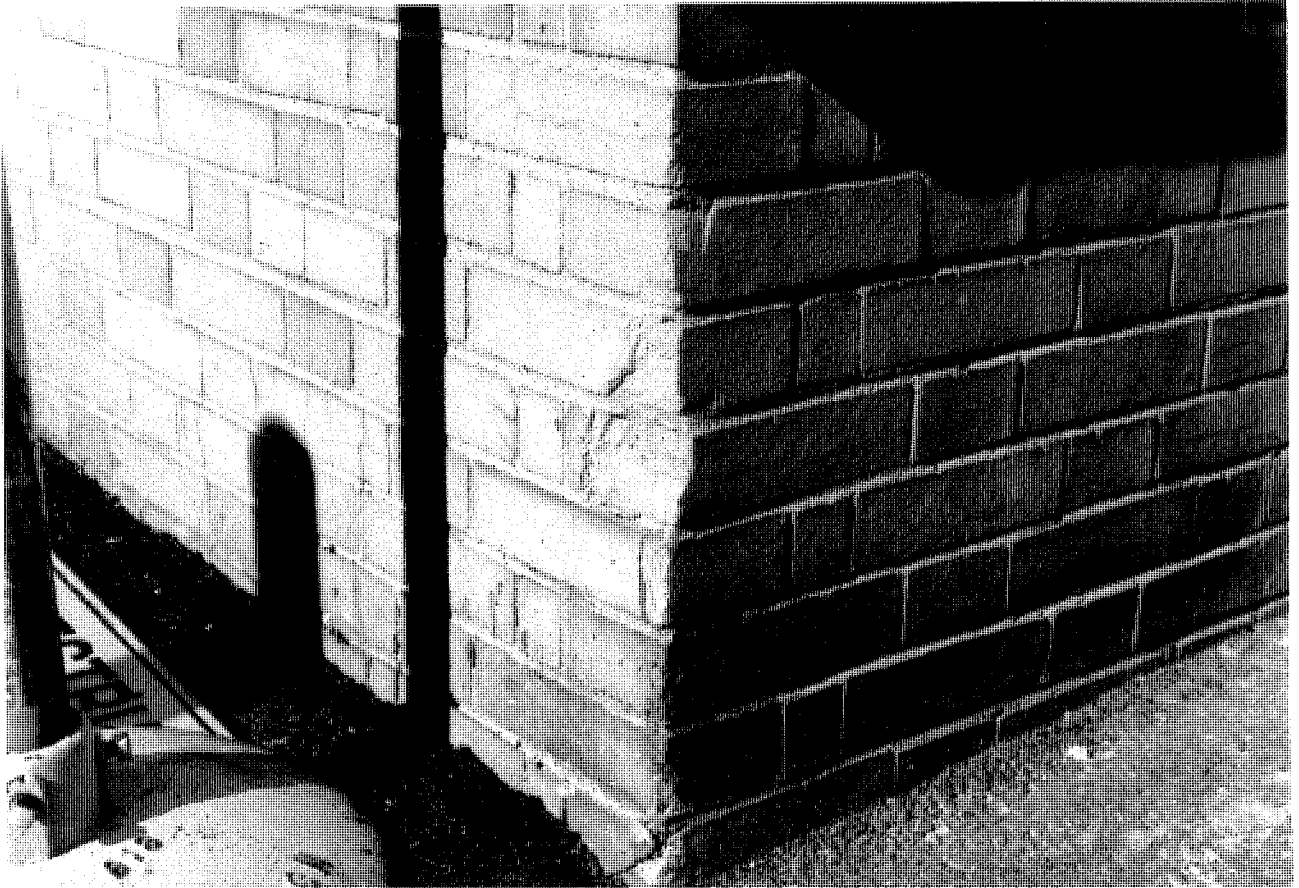
Figure 1-9

The northeast corner of Building 1 has damaged brick (Figure 1-9). There is a minor spall on the first floor window, second to the right from the main entrance (Figure 1-10).

Location: Northeast Corner of Building 1

Suggested Remedy: Brick should be removed and replaced to match existing texture, color and size and reset in mortar to match surrounding pointing in color, texture, and profile.

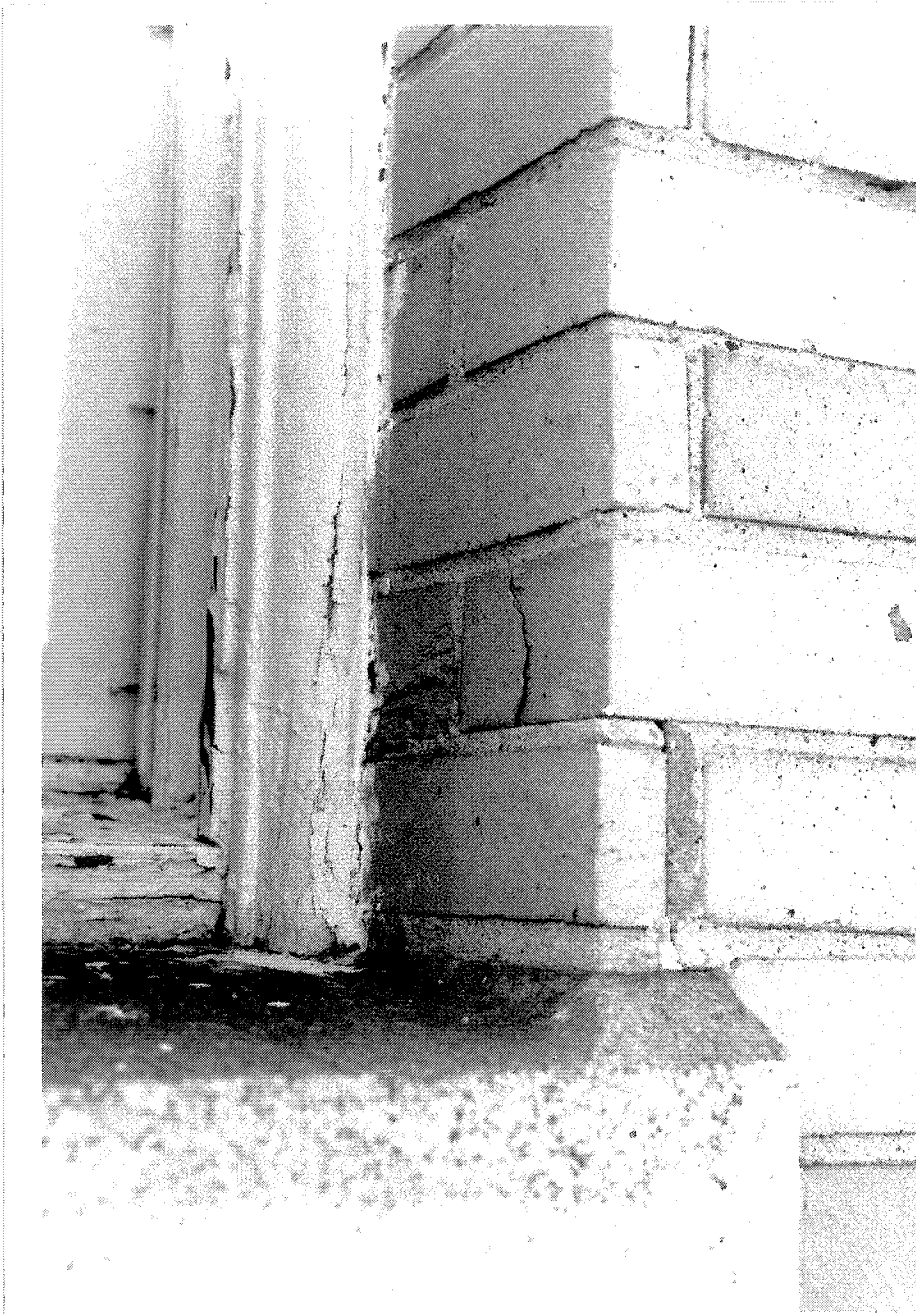
Figure 1-10

Location: East Elevation of Building 1 in Central Area

Suggested Remedy: Remove brickwork and assess for rusting iron anchors. If anchors are rusted they should be replaced with stainless steel anchors; brick should then be replaced to match existing texture, color and size and reset in mortar to match surrounding pointing in color, texture, and profile.

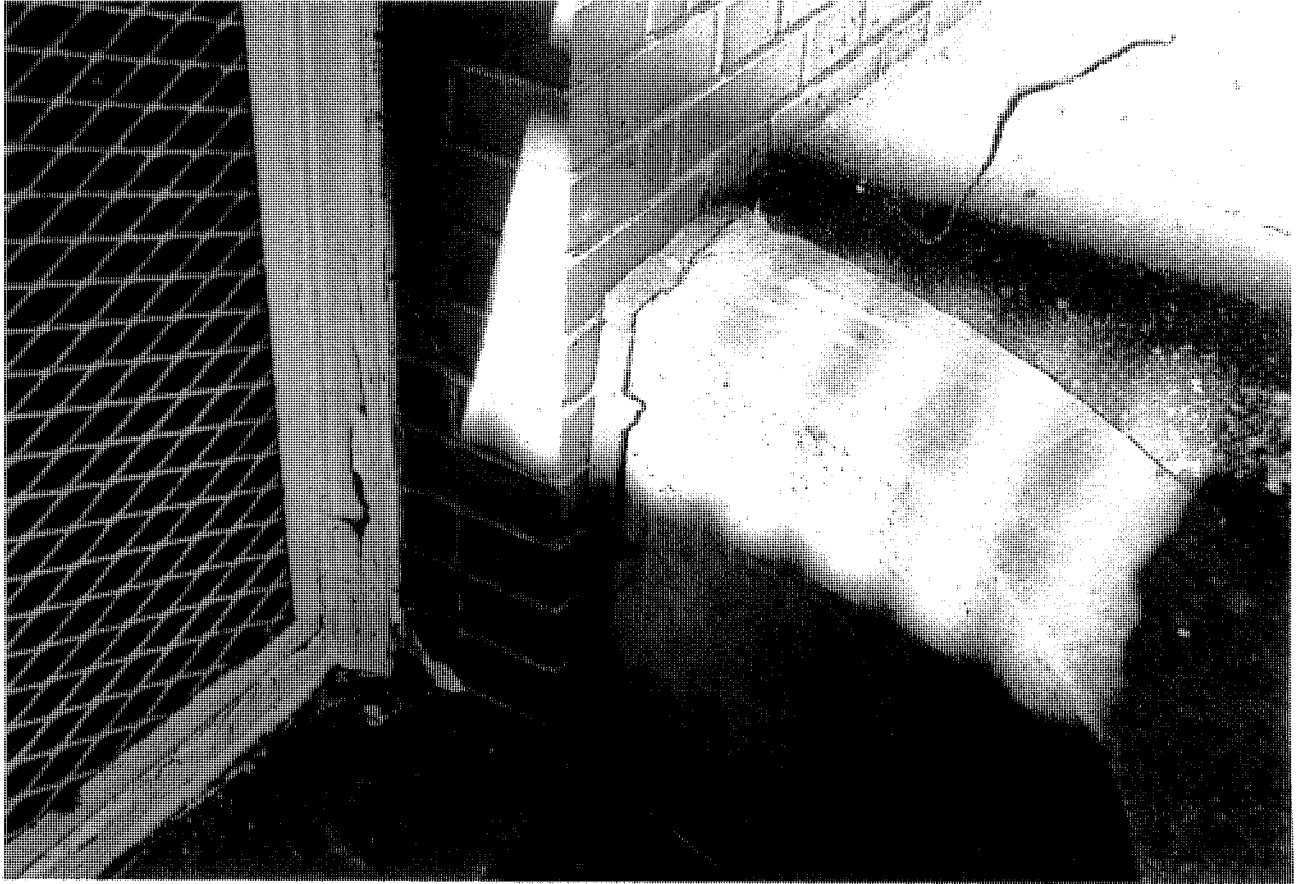
Figure I-11

Location: East Elevation of Building 1 at North End

Suggested Remedy: Demolish and rebuild

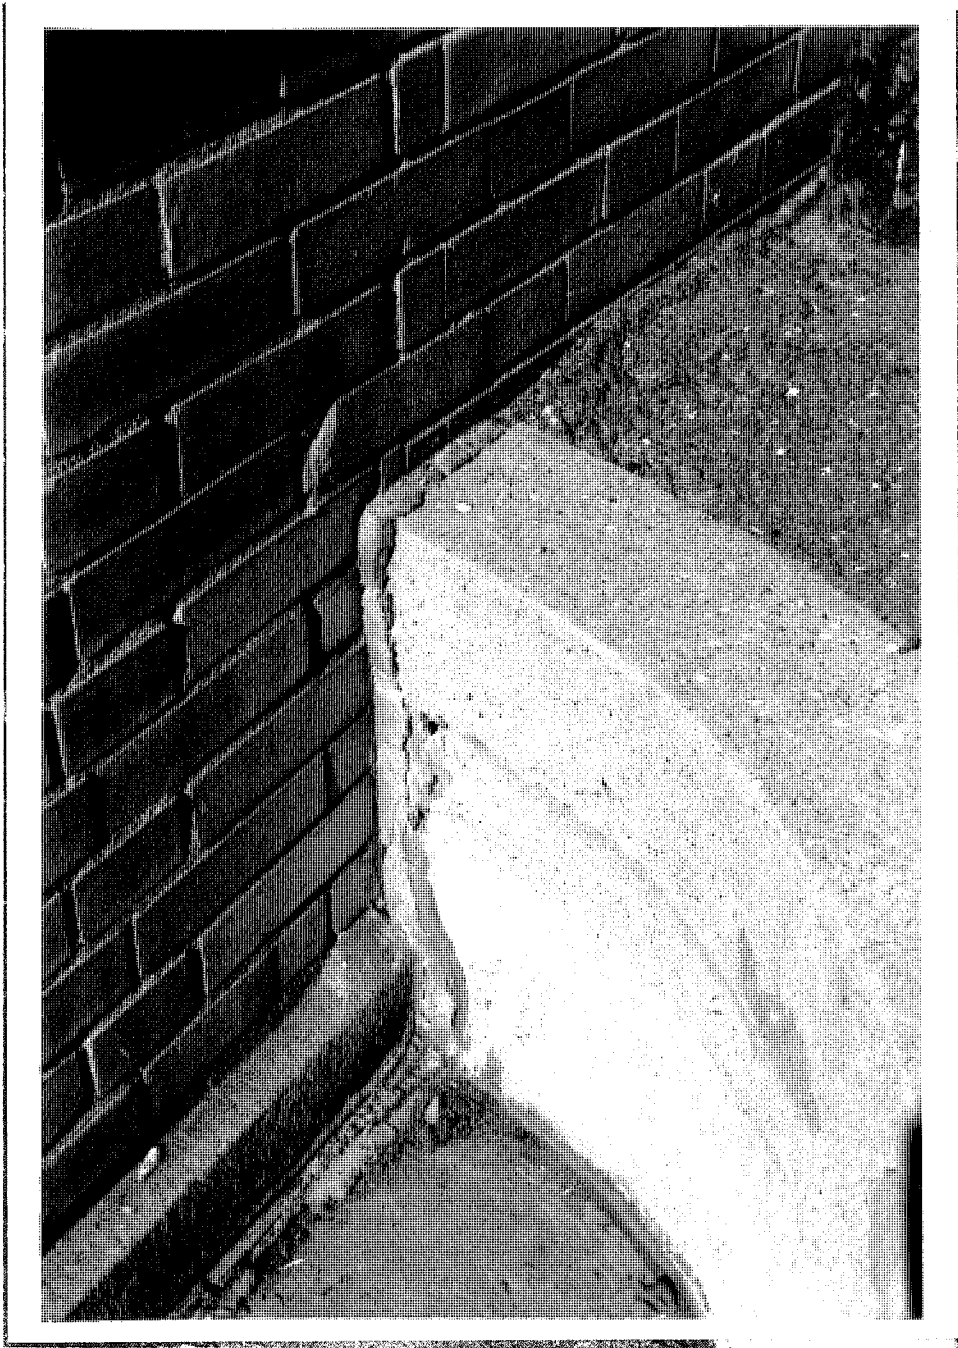
Figure 1-12

Location: East Elevation of Building 1 in Central Area

Suggested Remedy: Demolish and rebuild

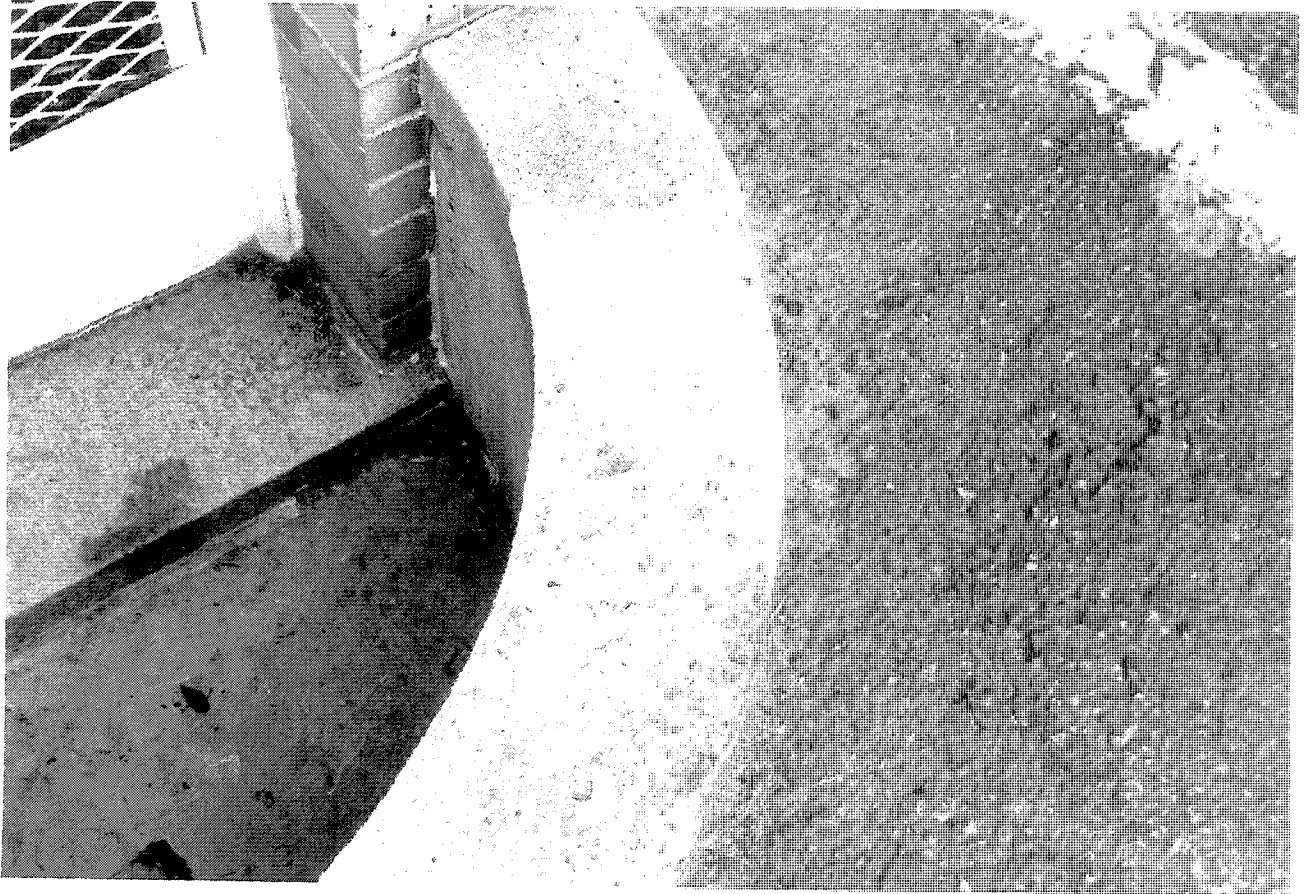
Figure 1-13

Location: East Elevation of Building 1 at North End

Suggested Remedy: Demolish and rebuild

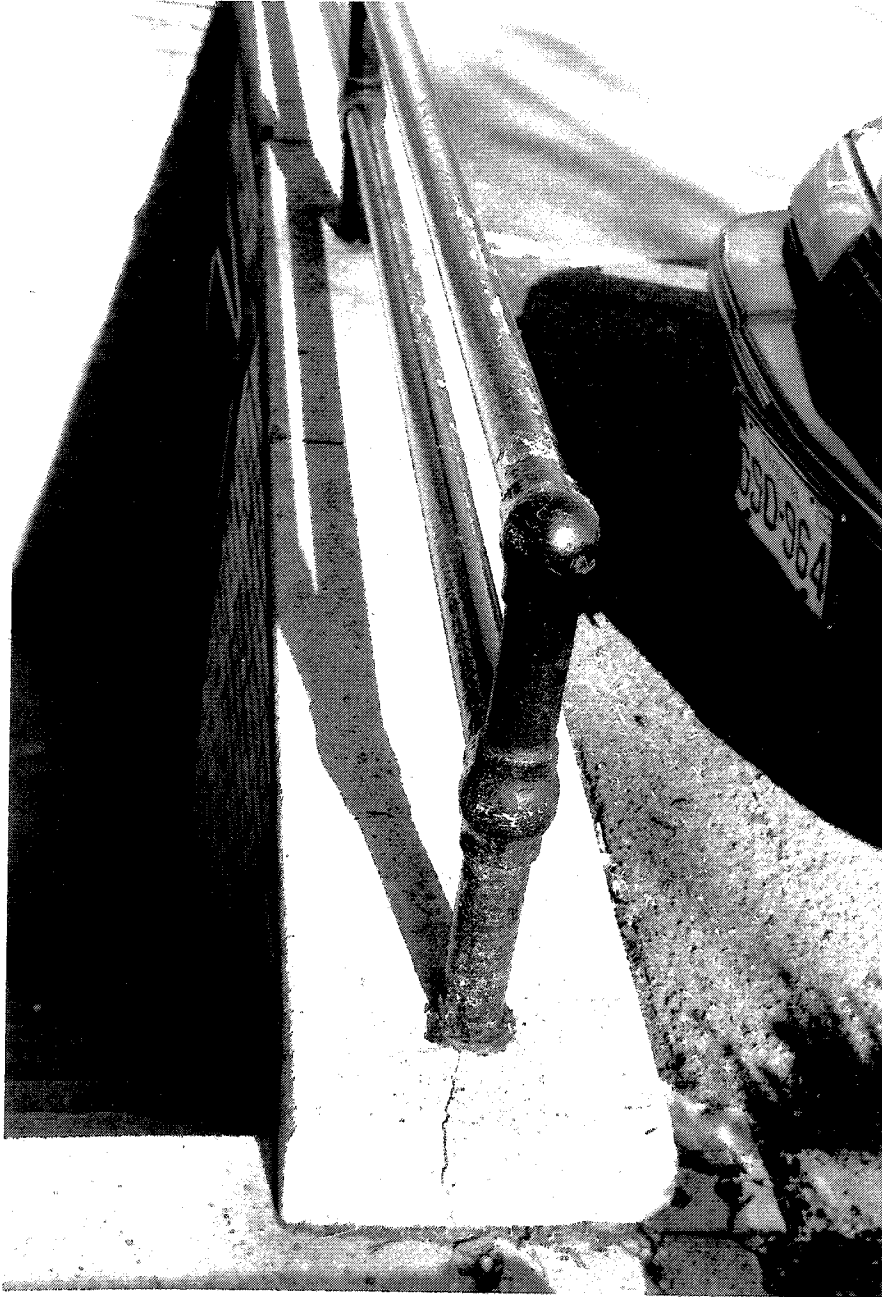
Figure 1-14

Location: East Elevation of Building 1 in Central Areaway

Suggested Remedy: Demolish and rebuild in concrete

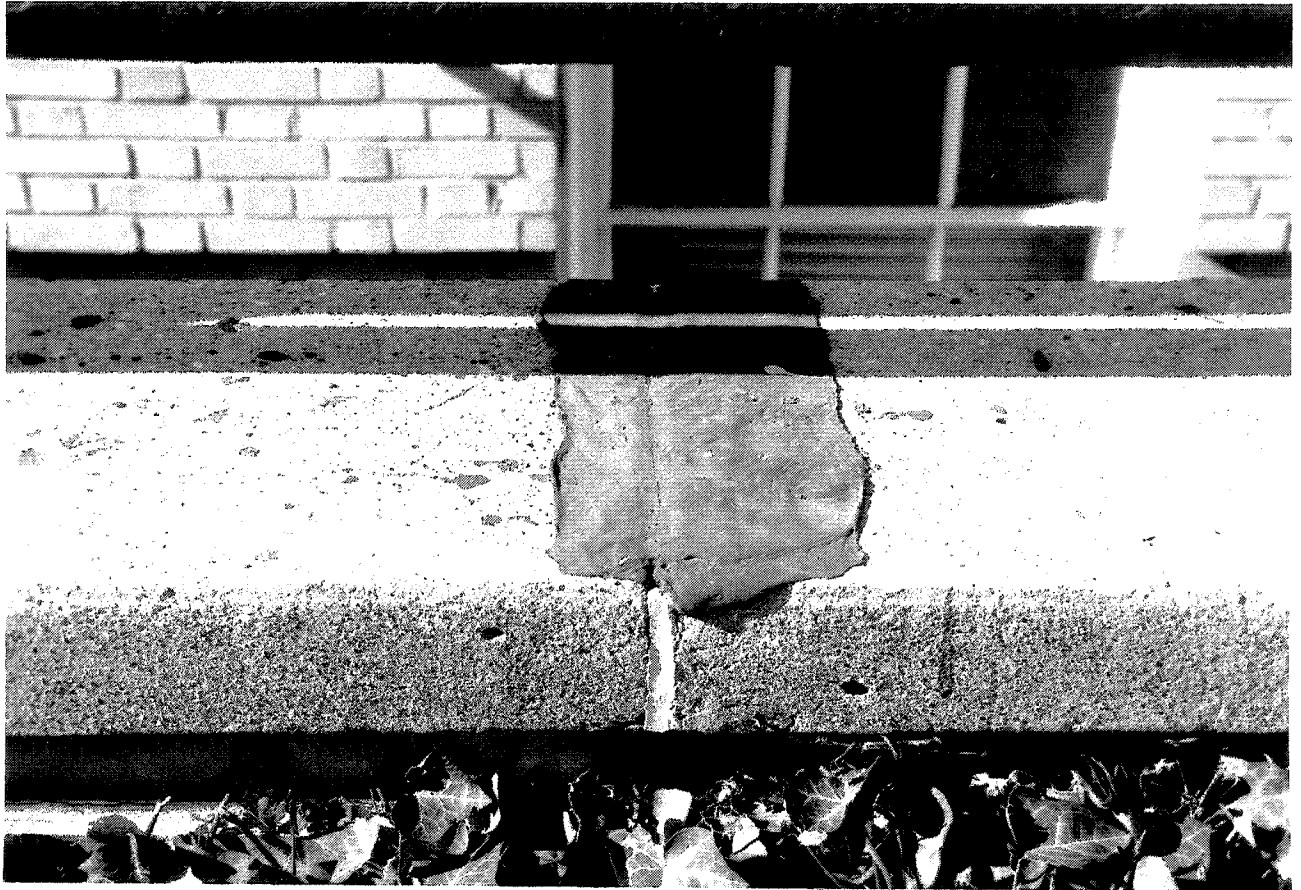
Figure 1-15

Location: East Elevation of Building 1 in South Areaway

Suggested Remedy: Remove bitumen; cut and repoint joint (if capstones are replaced this remedy is unnecessary)

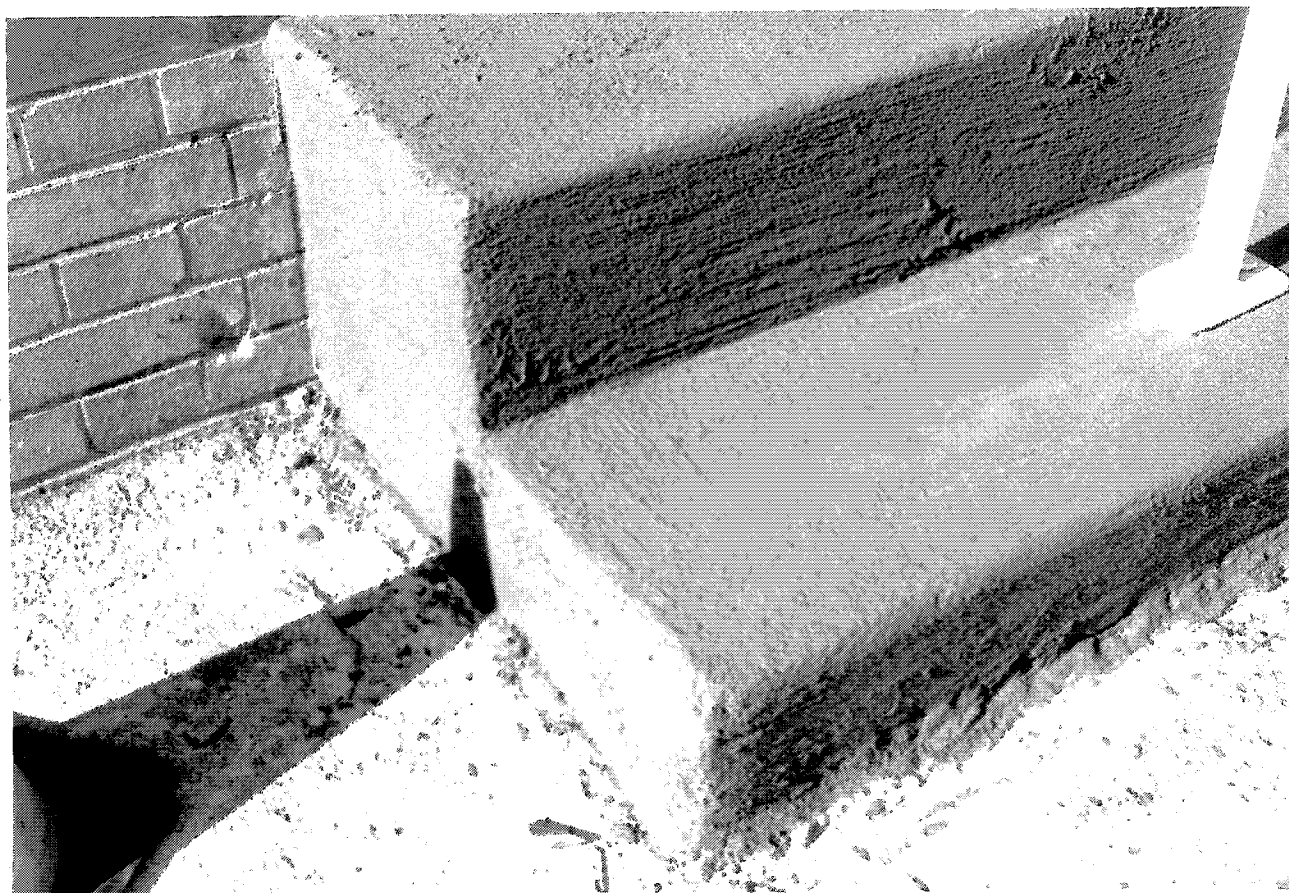
Figure 1-16

Location: East Elevation of Building 1 at South Entryway

Suggested Remedy: Demolish and repour concrete slab

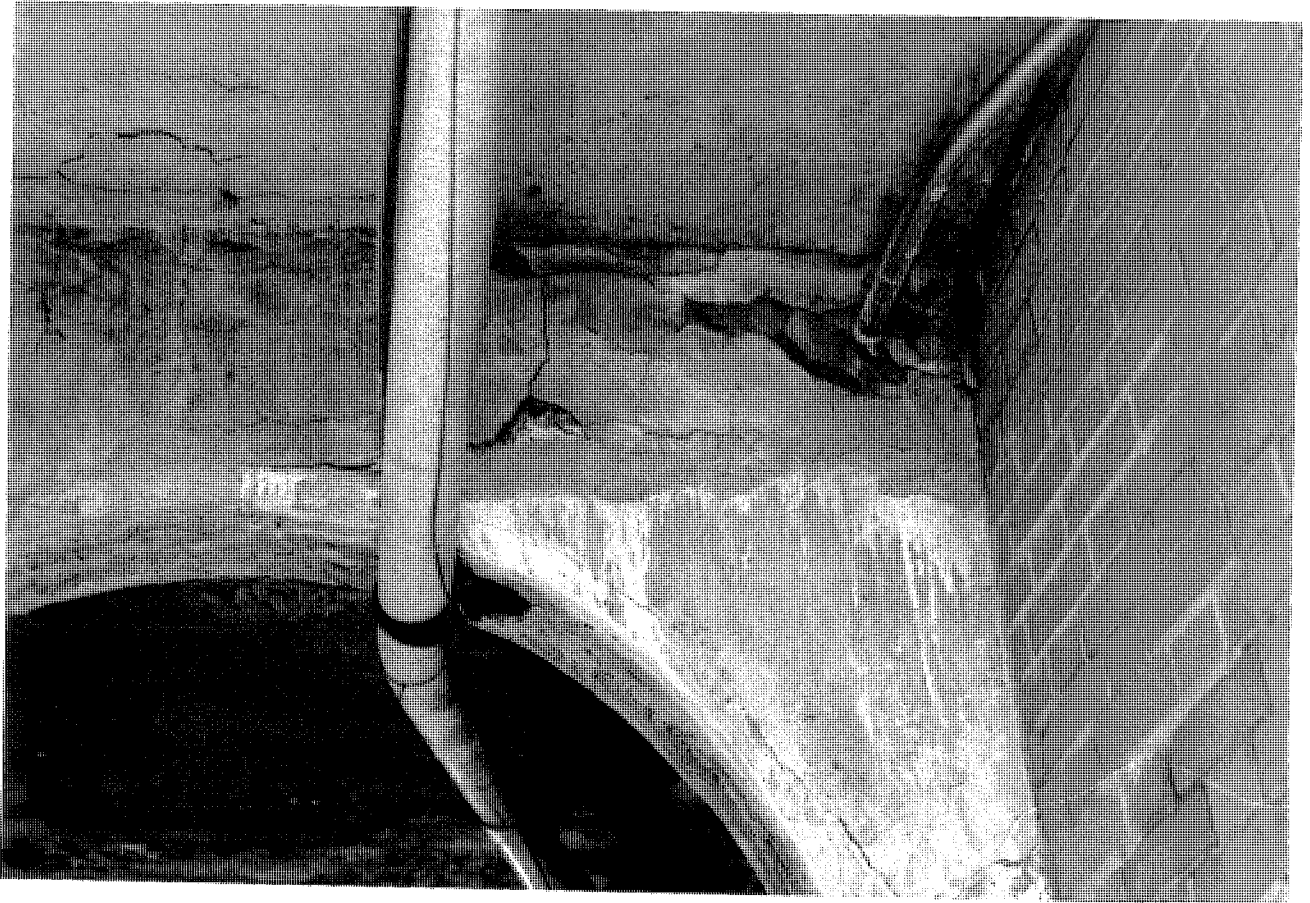
Figure 1-17

Location: South Elevation of Building 1 at South Areaway

Suggested Remedy: Demolish and repour concrete slab and arches

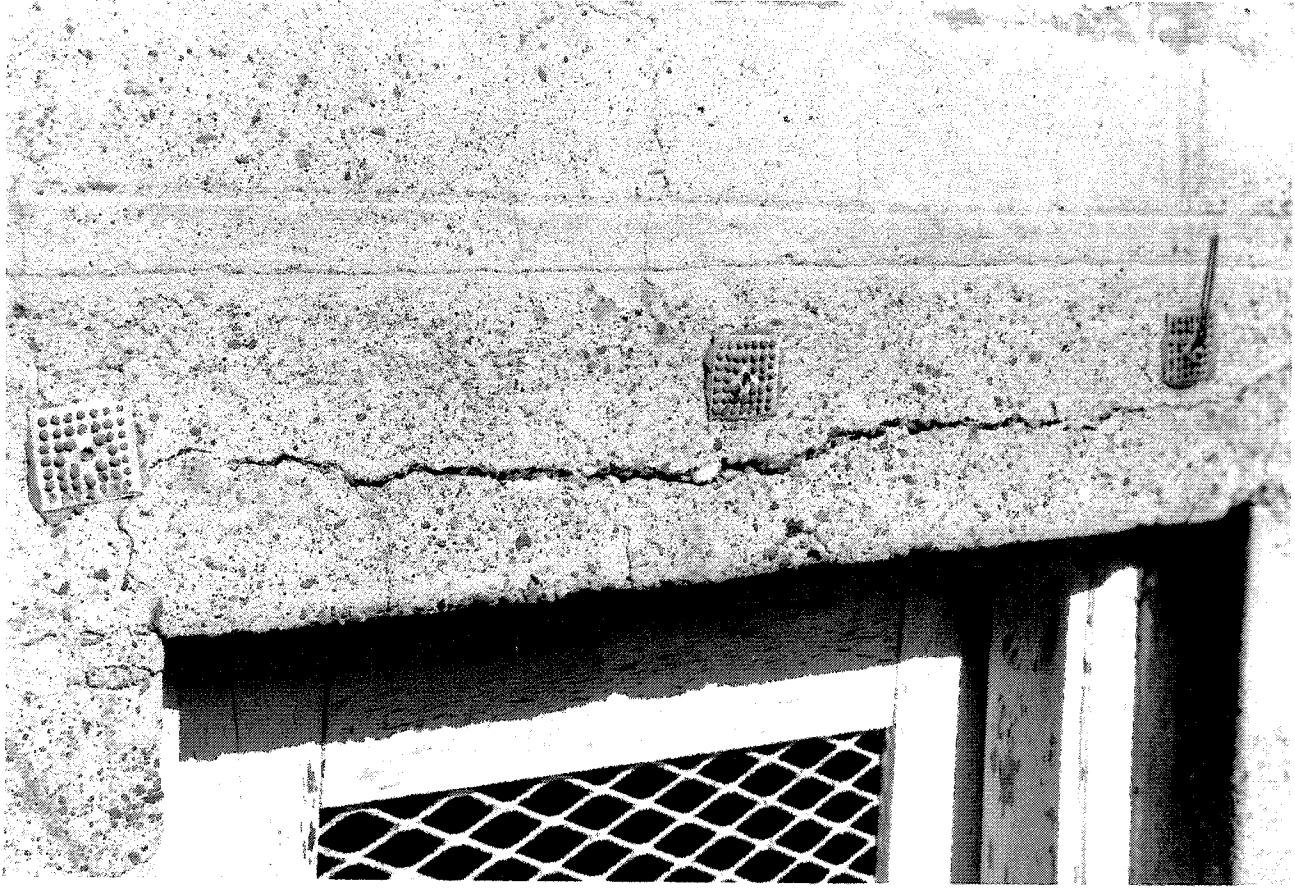
Figure 1-18

Concrete can be found at the window wells, capstones, and the two porches on Building 1. The window wells exhibit movement away from the building. The resulting damage from this movement has been repaired with cement and caulk which are now both failing (Figures 1-11 and 1-12). There is some damage to the concrete in the window wells (Figure 1-13). Cement capstones have been dislodged by contact with automobiles and have cracked from the rusting of embedded metal railings (Figure 1-14). Some of the joints in these capstones have been caulked and overlaid with bitumen (Figure 1-15). The slabs of the portico which were presumably cracked or disfigured have been coated with a cementitious material which is a poor match for surrounding concrete (Figure 1-16). The supporting arches for the south areaway consists of badly deteriorated concrete (Figure 1-17). The exposed concrete foundation on the south and rear of the building shows some deterioration due to rebar corrosion (Figure 1-18).

Location: South Elevation of Building 1 near Southwest Corner

Suggested Remedy: Rebar should be cleaned and painted and a cement patch installed
