Potomac Annex: Buildings 1 & 3-7

Historic Structures Report, Corrected Final Submission
General Services Administration Project Control Number: 44007

September 9, 1997

BUILDING 1: EXTERIOR EXISTING CONDITIONS

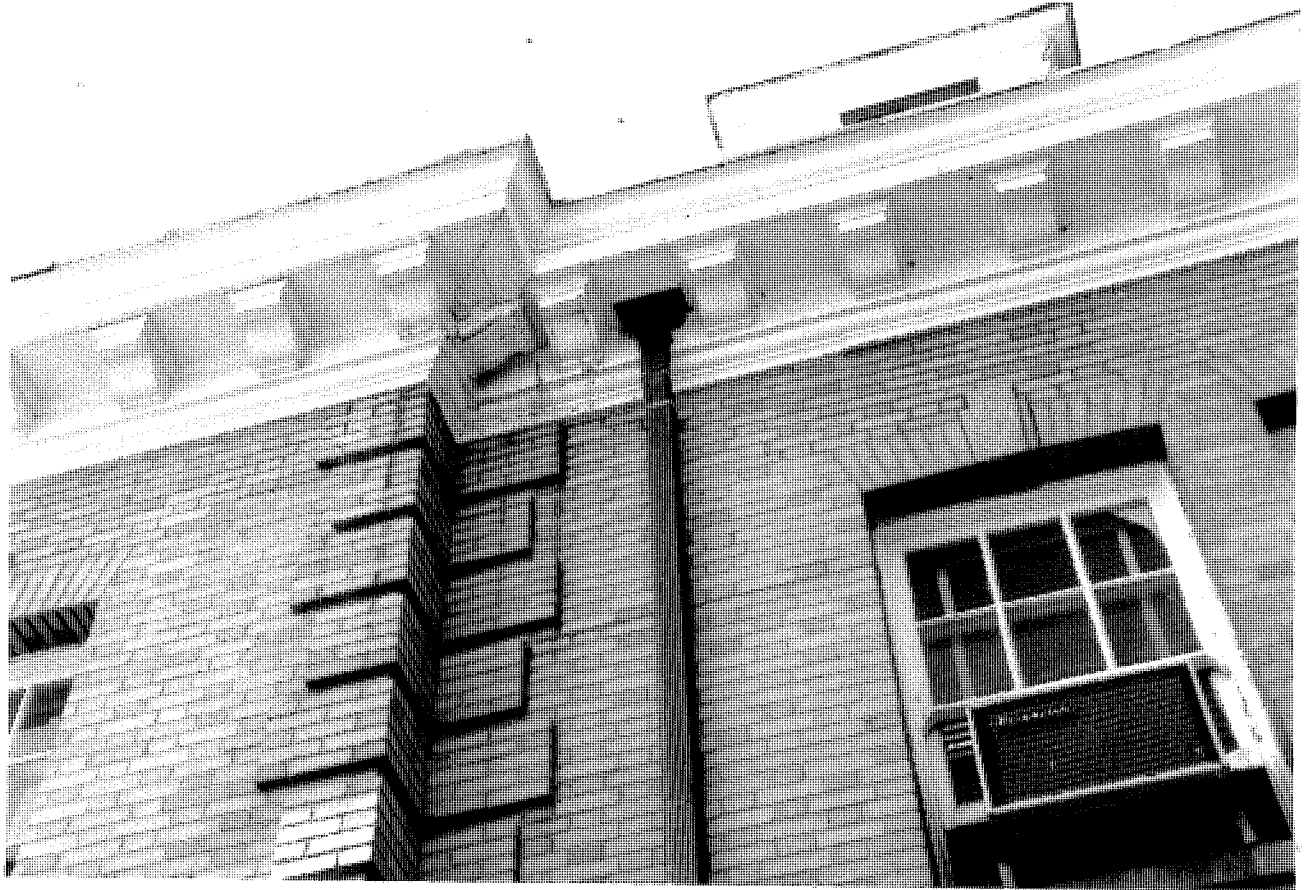
Figure 1-19

Copper leaders and roof flashing are in good condition. However, leaders and gutters require cleaning. Evidence of blockage and associated damage to the painted woodwork nearby is noted (Figure 1-19).

Location: East Elevation of Building 1 at North End

Suggested Remedy: Clear and maintain gutters and leaders.

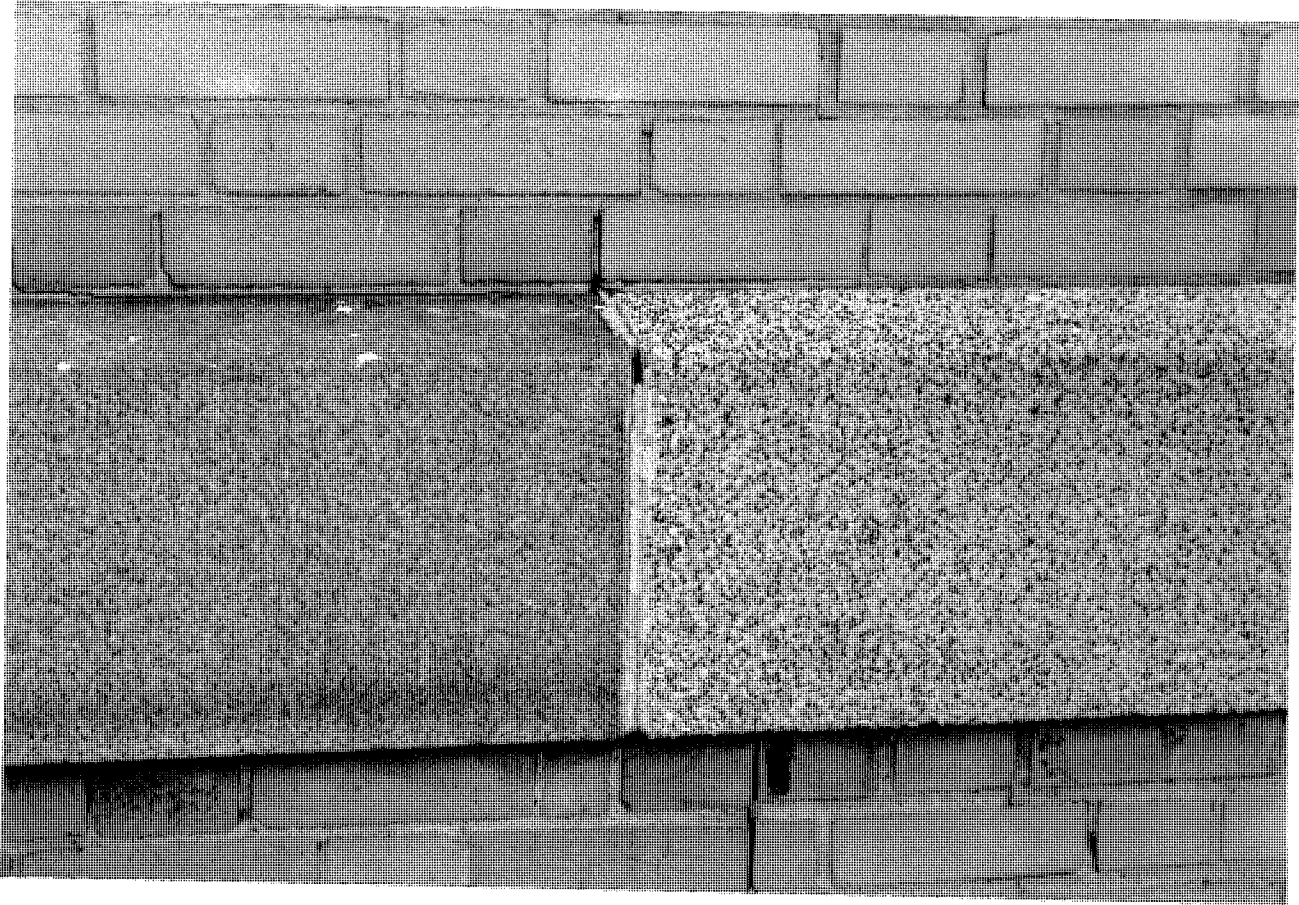
Figure 1-20

Location: North Elevation of Building 1 at near East End

Suggested Remedy: Cut and point (see Chapter VIII. Mortar Analysis for mortar suggestions)

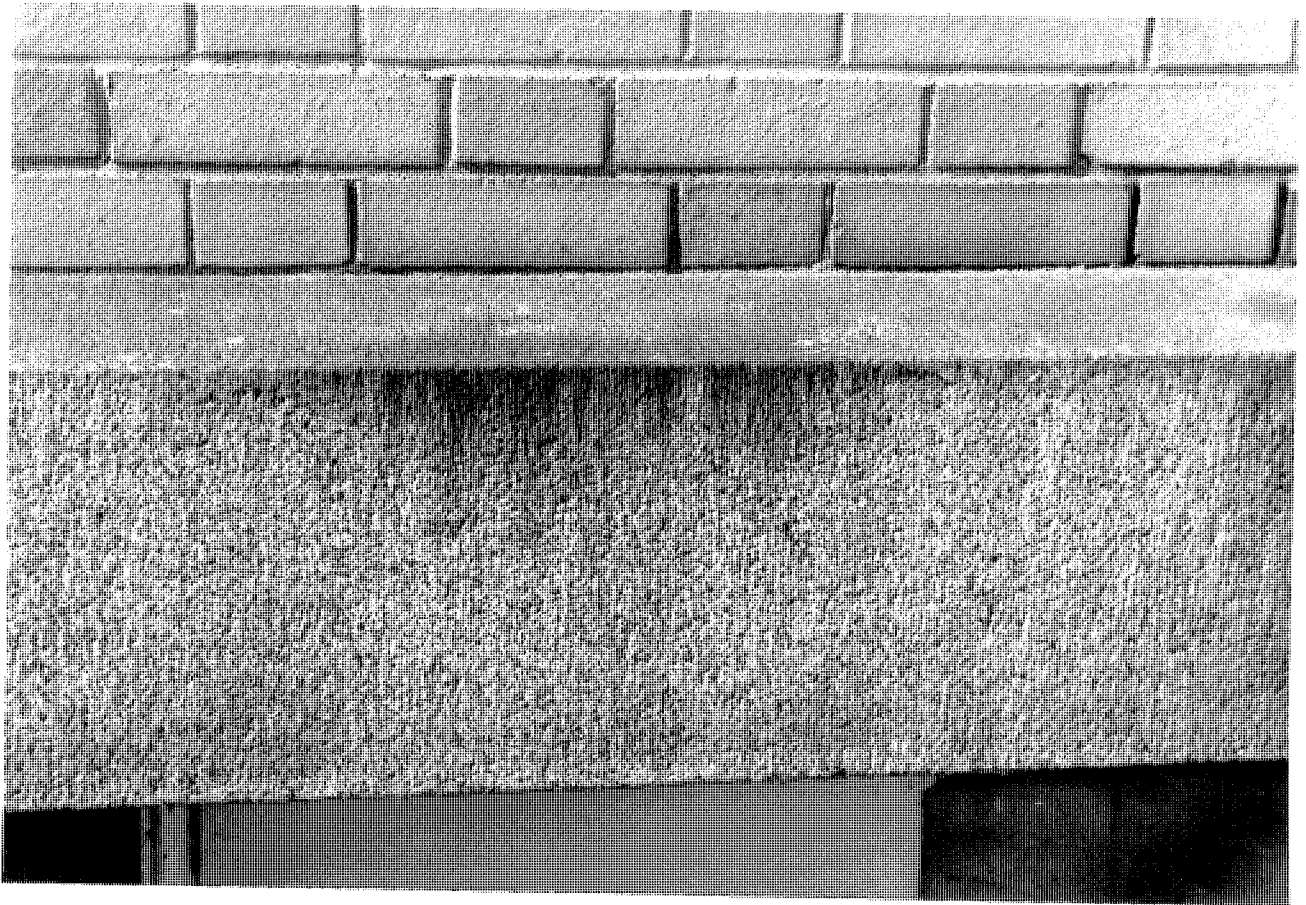
Figure 1-21

Granite and cast stone form the water table which surrounds the building at the base of the first floor. These elements - like the granite keystones - are generally in good condition but are lightly to heavily soiled. However, the joints between juxtaposed stones are open or have been filled with caulk (Figure 1-20). The bed joints and the top horizontal joints for the granite water table are generally open. Run-off from window air conditioners has stained the granite (Figure 1-21).

Location: East Elevation of Building 1 at near North Entrance

Suggested Remedy: Poultice with iron-chelating agent

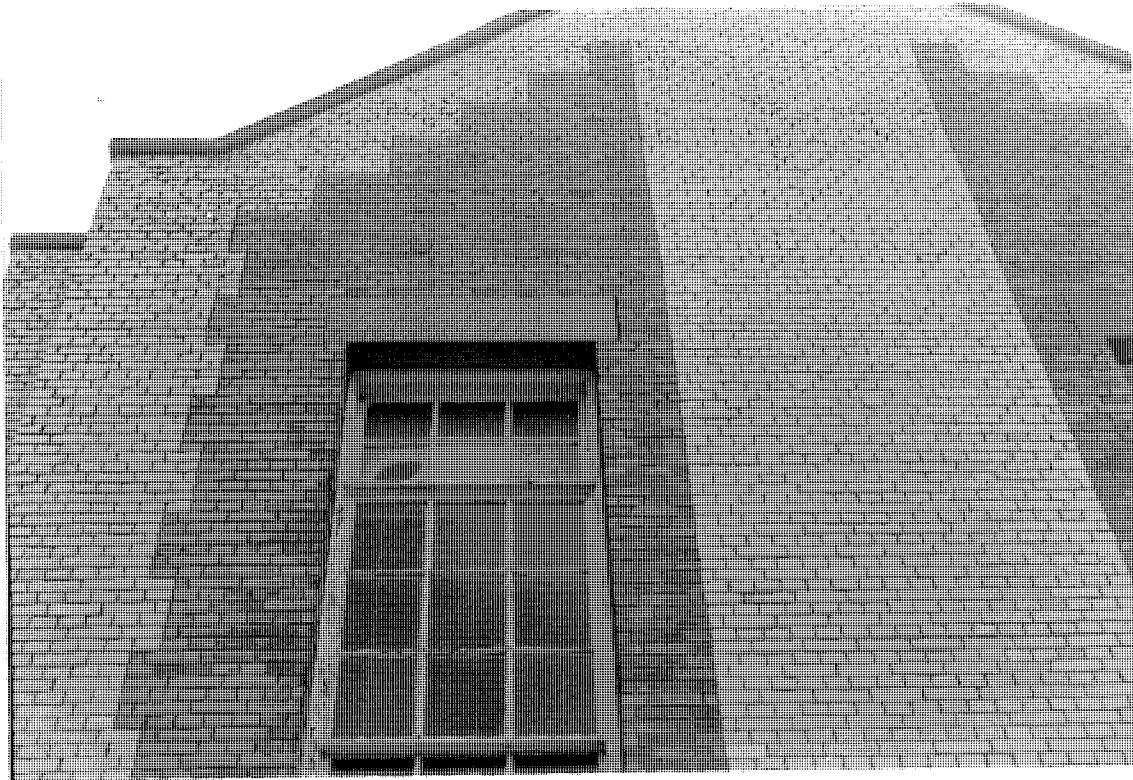
Figure 3-1

Location: West Elevation of Building 3 on West Pavilion

Suggested Remedy: The buff brick will not clean by conventional or unconventional methods (see also Chapter VIII. *Materials Cleaning Analysis*)

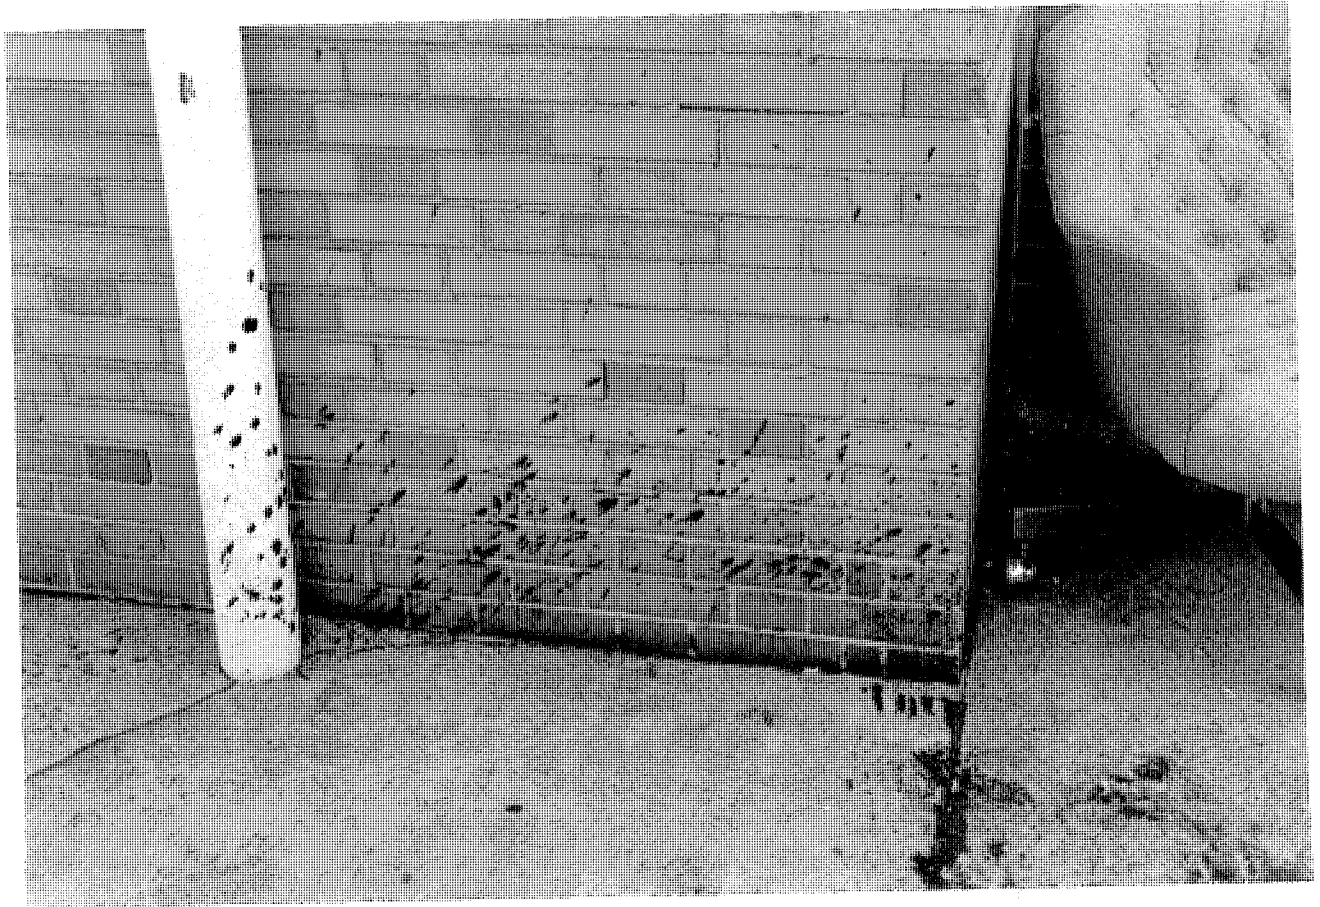
Figure 7-1

Location: West Elevation of Building 7 at South End
Problem: Bitumen waterproofing (and/or paint) on brick
Cause of Problem: Poor maintenance procedures
Suggested Remedy: Poultice with solvents

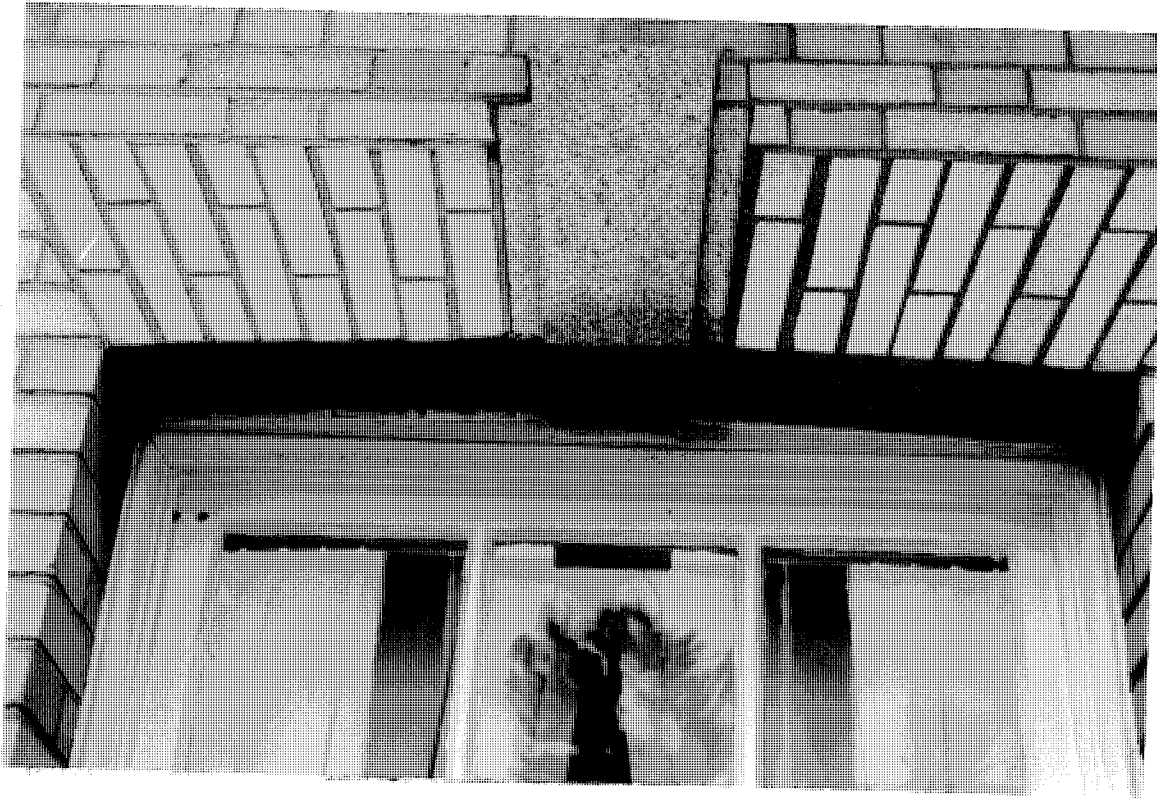
Figure 8-10

The water misting method was used to remove gypsum and flyash from the undersides of window lintels as shown here on the east elevation of Building 5. Good results were obtained after 6 hours (before cleaning condition can be seen on the right). This is a safe and effective method for removing this soiling and is the recommended techniques for this condition.

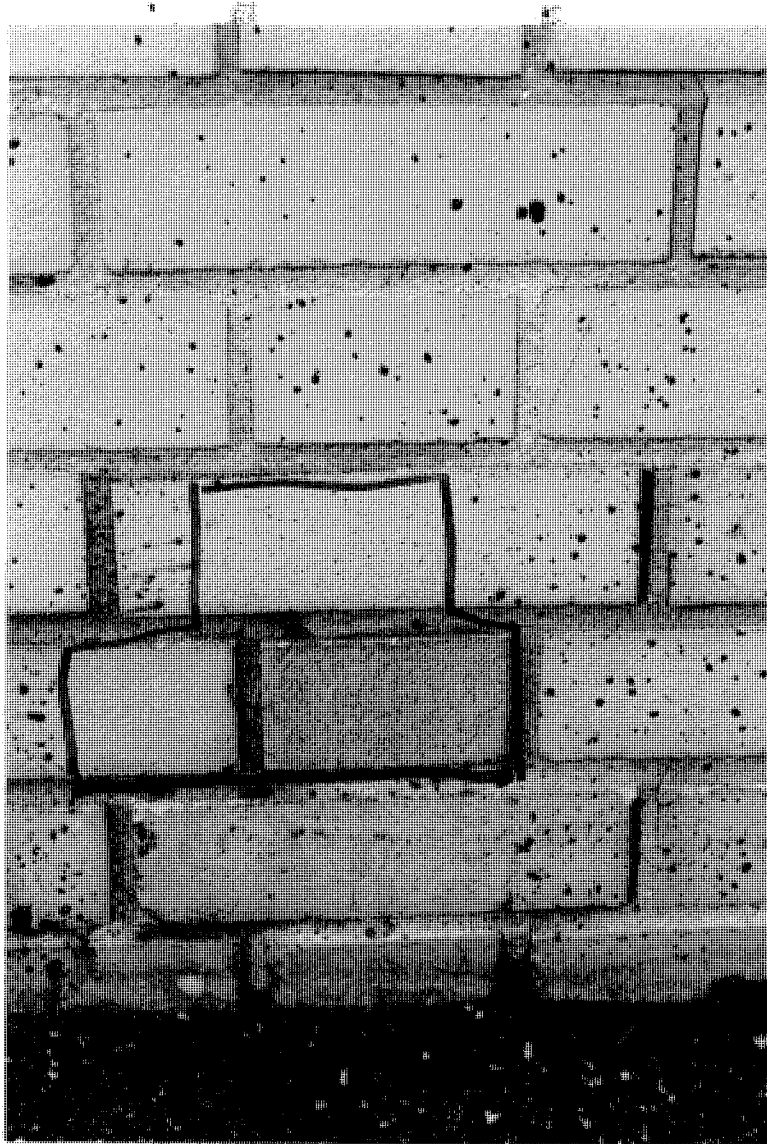
Figure 8-11

Bitumen-based deposits as shown here on the elevation of Building 5 were cleaned with PROSOCO'S Asphalt and Tar Remover - a solvent-based cleaner. The applied as a paste in attapulgate for 4 hours the deposit was then dislodged with paint scrapers taking care not to scrape the brick. The results shown here (uncleaned area on the left and cleaned area on the right) are good and this is the recommended method for removing these deposits.
