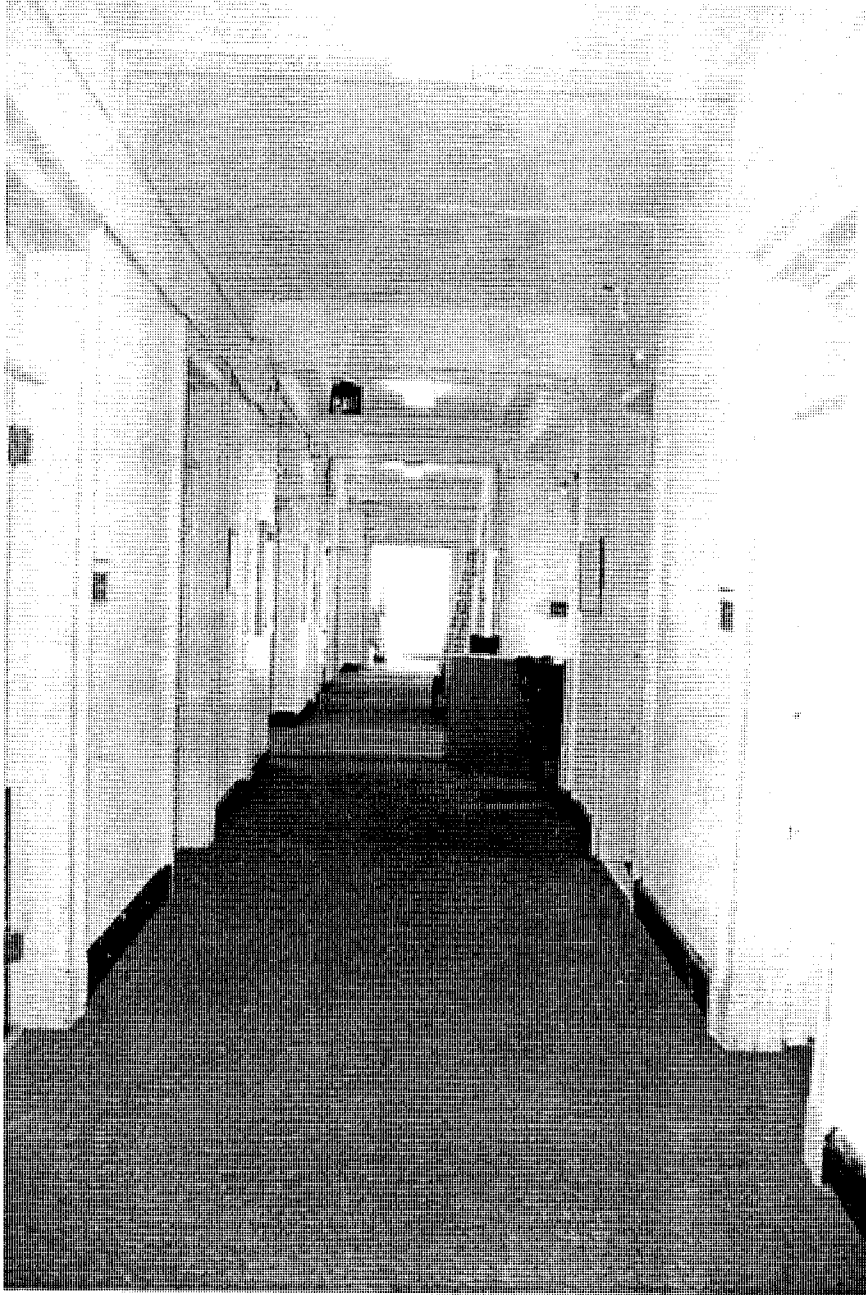
Figure 3-16.

Building 3. View of solarium corridor connecting Building 3 to Building 4. The flush wood doors are not original. They detract from the architectural character of the space. The heavy use of all of the solarium corridors for storage detracts from the appearance and poses a hazard for the occupants.

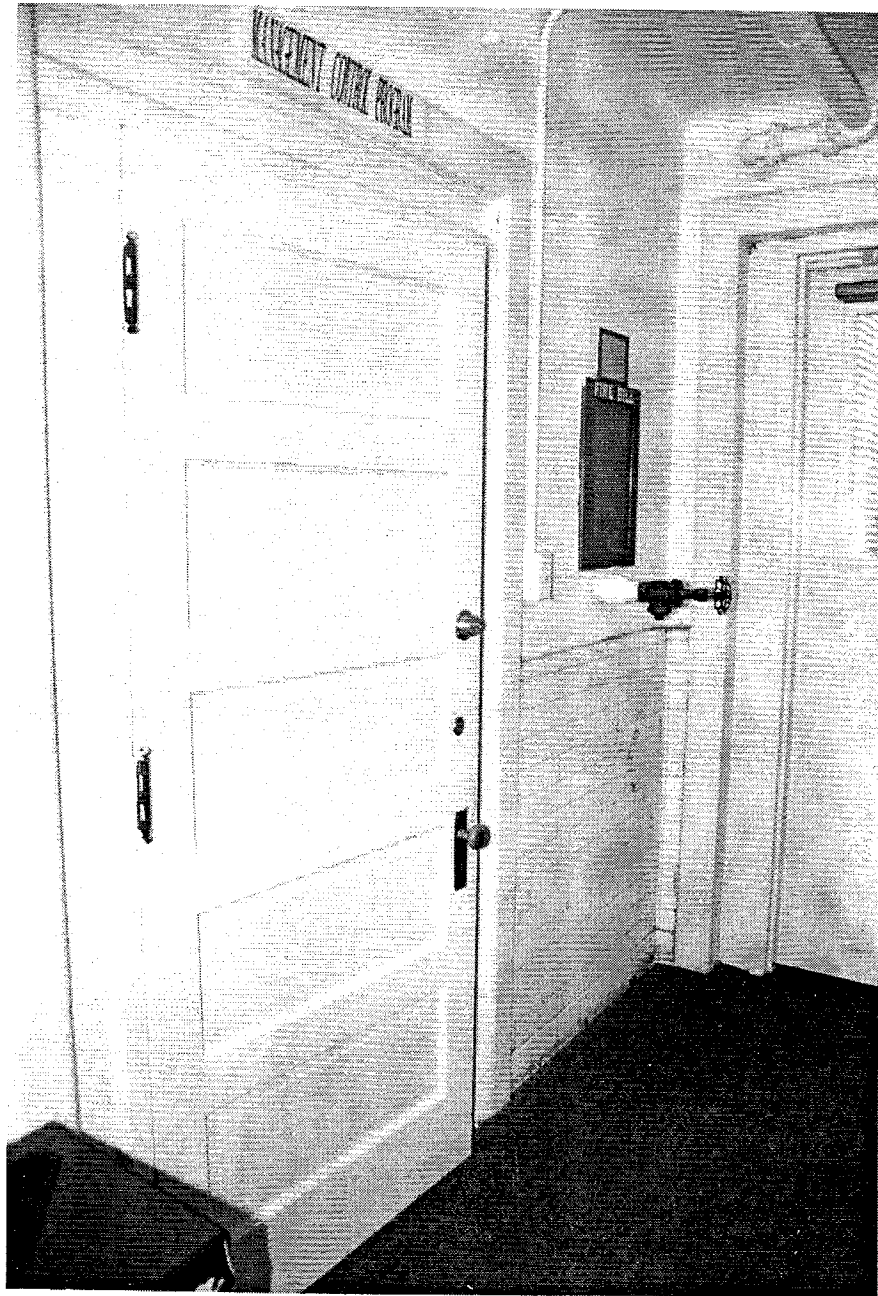
Figure 4-12.

Building 4. First floor. Operating Room ante room. Scuttle in the ceiling leads to the fan chamber above. Double entry was crudely infilled. Note remnants of original ceramic tile on either side of the door frame.

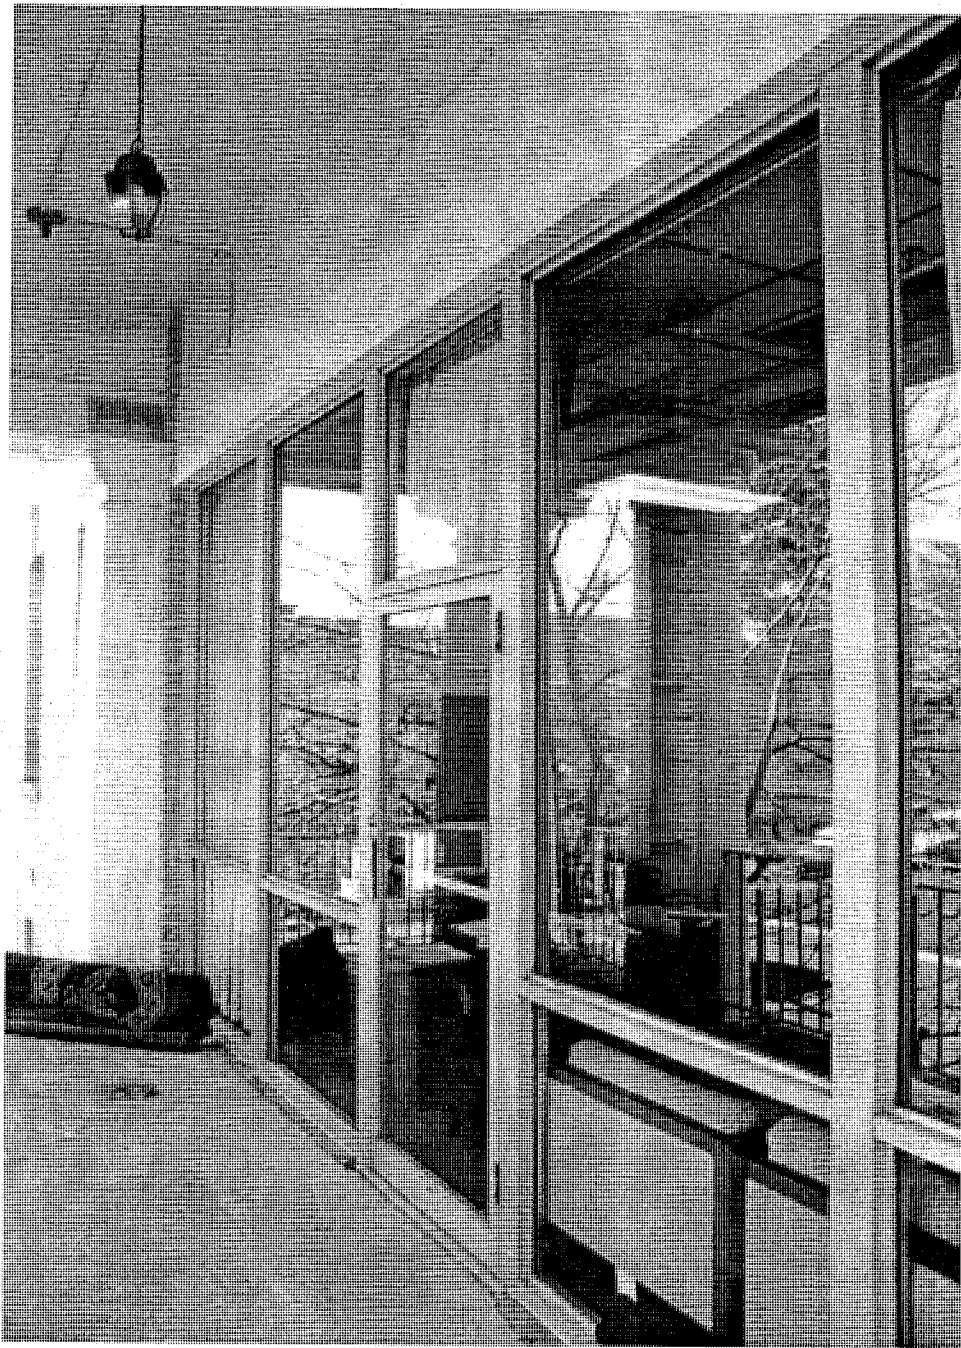
Figure 6-3.

The existing aluminum and glass entry infill (Figure 6-2) is most certainly an obtrusive later alteration. The second-floor balcony (Figure 6-3) has been treated in a similar manner. The original balustrades on both porch levels have been removed. On the first floor, they were replaced by a simple pipe rail; on the second floor, they were replaced by a thin metal railing.

Building 6. North elevation, entry portico. The aluminum and glass entry infill replaces a folding partition arrangement noted on original drawings. A glazed partition could be an appropriate solution to enclosing the building; but the heavy, mill-finish aluminum members of this system detract from the architectural integrity of the building. The steel stair (to the right of the canopy) and the metal railing along the second-floor balcony replace a wood balustrade; both elements detract from the building's design.

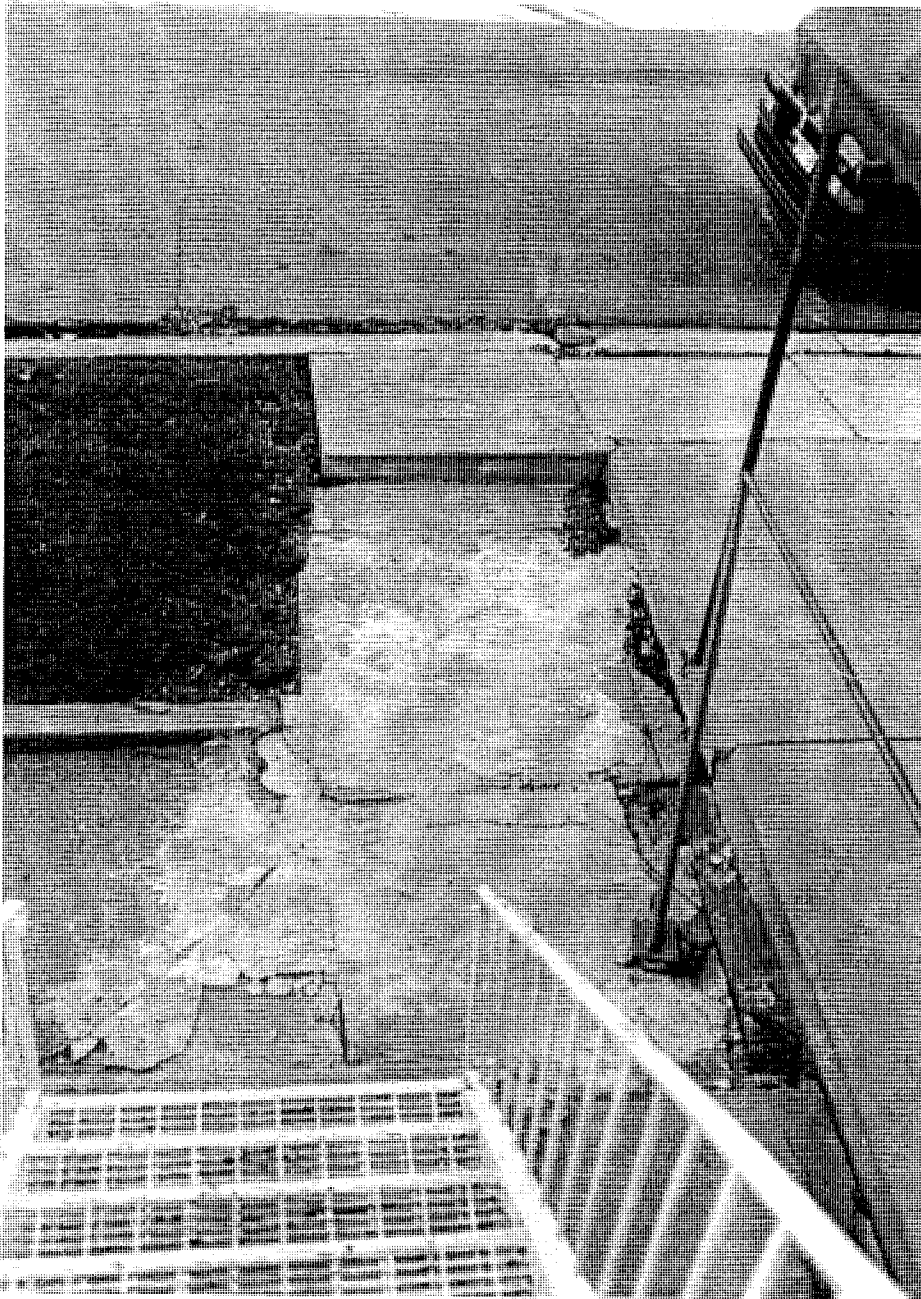
Figure 6-10.

A highly obtrusive metal stair (Figures 6-1, 6-2, 6-10) makes a straight run from grade to the second-floor level. It serves as an emergency egress, but it is frequently used by occupants as convenient access to the second floor. It is rusting in some areas and needs paint.

The landscaping around this building is spare. As indicated above, the lawn slopes sharply into the foundation on the north side (Figures 6-1, 6-4, 6-8, 6-9, 6-10). The area is unattractive and neither utilitarian nor ornamental. It has been utilized for the installation of A/C condensers on concrete pads. The east side of the slope is badly eroded and a drainage pipe protrudes near the top. The area near the foundation is damp, but no cracks or moisture-related problems were noted. A concrete sidewalk borders the west side of the north elevation. Concrete steps leading to the entry on the west side are cracked. A simple concrete path leads around the northwest corner; this is bordered by recent retaining walls made of treated wood timbers. Low plantings have been installed on the slope presumably to assist in stalling erosion. The east, south and west sides are bordered by parking lot and asphalt (or sidewalk concrete) meets the building at grade.

Building 6. Landscape, view looking down the slope toward the southeast. Note condensors, recent retaining walls and highly obtrusive cables running across the front of the building. Also note the fire pull station in background (in front of white car), which is one of a few early-20th century features remaining.
