POTOMAC ANNEX BUILDING 2

**HISTORIC STRUCTURES REPORT
CORRECTED FINAL SUBMISSION**

Prepared for the U.S. General Services Administration

Swanke Hayden Connell Architects

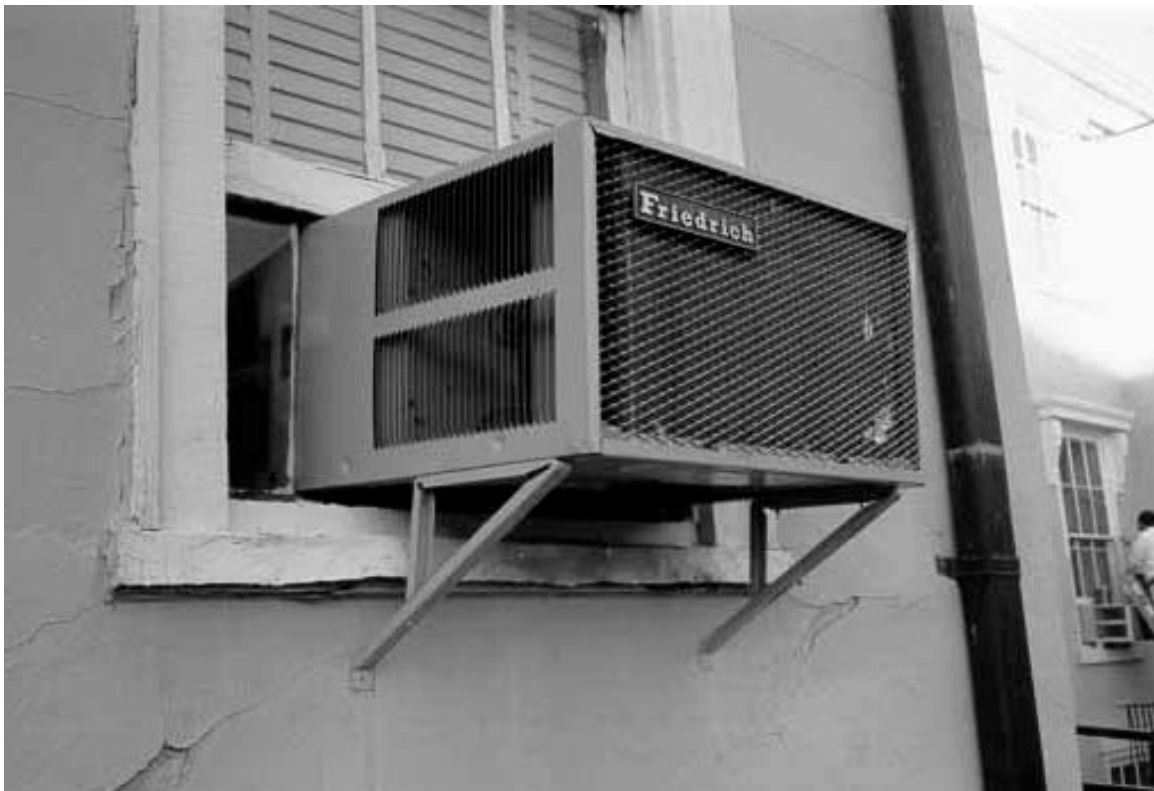
Figure 104
West Stucco Addition (1918)
Detail showing stucco failure.

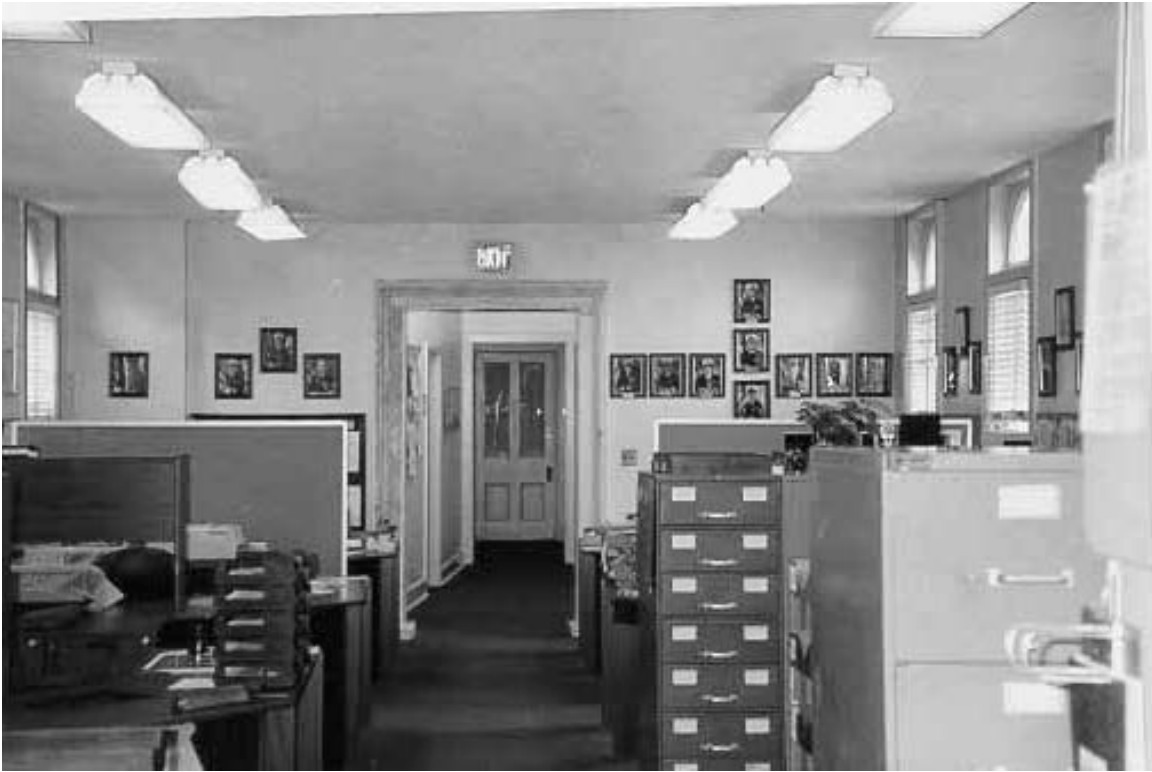
Figure 169
West 1902 Second Floor Addition. Note the intrusive partition wall and the water damage in the west wall and ceiling.

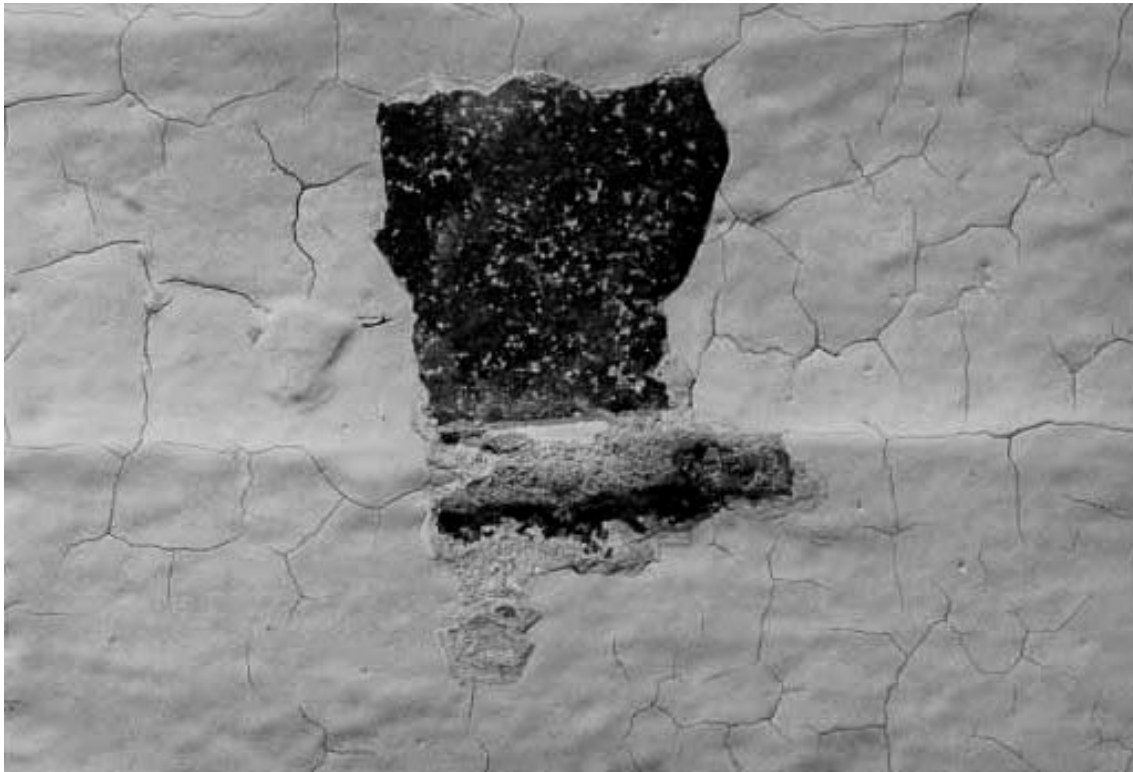
Figure 288
1847 Residence, North Elevation.
The most pervasive condition on Building 2 is lifting or detachment of paint. Loss of paint in the example shown here also reveals the narrow joints (1/8 inch) and 2 5/8 inch wide bricks which comprise most of the elevations.

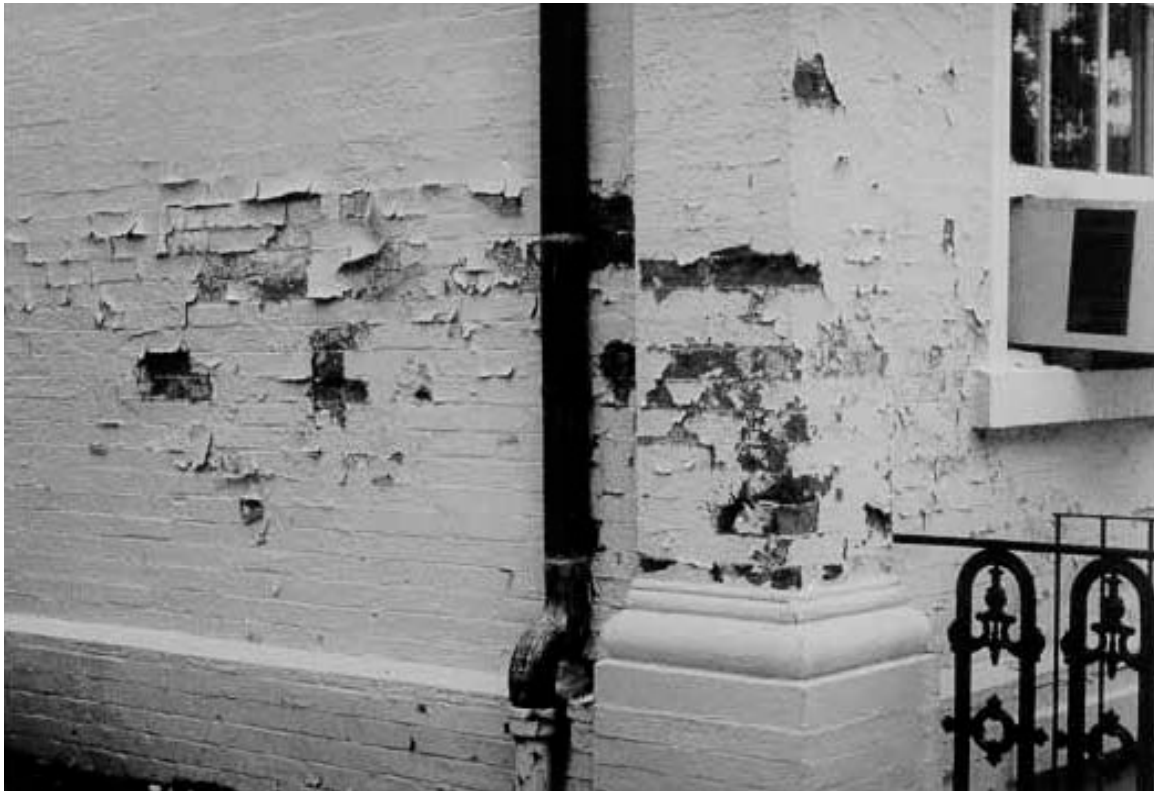
Figure 291
1844 Old Naval Observatory
Northeast corner of the main block. Where drainage systems have failed. The nearby brickwork is damaged by freezing water. Severe loss of paint is also noted in these areas. There is also some efflorescence and spalling associated with the failed drainage system.

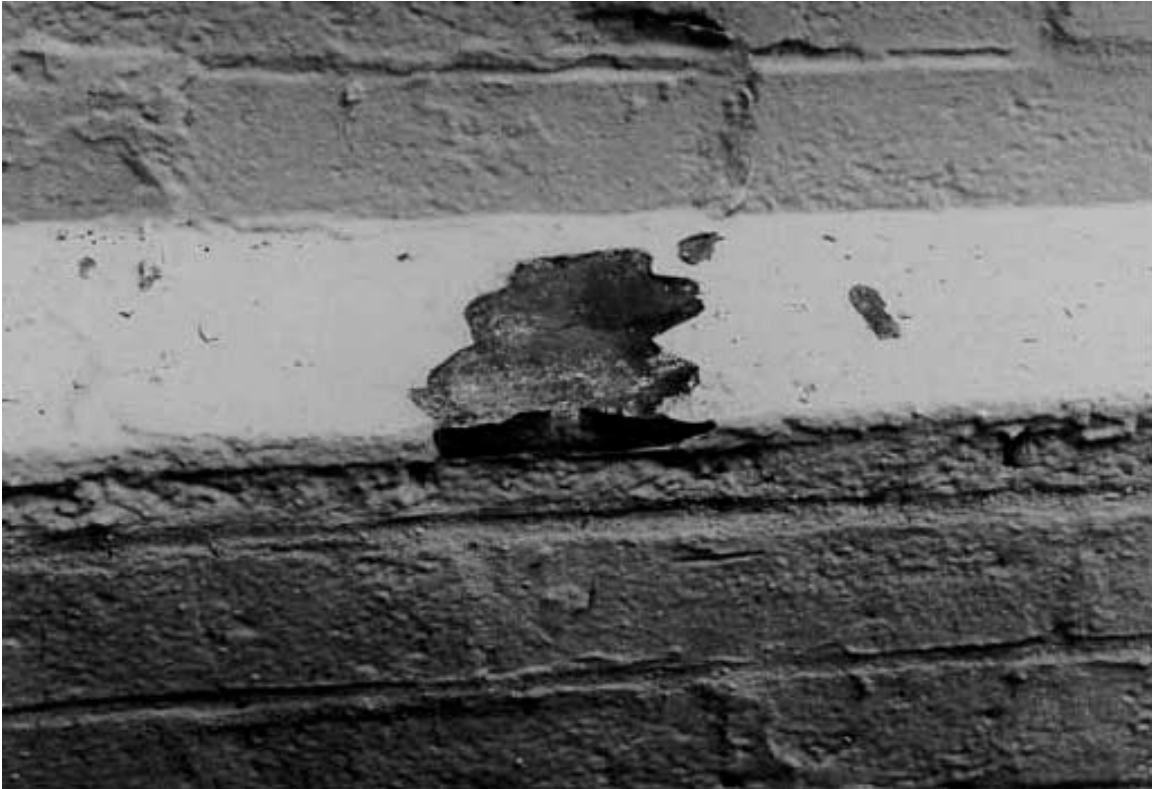
Figure 292
1844 Old Naval Observatory, East Elevation.
The cement-composite “capstone to the water table near grade is failing in many areas.

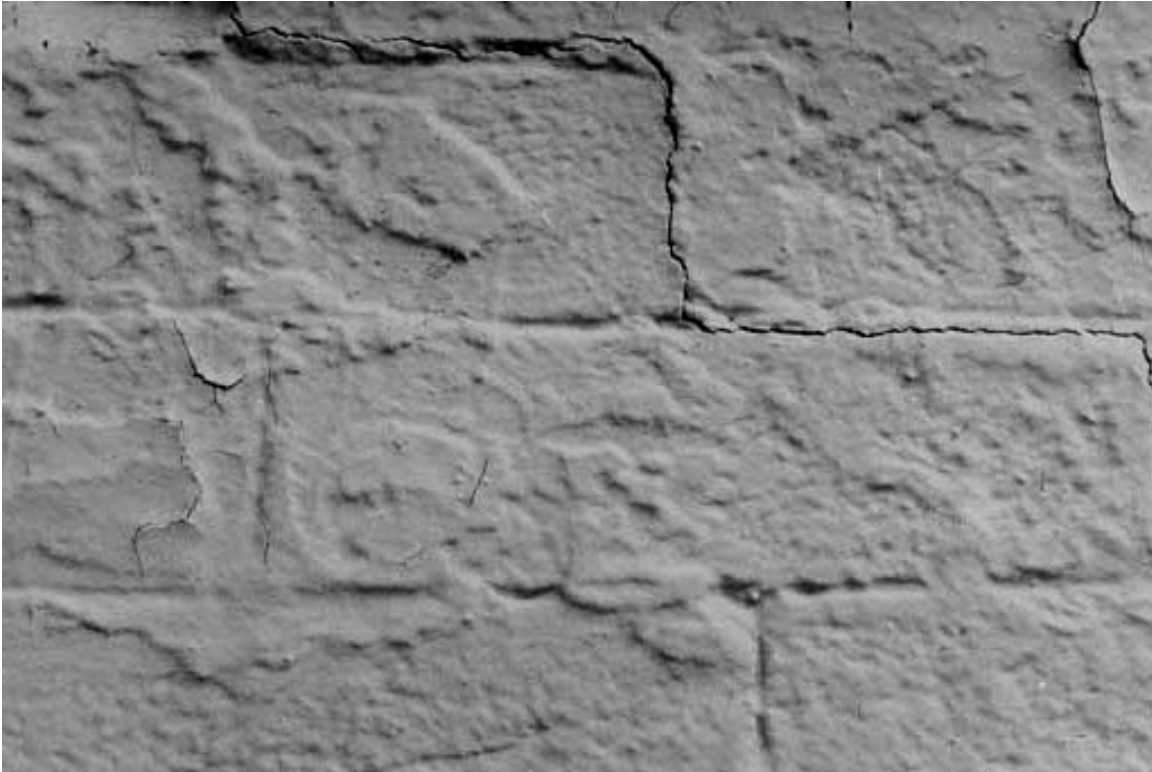
Figure 293
1847 Residence, East Elevation.
Minor stress cracks are found in the mortar joints, but does not extend through bricks.

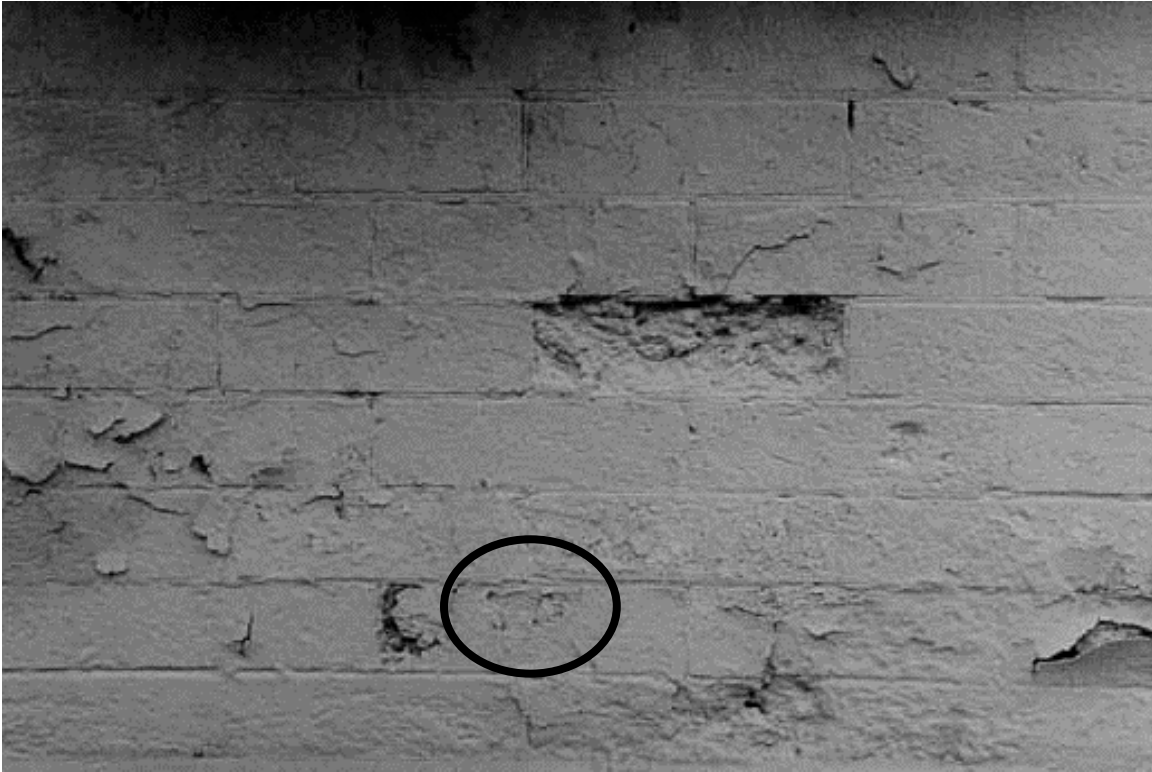
Figure 294
1844 Old Naval Observatory, North Elevation.
Occasionally, a single brick is damaged while surrounding bricks are in good condition. There is also some evidence of efflorescence that was probably caused by damp conditions that were caused by the drainage problems, circled item in photo.

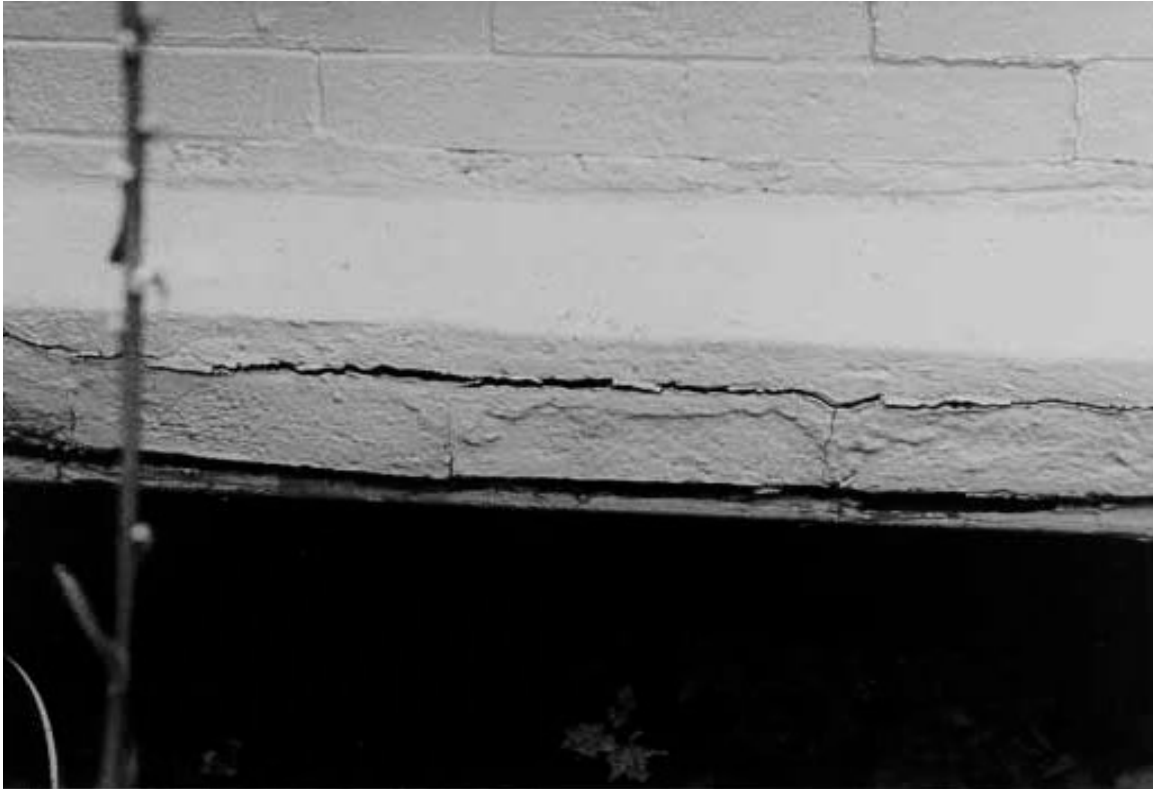
Figure 295
1844 Old Naval Observatory, West Wing, North Elevation
Small, basement level window frames are rotted and the nearby brickwork displaced.

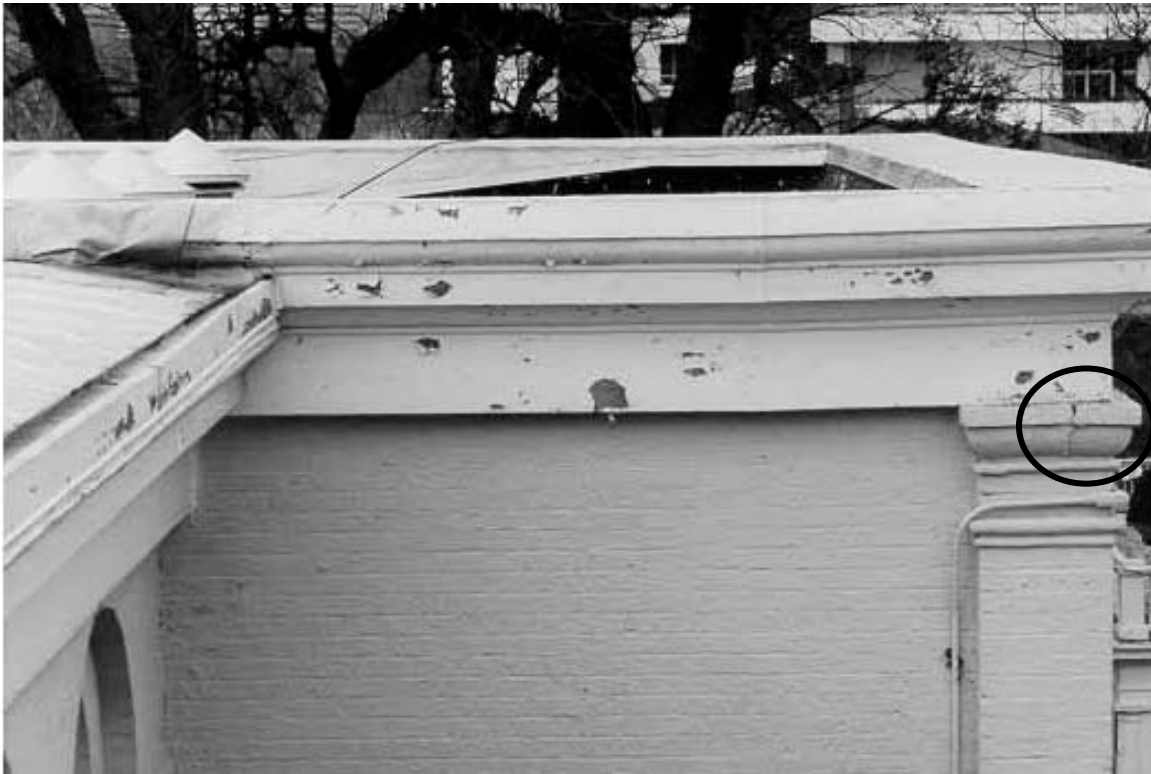
Figure 296
1895, West Addition, East Elevation.
The metal cornice on the north elevation is in good condition. The paint, however, is generally failing. Note the crack in the capital just below the cornice. There are possible roof problems that are effecting this capital, as well as the cornice, see circle in photo.

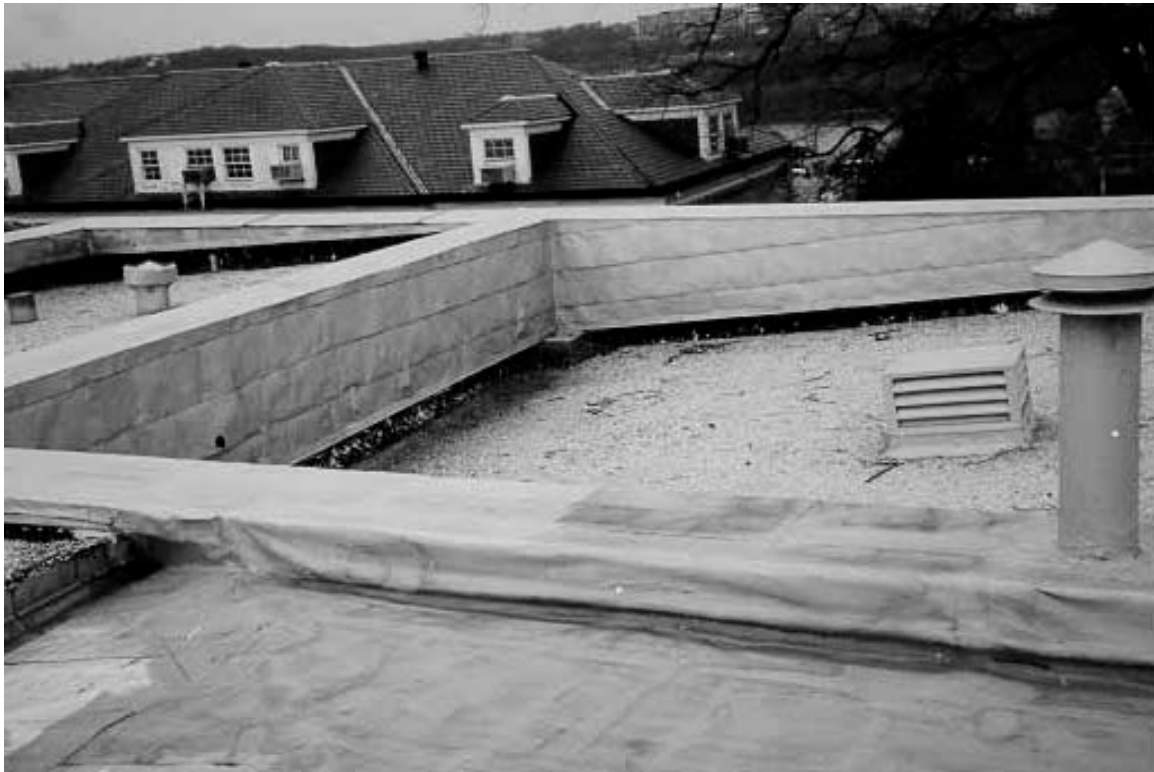
Figure 297
1895, West Addition and 1918 West Stucco Addition.
Roof drains become easily clogged by leaves from overhanging trees. Algae growth is evidence that standing water is present at times.

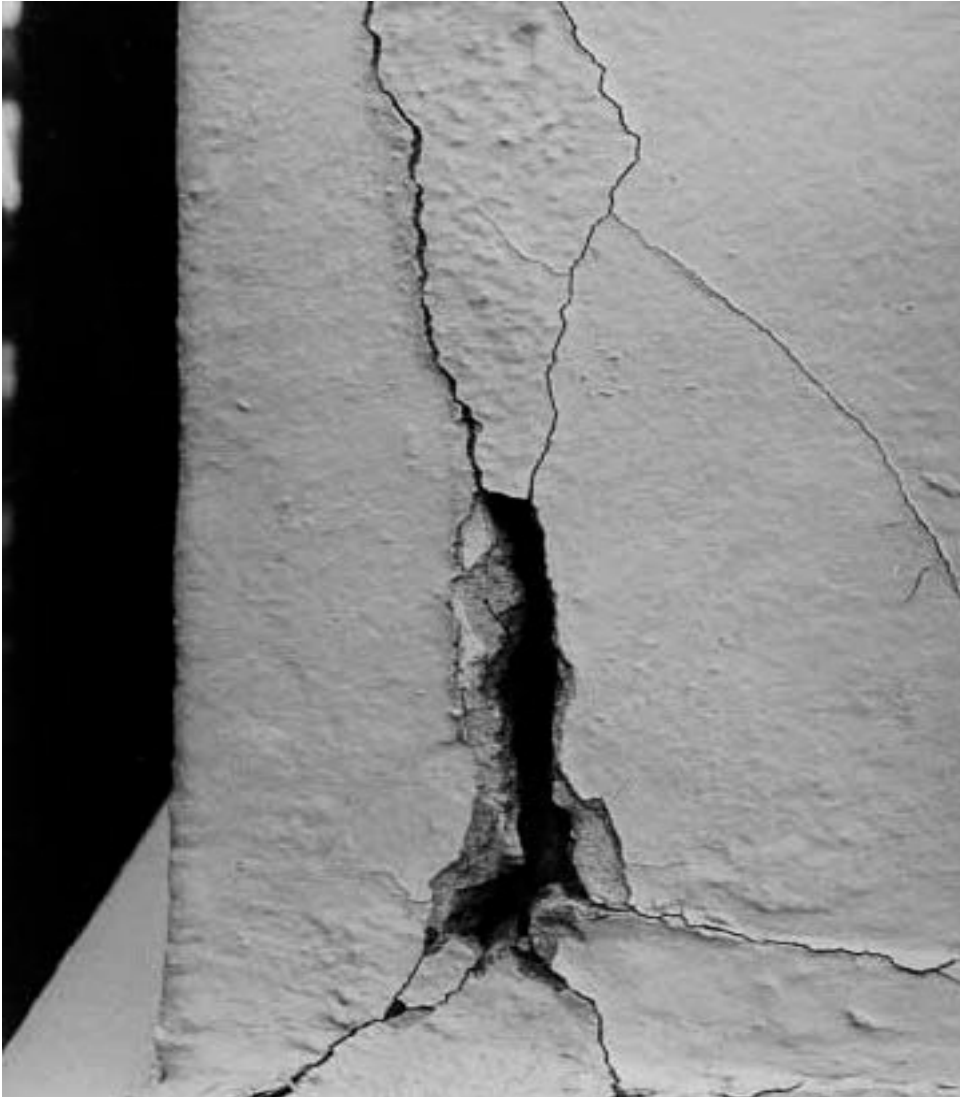
Figure 300
1918, West Stucco Addition.
There is active and extensive damage to the stucco throughout. This damage will continue to expand as the wire mesh further oxidizes.

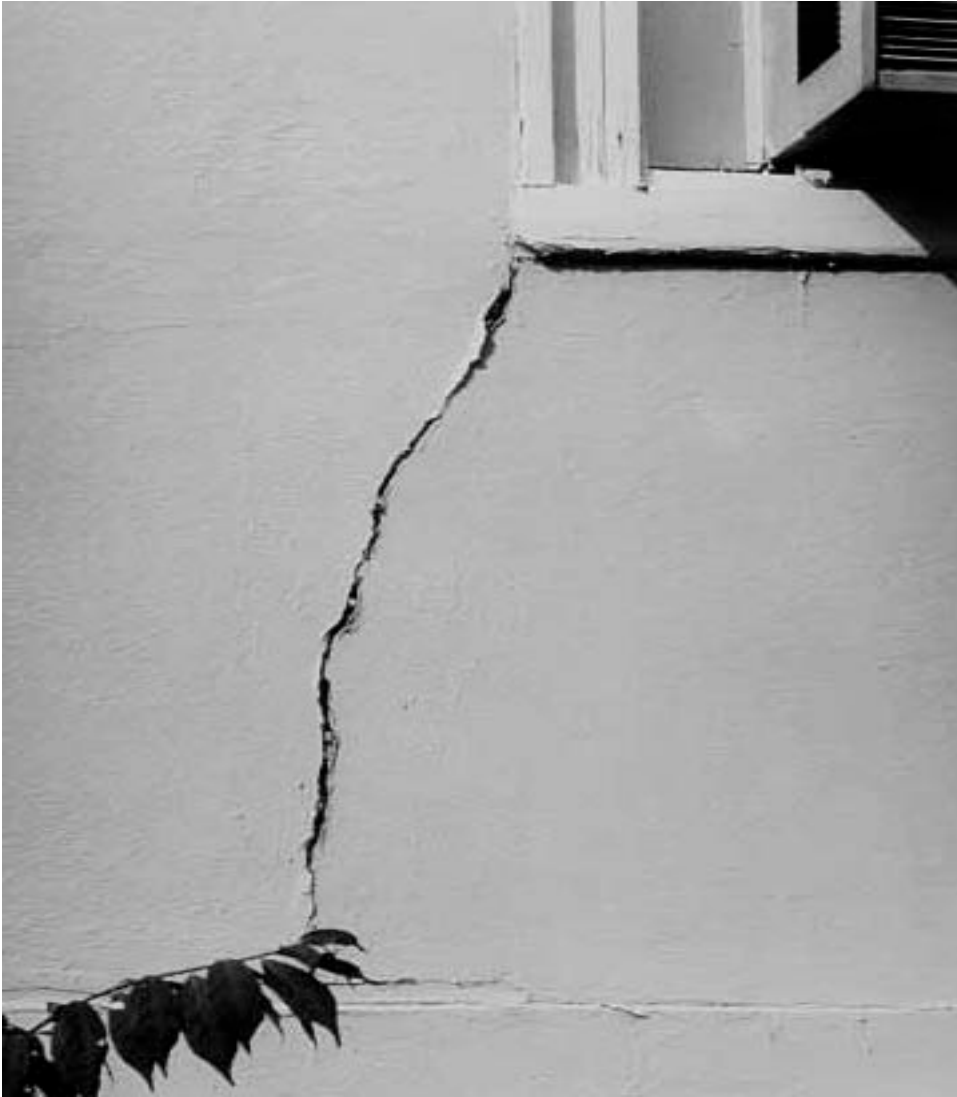
Figure 301
1918, East Stucco Addition, South Elevation.
Damage and failure of stucco on this wing is less extensive than on the west stucco addition.

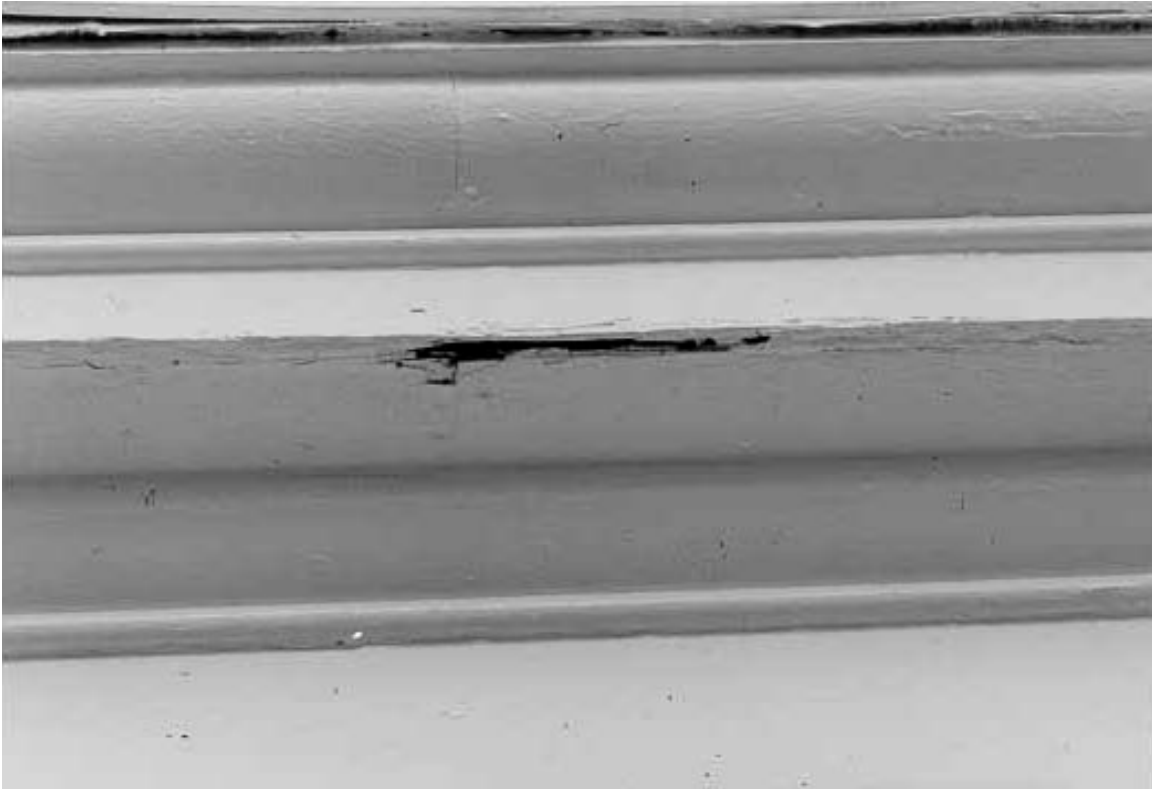
Figure 302
1844 Old Naval Observatory, West Wing, South Elevation.
Portions of the wood cornice exhibit decay.
