Prepared for the US General Services Administration

Oak Ridge National Laboratory

January 2015

# Catalyst-Based Nonchemical Water Treatment System Frank E. Moss US Courthouse Salt Lake City, Utah

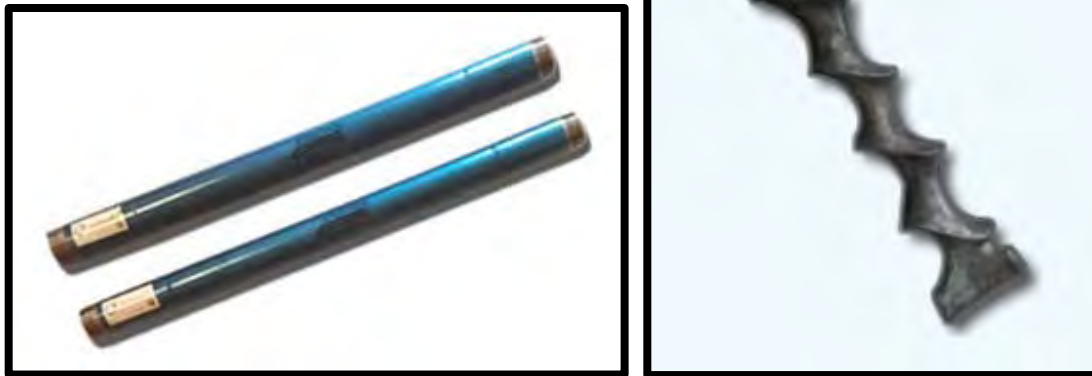
Figure ES-1 shows photographs of the device’s components. The image on the left shows what the exterior looks like. The image on the right shows the helical insert made out of the catalytic alloy. (Photo images were copied from the manufacturer’s website.)

**Figure ES-1. Novel Nonchemical Water Treatment System. No external energy sources are required to operate this device. Periodic maintenance issues that must be addressed are also minimal. Once installed, the system operates as a stand-alone device. The vendor reports that the system has a service life of 15–20 years.**

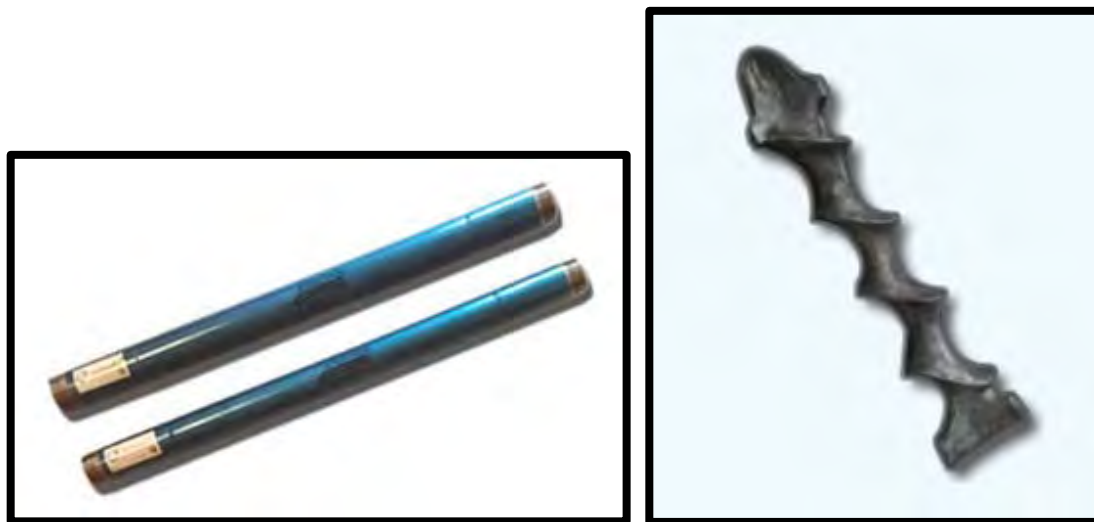
Figure 1 shows photographs of the device's components. The image on the left shows what the exterior looks like. The image on the right shows the helical insert made out of the catalytic alloy. (Photo images were copied from the manufacturer's website.)

**Figure 1. Novel Nonchemical Water Treatment System. No external energy sources are required to operate this device. Periodic maintenance issues that must be addressed are also minimal. Once installed, the system operates as a stand-alone device. The vendor reports that the system has a service life of 15–20 years.**

Inside the pipe is a fixed, immobile helical insert that is made from a proprietary catalytic alloy. As water passes through the pipe, the helical shape causes significant turbulence, which in turn allows water molecules and their associated chemicals to brush against the catalytic insert. According to the manufacturer, as water enters the pipe it impacts with the turbulator on the front end of the alloy. This turbulence causes calcium carbonate to form from the calcium and carbon in the source water. As this calcium carbonate forms and comes in direct contact with the alloy, the properties of the alloy cause it to

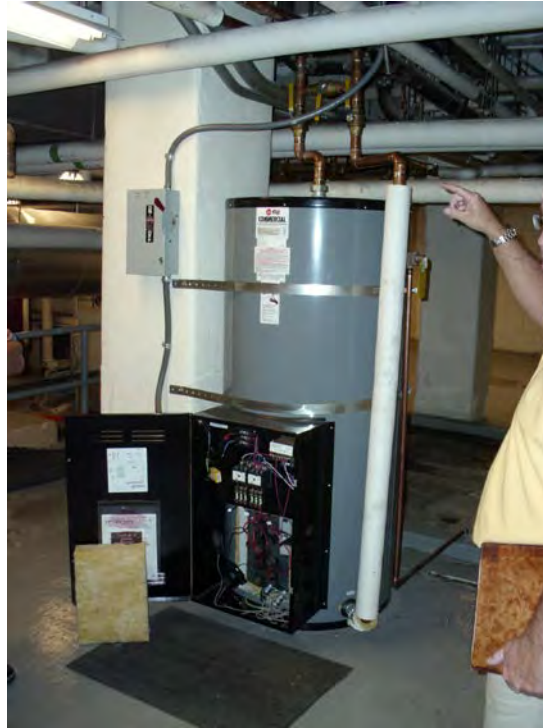
Figure 2 is a photograph of the electric water heater where the test was conducted. The insulated line on the right side is where the system's cold and recirculating water enters the tank.

**Figure 2. Electric Water Heater Where Test Was Conducted.**

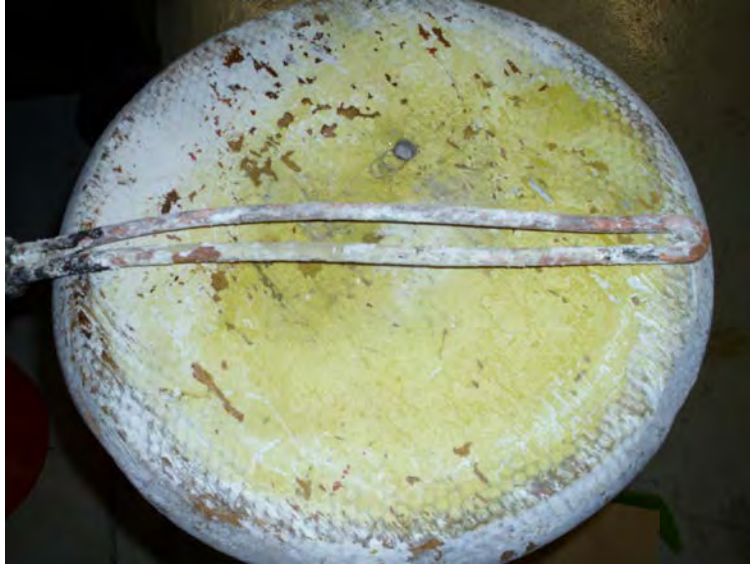
Figure 3 is a photograph of one of the heating elements that was removed. Please note the extensive buildup of calcium, the warped shape due to overheating, and the burn-through near the base of the element that caused it to fail.

**Figure 3. One of the Heating Elements Removed from the Electric Water Heater.**

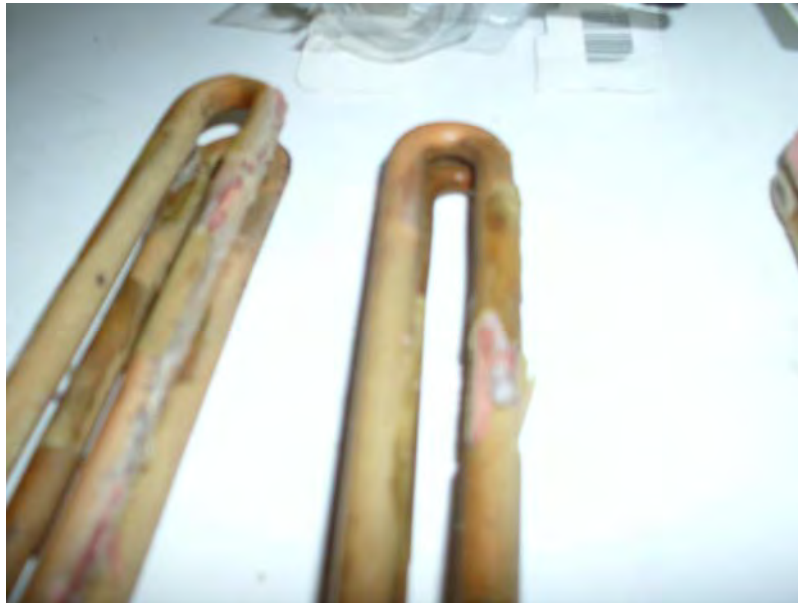
Figure 4 is another photo of a heating element taken at the moment it was removed from the tank. Please note the thickness of the calcite coating. It appears green in this photo due to it still being wet. This buildup was caused after just two months of operation in the tank.

**Figure 4. Heating Element Removed from the Electric Water Heater.**

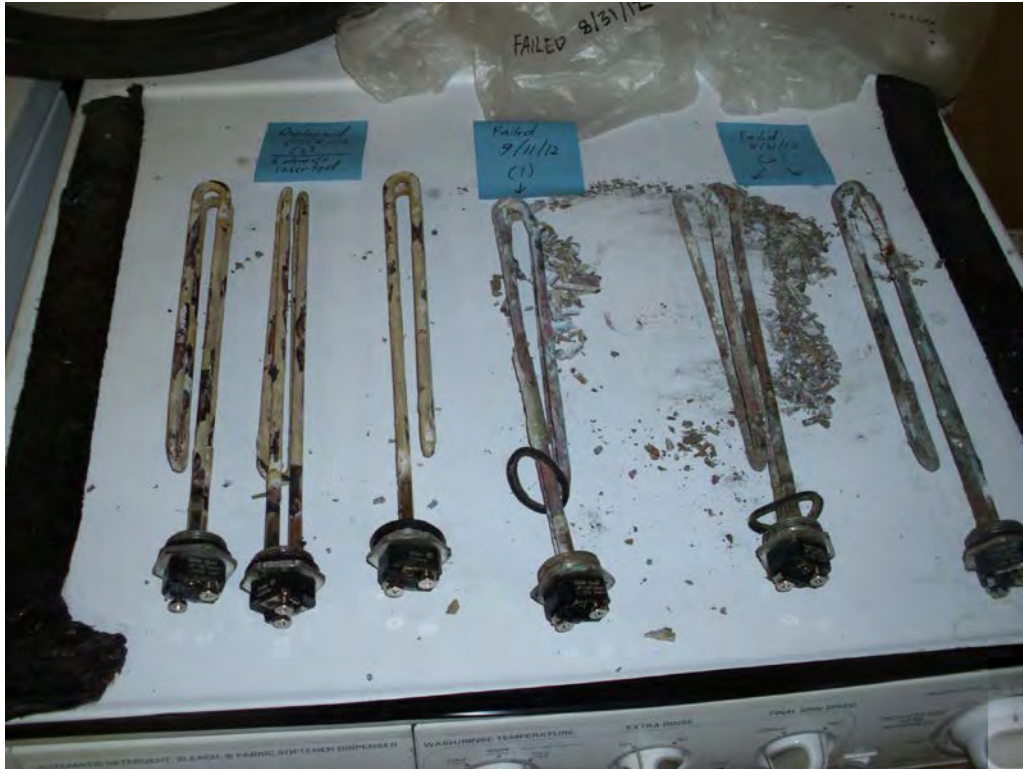
Figure 5 shows all six heating elements, which were removed by site operations personnel during one of the repair sessions. Three elements had failed, and all were severely coated with calcite.

**Figure 5. All Six Heating Elements Removed from the Electric Water Heater During a Repair Session.**

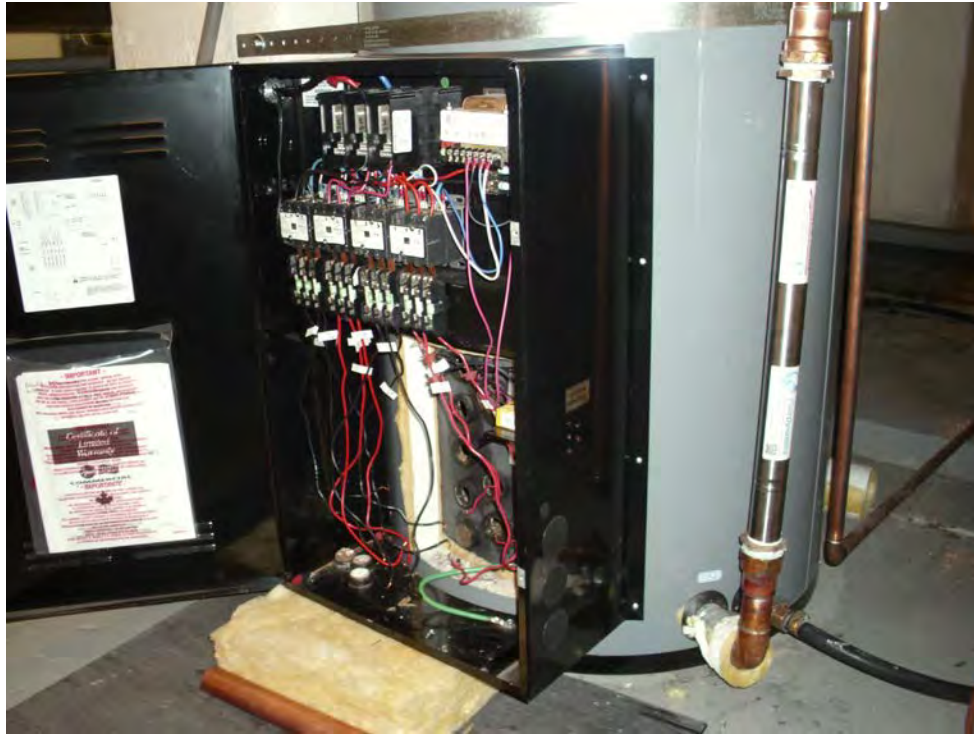
Figure 6 shows the device in its final configuration. It is the silver section of pipe on the right side of the black panel box. This is the cold water inlet to the water heater tank.

**Figure 6. Final Configuration for the Nonchemical Water Treatment System (silver section of pipe on the cold water inlet to the water heater tank).**

Installation of this technology is very straight forward. A section of the cold water and recirculating line was removed, appropriate pipe fittings were installed, and the technology was installed just as any pipe spool piece would be installed. Labor to install the device was only \$500 (10 person-hours at \$50/hr).

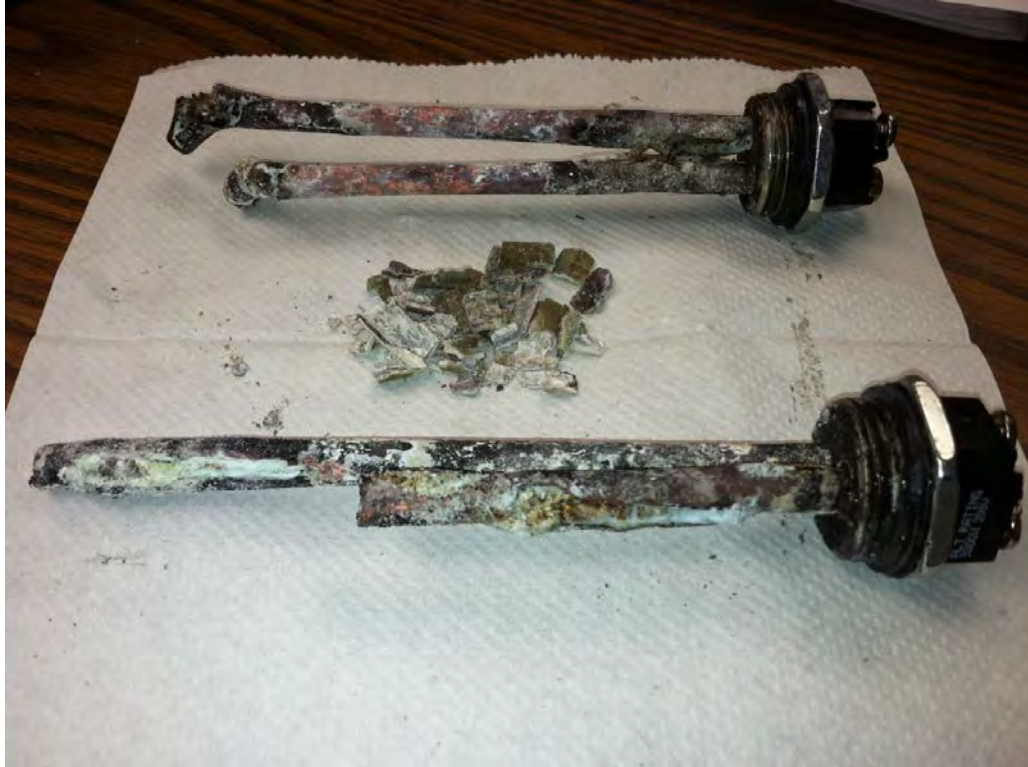
In December 2012, the GSA building manager contacted ORNL to say that it appeared that all three elements had again failed and ask for further guidance on what to do. After consultation with the project team, the elements were removed and their condition documented. Figure 7 shows two of the three failed elements.

**Figure 7. Two of the Three Failed Heating Elements from December 2012.**

The failure mode was the same as during the “before” test. Excess calcium buildup caused overheating and premature failure of the elements.

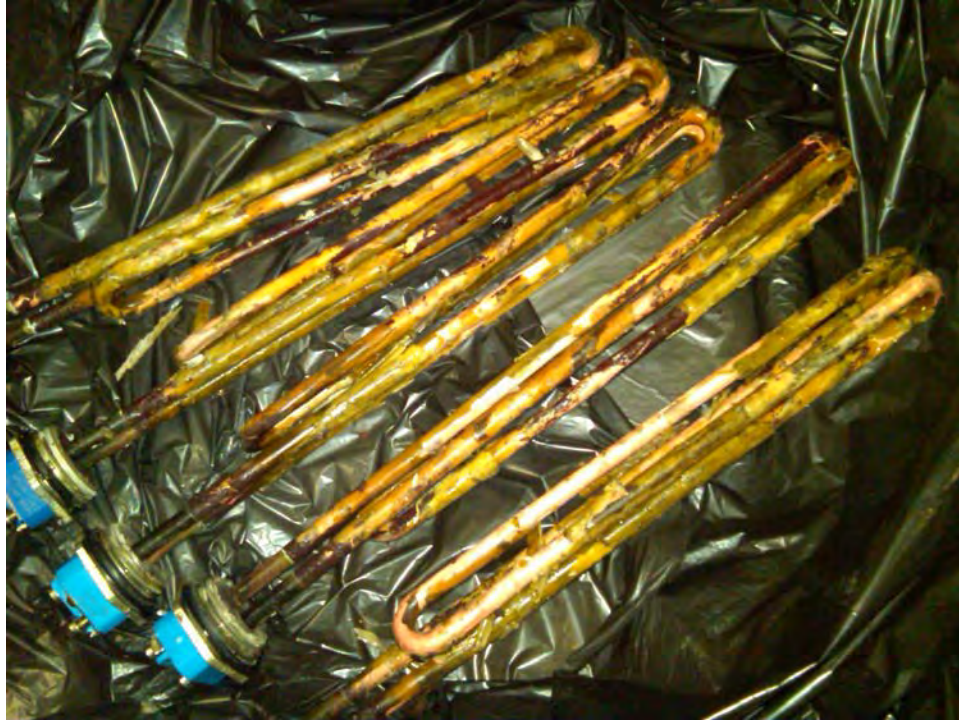
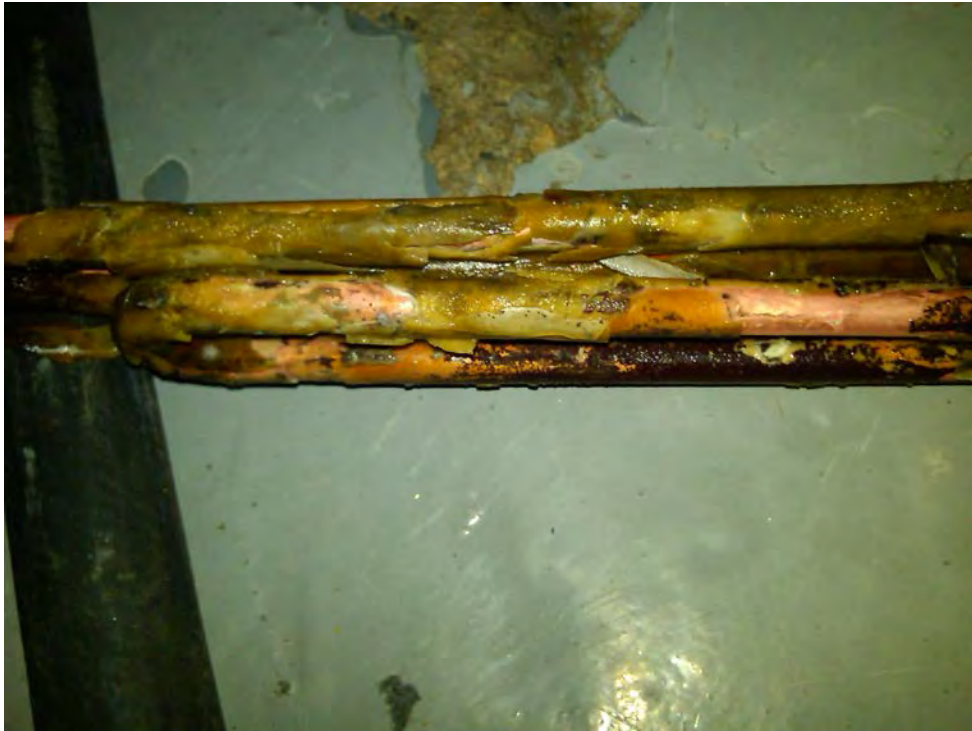
The heating elements that were removed all showed severe buildup of calcite, and this was after only two months of operation. They also showed signs of overheating and bending, which are precursors of failure (Figure 8).

**Figure 8. Heating Elements Removed June 2013.**

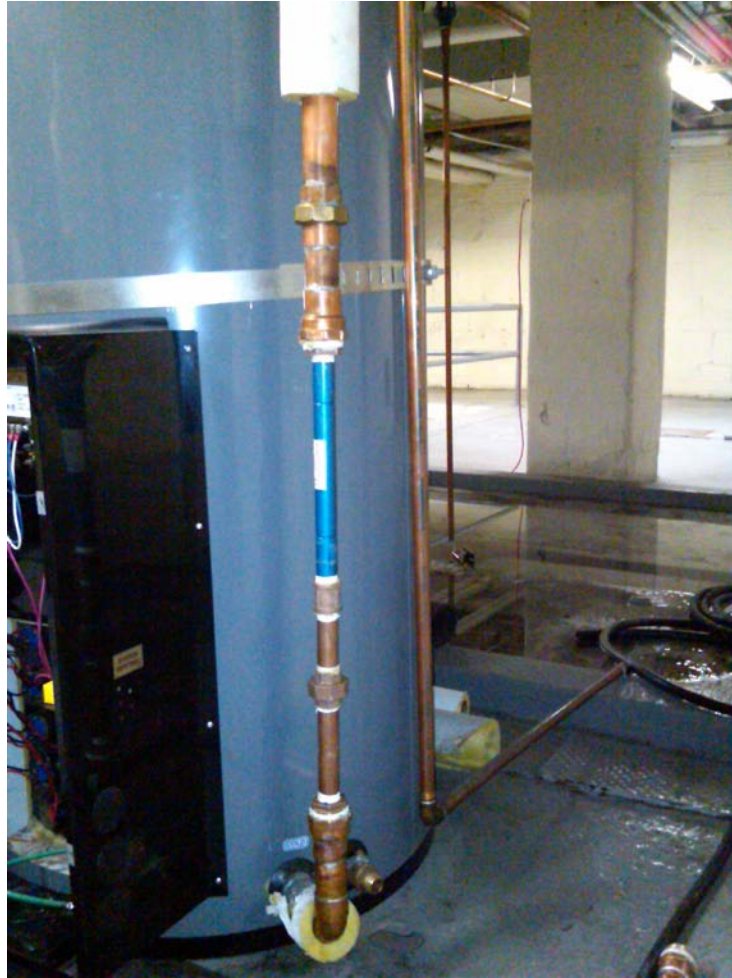
Figure 9 shows the 0.75 in. device installed where the 1.25 in. device had been located.

**Figure 9. Electric Water Heater Showing the 0.75 in. Device (blue) Installed on the Cold Water Inlet Pipe.**

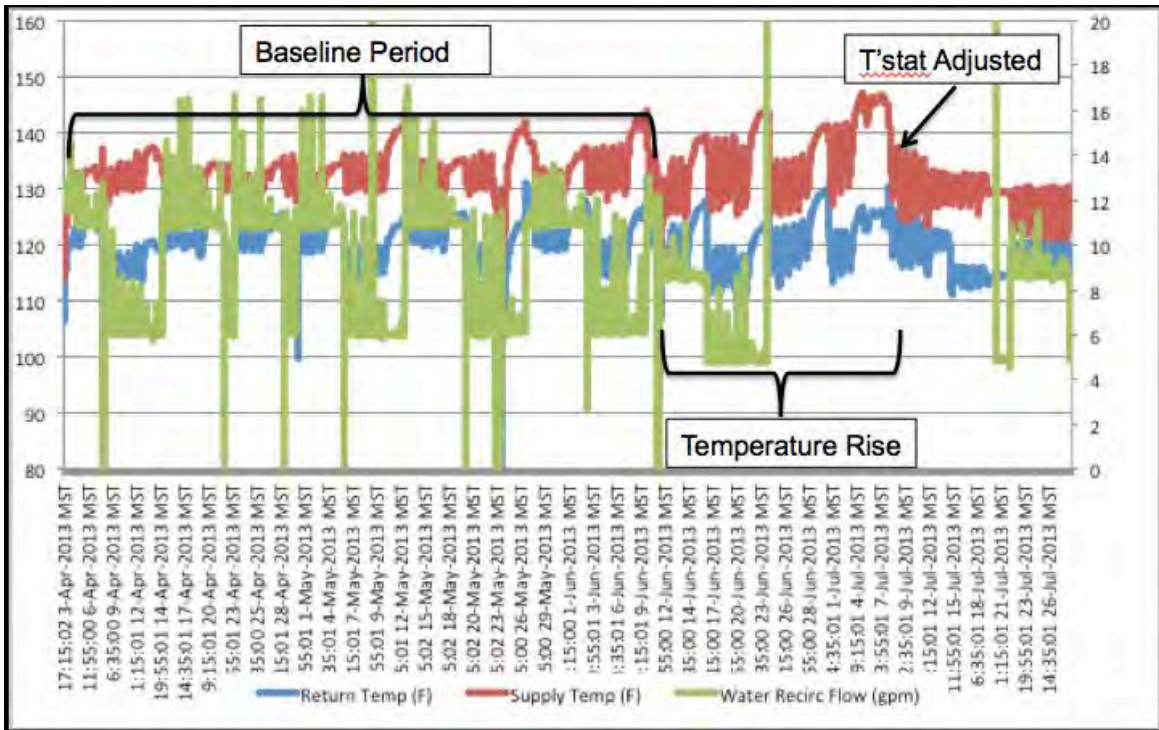
In early July 2013, site operations personnel observed that the temperature of the domestic water heating system had risen to almost 150°F. At this point they felt that it was too hot for safe use in the facility, so on July 12 they adjusted the thermostat to its next lowest setting. After checking the temperature trends of the system, personnel determined from the data that the temperature rise began at the same time that the catalyst-based NCWT device had been installed (Figure 10). It should be noted that the electric heating elements, in their efforts to maintain the temperature set point, remained energized 24 hours a day, even over weekends. This constant state of being energized was required because the elements were so caked with calcite, which was acting as an insulator and impeding heat energy from easily transferring from the element to the water.

**Figure 10. Graph Showing Water Heating System Temperature Trends Over Time.**

After the thermostat was adjusted, temperature in the system went back down to around 130°F, where it was supposed to be. Data from the electrical meter on the heater noted that at this point the heating elements began to cycle off when the temperature reached its set point. Figure 11 is a graph of the electric current showing it cycling off during the night and on weekends when usage is low.

The following is an enlarged image of Figure 10 from the main body of the report. It is being shown here for clarity's sake.

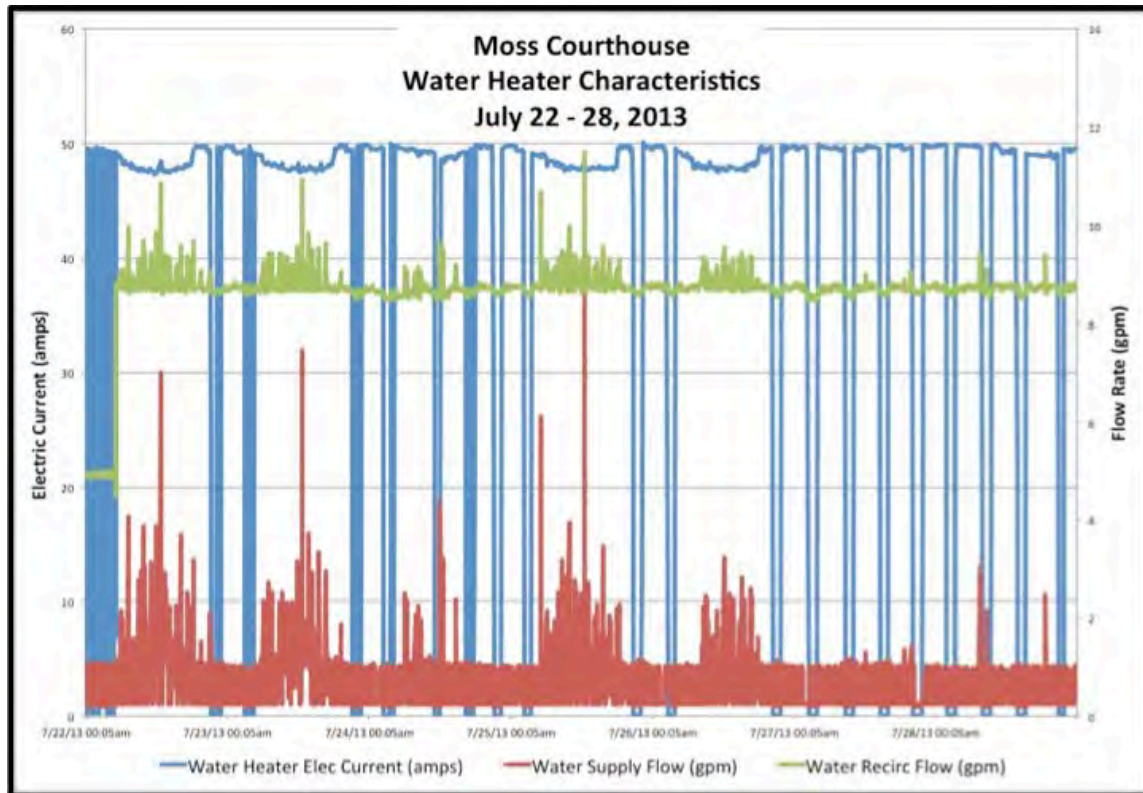
The manufacturer’s recommended flow rates are consistent with what was measured in the above graph. Please note that the step changes in flow rates are caused when the two circulating pumps alternate between each other. One pumps at about 6 gpm, the other around 11 gpm (Figure 10). It should be noted that a set of flow rate data was lost due to meter failure. However, discussions with site operations personnel plus analysis of data before and after the meter failure gave the evaluation team confidence that there were no variations in the building operating characteristics during the gap in data.

After scrutinizing the data, ORNL researchers concluded that it appeared that more heat was being transferred from the heating element into the water. The only thing that could have allowed this to happen is a reduced buildup of calcium on the heating elements.

**Figure 11. Graph Showing Electric Current and Water Flow Rates.**

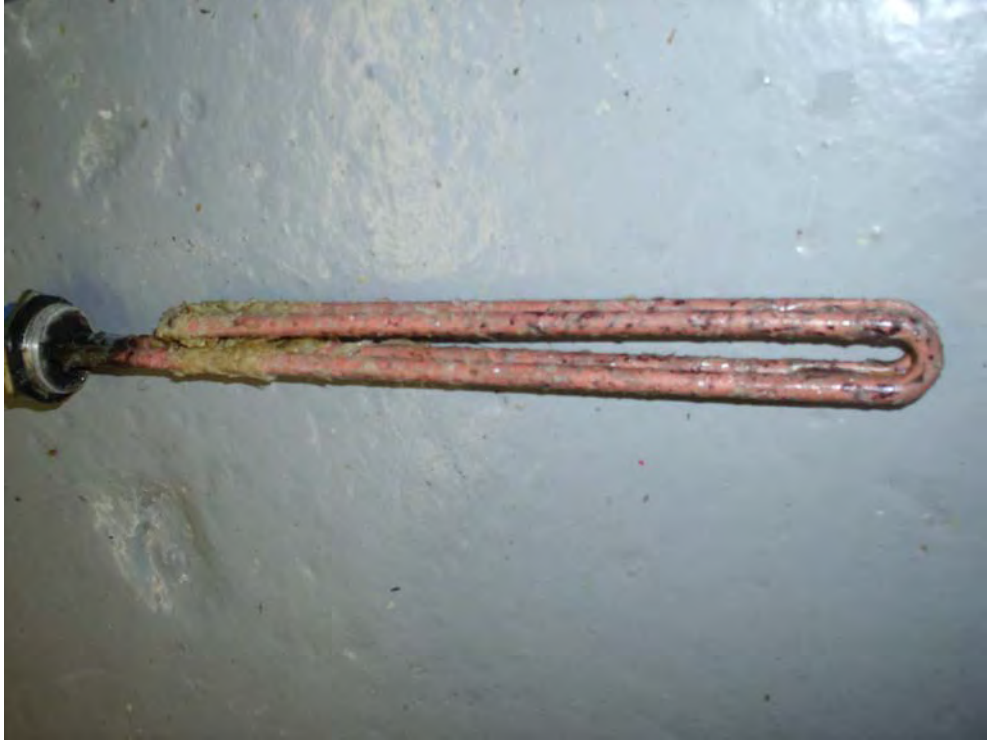
On August 20, 2013, the team met in Salt Lake City to examine the elements for calcium buildup. The six elements were removed, and they were indeed dramatically cleaner than had been seen in the past. Most of each element was bare metal with no buildup whatsoever. What calcium was found on the elements was in the form of very thin flakes. Also, there was no evidence of overheating or warping, which indicates there is no reason to fear impending failure of these elements (Figure 12).

**Figure 12. One of the Six Elements Examined August 20, 2013.**

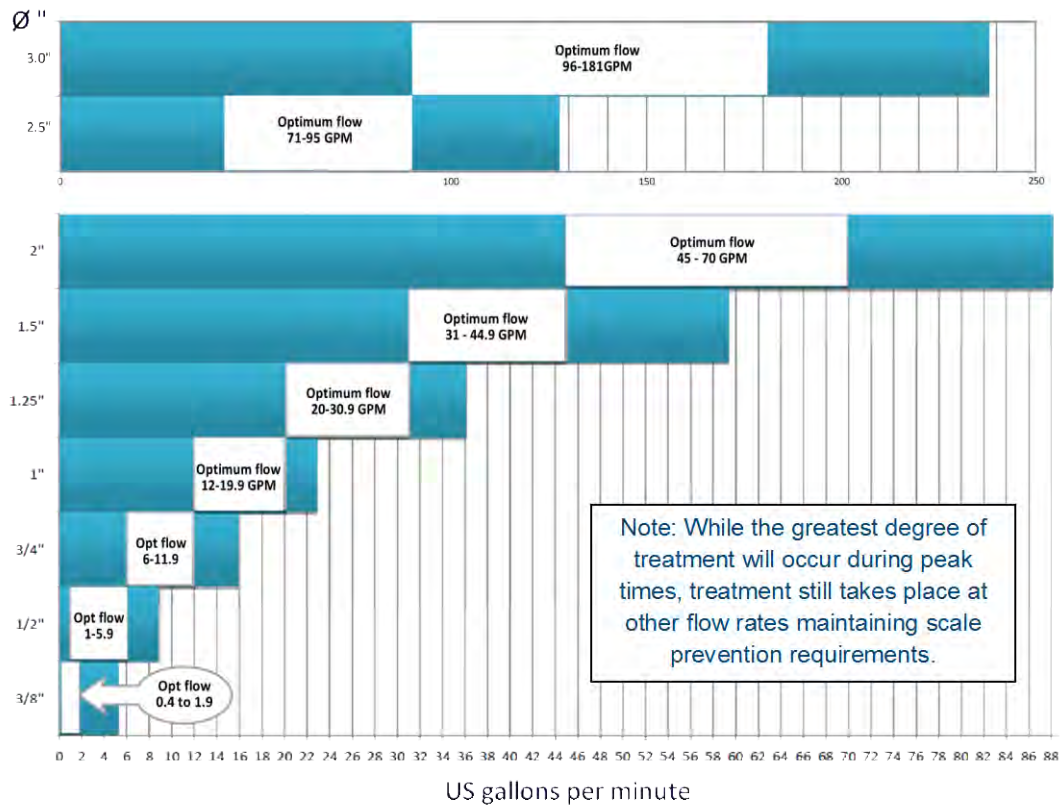
## PRODUCT SELECTION GUIDANCE CHART:

Actual maximum throughput (GPM) will vary according to system pressure.
