Case Study: Columbus US Land Port of Entry

SITES v2 (2019)

LOCATION: Columbus, New Mexico

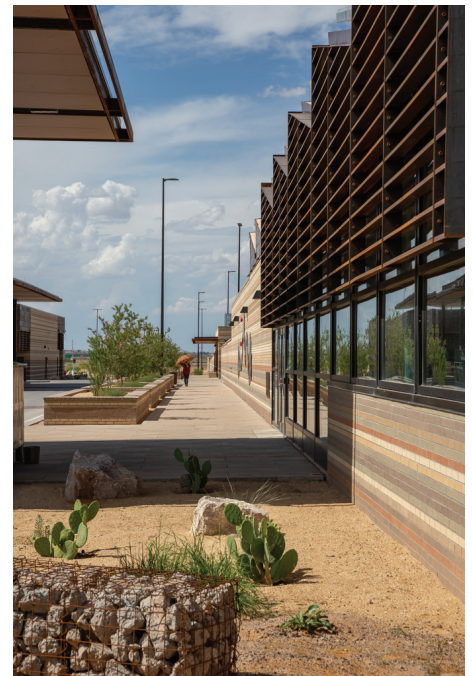
Gabion wall and planters along the west side of the main building. Photo by Robert Reck.

All roof runoff from the main building is directed to a runnel along the south side of the building. The runnel directs water to a series of planted water harvesting terraces and depressions. The terraces are formed by gabion walls, which are filled with concrete salvaged on-site from the original port.

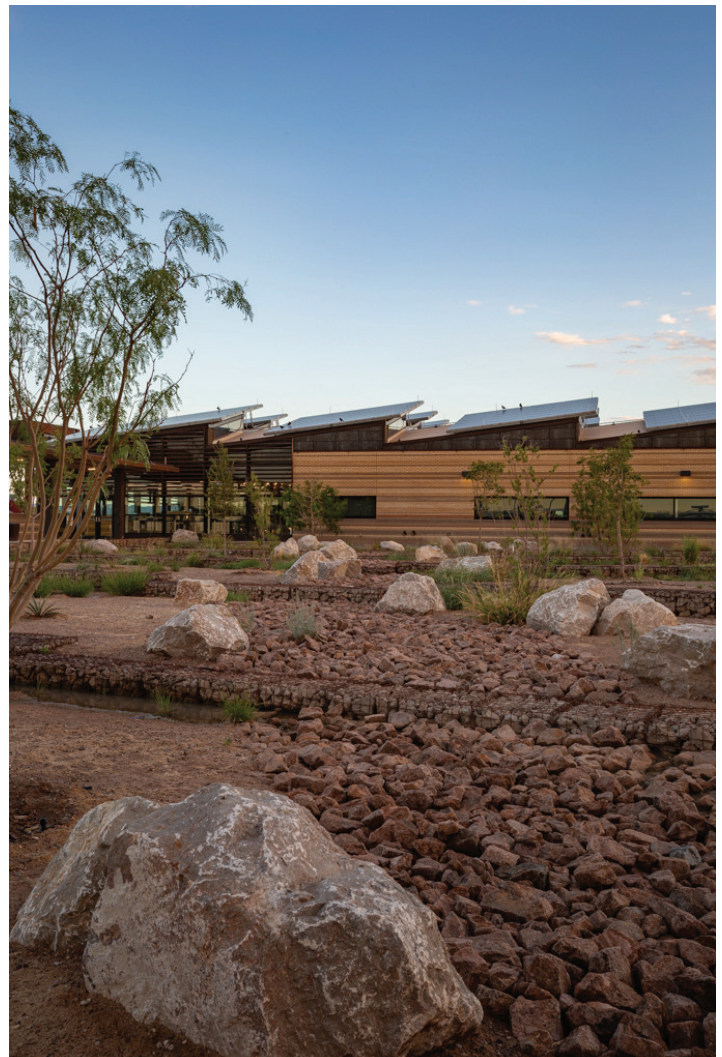
*A desert wash carries roof runoff through the landscape.
Photo by Robert Reck.*

The lowest point of the site has been transformed into a desert wash, including desert riparian vegetation, which creates an ecological and aesthetic amenity out of a requirement for on-site retention of large volumes of stormwater.

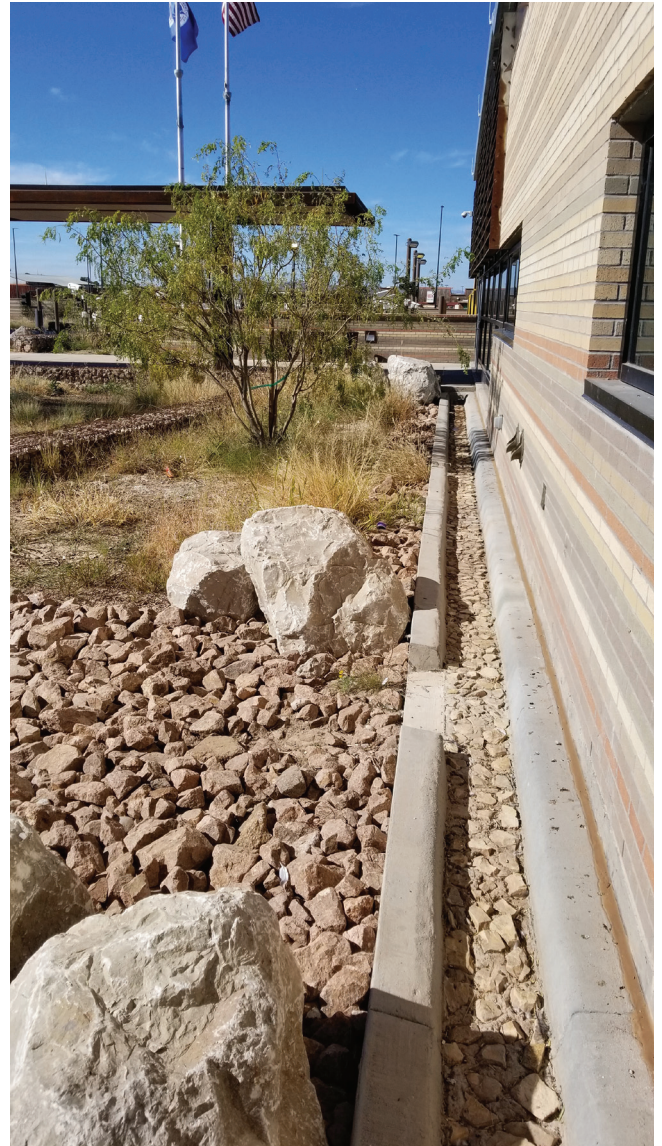
The runnel collects roof runoff, distributing it to water harvesting terraces. Photo by Aaron Zahm.

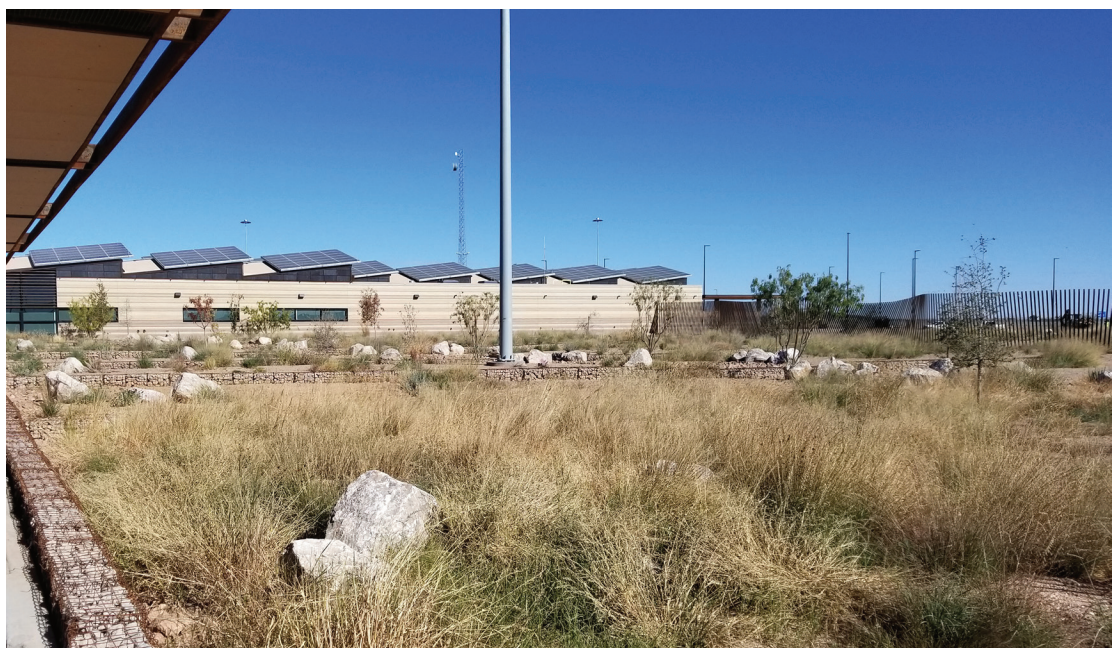
Restored grasslands on water harvesting terraces. Photo by Aaron Zahm

Water harvesting basins are located throughout the site. These basins are planted with desert riparian species and include compost soil sponges to increase plant health and infiltration rates. Flush curbs used throughout the site allow all runoff to flow into one of the water harvesting basins.

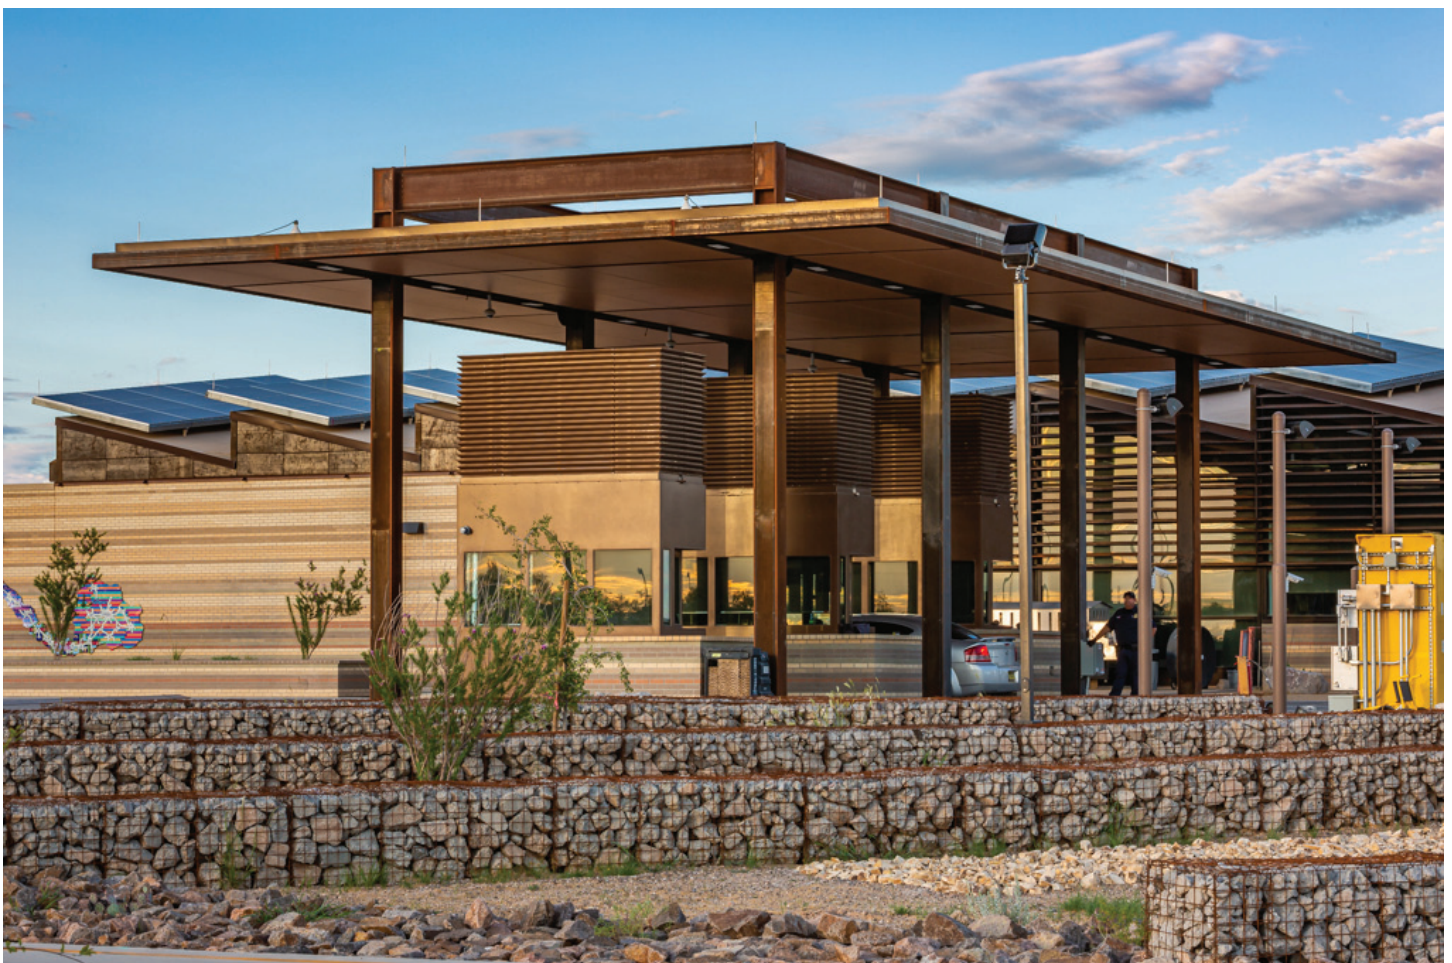
Salvaged concrete reused for gabion fill material. Photo by Robert Reck.

Inclusion of native and low-water-use plants decreases maintenance and fertilizer needs, which reduces the cost of maintenance. Trees and shade structures located near walkways and parking lots will increase the lifespan of concrete and improve human health by blocking solar radiation. On-site retention of stormwater decreases occasional flooding in the area, while also decreasing the cost of treating and delivering potable water for irrigation by 2-3 million gallons per year. Selection of efficient electrical equipment reduces annual kWh for outdoor use by 36% annually. All concrete and asphalt from the original port was salvaged and re-used in the expansion project.

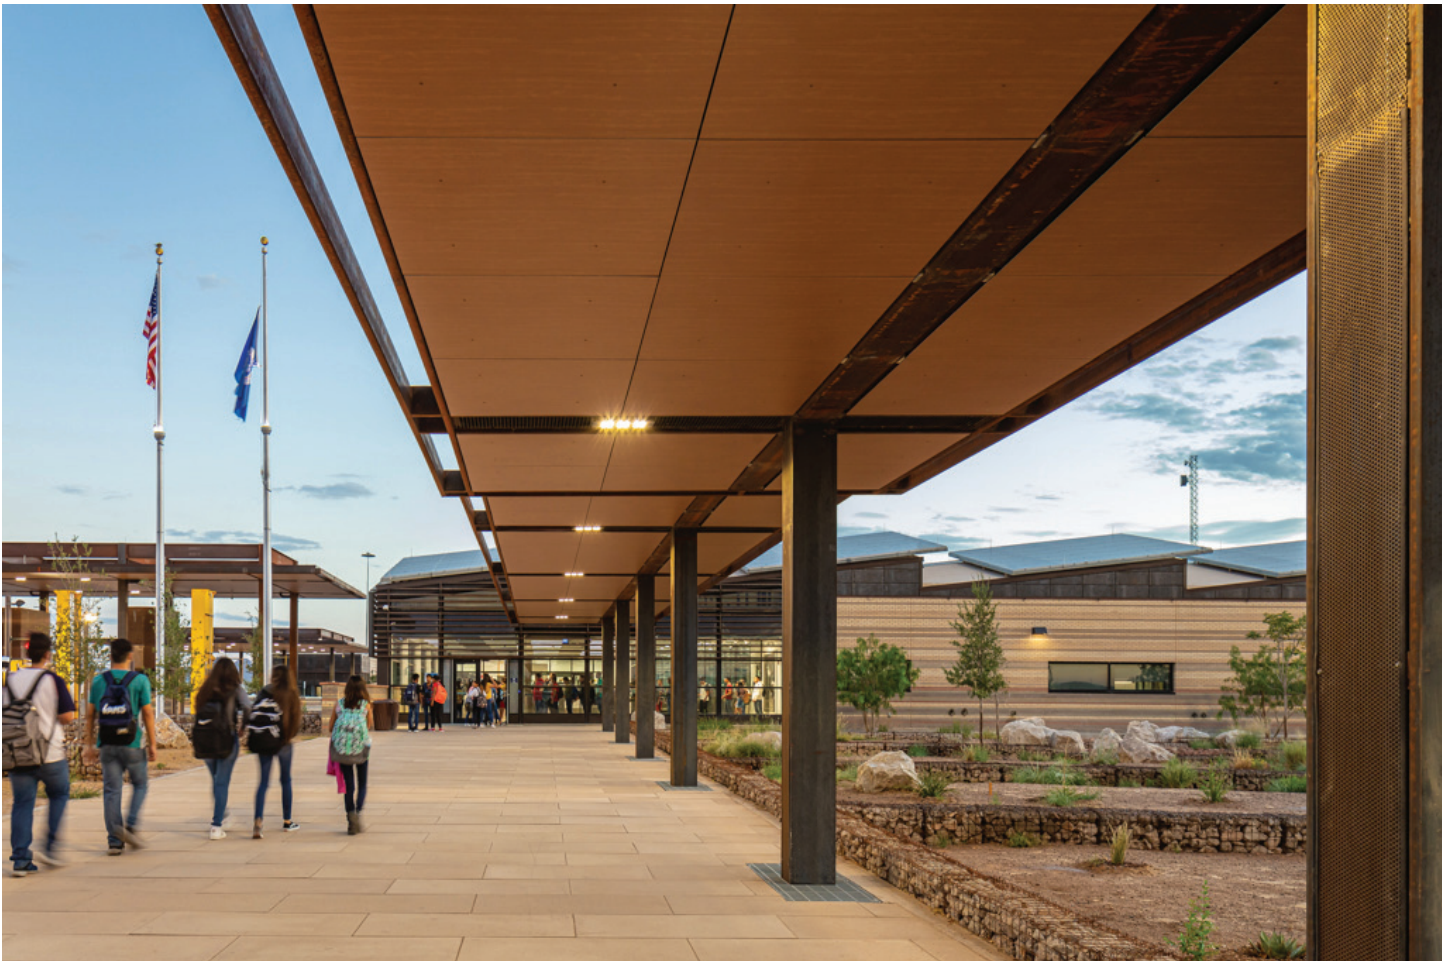
Shaded walkway leading to main pedestrian checkpoint. Photo by Robert Reck.

Any successful project in a desert needs to provide shade. This project did so through location of trees and shade structures along walkways. Within 10 years of planting, 13,360 square feet of walkways and driving surfaces will be shaded by trees, and an additional 37,610 square feet are shaded by overhead canopies. High Solar Reflectance Index (SRI) materials for all roofs and paved surfaces further mitigate surface temperatures.
