POTOMAC ANNEX BUILDING 2

**HISTORIC STRUCTURES REPORT
CORRECTED FINAL SUBMISSION**

Prepared for the U.S. General Services Administration

Swanke Hayden Connell Architects

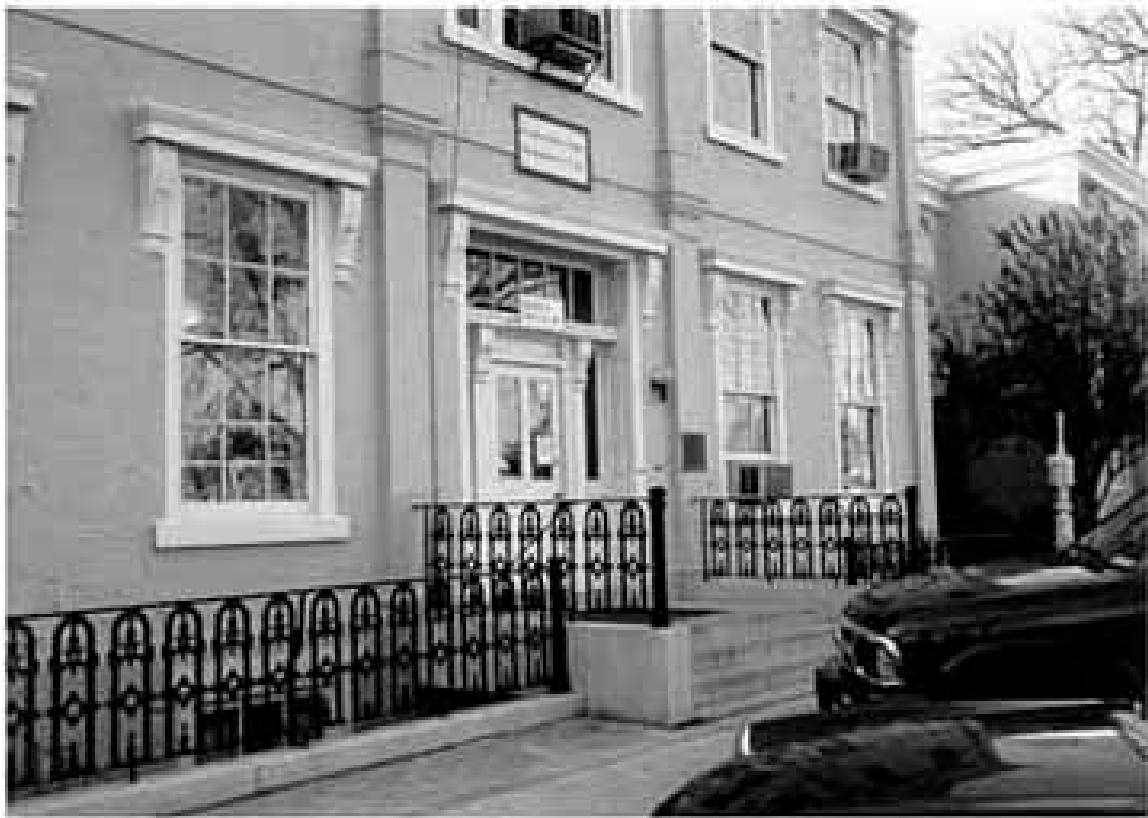
The retaining wall facing the basement level foundation wall is unpainted ashlar schist and gneiss. The wall is capped with an 8" light-gray granite coping stone. The mortar joints appear to have been re-pointed recently. The joints appear to be in good condition. An original cast iron fence is set into the granite coping. The coping runs along the front of the areaway and up to the front door see Figures 65 and 66. The railing is painted and is in good condition. However, there are rust stains that are visible on the granite adjacent to the railing stanchions.

Figure 65
Old Naval Observatory 1844)
First floor entryway, north elevation. Note that granite steps and areaway coping were replaced recently. Cast iron elements were stripped and refurbished.

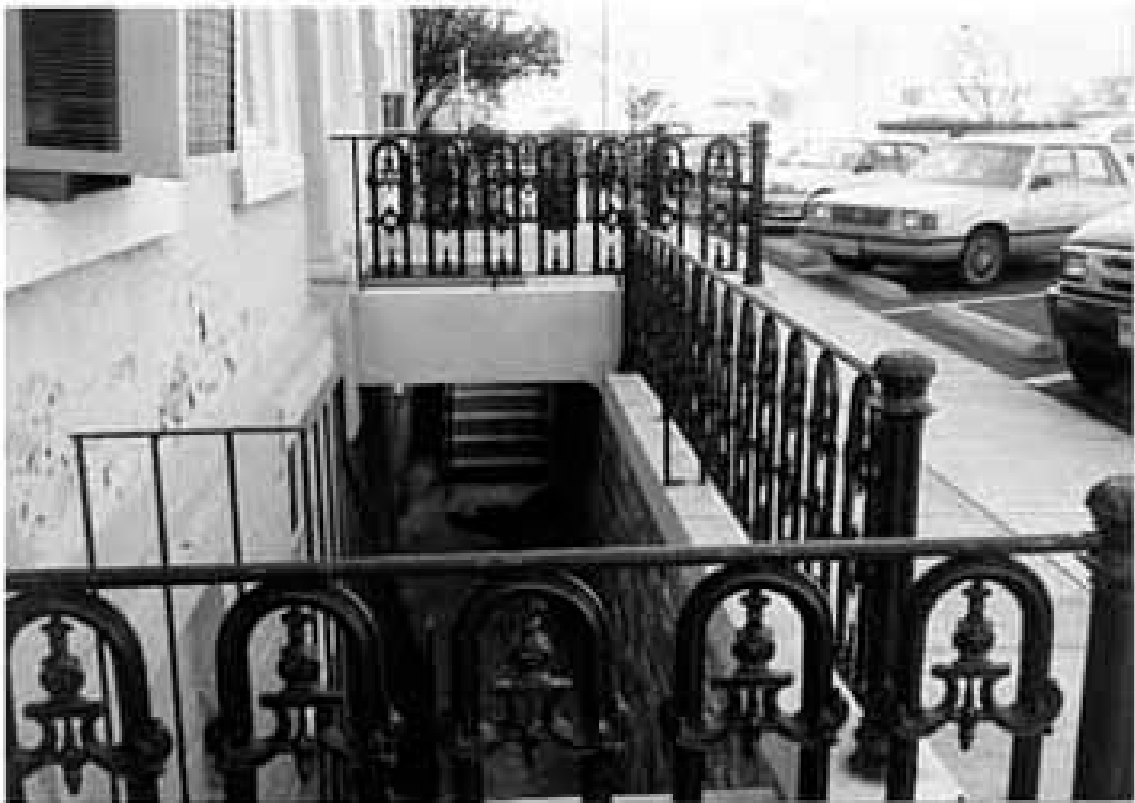
Figure 66
Old Naval Observatory (1844)
North Elevation. Detail of cast iron fence and areaway.

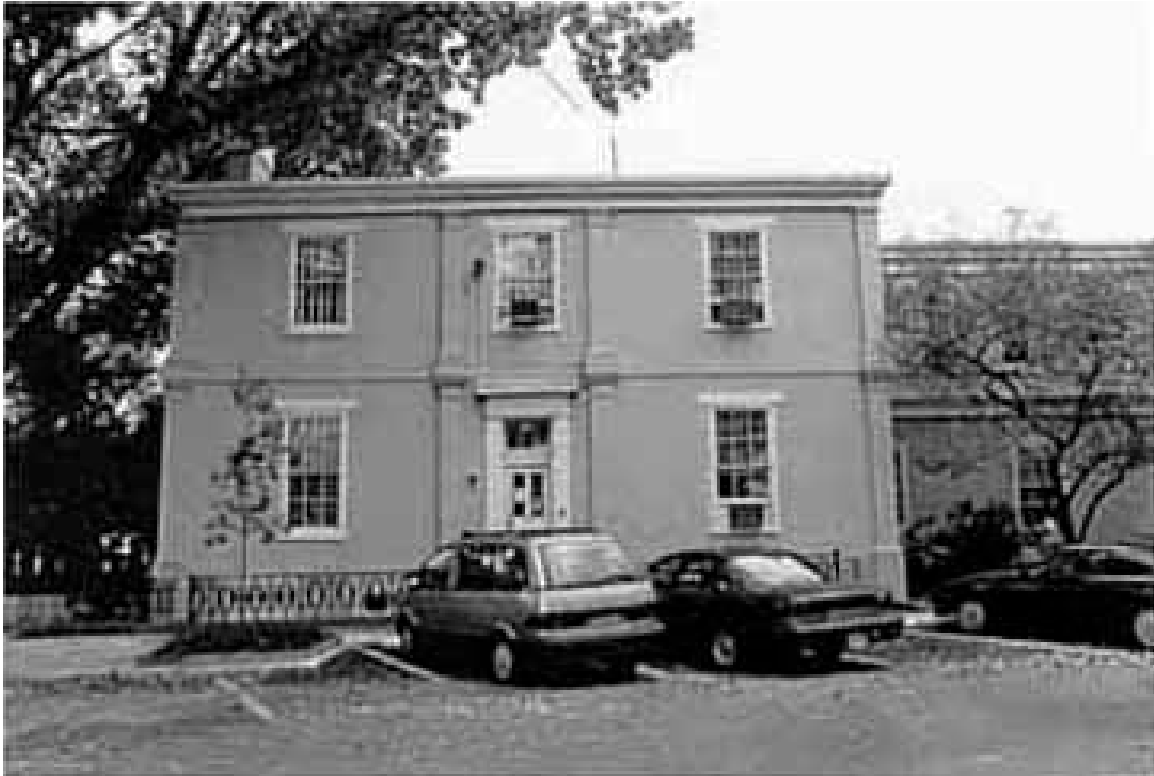
Figure 83
Residence (1847)
North Elevation. Residence is connected to the Old Naval Observatory by the east wing.

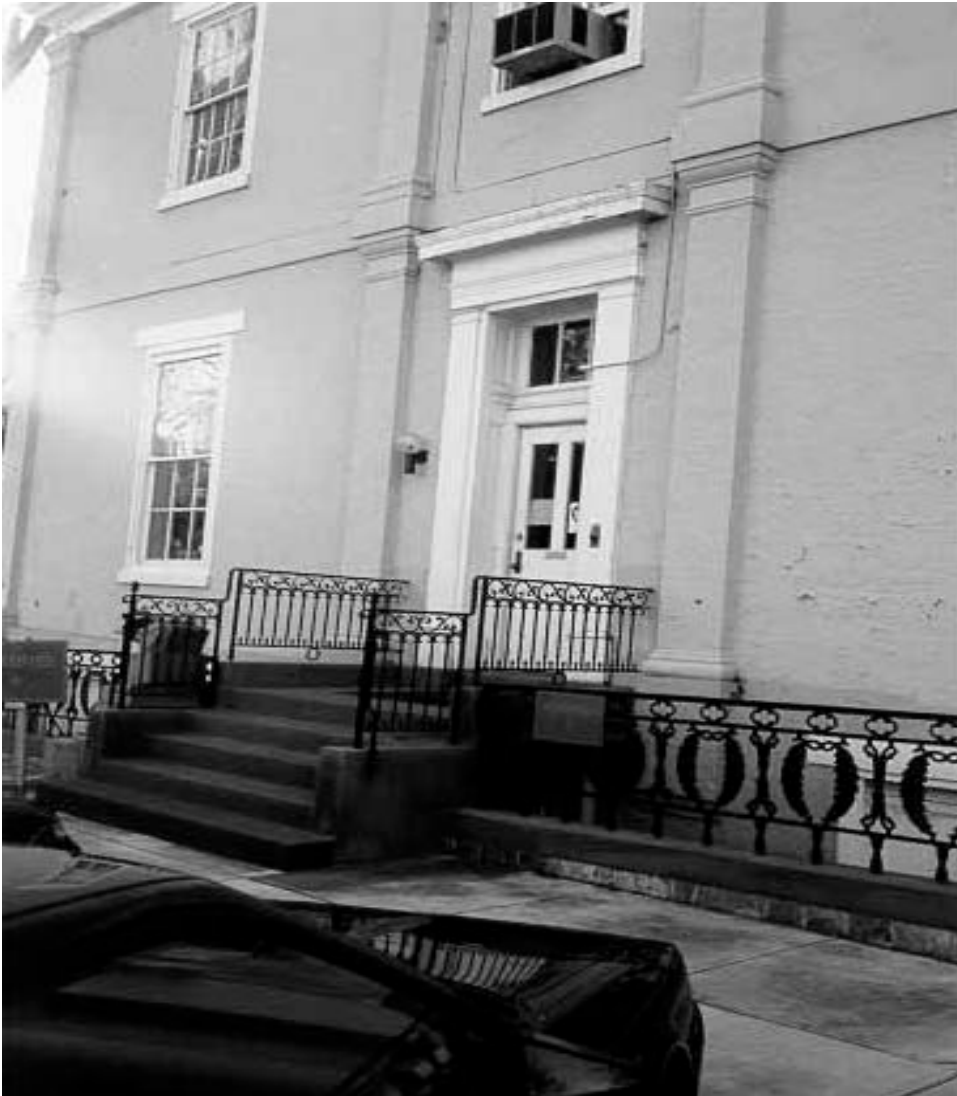
Figure 85

North Elevation entry. Red sandstone steps and coping were recently replaced in kind. Wrought and cast iron elements were stripped, painted, and refurbished.

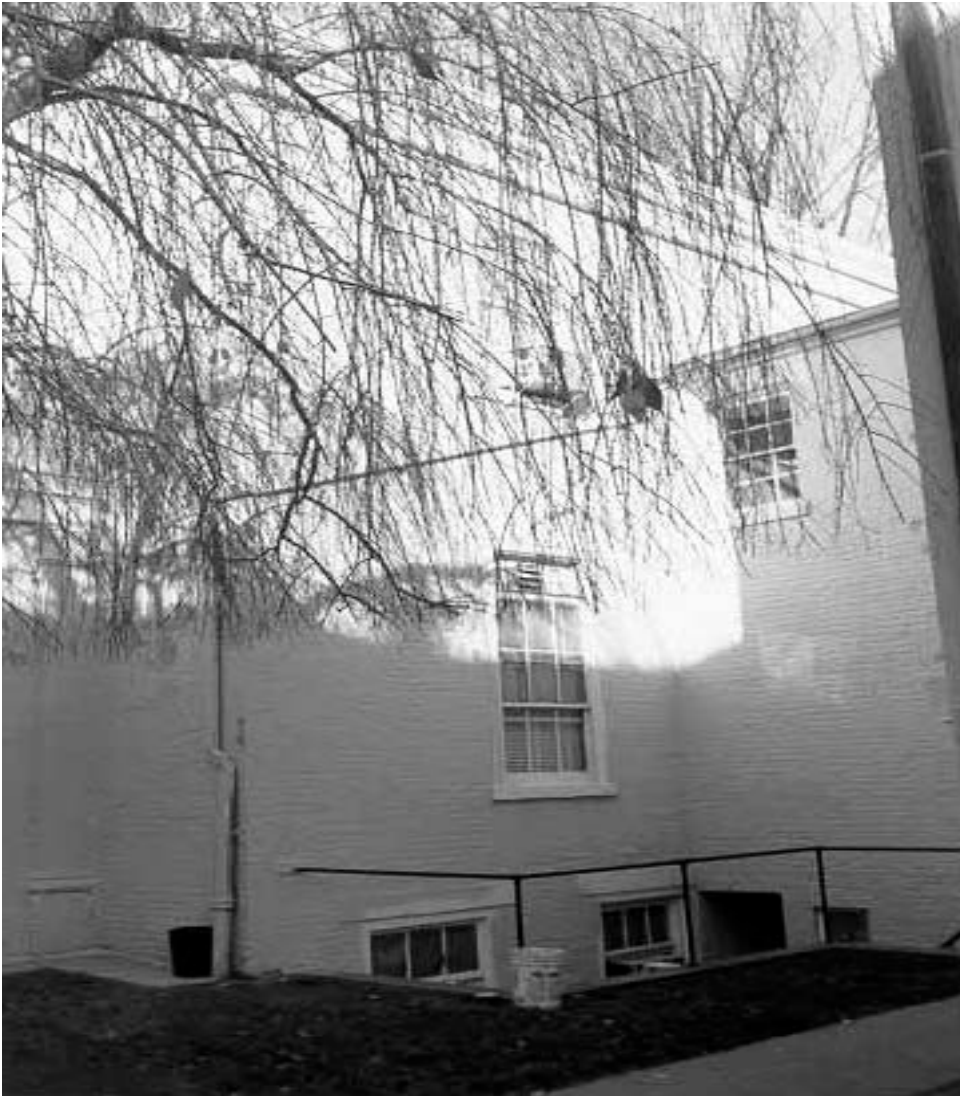
Figure 88

A painted iron pipe railing is mounted to the coping and brick façade. This railing runs along the edge of the areaway on the west side, Figure 88. On the east side, a utilitarian aluminum railing is mounted to the slate coping and brick façade. The railing continues up a stairway leading to the 1917-18-stucco addition. The southwest stair, leading up to the areaway, is constructed of concrete with slate treads. The slate is soiled and has recent paint stains on them. A painted iron pipe railing running along the west side of the stair is a continuation of the areaway railing. At the southeast end of the areaway, a concrete stair runs in the east-west direction and has a painted iron pipe railing running along either side. The concrete is cracked and spalled. A steel frame shed structure has been constructed over the stairway. The shed has a corrugated metal roof and siding, Figure 89. The areaways are original. However, the existing stair, handrails, coping and metal shed are not original.

Southwest elevation showing juncture with "Back Building" to the south. Note first-floor window was converted from a door, which led to a former porch.

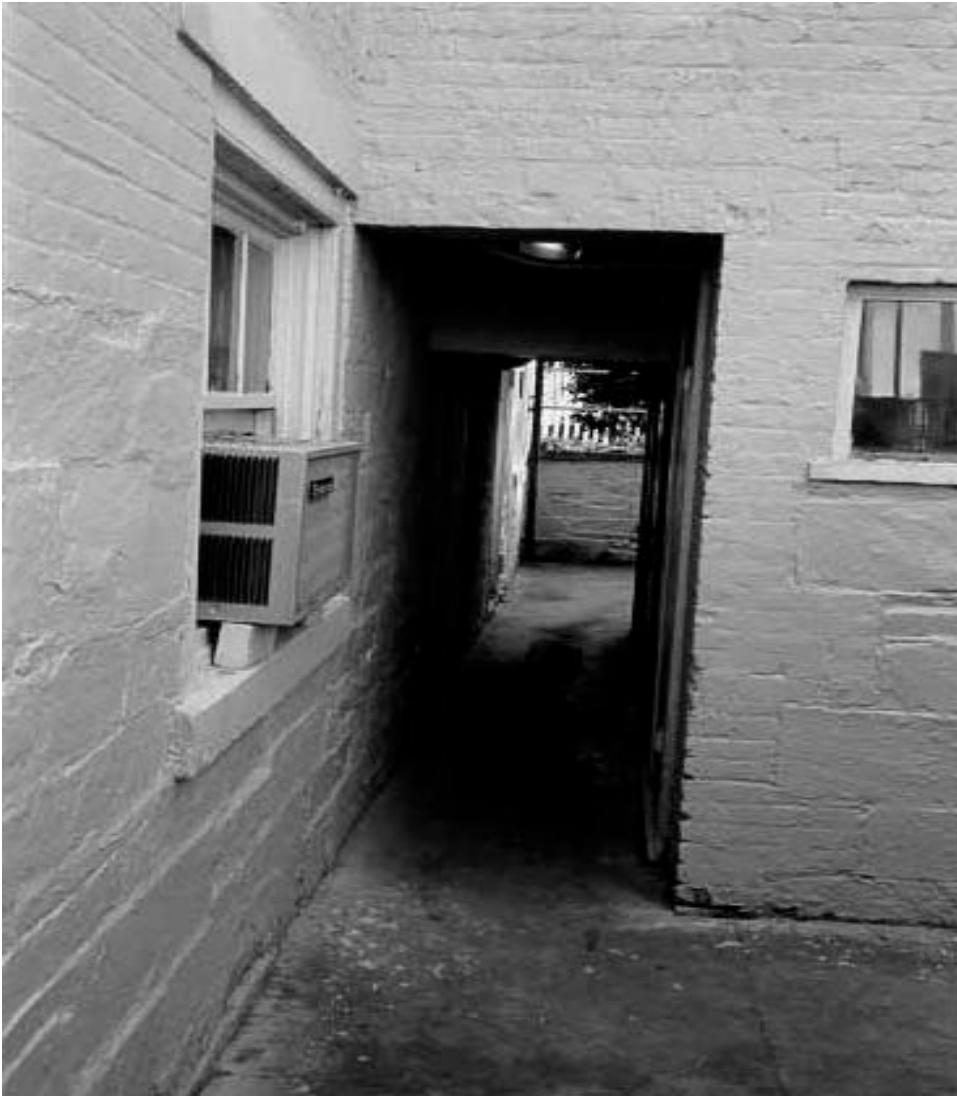
The back building of the Residence spans the areaway, Figure 90. The underside of the back building is surfaced with a 12" painted wood board. The brick walls are supported over the areaway by granite lintels. The lintel on the west side has a vertical hairline crack.

Figure 90
Residence (1847)
View through passageway under “Back Building”. Granite lintel, which supports structure above,
is cracked.

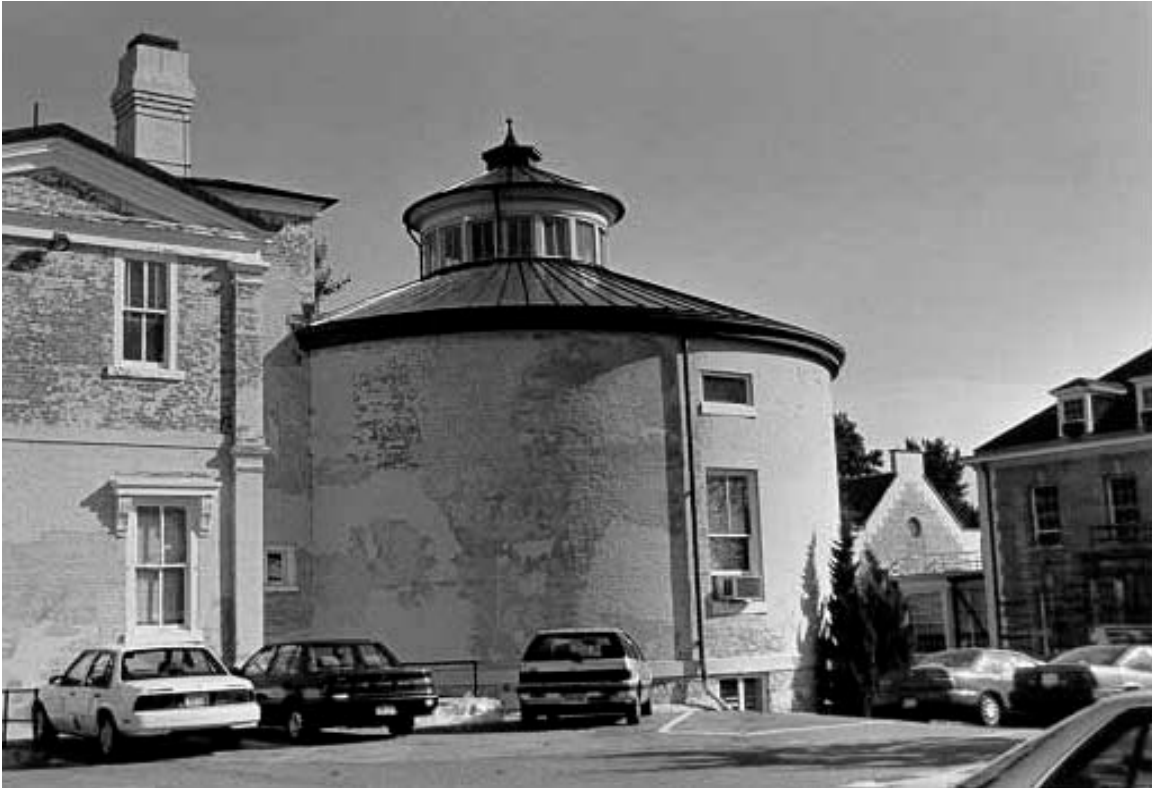
Figure 93

West Elevation. Wing to left was built contemporaneously as a one-story structure. Second-story added in 1903. Note paint stripping in progress.

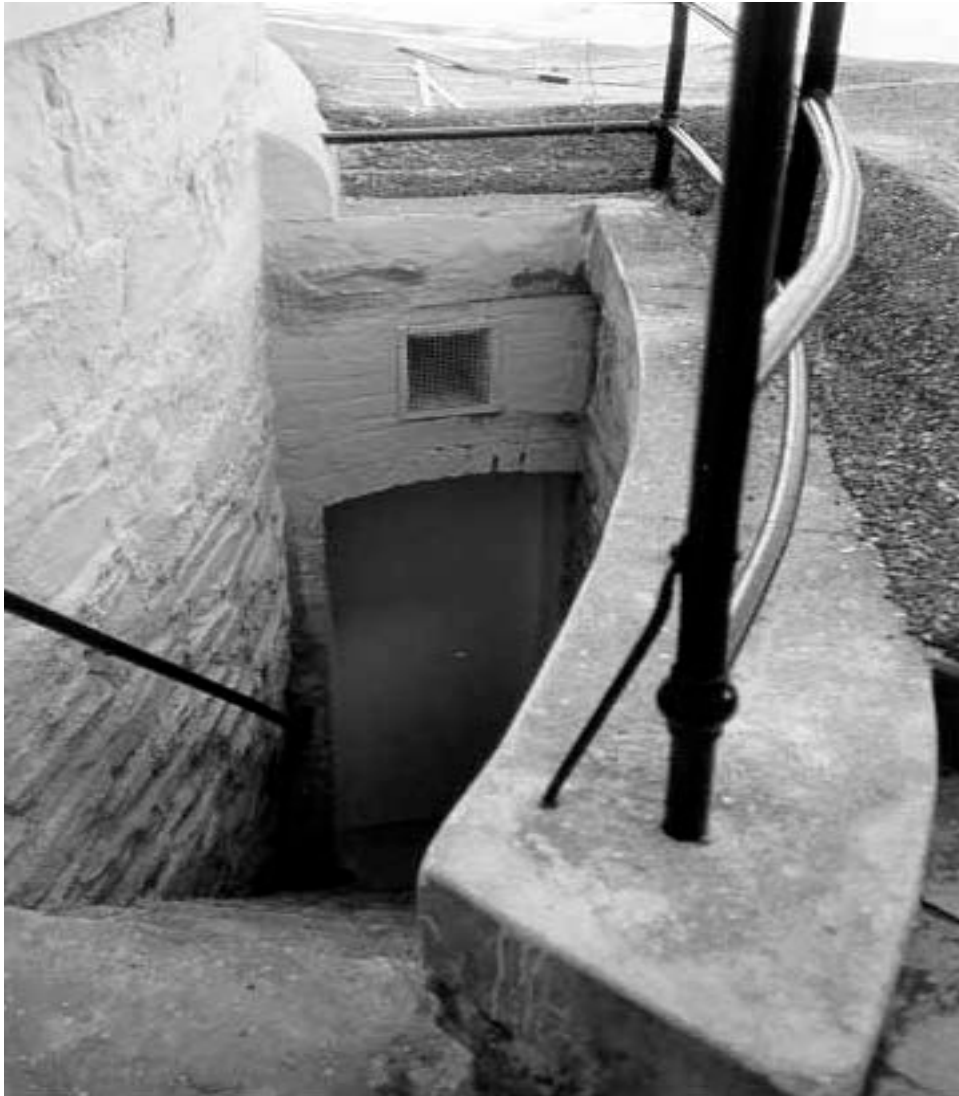
The other door opening also below grade on the west façade, Figure 95, is located at the north-west quadrant of the Rotunda, on the brick wall of a basement structure extending west from the Rotunda. This opening probably dates to the alterations undertaken in 1895. It is no longer functional. A dogleg stairway leads to the door, hugging the cylindrical wall of the Rotunda. The walls on either side of the stair are painted ashlar masonry. The west wall is coped with a 9" band of poured concrete and the east wall is the exposed foundation wall of the Rotunda itself. The stairway is constructed of concrete with slate slabs forming the treads. The slate is soiled from lack of cleaning and maintenance. A painted iron pipe railing section is mounted to the Rotunda foundation wall and another to the concrete coping of the west retaining wall. The door opening is arched above and had been filled with a plywood panel nailed to the wood frame door.

Figure 95
South Rotunda (1873, rebuilt ca. 1895)
Entry to vault. No longer in use.

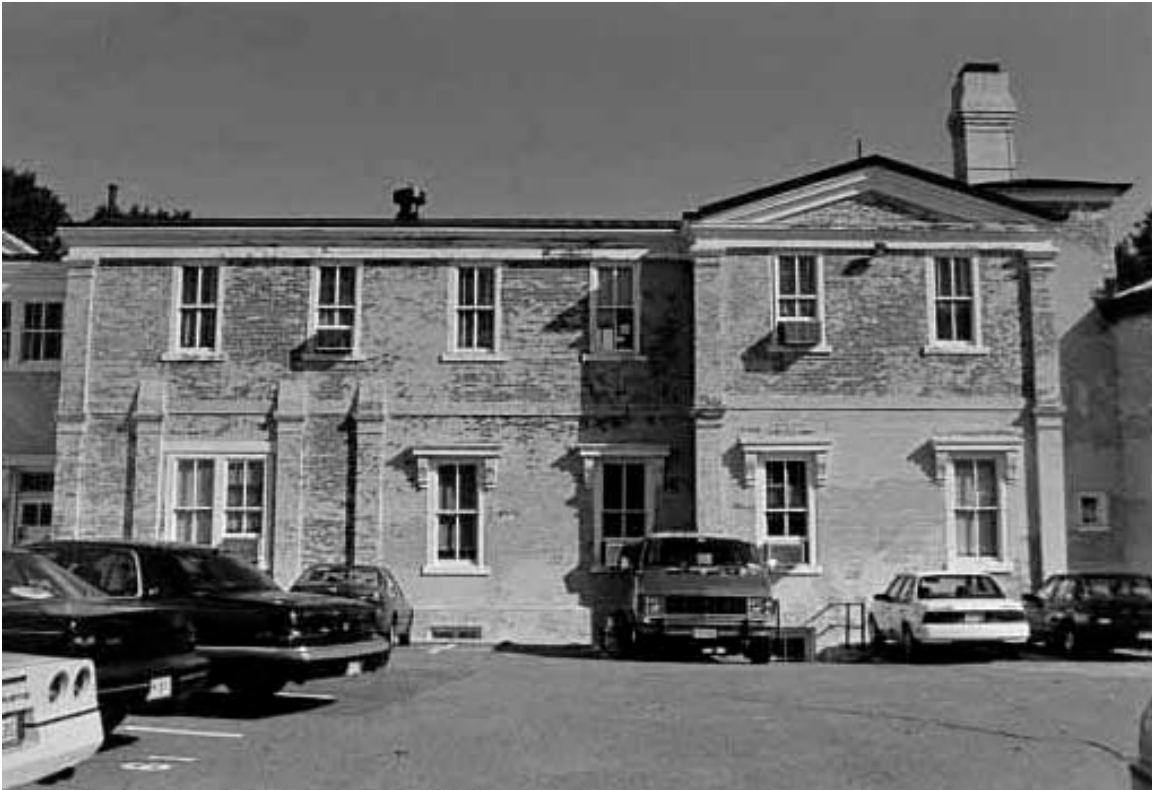
Figure 96

Second story constructed in 1903. First floor sections date from left to right. 1844 to southernmost pilaster. 1863-73 center section. 1873 projecting section. Note paint stripping project underway.

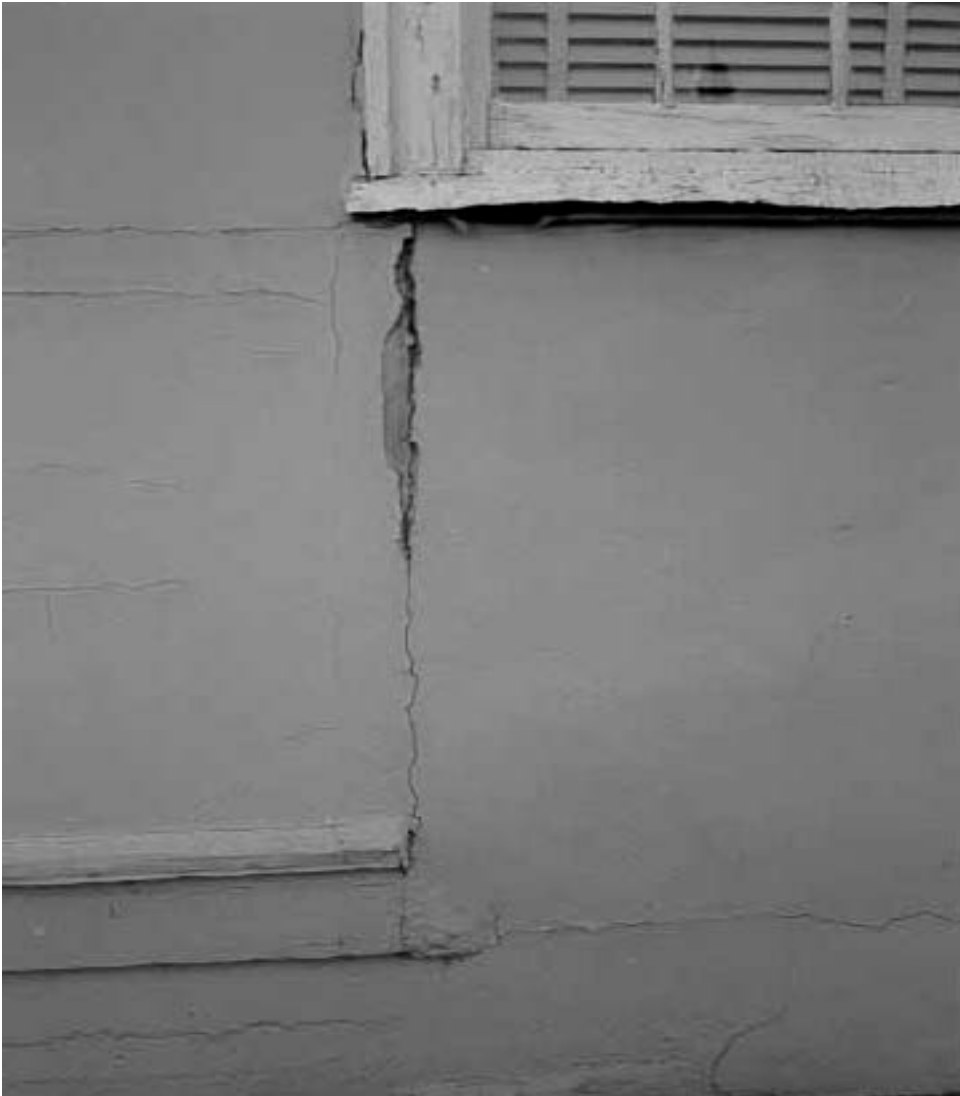
The stucco appears to be in fair condition with surface cracks throughout. Limited areas of buckling and spalling are also evident.

Figure 104
West Stucco Addition (1918)
Detail showing stucco failure.

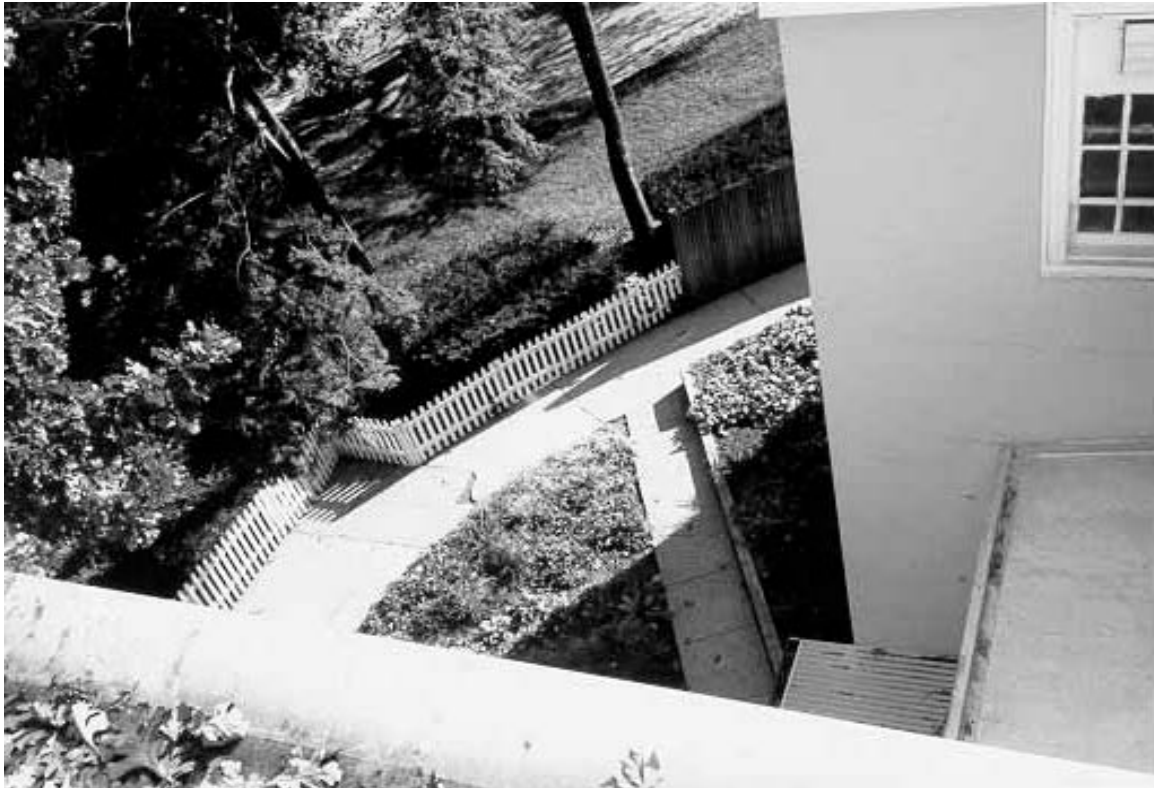
Figure 111

View to the southeast from roof showing small lawn area with concrete patch next to Building 2. Intrusive stockade fence cordons off the garden associated with one of the residences (not subject of the HSR). Note the driveway at upper right corner, which is part of extensive drive and parking area at the rear of the site.

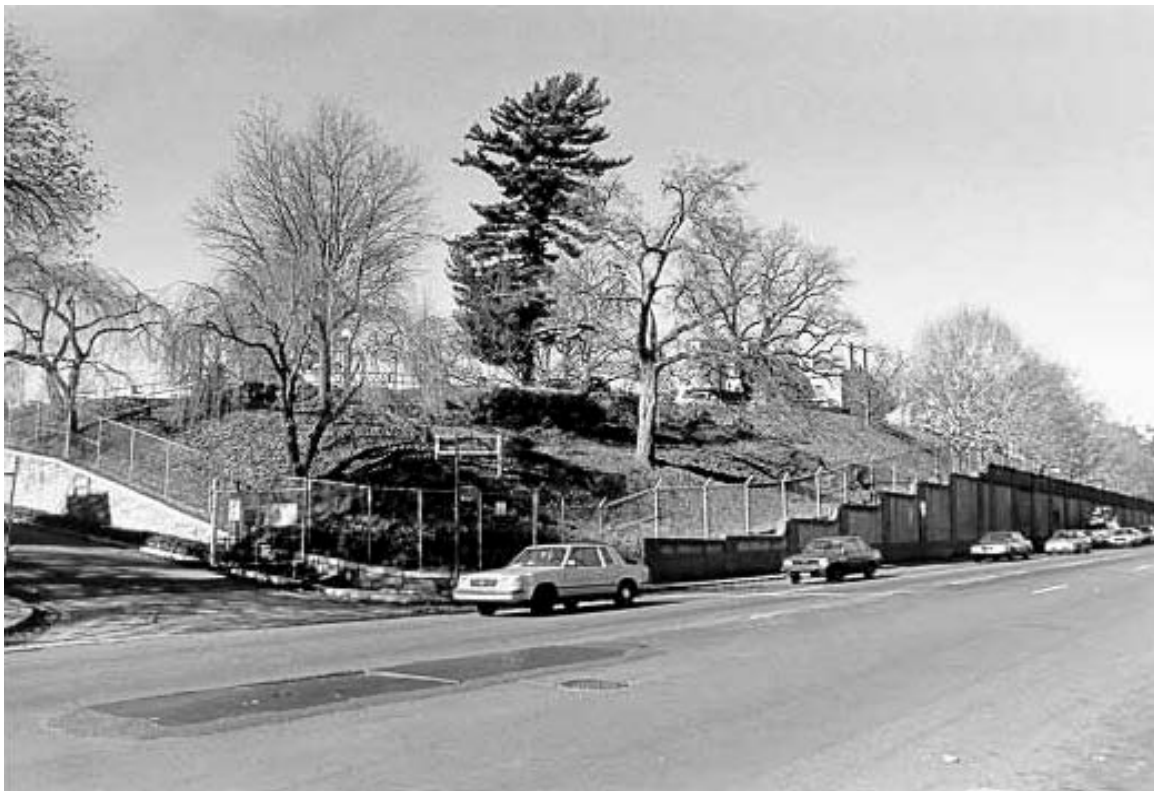
Figure 123

View into the site from the southeast. Building 6 is in the right foreground. Note obtrusive paving areas and chain link fences.

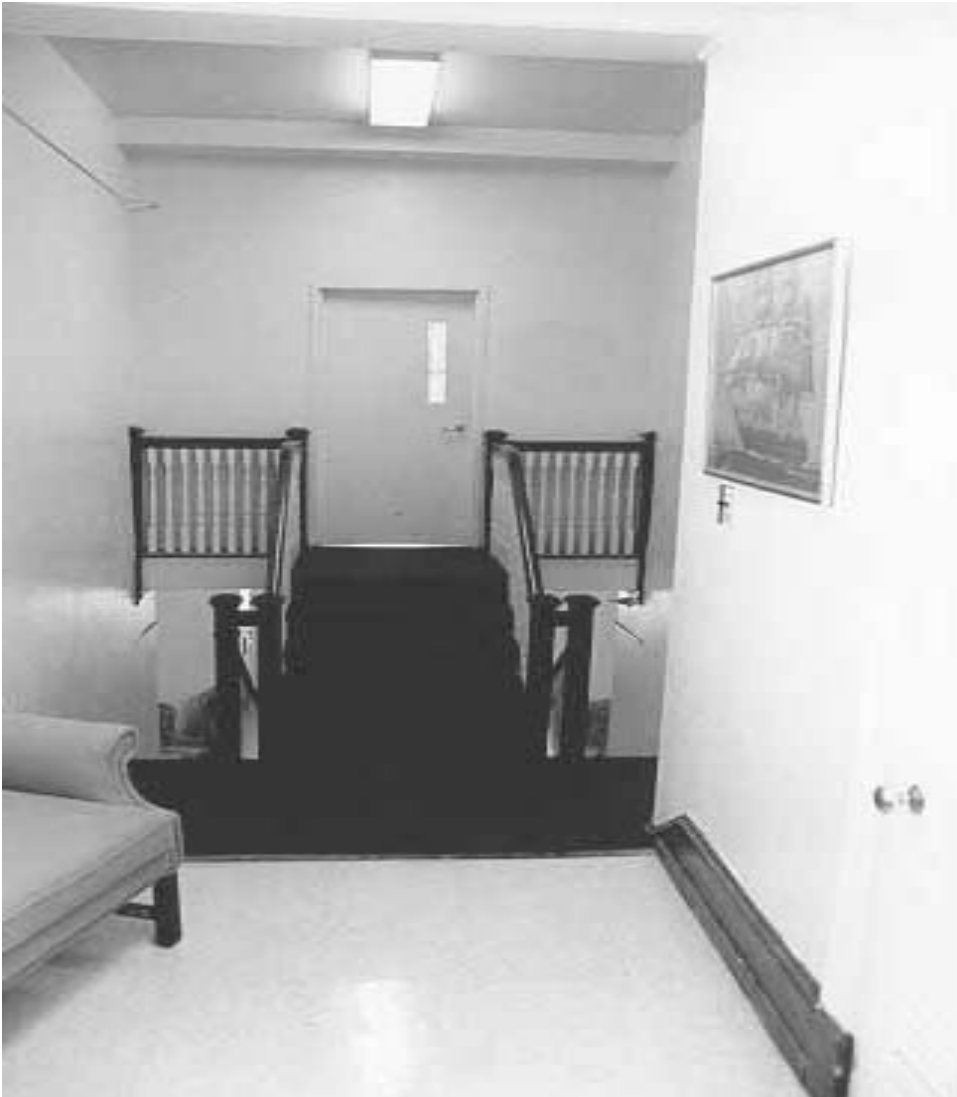
Figure 134
The Central Stair. View of run from the landing to the second floor. Photo taken from the 1903 Second Floor Addition looking north.

Partitioning a larger space created the woman's toilet on the landing, leading to the 1844 Old Naval Observatory, Figures 135 and 174.

The landing to the second story of the 1844 Old Naval Observatory, Figure 135, was part of a larger space, which was partitioned for Room 2210 (toilet).

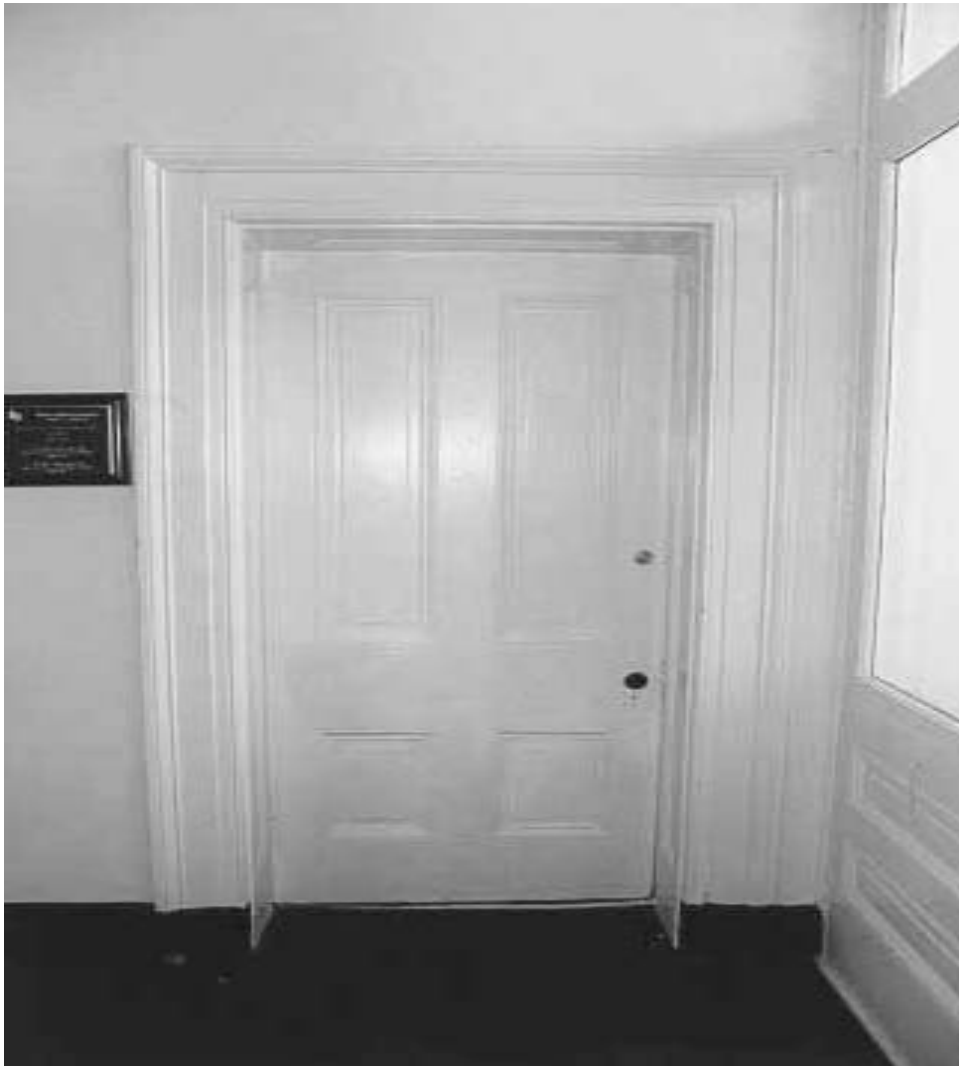
Figure 136
Door to Room 2108. Typical historic door found in the Old Naval Observatory and Residence.

The office doors are set within 8" molded wood frames with painted jambs. The only historic door in the space is the one entering room 2108. It is a four-panel wood door with steel hinges and an enameled doorknob and metal locks, which has been painted. This type of door is found on the second floor of the Old Naval Observatory and in the Residence. It is likely that most of these doors date to the 1890 alterations. A recent lock and closer have been installed on this door.

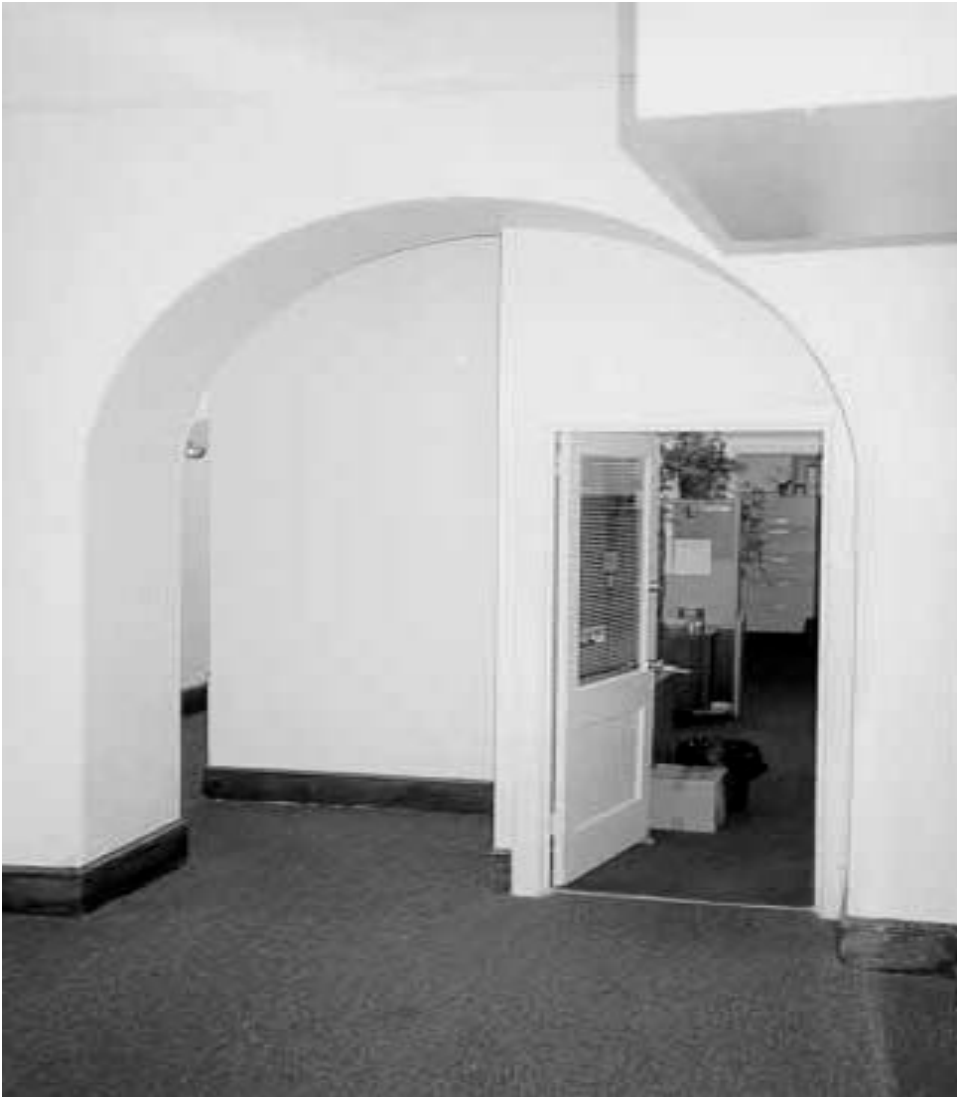
Figure 138

View of the arched opening from the central lobby to the east wing. The later partition detracts from the original spatial character and architectural integrity of the arch.

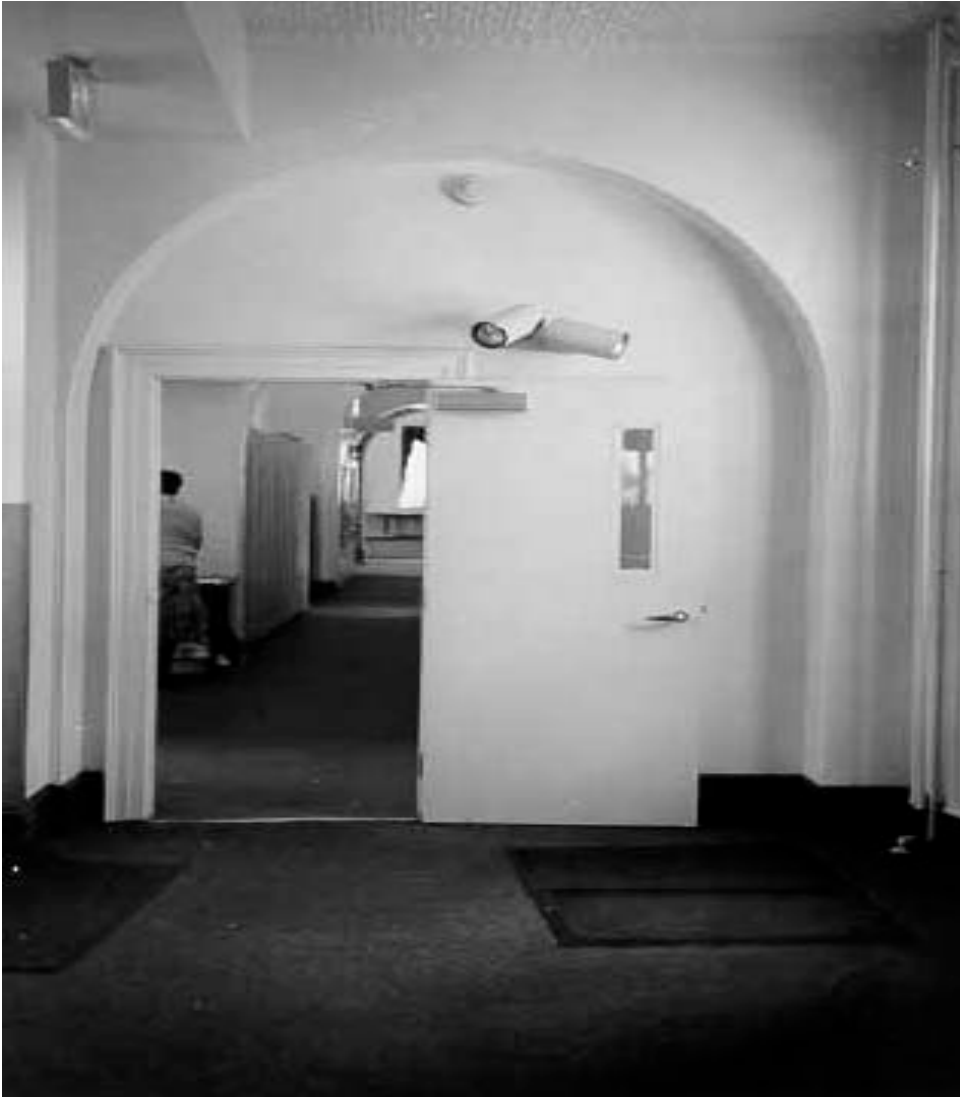
Figure 146

View of the passage leading to the 1844 south wing from the lobby. Note the gypsum board partition, which detracts from the spatial character of the space.

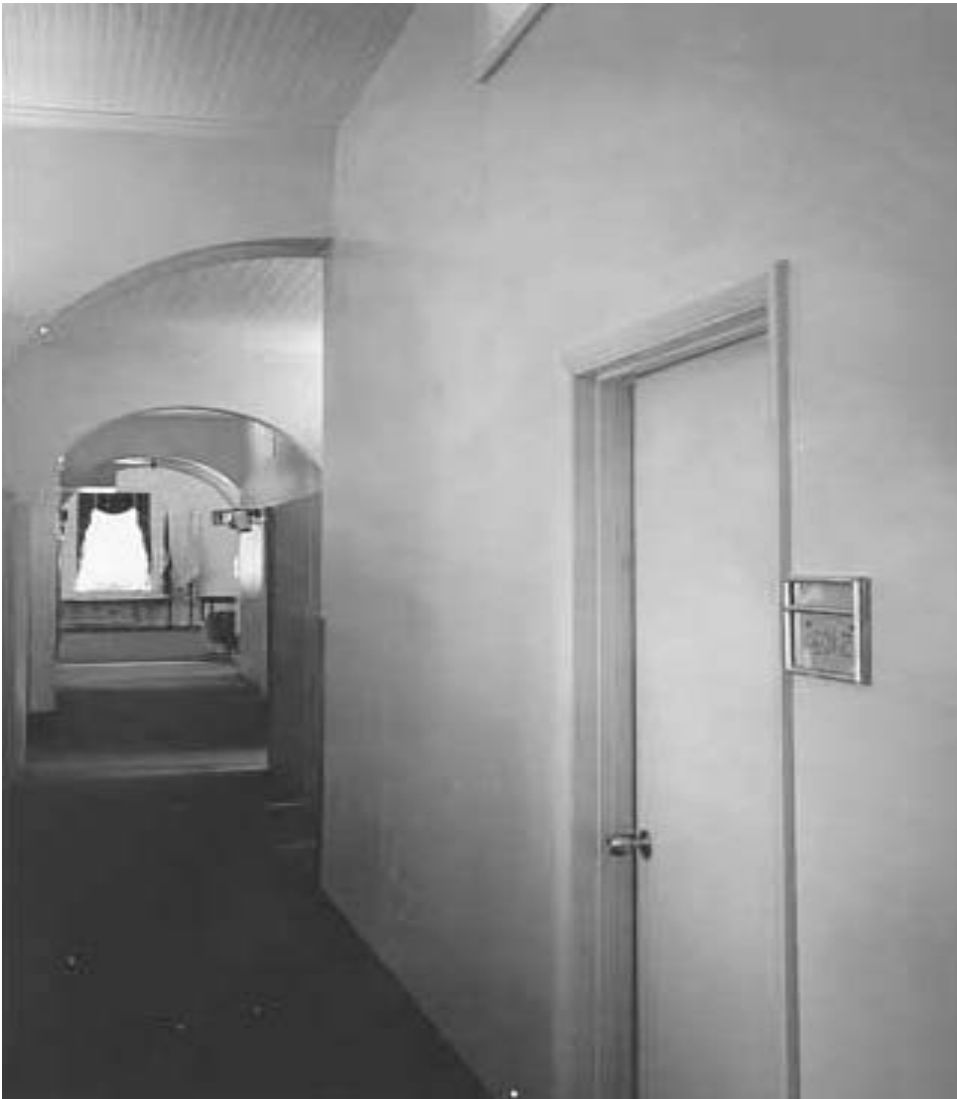
Figure 147
View of the 1844 south wing with the 1873 addition beyond. The partition in the foreground is from the spatial character of the room.

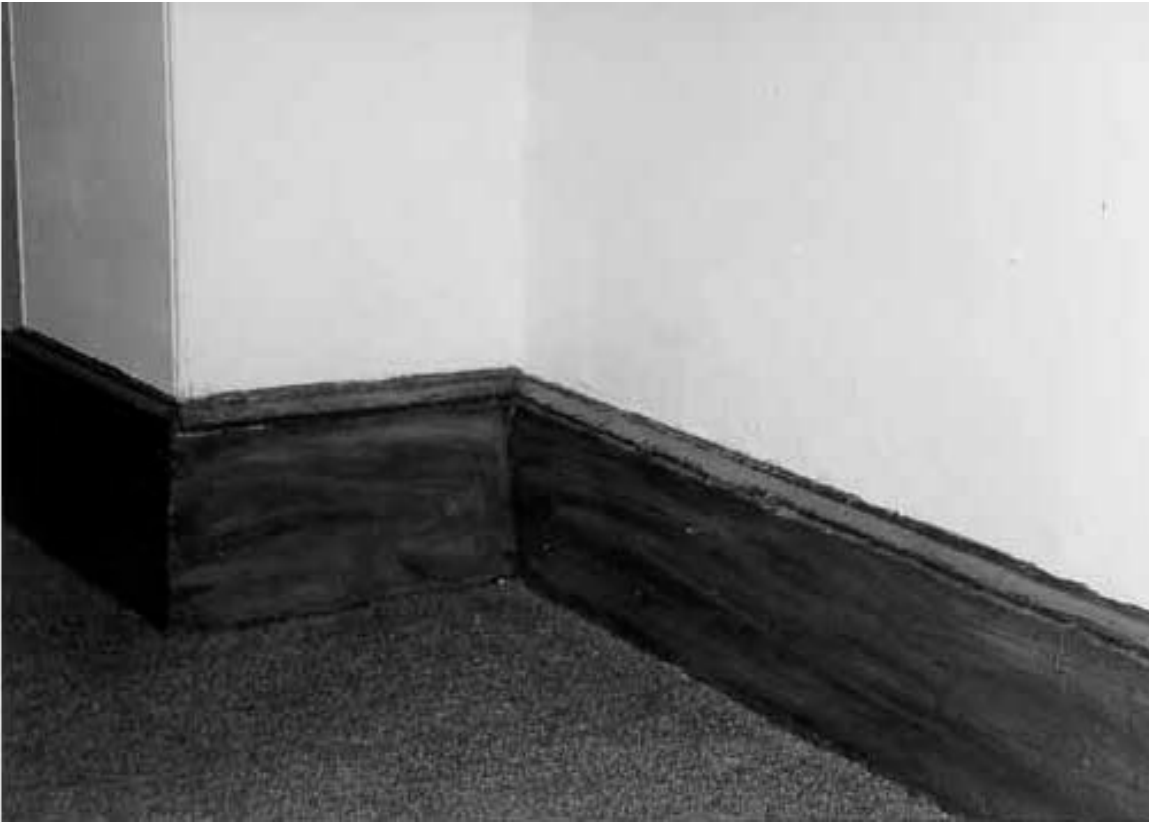
Figure 149

A typical baseboard found throughout the building. They range in height from 6 inches to 9 inches. The 9-inch perimeter baseboards may date to the 1840's. The 8-inch baseboards probably date to 1894, when new flooring was installed by the Naval Museum of Hygiene. Differing baseboard sizes are undoubtedly due to later attempts to match in the historic fabric. The grain painting was all undertaken during the last decade.

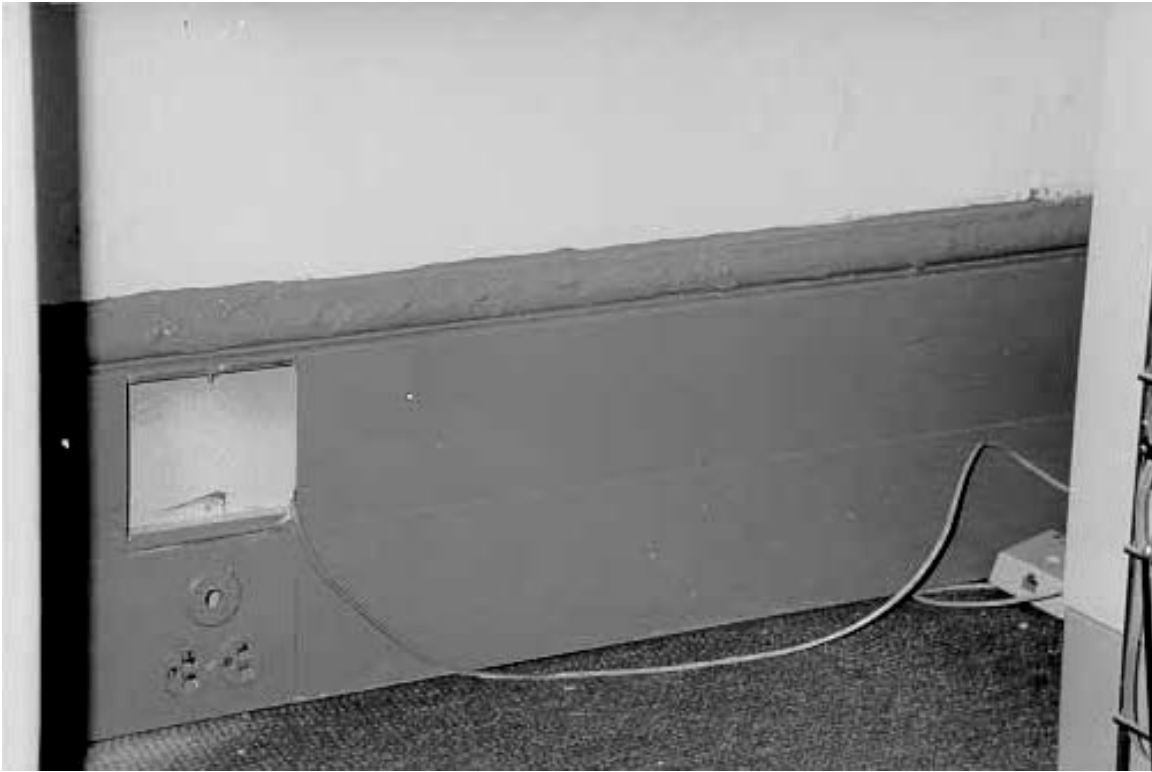
Figure 150

The baseboards along the northwest corner, near the curved wall section, are painted wood 7" high with cyma recta molding. The baseboards along the other walls are 12" steel electrical raceways, Figure 150.

An example of the hollow metal raceways typically found throughout the building. In some instances the molding was installed to approximate the appearance of the historic baseboards. Frequently, the molding was omitted.

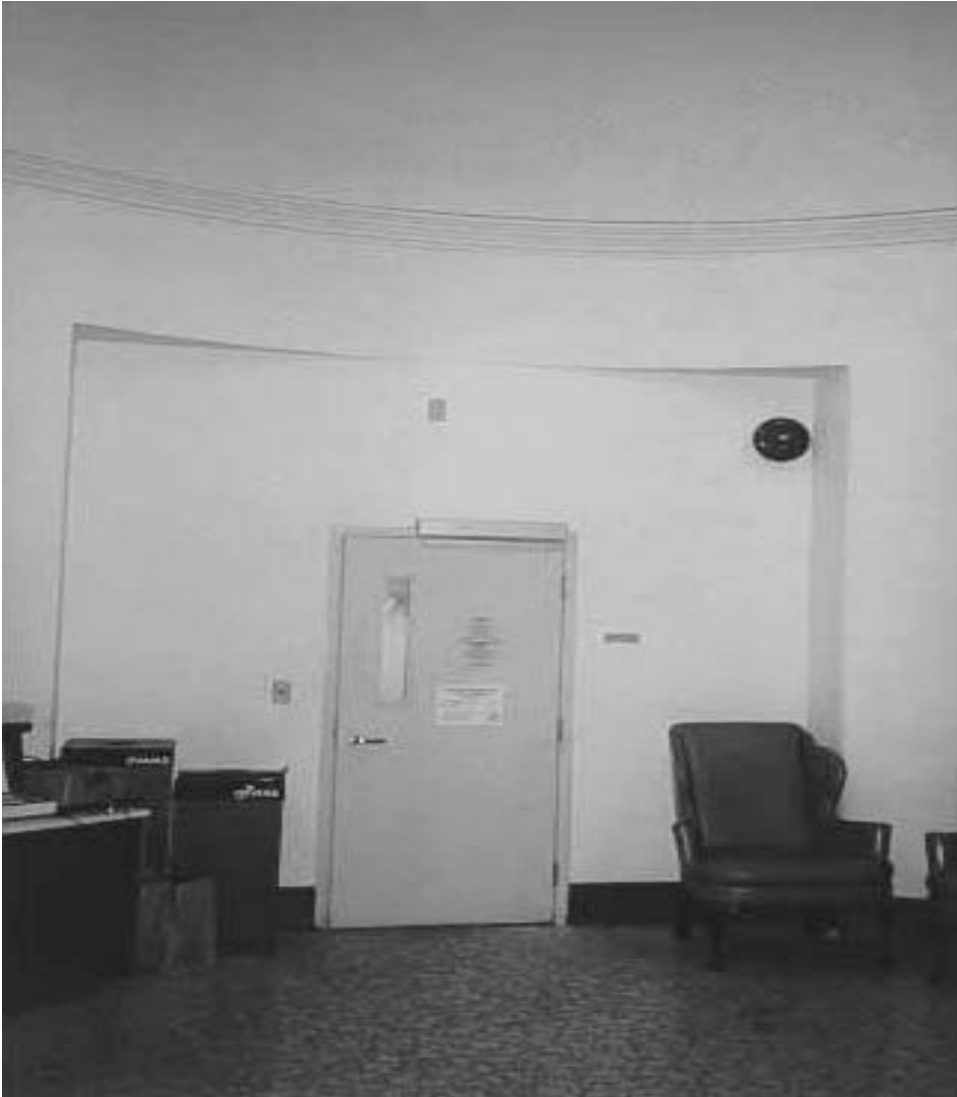
Figure 152

View of the dome room on the second floor looking south. Note the gypsum-board fill and the door separating the rotunda from the south stair.

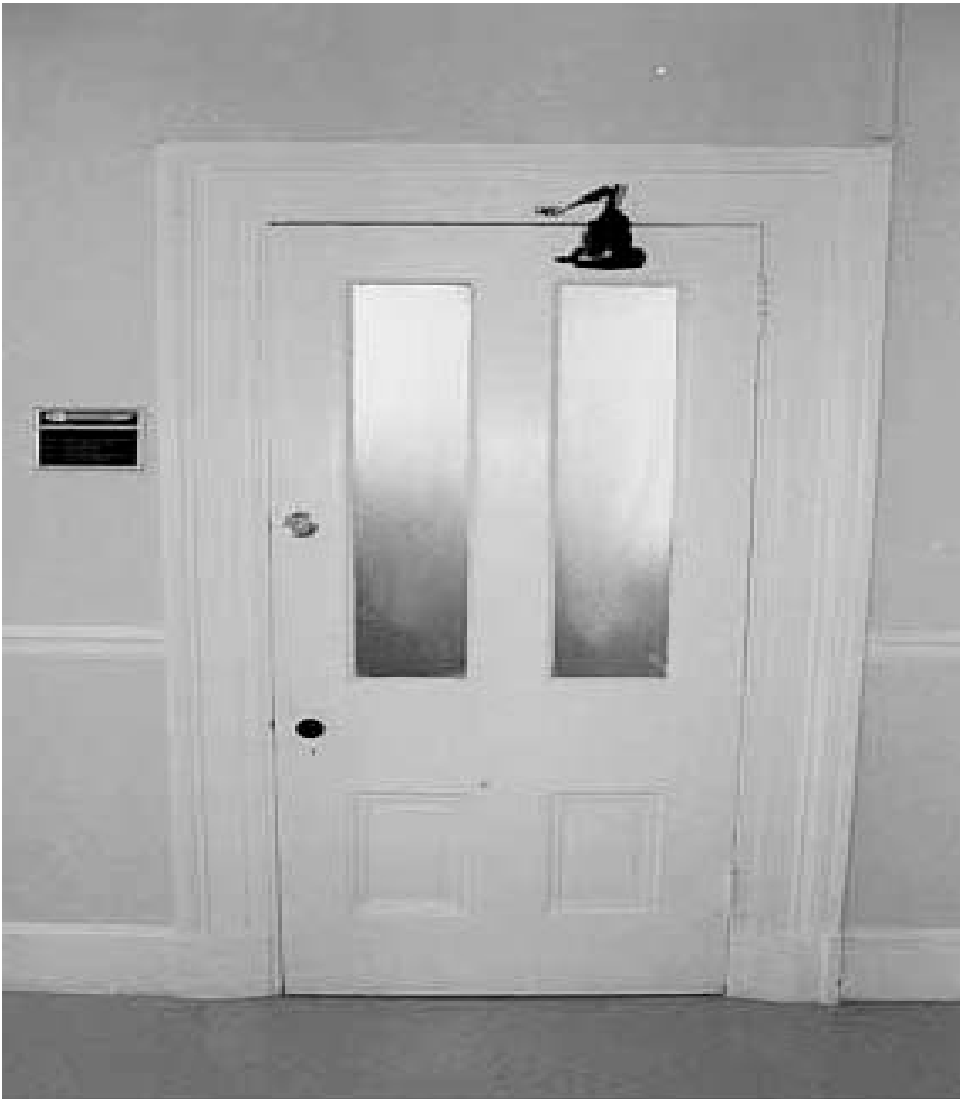
Figure 156
Door to Room 2207. Historic door has been retrofitted with glazed panels.
