POTOMAC ANNEX BUILDING 2

**HISTORIC STRUCTURES REPORT
CORRECTED FINAL SUBMISSION**

Prepared for the U.S. General Services Administration

Swanke Hayden Connell Architects

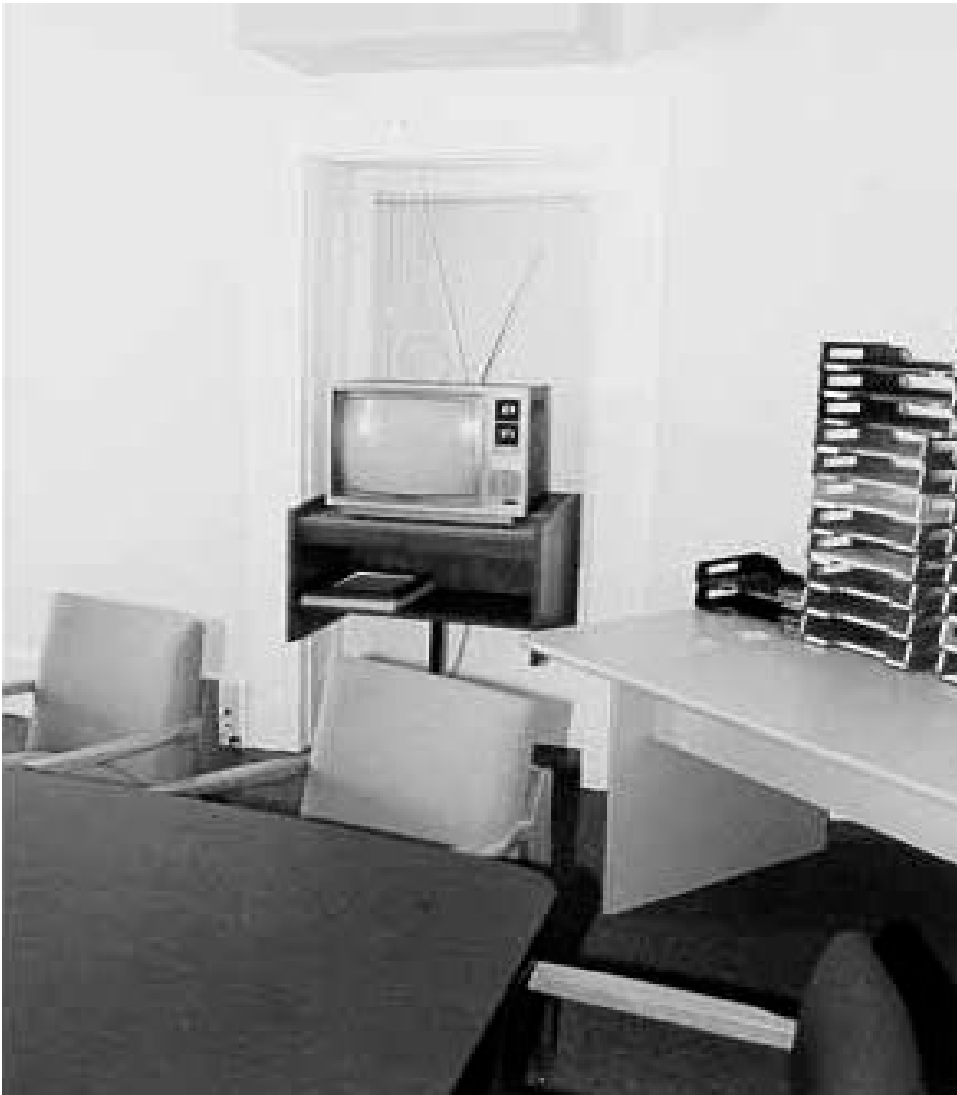
Figure 162

Room 2208. The door enters the north space between Rooms 2208 and 2216. The doorframe here is flat, with no moldings. The doorframe on the reverse side is eight inches wide with moldings typical of those found in the 1844 Old Naval Observatory. It appears that the opening is original, but that the door and frame were altered.

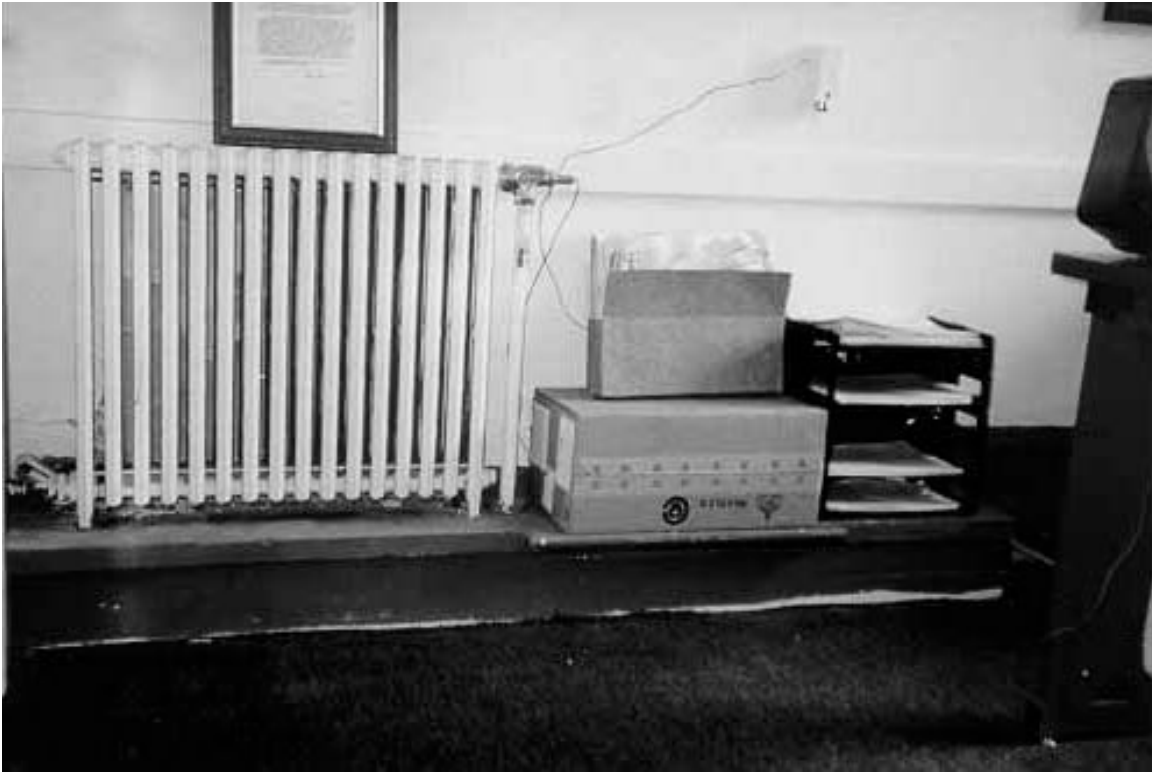
Figure 165
A view of the radiator in Room 2217, which on a raised platform. This appears to be a recent alteration.

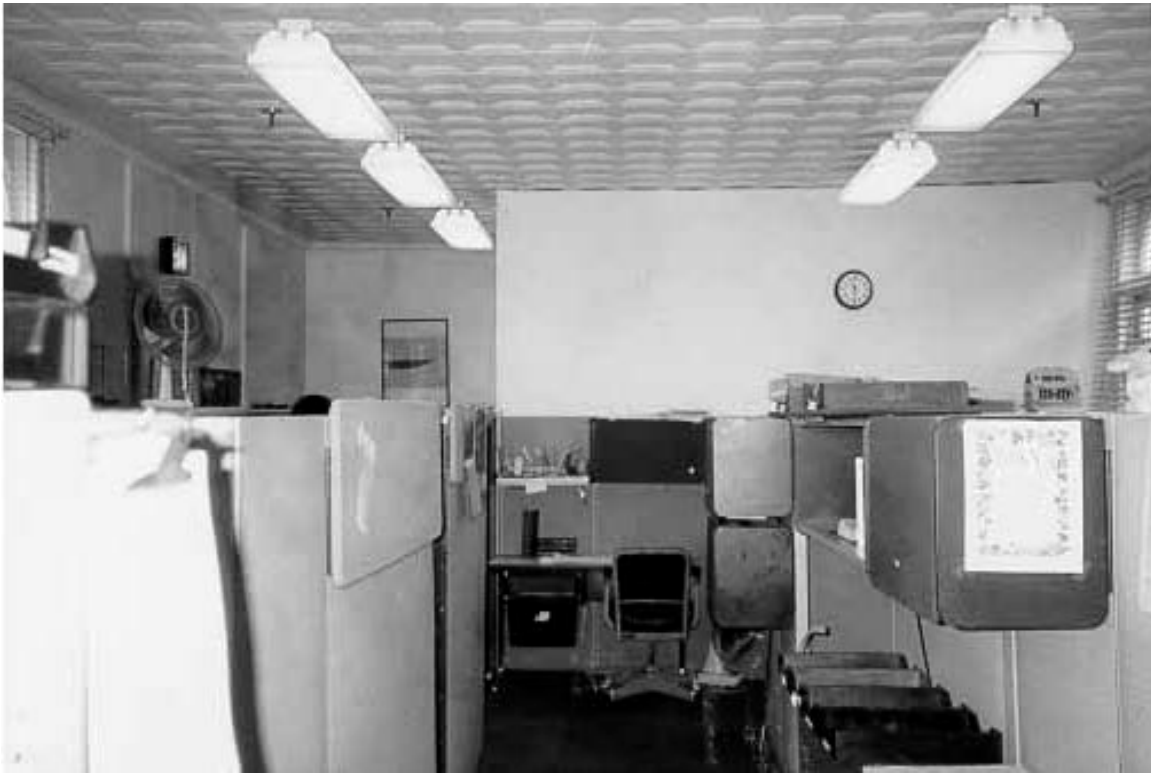
Figure 166
View of west 1902 Second Floor Addition, looking west. The partition in the foreground is a later addition.

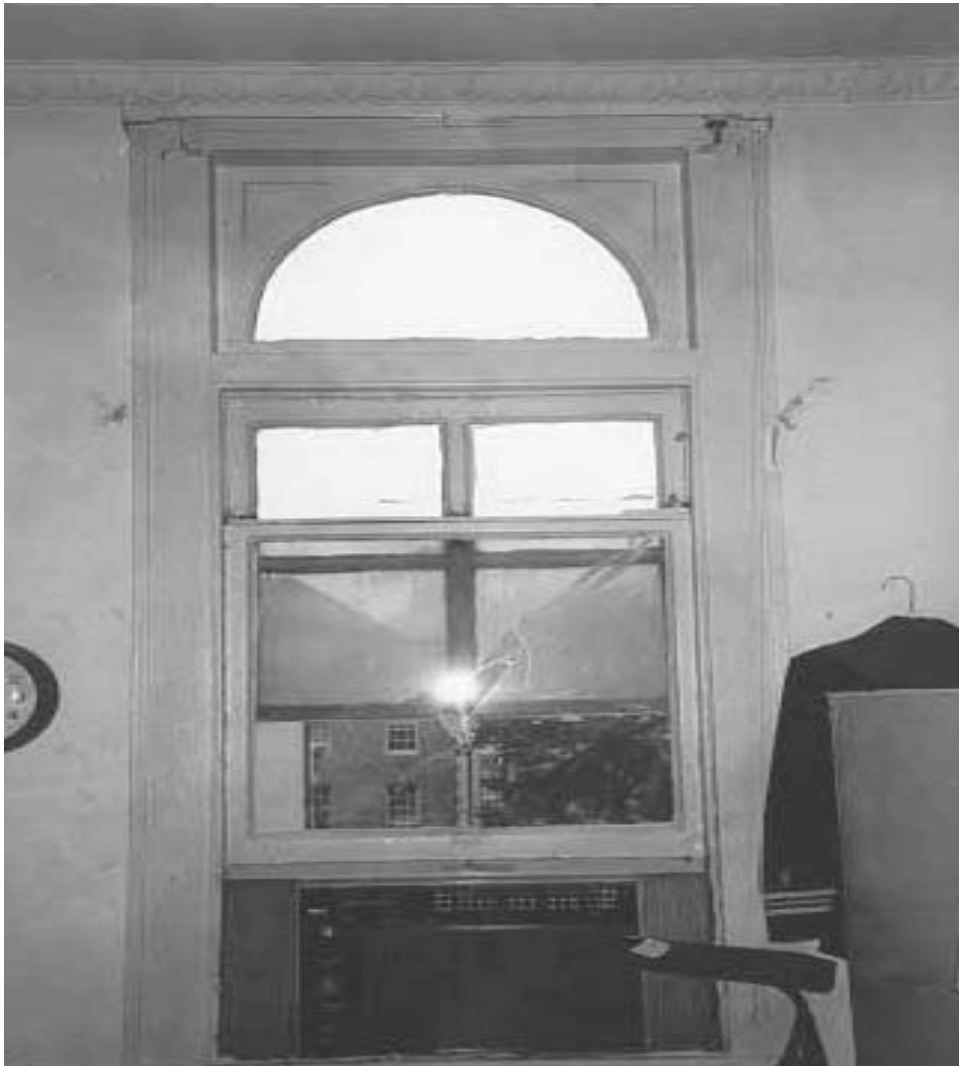
Figure 167
Typical window detail in the west 1902 Second Floor Addition.

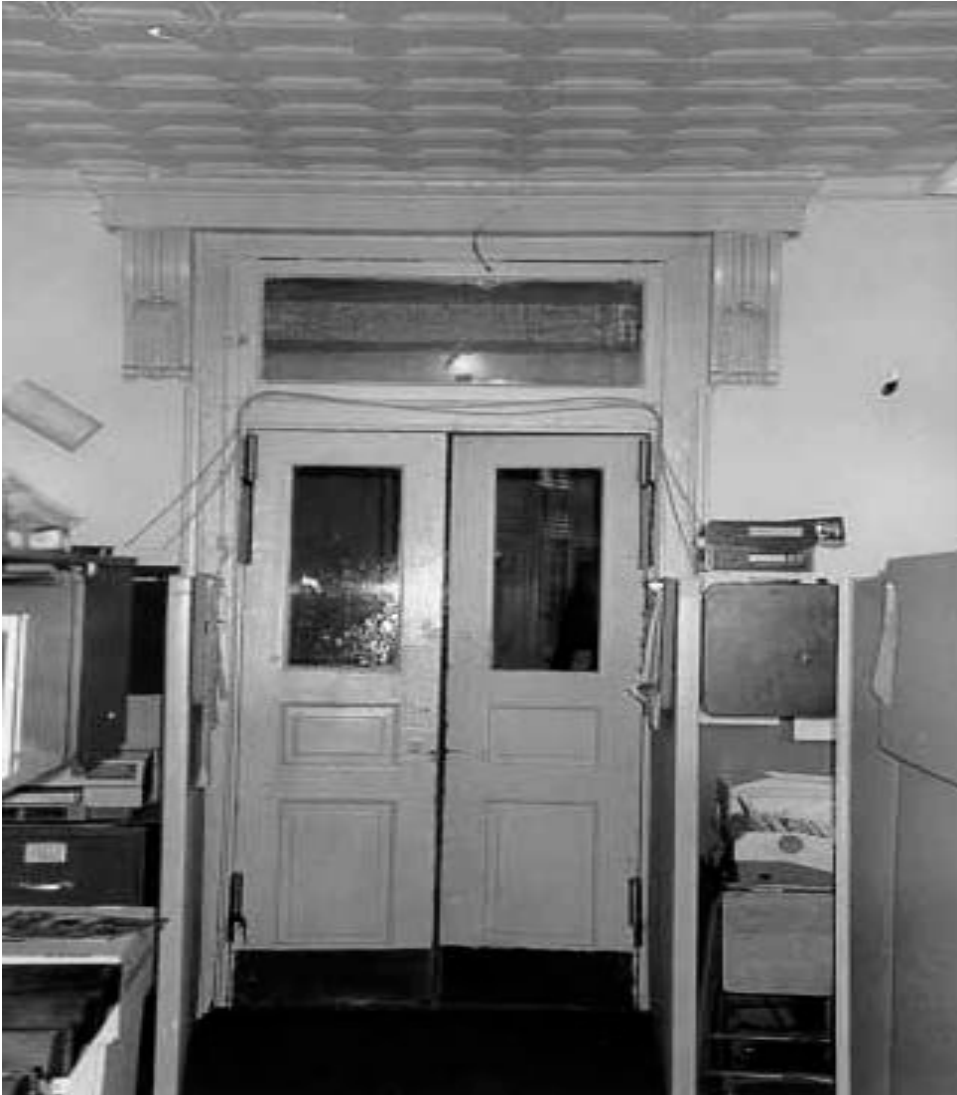
Figure 168

West 1902 Second Floor Addition looking east. This bracketed lintel indicates that this was originally an exterior wall of the 1844 Old Naval Observatory. The window was converted to a door in the new interior space.

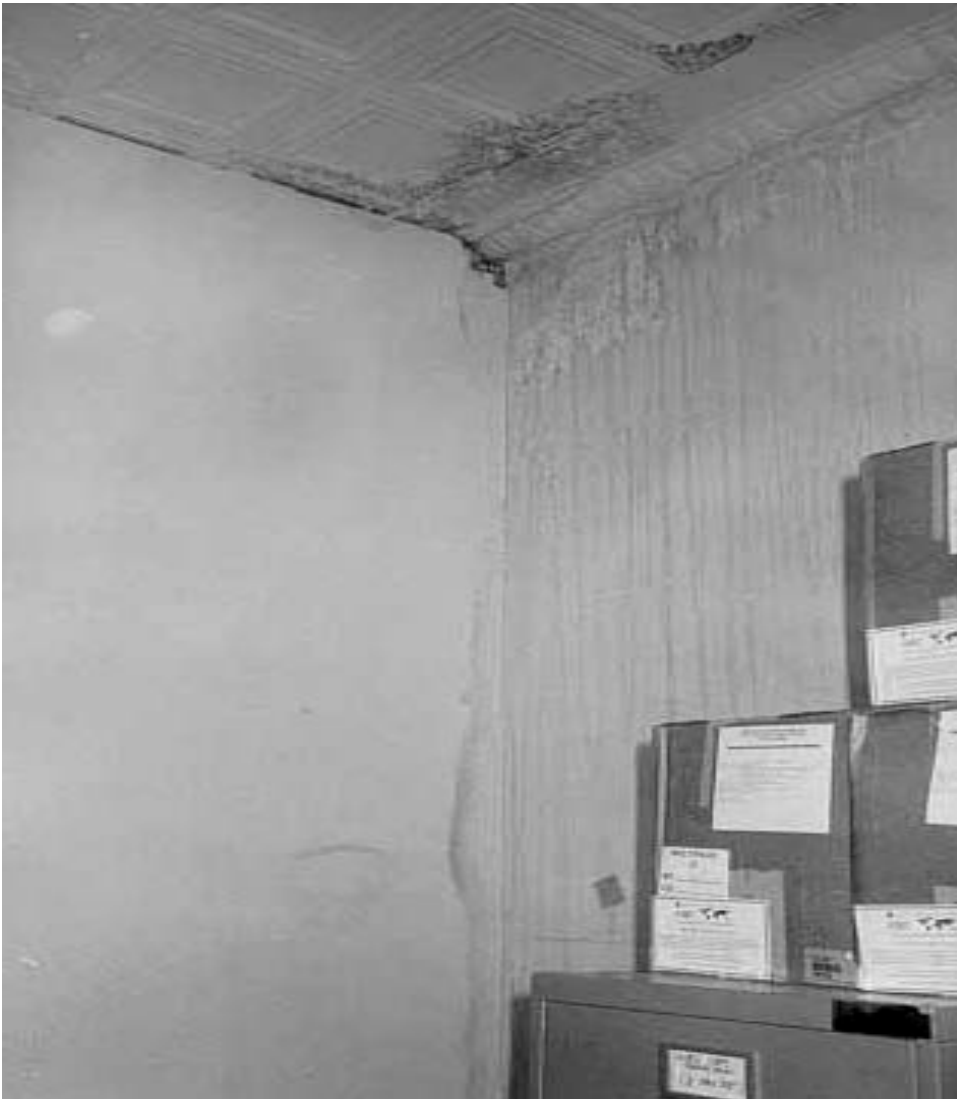
Figure 169
West 1902 Second Floor Addition. Note the intrusive partition wall and the water damage in the west wall and ceiling.

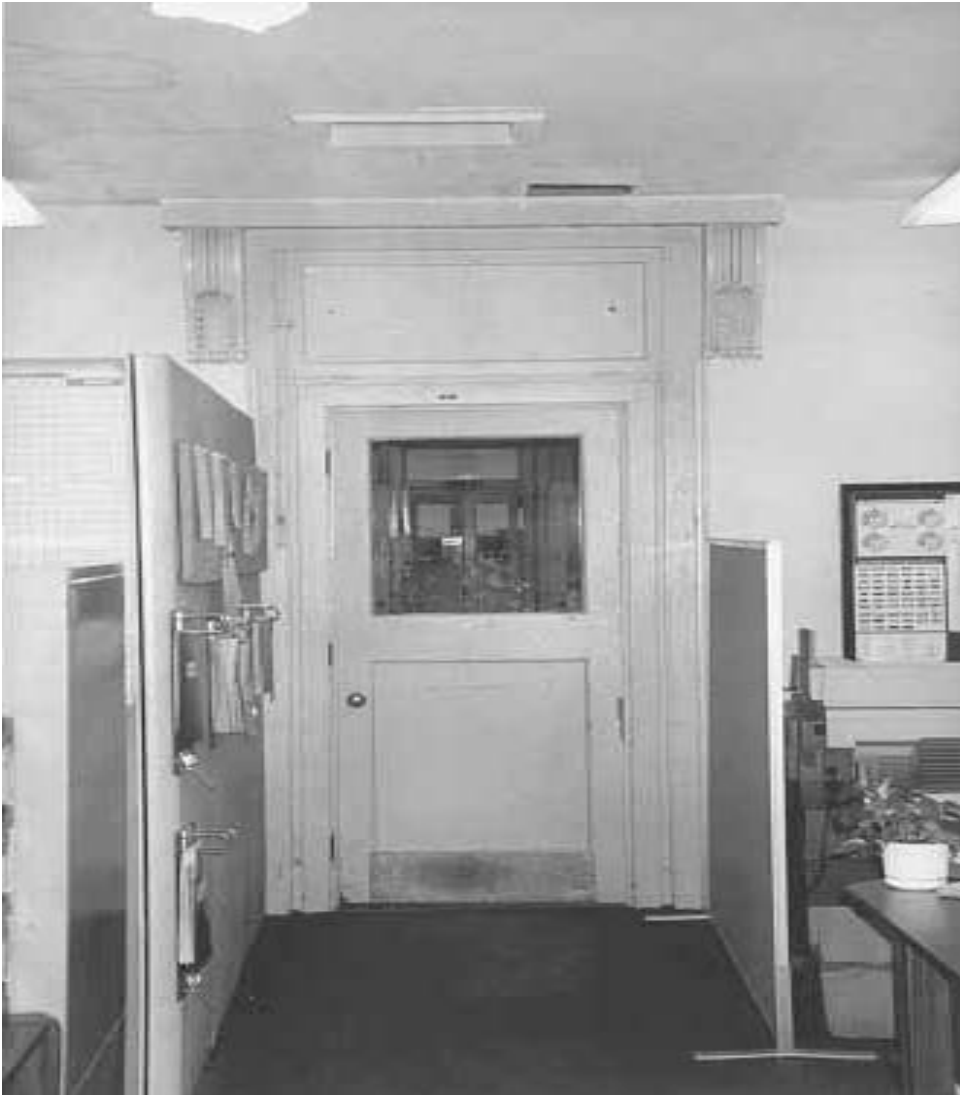
Figure 171

The bracketed lintel indicates that this was originally an exterior wall of the 1844 Old Naval Observatory. The window was converted to a door to the new interior space in 1902, when the East Second Floor Addition was added.

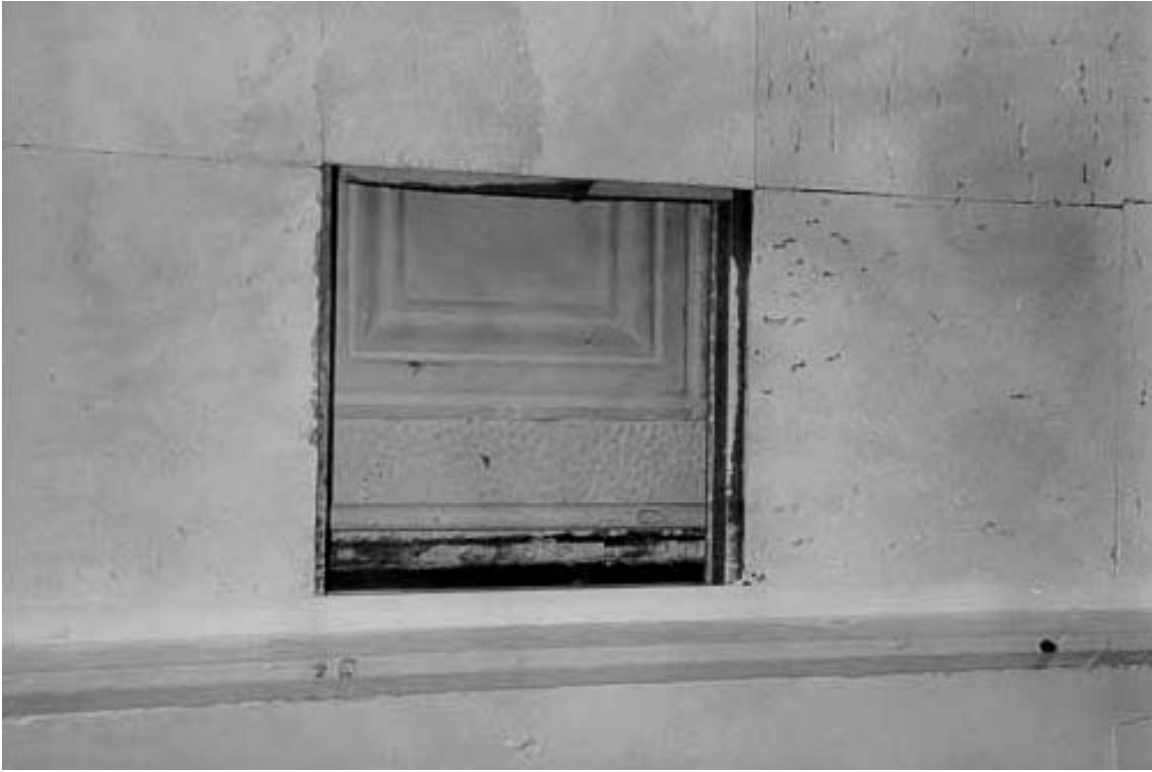
Figure 172
East 1902 Second Floor Addition. A detail of the original metal ceiling that is now obscured by an acoustical tiled ceiling.

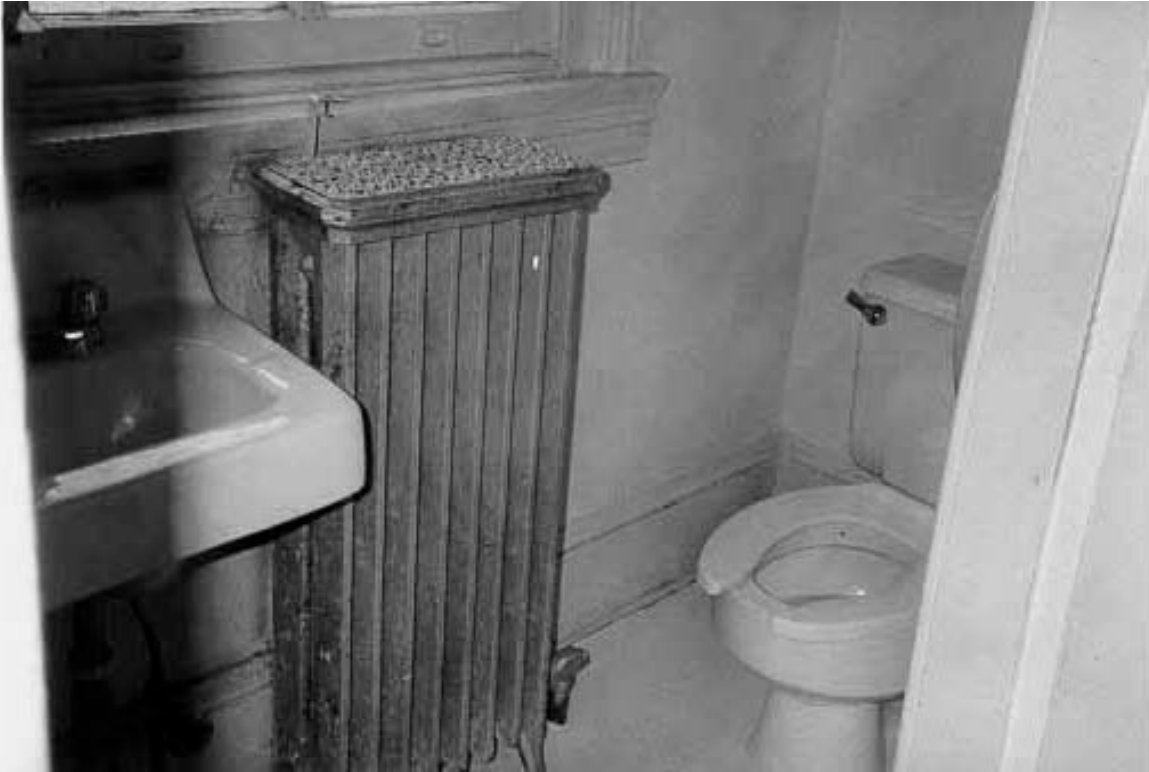
These rooms comprise the 1903 Second Floor Additions over the 1844 south wing and the 1873 addition leading to the South Rotunda. The Naval Medical School installed lockers and lounge space for the students. The spaces are currently used as offices and toilets. Rooms 2213 and 2214 were created from a single space sometime after 1927. Since they are discrete spaces, they are addressed separately, Figures 174 and 175.

Figure 174
The 1903 Second Floor Addition. View of the toilet on the landing.

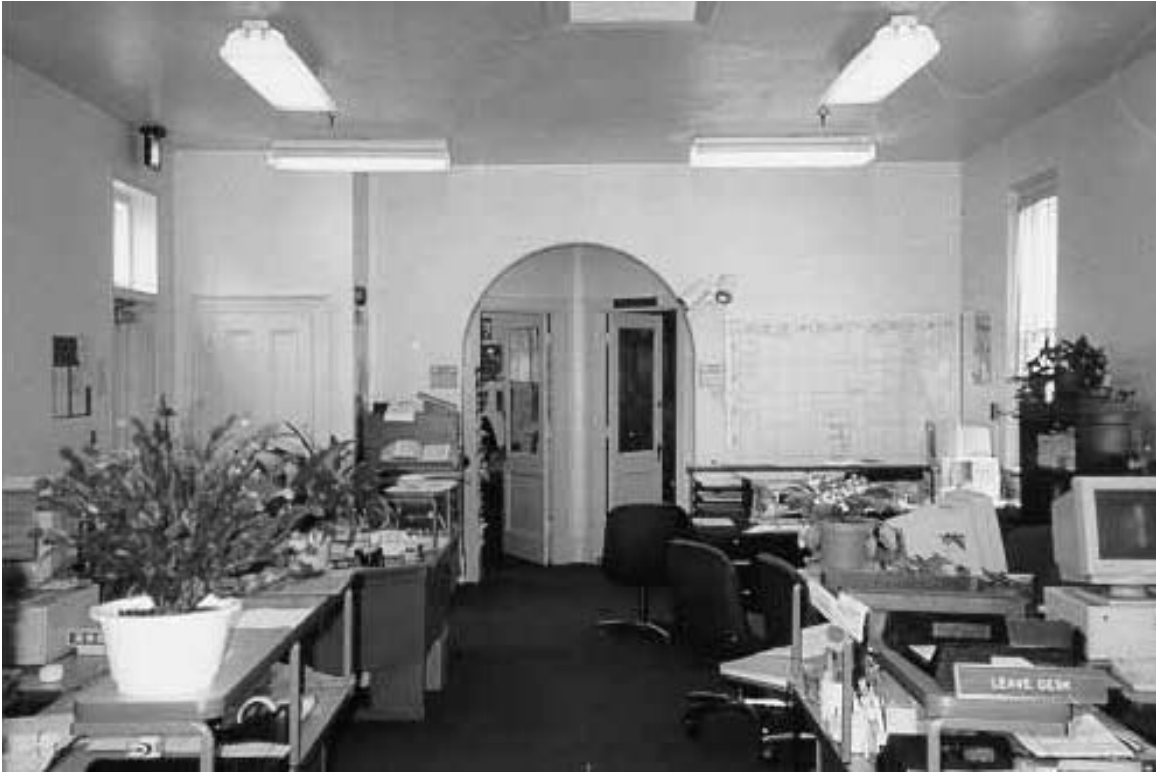
Figure 175
The 1903 Second Floor Addition. Overall view of the interior.

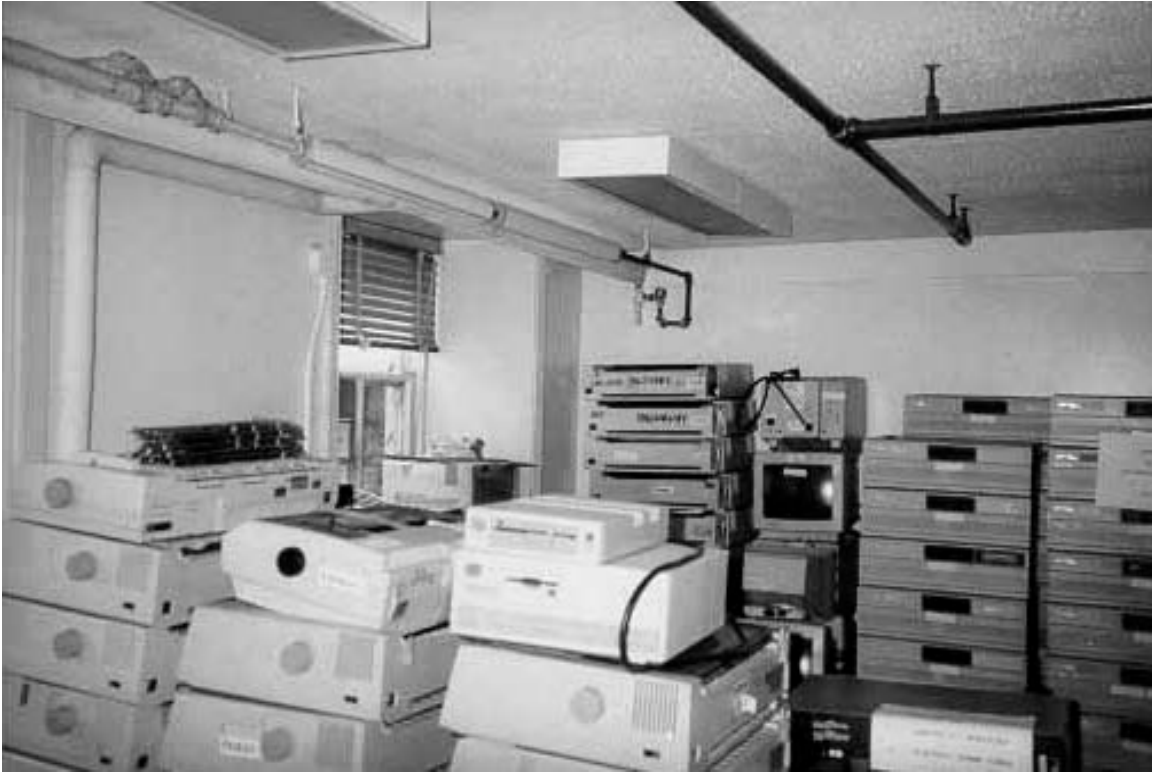
Figure 179
Observatory Basement
View of the southwest quadrant space, Room 2005. No original finishes remain.

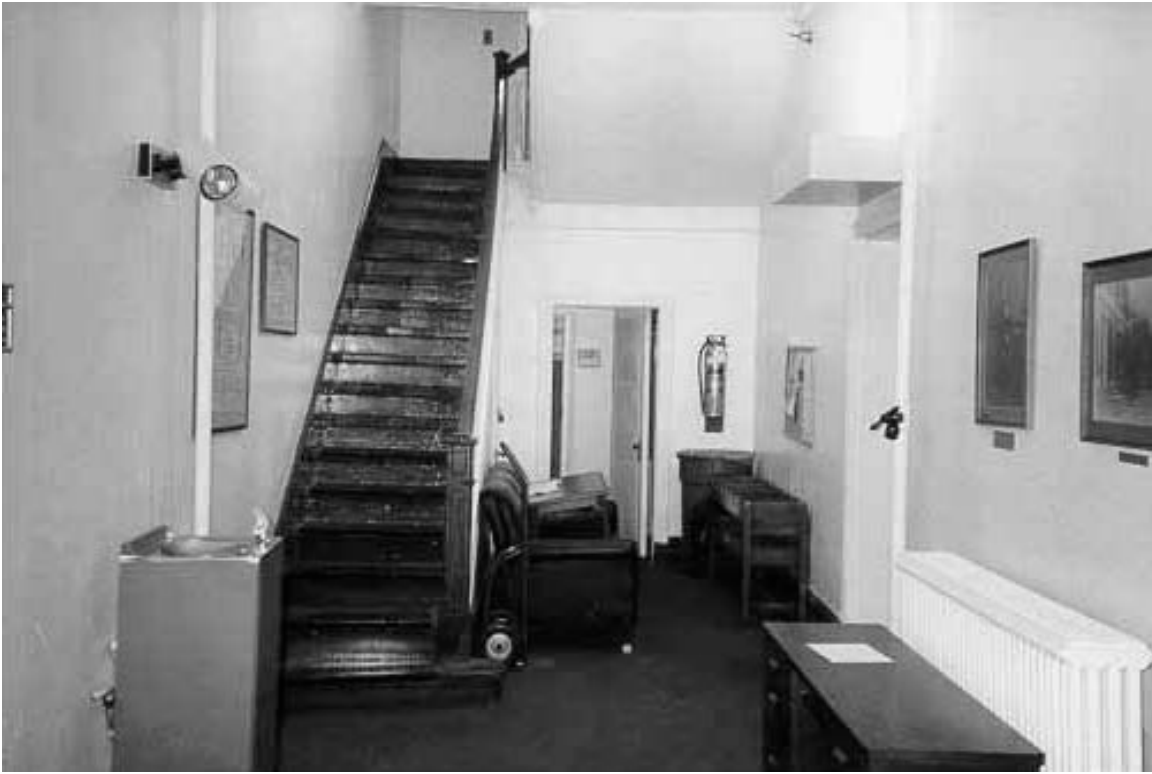
Figure 185
The Residence (1847)
First Floor. A view of the central stair. The stair has been heavily reconstructed. Most of the reconstruction dates to the 1894 alterations.

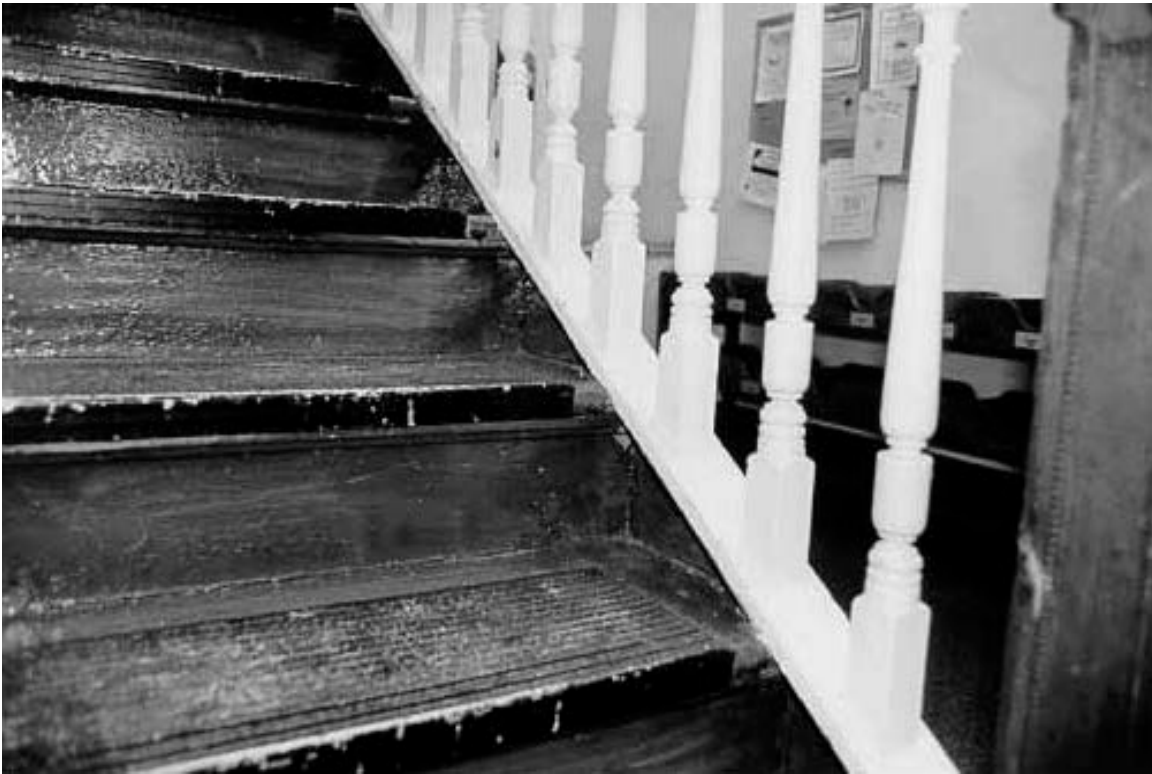
Figure 187
The Residence (1847)
First Floor. Stair detail. Grain-painted surfaces were done in the 1980's.

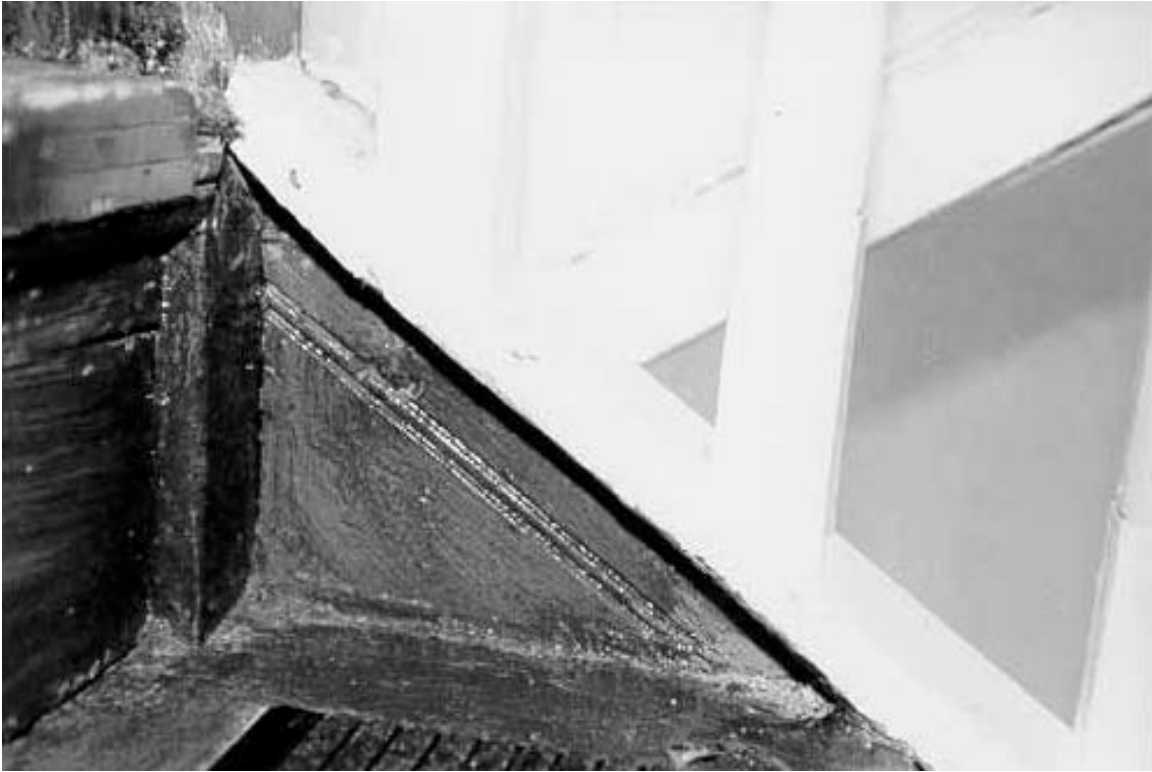
diaper pattern and an egg and dart cornice molding. A metal disc on the ceiling indicates location of former suspended light fixture. Currently, a wall-mounted fluorescent fixture illuminates the stair. There is a sprinkler head mounted to the ceiling and a wall-mounted lighted exit sign. The stair is generally in good condition, but the newels are scuffed and chipped with missing beads. The exact date and original configuration of the existing stair is not known. In architectural expression, the existing stair is classical in expression more typical of the 1890's than Greek Revival, which is what would be expected in a house of this period. Paint analysis shows that the original finish on the stringers, risers and balusters was grain-painting of rather poor quality, which appears to be close to that found on the stair in the Old Naval Observatory. It is quite clear that the existing stair has been heavily altered over time. The stair run from the first floor to the landing is narrow. The run from the landing to the second floor is quite wide. This in itself is an unusual condition. One expects a wider run to the public space with an equal or narrower run to the more private spaces on the second floor. Investigation also shows some discrepancy in construction details, which indicate more than one construction date. The underside of the unfinished stairs, Figure 190, indicates that it was never meant to be visible from the hall. The inner surface of the under stair closet is beaded board, Figure 191, which is between the structural and the decorative stringer supporting the turned balusters. The beaded board is similar to that found elsewhere in the building dating to 1902. The closet door, Figure 193, is clearly 20th century and is similar to a door found in the Nurses' Quarters. The stringers are rather crudely joined to the newel pendills, which suggests that the stringers and balusters were installed after the pendills, Figure 192. The inner surface of the stringer in the first run has beaded detail Figure 188, which is absent in the second run Figure 189.

Figure 188
The Residence (1847),
First Floor. Detail of stringer adjacent to landing newel. Note beaded detail in stringer. This detail is missing in the run from the landing to the second floor.

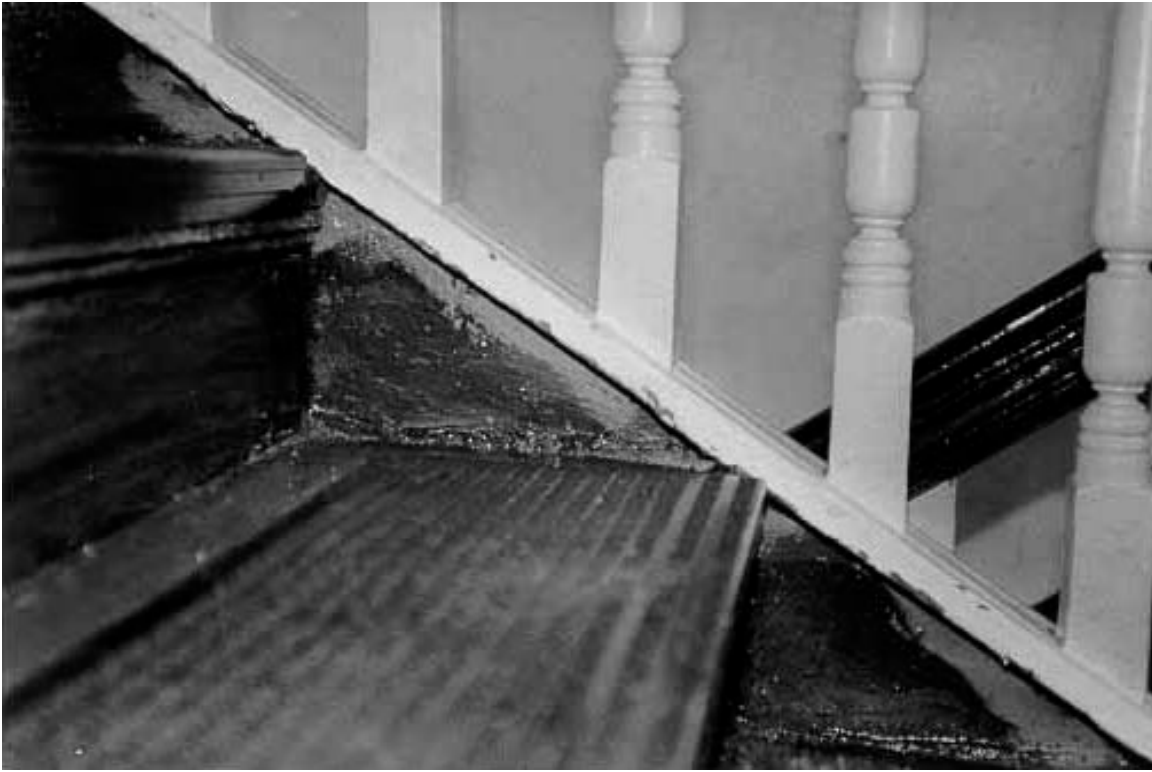
Figure 189
The Residence (1847)
First Floor . Detail of stringer on the stairrun from the landing to the second floor. Note the absence of the beaded detail.

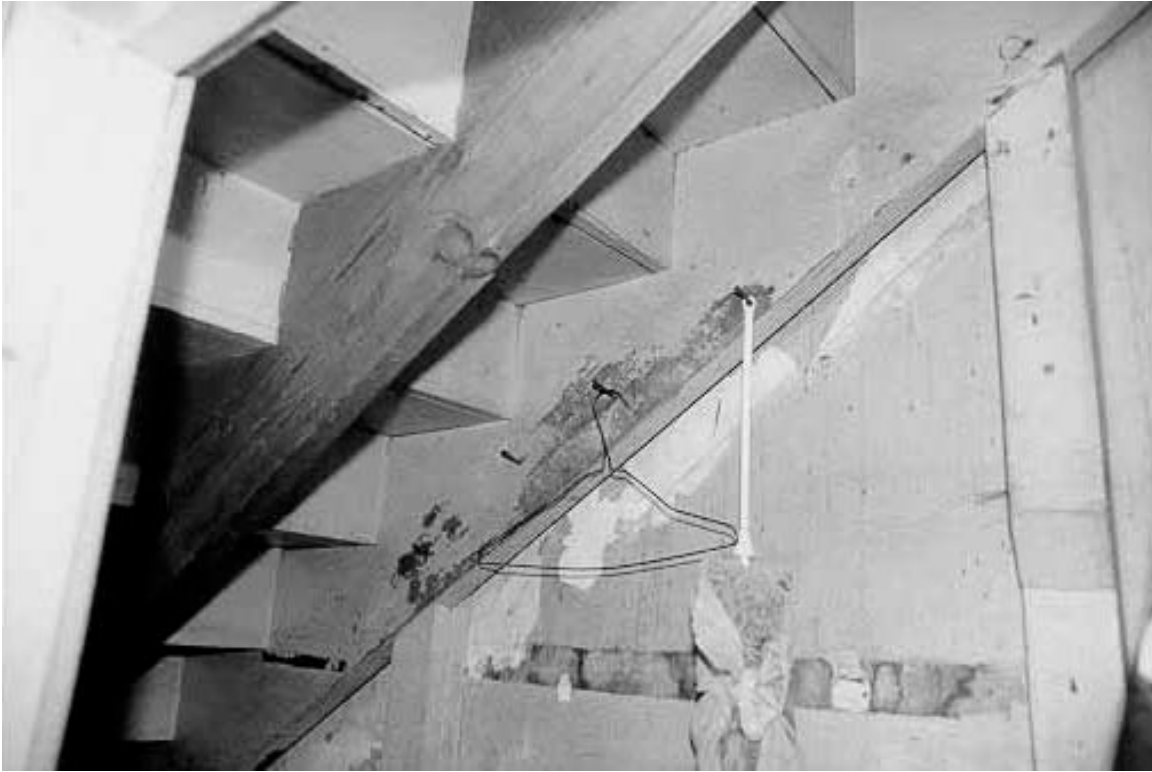
Figure 190

First Floor. Detail of underside of stair from the closet. Unfinished appearance indicated that it was never intended to be visible from the central hall. Vertical support (at right) and center stringer were added later, presumably to provide stability.

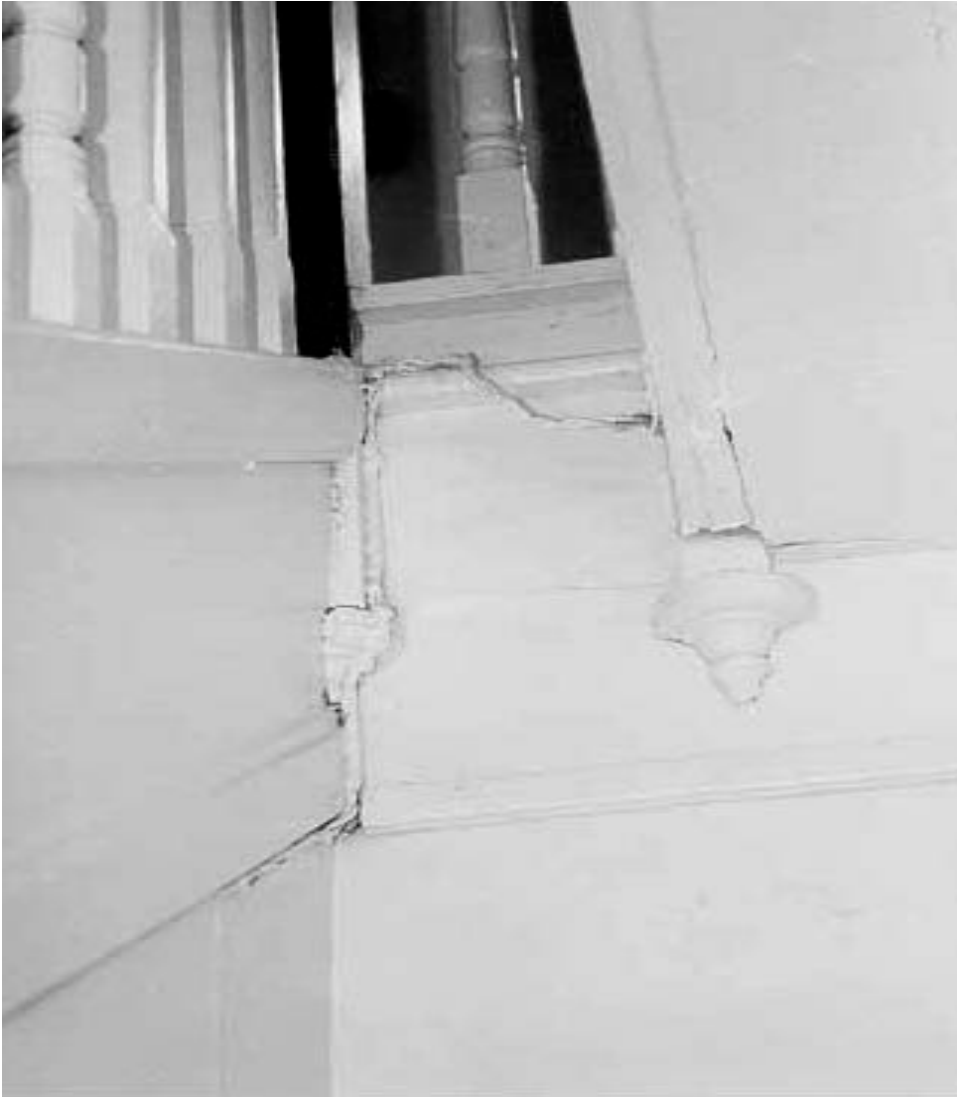
Figure 192
The Residence (1847)
First Floor. Detail of stair pendills. The difference in detail suggests different dates. The crude number in which the stringers join the pendills also support that the stairs were heavily reconstructed.

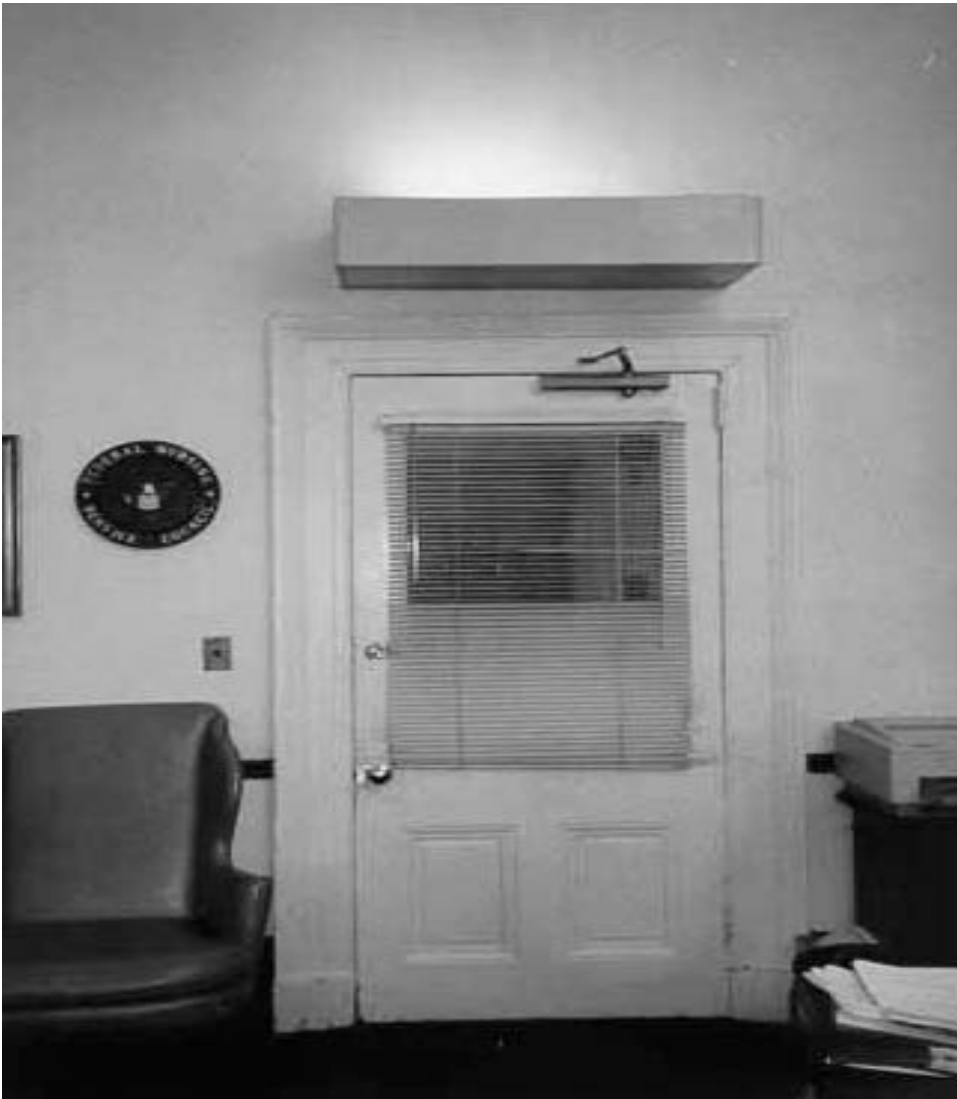
Figure 196

The door leading to the northeast parlor, Room 2124, is a 4-panel wood door, Figure 196. It is an historic door, which has been heavily altered by the installation of glazed upper panels, new hardware and closures. This door is similar to others found in the Residence and in the Old Naval Observatory, which are presumed to date to the 1890's alterations. Of the doors tested, this door is the only one that had a grain-painted finish. The finish appears to be of a much higher quality than that found on the stairs, which may indicate different dates of installation for the two features. The doorframe is the typical 8" with molding found throughout the Old Naval Observatory and Residence. The first finished layer was white.

First floor room 2124, the former northeast parlor, showing the door leading to the central hall. This door may be original to the construction of the residence but it has been heavily altered by the insertion of glazed panels and new hardware.

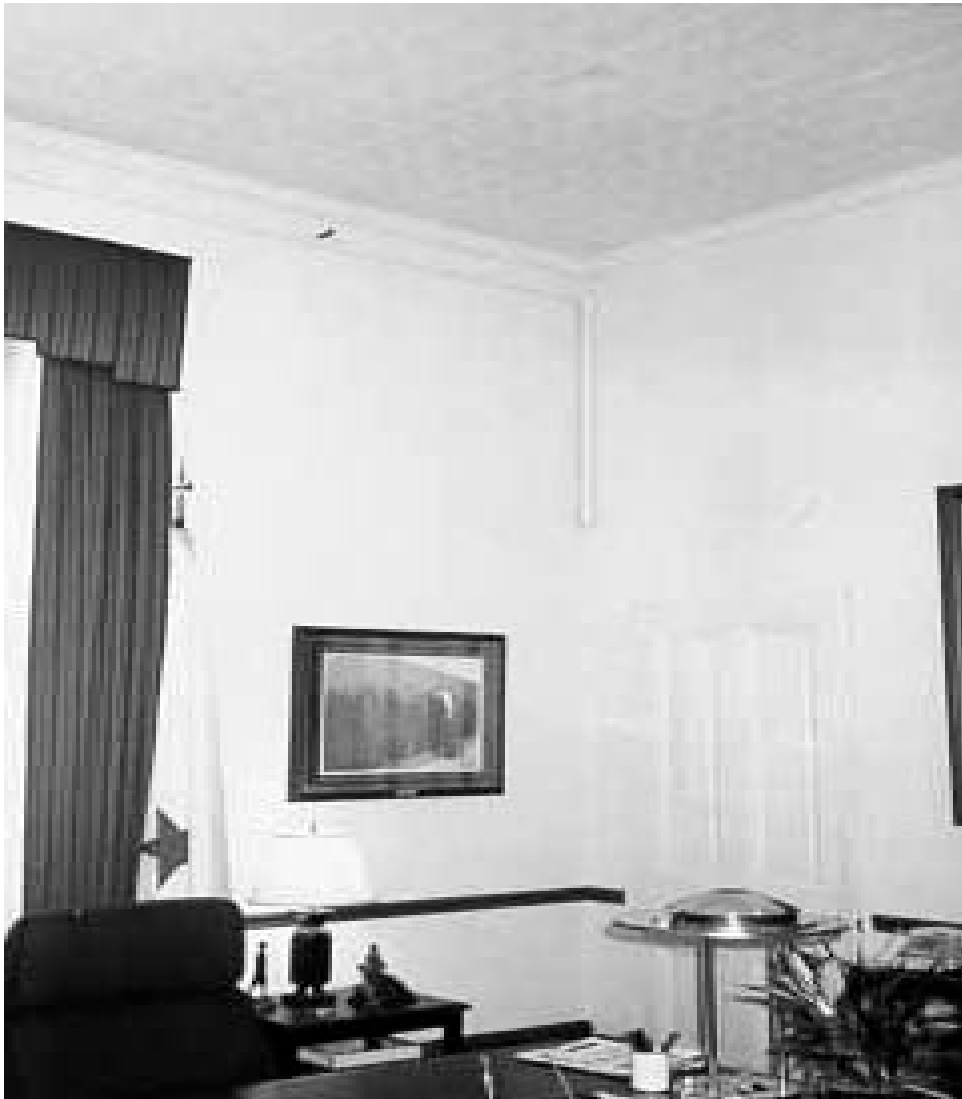
Figure 198

The door entering the closet from Room 2126, Figure 198, appears to be an historic 4-panel wood door. Its frame on the closet side is a typical 8" frame found throughout the Residence and the Old Naval Observatory. The closet doors are not historic.

This southeast room was designated in inventories of 1861, 1867 and 1877 as the dining room. It is currently used as an office, Figure 198.

First Floor. Room 2126 (the former dining room) looking southeast. The door frame casing was removed from this side, but the typical 8" molded casing exists on the reverse side.

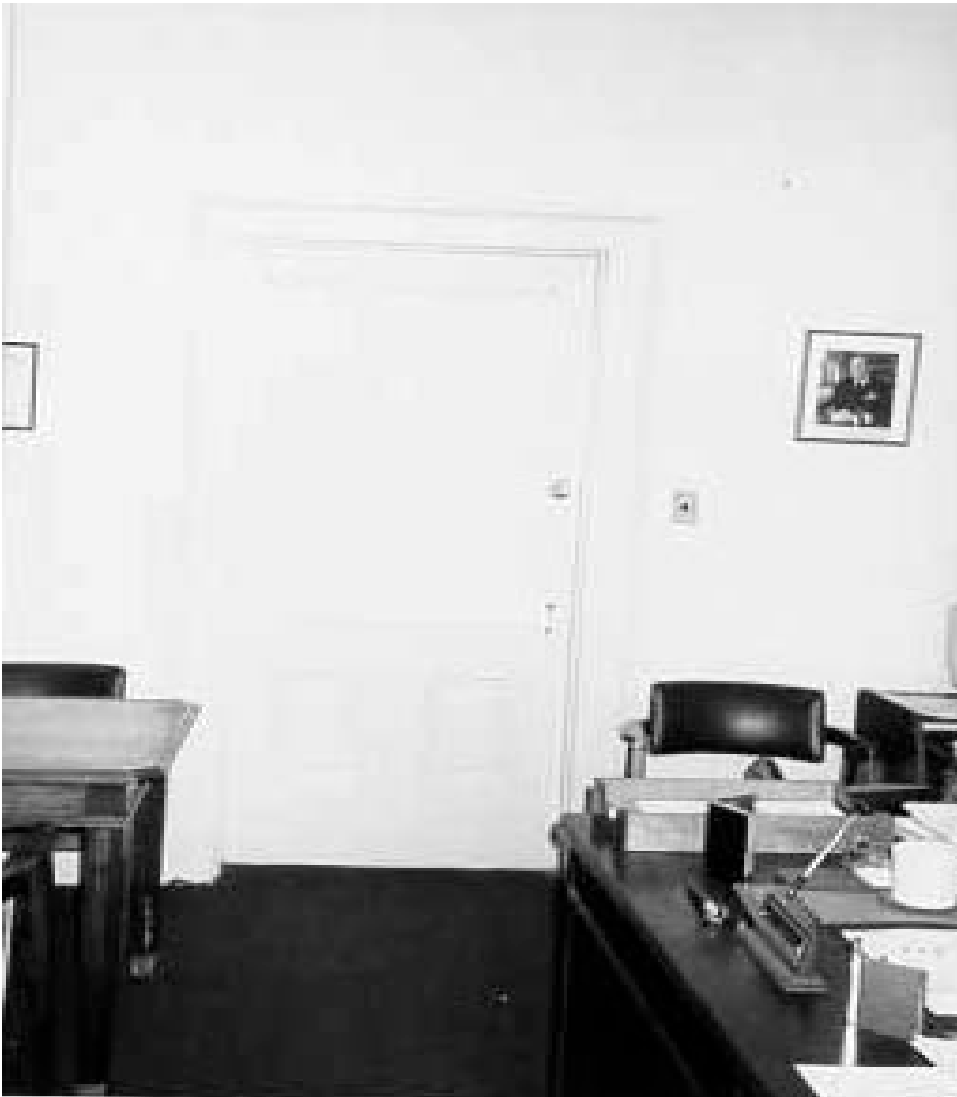
Figure 201

The door entering the northwest parlor, Room 2122, is a panel wood door, Figure 201. It is an historic door, which has been heavily altered by the installation of glazed upper panels, new hardware and closures. The doorframe casing on the hall side is missing. This is probably due to the installation of the plaster and metal lath furring mentioned above. The doorframe casing on the interior does not match other historic frames. This clearly indicates an alteration over time, but possibly indicating that the opening is not original.

First floor of room 2122 in the former northwest parlor. Detail of hall door. This historic door was heavily altered by the installation of a glazed panel and new hardware.

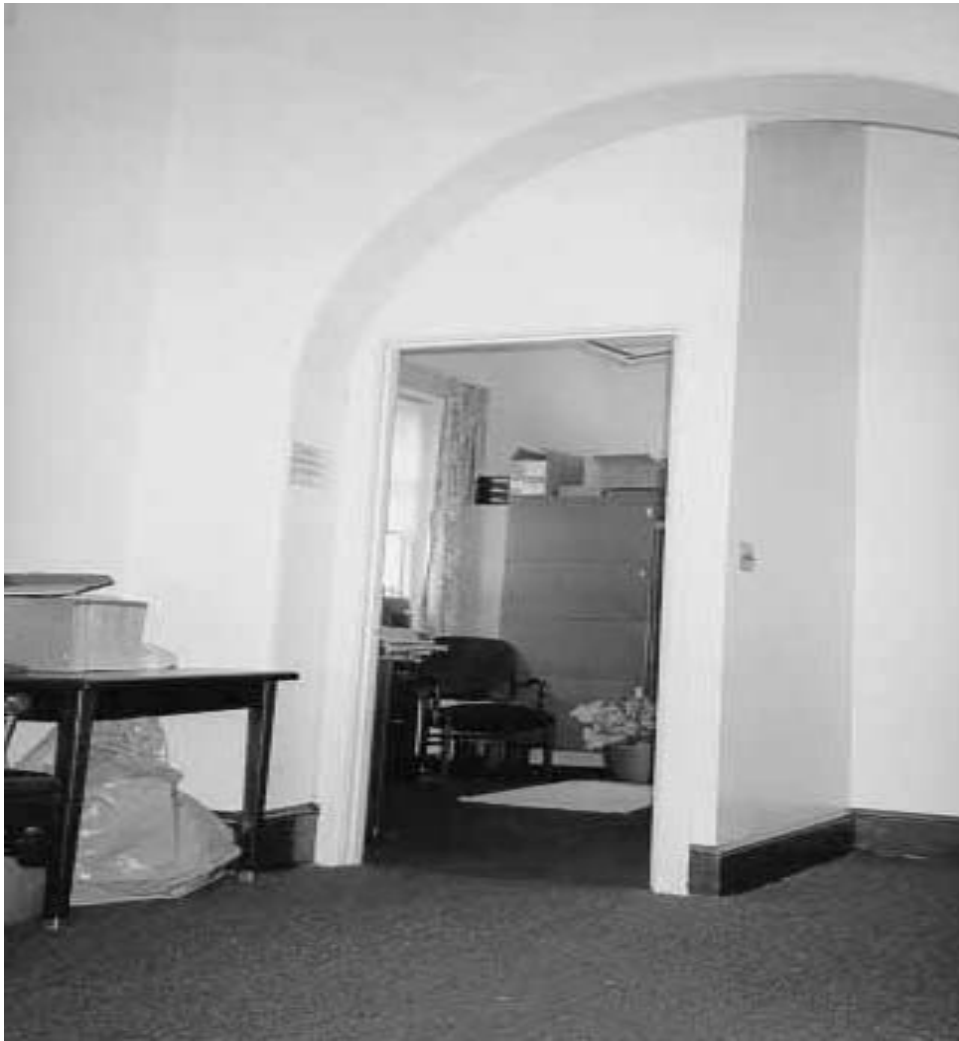
Figure 204

The walls are painted plaster. The wood-framed transom in the north wall is divided into five sections. Two openings have fixed painted panels and three are operable, although painted shut. There is an arched opening on the west, leading to the hyphen. Its architectural integrity is compromised by the gypsum board partition subdividing the office space in that area, Figure 204.

This space was constructed in 1848 to connect the residence to the Old Naval Observatory to the west. It has been bisected by an intrusive gypsum board partition, which detracts from the original size and volume of the space and the architectural expression of the arched opening to the east, Figure 204. The rooms are used for offices and a corridor leading to the west wing of the Old Naval Observatory.

Connects the Residence to the Old Naval Observatory. A view into the office space (Room 2121). Note the non-original partition, which detracts from the architectural integrity of the arch and the original spatial quality.
