POTOMAC ANNEX BUILDING 2

**HISTORIC STRUCTURES REPORT
CORRECTED FINAL SUBMISSION**

Prepared for the U.S. General Services Administration

Swanke Hayden Connell Architects

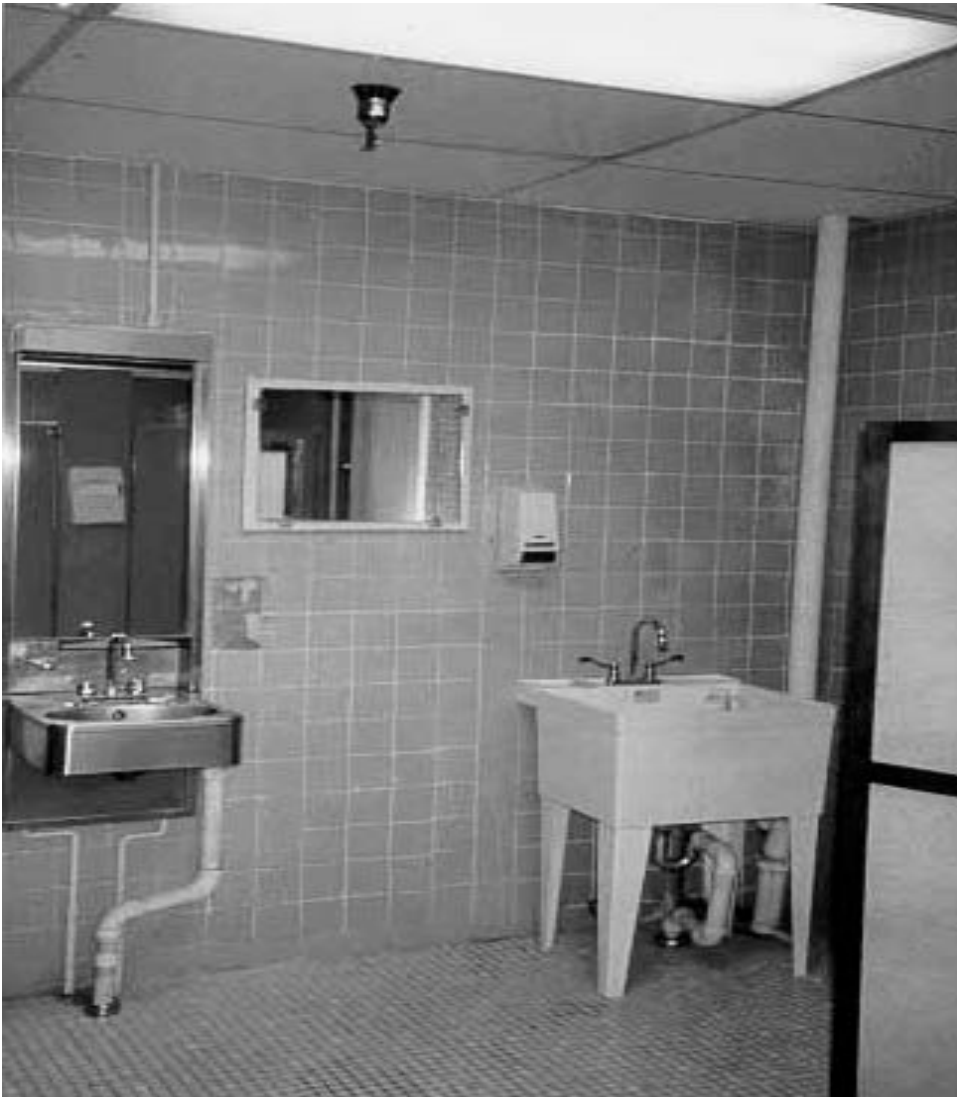
Figure 205
The Residence (1847)
First Floor. A view of Room 2123, in the former southwest part of the parlor. This space was converted to a bathroom sometime in the mid-to-late 20th century.

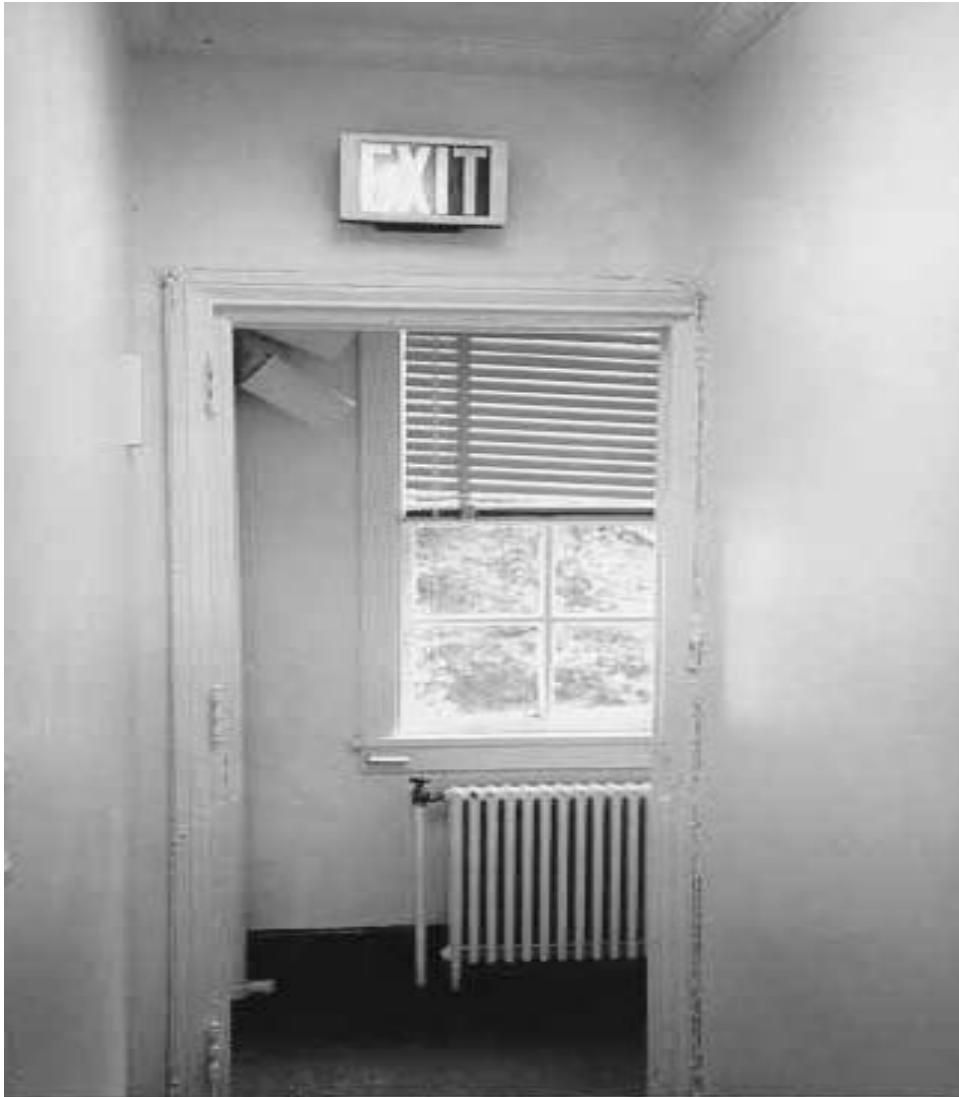
Figure 208
The Residence Back Building
First Floor. View of the corridor (Room 2125A) connecting the Residence to the back building.
The window is part of the east corridor constructed in 1918.

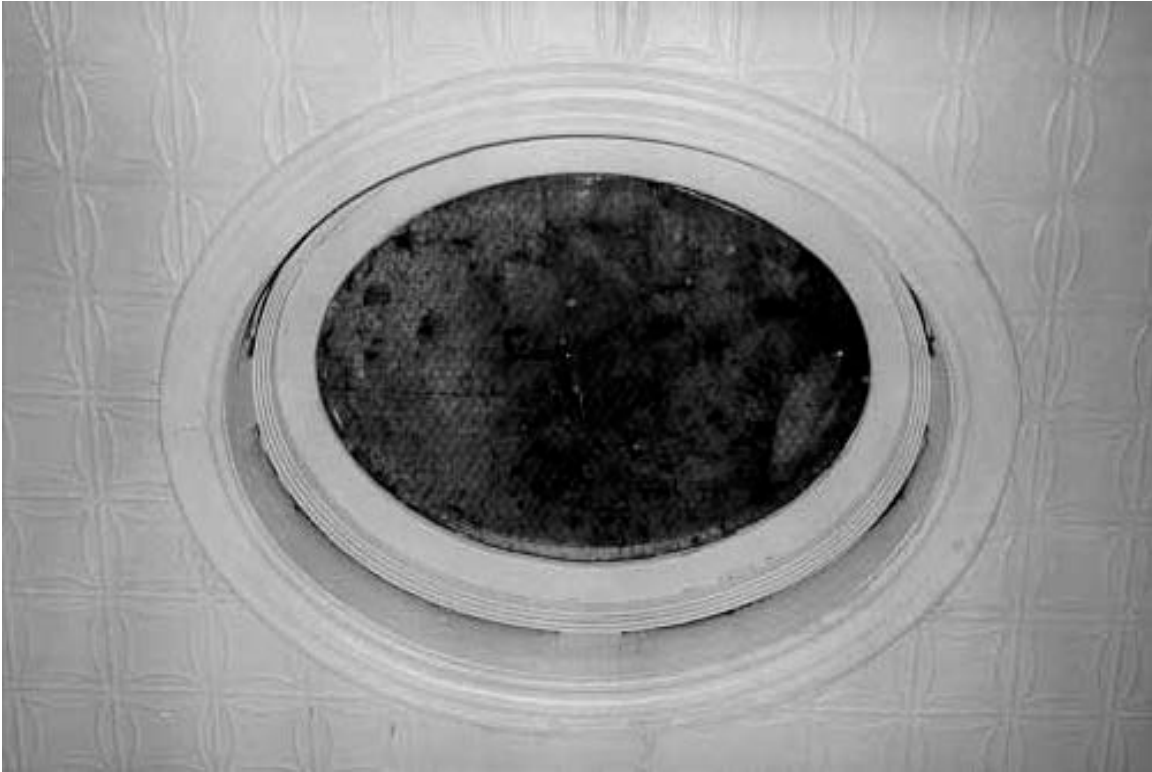
The ceiling is painted pressed metal with geometric diaper pattern and an egg and dart cornice molding. There is an oval wood-framed skylight in the ceiling with wire glass, Figure 209. The 19th-century inventories indicate that there was a skylight in the ceiling. However, there is no documentation for its appearance. The pressed metal ceiling probably dates to the 1894-1902 alterations. The casing of the skylight is placed over the surface of the ceiling suggesting that this casing, at least, date to the time of ceiling installation.

Figure 209
The Residence (1847)
Second Floor. A detail of the skylight in the central hall.

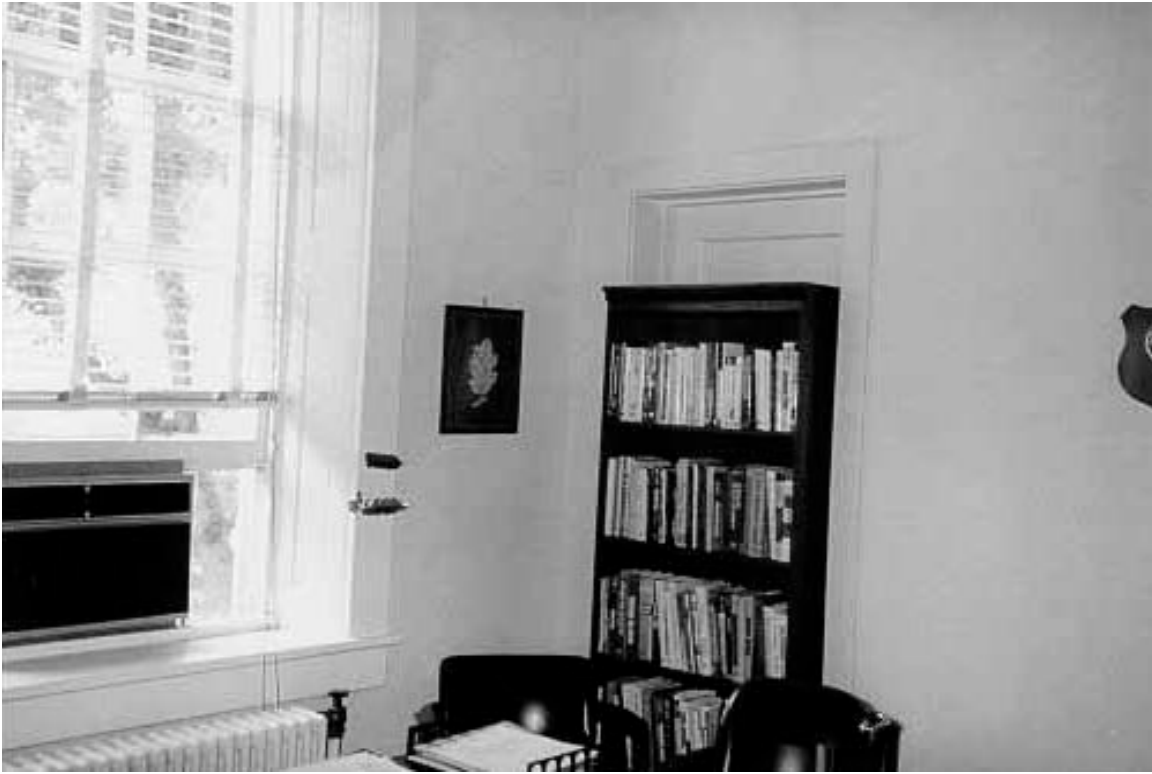
Room at north end of hall, Figure 210. Historic inventories identify this room as the library. It is currently used as office space. The west wall of this room is out of alignment with the remainder of the original partition wall indicating that part of the original partition was replaced with the existing, which makes this room larger than its original size. This condition is illustrated in the 1927 plan, suggesting an earlier alteration or an unlikely original condition.

Figure 210
The Residence (1847)
Second Floor. A view to the northeast of Room 2225A. The flat window and door casings are typical throughout the second floor of the residence.

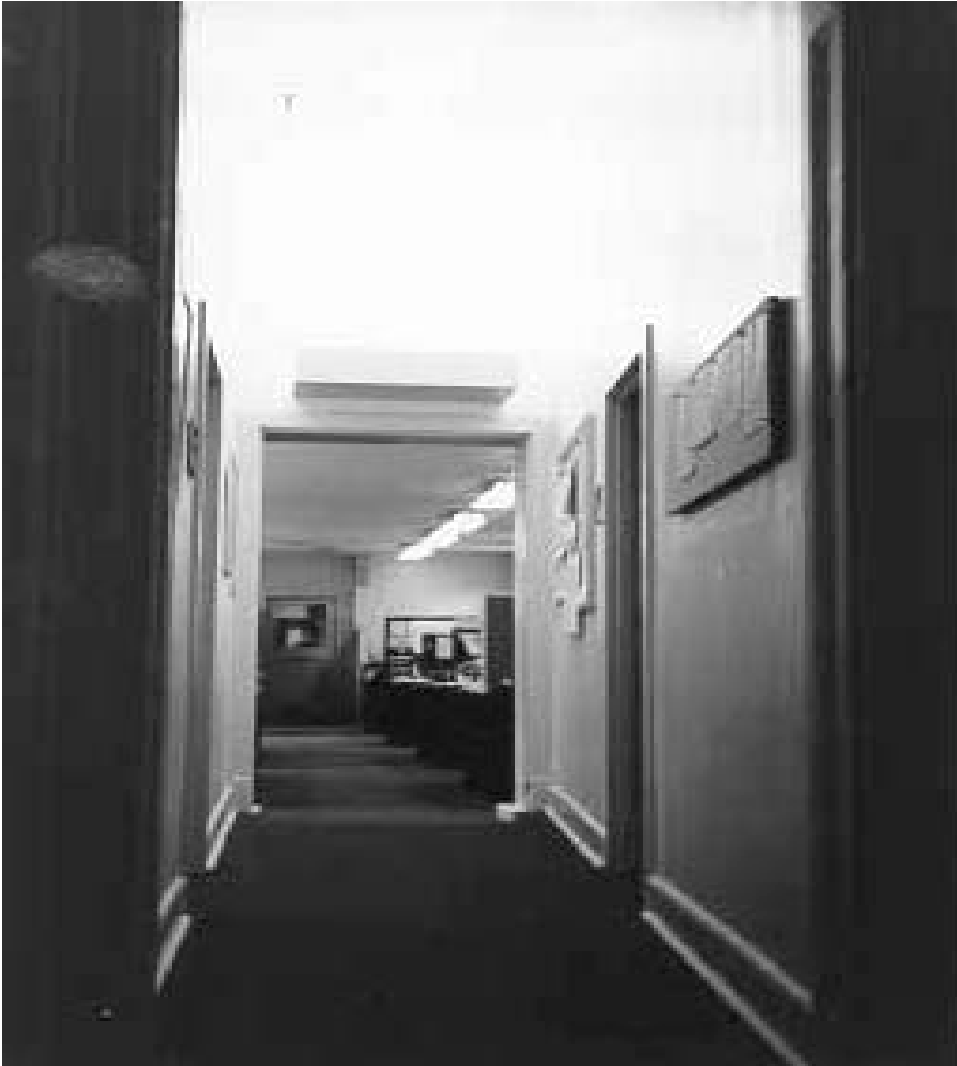
Corridor space between the second floor central hallway of house and the 1902-03 Second Floor Additions between the Residence and the Old Naval Observatory, Figure 212.

Figure 212
The Residence (1847)
Second Floor. The corridor (Room 2223A) leading to the 1902 addition. The angled configuration of the corridor indicates an alteration probably undertaken as part of the 1902 construction.

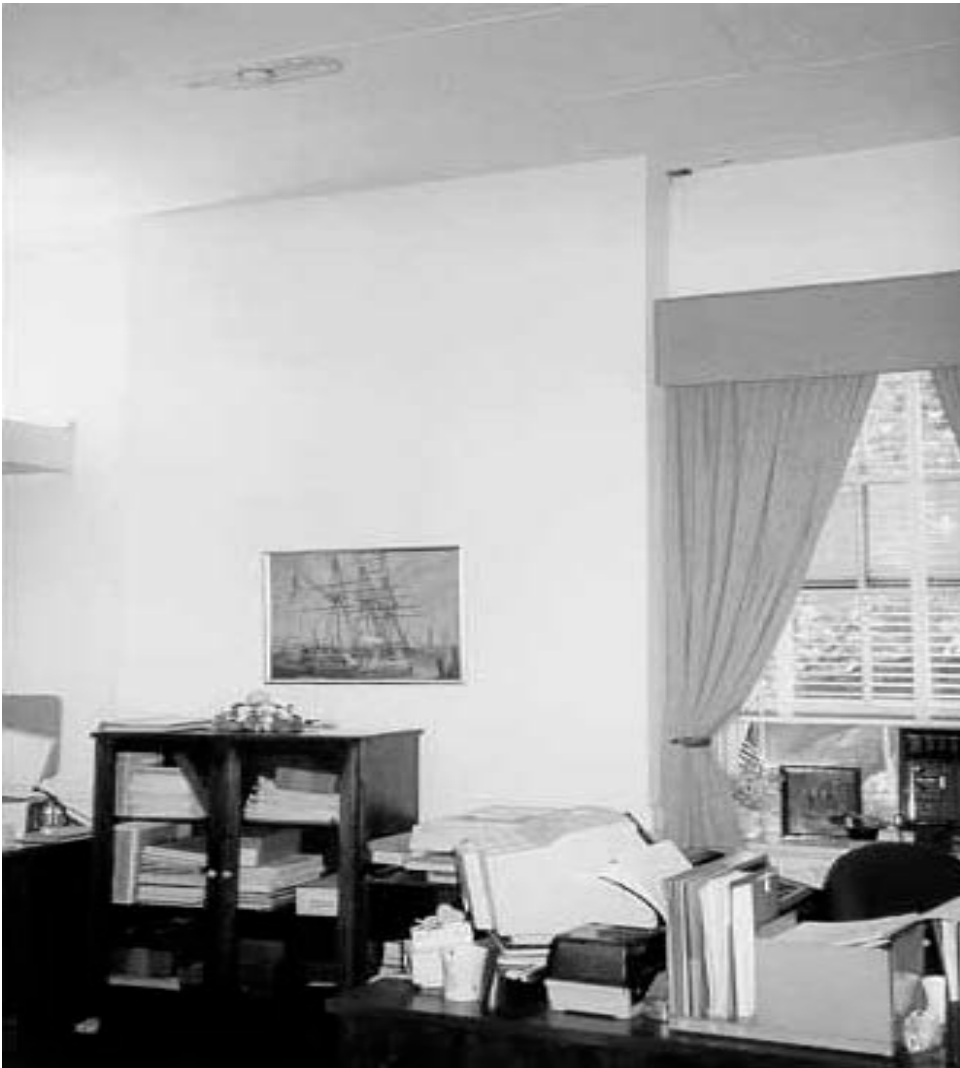
Historic inventories identify this as the northeast chamber. It is currently used for office and conference space, Figure 214.

Figure 214
The Residence (1847)
Second Floor. Room 2224 looking east. Note the blocked in fireplace.

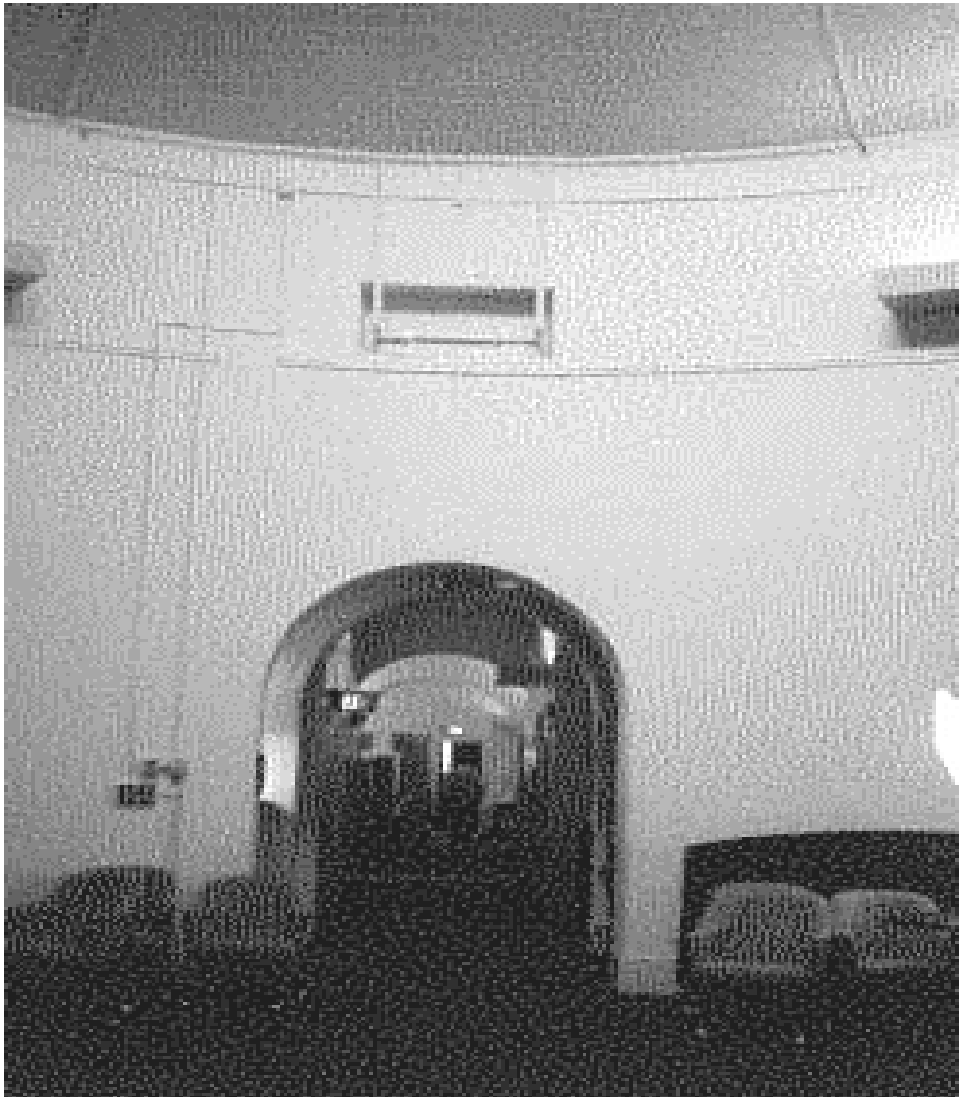
Figure 224

View to the north through the 1873 additions. The Rotunda was constructed in 1873 to house a new telescope; however, the historic photographs and documentation show that the existing structure dates to 1894.

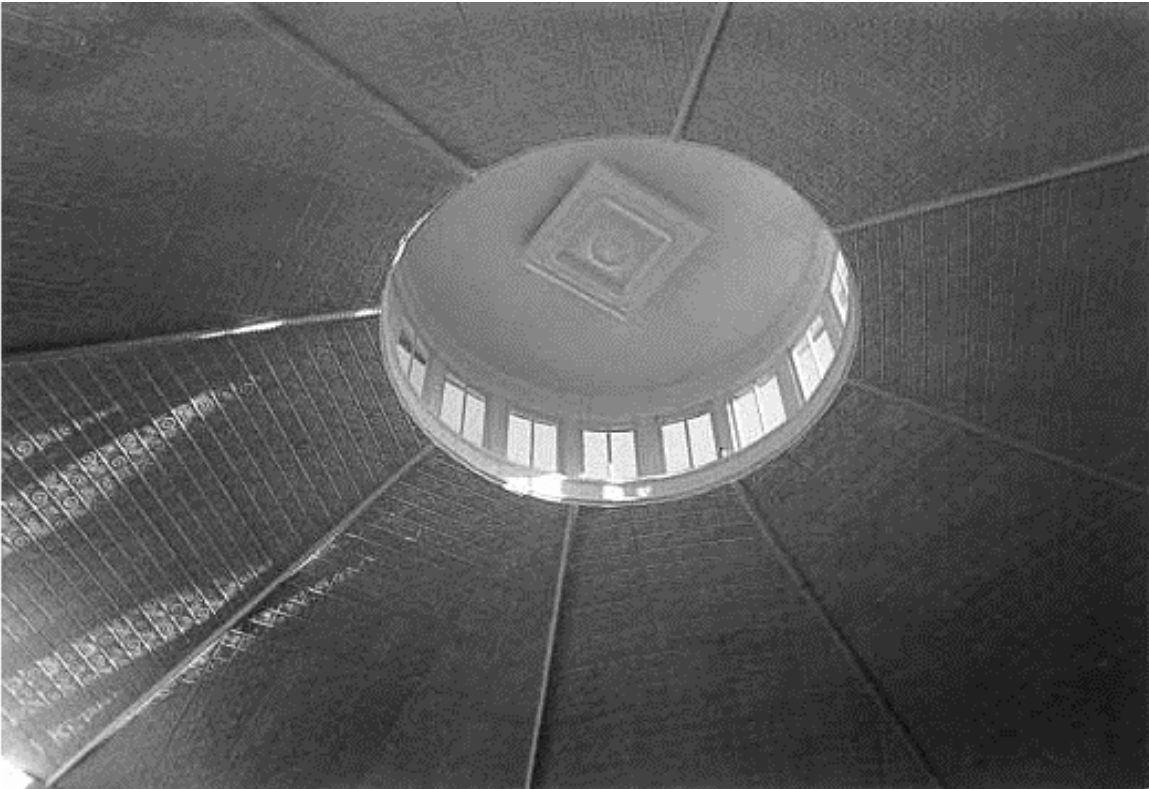
Figure 228

The ceiling is surfaced with pressed metal in a grid diaper pattern, an egg and dart pattern on the molded border and a radial rope molding to the lantern. The ceiling was installed during the 1980's and matches the previous existing ceiling. A pressed metal 4' square medallion is centered in the lantern roof. All ceiling elements are in good condition.

View of dome and lantern. The pressed metal ceiling was installed in the 1980's. It replaces the one that had existed previously.

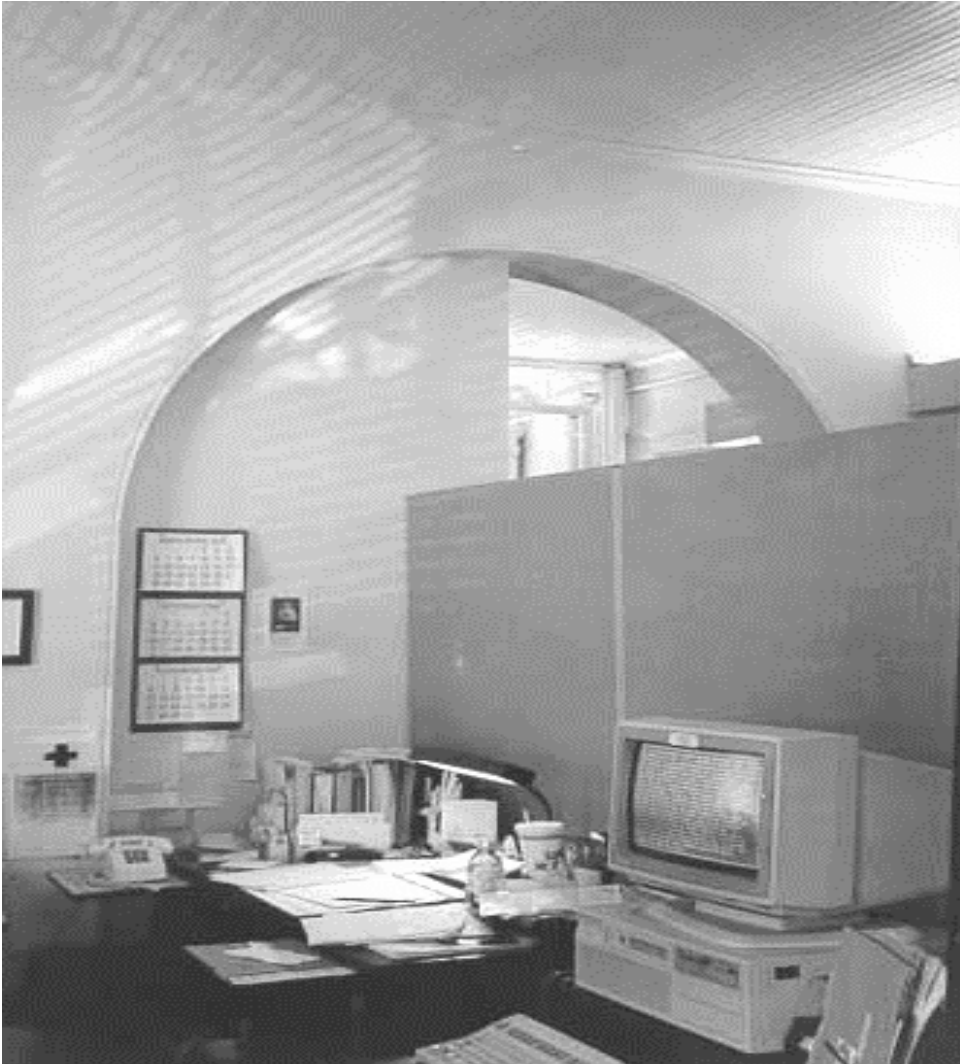
Figure 229
South Wing Extension (1873).
View looking north toward the 1843 south wing. The non-original partition detracts from the architectural integrity of the arch and spatial character.

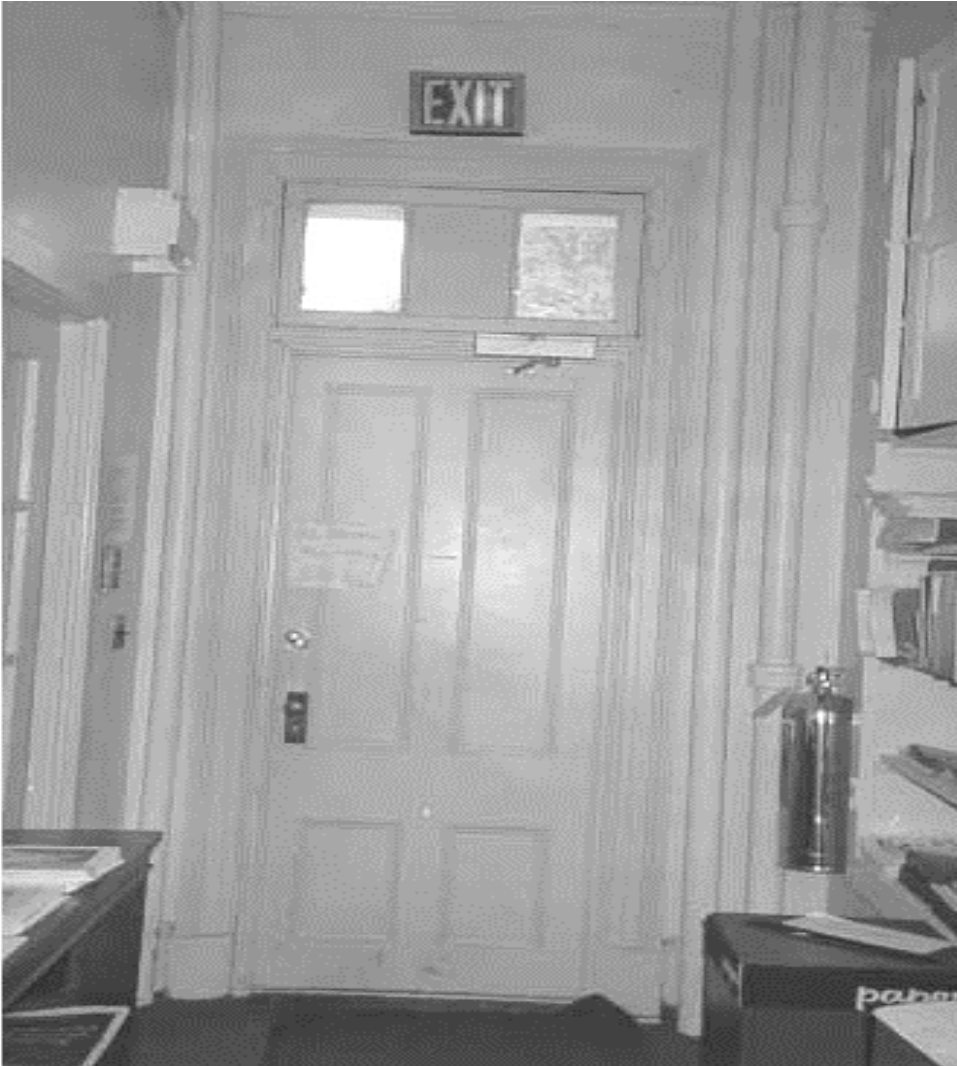
Figure 230
South Wing Extension (1873).
This door was originally a window; it was probably converted during the 1894-1902 alterations.

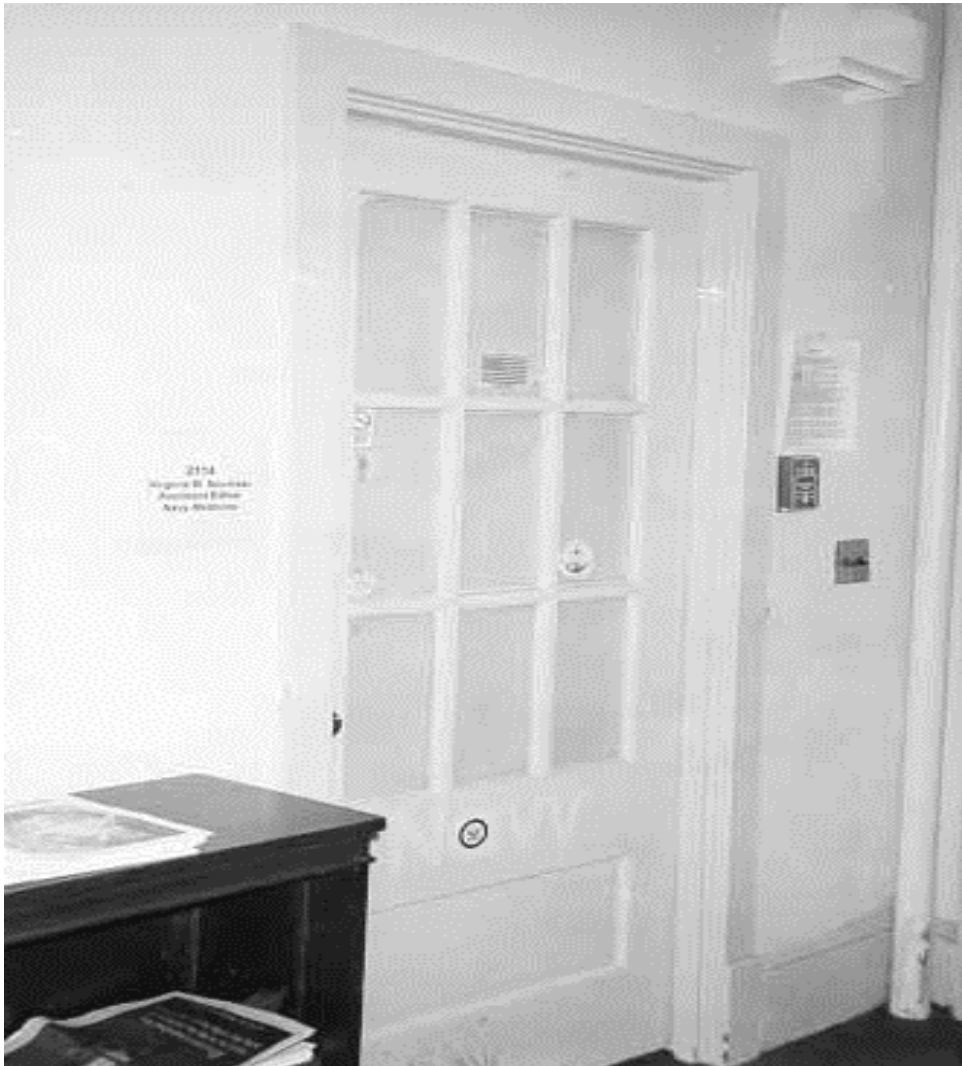
Figure 232
South Wing Extension (1873).
Door to Room 2114. This partition was probably added during the 1894-1902 alterations.

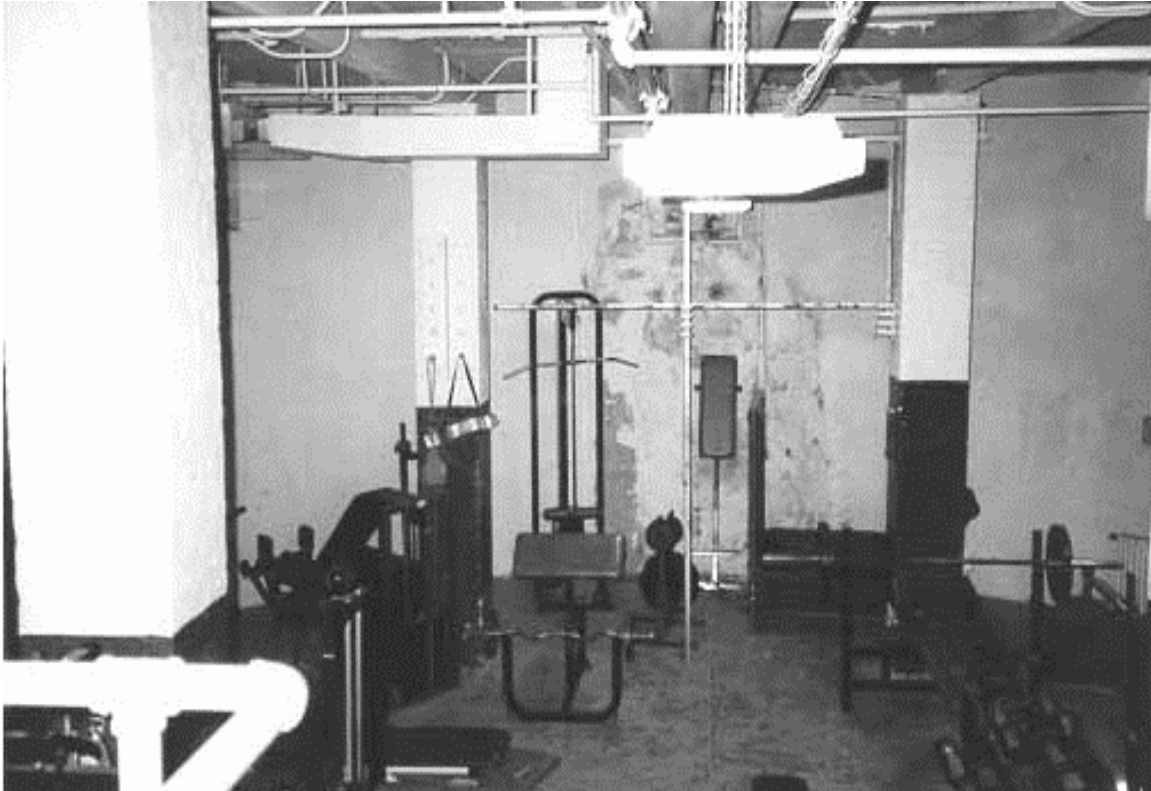
Figure 234

Basement view looking south. The brick piers and steel beams were installed ca. 1909 when the space above was used as a library.

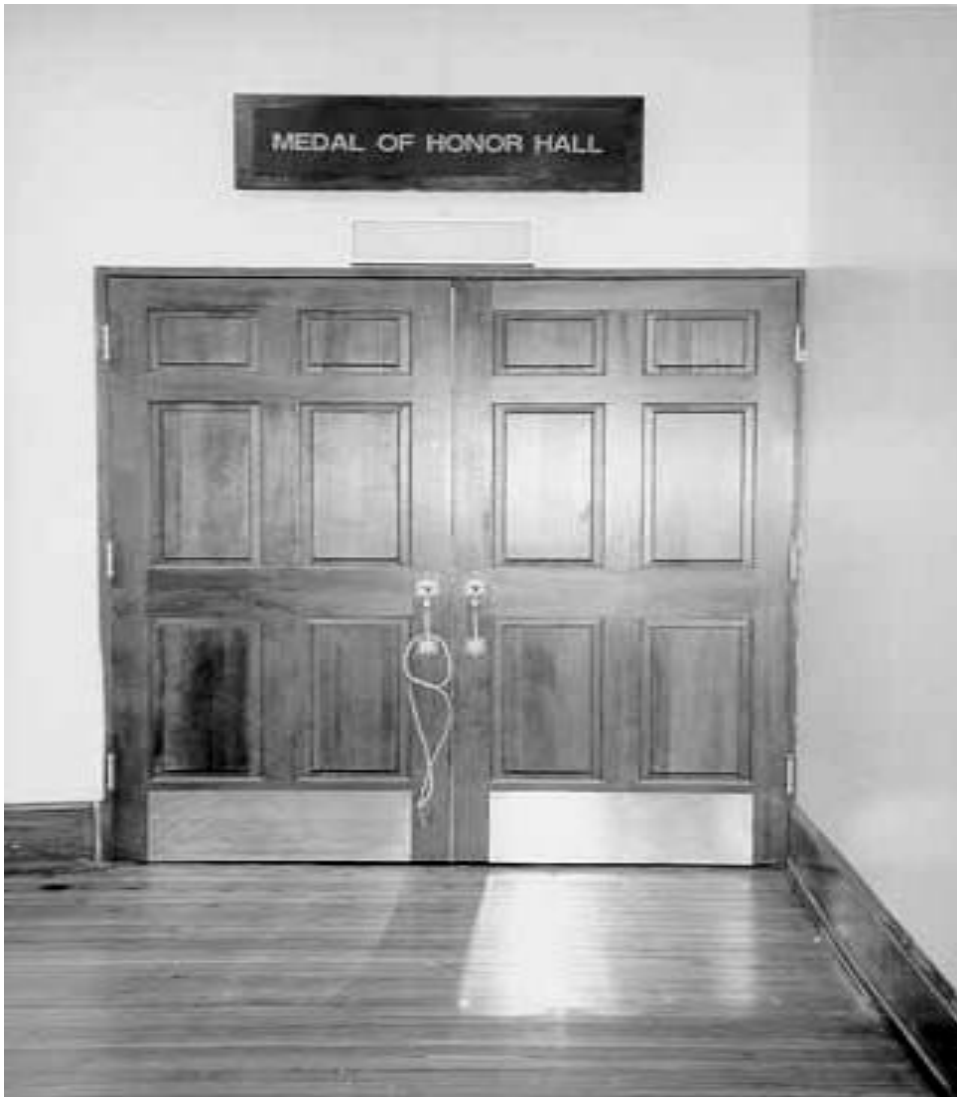
Figure 238

The west transit house was constructed in 1869. However, historic photographs and documentation indicate that the structure was replaced by the existing in 1895. An historic photograph shows an arched opening to this room similar to those seen throughout the Observatory. The partition and these doors are of more recent installation.

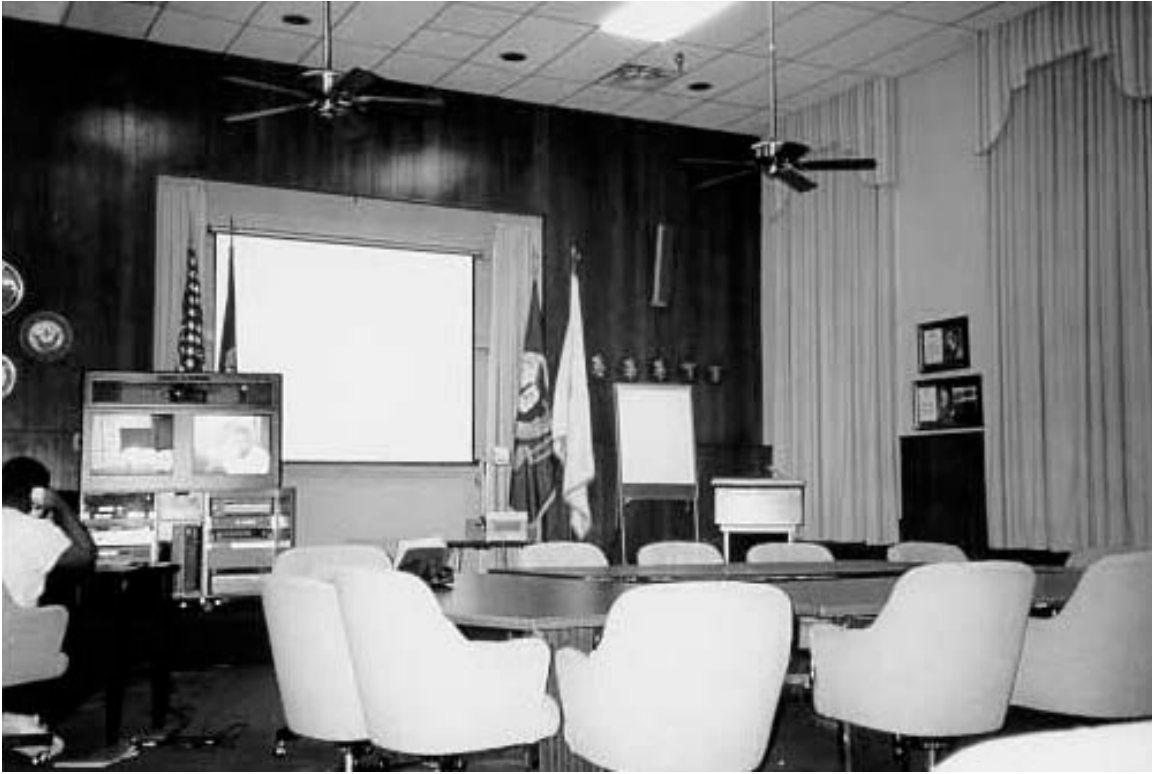
Figure 239

This space has always been used as a lecture room. However, with the exception of the window frames, the interior finishes have been compromised by the installation of the wood veneer paneling and the acoustic tile ceiling.

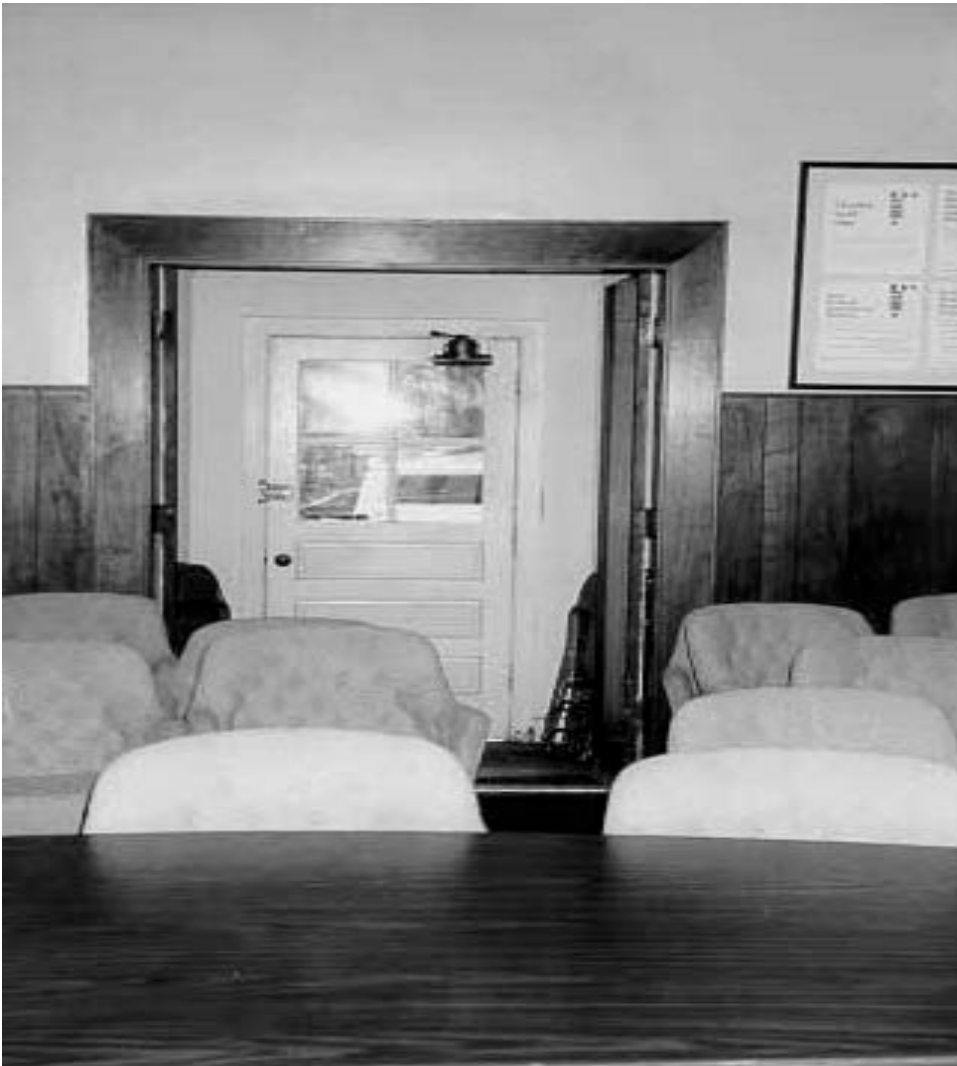
Figure 241

View looking north through double doors to covered porch space. The porch space was originally an open portico. (See historic photographs of the exterior).

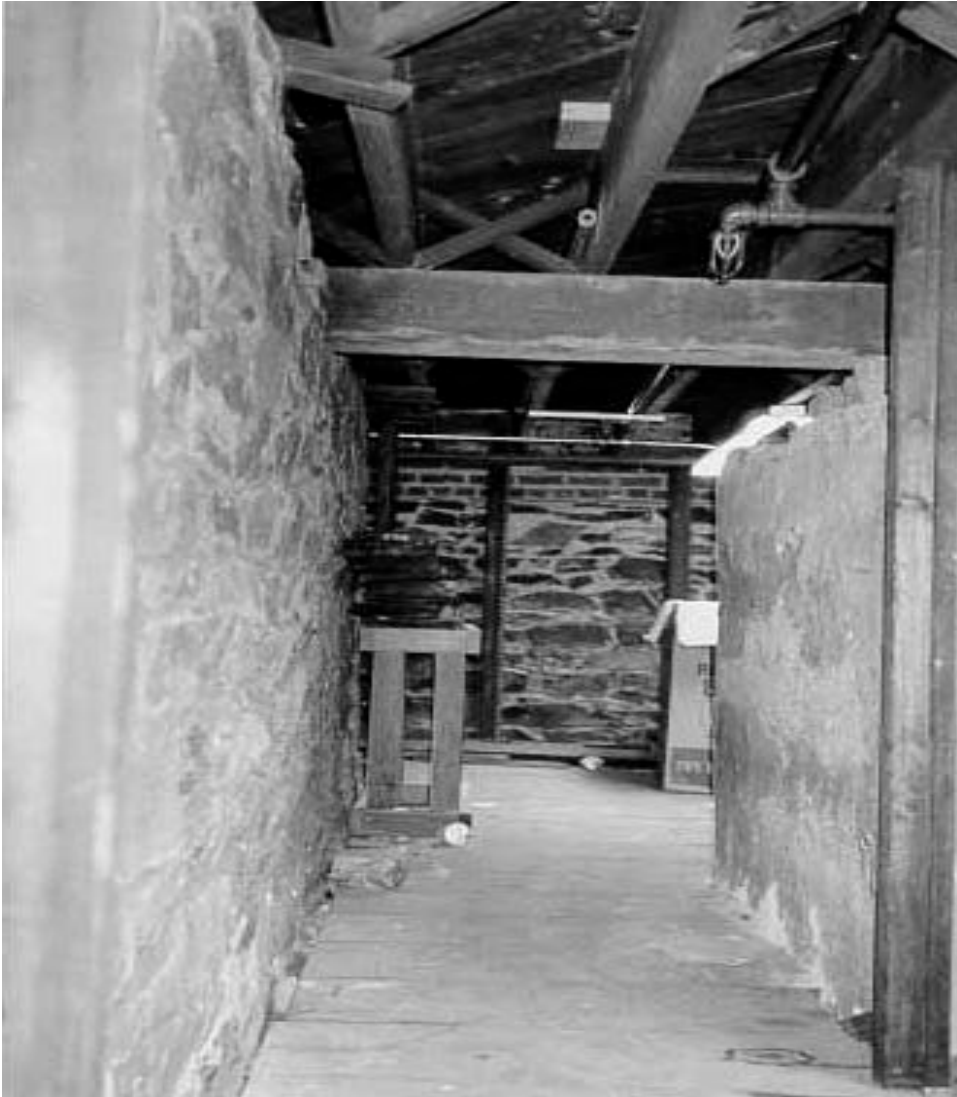
Figure 242

Basement view showing foundation wall (to the left) and the masonry pier, which originally supported the telescope above (to the right).

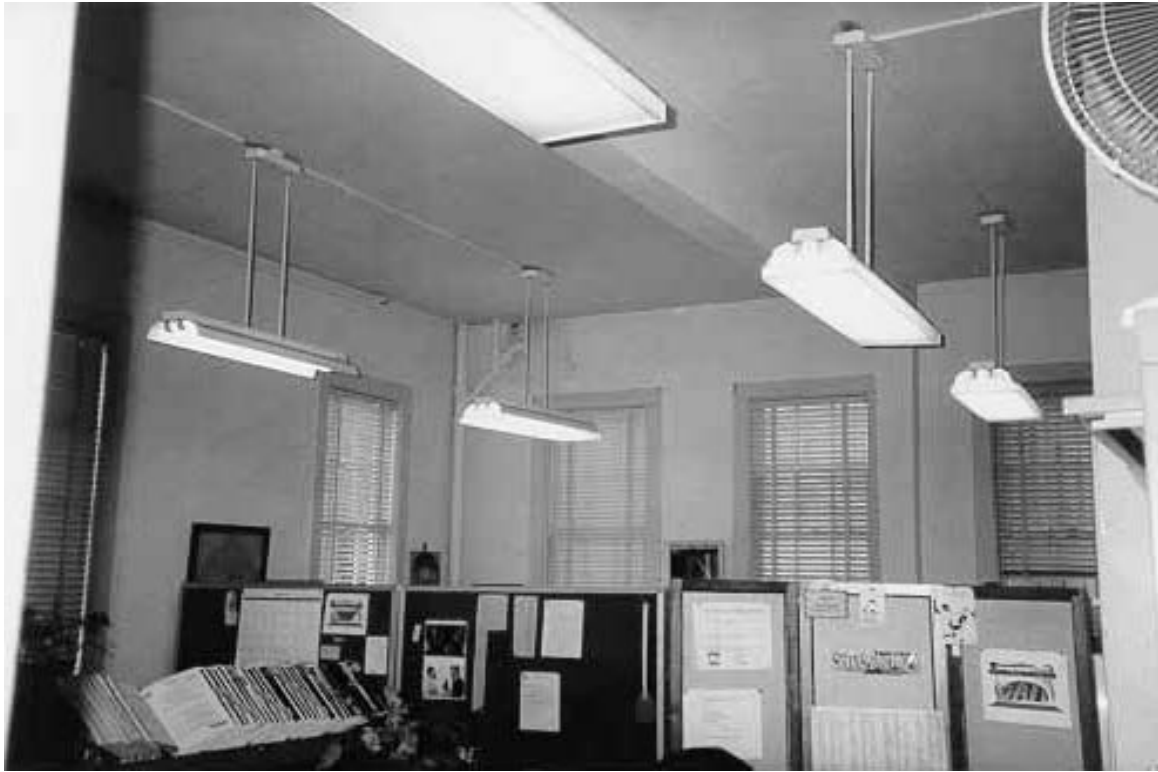
Figure 254

First floor. Room 2101. Although it appears that some original partitions may have been removed, the finishes in this room are original to the construction date.

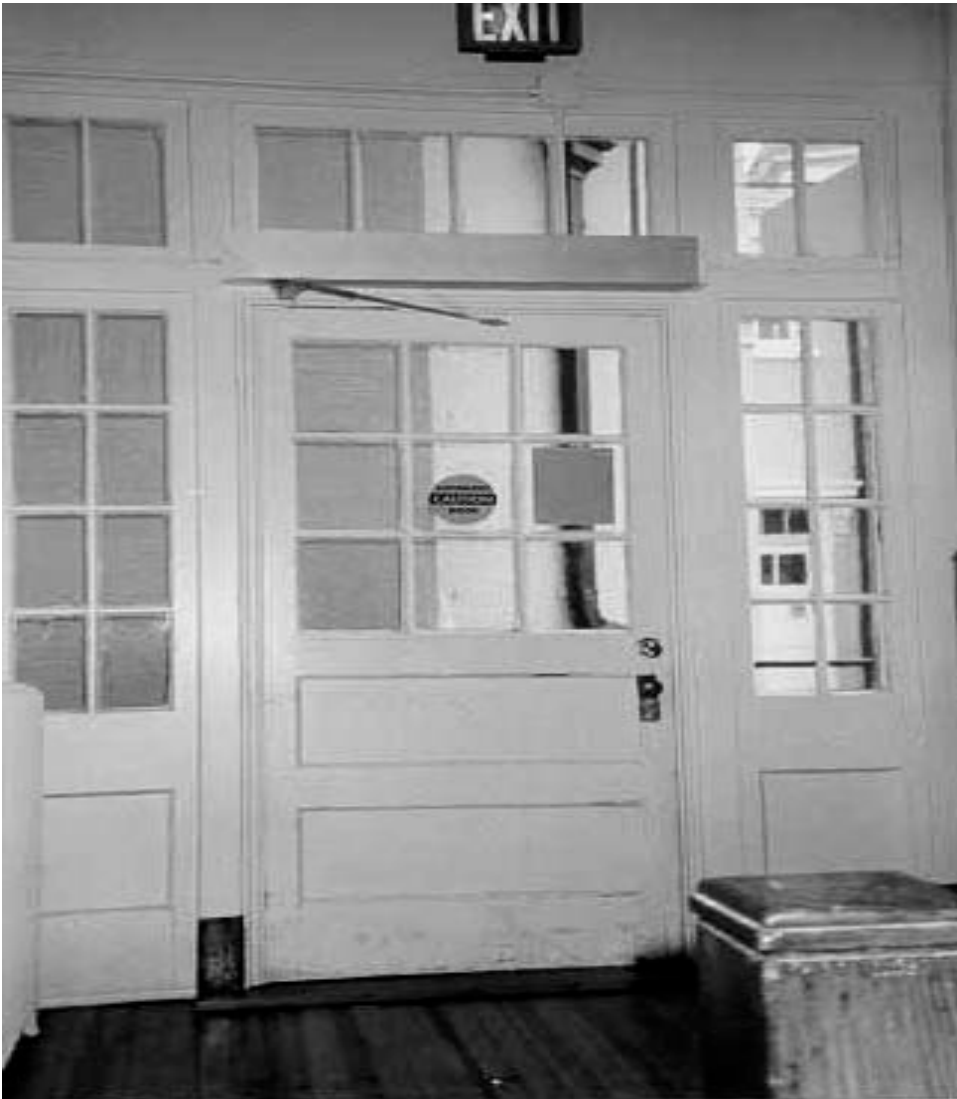
Figure 256

First floor. Stair hall entry. This entry and door appear to be original to the 1918 construction site.

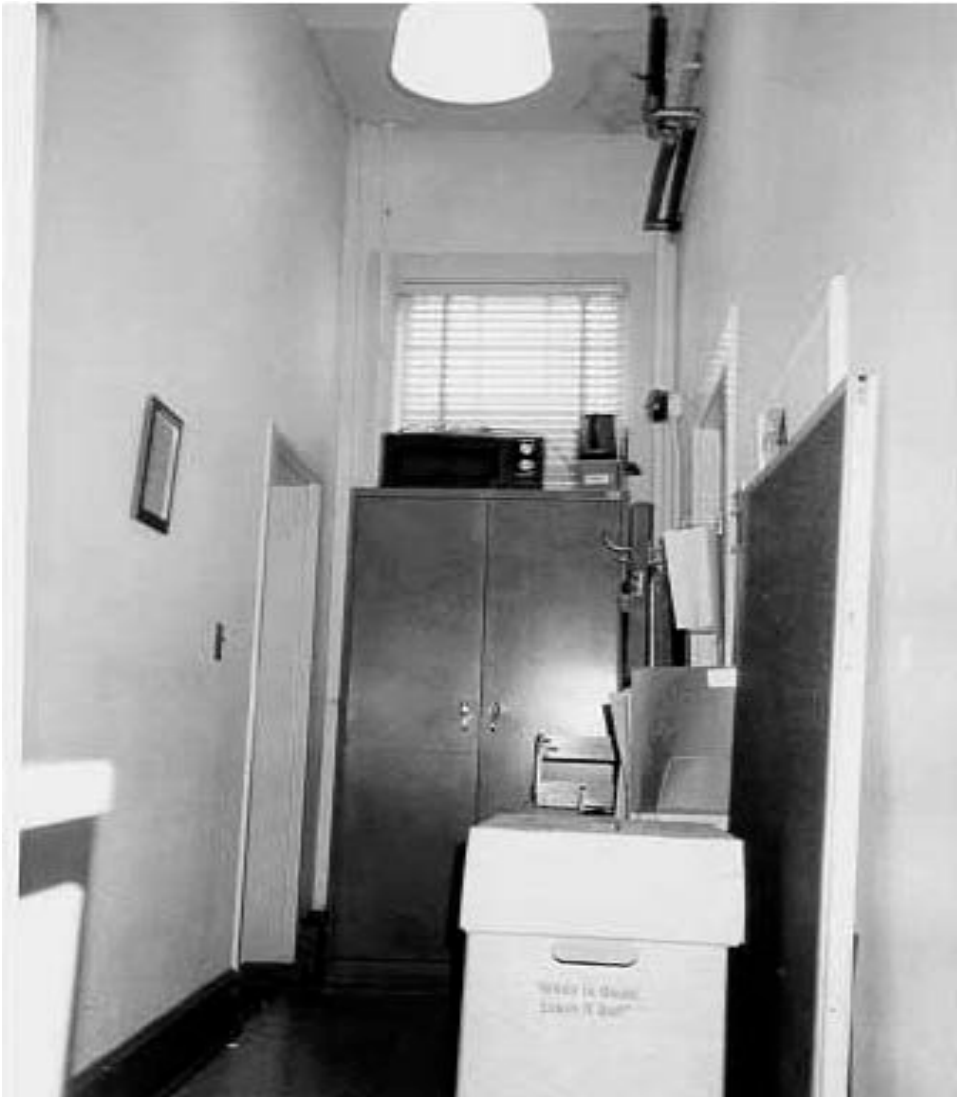
Figure 257
West Stucco Addition (1918)
First floor. Room 2103A. This room serves as a passageway from the entry vestibule to Room 2101.

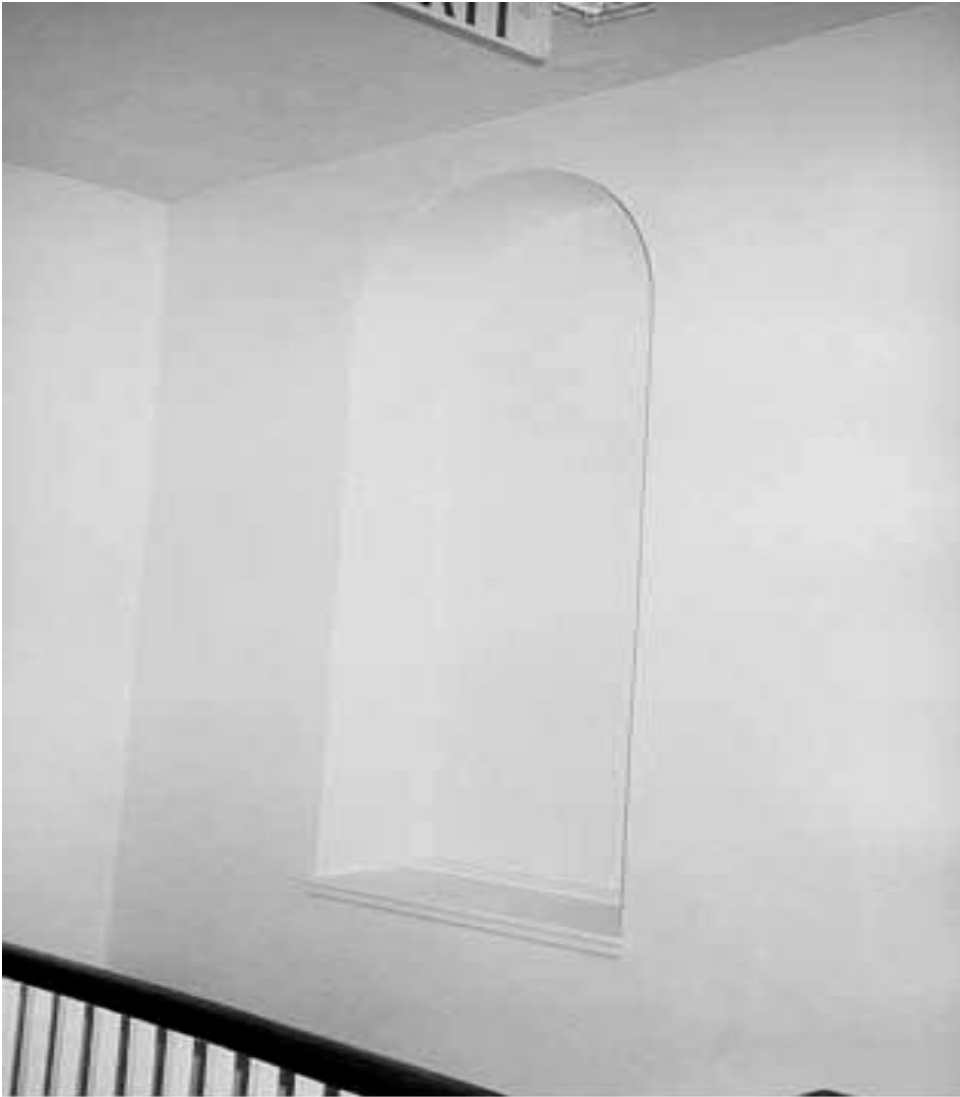
Figure 260

Second floor. This niche is what remains of a window in the 1902 west addition. It was enclosed by the construction of the 1918 East and West Stucco Additions.

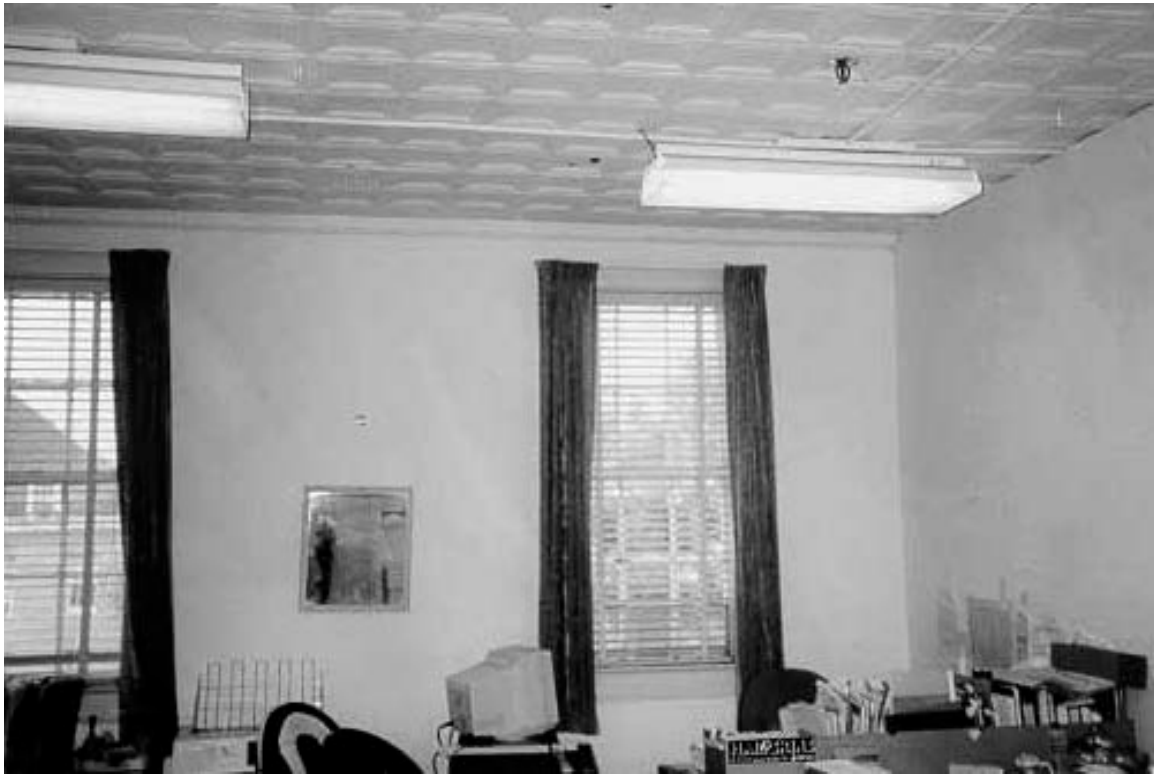
The ceiling is painted plaster and pressed metal ornamentation in a grid diameter pattern and egg and dart-molded border on the north, south and east walls. Chipping paint and some moisture soiling is evident in the southeast corner.

Figure 261
West Stucco Addition (1918)
Second floor. Room 2201.
