POTOMAC ANNEX BUILDING 2

**HISTORIC STRUCTURES REPORT
CORRECTED FINAL SUBMISSION**

Prepared for the U.S. General Services Administration

Swanke Hayden Connell Architects

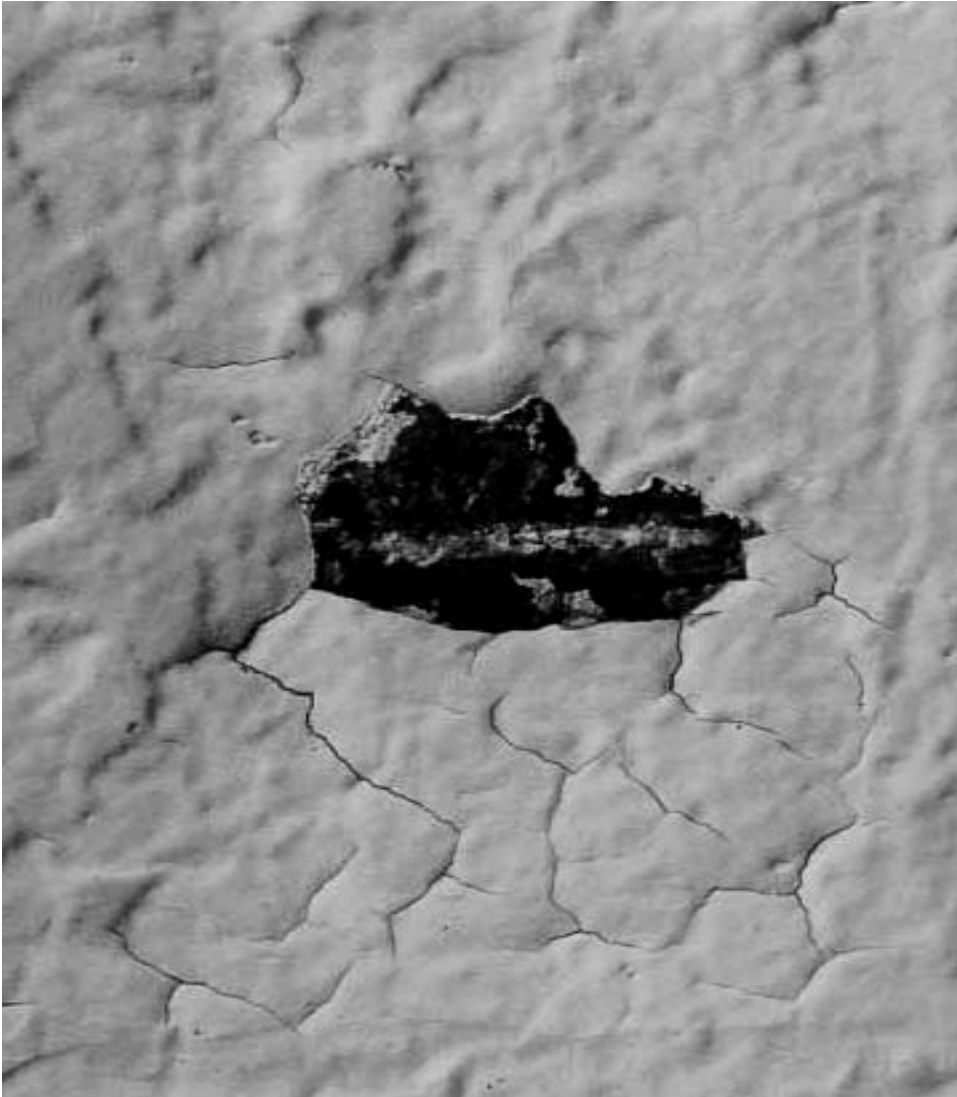
Figure 288
1847 Residence, North Elevation.
The most pervasive condition on Building 2 is lifting or detachment of paint. Loss of paint in the example shown here also reveals the narrow joints (1/8 inch) and 2 5/8 inch wide bricks which comprise most of the elevations.

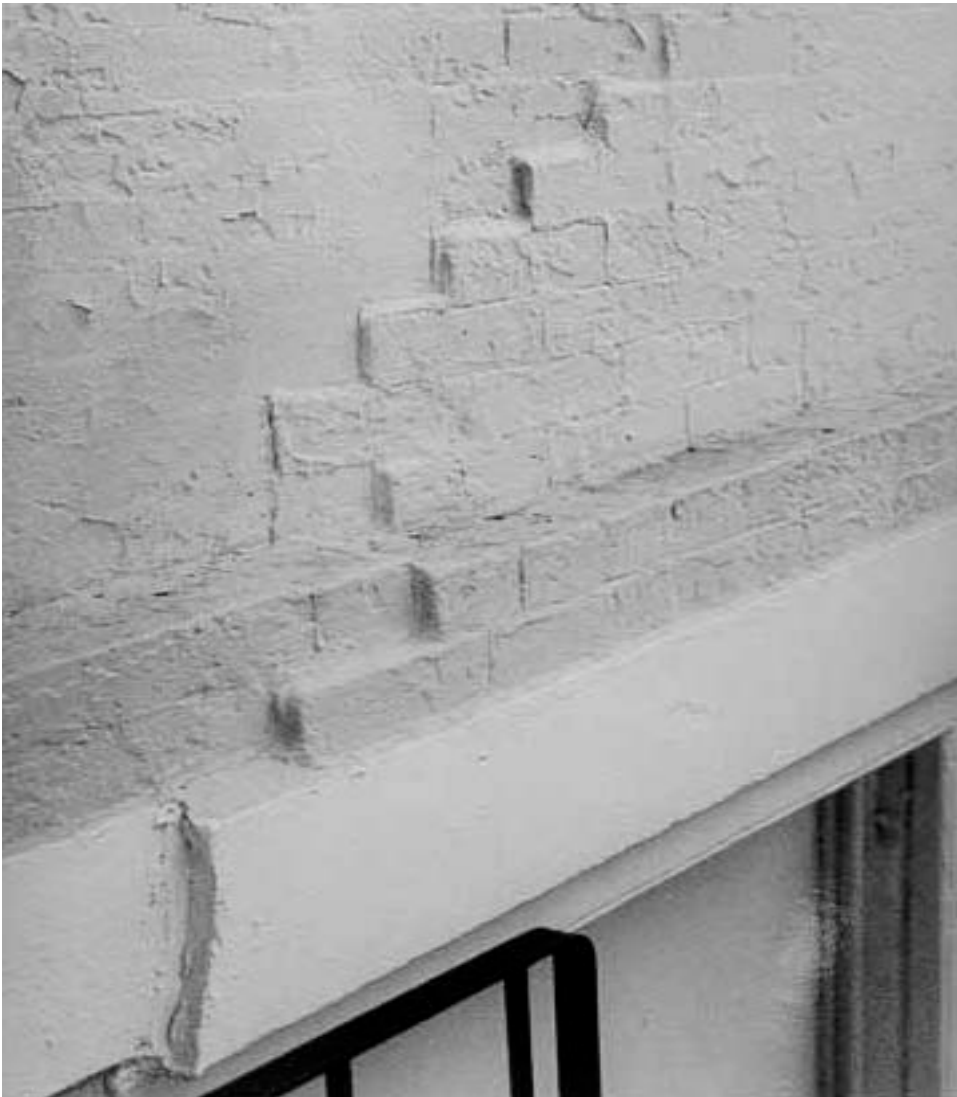
Figure 290

1847 Residence, North Elevation.

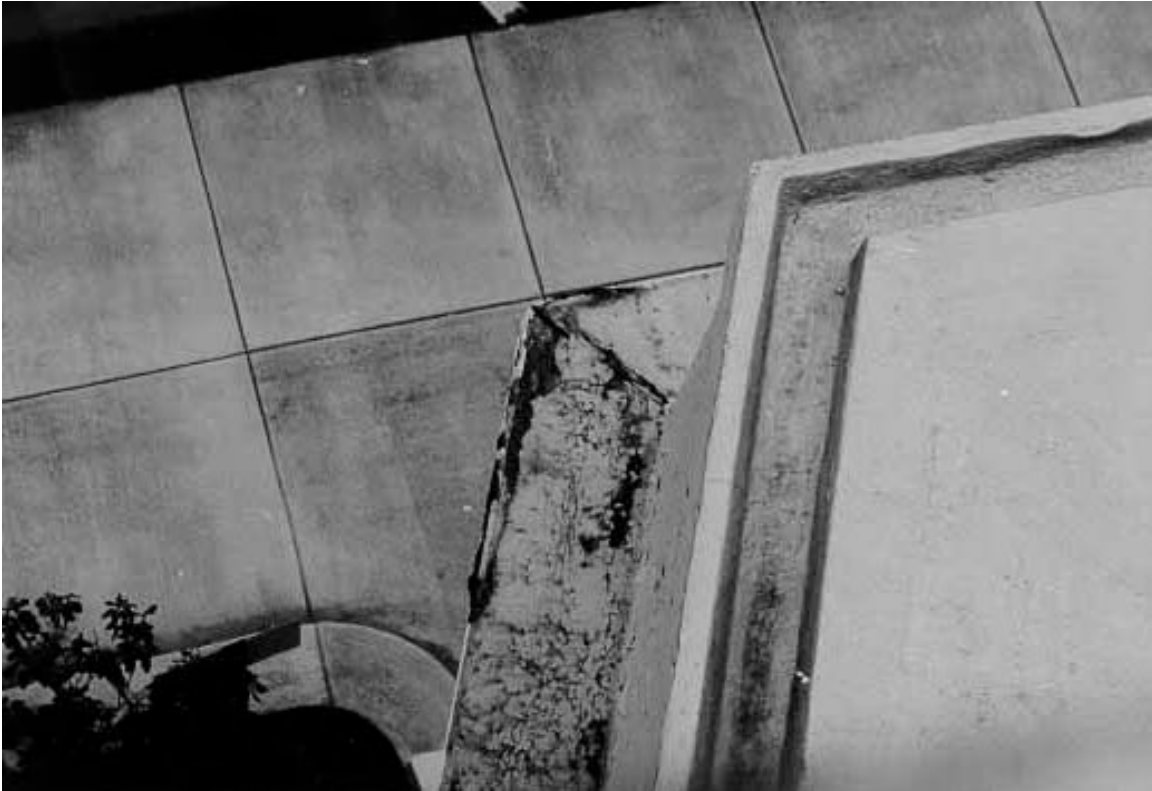
Figure 298
1844 Old Naval Observatory, West Wing.
North facing hemi-octagonal bay. Up facing surfaces of metal cornice show open seams, active oxidation, and associated paint loss.

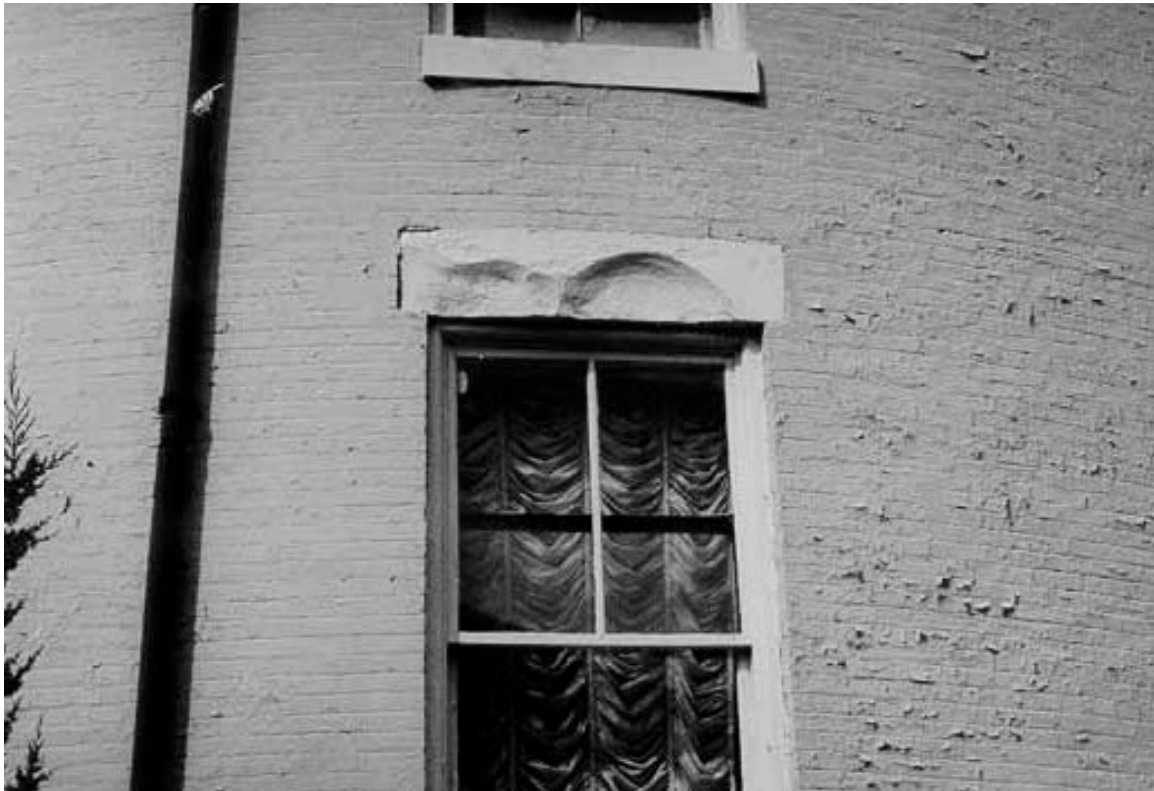
Figure 299
1895 Rotunda, South Elevation.
Window lintels and sills are made from bluestone on the South Rotunda. Bluestone has also been used for some window -sills on the East and West Wings, North and South elevations. There is also peeling paint throughout this portion of the south elevation wall.

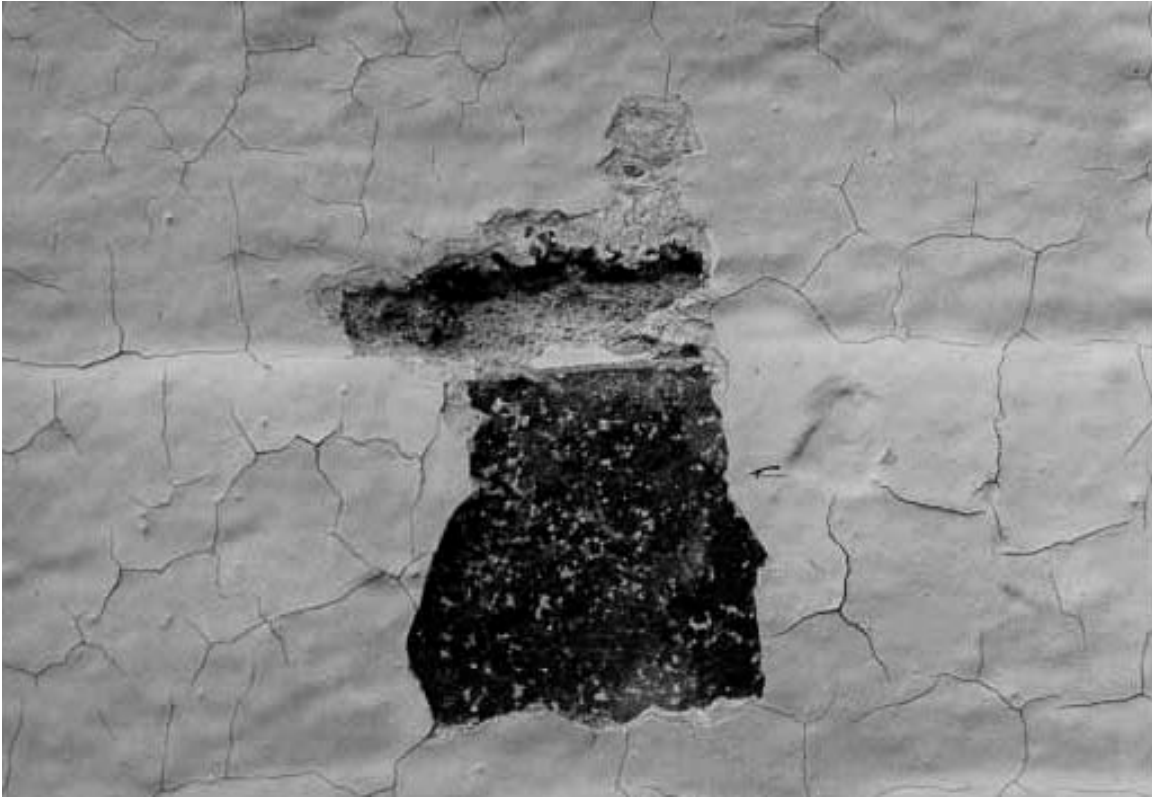
Figure 311
Mortar joint containing mortar sample 2pot1. Joint is concave.

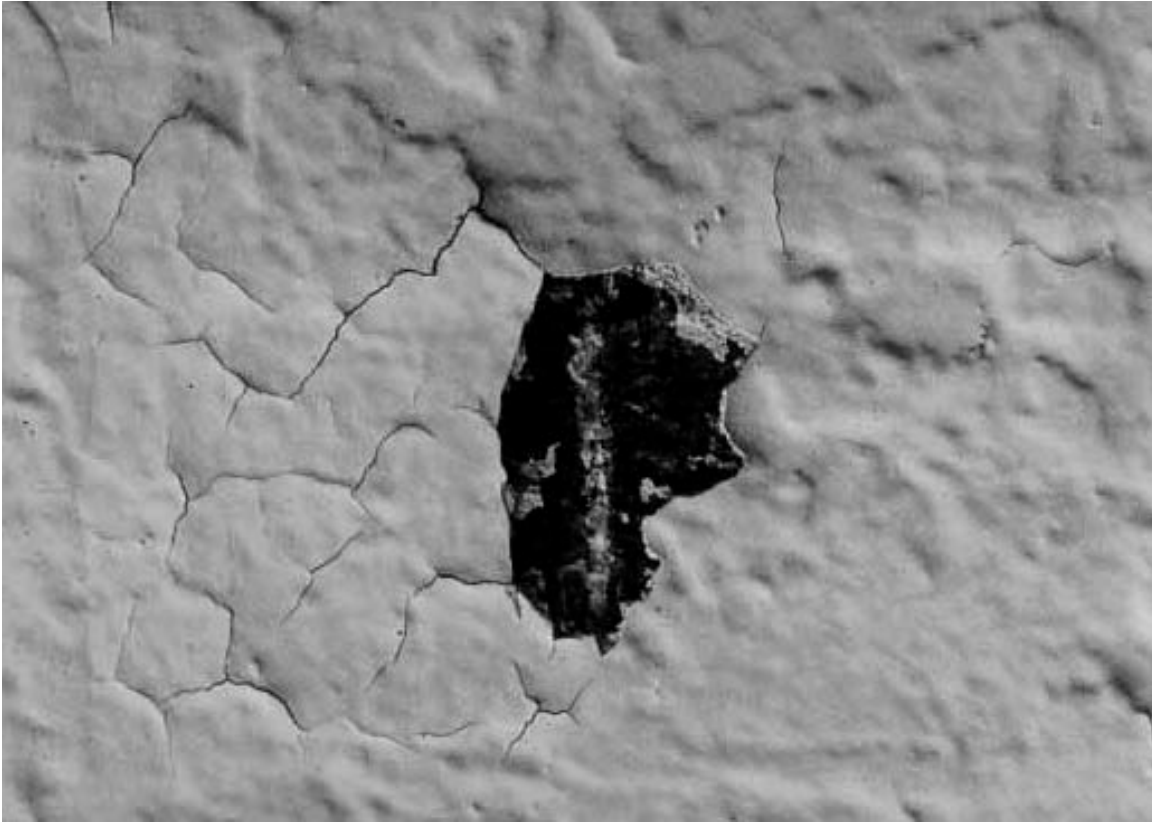
Figure 312
Mortar joint containing mortar sample 2potl2. Joint is flush.

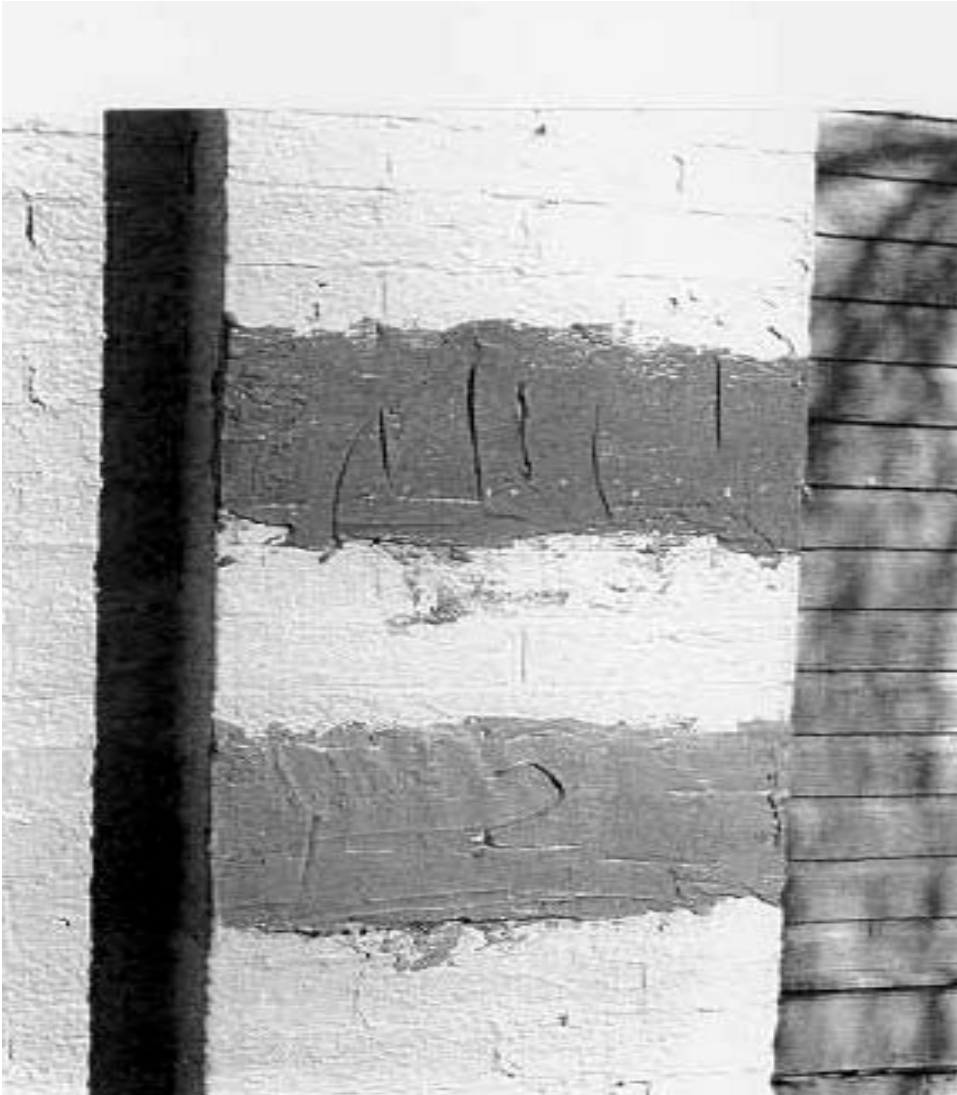
Figure 315
1844 Observatory – South Elevation – East Pilaster
Paint removal of samples 1 and 2.
