# Asbestos-Containing Material Inspection Report

## **NJ013 SIEVERS-SANDBERG UNITED STATES ARMY RESERVE CENTER**

U.S. Route 130  
Pedricktown, NJ 08067-3621

Final – Revision 01; 25 April 2013

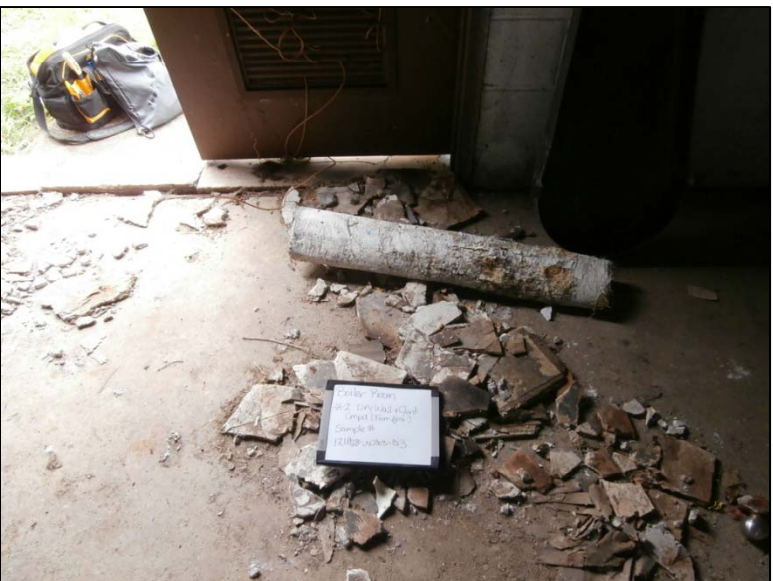
**Building:** 173  
**Photograph:** 14  
**Date:** 11/08/2012

**Description:**  
HA-NJ013-002  
Dry Wall in Boiler/Mechanical Room  
(Falling to floor from ceiling)

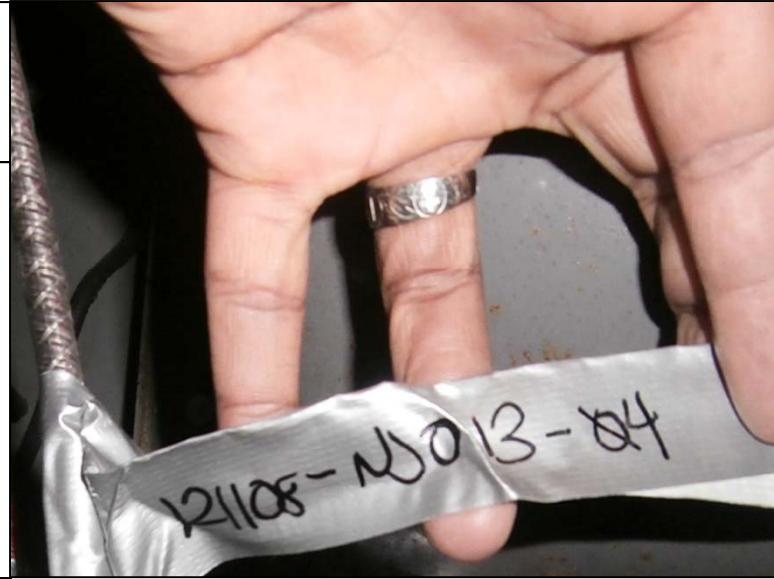
**Building:** 173  
**Photograph:** 15  
**Date:** 11/08/2012

**Description:**  
HA-NJ013-003  
Small Diameter Wire Wrap (Black)  
in Boiler/Mechanical Room

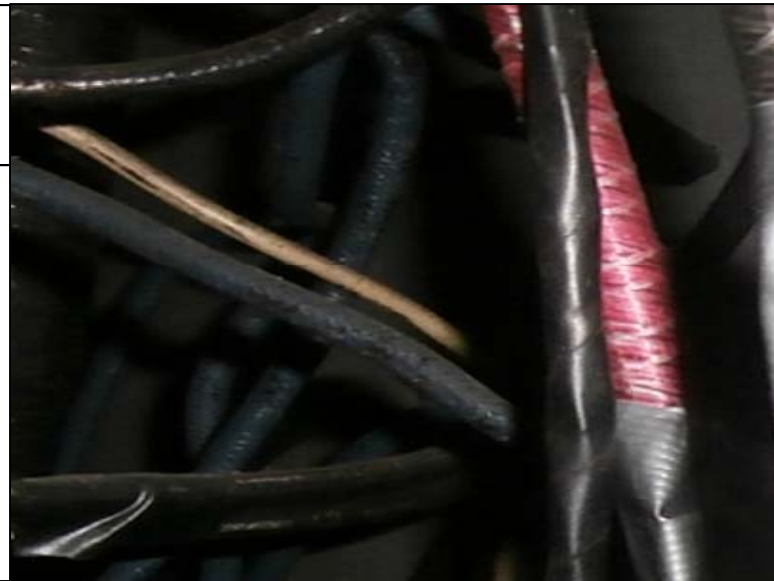
**Building:** 173  
**Photograph:** 16  
**Date:** 11/08/2012

**Description:**  
HA-NJ013-004  
Small Diameter Wire Wrap (Red)  
in Boiler/Mechanical Room

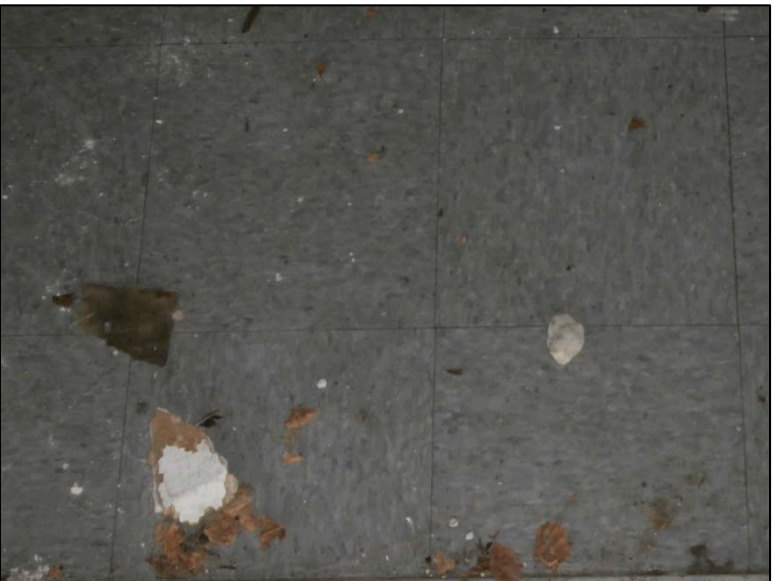
**Building:** 173  
**Photograph:** 24  
**Date:** 11/08/2012

**Description:**  
HA-NJ013-010A  
12" x 12" Light Gray Floor Tile with Dark Gray Flakes in Dining/ Mess Hall

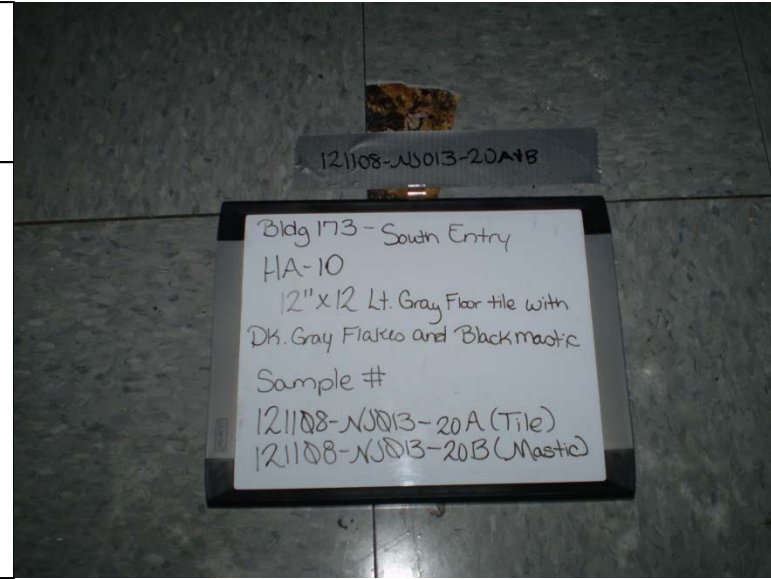
**Building:** 173  
**Photograph:** 25  
**Date:** 11/08/2012

**Description:**  
HA-NJ013-010B  
Black Mastic Under 12" x 12" Light  
Gray Floor Tile with Dark Gray Flakes  
in Dining/ Mess Hall

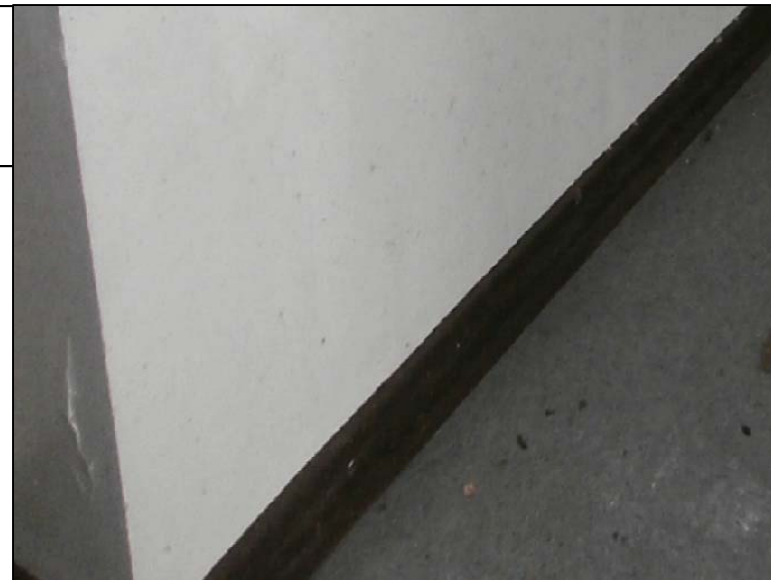
**Building:** 173  
**Photograph:** 26  
**Date:** 11/08/2012

**Description:**  
HA-NJ013-011  
Dark Brown Mastic on Brown Coving

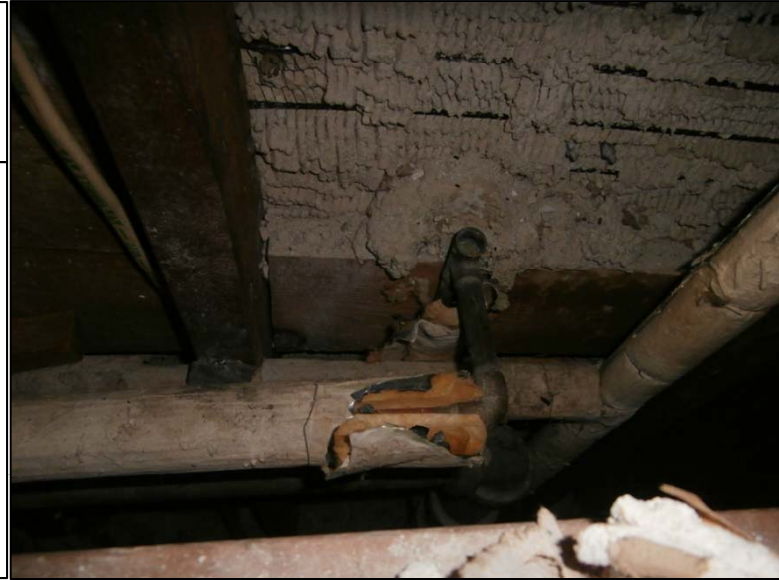
**Building:** 173  
**Photograph:** 27  
**Date:** 11/08/2012

**Description:**  
HA-NJ013-012  
Paper TSI Wrap around Fiberglass  
Insulation in Dining/ Mess Hall

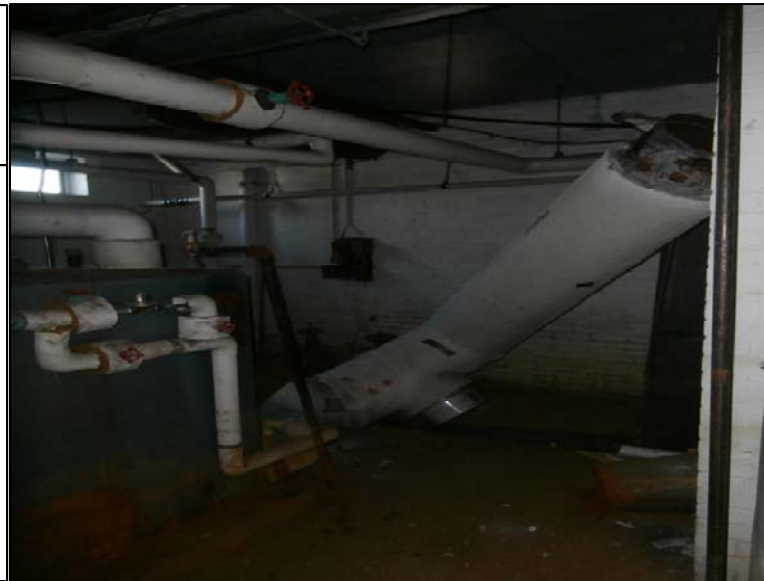
**Building:** 171  
**Photograph:** 28  
**Date:** 11/09/2012

**Description:**  
HA-NJ013-013  
Boiler Piping TSI in Boiler/Mechanical  
Room

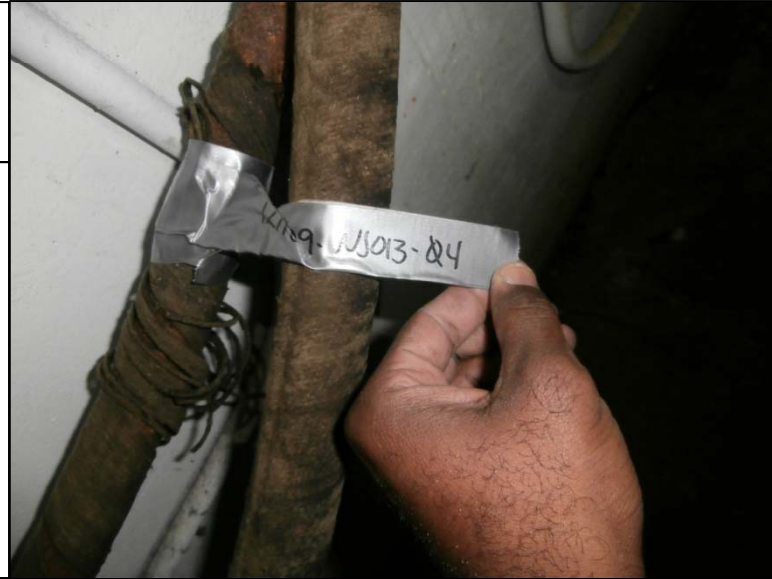
**Building:** 171  
**Photograph:** 29  
**Date:** 11/09/2012

**Description:**  
HA-NJ013-014  
Electrical Wire Wrap (Black) in  
Boiler/Mechanical Room

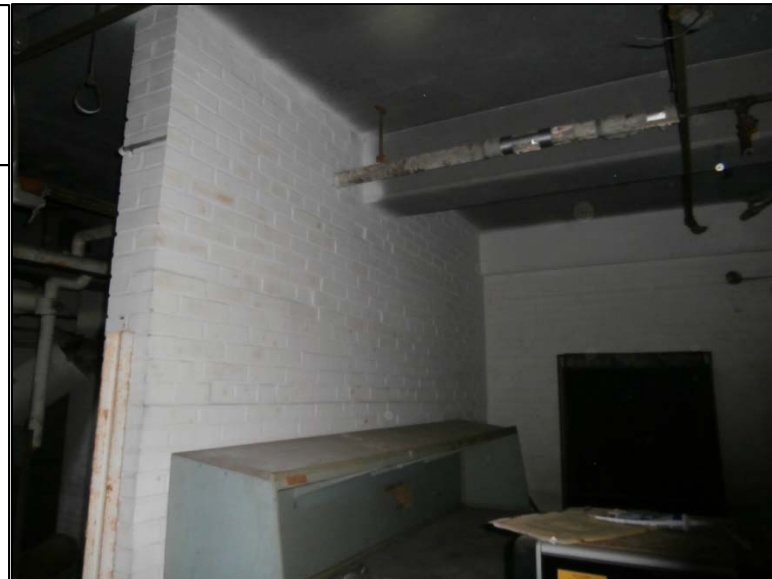
**Building:** 173  
**Photograph:** 30  
**Date:** 11/09/2012

**Description:**  
HA-NJ013-015  
Straight Run TSI (BLDG 171) in  
Boiler/Mechanical Room

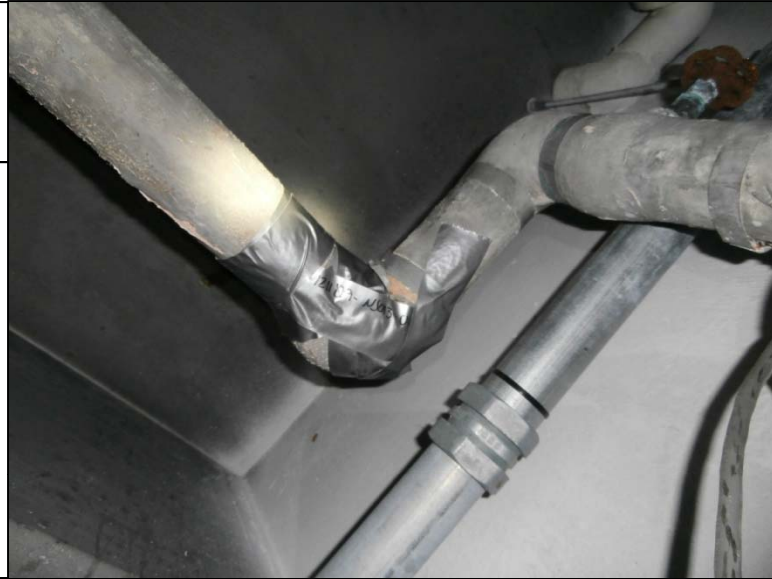
**Building:** 171  
**Photograph:** 31  
**Date:** 11/09/2012

**Description:**  
HA-NJ013-016  
Elbow TSI (BLDG 171) in  
Boiler/Mechanical Room

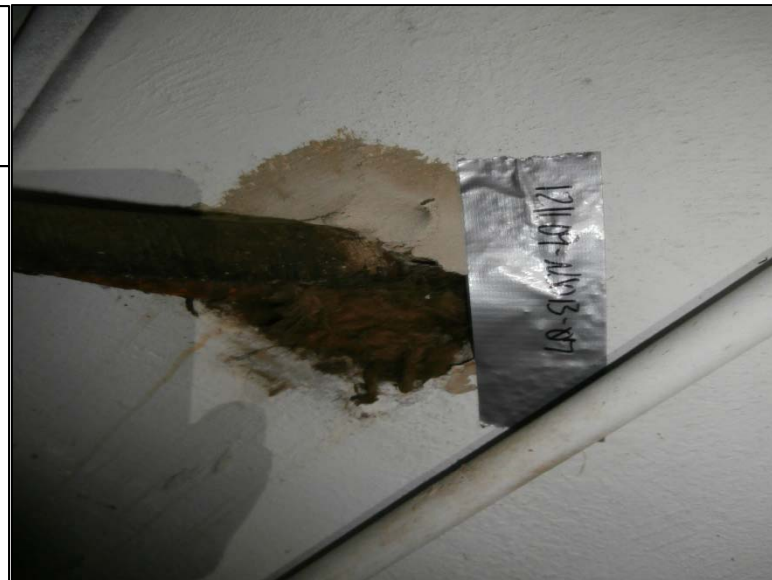
**Building:** 171  
**Photograph:** 32  
**Date:** 11/09/2012

**Description:**  
HA-NJ013-017  
Wall Insulation in Boiler/Mechanical  
Room

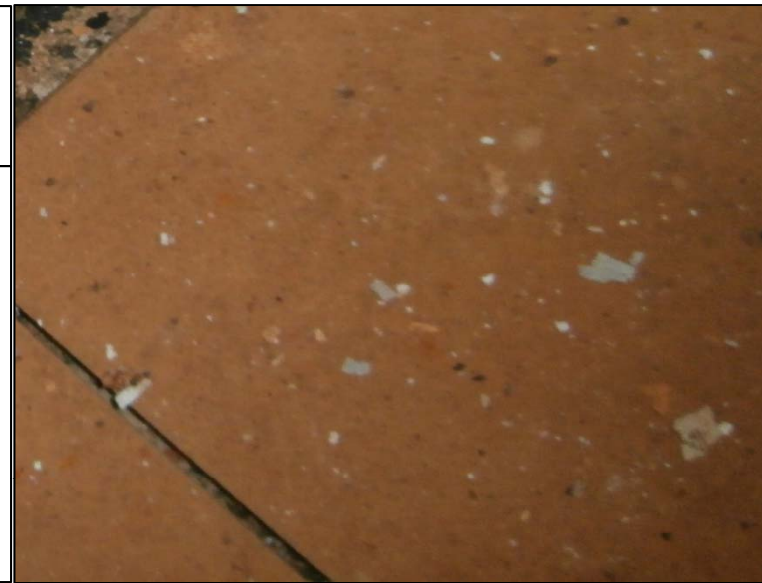
**Building:** 171  
**Photograph:** 33  
**Date:** 11/09/2012

Description:  
HA-NJ013-018A  
12" x 12" Basement Floor Tile

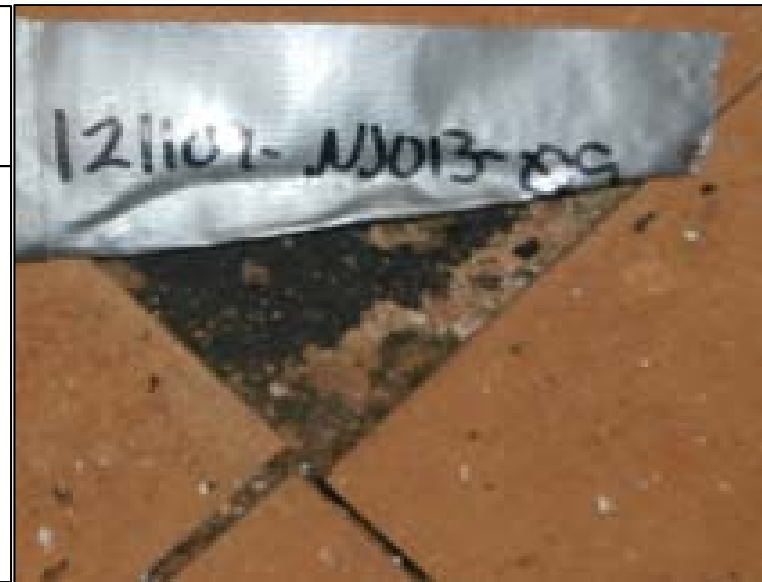
**Building:** 171  
**Photograph:** 34  
**Date:** 11/09/2012

Description:  
HA-NJ013-018B  
Black Mastic Under 12" x 12"  
Basement Floor Tile

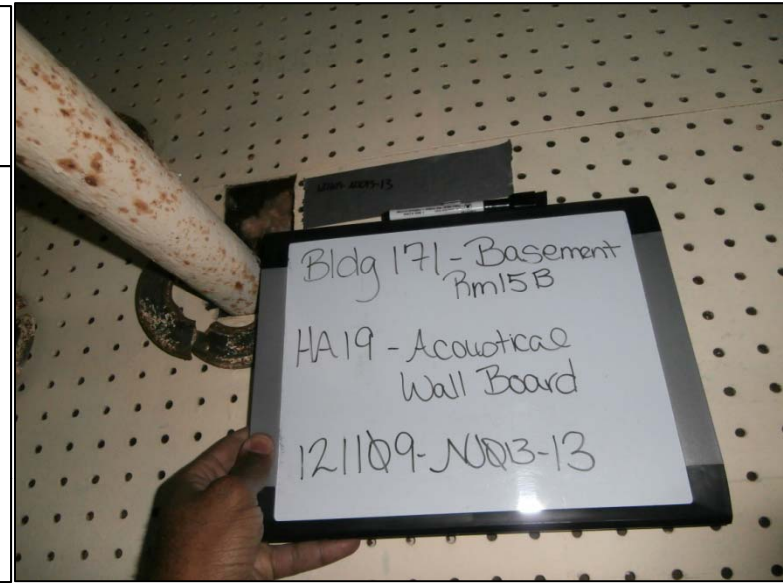
**Building:** 171  
**Photograph:** 35  
**Date:** 11/09/2012

**Description:**  
HA-NJ013-019  
Acoustical Wall Board

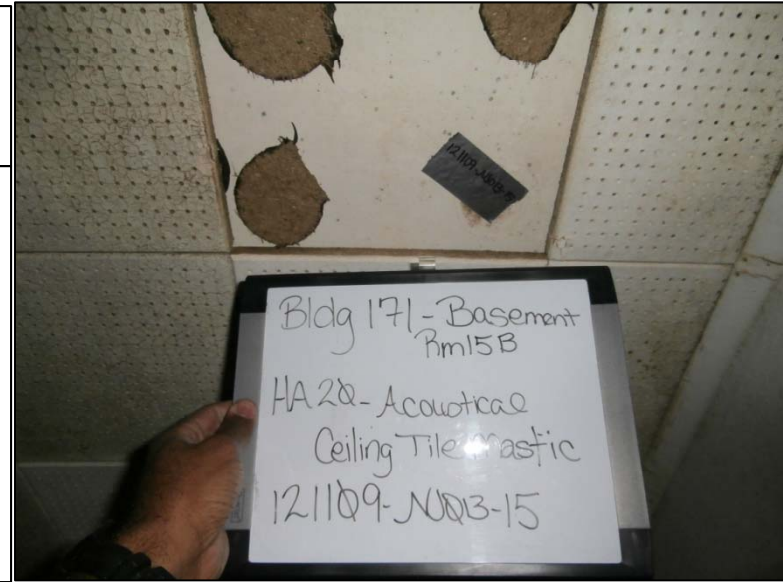
**Building:** 171  
**Photograph:** 36  
**Date:** 11/09/2012

**Description:**  
HA-NJ013-020  
Brown Mastic from Acoustical Ceiling Tile

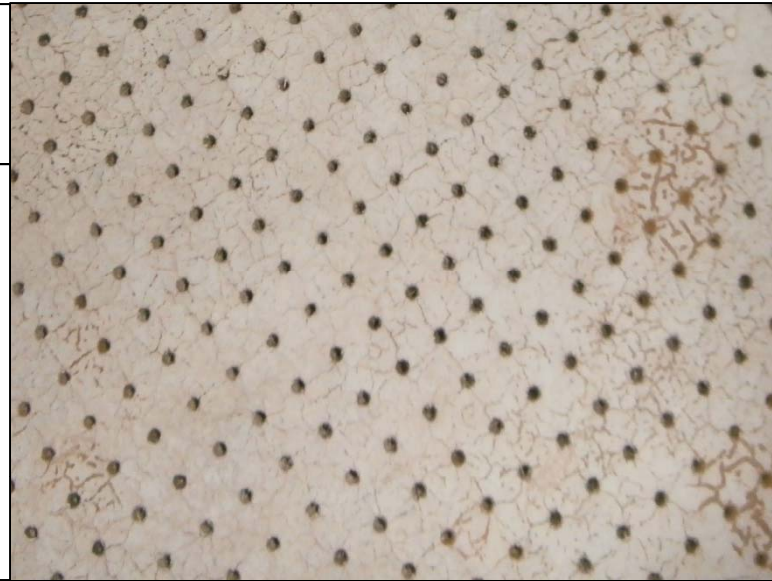
**Building:** 171  
**Photograph:** 37  
**Date:** 11/09/2012

**Description:**  
HA-NJ013-021  
Acoustical Ceiling Tile Basement  
Rooms B15, B15-A, and B15-B.

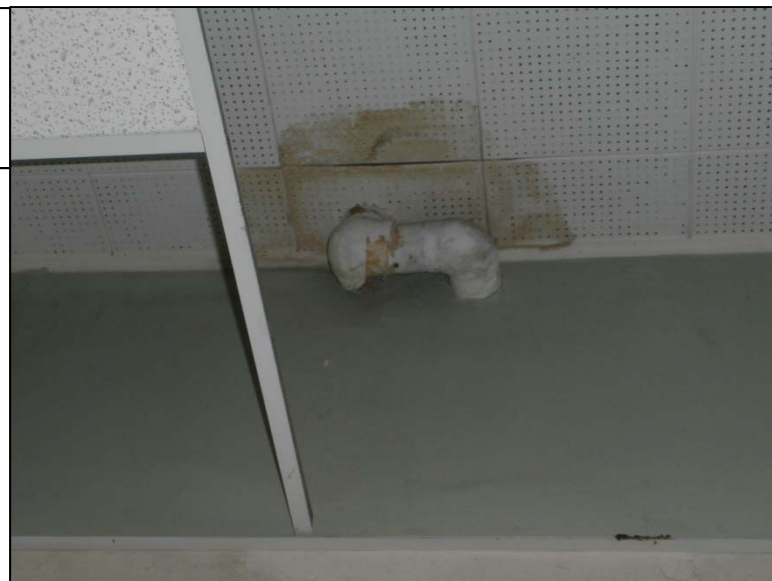
**Building:** 171  
**Photograph:** 38  
**Date:** 11/09/2012

**Description:**  
HA-NJ013-022  
Water Line TSI (ASSUMED) Classrooms  
(1<sup>st</sup> Floor Rooms 103, 106, 107, and  
107A)

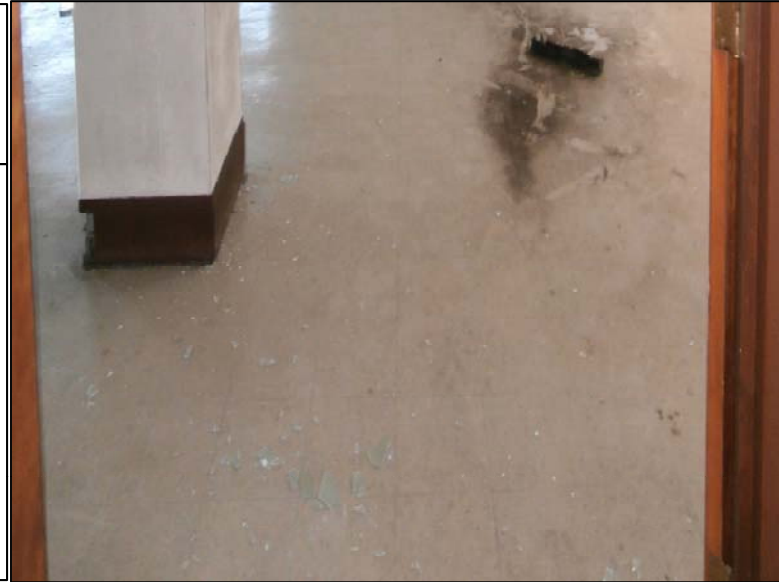
**Building:** 171  
**Photograph:** 39  
**Date:** 11/09/2012

**Description:**  
HA-NJ013-023A  
12" x 12" Cream Floor Tile with Gray  
Flakes

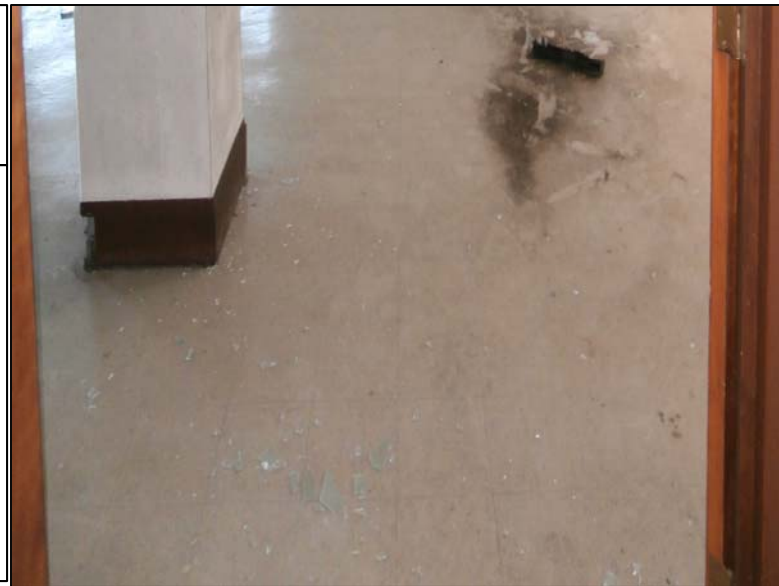
**Building:** 171  
**Photograph:** 40  
**Date:** 11/09/2012

**Description:**  
HA-NJ013-023B  
Black Mastic on 12" x 12" Cream Floor  
Tile with Gray Flakes

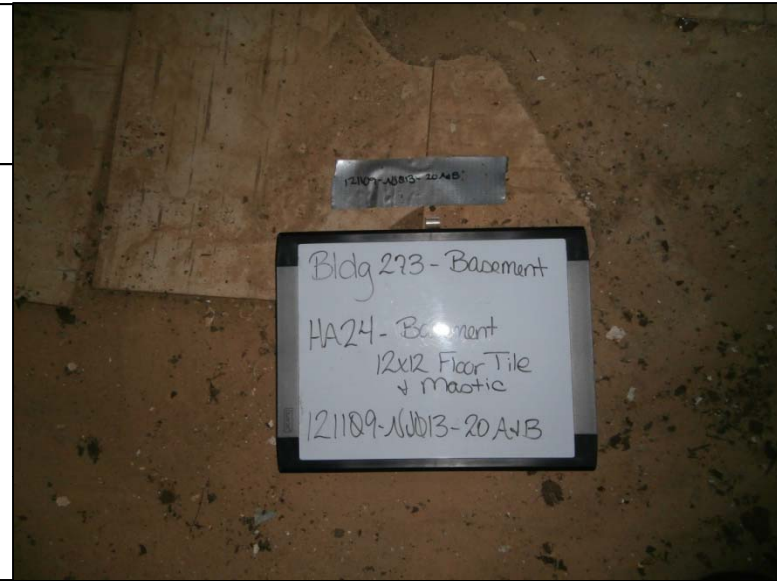
**Building:** 273  
**Photograph:** 41  
**Date:** 11/09/2012

**Description:**  
HA-NJ013-024A  
12" X 12" Basement Floor Tile

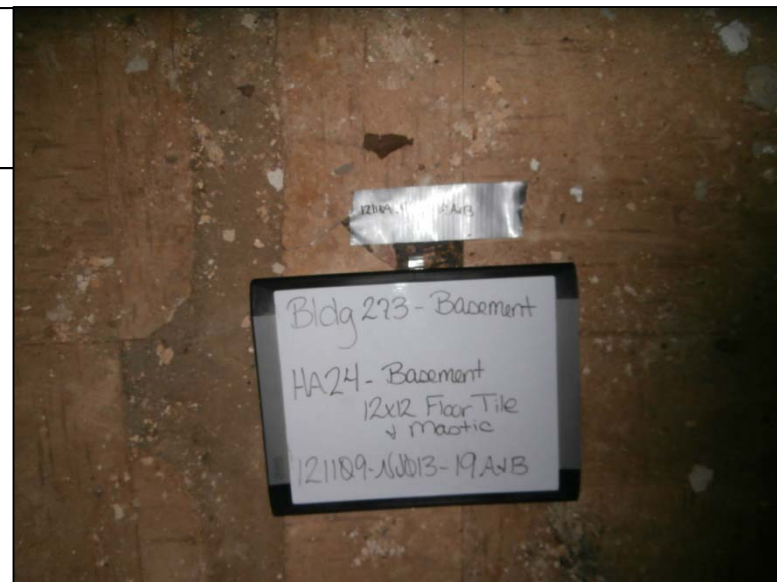
**Building:** 273  
**Photograph:** 42  
**Date:** 11/09/2012

**Description:**  
HA-NJ013-024B  
Black Mastic 12" X 12" Basement  
Floor Tile

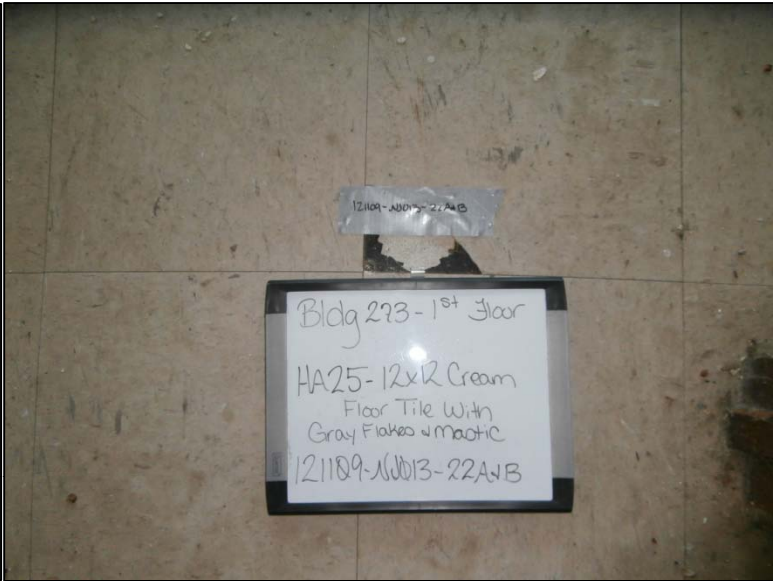
**Building:** 273  
**Photograph:** 43  
**Date:** 11/09/2012

**Description:**  
HA-NJ013-025A  
12" x 12" Cream Floor Tile with Gray  
Flakes

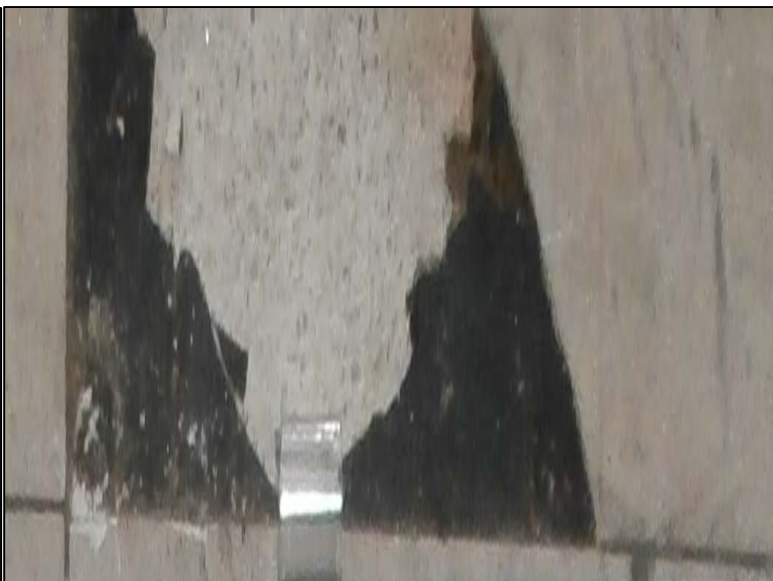
**Building:** 273  
**Photograph:** 44  
**Date:** 11/09/2012

**Description:**  
HA-NJ013-025B  
Black Mastic Under 12" x 12" Cream  
Floor Tile with Gray Flakes

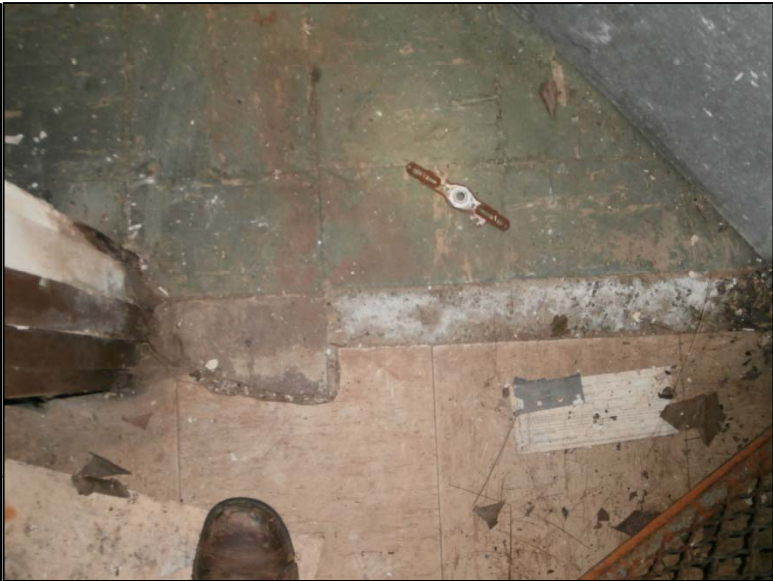
**Building:** 274  
**Photograph:** 47  
**Date:** 11/09/2012

**Description:**  
HA-NJ013-027B  
Mastic under 9" x 9" Green Floor Tile with Tan Streaks in Supply Storage Vault in Basement (ASSUMED)

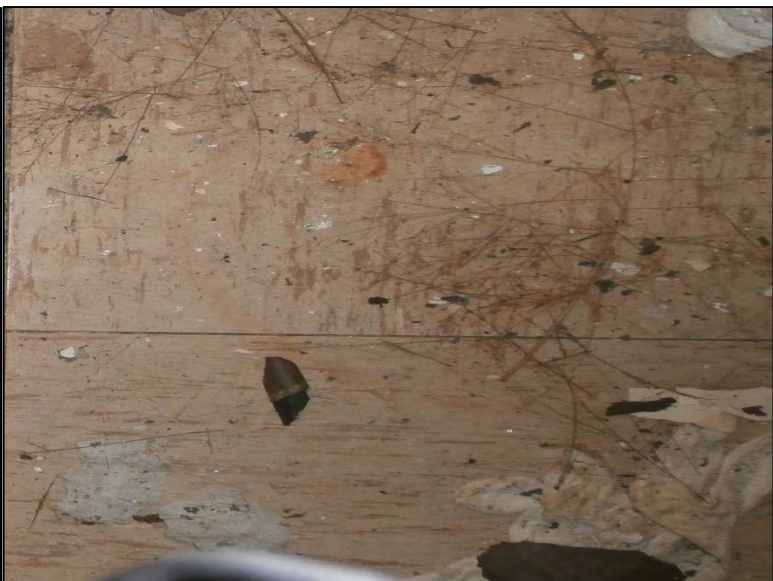
**Building:** 274  
**Photograph:** 48  
**Date:** 11/09/2012

**Description:**  
HA-NJ013-028A  
12" x 12" Cream Floor Tile with Tan Streaks in Storage Area and Office Space (Basement)

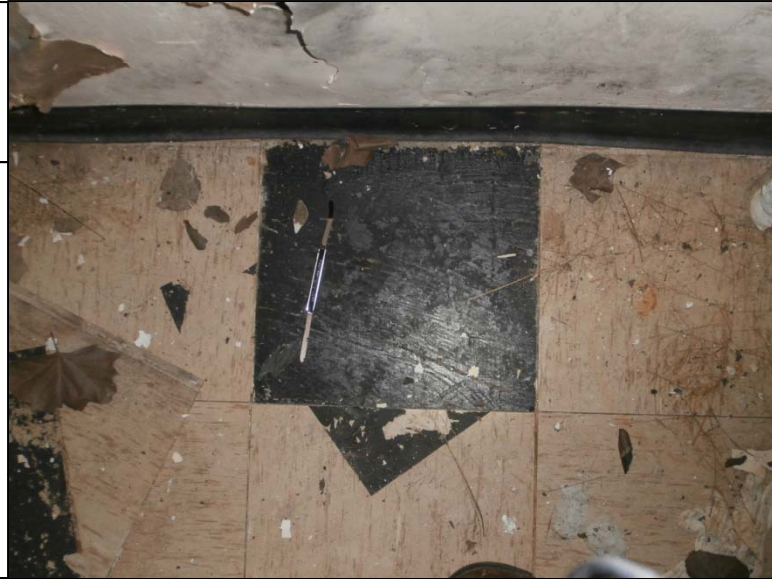
**Building:** 274  
**Photograph:** 49  
**Date:** 11/09/2012

**Description:**  
HA-NJ013-028B  
Black Mastic under 12" x 12" Cream  
Floor Tile with Tan Streaks in Storage  
Area and Office Space (Basement)

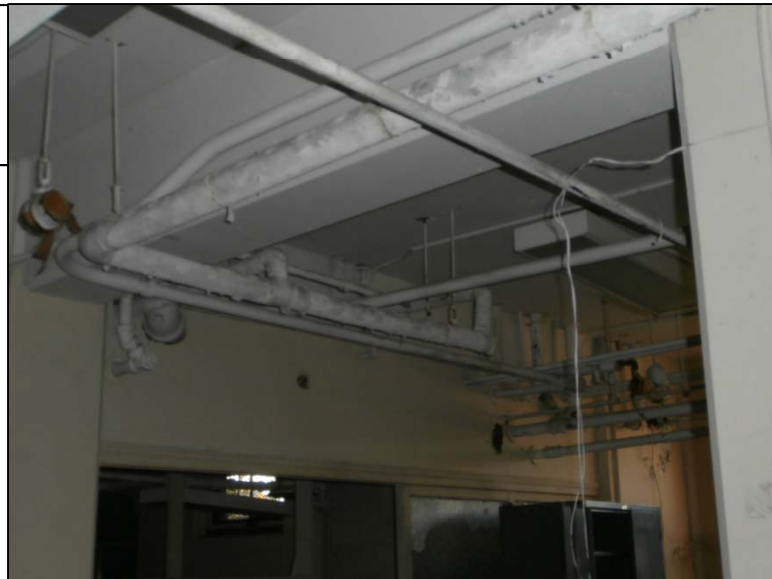
**Building:** 274  
**Photograph:** 50  
**Date:** 11/09/2012

**Description:**  
HA-NJ013-029  
Straight Run TSI

HA-NJ013-029	121110-NJ013-03	11/10/2013	2" Piping Straight Run TSI	274	75	Damaged	Friable	15
HA-NJ013-030	121110-NJ013-04	11/10/2013	2" Piping Elbow	274	1 SF	Damaged	Friable	50
HA-NJ013-031A&B	ASSUMED	11/10/2013	9x9 Brown Floor Tile with Tan Streaks	274	3800 SF	Good	Non-Friable	ASSUMED
HA-NJ013-031A&B	ASSUMED	11/10/2013	9x9 Brown Floor Tile with Tan Streaks - Mastic	274	-	Good	Non-Friable	ASSUMED
HA-NJ013-032	121110-NJ013-05	11/10/2013	Ceiling Tile Insulation	274	400 SF	Good	Friable	ND
HA-NJ013-033	121110-NJ013-06	11/10/2013	1/4" Ceiling Drywall	274	5700 SF	Good	Friable	ND
HA-NJ013-034	121110-NJ013-07	11/10/2013	1/2" Drywall	274	12500 SF	Good	Friable	ND
HA-NJ013-035	ASSUMED	11/10/2013	9x9 entry(vestibule)	277	35 SF	Good	Non-Friable	ASSUMED
HA-NJ013-036A&B	121110-NJ013-08A	11/10/2013	12x12 Cream Floor tile	277	35 SF	Sig. Damaged	Friable	ND
HA-NJ013-036A&B	121110-NJ013-08B	11/10/2013	12x12 Cream Floor tile - Mastic	277	-	Sig. Damaged	Friable	ND

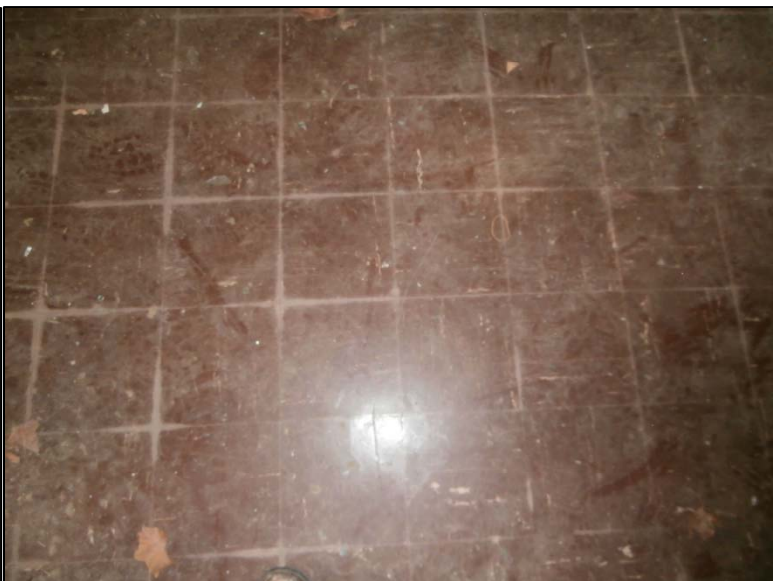
**Building:** 274  
**Photograph:** 52  
**Date:** 11/09/2012

**Description:**  
HA-NJ013-031A  
9" x 9" Brown Floor Tile with Tan Streaks 1<sup>st</sup> Floor Offices Spaces and Hallways (ASSUMED)

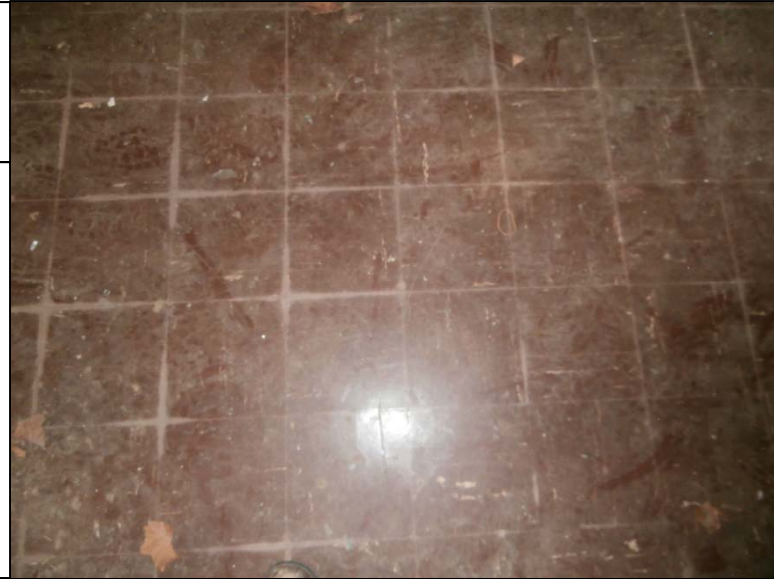
**Building:** 274  
**Photograph:** 53  
**Date:** 11/09/2012

**Description:**  
HA-NJ013-031B  
9" x 9" Brown Floor Tile with Tan  
Streaks 1<sup>st</sup> Floor Offices Spaces and  
Hallways (ASSUMED)

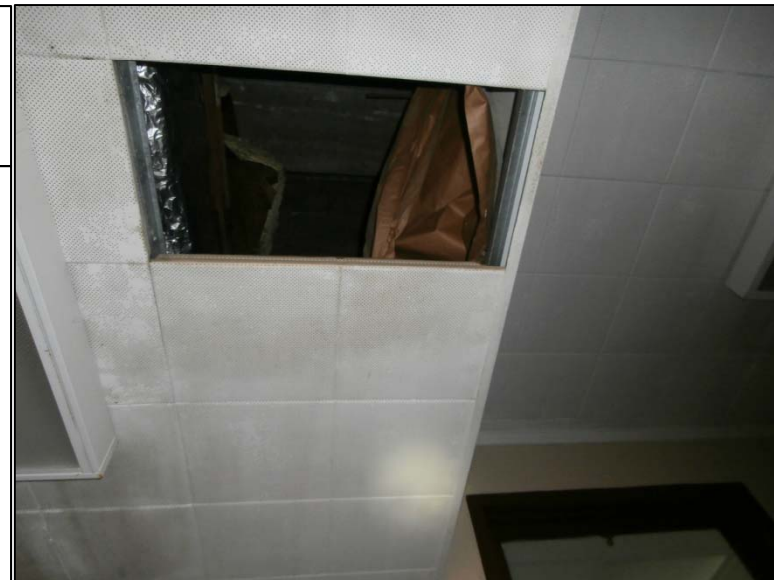
**Building:** 274  
**Photograph:** 54  
**Date:** 11/09/2012

**Description:**  
HA-NJ013-032  
Ceiling Tile Insulation in 1<sup>st</sup> Floor  
Hallways

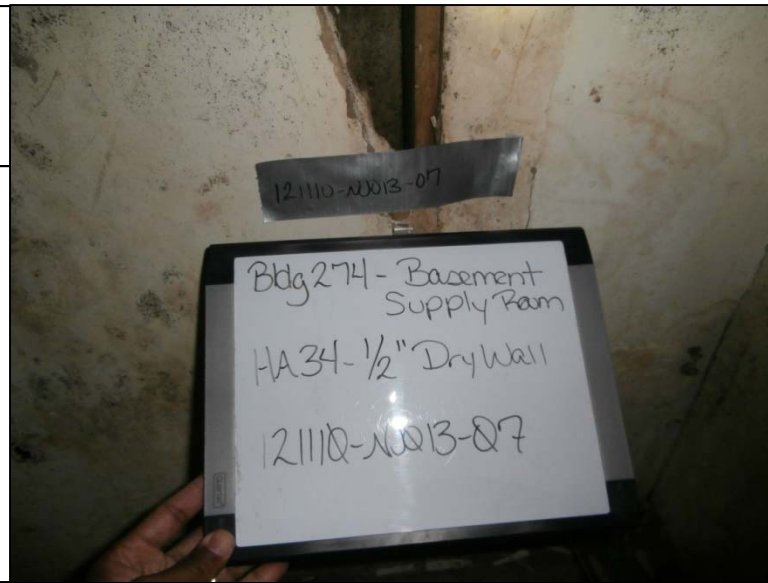
**Building:** 274  
**Photograph:** 55  
**Date:** 11/09/2012

**Description:**  
HA-NJ013-033  
Basement ¼" Ceiling Drywall  
(note – sign inaccurately labels material as ½" drywall which is depicted in photograph 56)

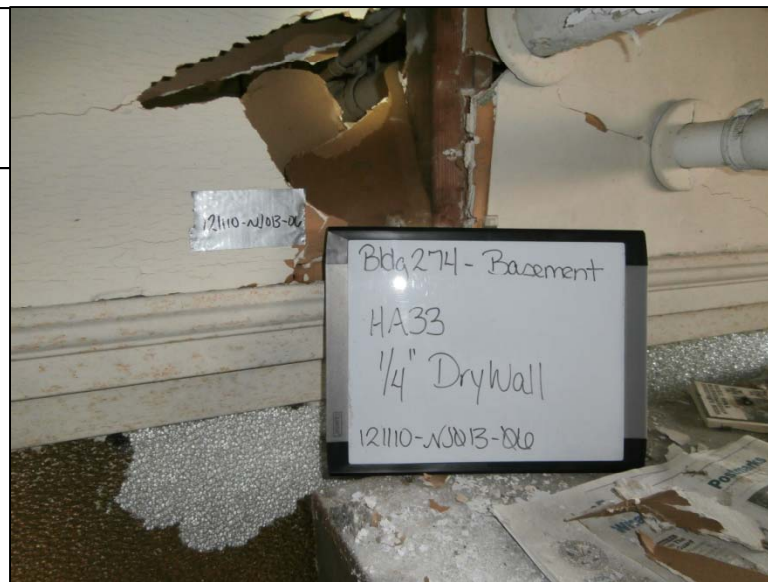
**Building:** 274  
**Photograph:** 56  
**Date:** 11/09/2012

**Description:**  
HA-NJ013-034  
½" Drywall  
(note – sign inaccurately labels material as ¼" ceiling drywall which is depicted in photograph 55)

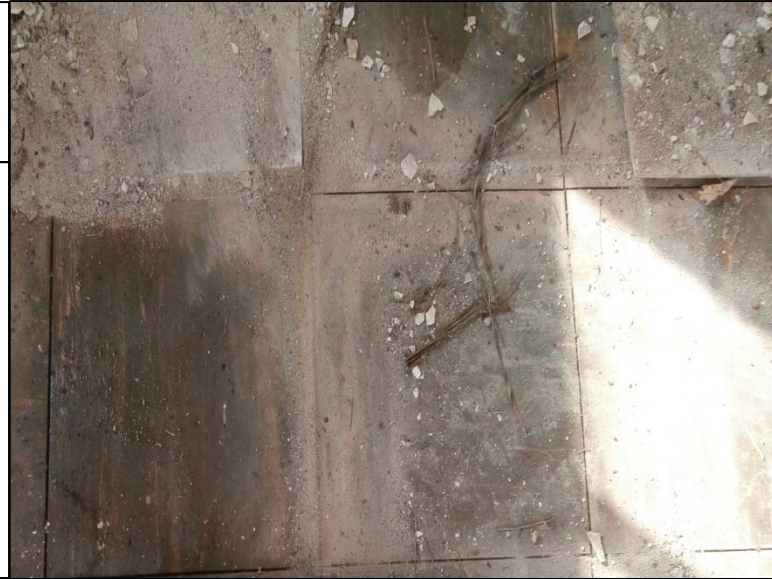
**Photograph:** 57

9" x 9" Floor Tile in entry vestibule  
(ASSUMED)

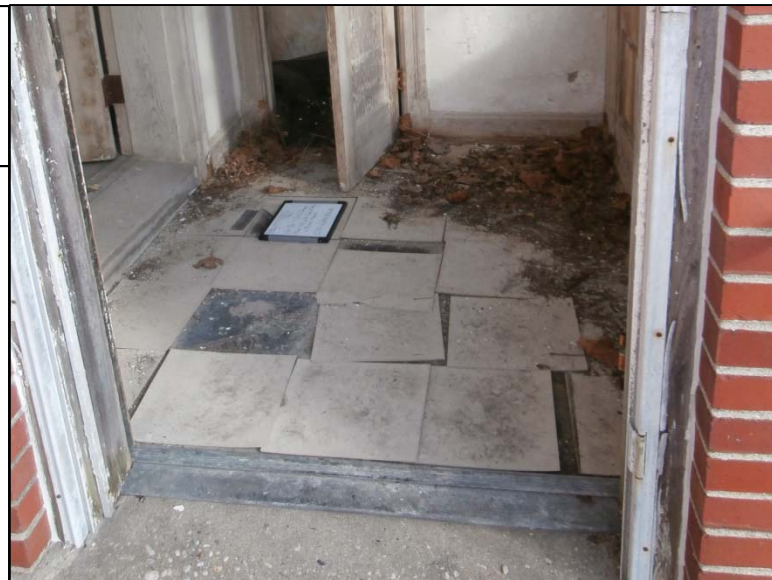
**Photograph:** 58

12" x 12" Cream Floor Tiles with Gray  
Flakes

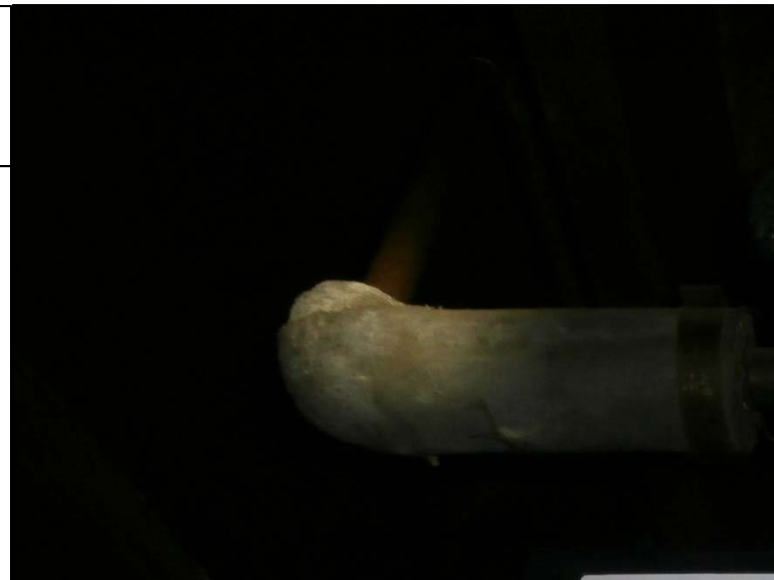
**Building:** 276, 277, 278  
**Photograph:** 62  
**Date:** 11/10/2012

**Description:**  
HA-NJ013-039  
Basement TSI Elbow (ASSUMED)

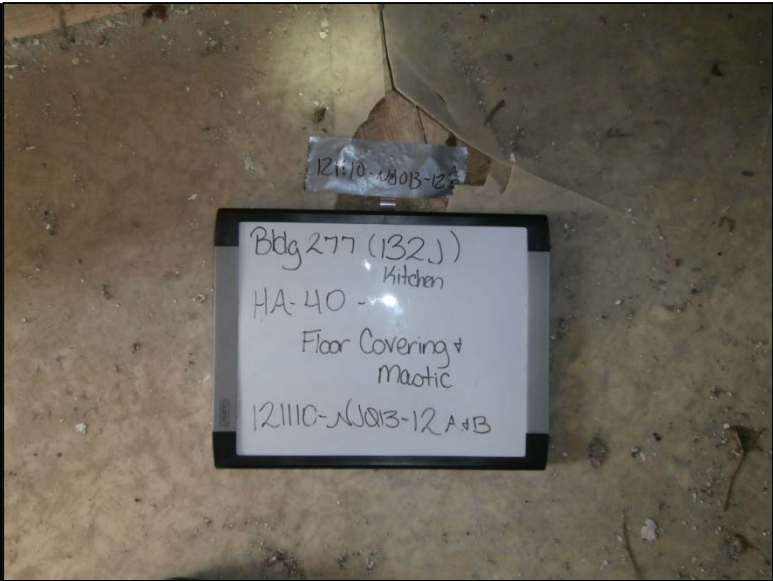
**Building:** 276, 277, 278  
**Photograph:** 63  
**Date:** 11/10/2012

**Description:**  
HA-NJ013-040A  
Kitchen Floor Covering

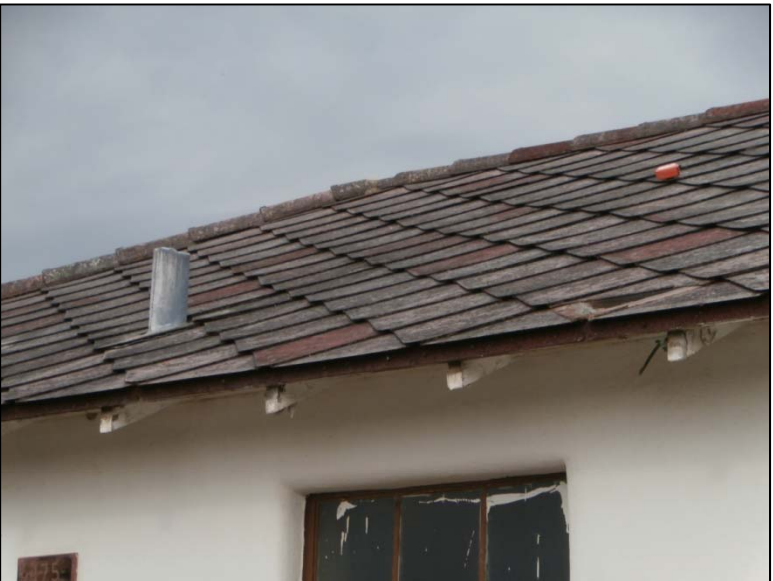
Description:  
HA-NJ013-042  
Multi Color Transite Roof (ASSUMED)

HA-NJ013-042	ASSUMED	11/10/2013	Transite roof	475	300 SF	Good	Non-Friable	ASSUMED
HA-NJ013-043A&B	121110-NJ013-13A	11/10/2013	12x12 Light Gray Tile with Dark Gray Flakes	475	410 SF	Damaged	Non-Friable	ND
HA-NJ013-043A&B	121110-NJ013-13B	11/10/2013	12x12 Light Gray Tile with Dark Gray Flakes - Tan Mastic	475	-	Sig. Damaged	Non-Friable	ND
HA-NJ013-044A&B	121110-NJ013-14A	11/10/2013	Drywall Ceiling	475	410 SF	Sig. Damaged	Friable	ND
HA-NJ013-044A&B	121110-NJ013-14B	11/10/2013	Drywall Ceiling - Mastic	475	-	Sig. Damaged	Friable	ND
HA-NJ013-043A&B	121110-NJ013-15	11/10/2013	12x12 Light Gray Floor Tile with Dark Gray Flakes (A) and Tan Mastic (B)	475	-	Sig. Damaged	Friable	ND
HA-NJ013-044A&B	121110-NJ013-16	11/10/2013	Drywall Ceiling (analytical result reported as Drywall/Compound)	475	-	Sig. Damaged	Friable	ND/3
HA-NJ013-045A&B	121111-NJ013-01A	11/11/2012	12x12 Cream Floor Tile with Brown Flakes	404	2860SF	Good	Non-Friable	ND

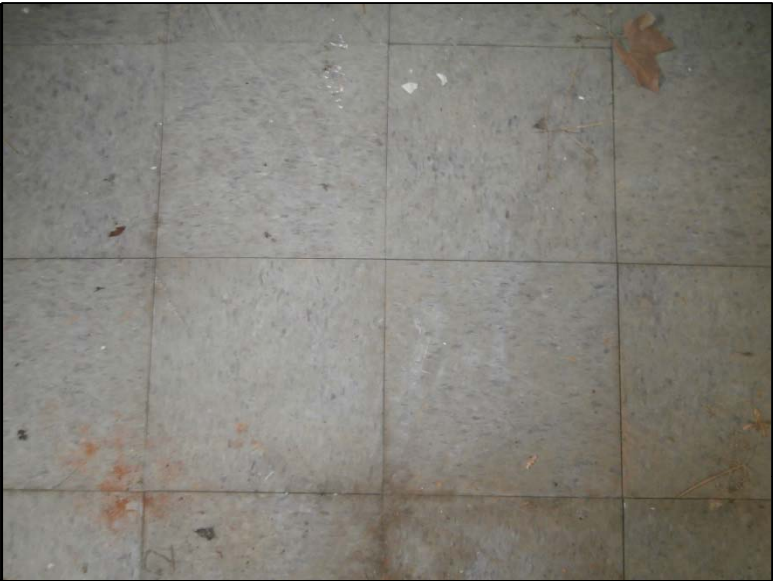
**Building:** 475  
**Photograph:** 67  
**Date:** 11/10/2012

**Description:**  
HA-NJ013-043A  
12" x 12" Light Gray Tile with Dark Gray Flakes

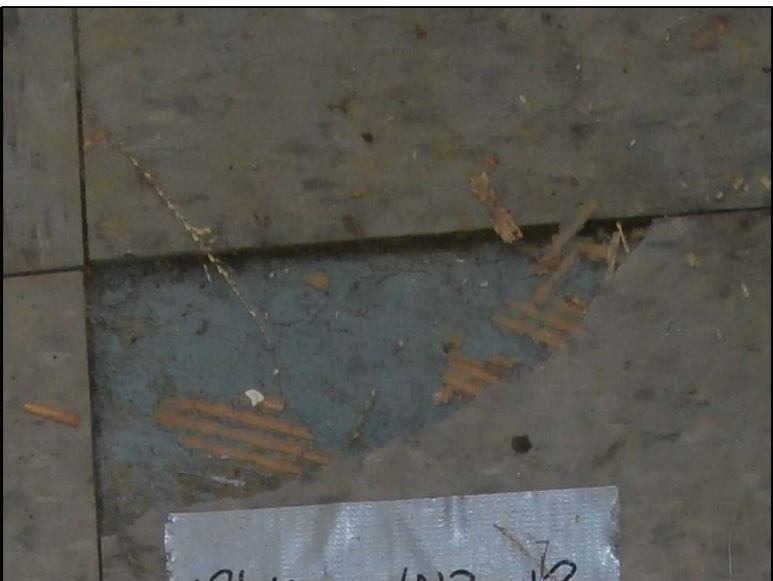
**Building:** 475  
**Photograph:** 68  
**Date:** 11/10/2012

**Description:**  
HA-NJ013-043B  
12" x 12" Light Gray Tile with Dark Gray Flakes Tan Mastic

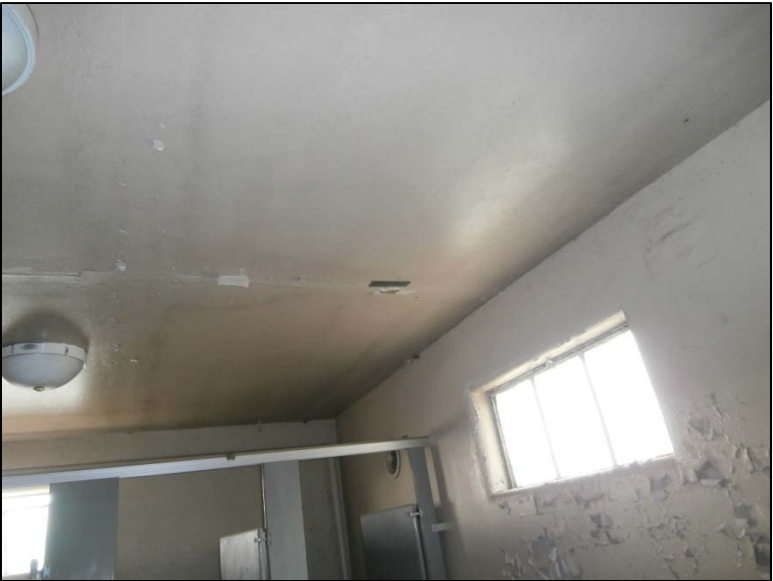
**Building:** 475  
**Photograph:** 69  
**Date:** 11/10/2012

**Description:**  
HA-NJ013-044  
Drywall Ceiling

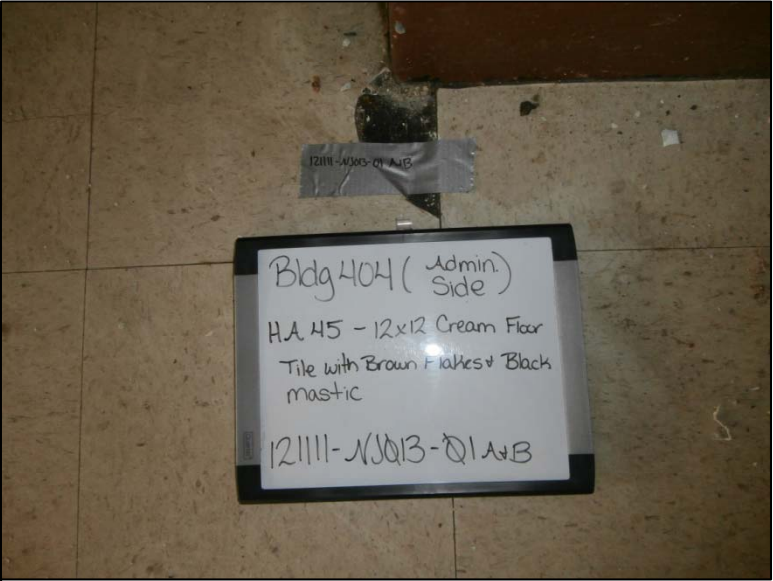
**Building:** 404  
**Photograph:** 70  
**Date:** 11/11/2012

**Description:**  
HA-NJ013-045A  
12" x 12" Cream Floor Tile with Brown  
Flakes

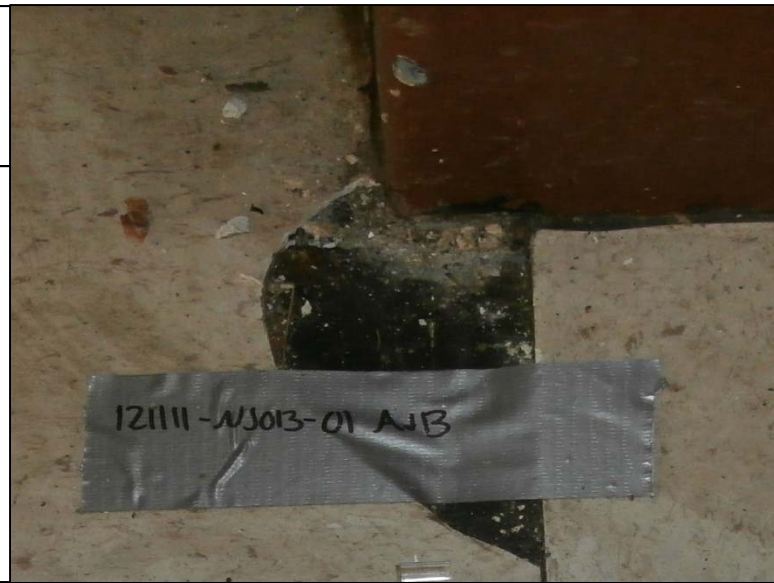
**Building:** 404  
**Photograph:** 71  
**Date:** 11/11/2012

**Description:**  
HA-NJ013-045B  
Black Mastic under 12" x 12" Cream  
Floor Tile with Brown Flakes

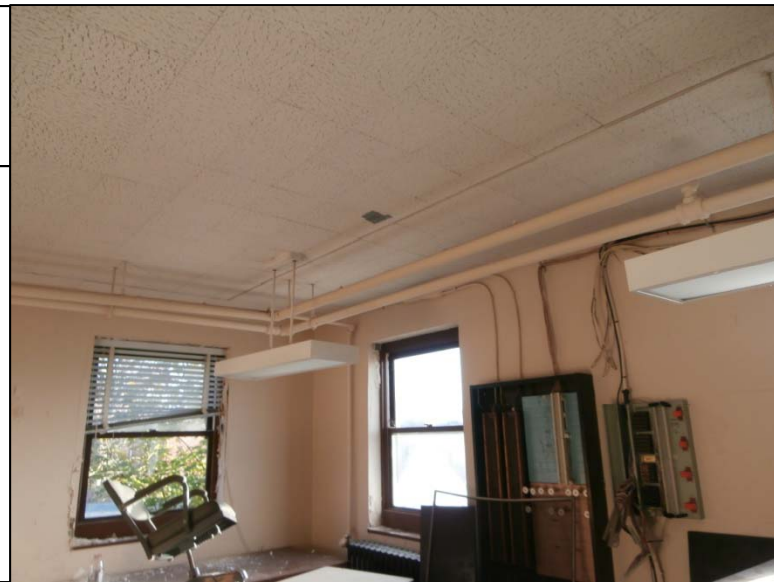
**Building:** 404  
**Photograph:** 72  
**Date:** 11/11/2012

**Description:**  
HA-NJ013-046A  
12" x 12" Ceiling with Pinholes and  
Large Fissures

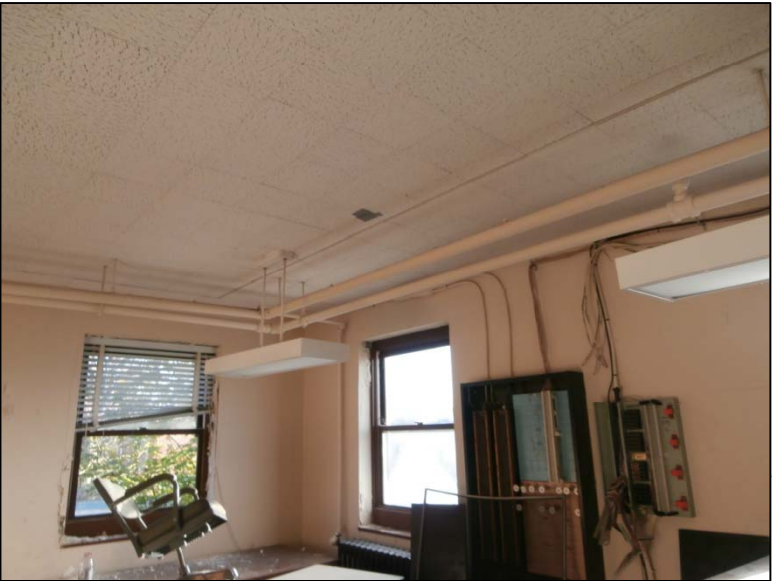
<p><b>Building:</b> 404 <b>Photograph:</b> 73 <b>Date:</b> 11/11/2012</p>

<p><b>Description:</b> HA-NJ013-046B 12" x 12" Ceiling with Pinholes and Large Fissures Brown Mastic</p>

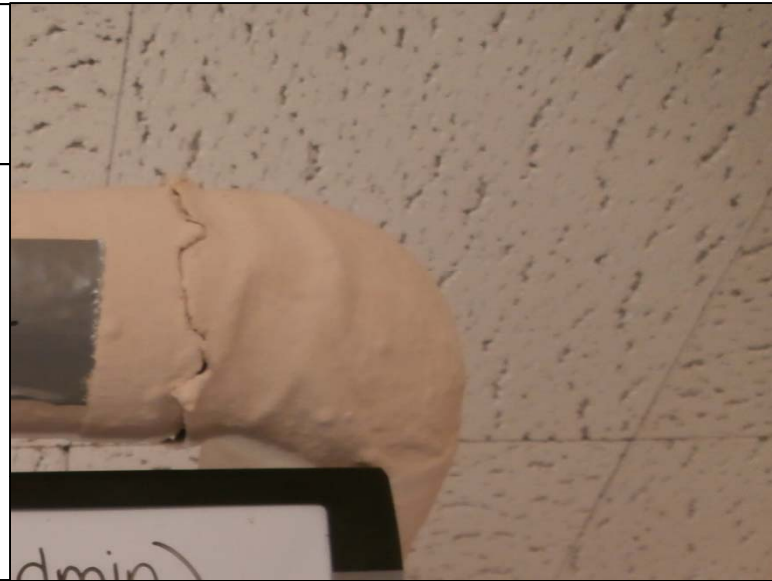
**Building:** 404  
**Photograph:** 75  
**Date:** 11/11/2012

**Description:**  
HA-NJ013-048  
Elbow TSI cloth wrap & gray insulation/mud
