# Asbestos-Containing Material Inspection Report

## **NJ013 SIEVERS-SANDBERG UNITED STATES ARMY RESERVE CENTER**

U.S. Route 130  
Pedricktown, NJ 08067-3621

Final – Revision 01; 25 April 2013

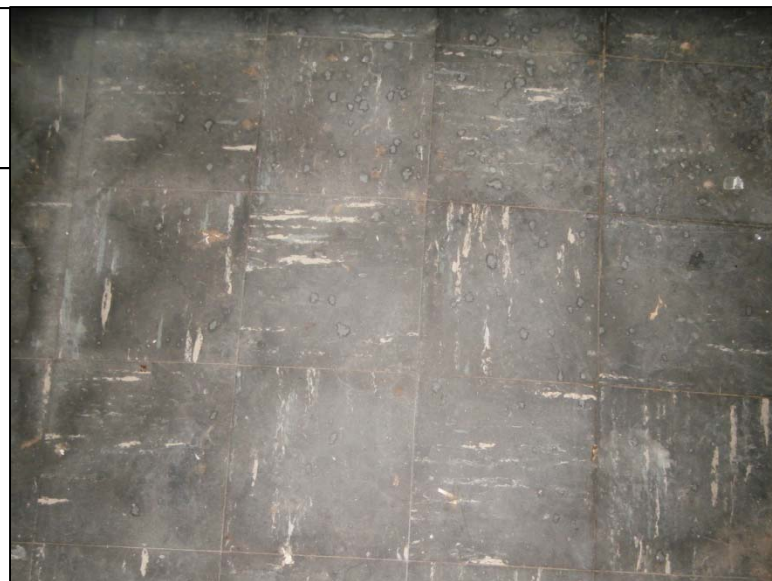
**Building:** 404  
**Photograph:** 76  
**Date:** 11/11/2012

**Description:**  
HA-NJ013-049  
9" x 9" Black Floor Tile with White Streaks and Mastic (ASSUMED)

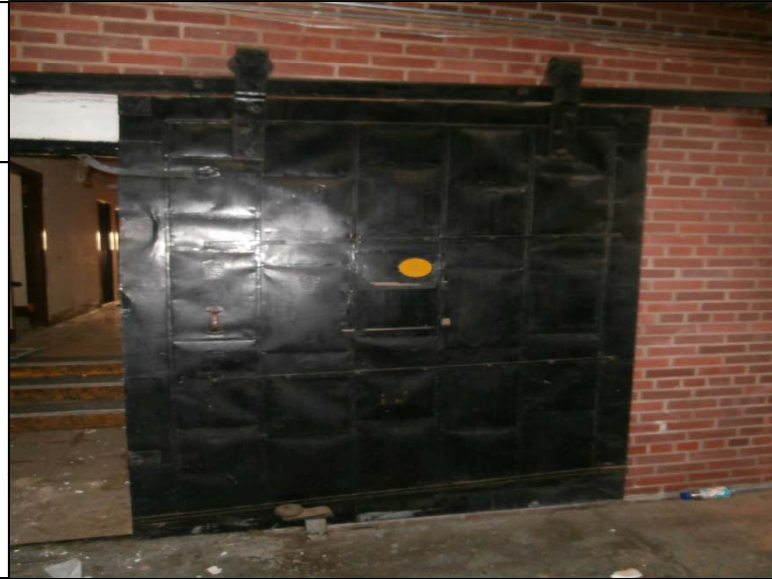
**Building:** 404  
**Photograph:** 77  
**Date:** 11/11/2012

**Description:**  
HA-NJ013-050  
Fire door (ASSUMED)

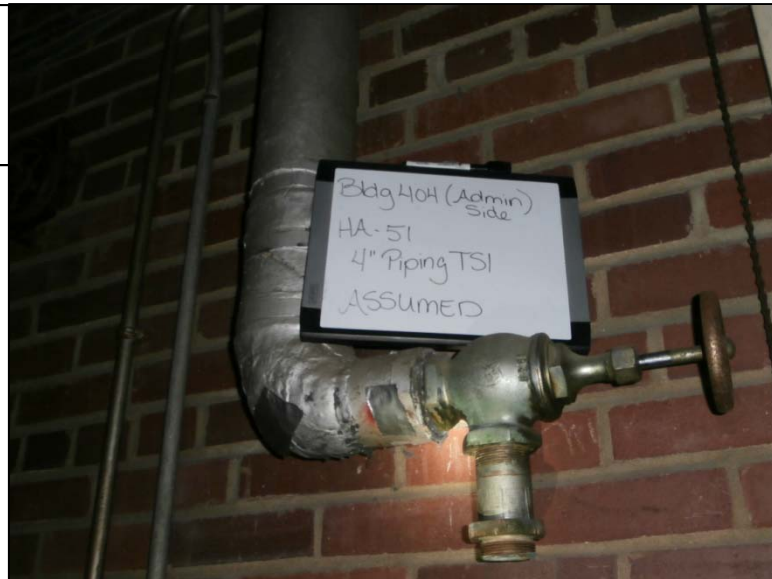
**Building:** 404  
**Photograph:** 78  
**Date:** 11/11/2012

**Description:**  
HA-NJ013-051  
TSI on 4" Piping (ASSUMED)

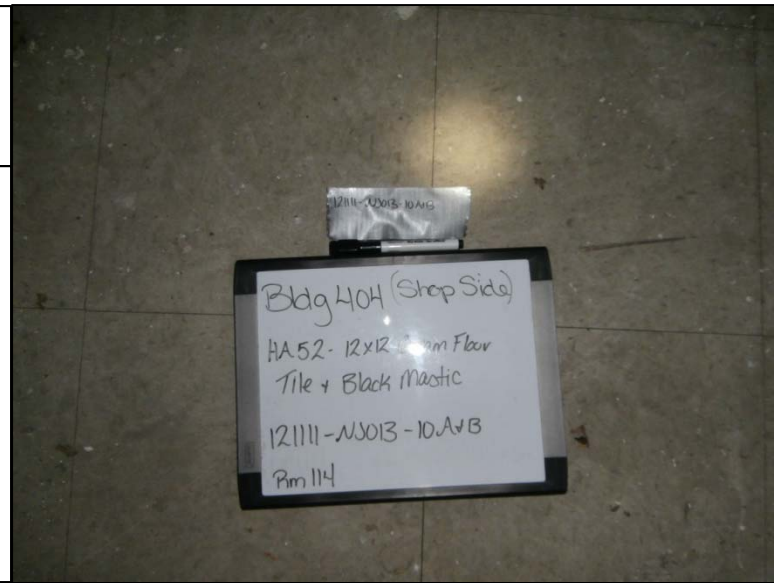
**Building:** 404  
**Photograph:** 79  
**Date:** 11/11/2012

**Description:**  
HA-NJ013-052A  
12" x 12" Cream Floor Tile with Brown Flakes

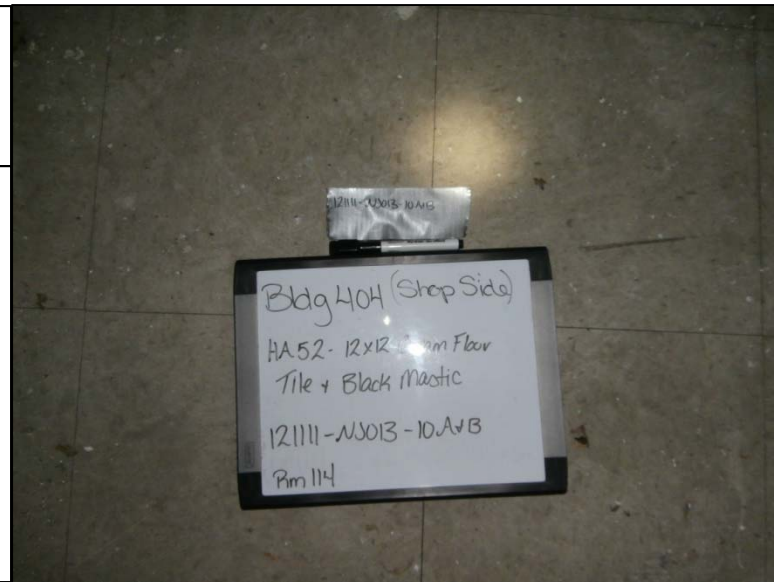
**Building:** 404  
**Photograph:** 80  
**Date:** 11/11/2012

**Description:**  
HA-NJ013-052B  
Black Mastic 12" x 12" Cream Floor Tile with Brown Flakes

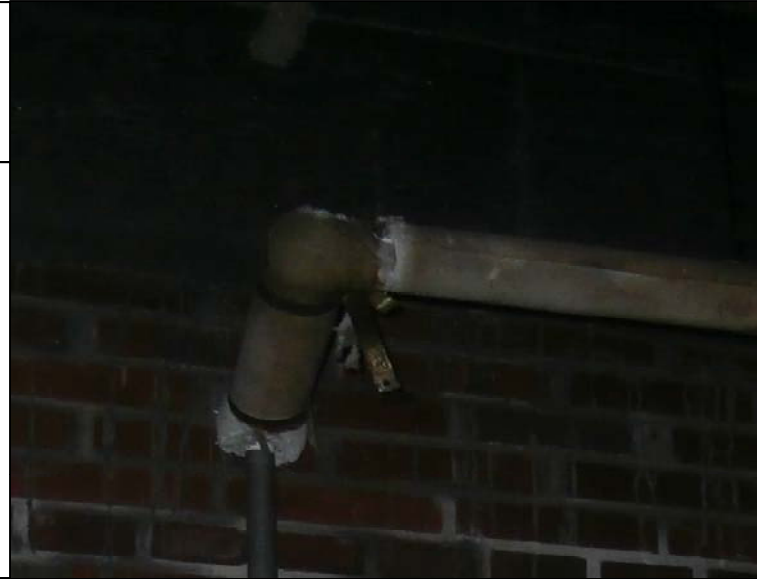
**Building:** 404  
**Photograph:** 81  
**Date:** 11/11/2012

Description:  
HA-NJ013-053  
2" Elbow TSI

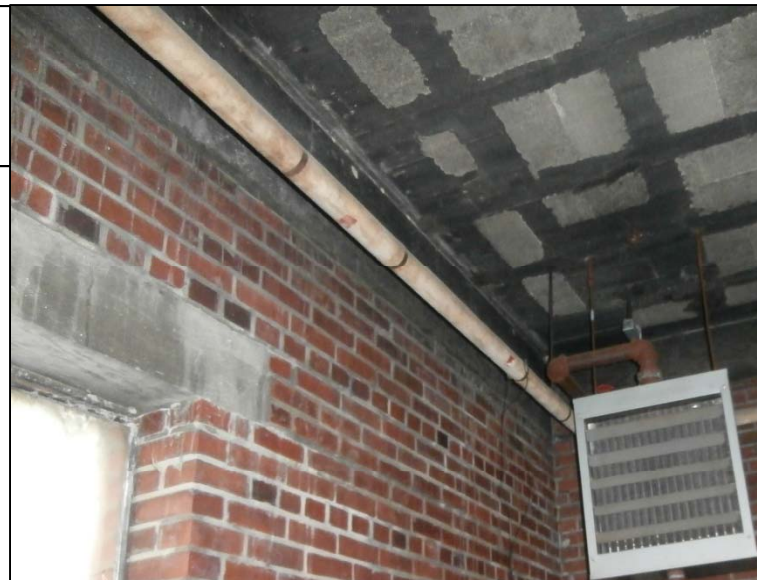
**Building:** 404  
**Photograph:** 82  
**Date:** 11/11/2012

Description:  
HA-NJ013-054  
2" Straight Run TSI

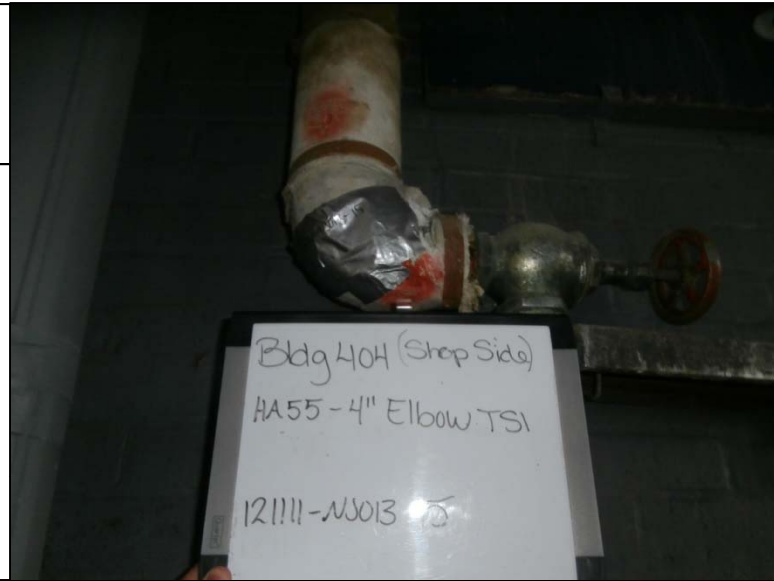
**Building:** 404  
**Photograph:** 83  
**Date:** 11/11/2012

**Description:**  
HA-NJ013-055  
4" Elbow TSI

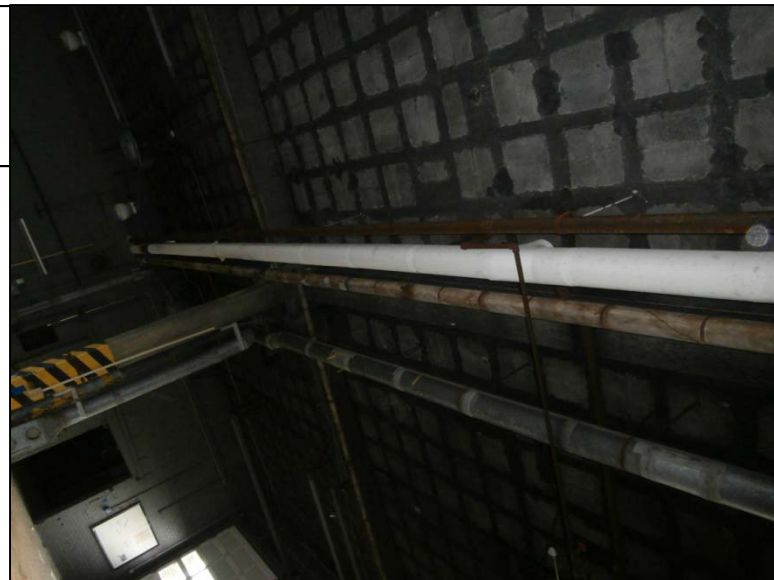
**Building:** 404  
**Photograph:** 84  
**Date:** 11/11/2012

**Description:**  
HA-NJ013-056  
4" Straight Run TSI (Cloth and Brown  
Air O Cell)

HA-NJ013-056	121111-NJ013-16	11/11/2012	4" Straight Run TSI	404	2000 LF	Good	Friable	20
HA-NJ013-056	121111-NJ013-17	11/11/2012	4" Straight Run TSI	404	100 LF	Damaged	Friable	20
HA-NJ013-057	121111-NJ013-18	11/11/2012	4" Boiler Room Straight Run TSI	404	100 LF	Sig. Damaged	Friable	15
HA-NJ013-058A&B	121112-NJ013-01A	11/12/2012	12x12 Light Gray Tile with Dark Gray Streaks and Flakes	464 (S. Section)	150 SF	Damaged	Non-Friable	ND
HA-NJ013-058A&B	121112-NJ013-01B	11/12/2012	12x12 Light Gray Tile with Dark Gray Streaks and Flakes - Mastic	464 (S. Section)	-	Damaged	Non-Friable	ND
HA-NJ013-058A&B	121112-NJ013-02A	11/12/2012	12x12 Light Gray Tile with Dark Gray Streaks and Flakes	464 (S. Section)	150 SF	Damaged	Non-Friable	ND
HA-NJ013-058A&B	121112-NJ013-02B	11/12/2012	12x12 Light Gray Tile with Dark Gray Streaks and Flakes - Mastic	464 (S. Section)	-	Damaged	Non-Friable	2
HA-NJ013-059A&B	121112-NJ013-03A	11/12/2012	12x12 Blue-Gray floor tile with shite and gray flakes	464 (S. Section)	540 SF	Good	Non-Friable	ND

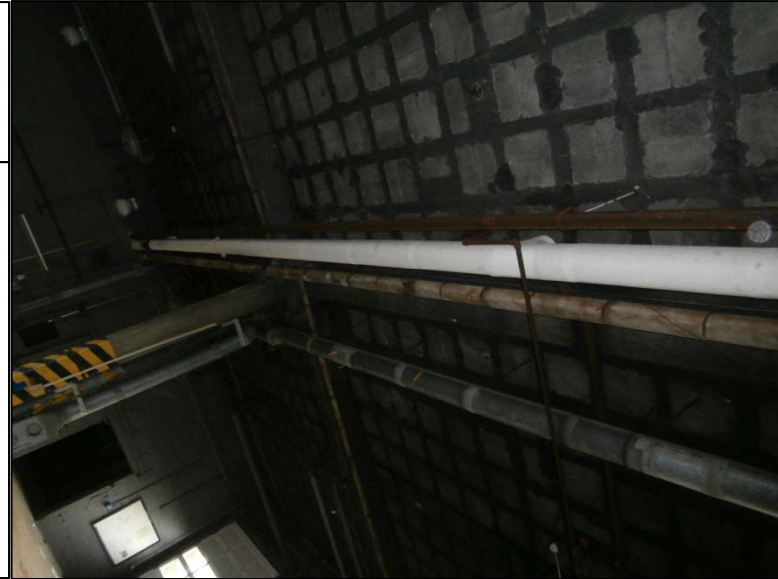
**Building:** 404  
**Photograph:** 85  
**Date:** 11/11/2012

**Description:**  
HA-NJ013-057  
4" Boiler Room Straight Run TSI

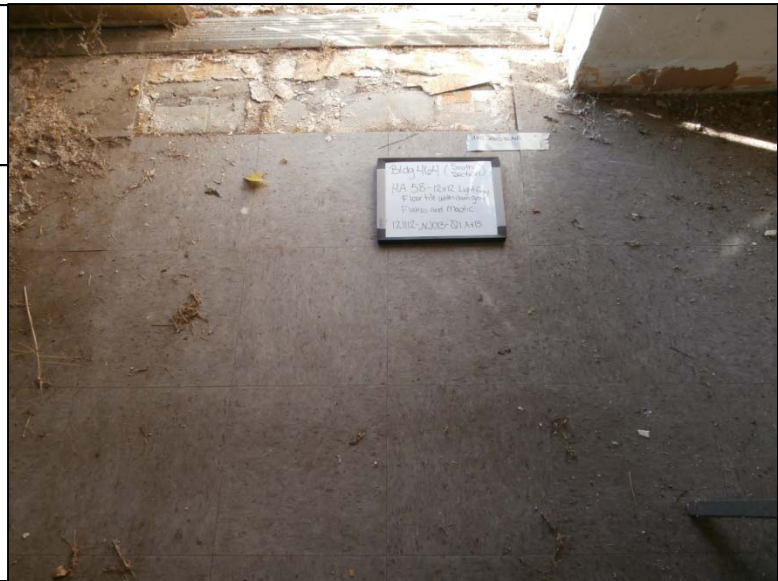
**Building:** 464 (South Section)  
**Photograph:** 86  
**Date:** 11/12/2012

**Description:**  
HA-NJ013-058A  
12" x 12" Light Gray Tile with Dark  
Gray Streaks and Flakes

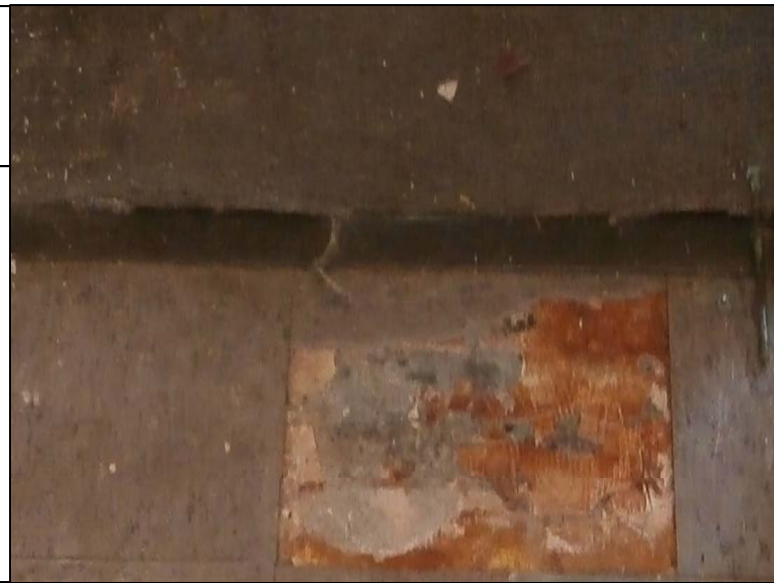
**Building:** 464 (South Section)  
**Photograph:** 87  
**Date:** 11/12/2012

**Description:**  
HA-NJ013-058B  
Tan Mastic under 12" x 12" Light Gray  
Tile with Dark Gray Streaks and Flakes

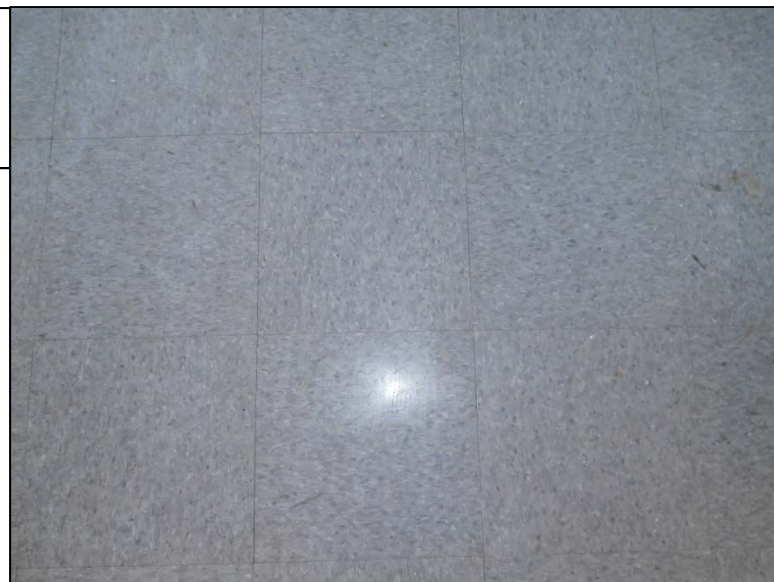
**Building:** 464 (South Section)  
**Photograph:** 88  
**Date:** 11/12/2012

**Description:**  
HA-NJ013-059A  
12" x 12" Blue-Gray Floor Tile with  
White and Gray Flakes

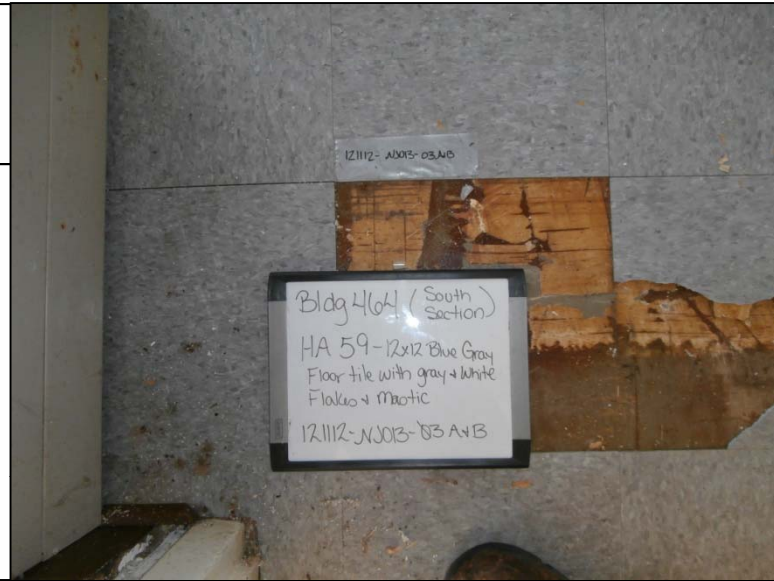
**Photograph:** 89

Tan Mastic under 12" x 12" Blue-Gray  
Floor Tile with White and Gray Flakes

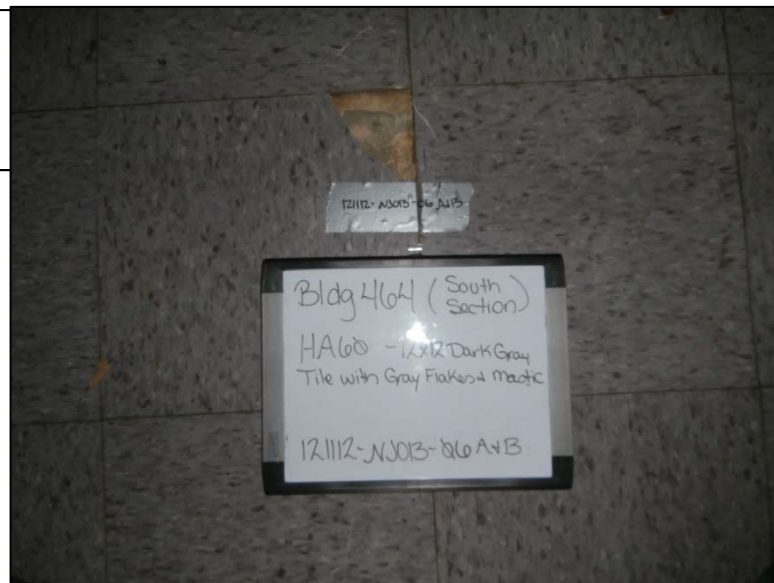
**Photograph:** 90

Dark Gray Floor Tile with Gray Flakes

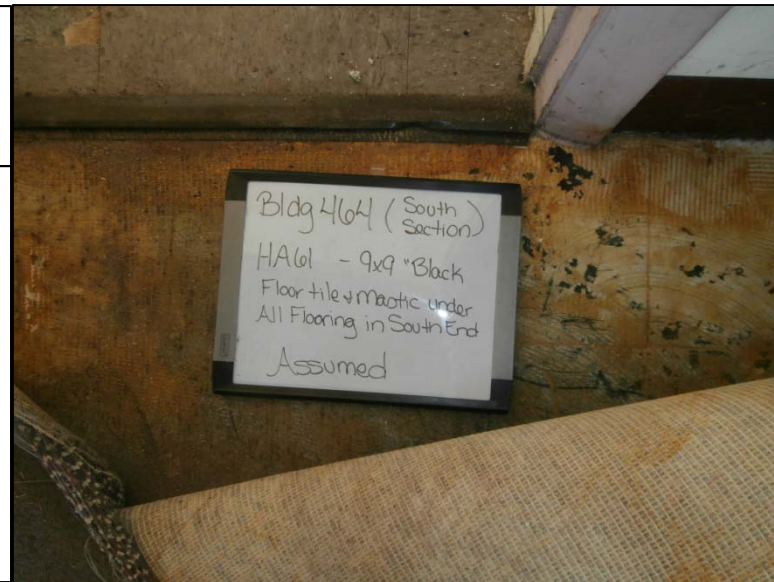
**Building:** 464 (South Section)  
**Photograph:** 92  
**Date:** 11/12/2012

**Description:**  
HA-NJ013-061  
"Black" 9" x 9" Floor Tile and Mastic under all flooring in South end of 464 (ASSUMED)

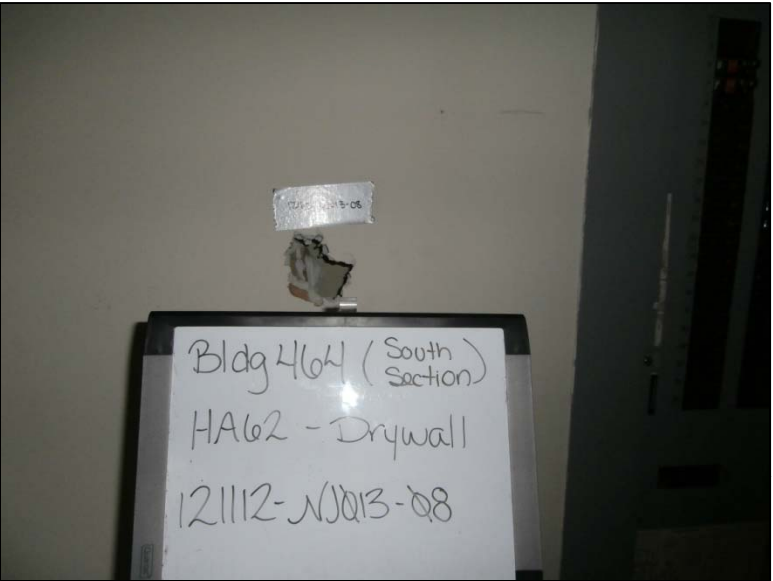
**Building:** 464 (South Section)  
**Photograph:** 93  
**Date:** 11/12/2012

**Description:**  
HA-NJ013-062  
White Drywall (Throughout Bldg)

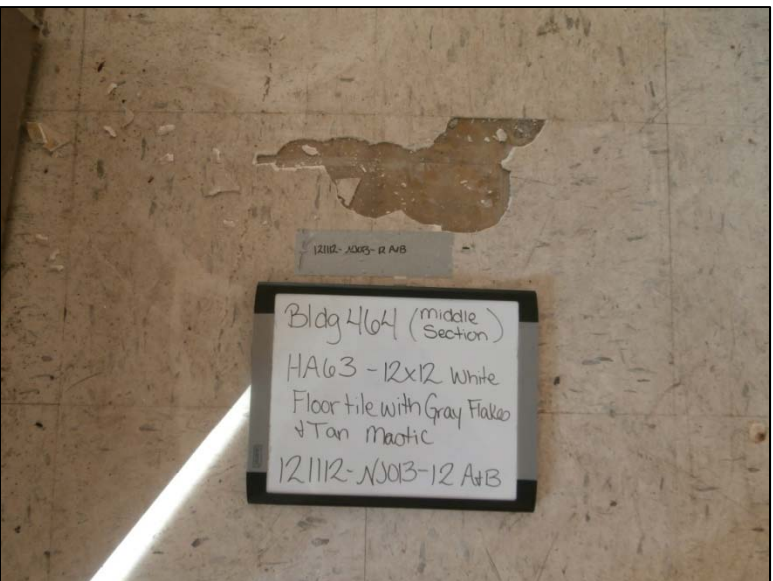
**Building:** 464 (Middle Section)  
**Photograph:** 94  
**Date:** 11/12/2012

**Description:**  
HA-NJ013-063A  
12" x 12" White Floor Tile with Gray  
Flakes

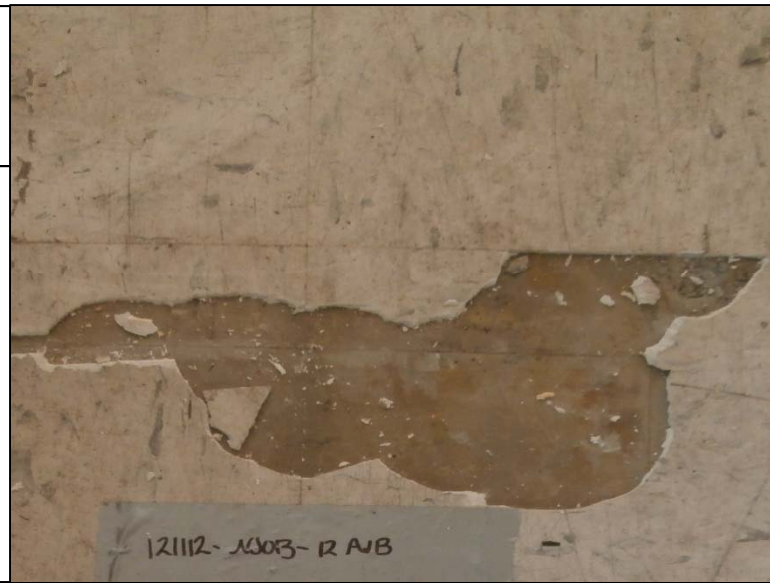
**Building:** 464 (Middle Section)  
**Photograph:** 95  
**Date:** 11/12/2012

**Description:**  
HA-NJ013-063B  
Tan Mastic under 12" x 12" White  
Floor Tile with Gray Flakes

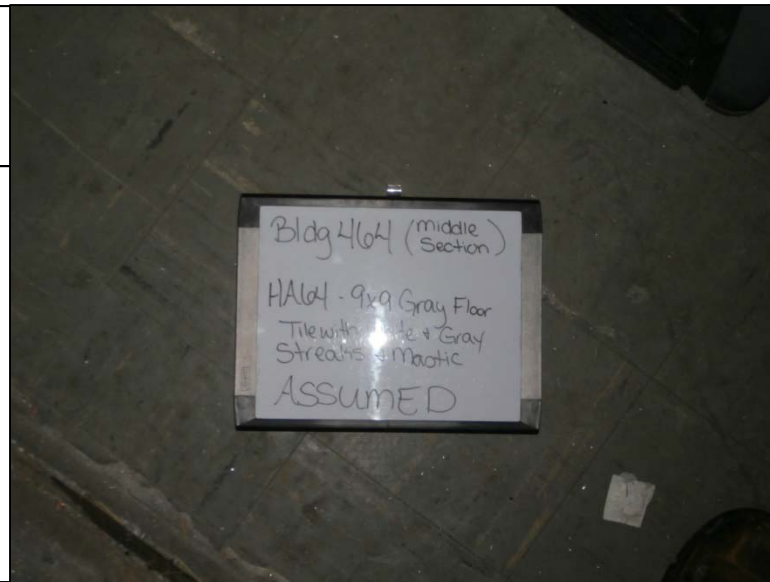
**Building:** 464 (Middle Section)  
**Photograph:** 96  
**Date:** 11/12/2012

**Description:**  
HA-NJ013-064  
9" x 9" Gray Floor Tile with White and  
Gray Streaks and Mastic (ASSUMED)

HA-NJ013-063A&B	121112-NJ013-12B	11/12/2012	12x12 White floor Tile with Gray flakes - Mastic	464 (Mid. Section)	4860	Sig. Damaged	Friable	ND
HA-NJ013-063A&B	121112-NJ013-13A	11/12/2012	12x12 White floor Tile with Gray flakes	464 (Mid. Section)	4860	Sig. Damaged	Friable	ND
HA-NJ013-063A&B	121112-NJ013-13B	11/12/2012	12x12 White floor Tile with Gray flakes - Mastic	464 (Mid. Section)	4860	Sig. Damaged	Friable	ND
HA-NJ013-063A&B	121112-NJ013-14A	11/12/2012	12x12 White floor Tile with Gray flakes	464 (Mid. Section)	4860	Sig. Damaged	Friable	ND
HA-NJ013-063A&B	121112-NJ013-14B	11/12/2012	12x12 White floor Tile with Gray flakes - Mastic	464 (Mid. Section)	4860	Sig. Damaged	Friable	ND
HA-NJ013-064	ASSUMED	11/12/2012	9x9 Gray Floor Tile with White and Gray Streaks and Mastic	464 (Mid. Section)	4860	Good	Non-Friable	ASSUMED
HA-NJ013-065	121112-NJ013-15	11/12/2012	10x10 Acoustical Ceiling Tile	464 (Mid. Section)	196	Damaged	Friable	ND

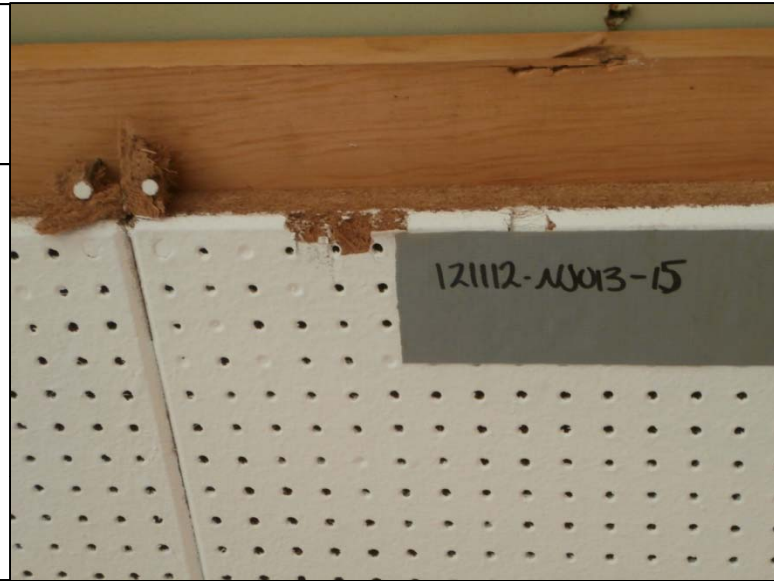
**Photograph:** 97

HA-NJ013-065

12" x 12" Acoustical Ceiling Tiles

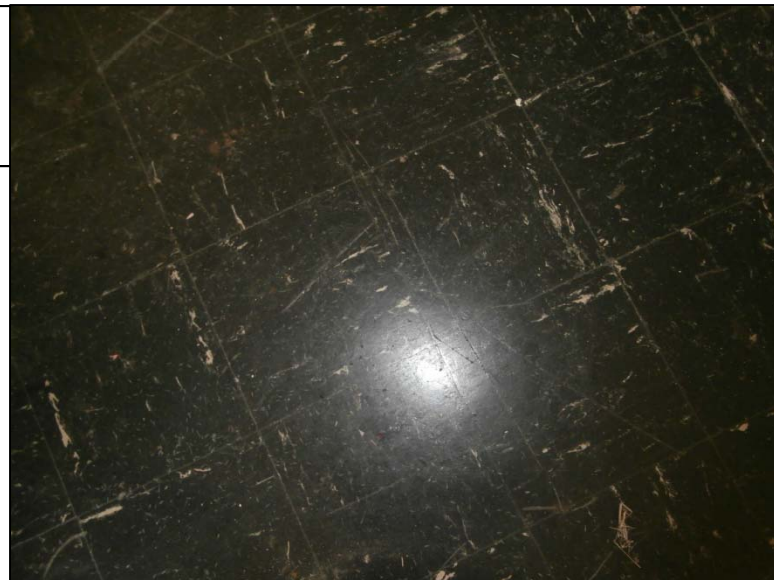
**Photograph:** 98

HA-NJ013-066

9" x 9" Black Floor Tile with White  
Streaks and Mastic (ASSUMED)

HA-NJ013-066	ASSUMED	11/12/2012	9x9 Black Floor tile with white streaks and Mastic	464 (N. Section)	4725	Damaged	Non-Friable	ASSUMED

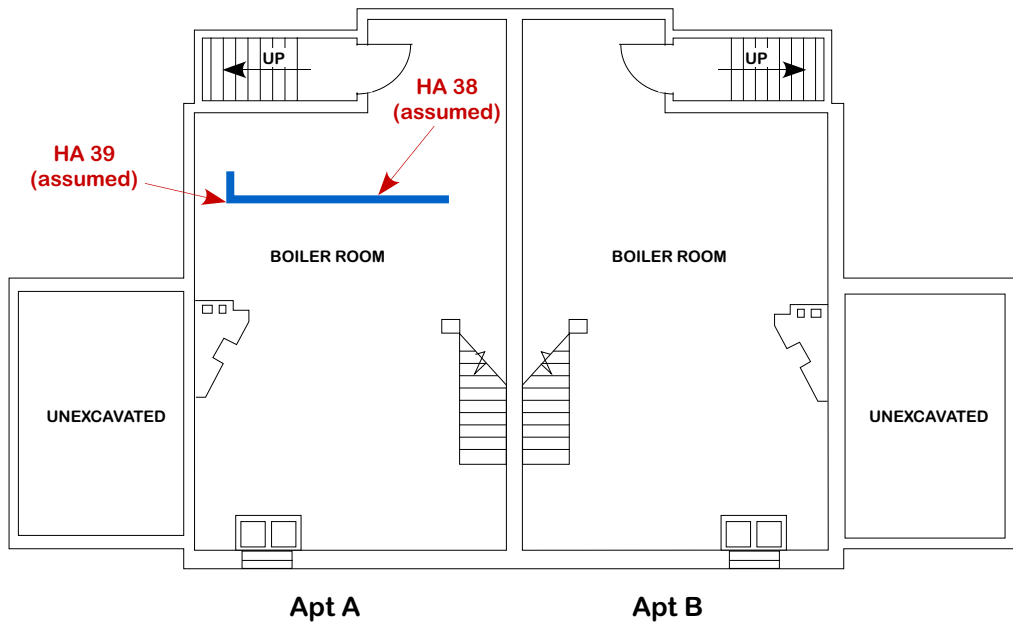
# DIAGRAM E.8

STRAIGHT RUN TSI - ASSUMED ACM
