**APPENDIX C:
KIT CARSON MONUMENT CONDITION ASSESSMENT REPORT**

Christopher “Kit” Carson Monument, S. Federal Place, Santa Fe, NM.

Condition Assessment

Prepared by Crocker Ltd
11 November 2024

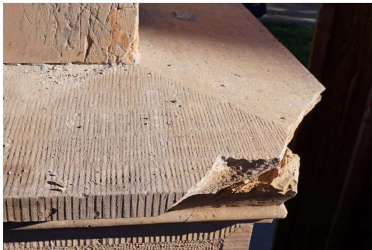
Cornice
Stone B1S/B1N - east

Mortar deterioration

Stratification separation

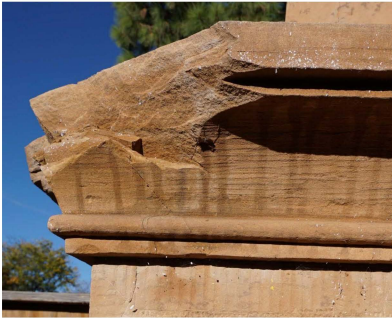
**Cornice
Stone B1S – south**

There is delamination along the bedding planes approximately midway through the top 1½-inches of the vertical face of B1S. This delamination appears to continue through all three exposed edges. There are signs of chipping across B1S. The worst damage is found at the SE corner where the combination of A1, A2, and A3 struck as it was rotated from A4. Diagonal cracking from the impact extends down through the remaining thickness of the stone. The remaining stone bounded by this cracking is subject to failure.

There are small divots, either from natural causes or minor vandalism. The exposed portions of mortar joints between B1N and B1S are largely compromised.

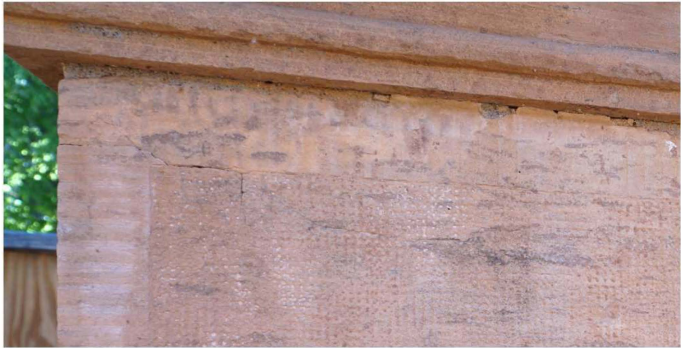
Inscription Stone
B3 – south

Material cracking, depth unknown.

Material cracking, depth unknown, may correspond with adjacent face which will eventually lead to fragmentation. Some natural chipping.

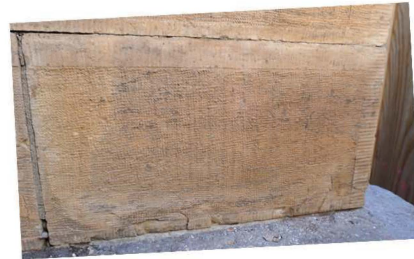
Previously replaced stone
