Potomac Annex: Buildings 1 & 3-7

Historic Structures Report, Corrected Final Submission
General Services Administration Project Control Number: 44007

September 9, 1997

BUILDING 1: EXTERIOR EXISTING CONDITIONS

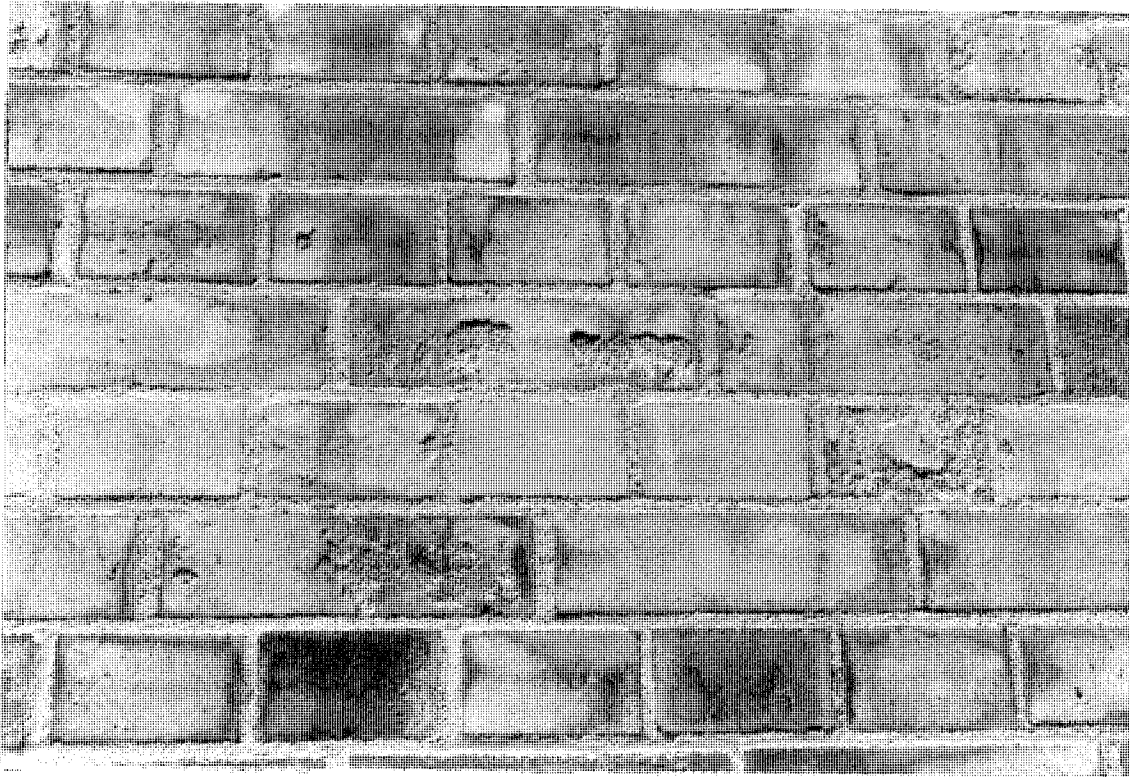
Figure 3-2

The buff brick is soiled moderately and selectively giving it a mottled appearance (Figure 3-1). This brick exhibits a crazed and cracked outer skin which entraps much of the soiling (Figure 3-2). Minor graffiti and bitumen deposits are found on this brick (Figure 3-3). The removal of window grates at the basement level damaged some of the brick (Figure 3-4).

Location: North Elevation of Building 3 near West Pavilion

Cause of Problem: Unknown but may be poorly fabricated brick

Suggested Remedy: There is no remedy other than replacement of all buff brick

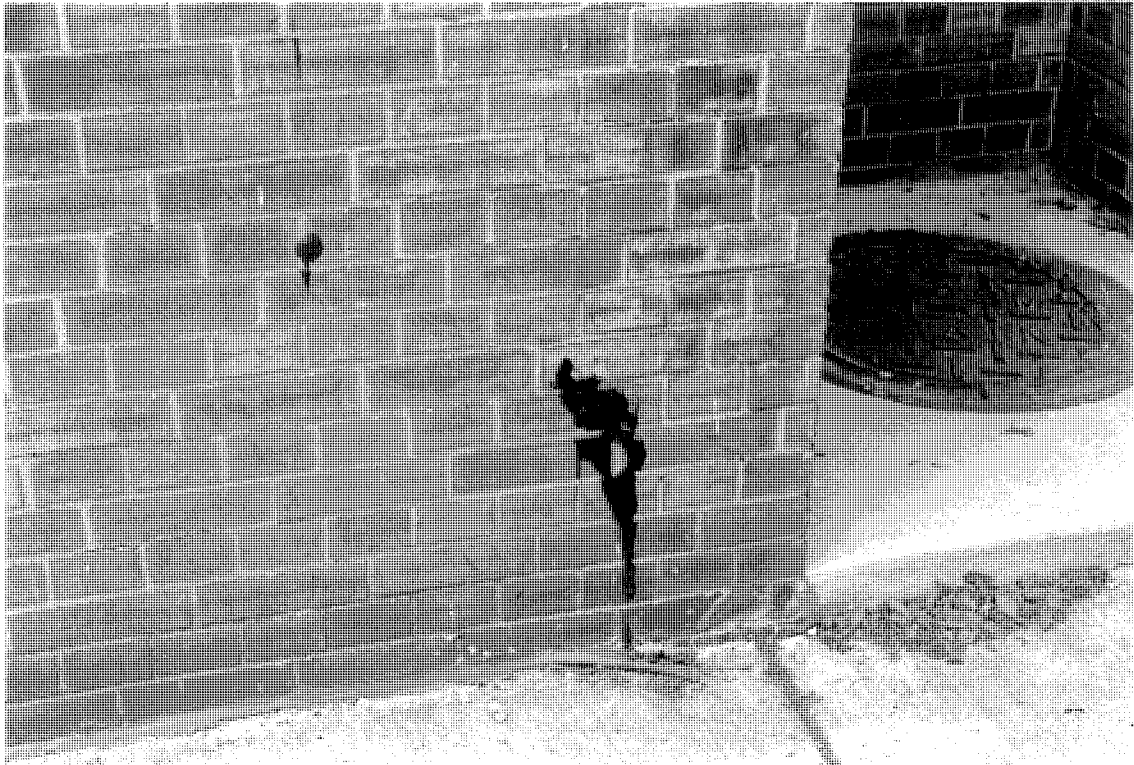
Figure 3-3

Location: North Elevation of Building 3 near West Pavilion

Cause of Problem: Poorly executed maintenance procedures

Suggested Remedy: Remove with solvent poultice (details are discussed in Chapter VIII. *Materials Cleaning Analysis*)

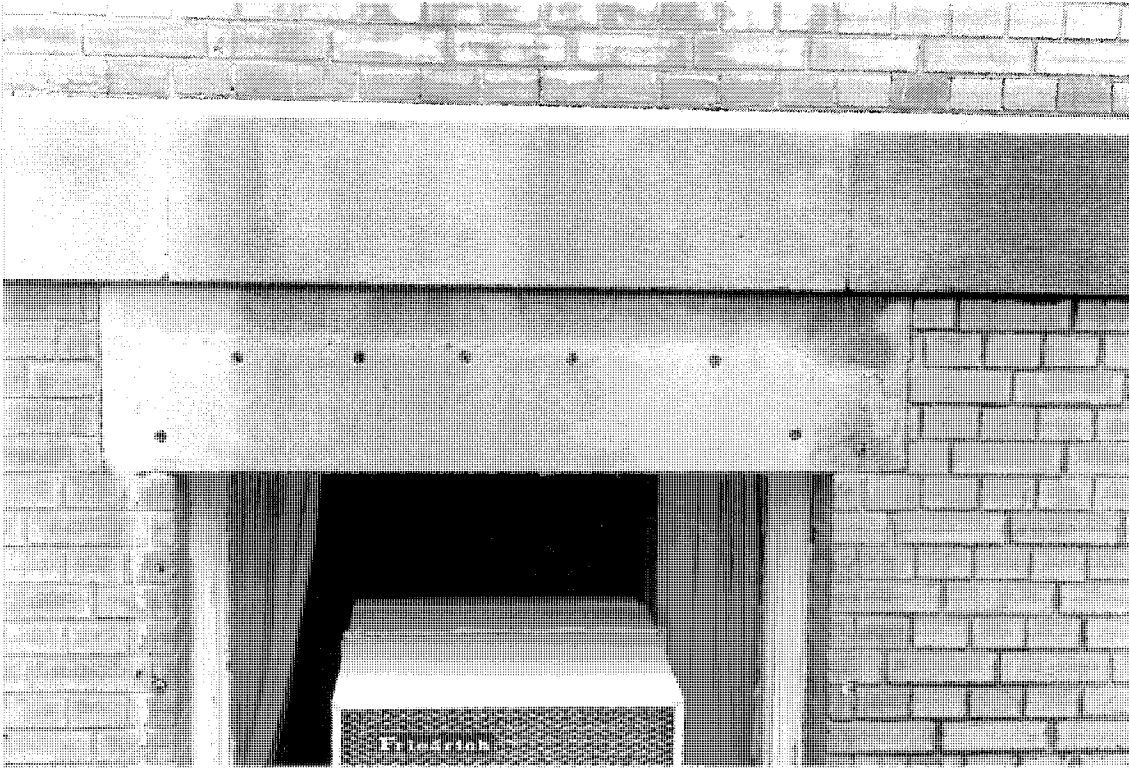
Figure 3-4

Location: South Elevation of Building 3 on East Pavilion

Cause of Problem: Installation of window grates

Suggested Remedy: Remove inserts and fill all holes

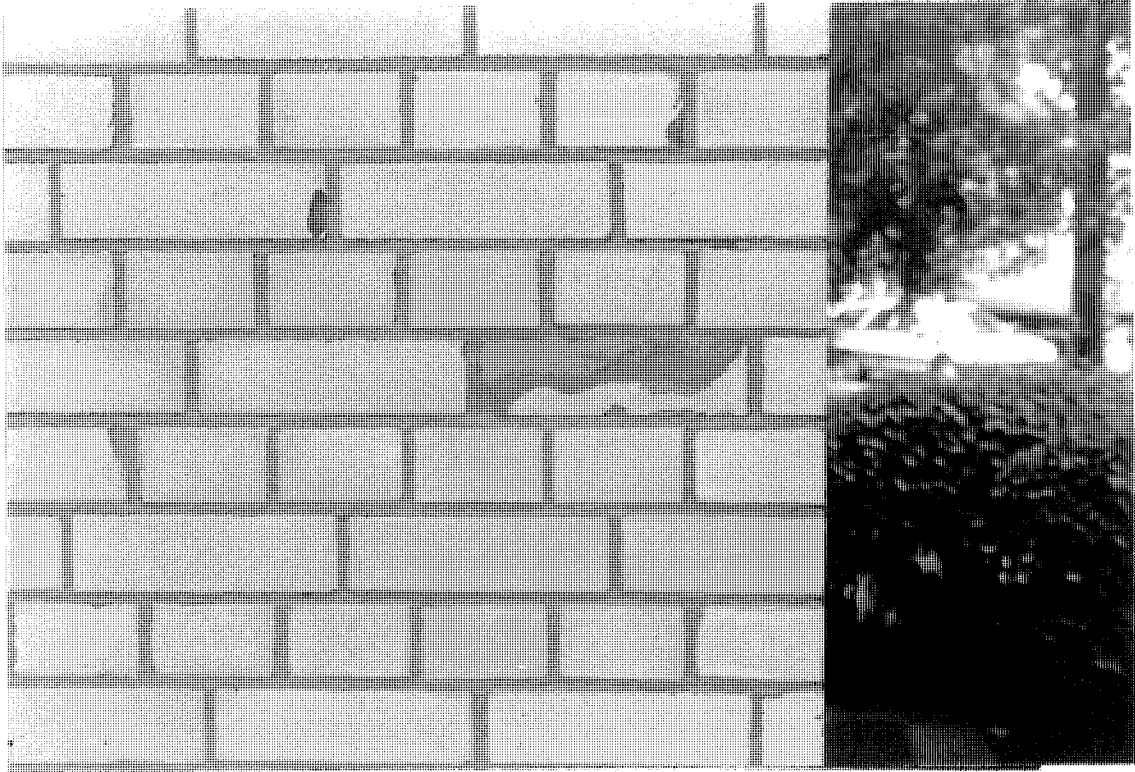
Figure 3-5

The white glazed brick, like the buff brick, is selectively damaged but to a much lesser extent (Figure 3-5). The areas of loss comprise about twenty percent of the total surface area of this brick.

Location: East Elevation of Building 3 on West Pavilion

Cause of Problem: Unknown but may be freezing water or impact damage

Suggested Remedy: Replace with matching brick and mortar

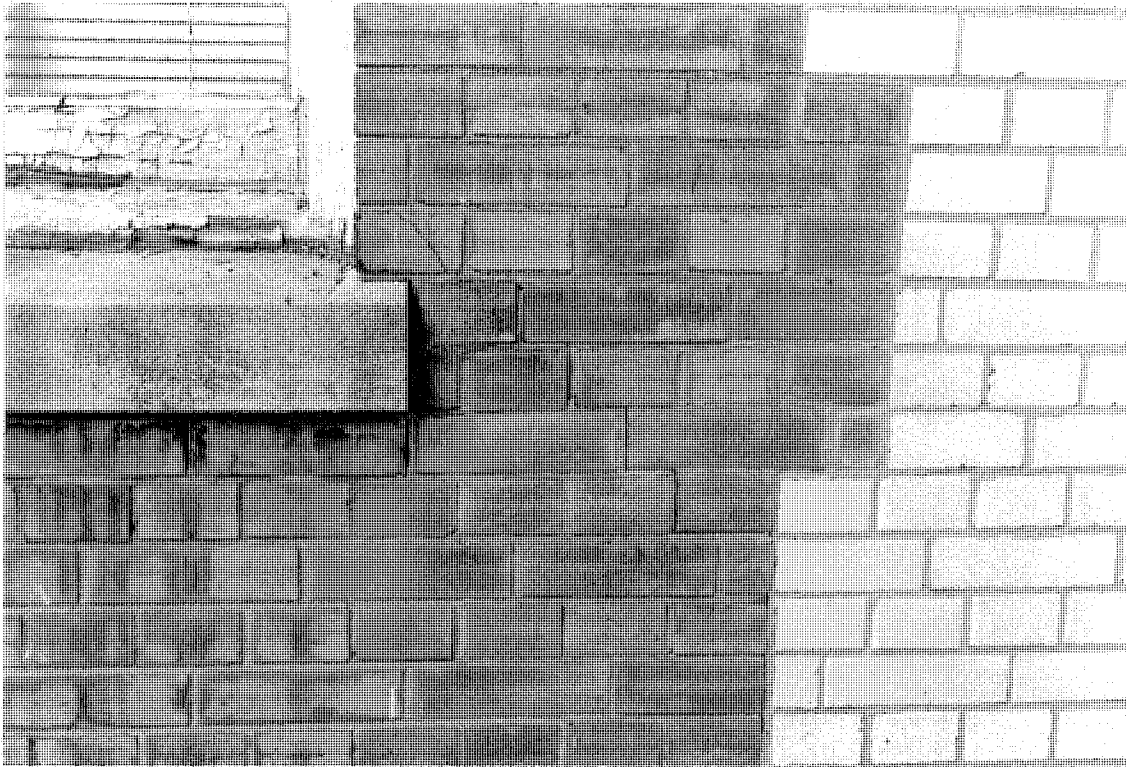
Figure 3-6

Stress cracks and open joints are found on Building 3 in association with the vertical or head joints of the limestone water table (Figure 3-6). Stress cracks and open joints have been caulked

Location: East Elevation of Building 3 on East Pavilion

Cause of Problem: Freezing water in open joints and/or rusting of iron anchors

Suggested Remedy: Remove brickwork and assess for rusting iron anchors. If anchors are rusted they should be replaced with stainless steel anchors; brick should then be replaced to match existing texture, color and size and reset in mortar to match surrounding pointing in color, texture, and profile.

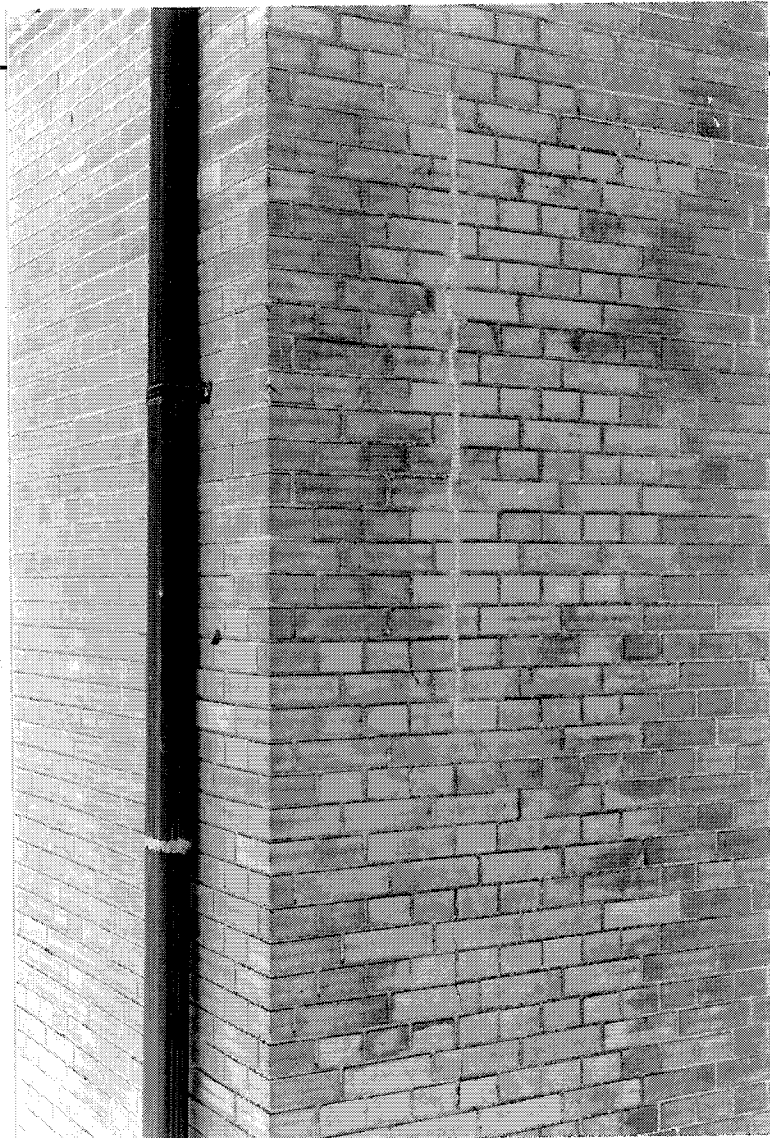
Figure 3-7

at the basement level (Figure 3-7). Caulk repairs are also seen at grade for open joints between brick and concrete sidewalks (Figure 3-8).

Location: South Elevation of Building 3 at West Corner

Cause of Problem: Unknown but possibly differential heat stress

Suggested Remedy: Remove brickwork and replaced to match existing texture, color and size and reset in mortar to match surrounding pointing in color, texture, and profile

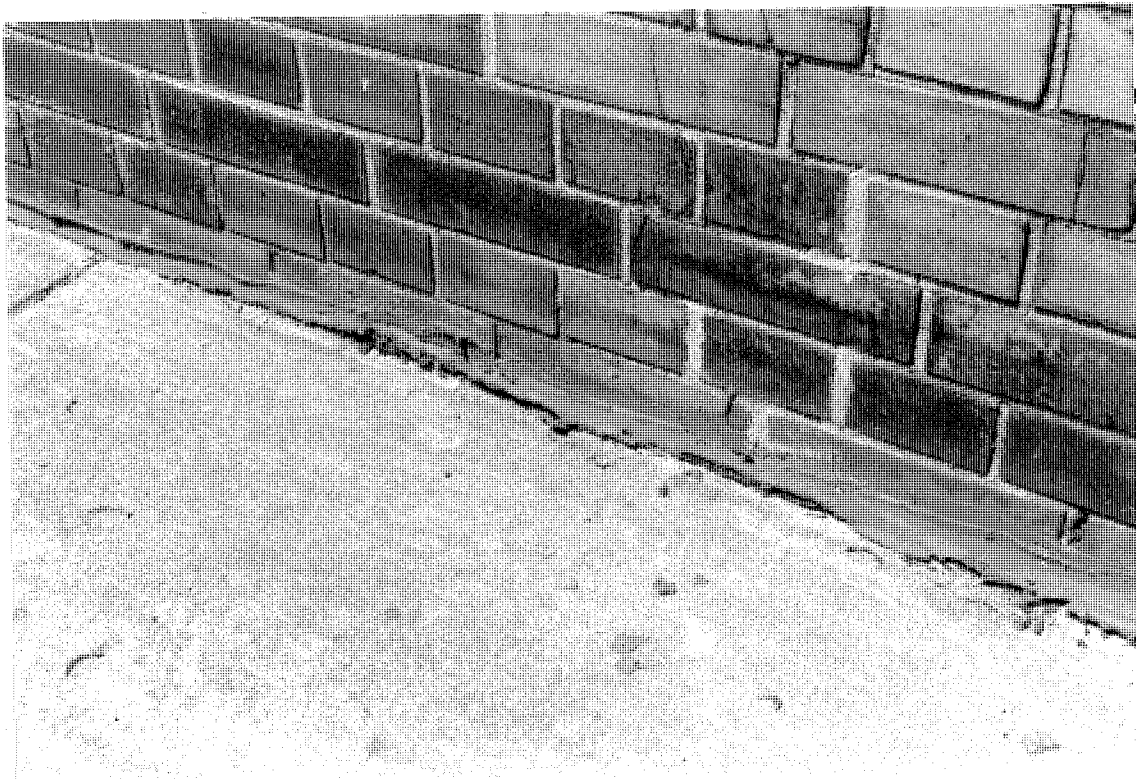
Figure 3-8

Location: East Elevation West Pavilion on North Side of Building 3

Cause of Problem: Improper maintenance

Suggested Remedy: Remove caulk and repoint with mortar

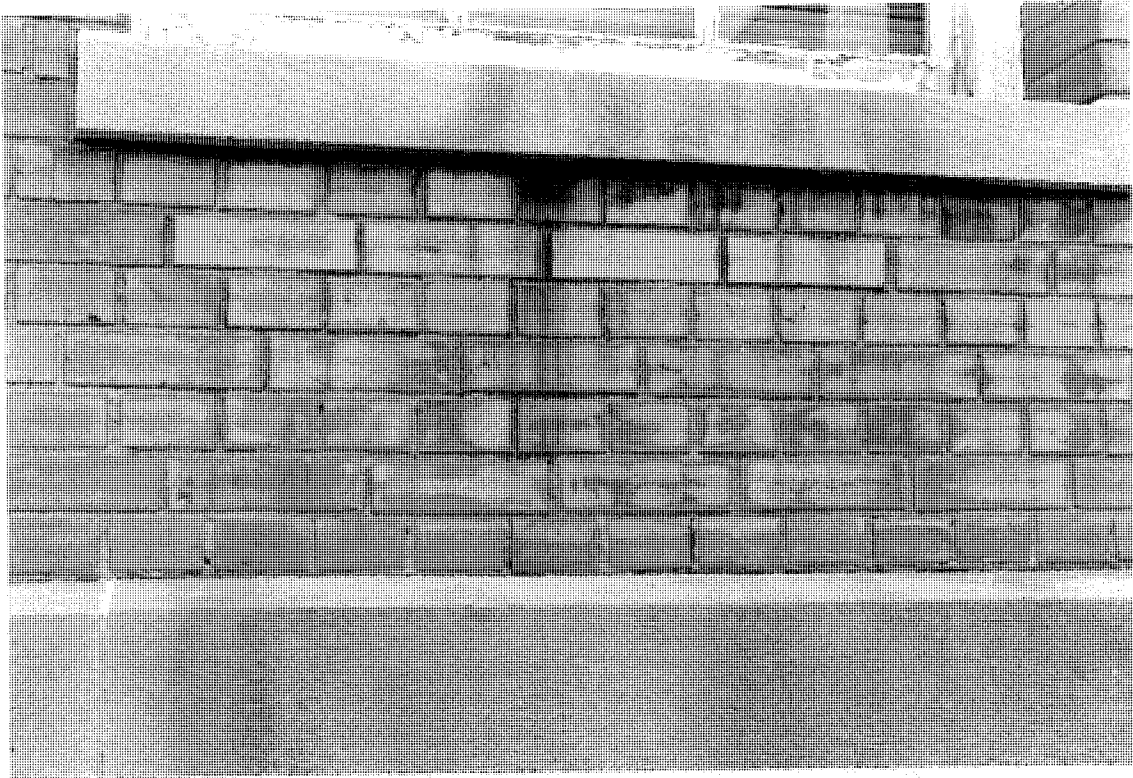
Figure 3-9

Location: South Elevation of Building on East Pavilion

Cause of Problem: Atmospheric pollution

Suggested Remedy: Water misting cleaning (for details see Chapter VIII. *Materials Cleaning Analysis*)

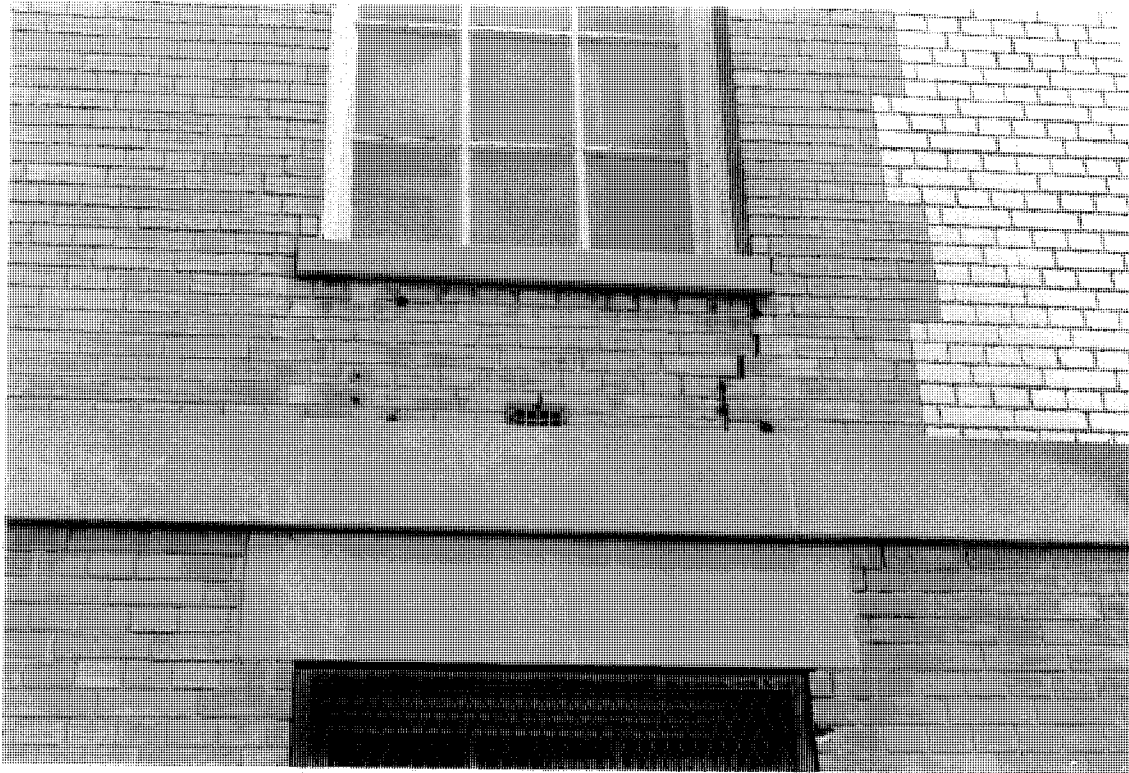
Figure 3-10

Limestone is used for capstones on the raked cornices, parapet walls, keystones and some window lintels, sills and belt courses (or water tables) on Building 3. All of these limestone elements shows signs of loss but do not suffer from active granular disintegration or stress cracking. The light build up of gypsum and flyash appears to be confined to the window lintels and keystones and sills (Figure 3-9). The head joints in the water table and the joints of most of the limestone elements are open or have been repointed with visually or physically incompatible materials (Figure 3-10).

Location: South Elevation of Building 3 on West Pavilion

Cause of Problem: Freezing water in open joints and/or rusting iron anchors in window sills.

Suggested Remedy: Remove brickwork and assess for rusting iron anchors. If anchors are rusted they should be replaced with stainless steel anchors; brick should then be replaced to match existing texture, color and size and reset in mortar to match surrounding pointing in color, texture, and profile.

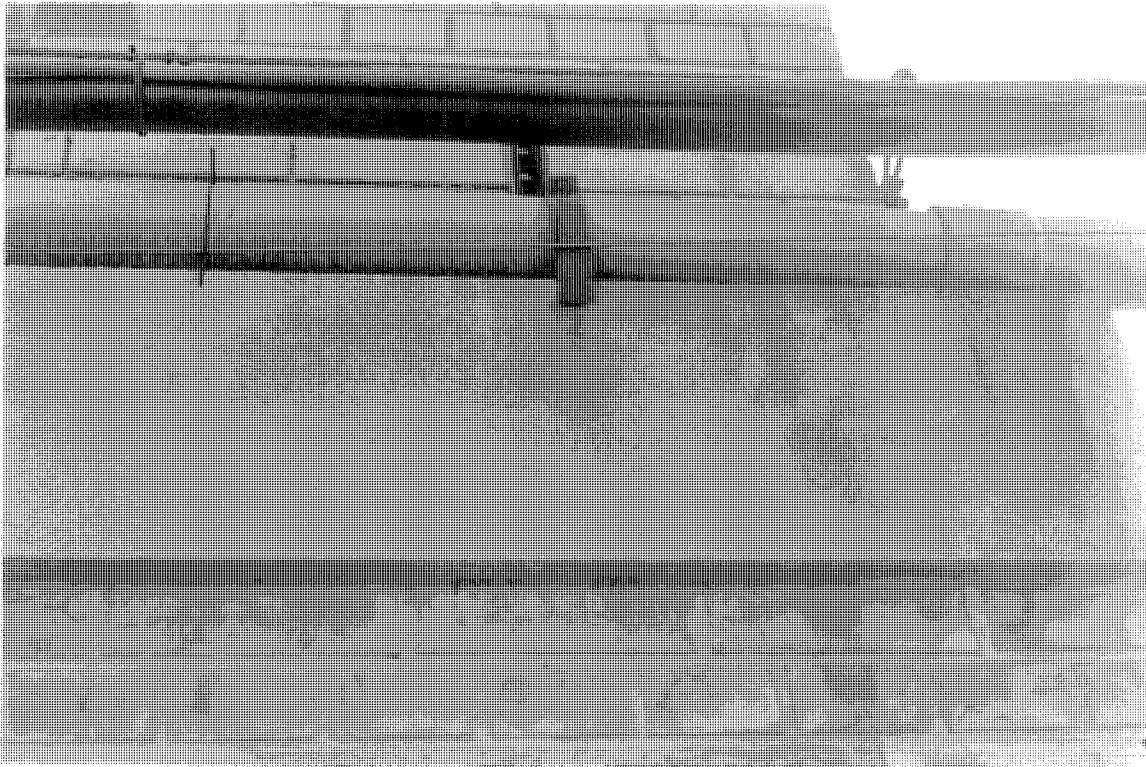
Figure 3-11

Metal brackets supporting the power lines have rusted and stained the limestone water table (Figure 3-11). In addition, the window air conditioning units have stained this water table as well as some of the limestone window sills (Figure 3-12). During the most recent campaign of repainting of the woodwork, paint has been splattered on the limestone elements. Limestone elements near parking areas or areas of vehicular exhibit percussive damage (Figure 3-13).

Location: North Elevation of Building 3 on West Pavilion

Cause of Problem: Rusting iron attachments

Suggested Remedy: Remove stain with iron poultice (scrape and paint iron elements)

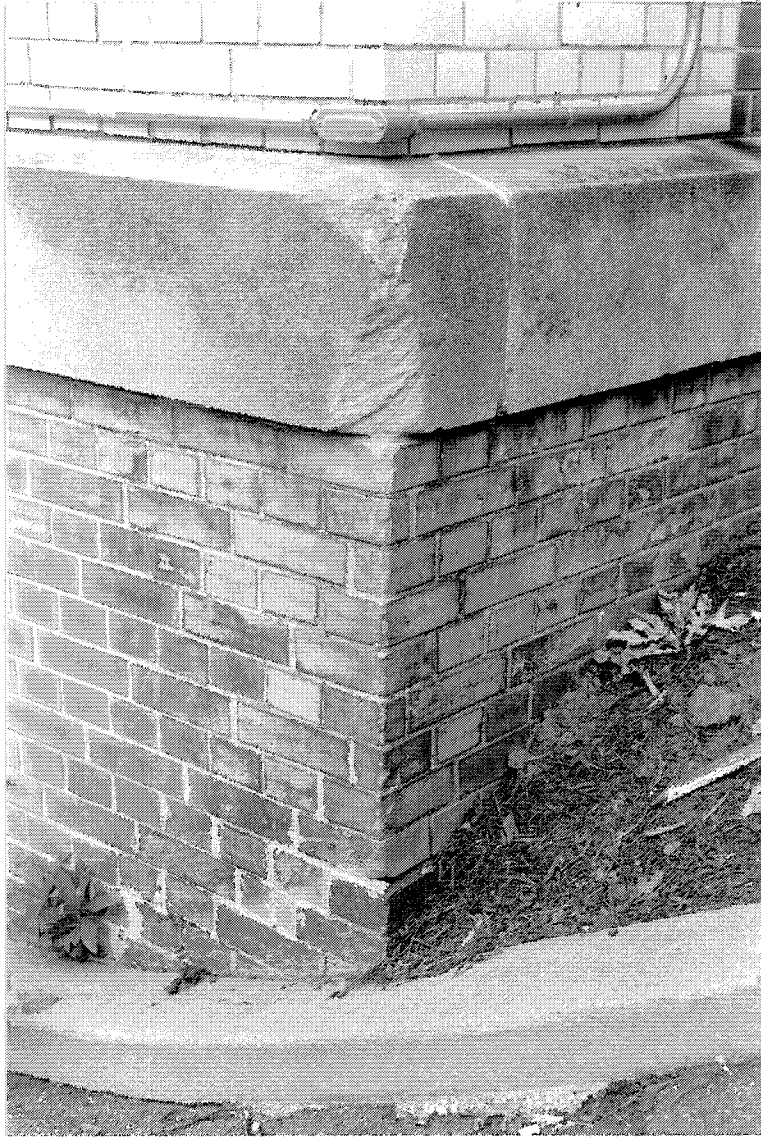
Figure 3-13

Location: East Elevation of Building 3 on South Corner of East Pavilion

Cause of Problem: Impact from vehicles

Suggested Remedy: Repair with patching mortar

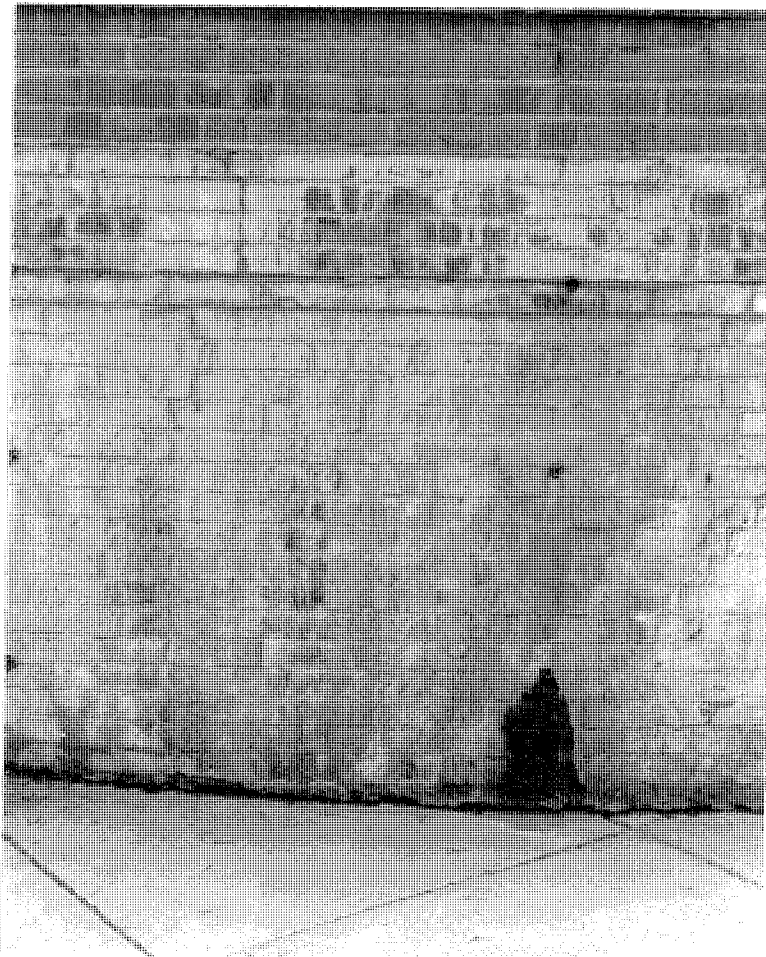
Figure 3-14

The concrete has not fared well on Building 3. The curved brick retaining wall on the north elevation of Building 3 is bulging significantly and exhibits extensive efflorescence (Figure 3-14). Capstones are crumbling (Figure 3-15) and previous repairs are failing (Figure 3-16). (It should be noted that during the examination of the facades, bluestone was found on the north stairway, indicating that it, not concrete, was probably the original material for the steps.) The underside of the concrete slab that forms the floor of the entrance portico to Building 3 is very badly damaged (associated with corroding rebar) with losses are as large as several inches in depth (Figure 3-17). These losses are associated with dampness, efflorescence and extensive corrosion of the rebar.

Location: North Elevation of Building 3 in Central Areaway

Cause of Problem: Water infiltration

Suggested Remedy: Excavate, waterproof, cut and point

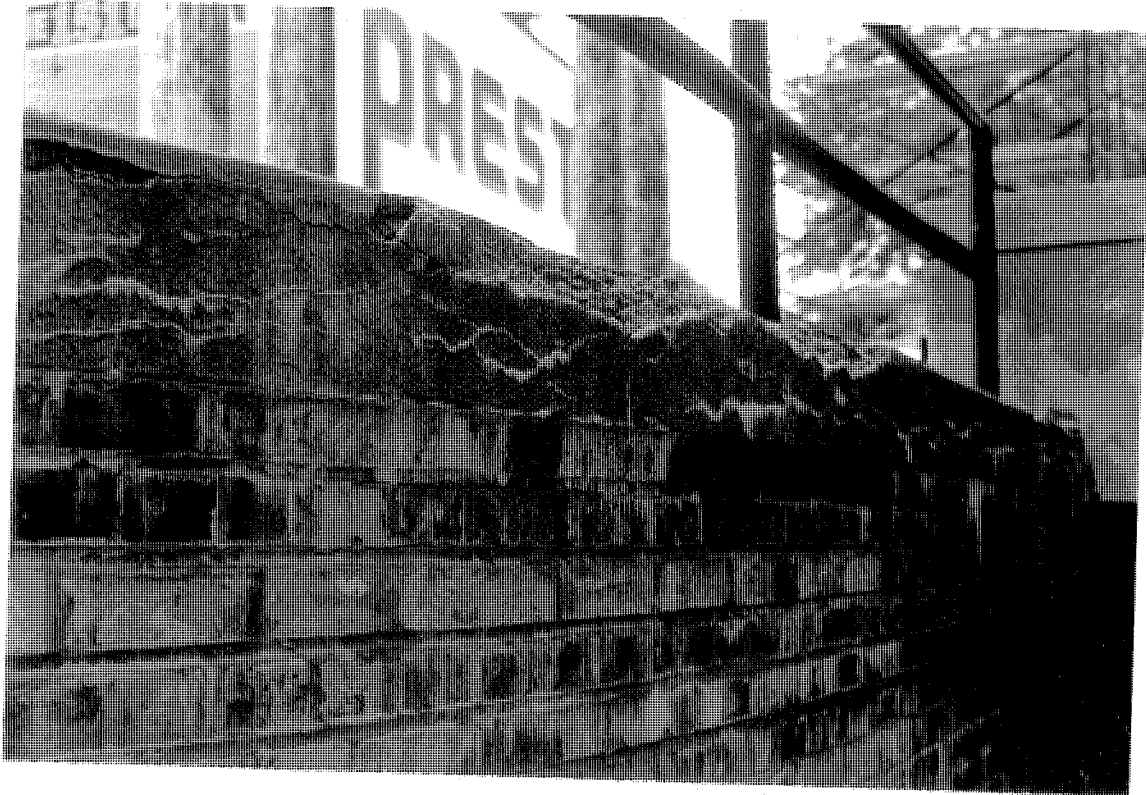
Figure 3-15

Location: North Elevation of Building 3 in Central Areaway

Cause of Problem: Water infiltration and corroding iron railings

Suggested Remedy: Remove and replace with new concrete

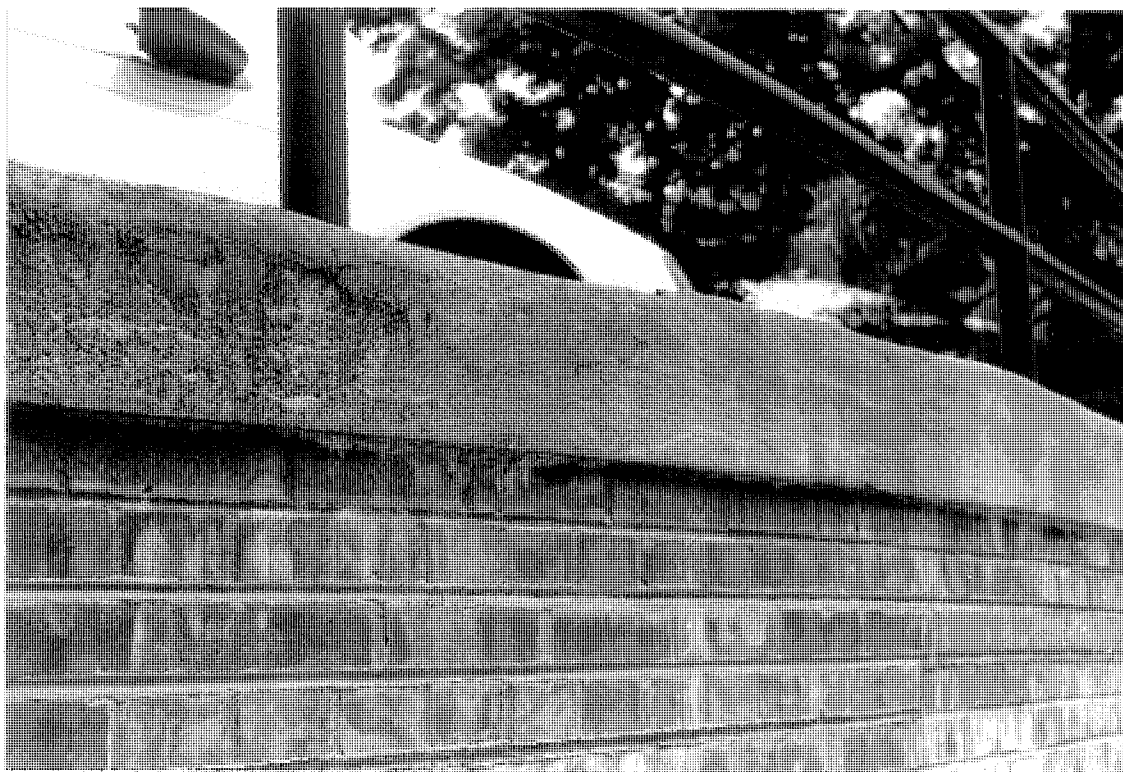
Figure 3-16

Location: North Elevation of Building 3 in Central Areaway

Cause of Problem: Improper and unsightly maintenance procedures

Suggested Remedy: Remove and replace with new concrete

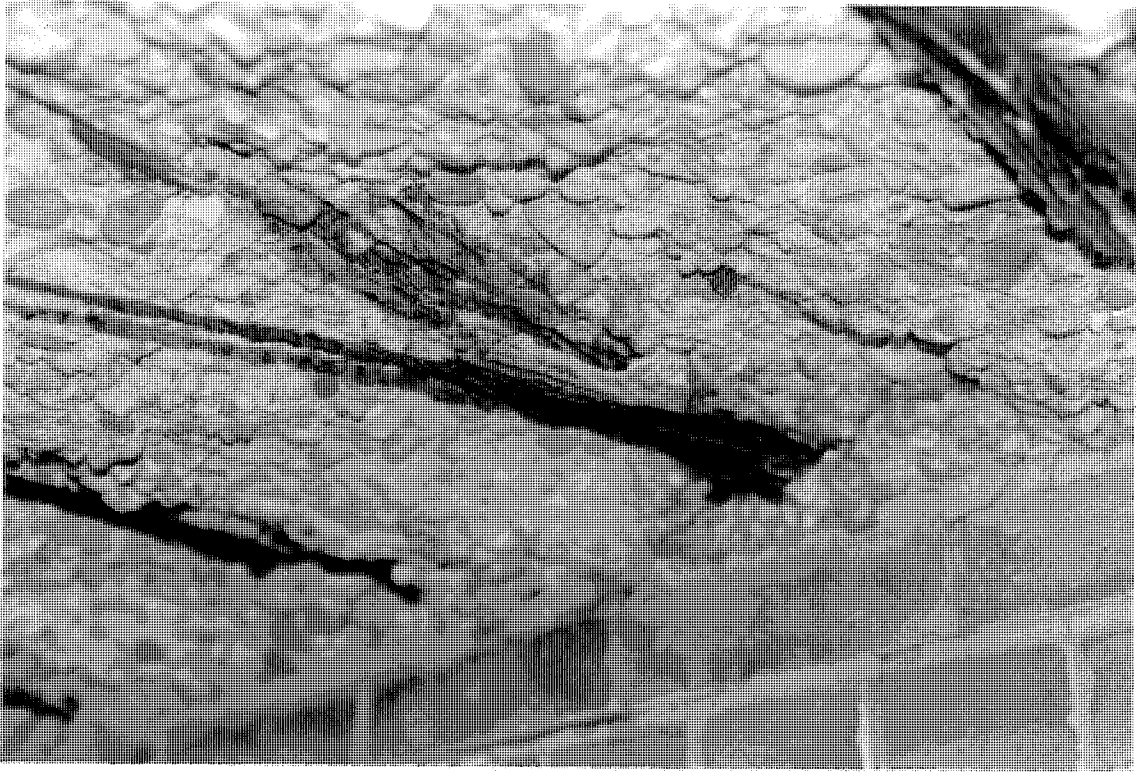
Figure 3-17

Location: North Elevation of Building 3 in Central Areaway

Cause of Problem: Water infiltration

Suggested Remedy: Demolish and rebuild

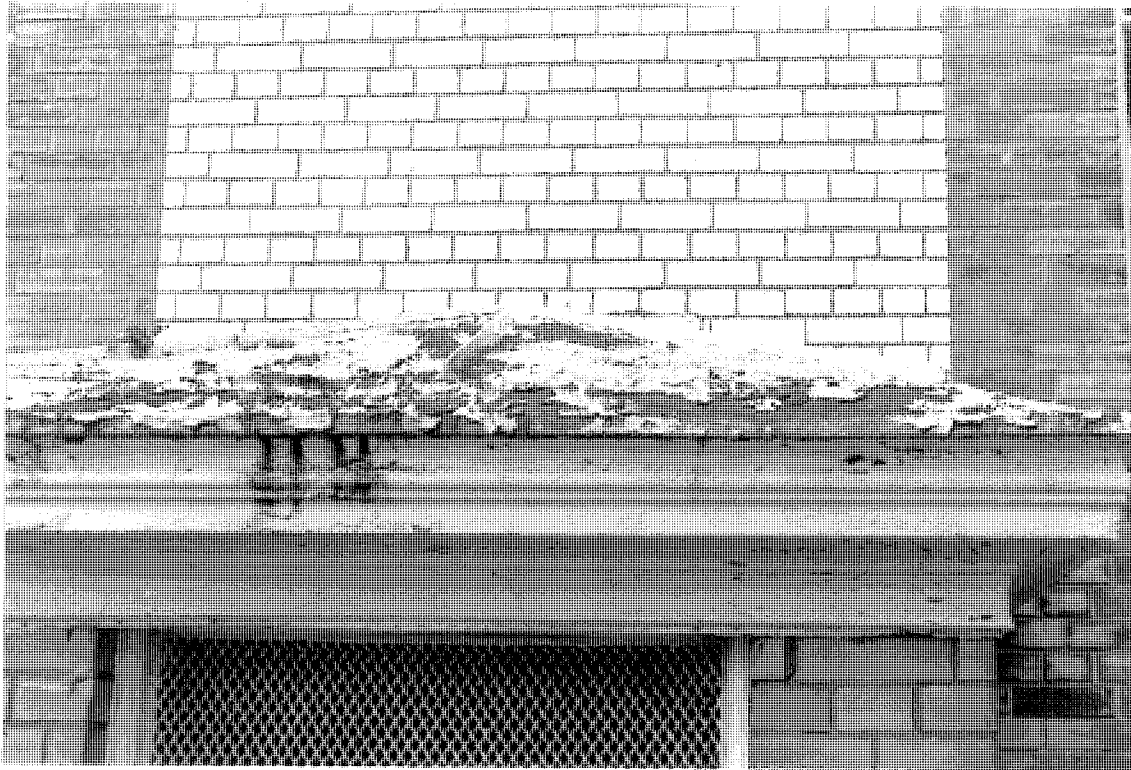
Figure 3-18

Tin roofs which have been painted show extensive loss and lack of adhesion of paint (Figure 3-18).

Location: East Elevation of Building 3 on East Pavilion

Cause of Problem: Inadequate maintenance

Suggested Remedy: Scrape, prime and paint

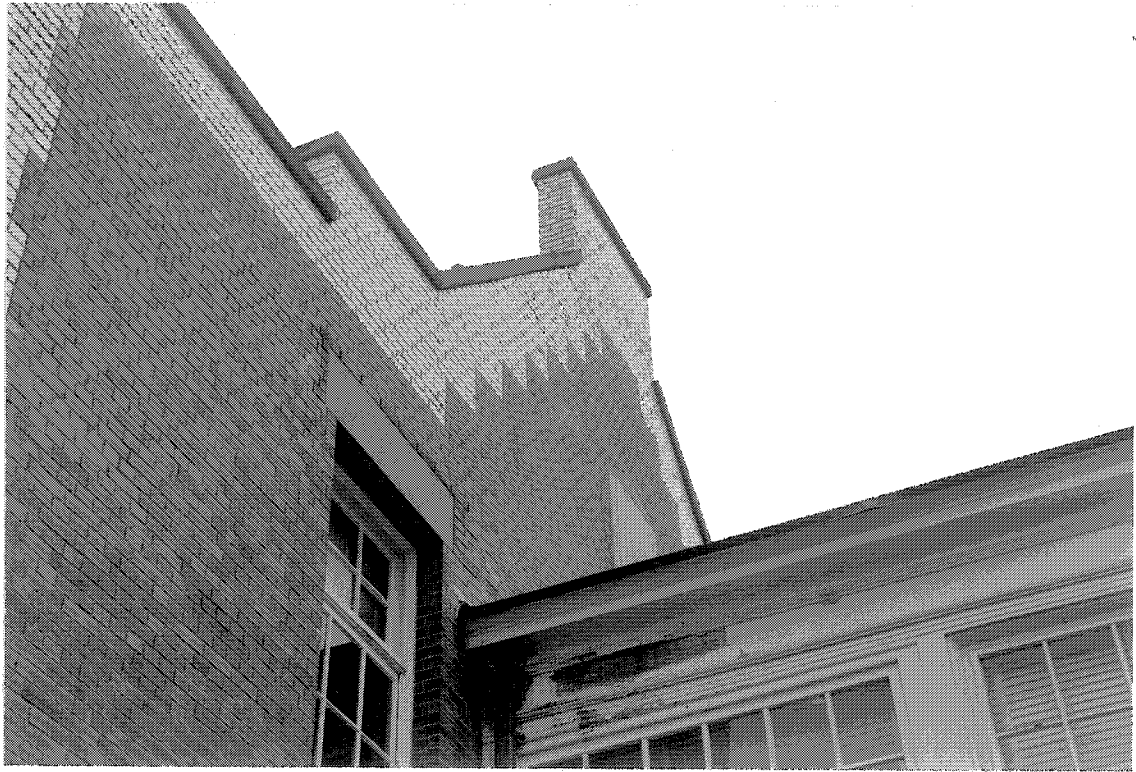
Figure 4-1

The buff brick is soiled moderately and selectively giving it a mottled appearance (Figure 4-1). This brick exhibits a crazed and cracked outer skin which entraps much of the soiling. Bitumen deposits are found on this brick (Figures 4-2 and 4-3).

Location: East Elevation of East Pavilion on Building 4

Cause of Problem: Atmospheric pollution

Suggested Remedy: The buff brick will not clean by conventional or unconventional methods (see also Chapter VIII).

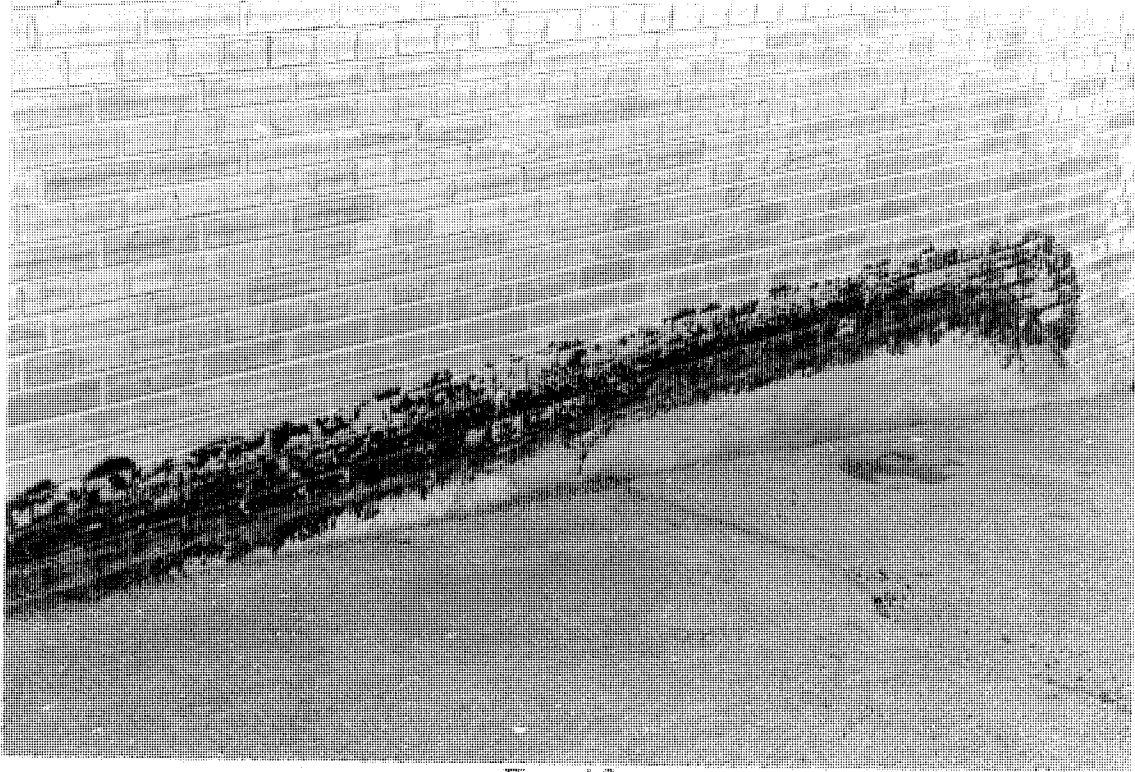
Figure 4-2

Location: North Elevation of Building 4 on West Pavilion

Cause of Problem: Poorly executed maintenance procedures

Suggested Remedy: Remove with solvent poultice (details are discussed in Chapter VIII. *Materials Cleaning Analysis*)

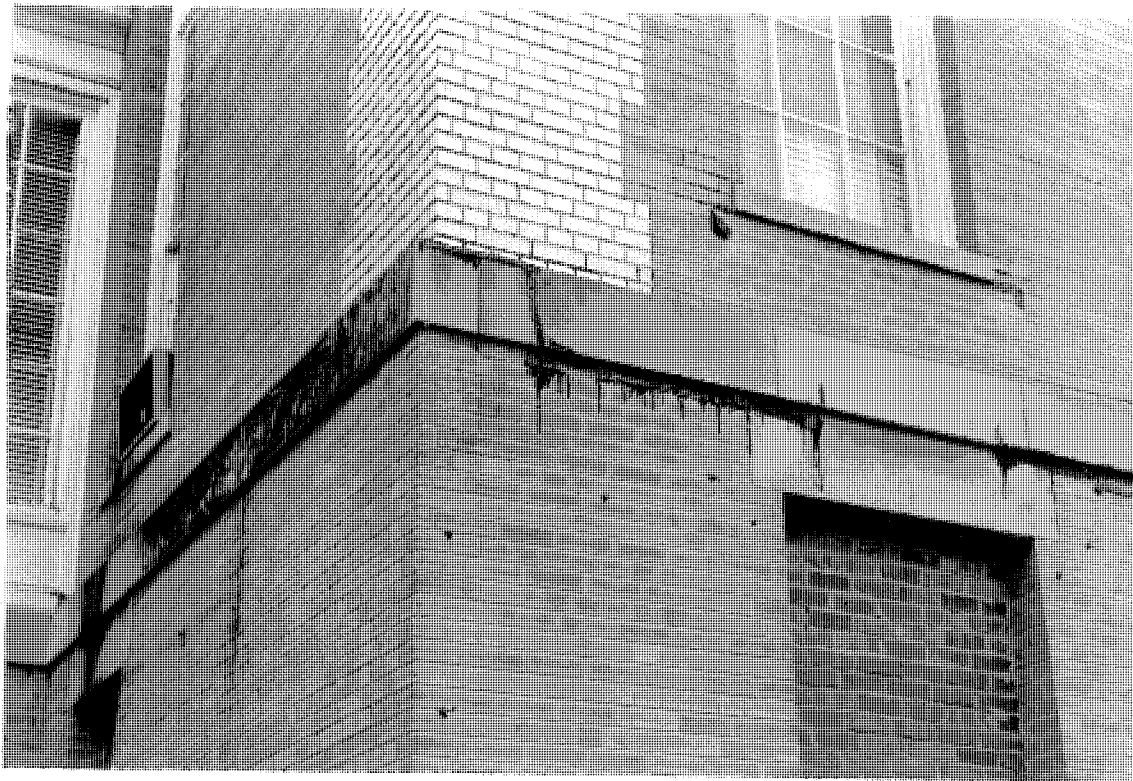
Figure 4-3

Location: South Elevation of Building 4 on East Pavilion

Cause of Problem: Poorly executed maintenance procedures

Suggested Remedy: Remove with solvent poultice (details are discussed in Chapter VIII. *Materials Cleaning Analysis*)

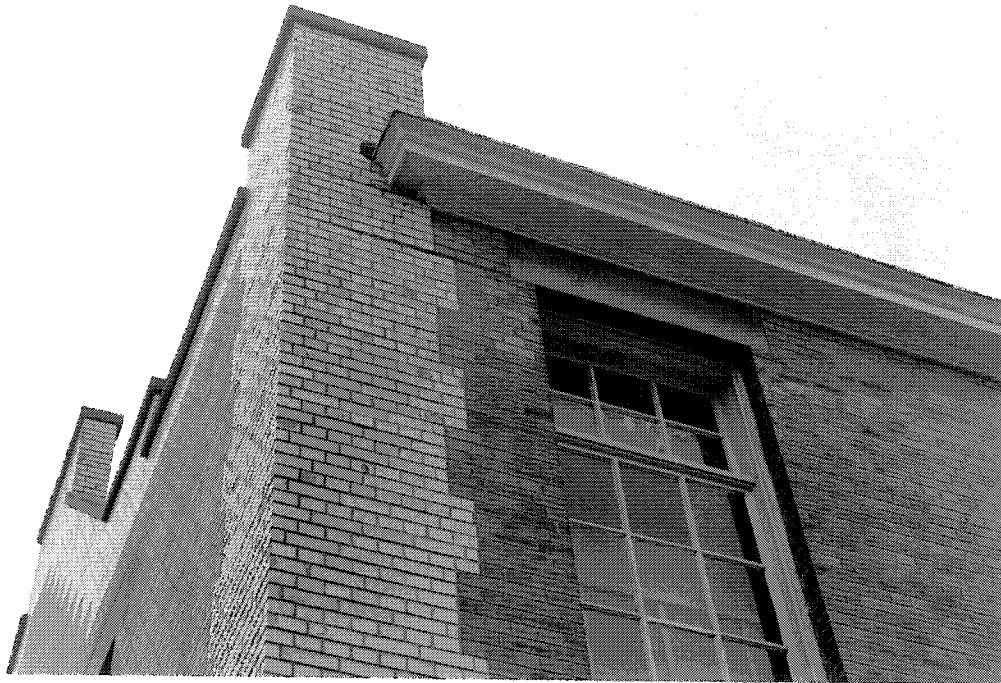
Figure 4-4

The white glazed brick, like the buff brick, is selectively damaged but to a much lesser extent (Figure 4-4). The areas of loss comprise about twenty percent of the total surface area of this brick.

Location: North Elevation of Building 4 on West Pavilion

Cause of Problem: Unknown but possibly freezing water or impact damage

Suggested Remedy: Replace with matching brick and mortar

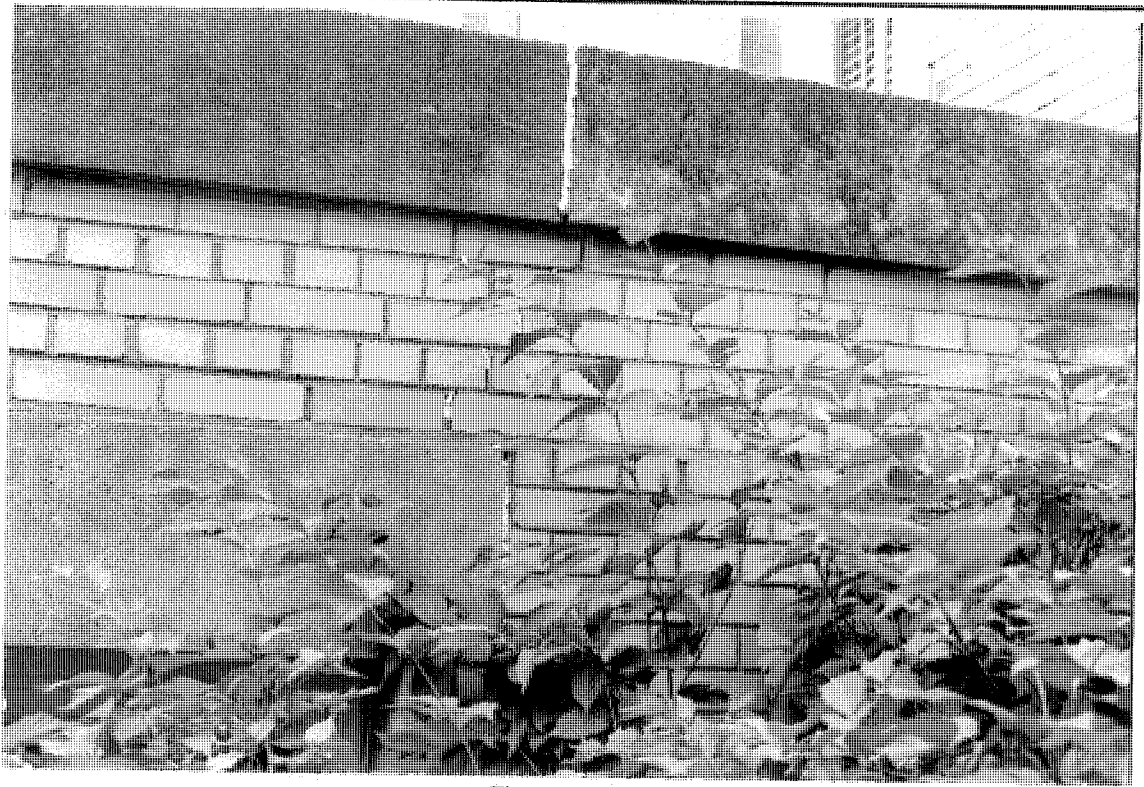
Figure 4-5

Stress cracks and open joints are found on Building 4 in association with the vertical or head joints of the limestone water table in the same way as on Building 3 (Figure 4-5).

Location: East Elevation of East Pavilion on Building 4

Cause of Problem: Freezing water in open joints and/or rusting of iron anchors

Suggested Remedy: Remove brickwork and assess for rusting iron anchors. If anchors are rusted they should be replaced with stainless steel anchors; brick should then be replaced to match existing texture, color and size and reset in mortar to match surrounding pointing in color, texture, and profile.

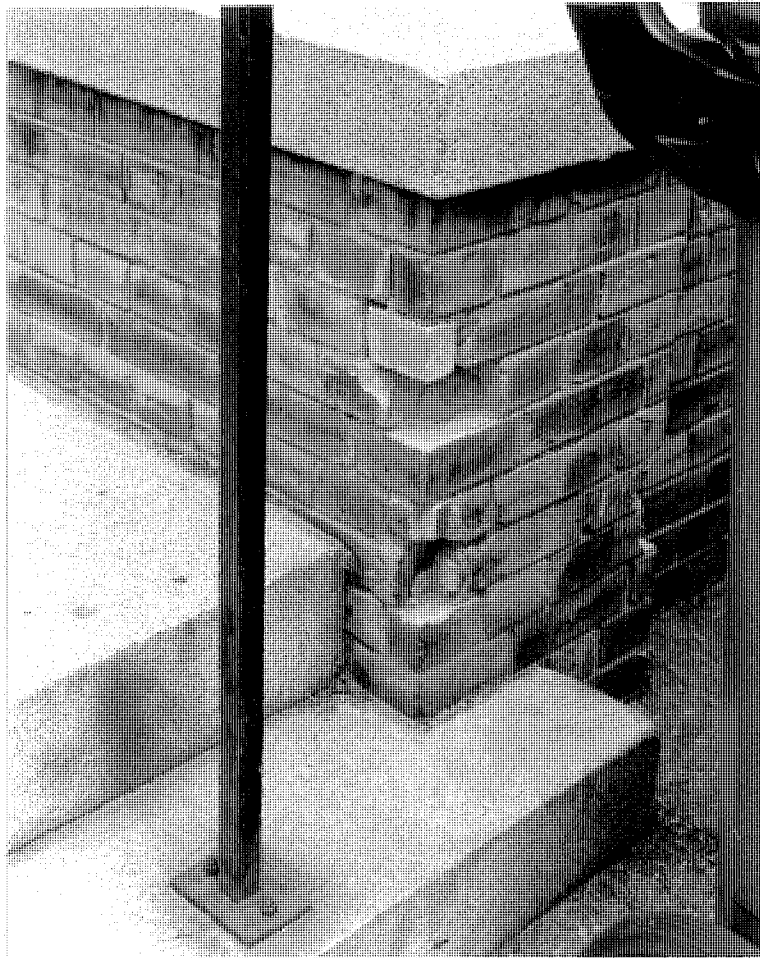
Figure 4-6

Brick has been dislodged and broken by impact at entryways (Figure 4-6).

Location: East Elevation of Building 3 on East Pavilion

Cause of Problem: Vehicular impact

Suggested Remedy: Remove damaged; brick should then be replaced to match existing texture, color and size and reset in mortar to match surrounding pointing in color, texture, and profile

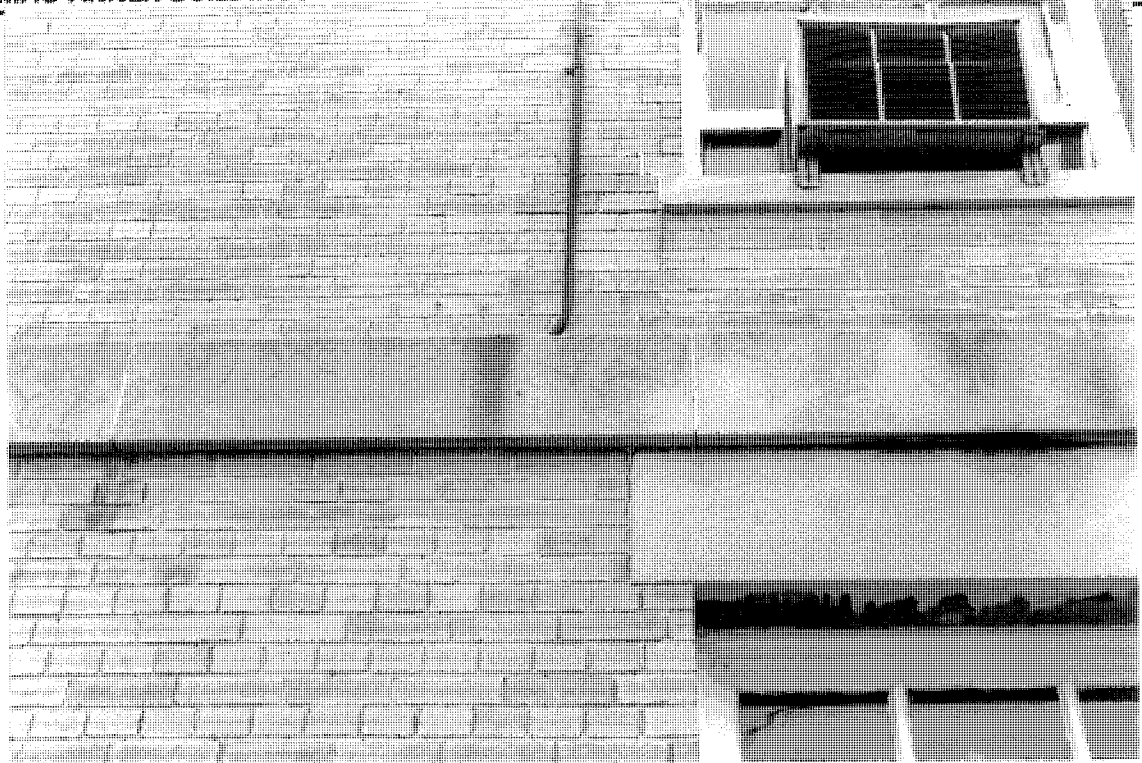
Figure 4-7

Location: North Elevation of Building 4 on West Pavilion

Cause of Problem: Atmospheric pollution

Suggested Remedy: Water misting cleaning (for details see Chapter VIII. *Materials Cleaning Analysis*)
