Potomac Annex: Buildings 1 & 3-7

Historic Structures Report, Corrected Final Submission
General Services Administration Project Control Number: 44007

September 9, 1997

BUILDING 1: EXTERIOR EXISTING CONDITIONS

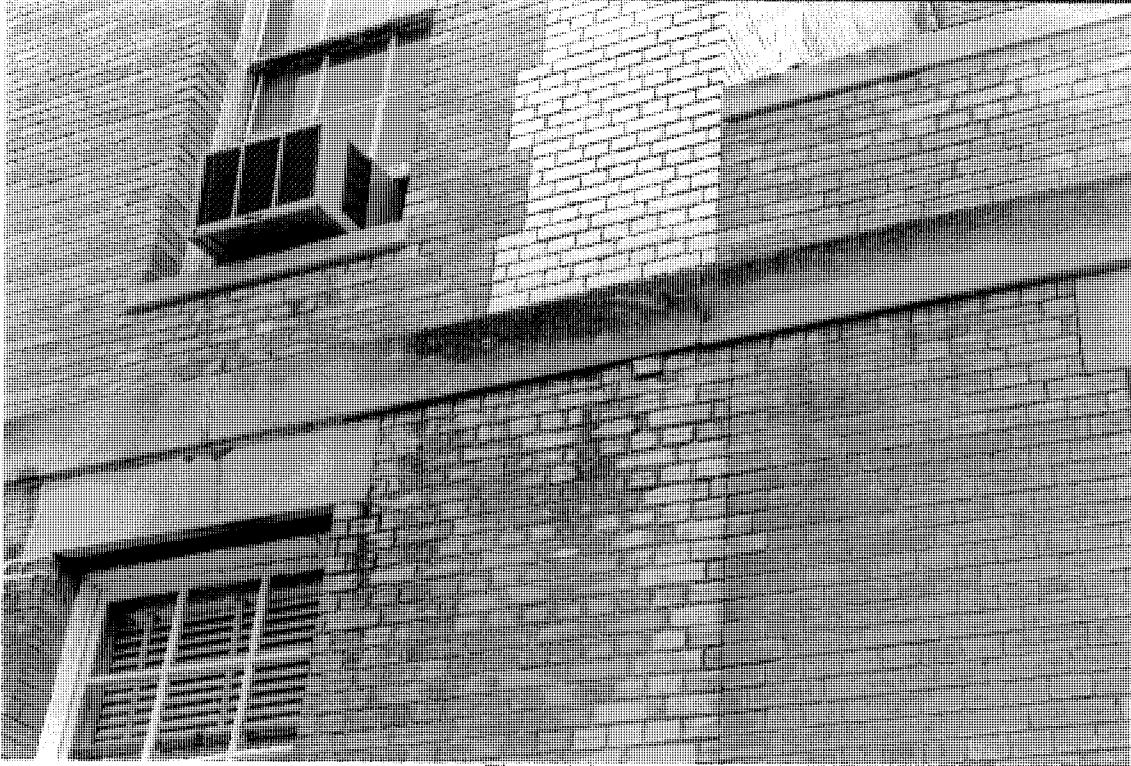
Figure 4-8

Limestone is used for capstones on the raked cornices, parapet walls, keystones and some window lintels, sills and belt courses (or water tables) on Building 4. All of these limestone elements shows signs of loss, but do not suffer from active granular disintegration or stress cracking. The light build up of gypsum and flyash appears to be confined to the window lintels and keystones and sills (Figure 4-7). The head joints in the water table and the joints of most of the limestone elements are open or have been repointed with visually or physically incompatible materials. Limestone elements are often soiled with biological growth (Figure 4-8).

Location: West Elevation of Building 4

Cause of Problem: Slow drying and overhanging trees

Suggested Remedy: Clean with power wash and detergent (for details see Chapter VIII. *Materials Cleaning Analysis*)

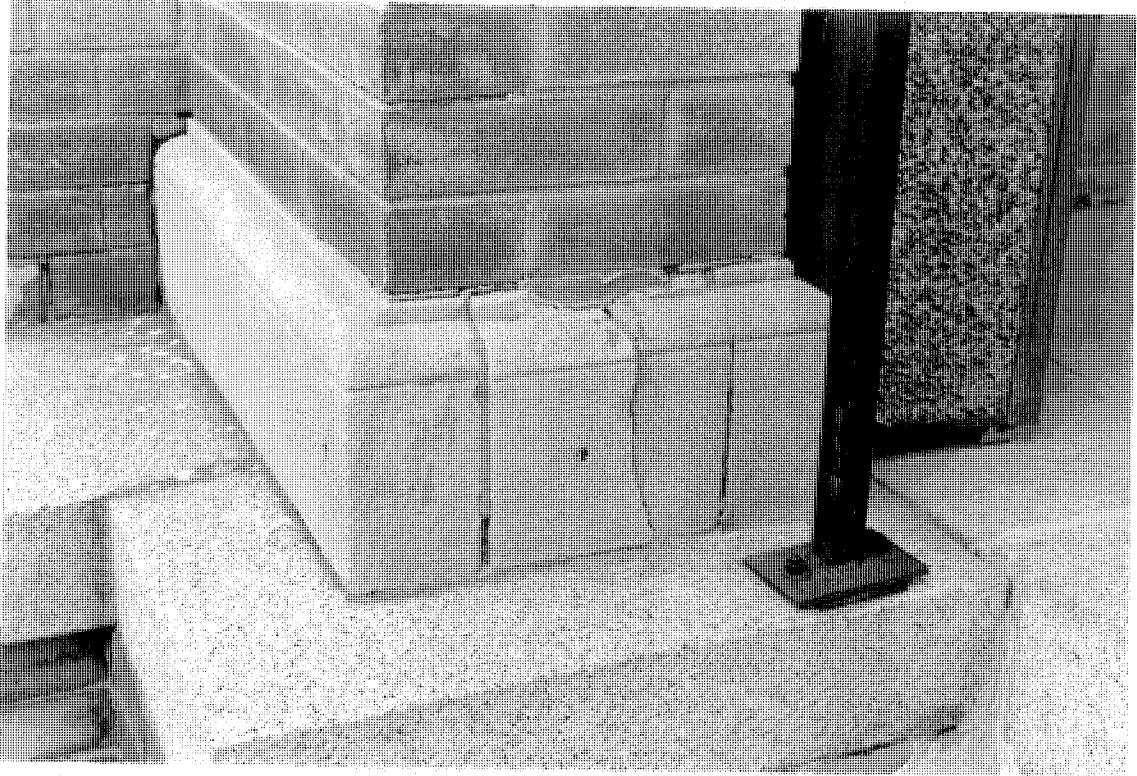
Figure 4-9

Damage has occurred to limestone elements both by impact from vehicles and by corrosion of iron anchors (Figures 4-9, 4-10, 4-11, 4-12). (Vehicular impact has also displaced granite capstones and corrosion has also cracked some nearby bricks.) Some previous repairs to limestone are unsightly (Figure 4-13).

Location: West Elevation of Building 4 on South Portico

Cause of Problem: Impact damage or corrosion of iron anchors

Suggested Remedy: Remove damaged limestone and assess anchors; replace with stainless steel if corroded and replace limestone with dutchman

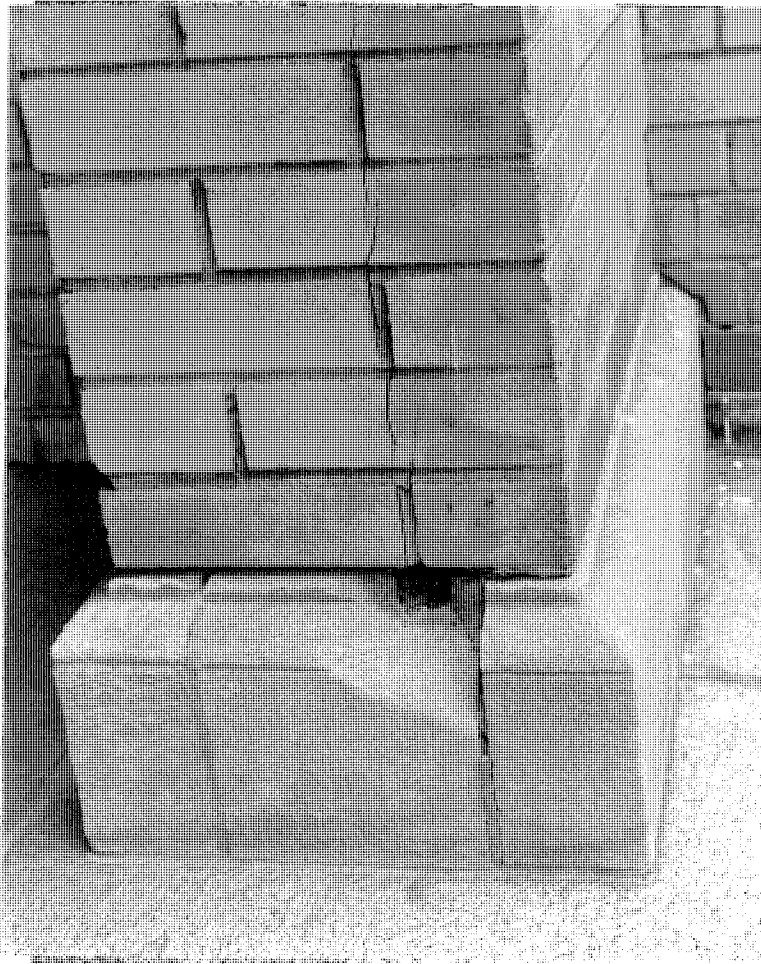
Figure 4-10

Location: South Elevation of Building 4 on South Portico

Cause of Problem: Corrosion of iron anchors

Suggested Remedy: Replace anchors with stainless steel and replace limestone with dutchman

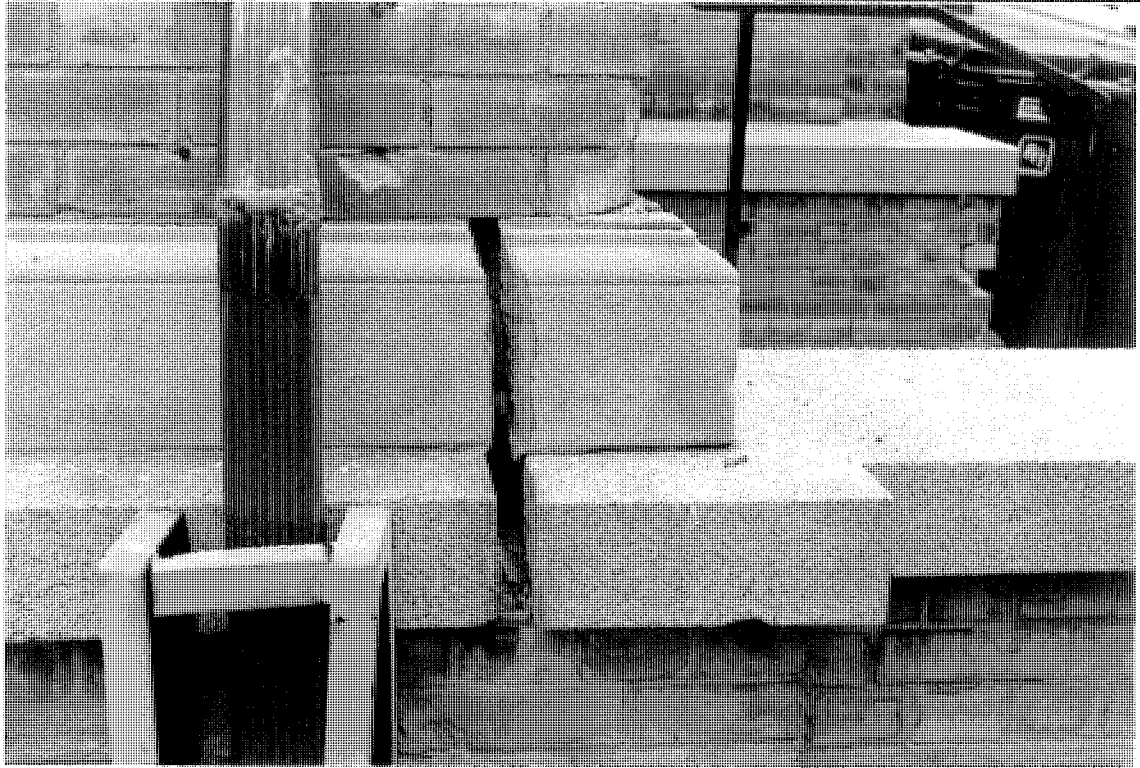
Figure 4-11

Location: South Elevation of Building 4 on South Portico

Cause of Problem: Vehicular impact

Suggested Remedy: Replace limestone with dutchman

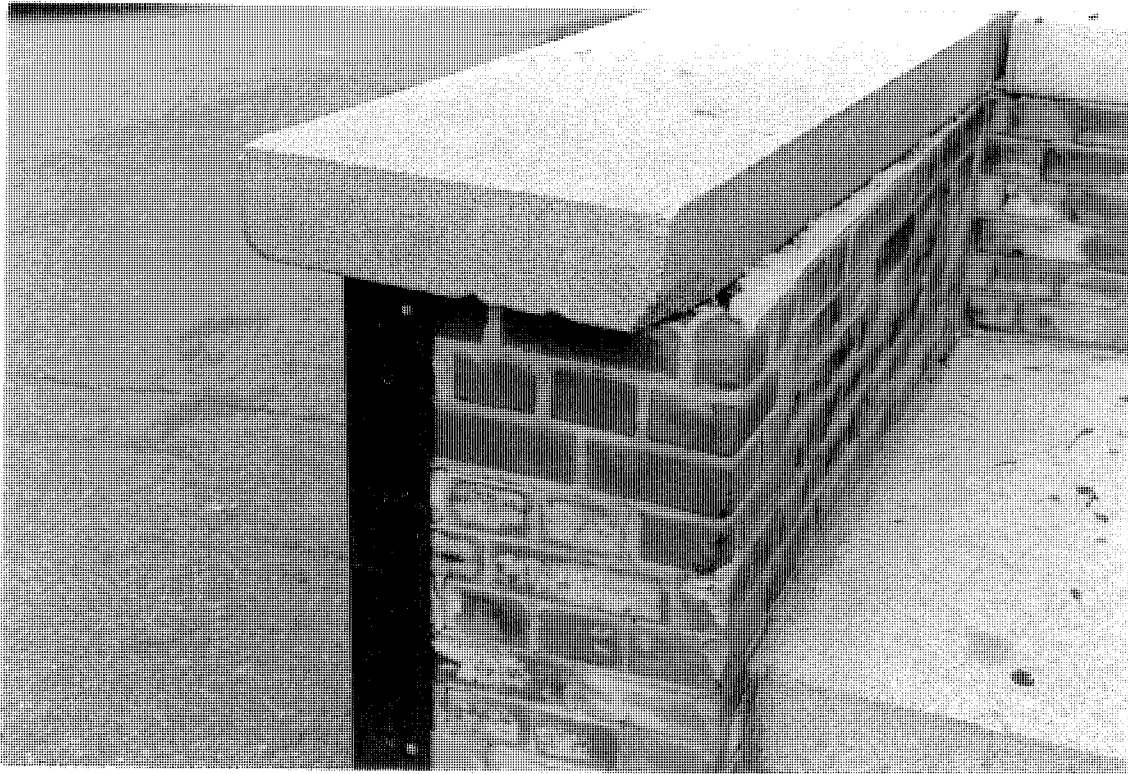
Figure 4-12

Location: South Elevation of Building 4 on South Portico

Cause of Problem: Vehicular impact

Suggested Remedy: Reset and re-anchor granite

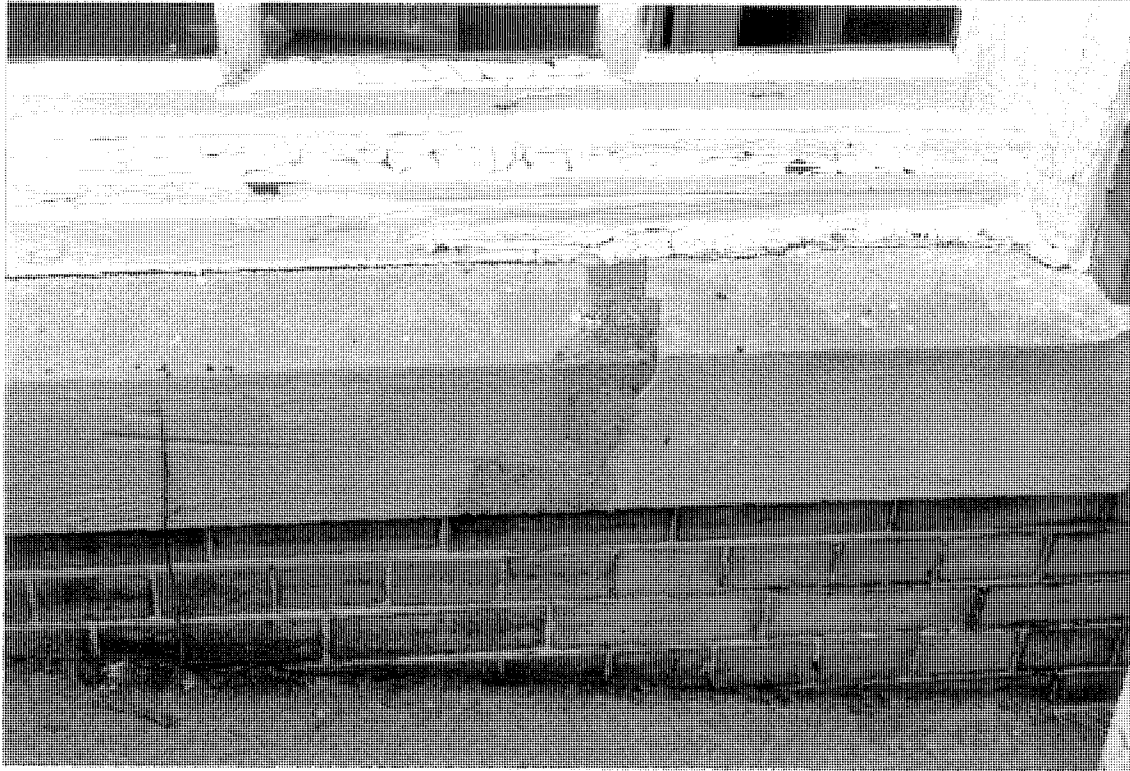
Figure 4-13

Location: West Elevation of Breezeway between Buildings 3 and 4

Cause of Problem: Improper choice of materials

Suggested Remedy: Remove and replace with better matching patching mortar

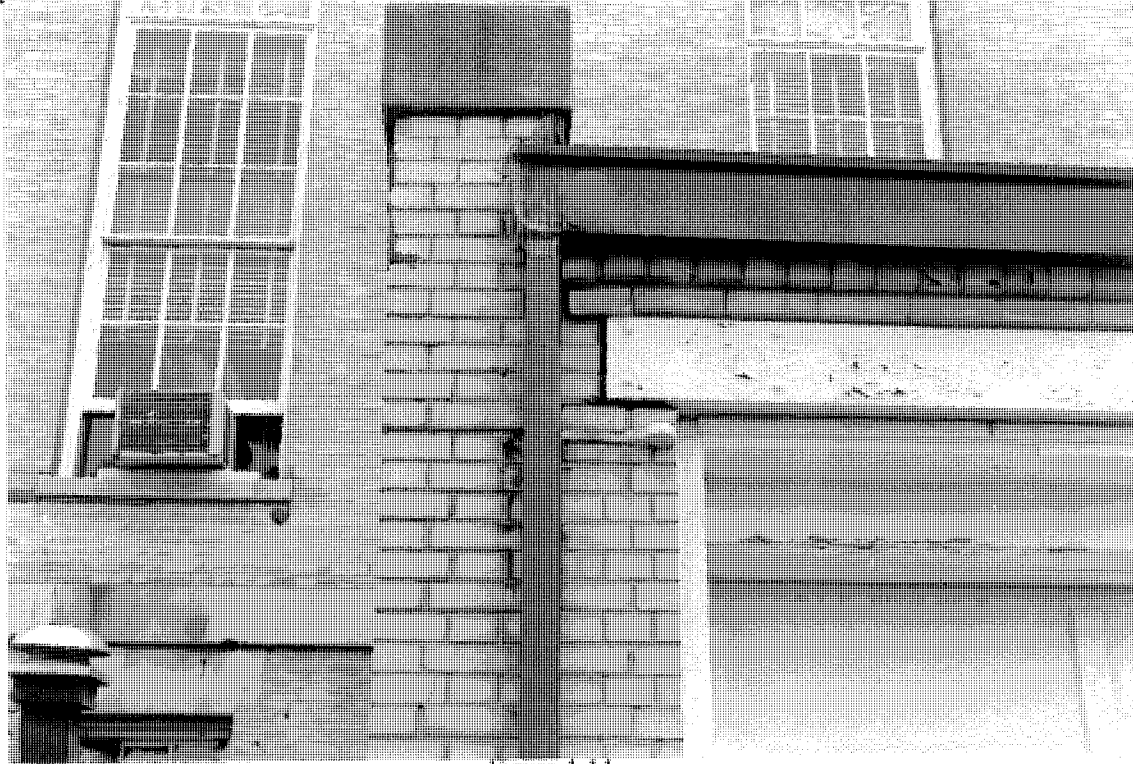
Figure 4-14

Copper leaders are generally in good condition, but there are some blockages associated with damaged brickwork (Figures 4-14 and 4-15).

Location: South Elevation of Building 4 on Garage of East Pavilion

Cause of Problem: Water infiltration from poorly functioning gutter and leader

Suggested Remedy: Clear gutters and leaders; reset brick with proper mortar

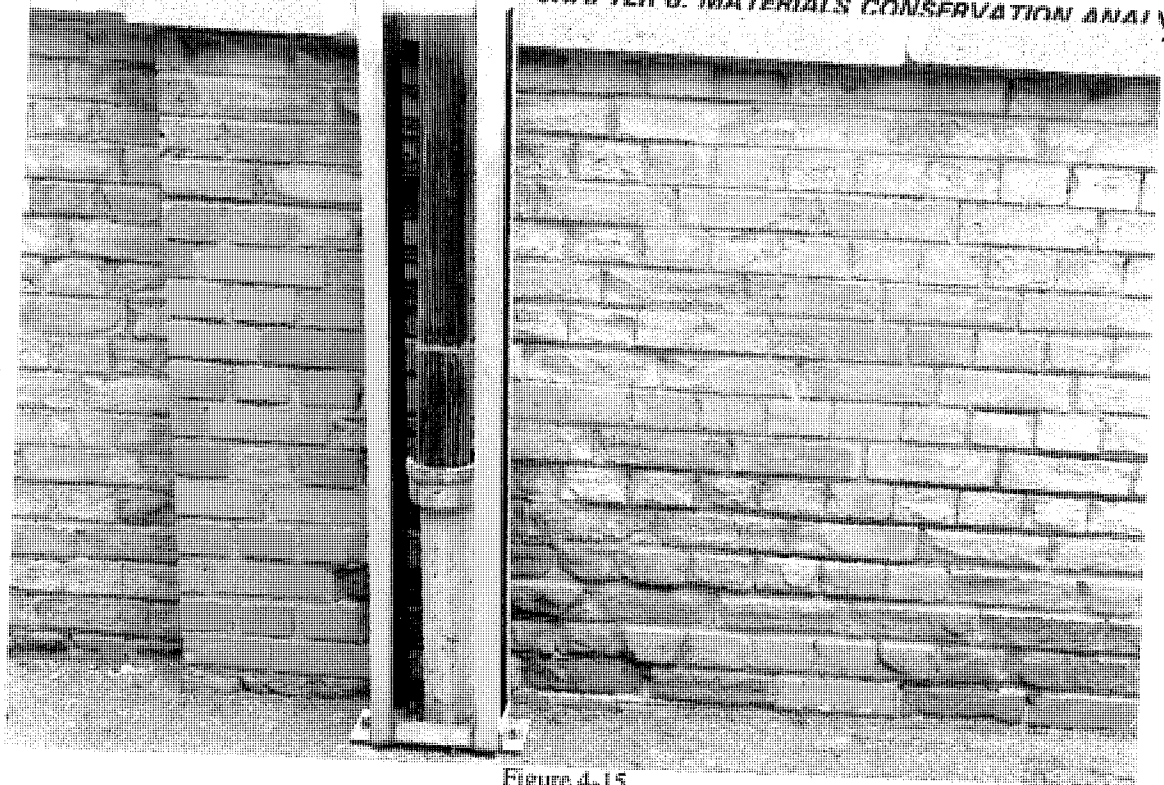
Figure 4-15

Location: South Elevation of Building 4 on South Portico

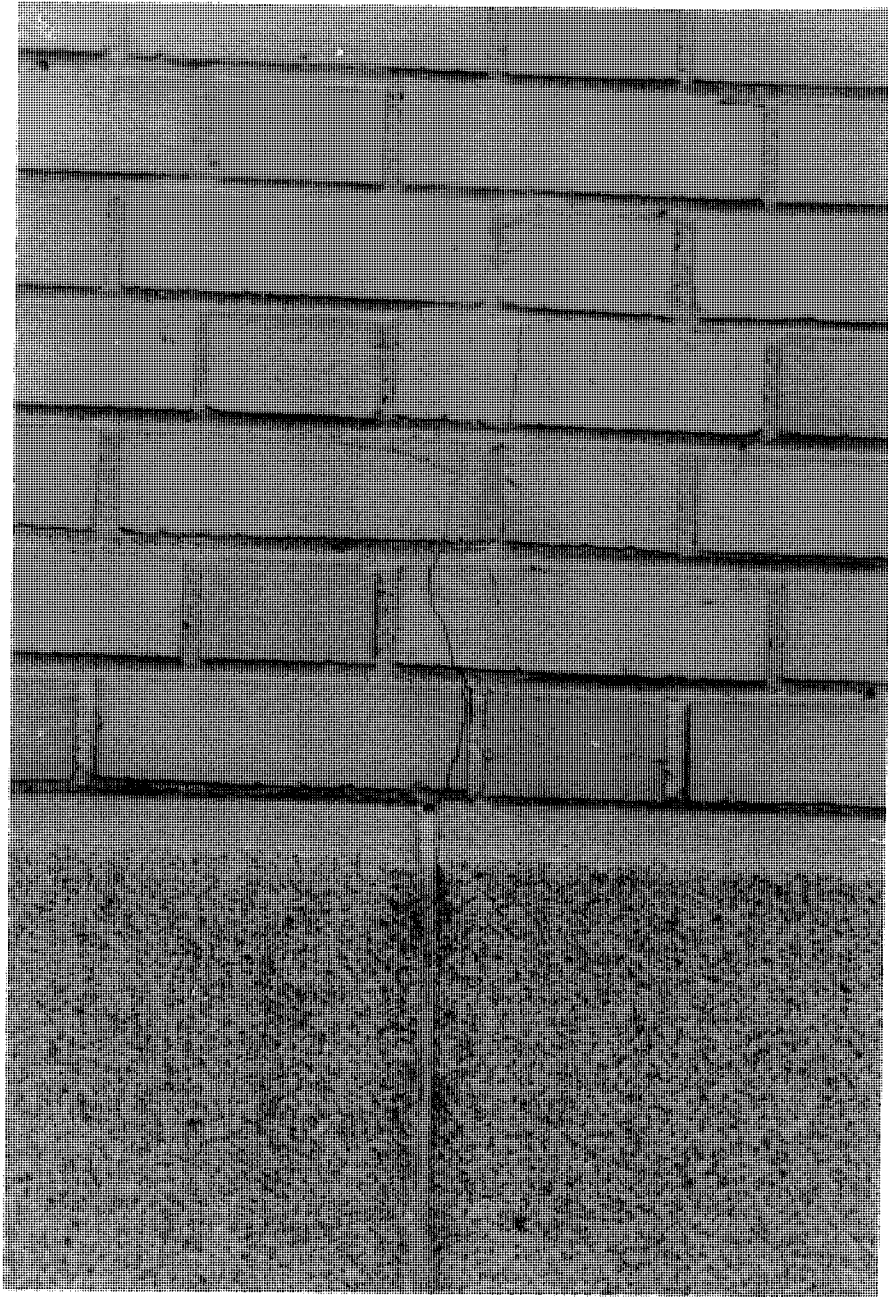
Figure 5-1

Location: North Elevation of Building 5 near West End

Problem: Stress cracks in brick and open mortar joints

Cause of Problem: Freezing water in open joints of water table and/or rusting iron anchors in window lintels and sills.

Suggested Remedy: Remove brickwork and assess for rusting iron anchors. If anchors are rusted they should be replaced with stainless steel anchors; brick should then be replaced to match existing texture, color and size and reset in mortar to match surrounding pointing in color, texture, and profile.

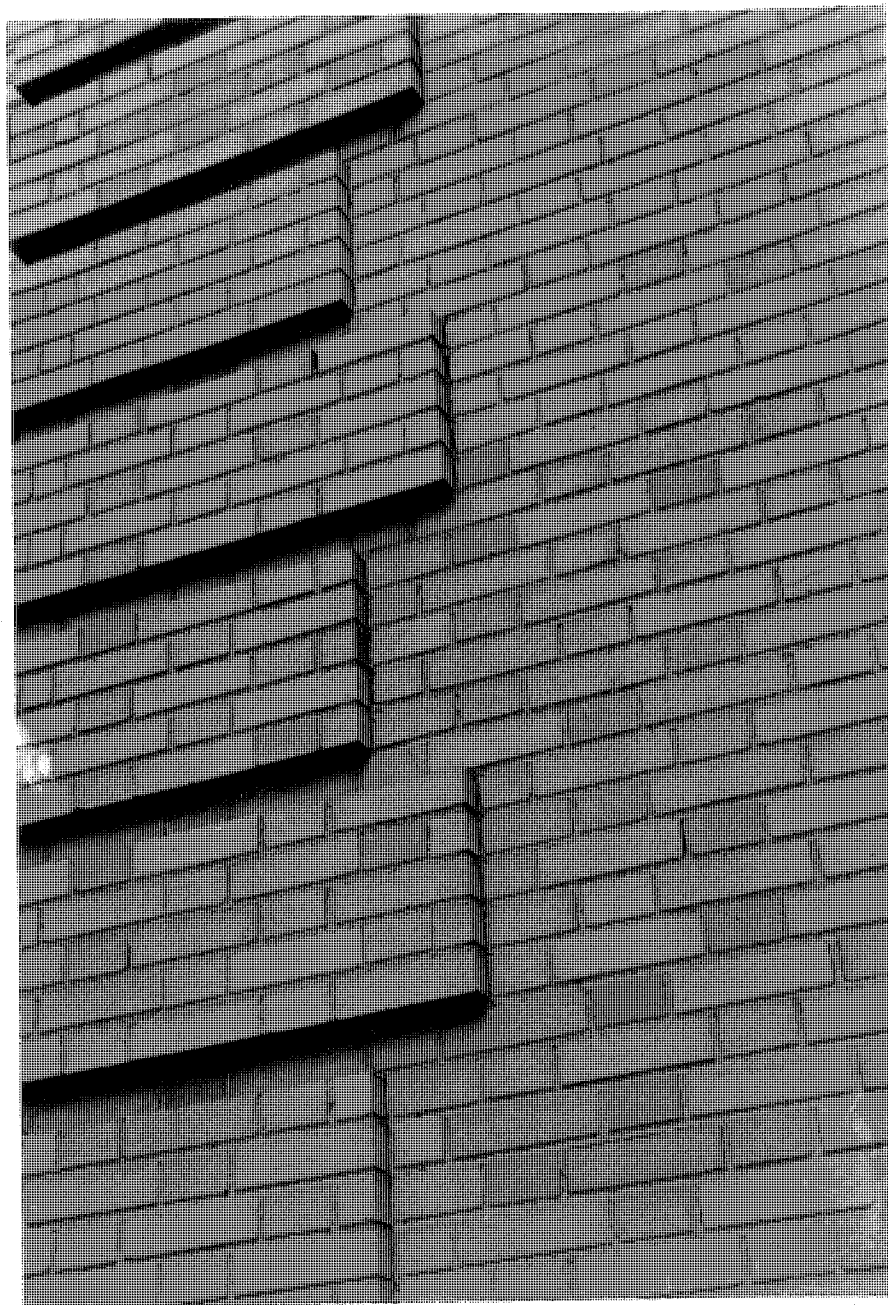
Figure 5-2

Location: East Elevation of Building 5 near South End

Cause of Problem: Freezing water in joints

Suggested Remedy: cut and point joints

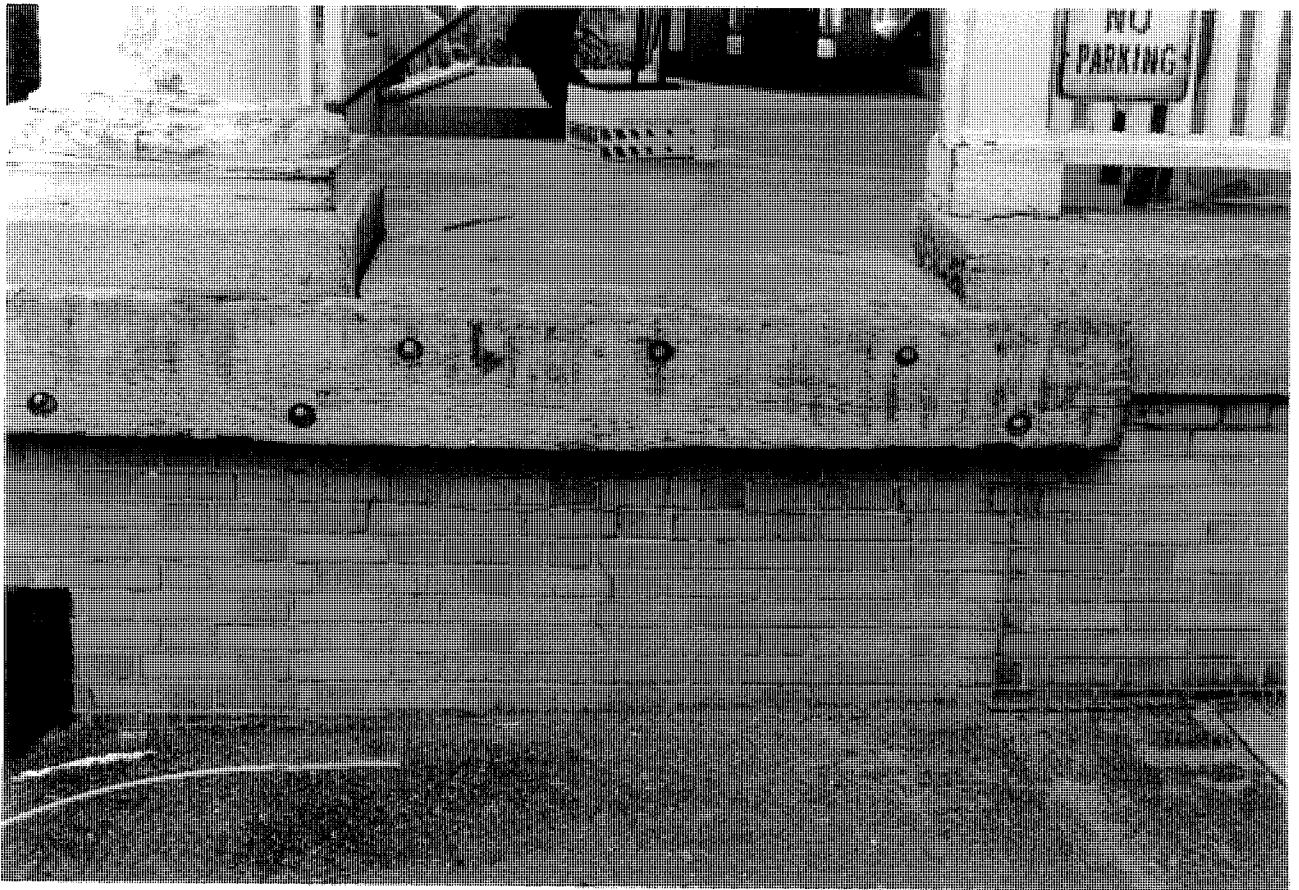
Figure 5-3

Location: North Elevation of Building 5 at West End of Porch

Problem: Open mortar joints and stress cracks in brick

Cause of Problem: Freezing water in joints; impact damage

Suggested Remedy: Brick should be removed and then replaced to match existing texture, color and size and reset in mortar to match surrounding pointing in color, texture, and profile

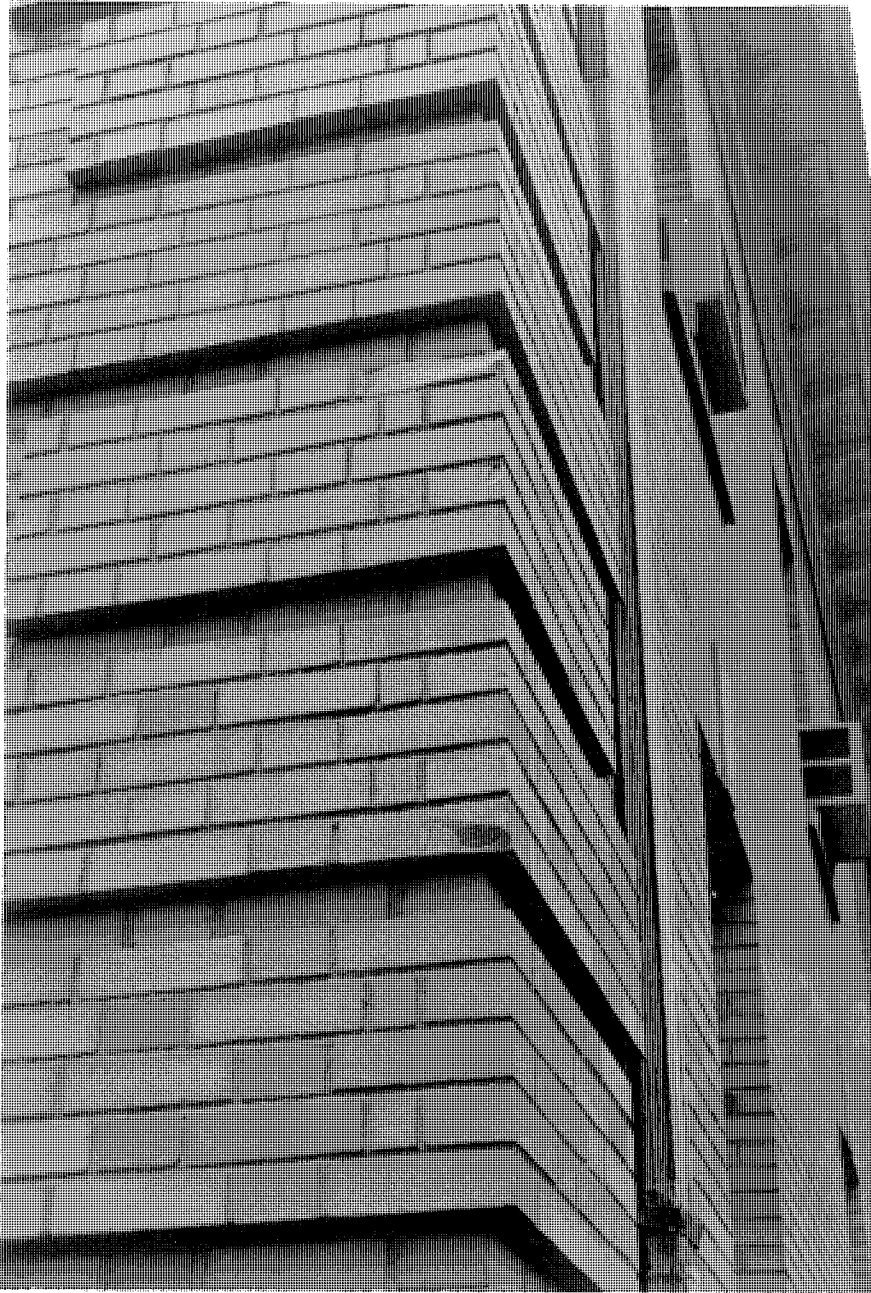
Figure 5-4

Location: Northwest Corner of Building 5

Problem: Damage brick

Cause of Problem: Unknown but perhaps impact damage

Suggested Remedy: Brick should be removed and then replaced to match existing texture, color and size and reset in mortar to match surrounding pointing in color, texture, and profile

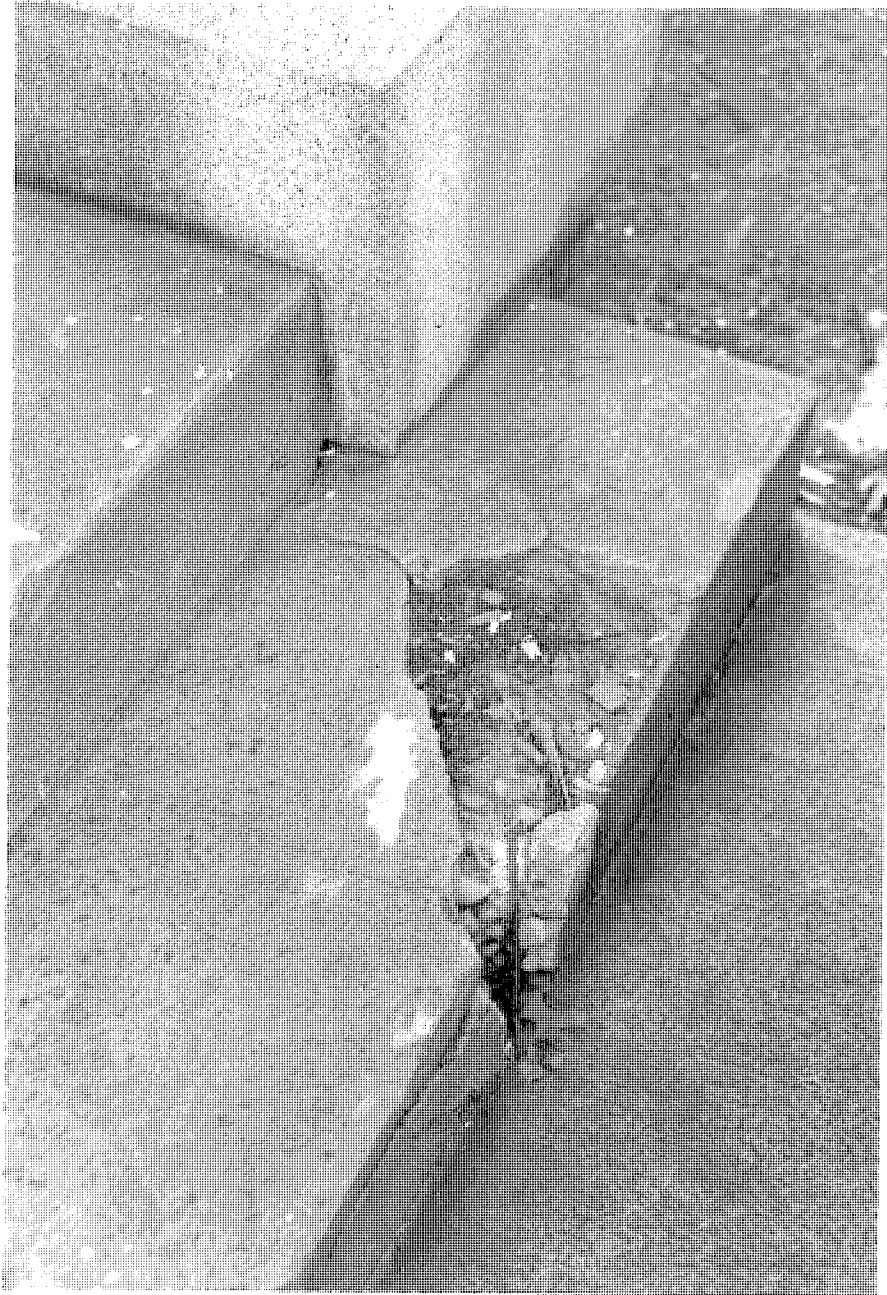
Figure 5-5

Location: West Elevation of Building 5 at Central Entryway

Problem: Damaged concrete

Cause of Problem: Water penetration and freezing

Suggested Remedy: Demolish and rebuild

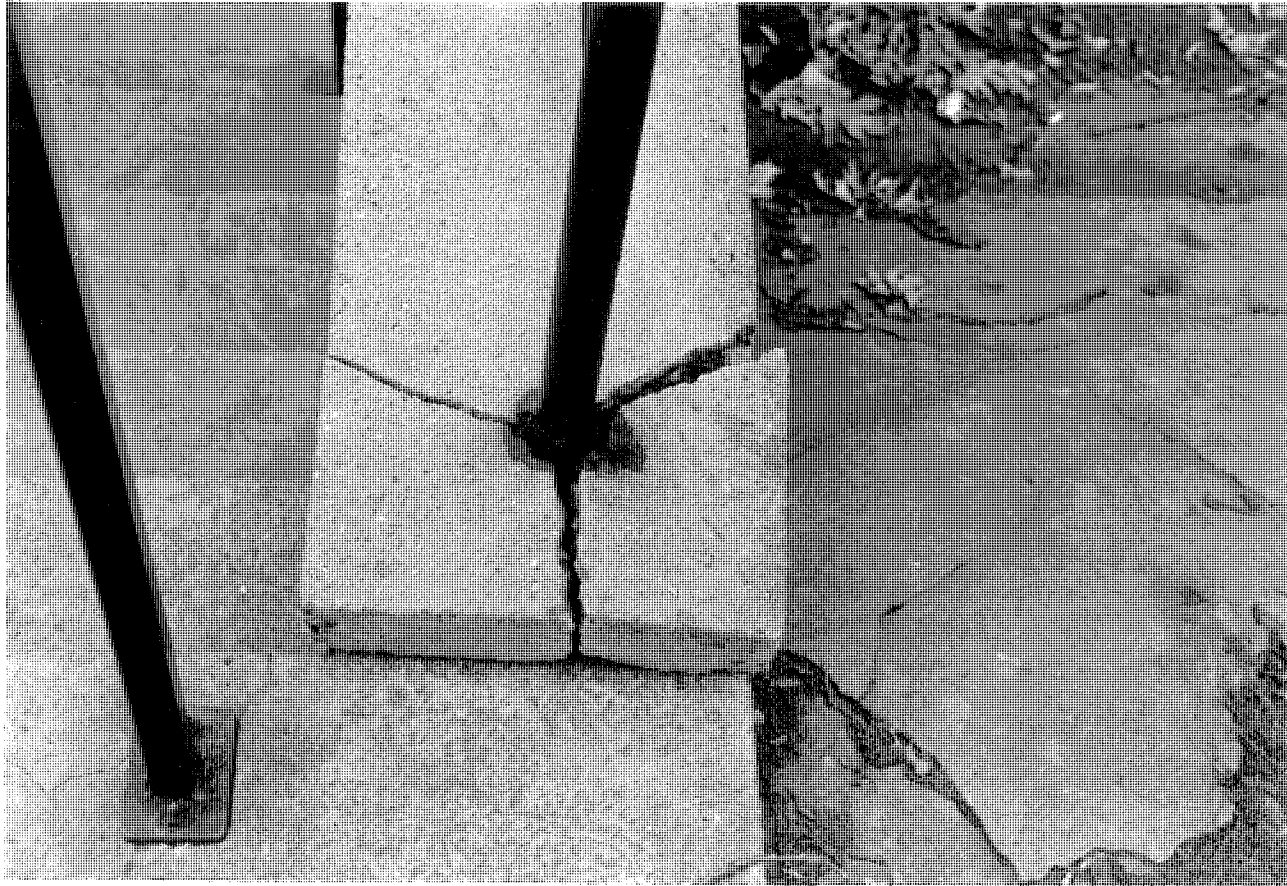
Figure 5-6

Location: West Elevation of Building 5 at Steps to Areaway

Problem: Damaged concrete

Cause of Problem: Water penetration and freezing; rusting of iron railings

Suggested Remedy: Demolish and rebuild

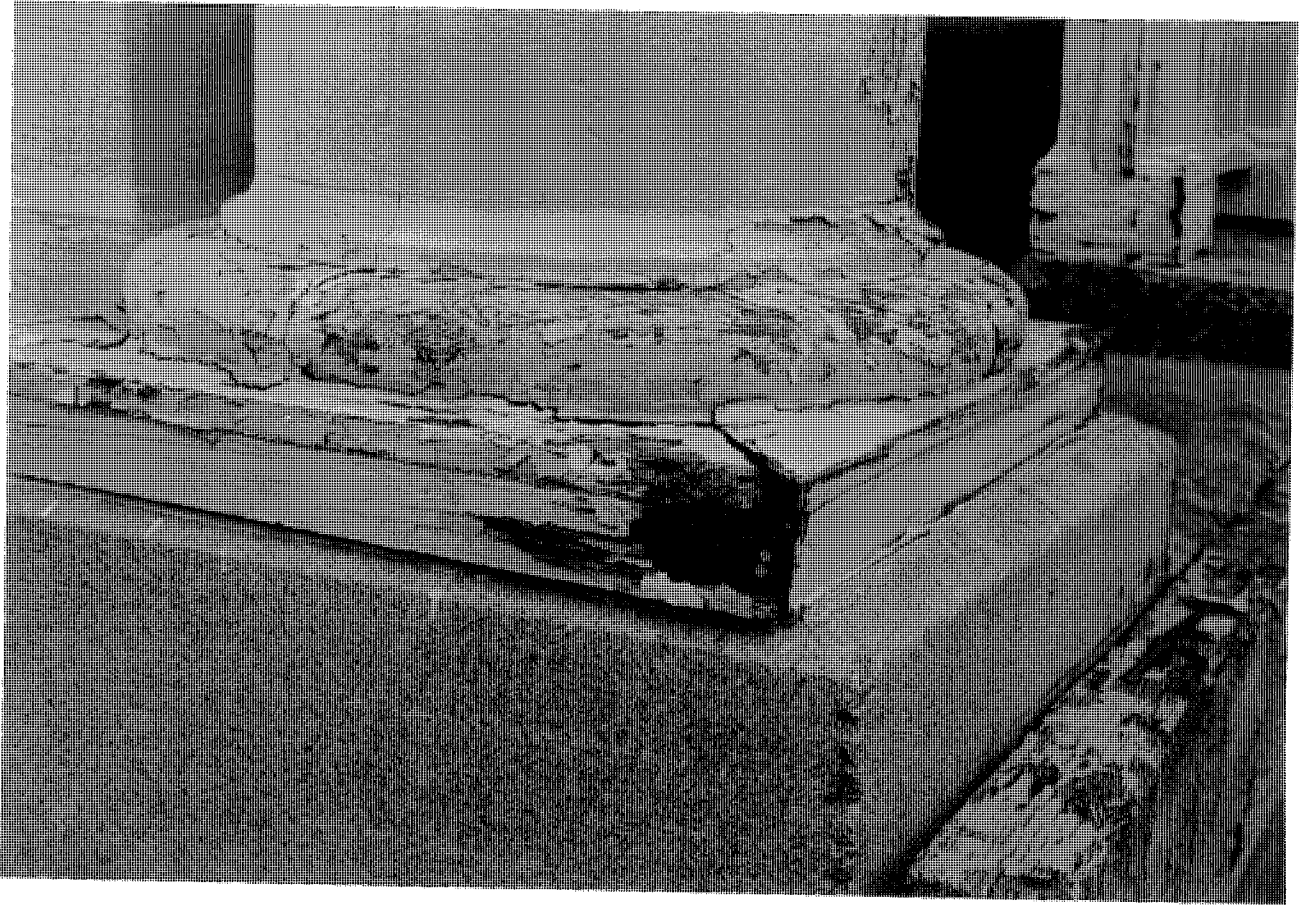
Figure 5-7

Location: North Elevation of Building 5 at Westernmost Column of Portico

Problem: Damaged wooden base

Cause of Problem: Water penetration and poor maintenance

Suggested Remedy: Remove rotted wood and replace with new elements

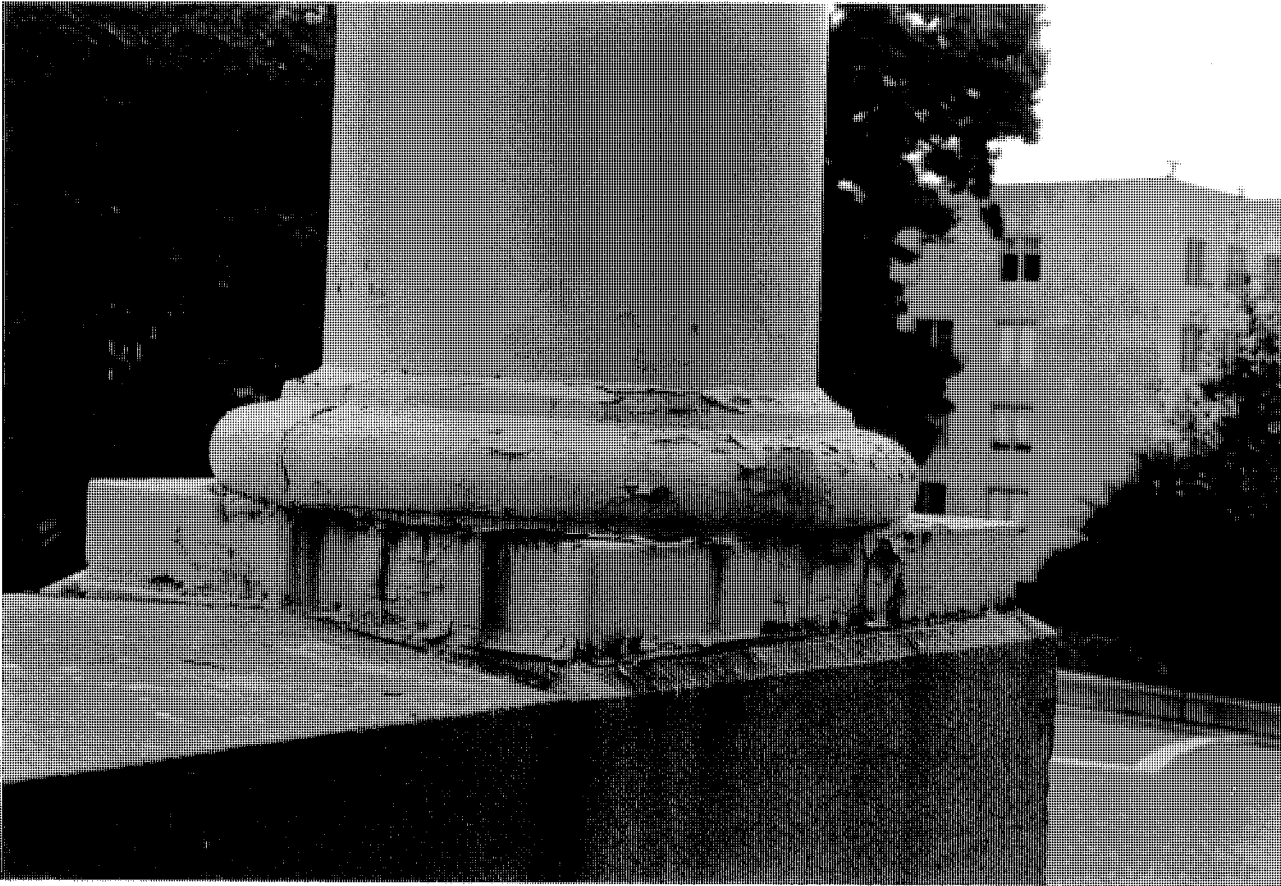
Figure 5-8

Location: North Elevation of Building 5 at Easternmost Column of Portico

Problem: Rusting of column leading to staining of granite

Cause of Problem: Water penetration of paint film and poor maintenance of paint

Suggested Remedy: Scrape and repaint column; poultice iron stain with chelating agent

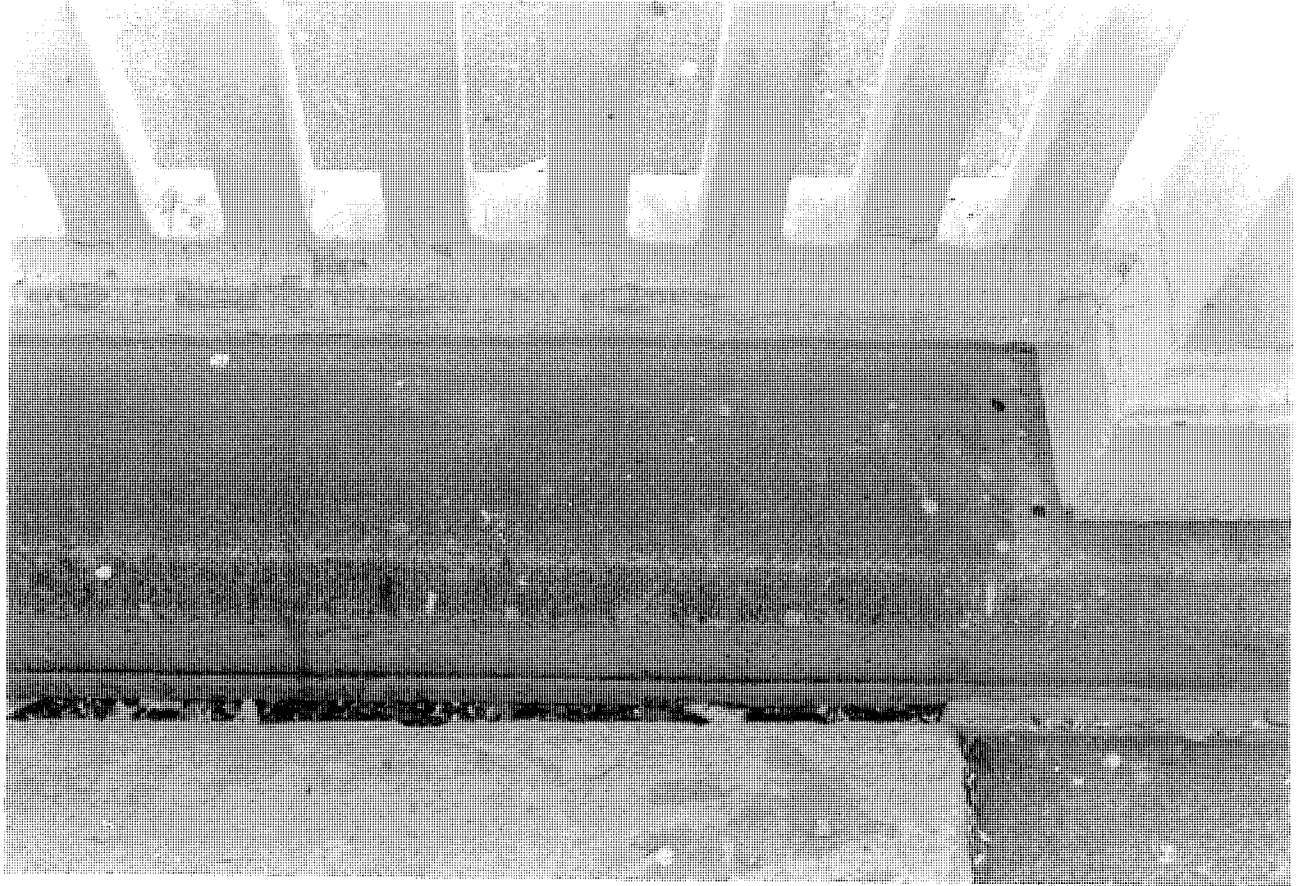
Figure 5-9

Location: North Elevation of Building 5 at Portico Balustrade

Cause of Problem: Atmospheric pollution

Suggested Remedy: Chemical cleaning (see Chapter VIII. Materials Cleaning Analysis for details)

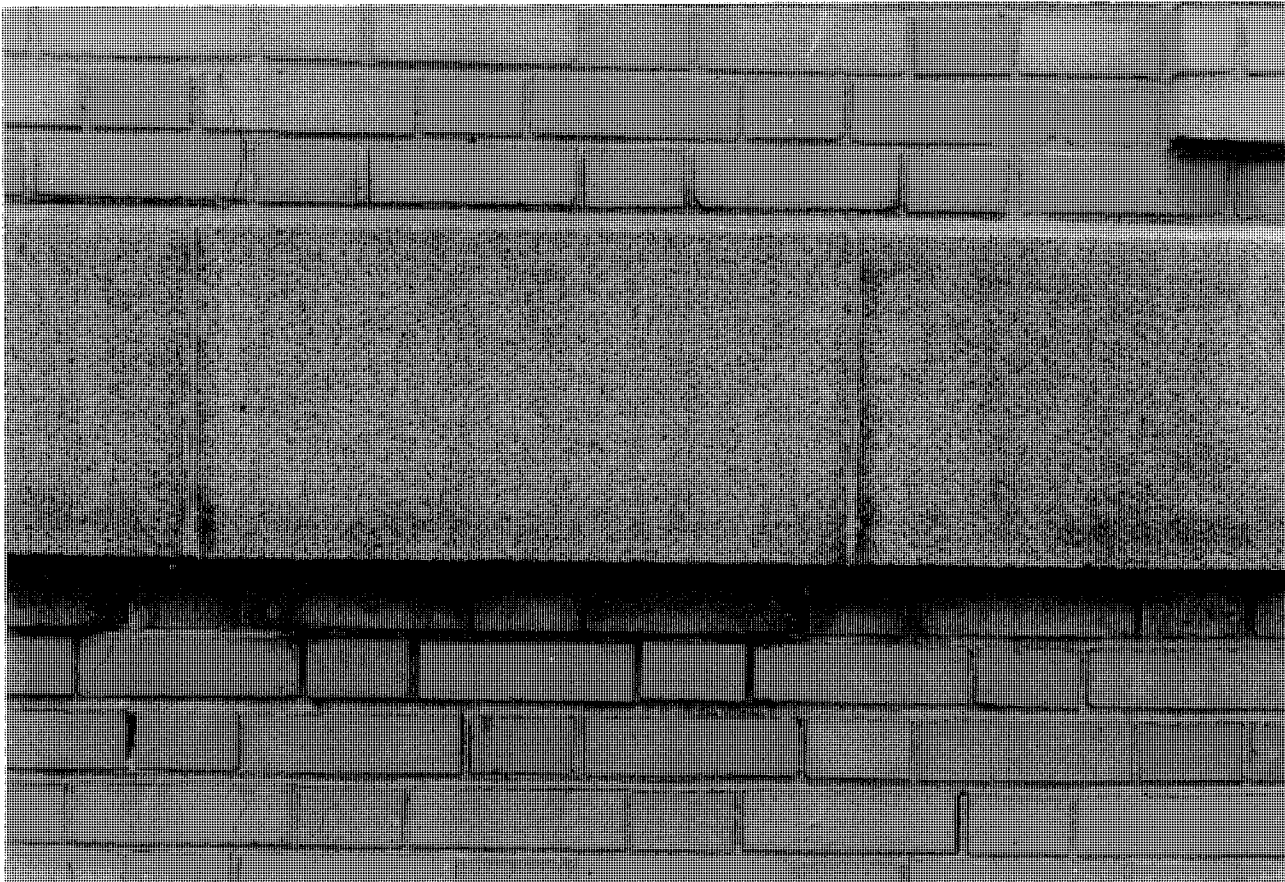
Figure 5-10

Location: North Elevation of Building 5 at West End

Cause of Problem: Susceptibility of vertical joints to water run-off; improper maintenance procedures

Suggested Remedy: Cut and point (see Chapter VII. Mortar Analysis for a discussion of replacement mortar)

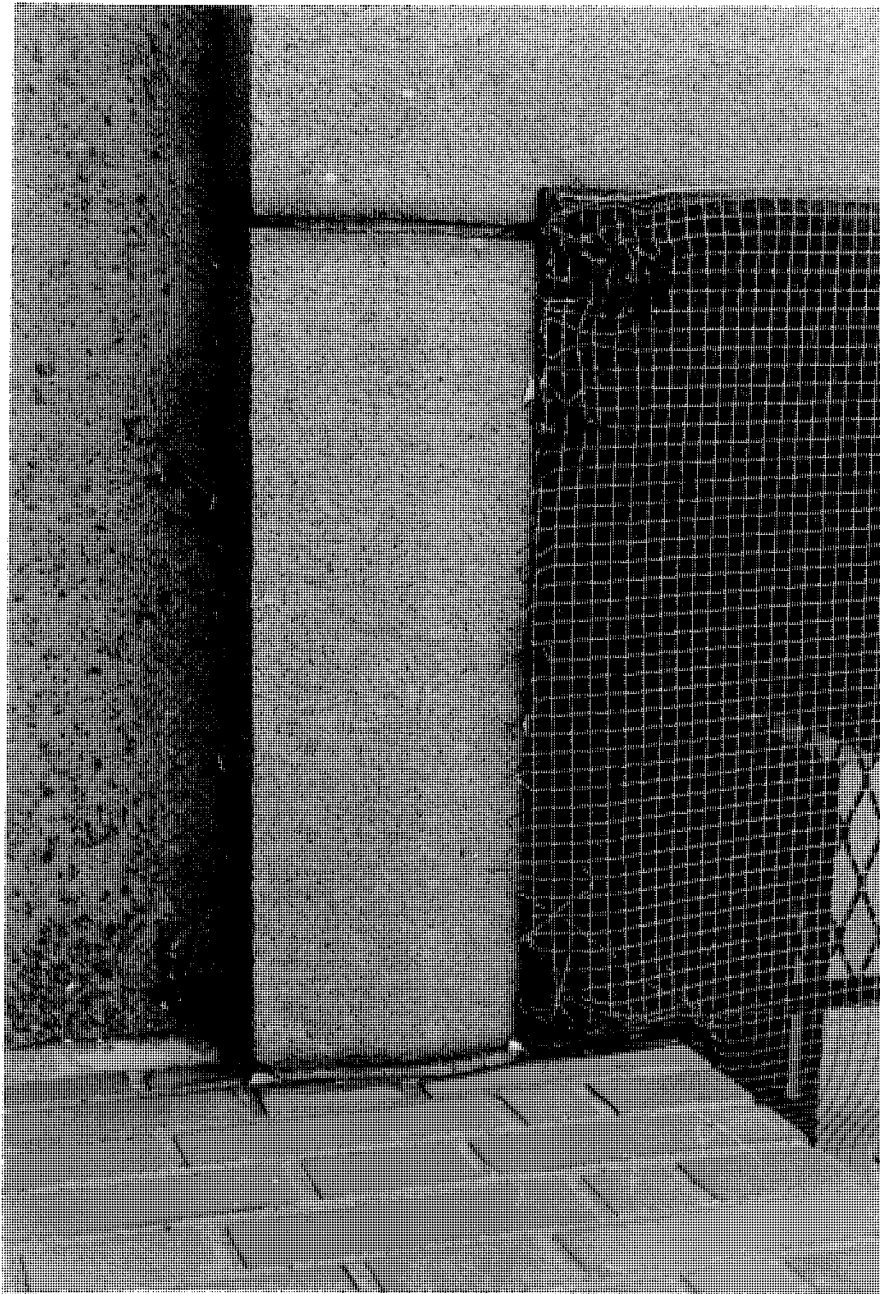
Figure 5-11

Location: West Elevation of Building 5 at North End

Cause of Problem: Susceptibility of vertical joints to water run-off; improper maintenance procedures

Suggested Remedy: Cut and point (see Chapter VII. Mortar Analysis for a discussion of replacement mortar)

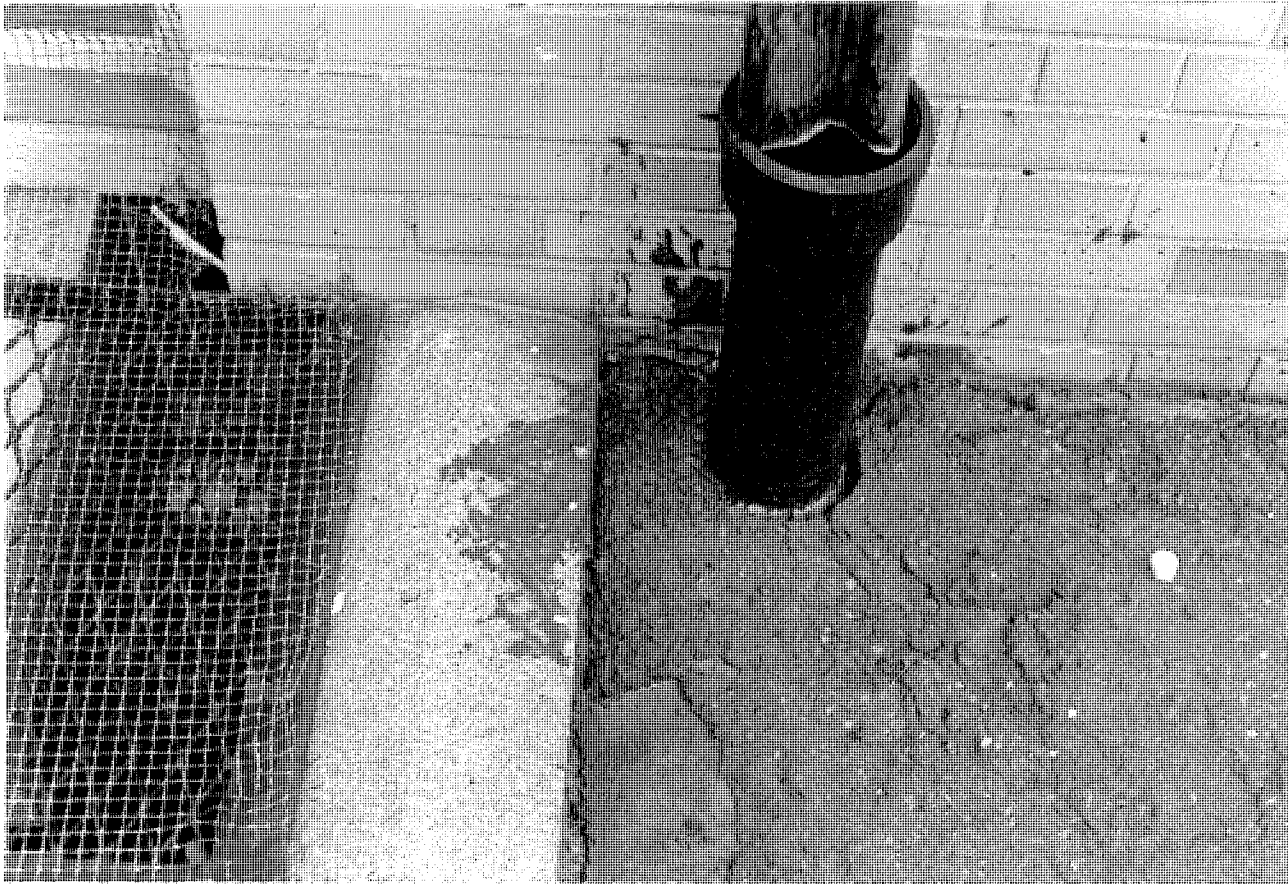
Figure 5-12

Location: West Elevation of Building 5 at North End

Cause of Problem: Sloppy application of waterproofing material for drain

Suggested Remedy: Poultice cleaning with solvent (see Chapter VIII. Materials Cleaning Analysis for details of treatment)
