Potomac Annex: Buildings 1 & 3-7

Historic Structures Report, Corrected Final Submission
General Services Administration Project Control Number: 44007

September 9, 1997

BUILDING 1: EXTERIOR EXISTING CONDITIONS

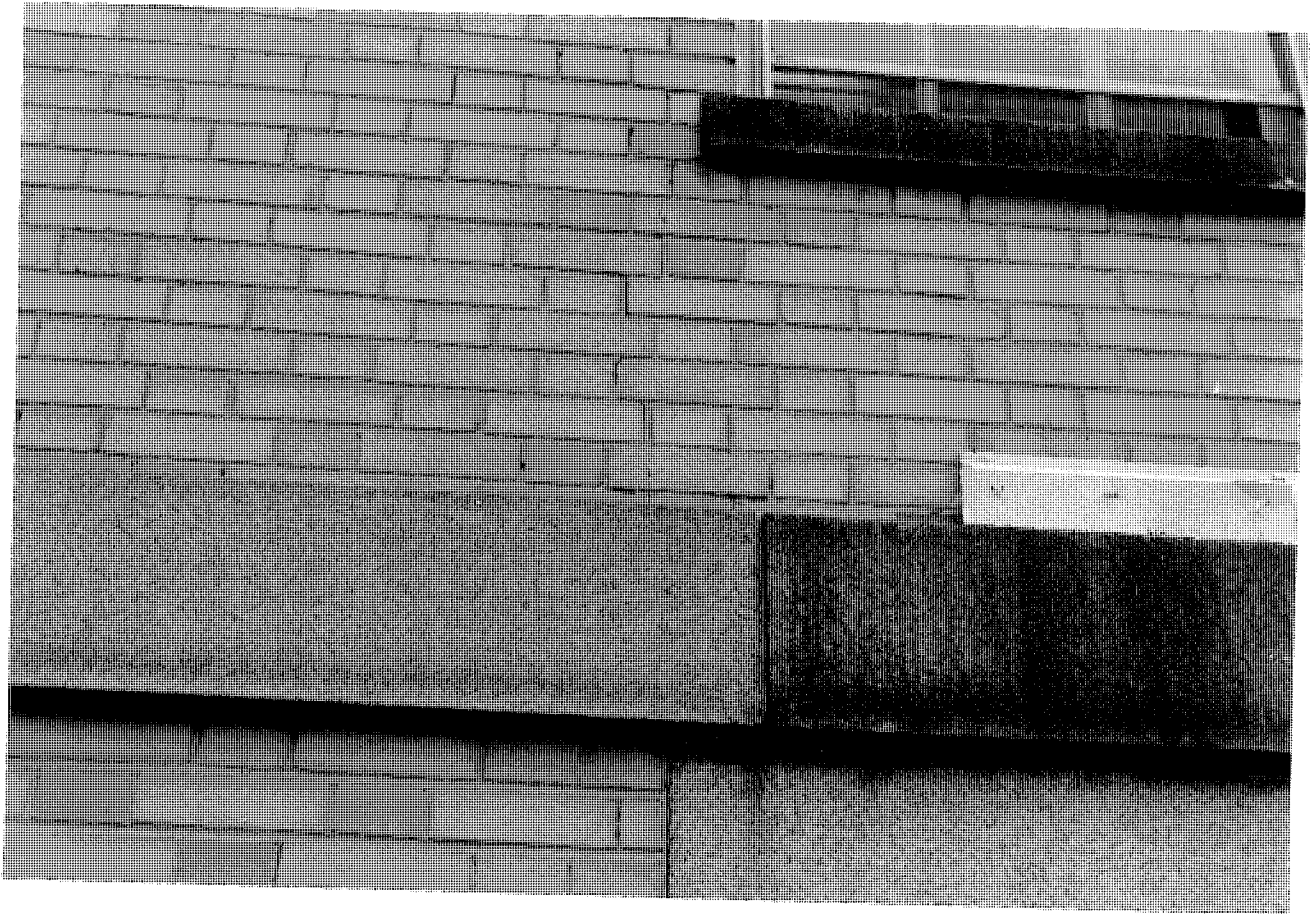
Figure 6-1

Location: North Elevation of Building 6 at West End

Problem: Stress cracks and open mortar joints

Cause of Problem: Freezing water in open joints of water table and/or rusting iron anchors in window lintels and sills.

Suggested Remedy: Remove brickwork and assess for rusting iron anchors. If anchors are rusted they should be replaced with stainless steel anchors; brick should then be replaced to match existing texture, color and size and reset in mortar to match surrounding pointing in color, texture, and profile

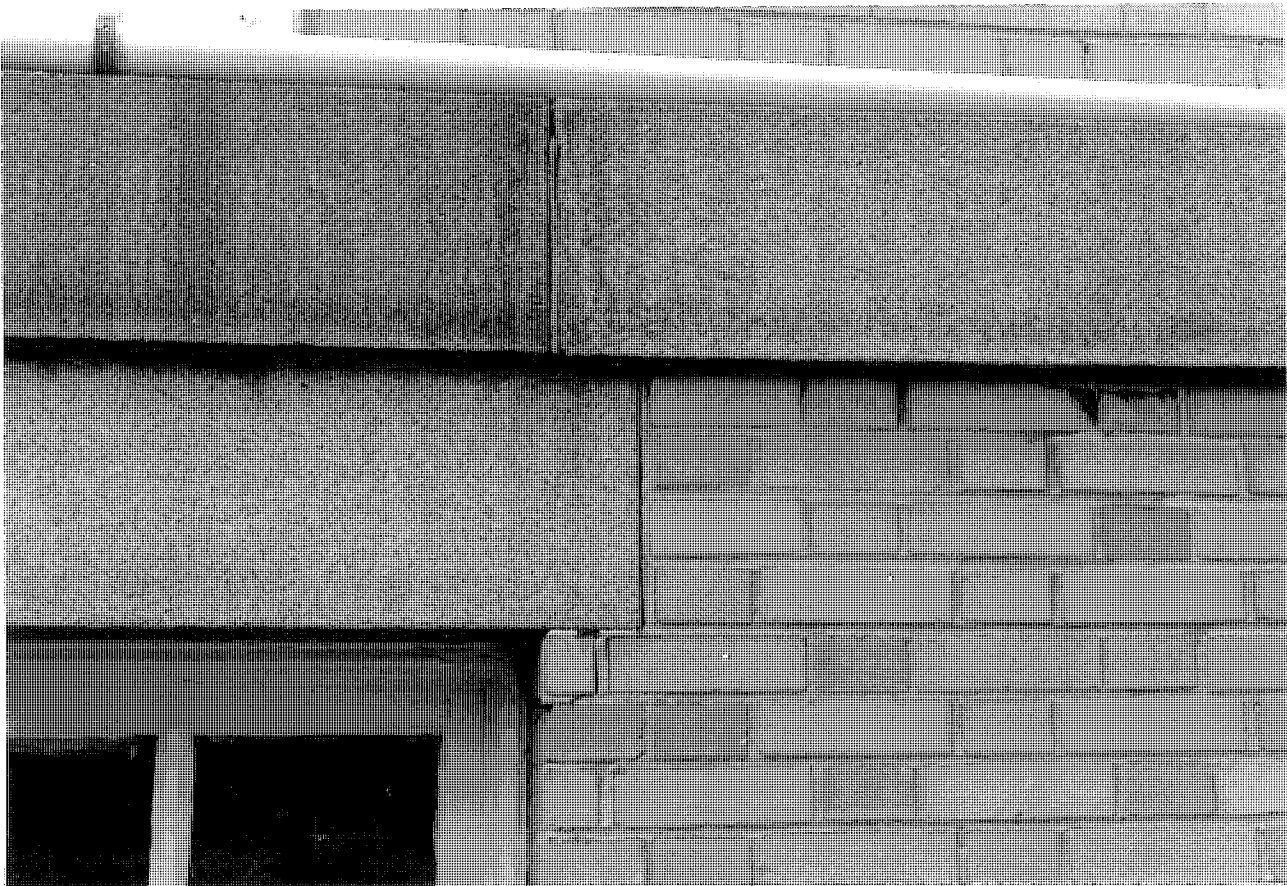
Figure 6-2

Location: North Elevation of Building 6 at West End

Problem: Stress cracks and open mortar joints

Cause of Problem: Freezing water in open joints of water table and/or rusting iron anchors in window lintels and sills.

Suggested Remedy: Remove brickwork and assess for rusting iron anchors. If anchors are rusted they should be replaced with stainless steel anchors; brick should then be replaced to match existing texture, color and size and reset in mortar to match surrounding pointing in color, texture, and profile.

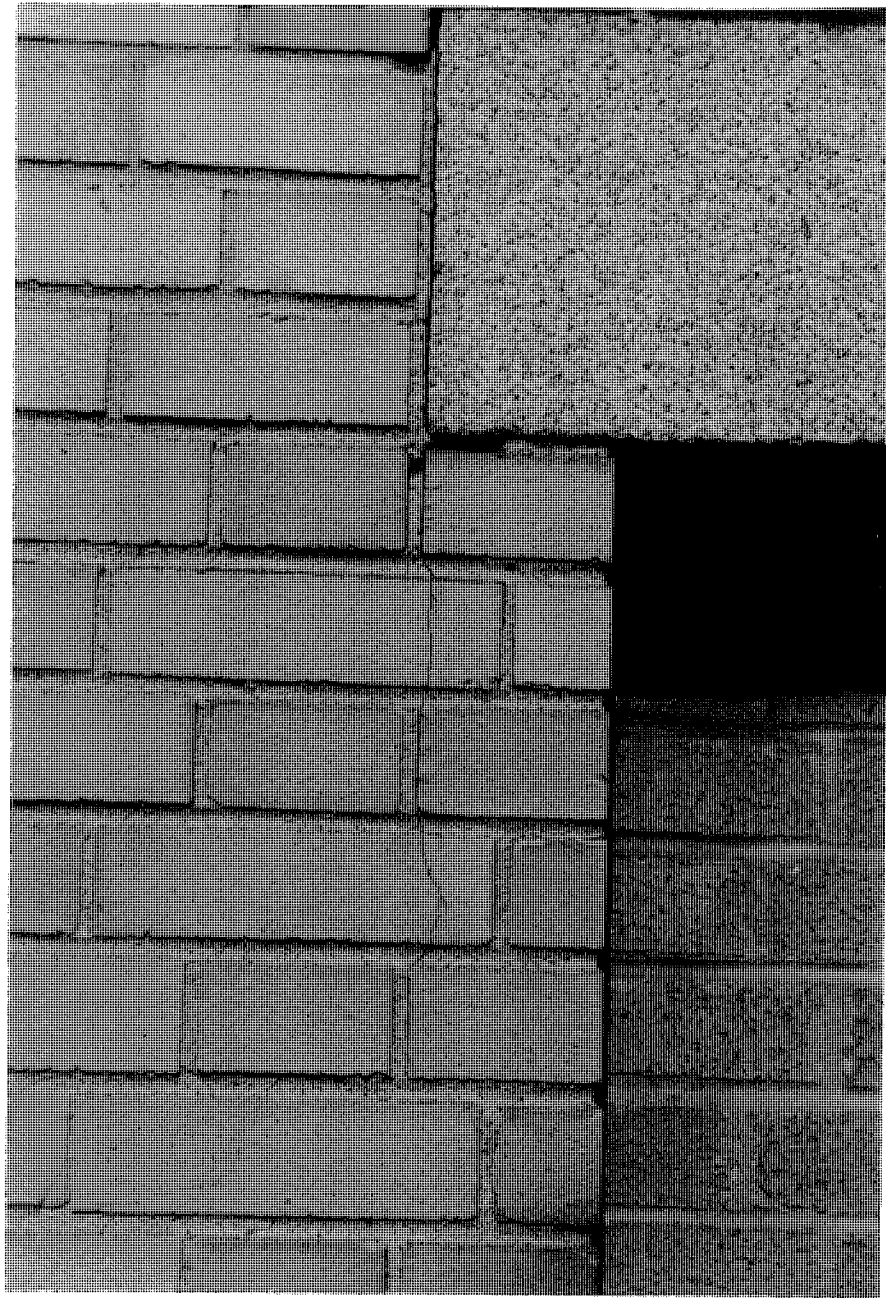
Figure 6-3

Location: East Elevation of Building 6 at North End

Problem: Stress cracks and open mortar joints

Cause of Problem: Freezing water in open joints of water table and/or rusting iron anchors in window lintels and sills.

Suggested Remedy: Remove brickwork and assess for rusting iron anchors. If anchors are rusted they should be replaced with stainless steel anchors; brick should then be replaced to match existing texture, color and size and reset in mortar to match surrounding pointing in color, texture, and profile.

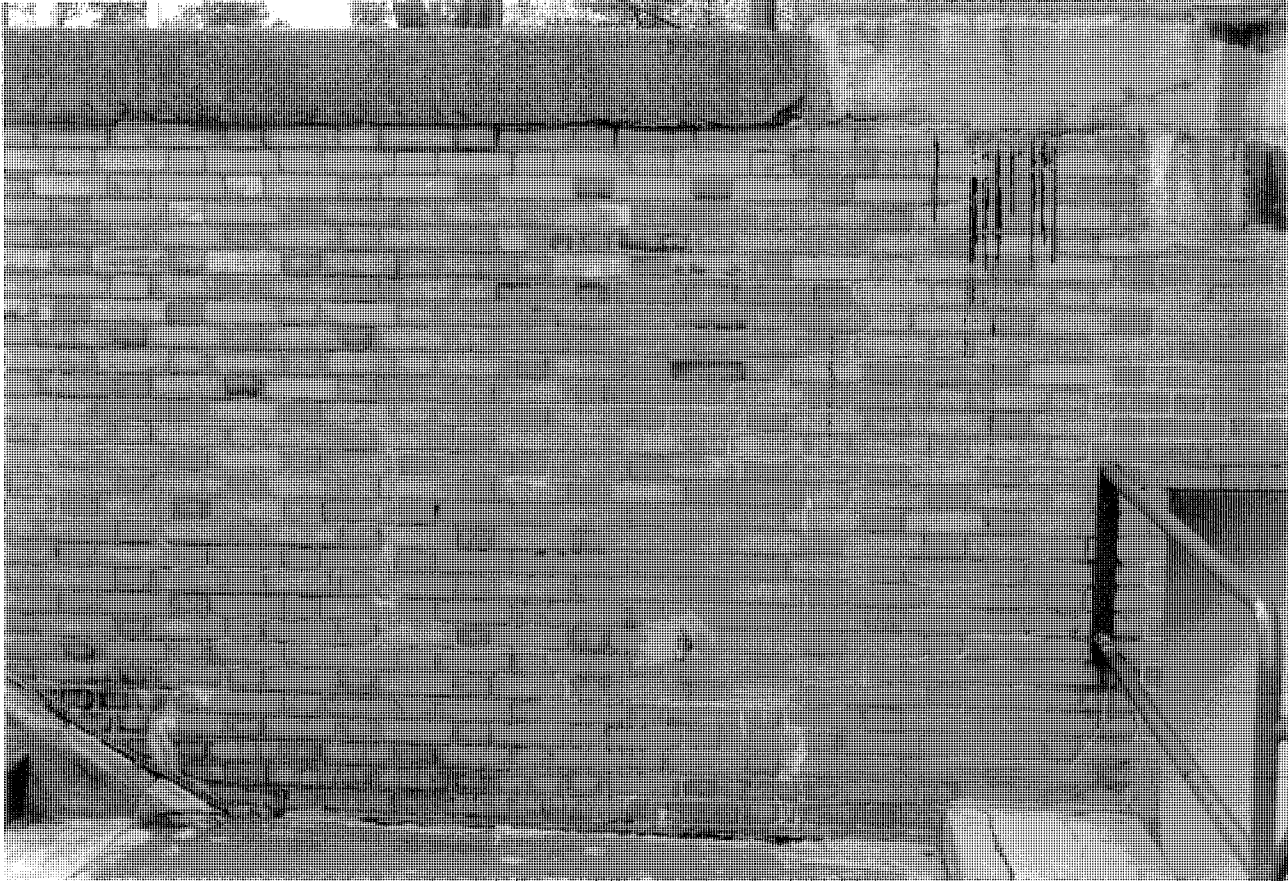
Figure 6-4

Location: West Wall of Entryway on North Elevation of Building 6

Cause of Problem: Water penetration through concrete slab

Suggested Remedy: Cut and point; waterproof concrete slab or replace concrete slab

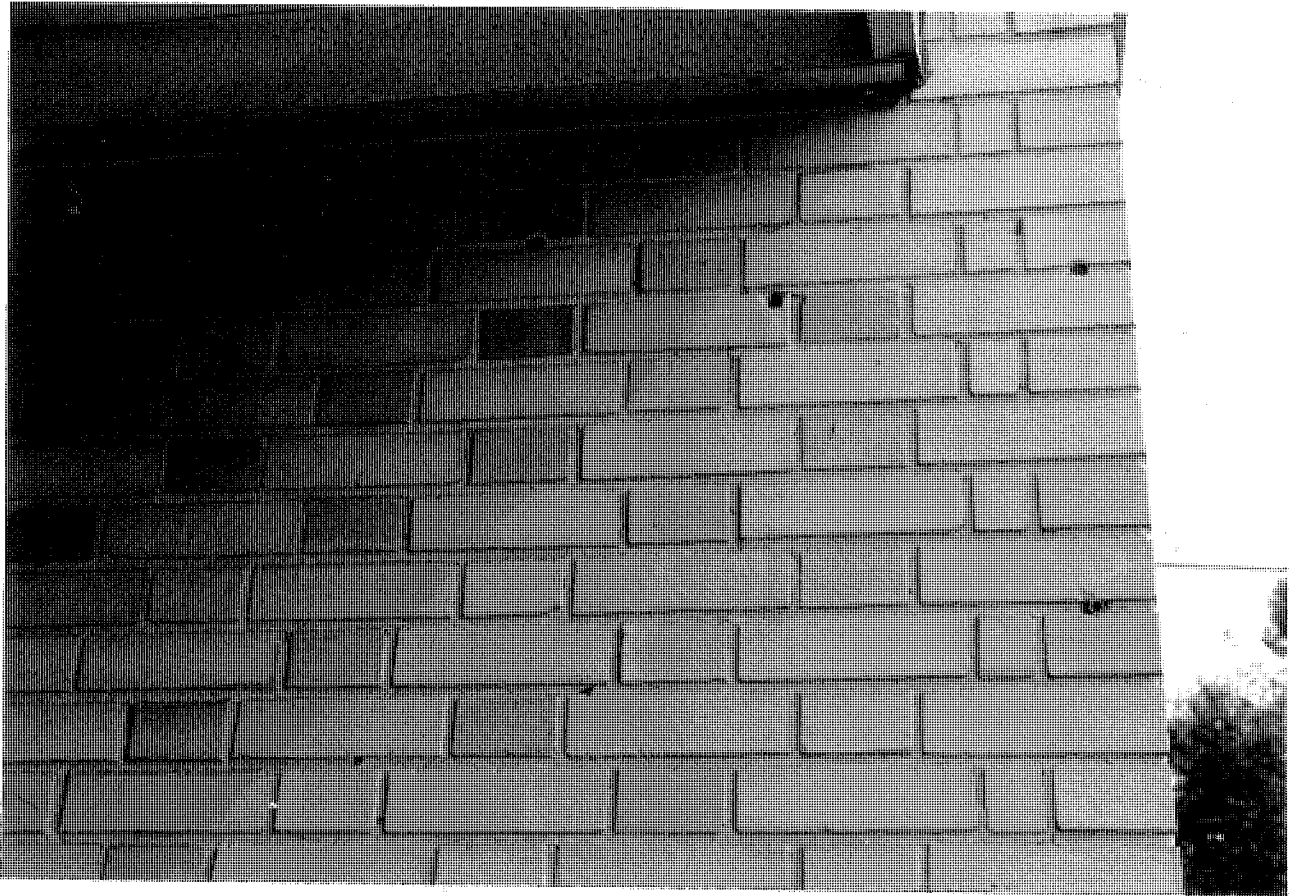
Figure 6-5

Location: South Elevation of Building 6 at East End

Problem: Damaged brick

Cause of Problem: Water penetration and freezing near metal anchors

Suggested Remedy: Remove anchors and fill with pointing mortar

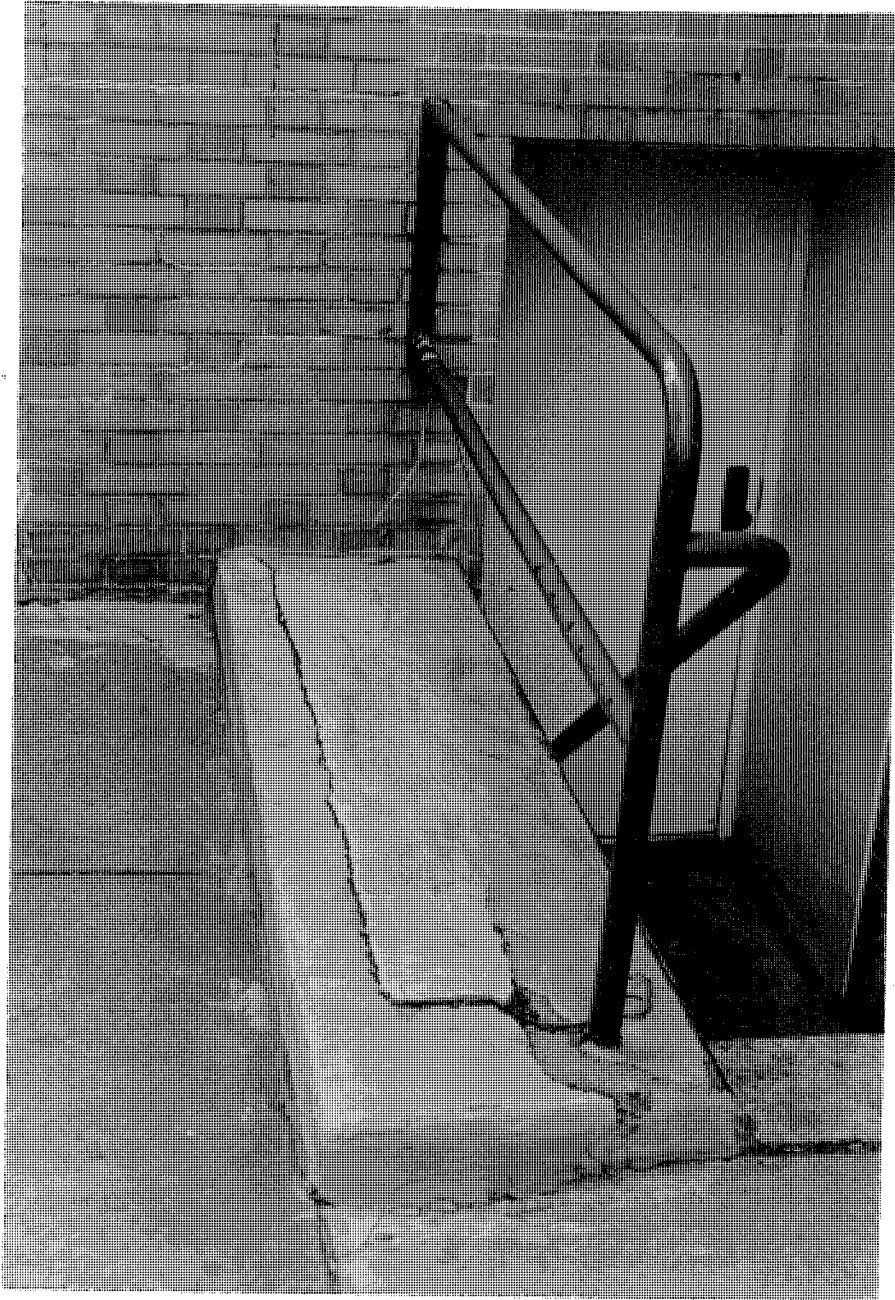
Figure 6-6

Iron railings are generally in good condition. They require periodic scraping and painting. Water entry at their bases has rusted some of the railings, causing damage to the concrete. (Figure 6-6).

Location: West Wall of Entryway on North Elevation of Building 6

Problem: Damaged concrete capstones

Cause of Problem: Water penetration and freezing; rusting of iron railings

Suggested Remedy: Demolish and rebuild

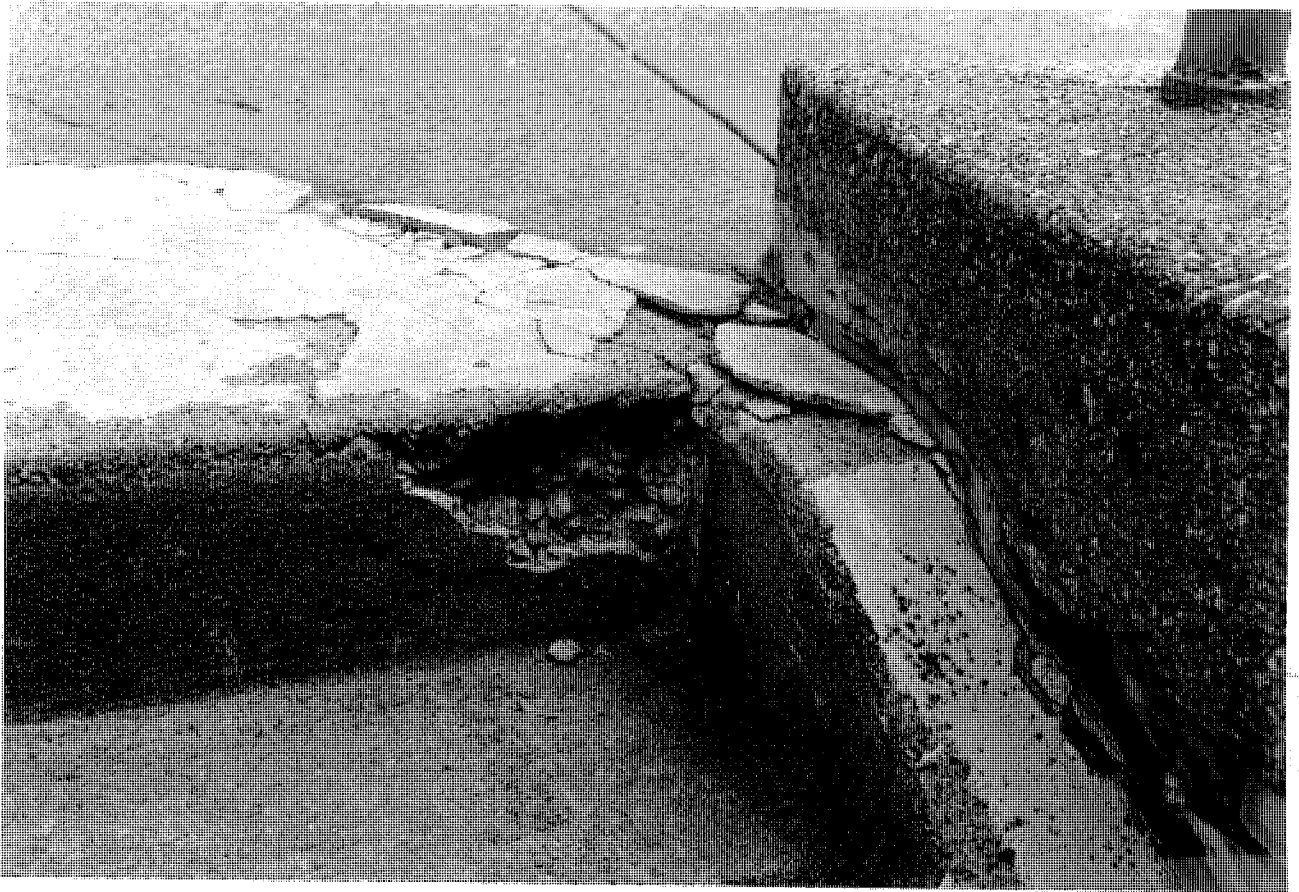
Figure 6-7

Location: West Side of Entryway on North Elevation of Building 6

Problem: Damaged concrete

Cause of Problem: Water penetration and freezing

Suggested Remedy: Demolish and rebuild

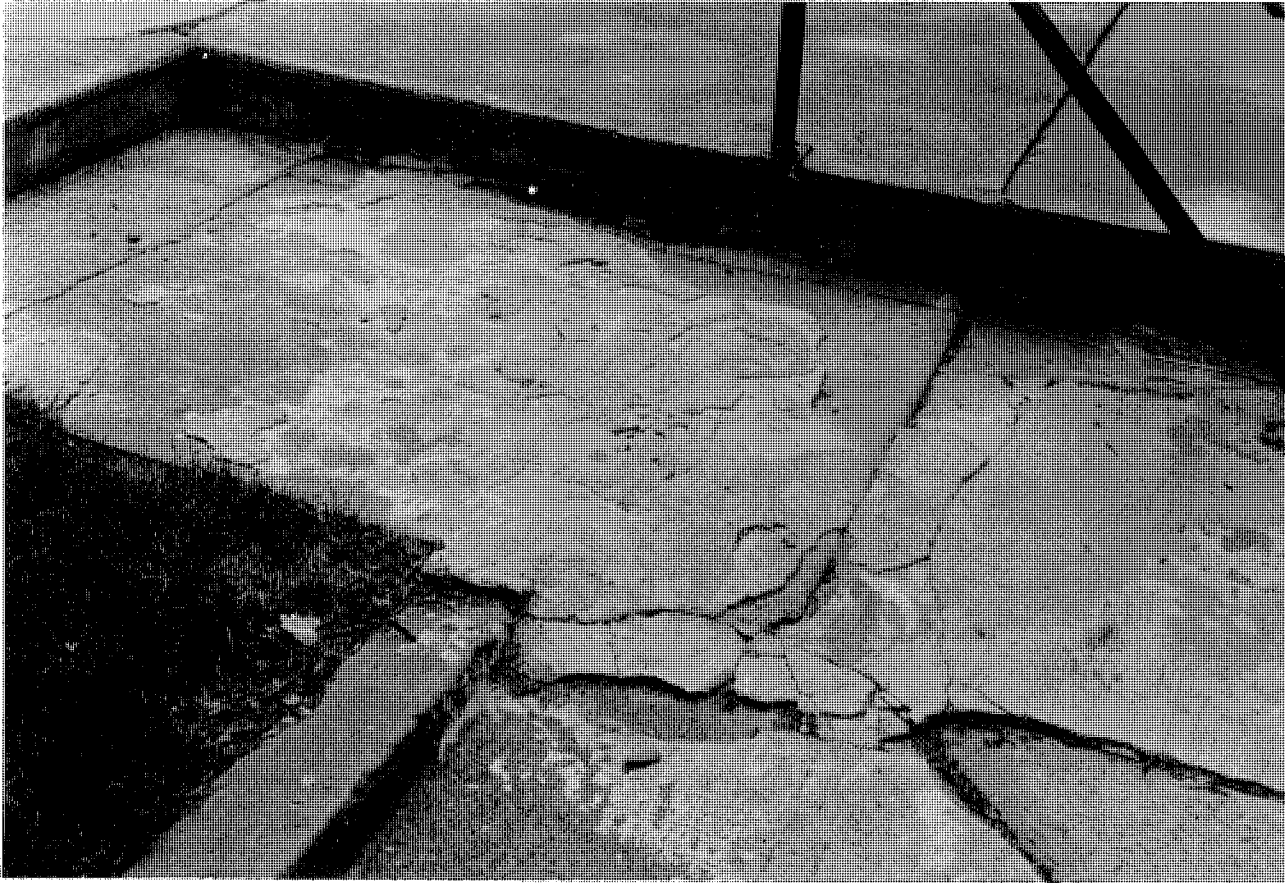
Figure 6-8

Location: West Wall of Entryway on North Elevation of Building 6

Problem: Damaged concrete

Cause of Problem: Water penetration and freezing

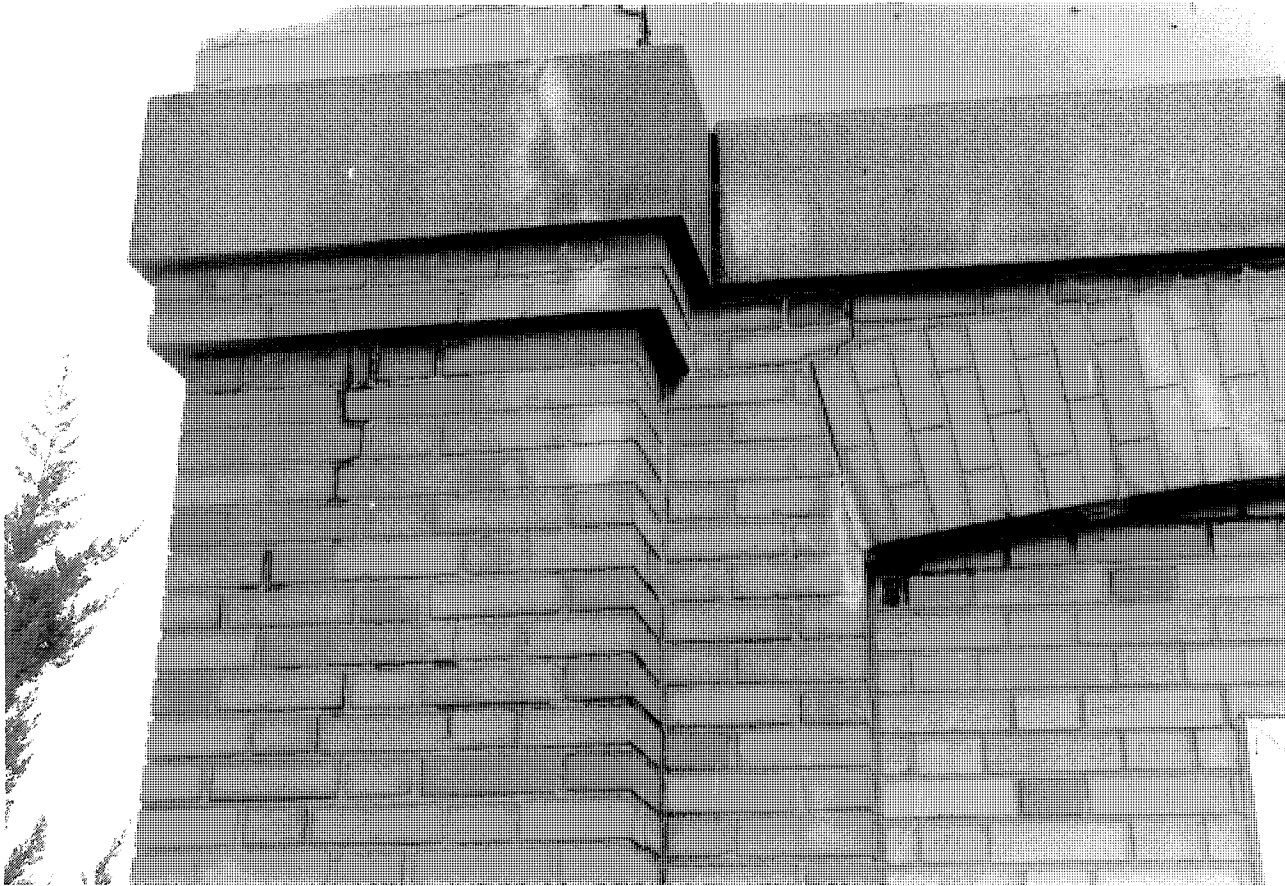
Figure 7-2

Location: South Elevation of Building 7 at West End

Cause of Problem: Water penetration and freezing

Suggested Remedy: Cut and point

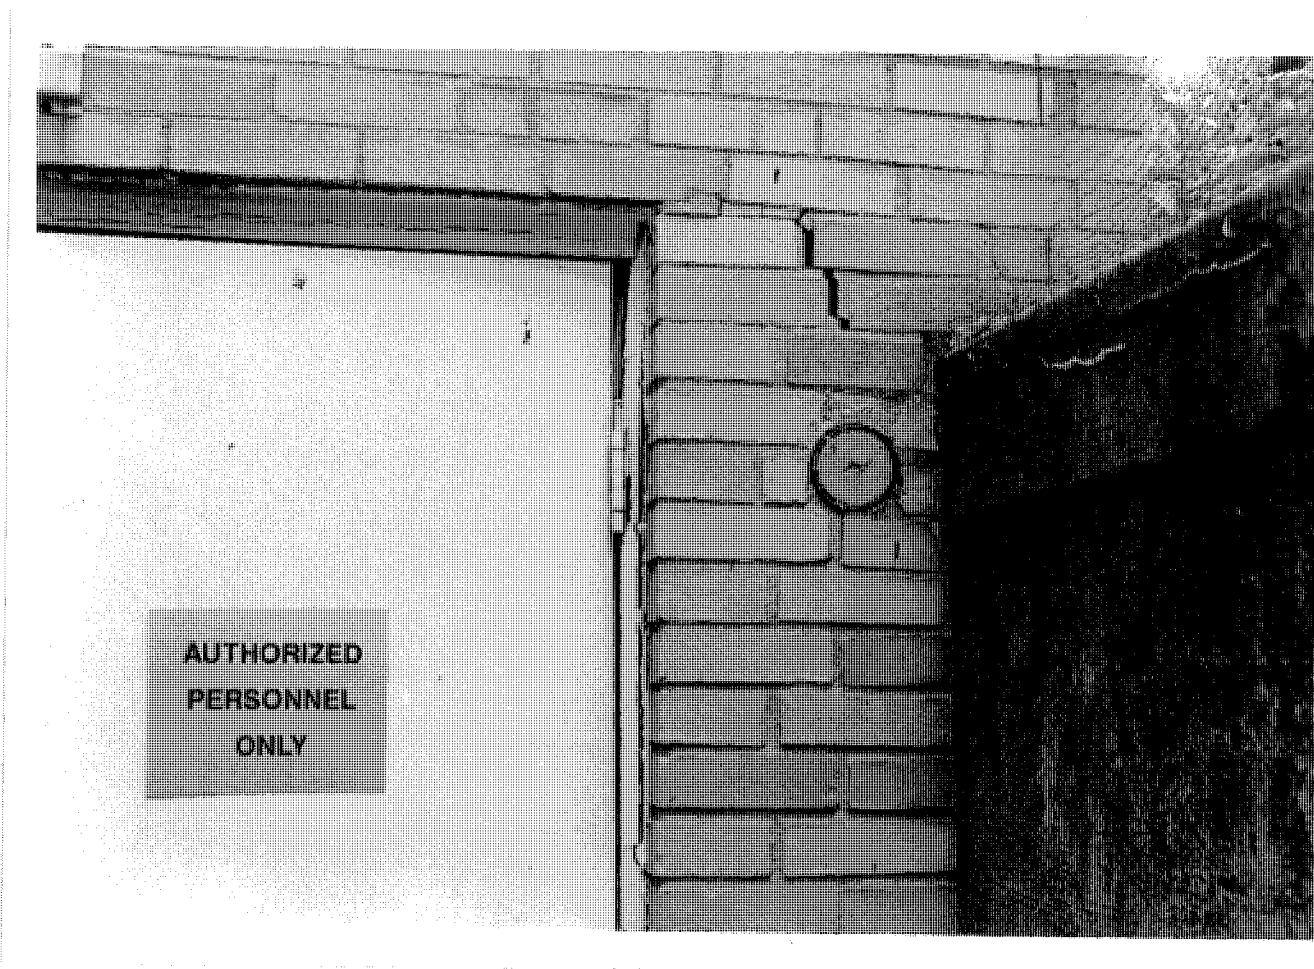
Figure 7-3

Stress cracks and open joints are found on Building 7 in association with the vertical or head joints of the granite water table. The stresses associated with the open joints transfer up and through the brick above, following the mortar joint pattern. Frequently they continue up to the first floor granite window sills. Articulated brick corners have consistently open joints where the corners meet the plane of the brick walls. These conditions are pervasive on all elevations. Semi-round brick arches also have open mortar joints (Figure 7-2). Brickwork near a concrete retaining wall contains open joints due to shifting of the concrete wall (Figure 7-3).

Location: North Side of Entryway on West Elevation of Building 7

Cause of Problem: Water penetration and freezing; rusting of door lintel

Suggested Remedy: Remove brick and assess condition of lintel; replace if necessary and reset brick with mortar to match existing in color, texture and profile

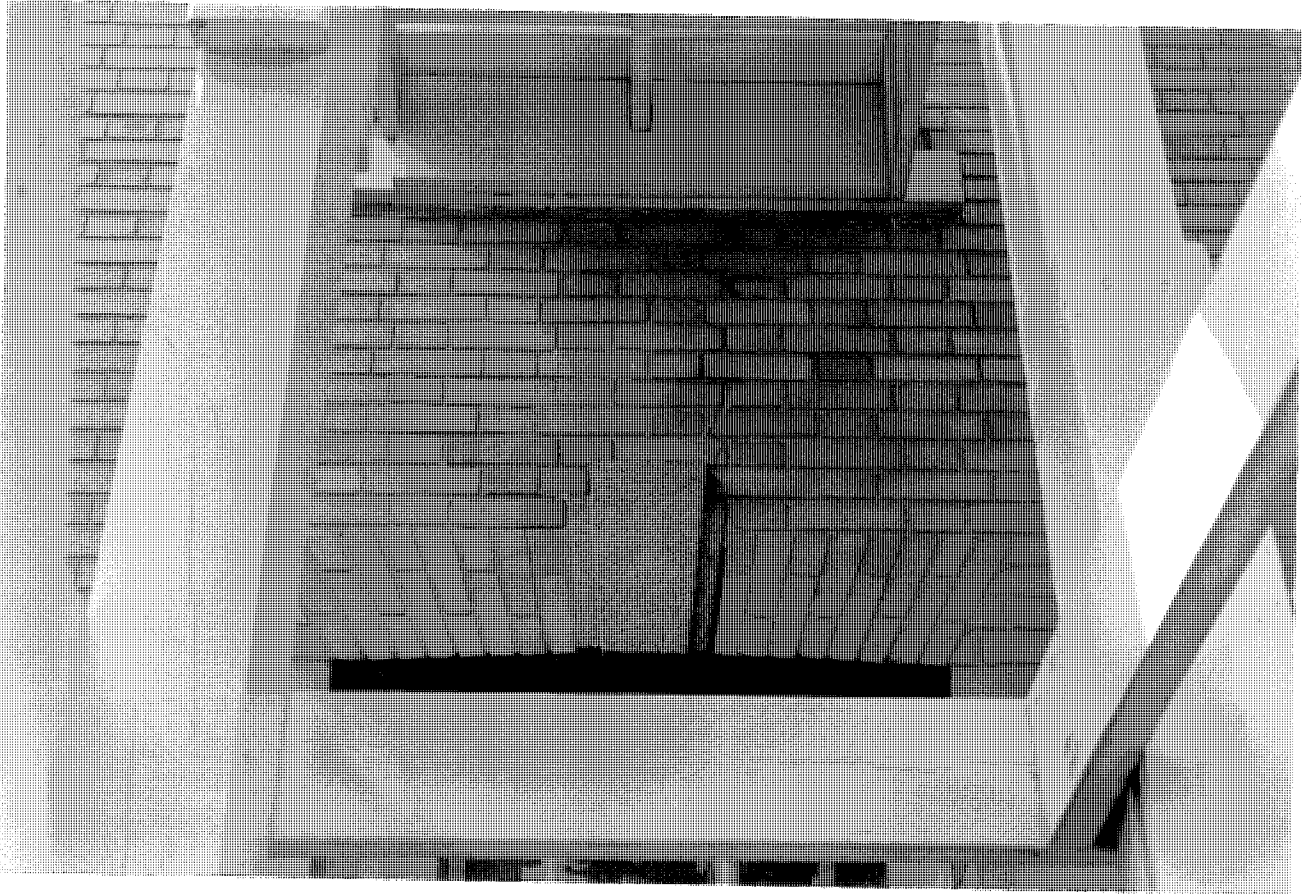
Figure 7-4

The head of the windows in Building 7 consist of wedged shaped brick voussoirs with granite keystones. The joints between the keystones and brick are consistently open as are the joints between the brick voussoir at each end of the window head trim and the surrounding brickwork of the wall (Figure 7-4).

Location: North Elevation of Building 7 in Central Area

Cause of Problem: Water penetration and freezing

Suggested Remedy: Cut and point

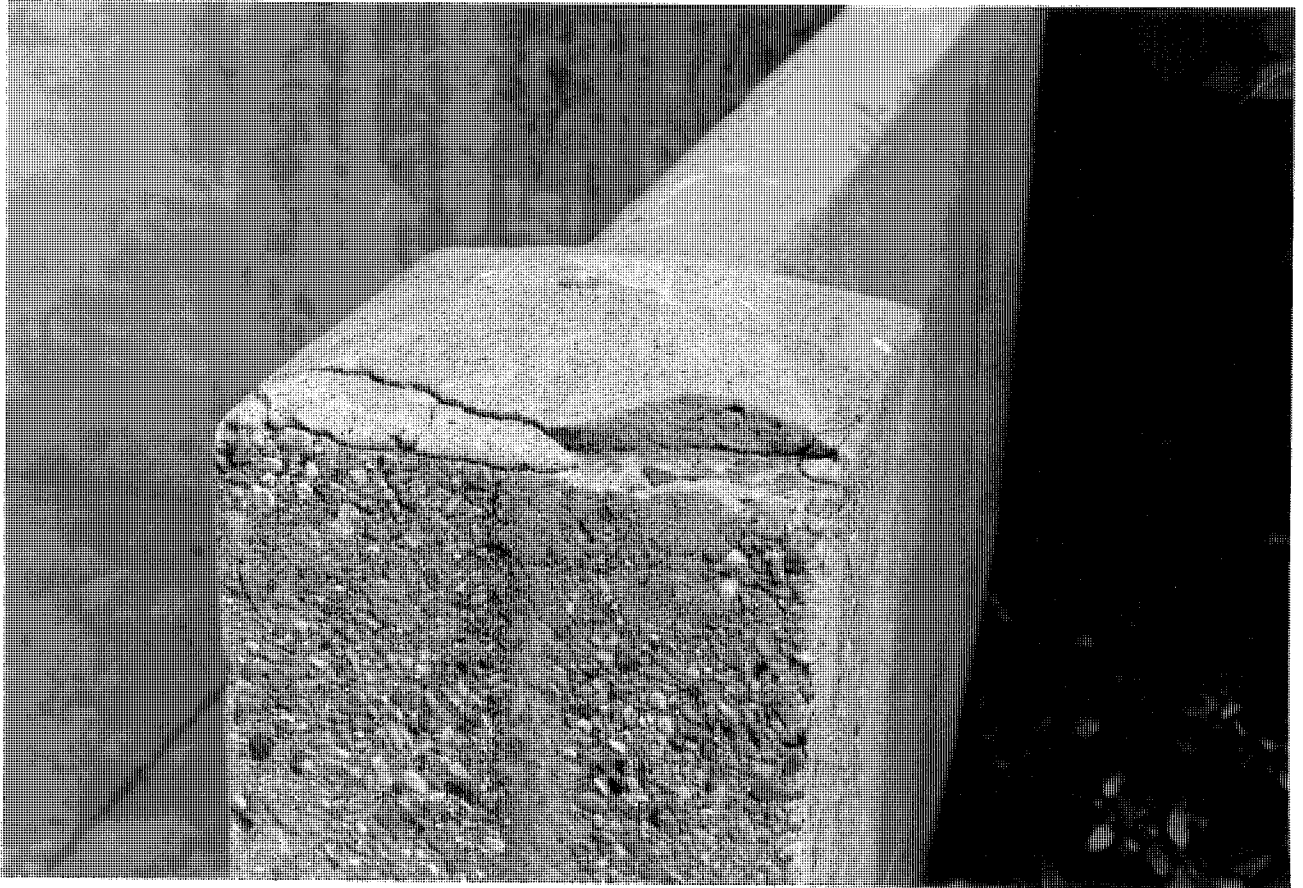
Figure 7-5

Concrete is used for the walkways and nearby walls as well as a retaining wall on Building 7. The tops of the walls associated with walkways have been repaired in the past, and these repairs are failing (Figure 7-5). Some concrete stucco is also failing where it has been directly applied to brickwork (Figure 7-6). A concrete retaining wall on the west elevation near the main entrance portico shows efflorescence and some bulging (Figure 7-7). Concrete bases for the piers under the entrance portico are damaged (Figure 7-8). Other sidewalk walls have damaged capstones (Figure 7-9).

Location: East Elevation of Building 7 at North End (patio wall)

Problem: Damaged concrete

Cause of Problem: Water penetration and freezing

Suggested Remedy: Repair with concrete patching material

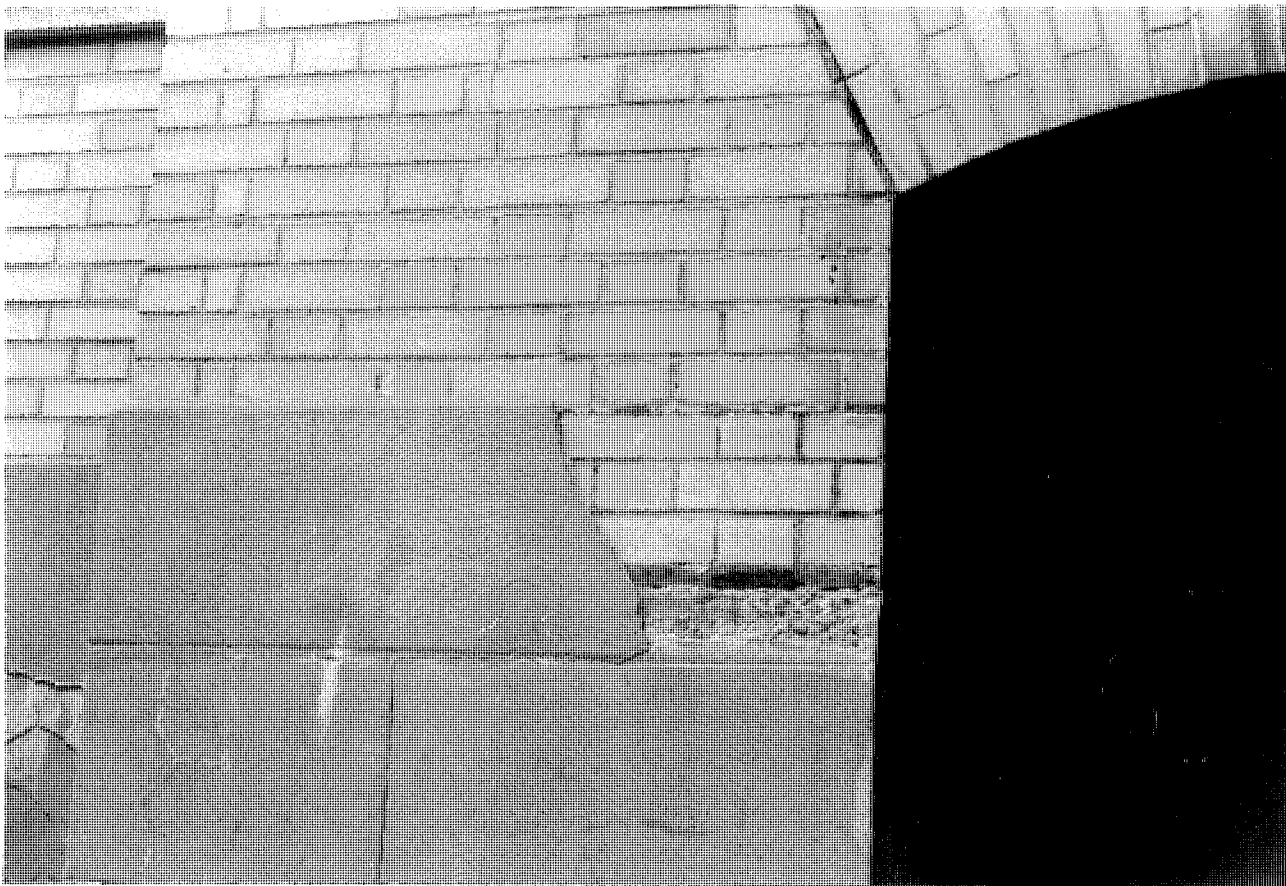
Figure 7-6

Location: South Elevation of Building 7 at West End

Problem: Damaged and failing stucco

Cause of Problem: Water penetration and freezing

Suggested Remedy: Repair with new stucco

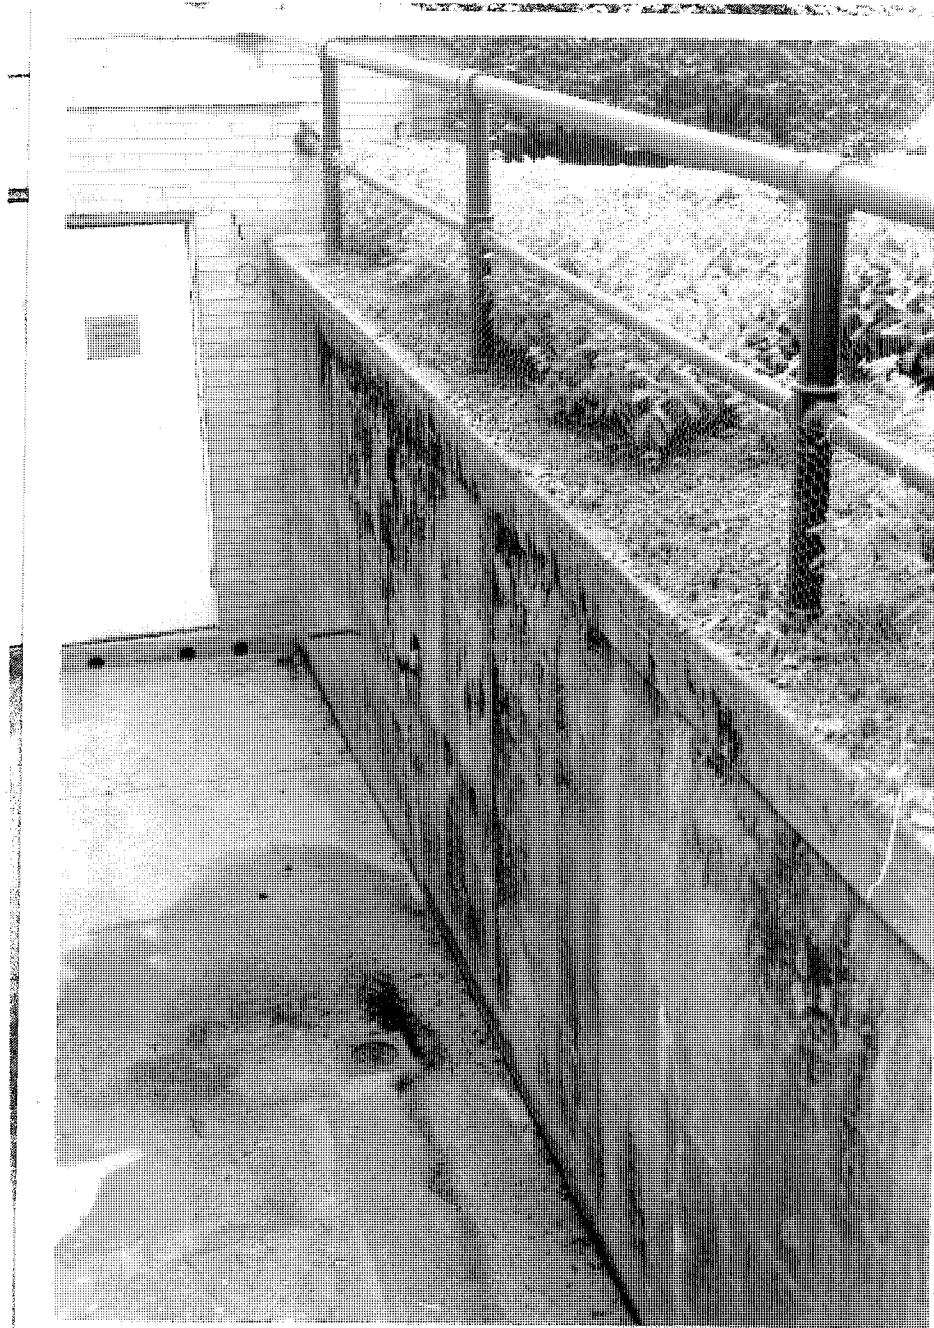
Figure 7-7

Location: West Elevation of Building 7 along North Areaway

Cause of Problem: Water penetration and freezing; pressure from soil

Suggested Remedy: Demolish and rebuild

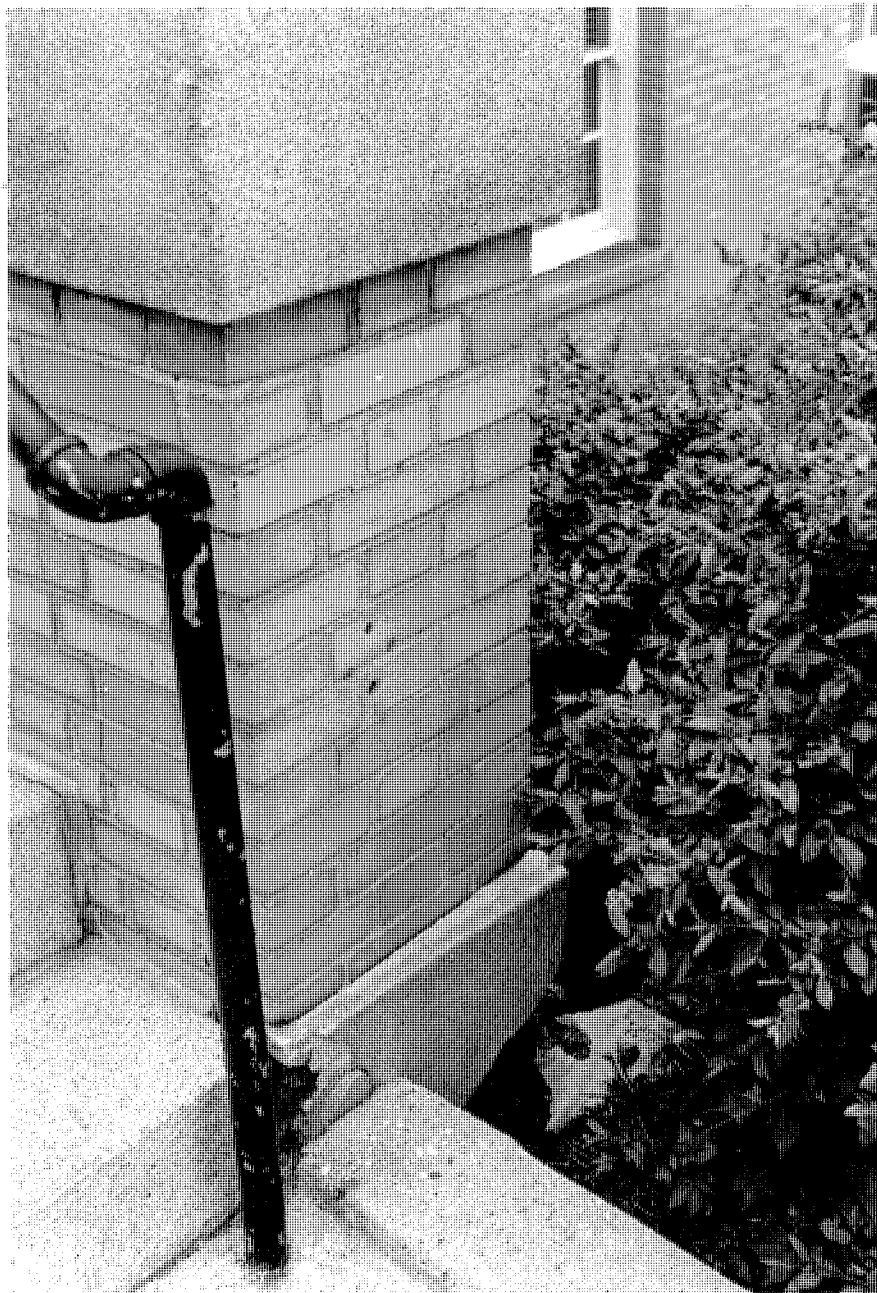
Figure 7-8

Location: West Elevation of Building 7 at Central Entryway

Problem: Damaged and deteriorating concrete piers

Cause of Problem: Water penetration and freezing

Suggested Remedy: Repair with concrete patching material

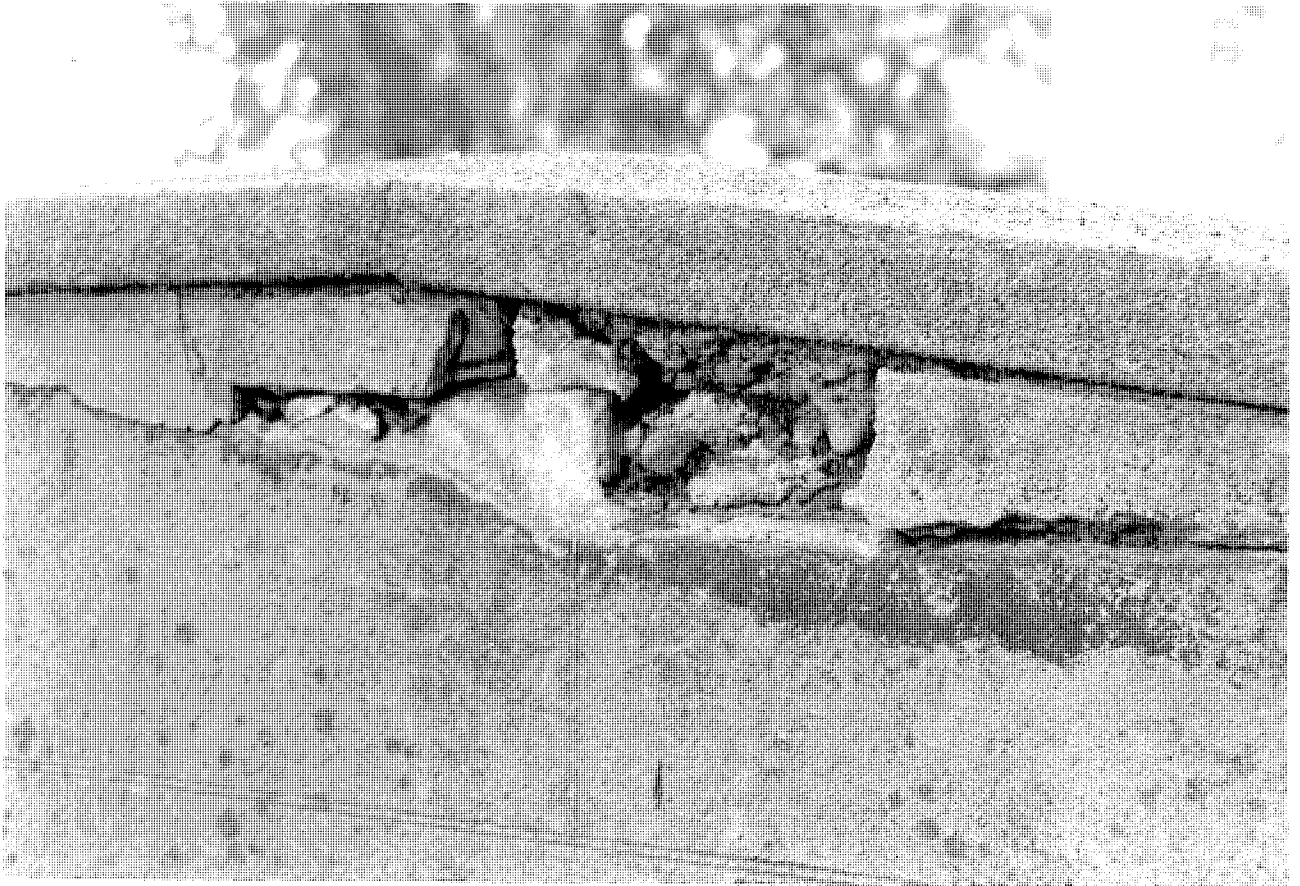
Figure 7-9

Location: North Elevation of Building 7 at West End (Walkway Wall)

Problem: Damaged and deteriorating concrete capstone

Cause of Problem: Water penetration and freezing

Suggested Remedy: Remove and replace

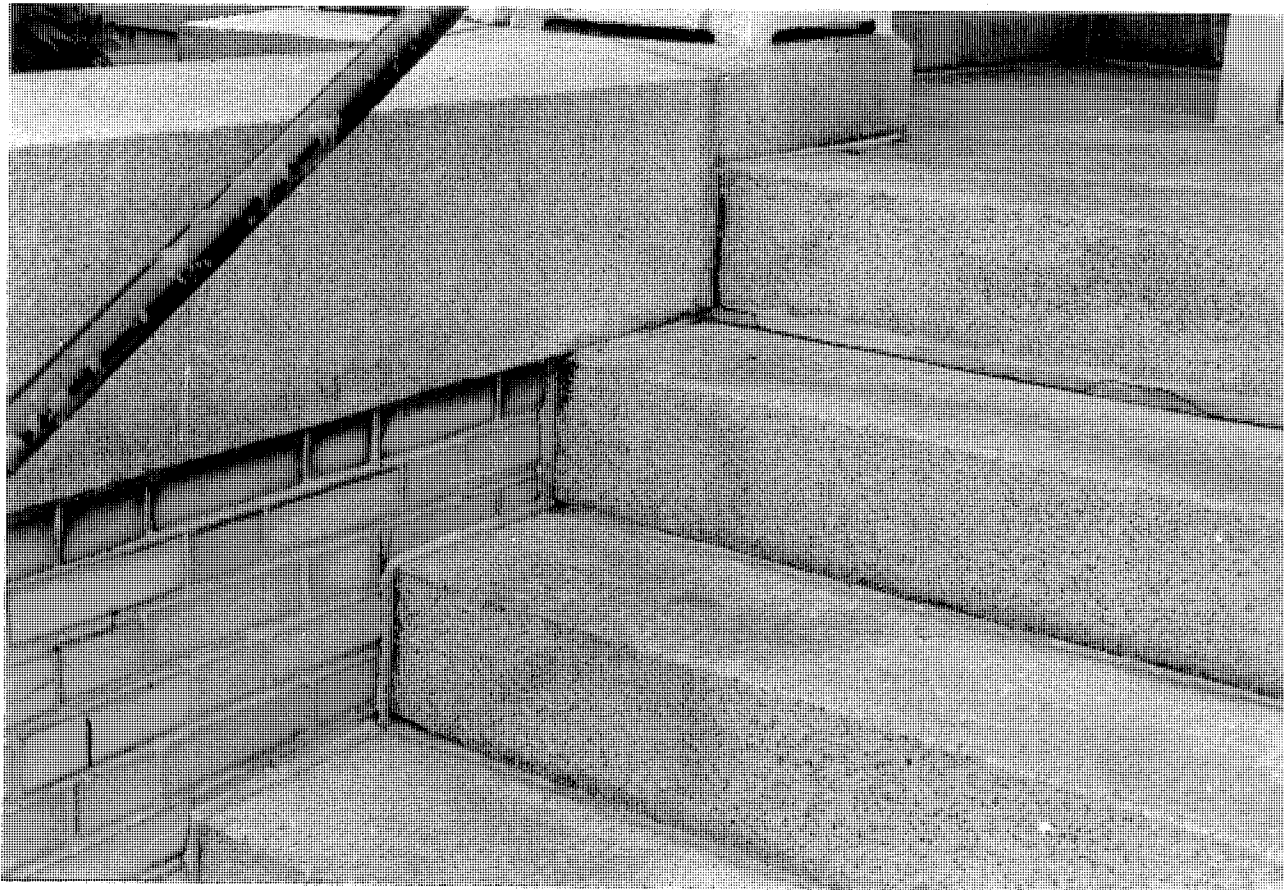
Figure 7-10

Granite forms the water table which surrounds the building at the base of the first floor. These elements - like the granite keystones - are generally in good condition but are soiled in a range from light to heavy. However, the joints between juxtaposed stones are open or have been filled with caulk. The bed joints and the top horizontal joints for the granite water table are generally open. Run-off from window air conditioners has stained some of the granite. Granite steps exhibit failing pointing and caulking (Figure 7-10).

Location: West Elevation of Building 7 at Central Entryway

Cause of Problem: Water penetration and freezing; improper maintenance procedures
