Potomac Annex: Buildings 1 & 3-7

Historic Structures Report, Corrected Final Submission
General Services Administration Project Control Number: 44007

September 9, 1997

BUILDING 1: EXTERIOR EXISTING CONDITIONS

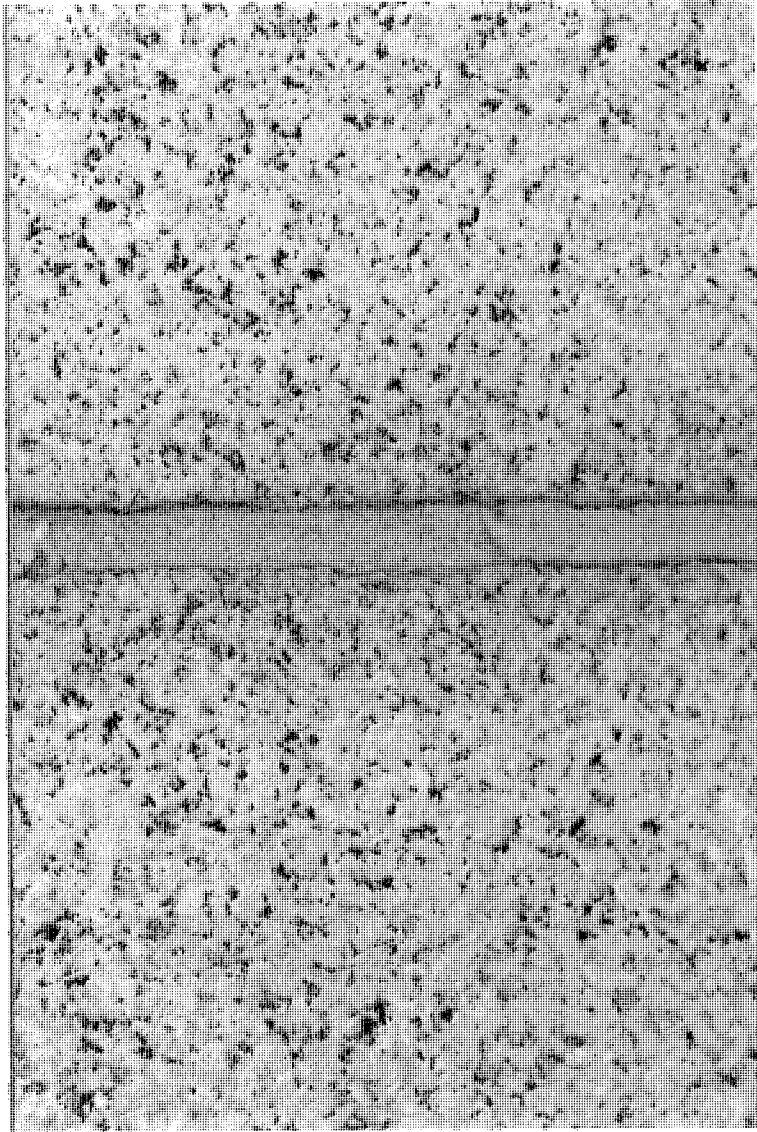
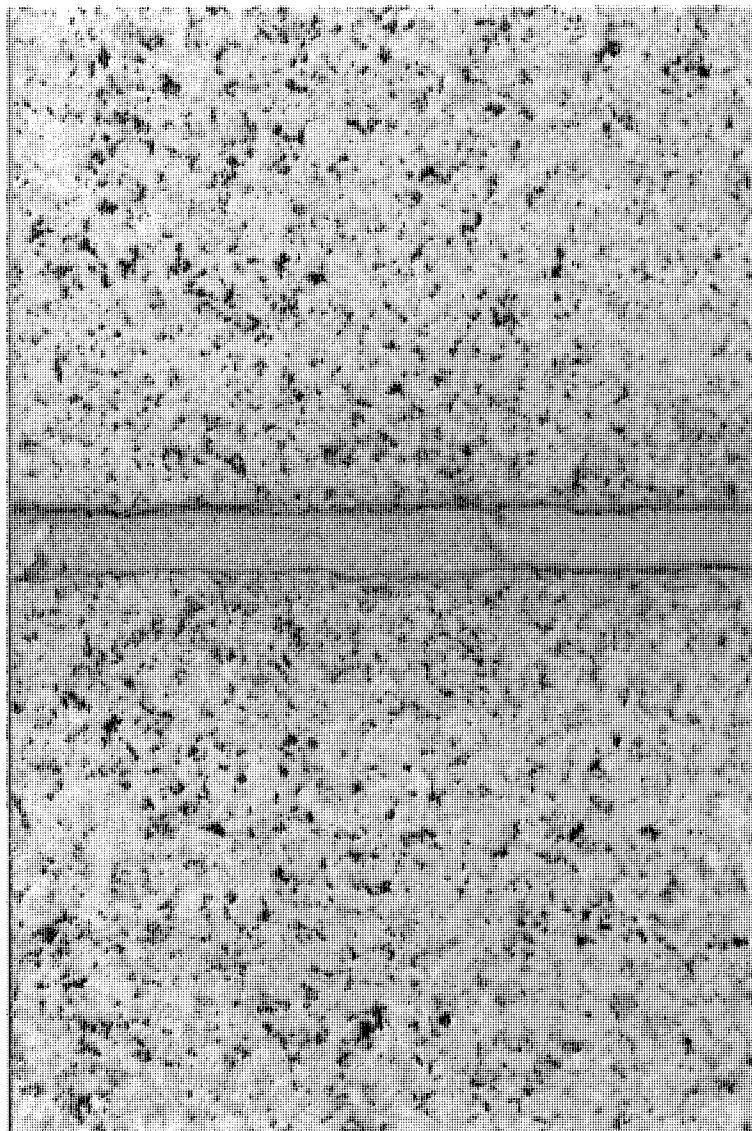
Figure 7-2

Designation: 1POTMWT (Figure 7-2)
Location: Northeast basement corner of Building 1 at eye level
Integrity: Appears to be original
Description: White-grey with fine aggregate and some dark inclusions
 Munsell Color Notation - Mortar: 5 Y 9/1

Deterioration: The mortar is lost in many areas due to movement and hardness of granite; more frequent repointing may be required at the water table.

Building 1 - Granite Pointing Mortar

Recommended Profile: 3/8" wide, 1/16" deep, concave - both vertical and horizontal

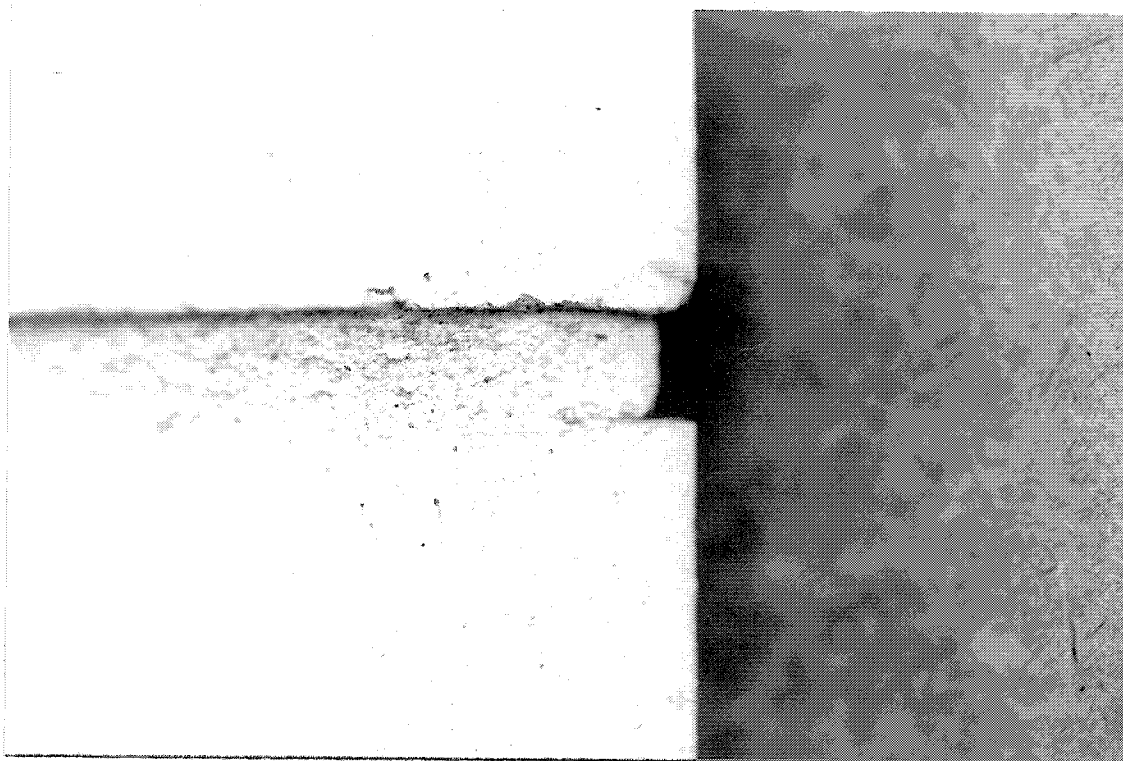
Figure 7-1

Designation: 1POTM (Figure 7-1)
Location: Northeast corner of Building 1 at eye level
Integrity: Appears to be original
Description: White-grey with fine aggregate; some dark inclusions
 Munsell Color Notation - Mortar: 5 Y 9/1

Deterioration: The mortar is in generally good condition and is well bonded except in step or stress cracks

Building 1 - Brick Pointing Mortar

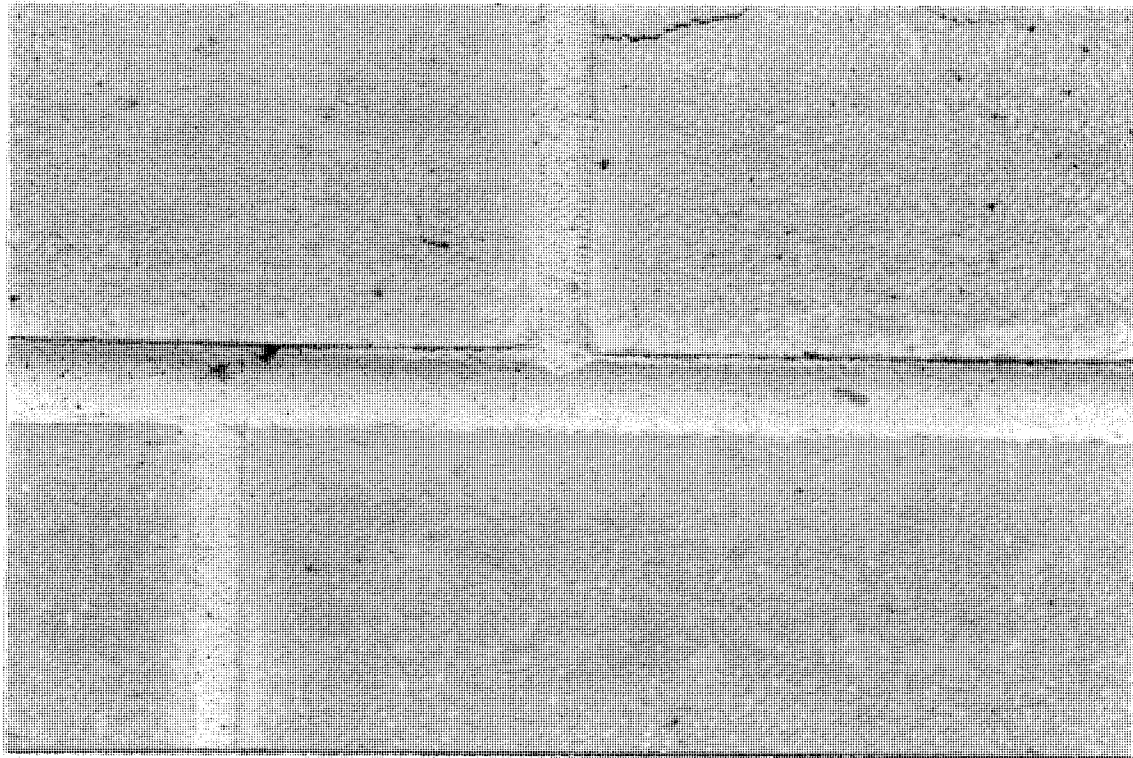
Figure 7-3

Designation: 3POTM (Figure 7-3)
Location: Southeast corner of Building 3
Integrity: Appears to be original
Description: Grey-to-light tan with fine aggregate
 Munsell Color Notation - Mortar: 10 YR 8/1

Deterioration: The mortar is in generally good condition except in areas of step or stress cracks.

Building 3 - Brick Pointing Mortar

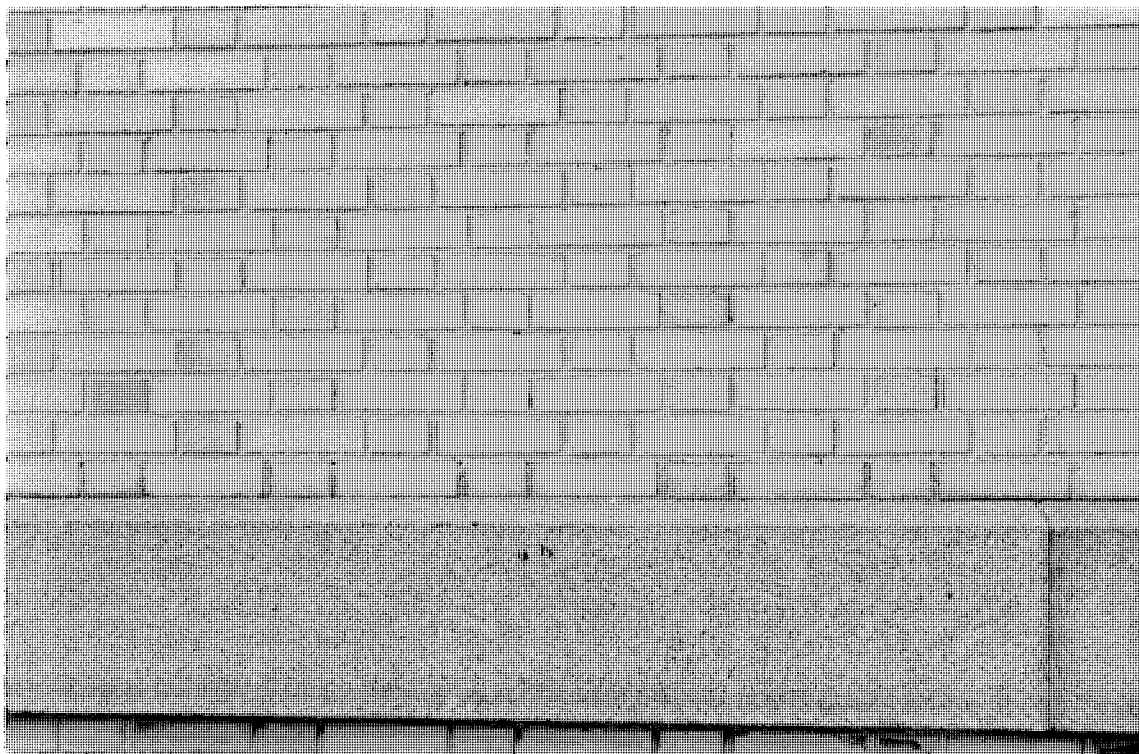
Figure 8-1

- Light soiling of the brick (Figure 8-1)
- Light soiling of the granite elements (Figure 8-1)
- Soiling by gypsum and flyash of the undersides of granite (and brick) elements and window lintels and sills (Figure 8-2)
- Soiling of granite and brick by bitumen-based materials (Figure 8-3)
- Rust Stains on Granite

The brick and granite on Buildings 1, 5, 6 and 7 is only lightly soiled as seen here on the elevation of Building 1.

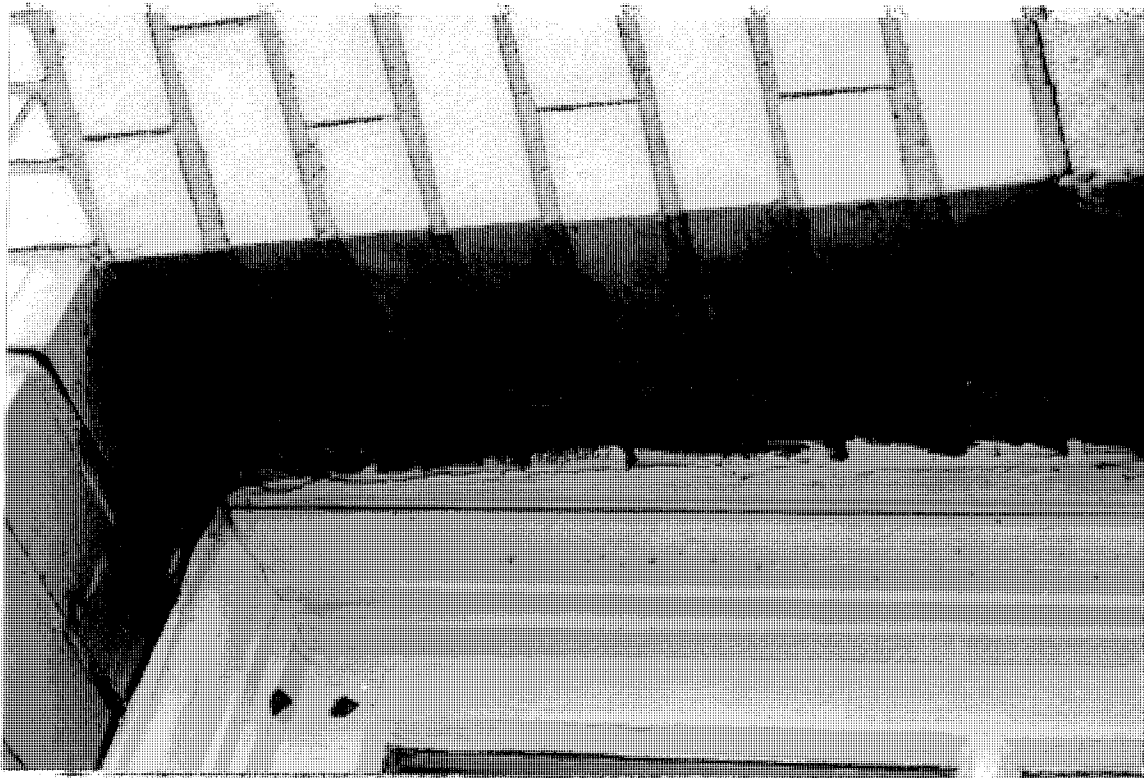
Figure 8-2

Gypsum and flyash have deposited on the undersides of window lintels and sills as seen here on the elevation of Building 3.

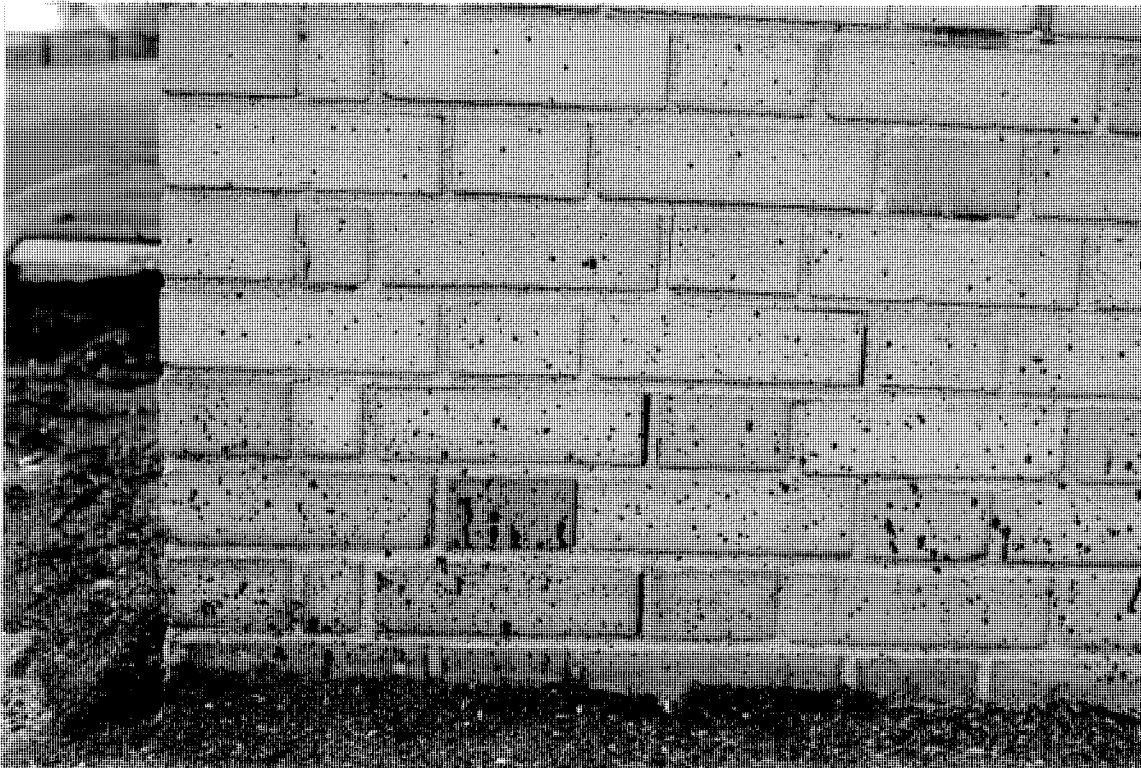
Figure 8-3

Bitumen-based materials have been accidentally splashed onto the brick and granite as seen here on the elevation of Building 7.

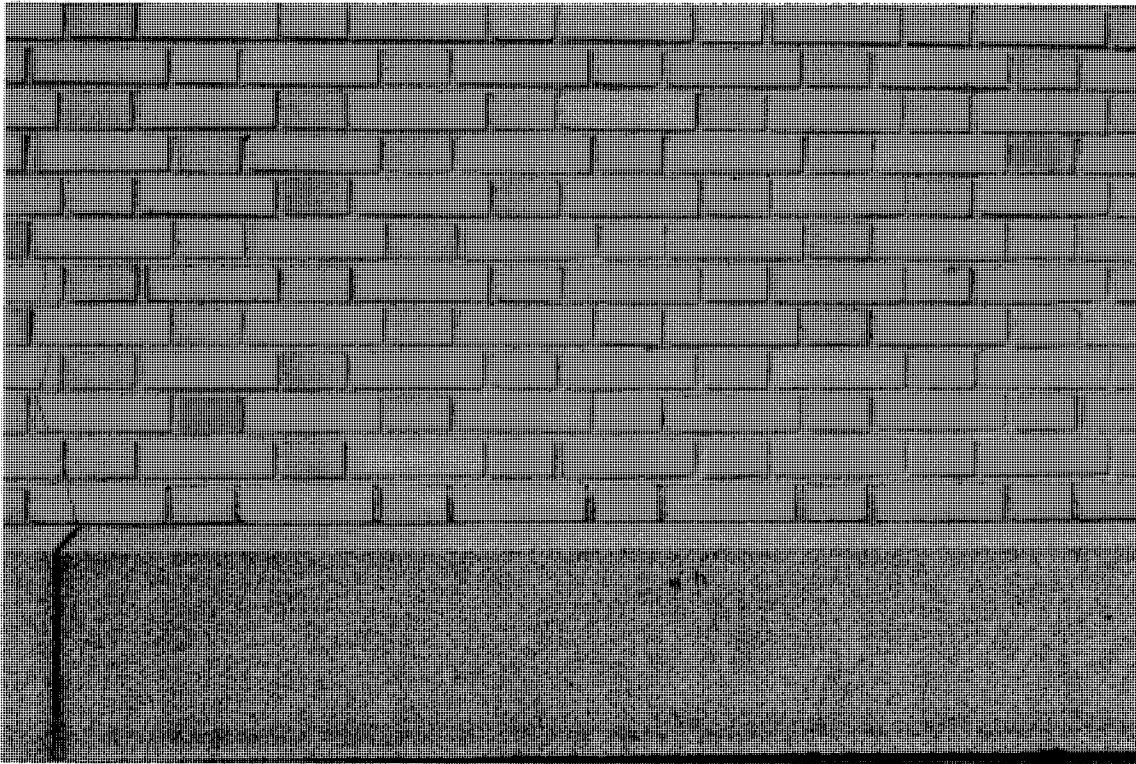
Figure 8-4

The condition of the brick can be seen in Figure 8-4. Two methods of cleaning were chosen: 1) Application of detergent (ProSoCo's 1026) followed by low-pressure power wash; 2) Application of alkaline pre-wash followed by an acid after-wash with low-pressure power wash after each step. The conditions for each test are outlined below.

Condition of the lightly soiled brick on the east elevation of Building 5 before commencing cleaning tests.

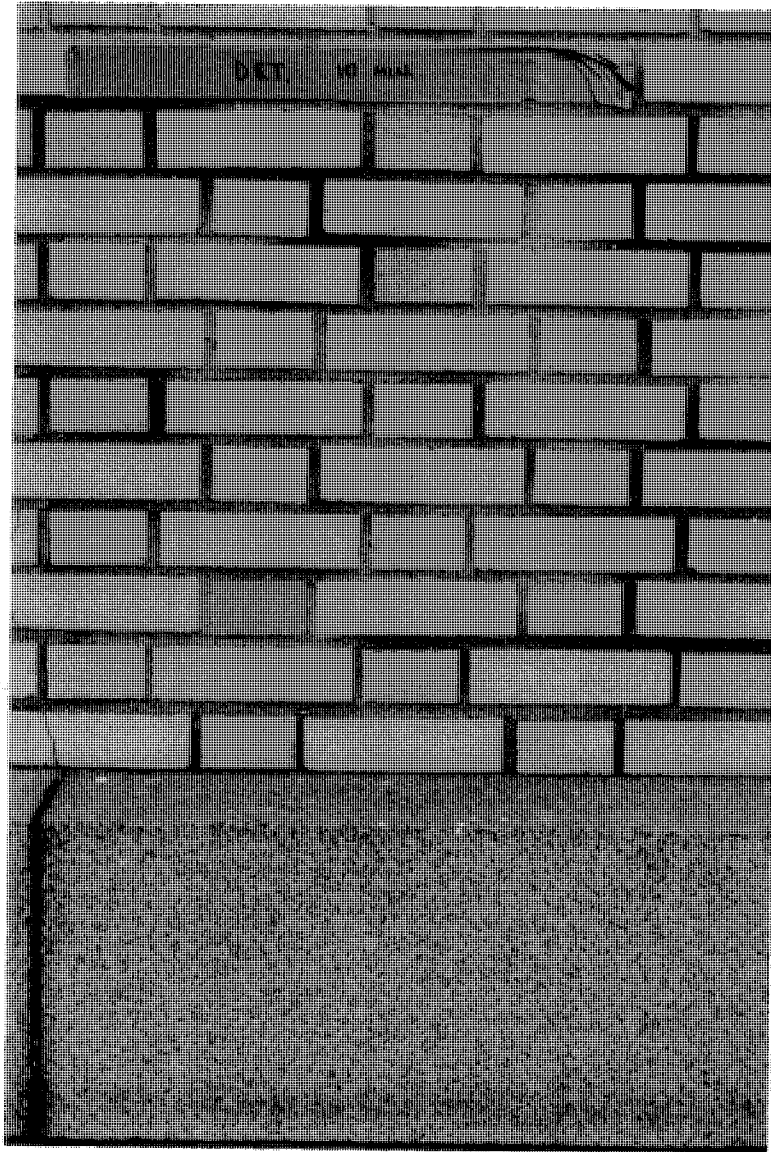
Figure 8-5

Condition of lightly soiled brick on the east elevation of Building 5 after cleaning with detergent (10 minute dwell time) and power wash (approximately 400 psi). Good results are obtained with little risk of damaging the brick.

The result of cleaning the light soiling of the brick with Method 1 is shown in Figure 8-5. This method achieved good cleaning results while being safe for the brick. The result of cleaning the light soiling of the brick with Method 2 is shown in Figure 6. This method also achieved good cleaning, but is more aggressive than Method 1. Therefore, the more gentle Method 1 is recommended for cleaning the brick on Building 1, 3, 5, 6 and 7.

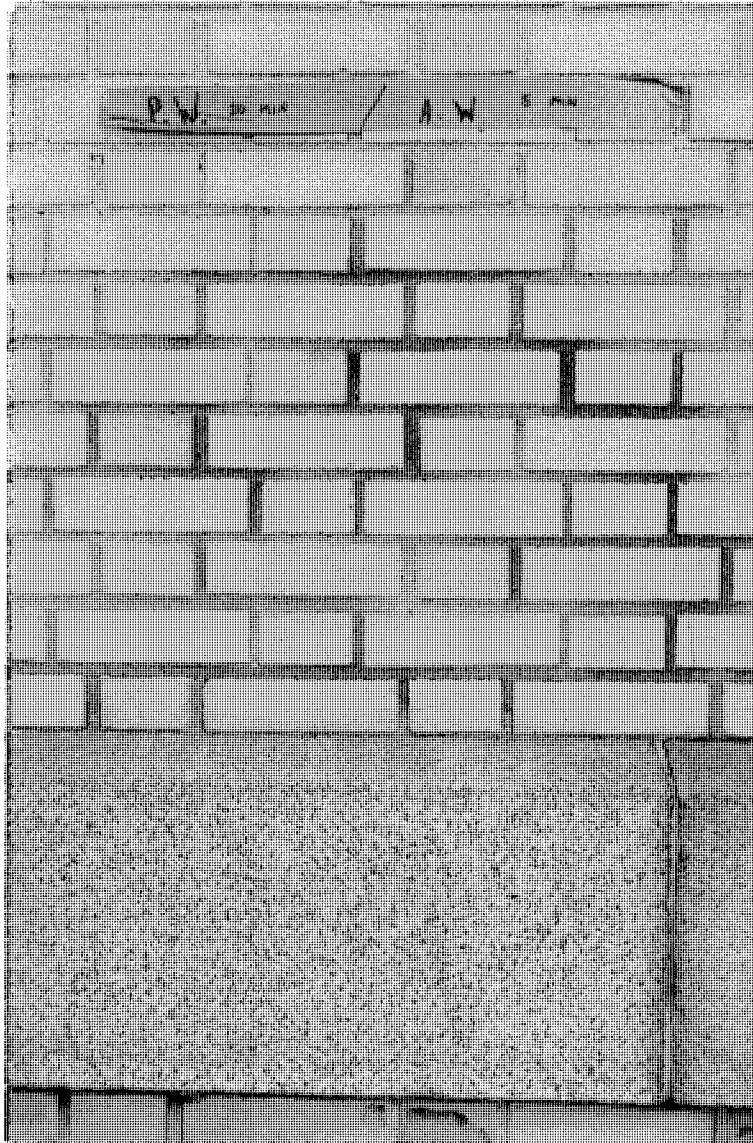
Figure 8-6

The light soiling of the brick on the east elevation of Building 5 was also cleaned by an alkaline pre-wash/acid after-wash system. The results of the cleaning are good but this system is more aggressive than the detergent cleaning which also achieved good results as seen in Figure 5. Therefore, the detergent cleaning is the recommended method for cleaning the lightly soiled brick on Buildings 1, 5, 6 and 7.

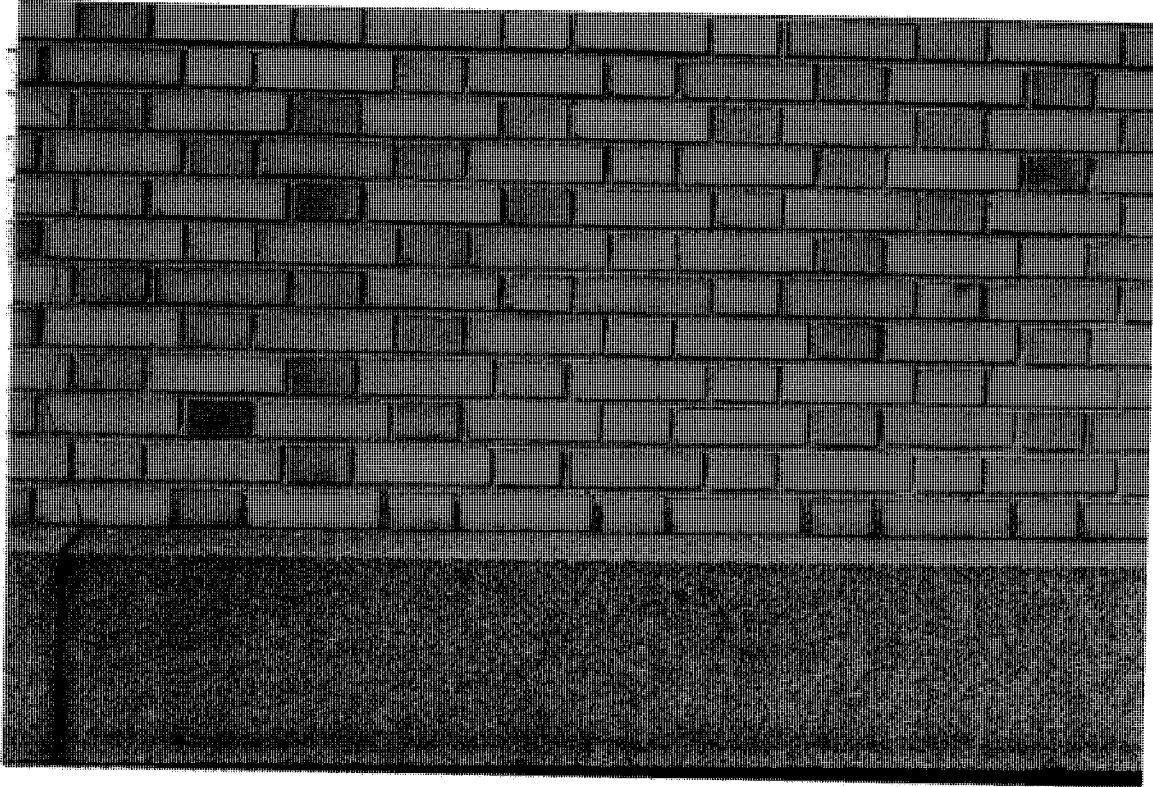
Figure 8-7

The condition of the granite can be seen in Figure 8-7. Two methods of cleaning were chosen: 1) Application of detergent (PROSOCO'S 1026) followed by low pressure power wash; 2) Application of alkaline pre-wash followed by an acid after-wash with low pressure power wash after each step. The conditions for each test are outlined below.

The granite water tables (as well as other granite elements) on Buildings 1, 5, 6 and 7 are lightly soiled as seen here on the east elevation of Building 5 before cleaning tests commenced.

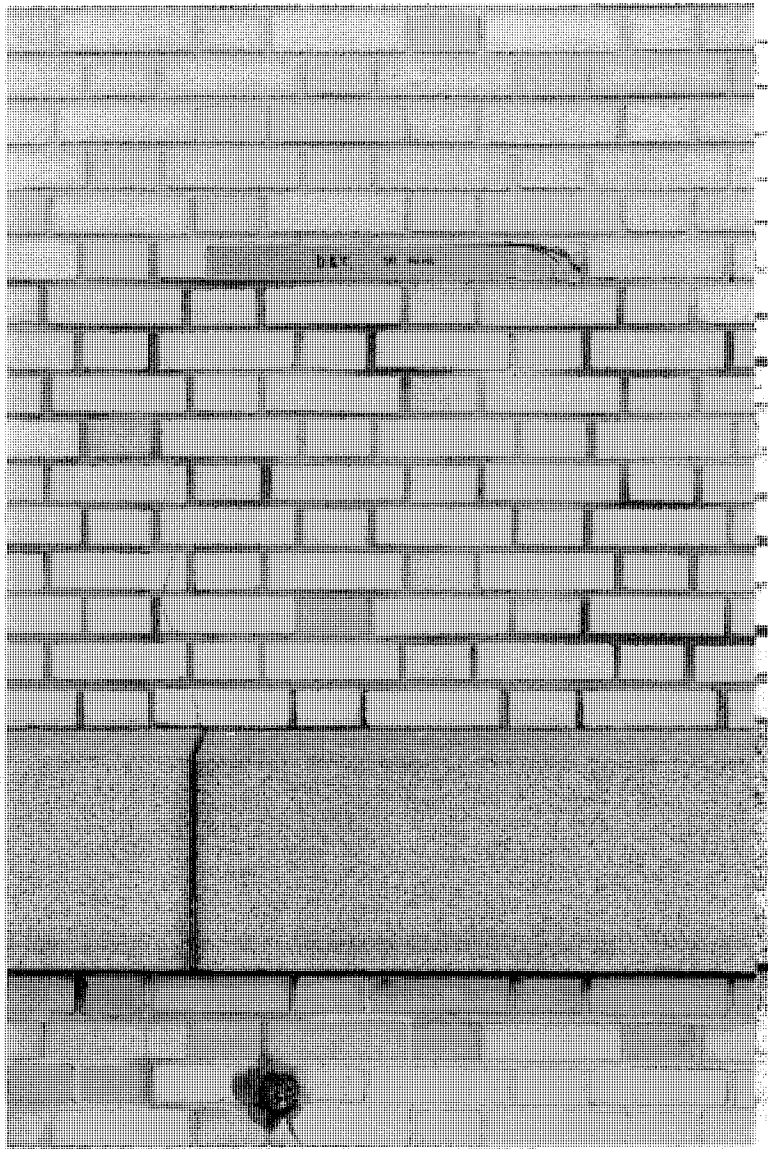
Figure 8-8

The detergent cleaning of the granite water table on the east elevation of Building 5 was unsuccessful.

The result of cleaning the light soiling of the granite with Method 1 is shown in Figure 8-8; no cleaning of the granite was achieved by this method. The results of Method 2 are documented in Figure 9. Good cleaning of the granite was achieved by this method; therefore the appearance resulting in the application of Method 2, as represented by Figure 8-9, is the recommended cleaning technique.

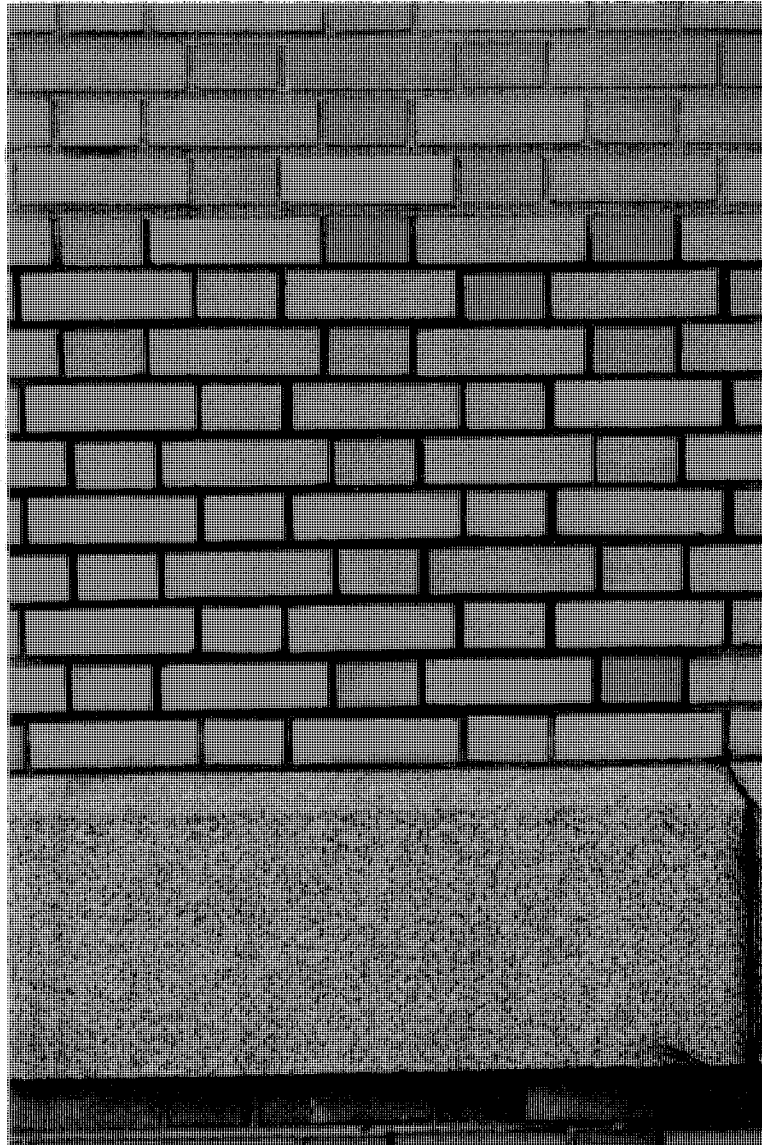
Figure 8-9

The lightly soiled granite was cleaned well by the alkaline pre-wash/acid after-wash system as seen here on the east elevation of Building 5. This method is recommended for the cleaning of all granite elements on Buildings 1, 5, 6 and 7.

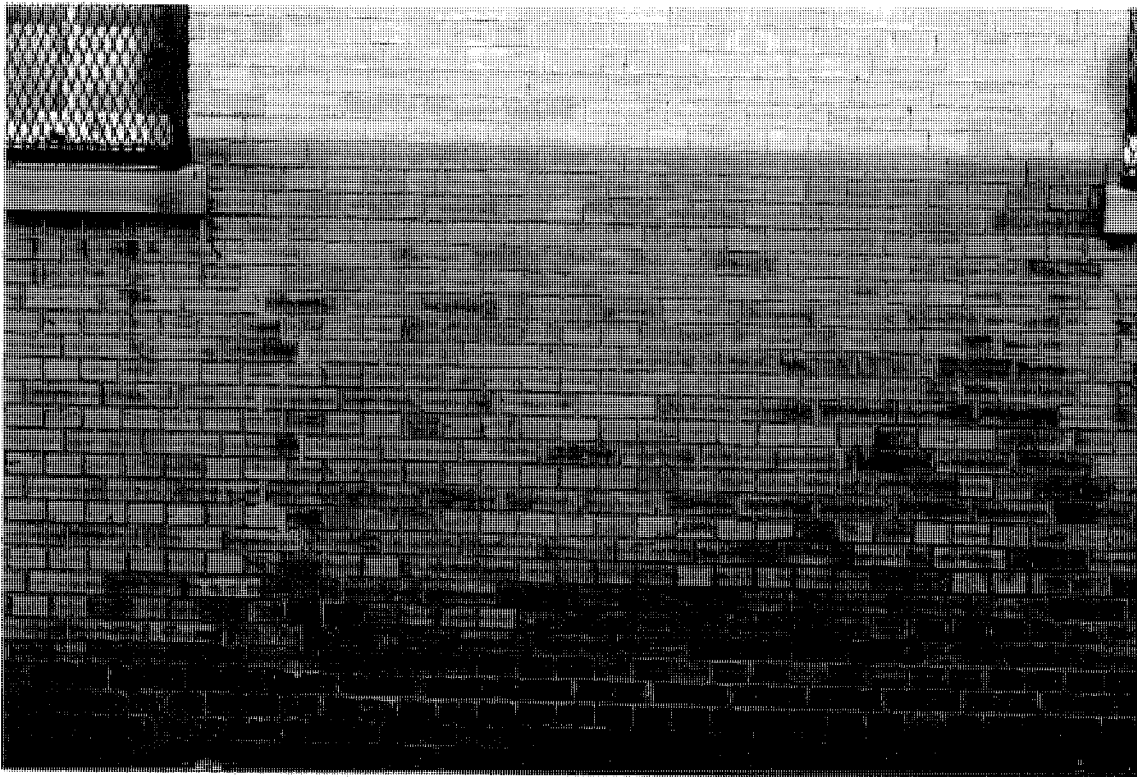
Figure 8-12

Soiling of the brick (Figure 8-12)

The soiling of the brick on Building 3 and 4 is more severe than on Buildings 1, 5, 6 and 7 as seen here on the elevation of Building 3. The brick on Buildings 3 and 4 is also different from the brick on Building 1, 5, 6 and 7.

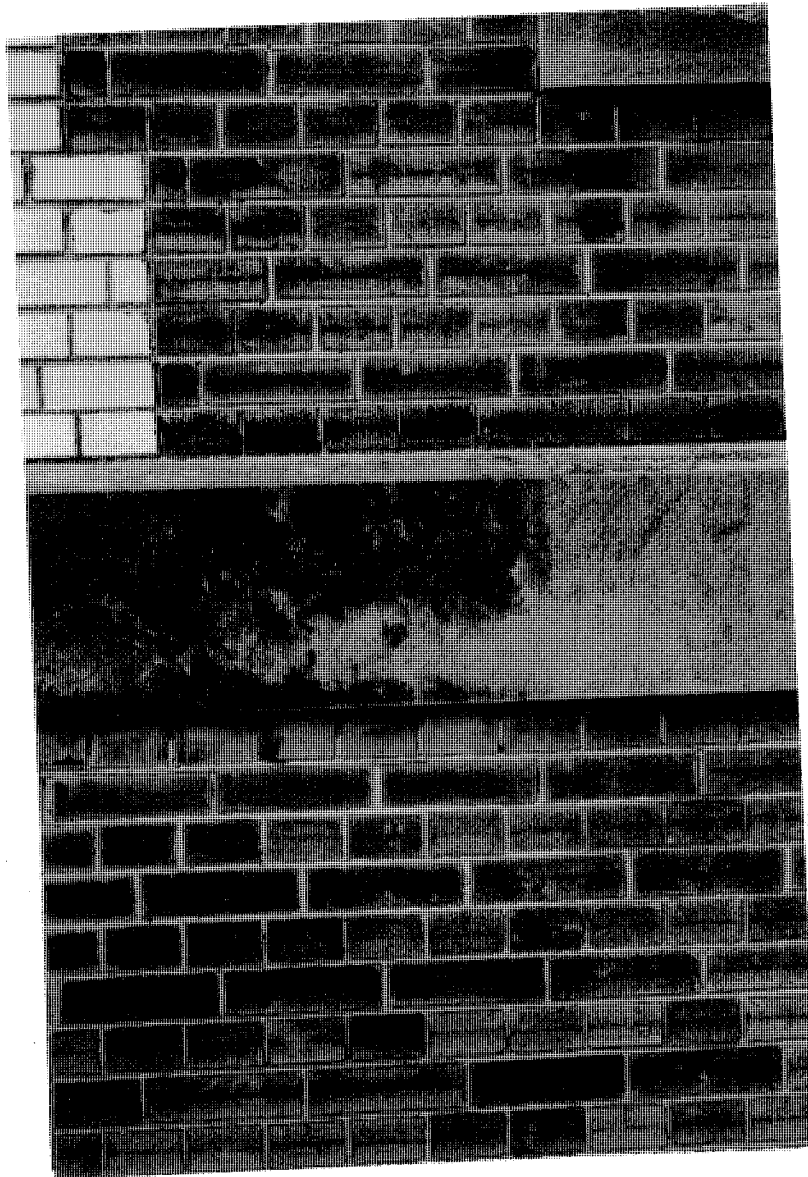
Figure 8-13

Soiling of the limestone (Figure 8-13)

The water tables (and other decorative elements) on Buildings 3 and 4 are limestone. This limestone is moderately soiled as seen here on the elevation of Building 3.

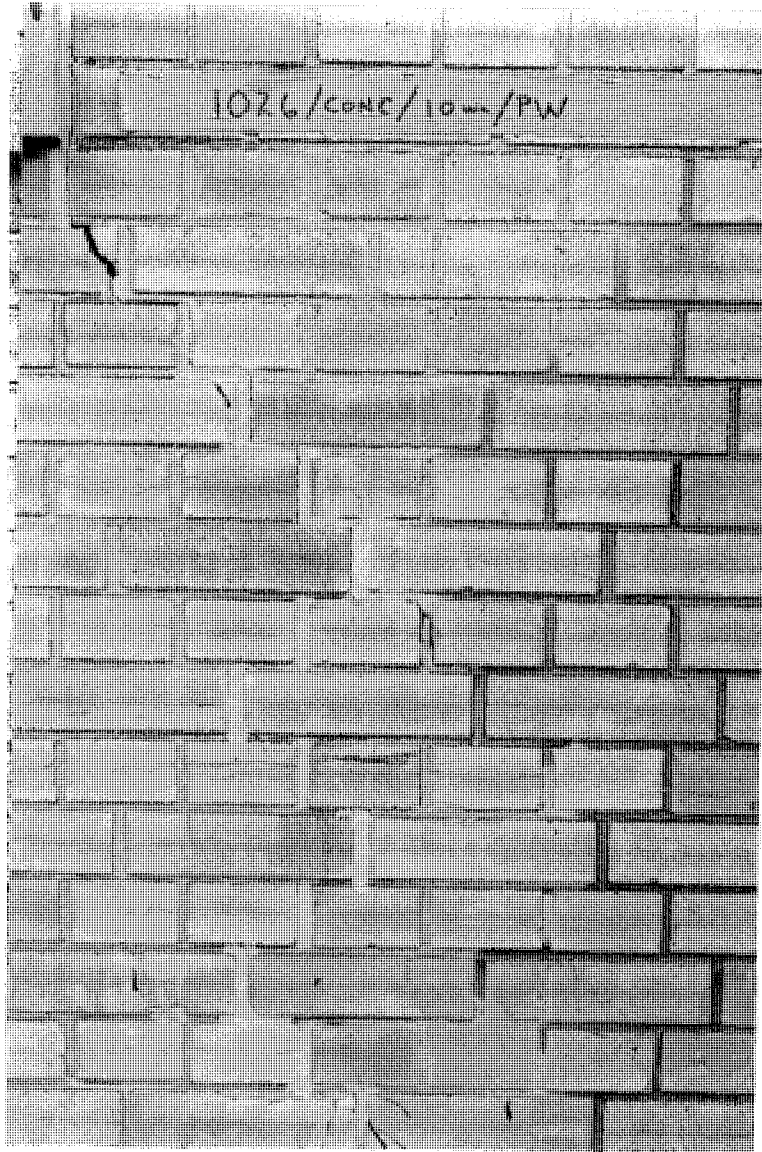
The result of cleaning the soiling of the brick with Method 2 is shown in Figure 8-15 (the before condition is seen on the middle-left side of Figure 12). No cleaning has been achieved by this method. The result of cleaning the soiling of the brick with Method 1 is shown in Figure 8-14 (the before condition is seen on the left side of Figure 8-12). No cleaning has been achieved by this method. The result of cleaning the soiling of the brick with Method 3 is shown in Figure 16 (the before condition is seen on the middle right side of Figure 8-12). No cleaning has been achieved by this method.

A cleaning test was executed with PROSOCO'S 1026 detergent on the brick of the south elevation of Building 3. No cleaning was achieved by this method (the left side of Figure 12 shows this area before cleaning).

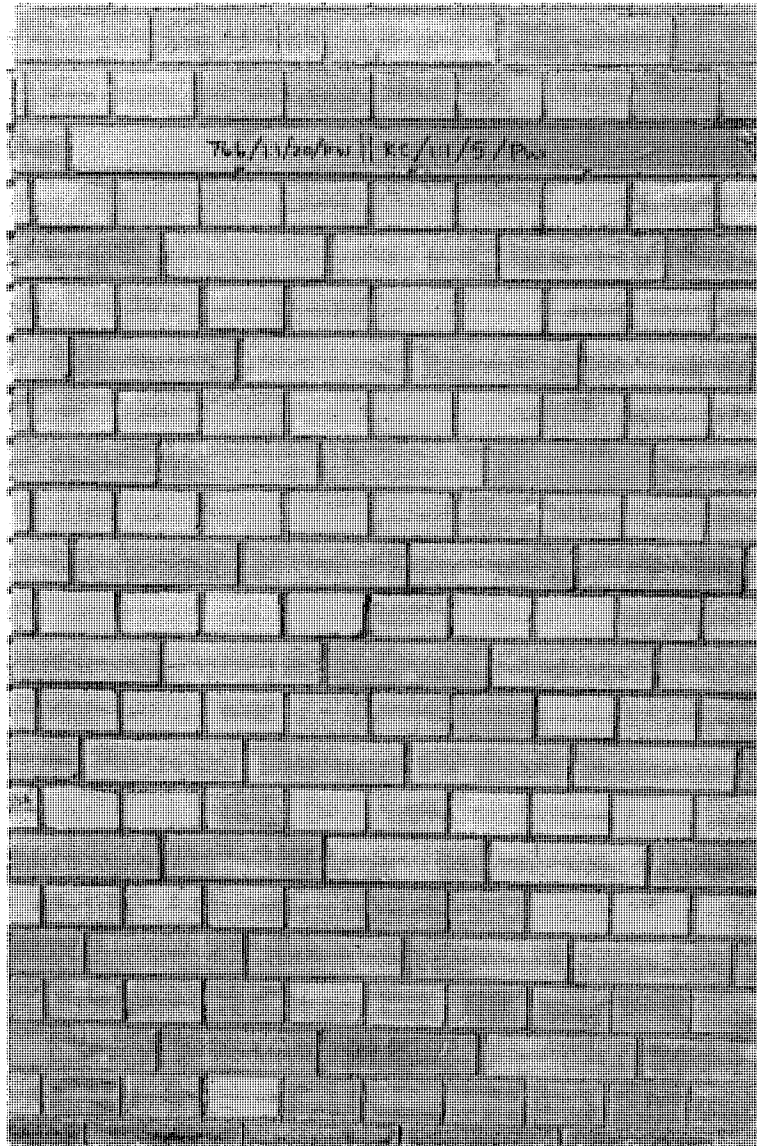
Figure 8-15

Cleaning tests on the brick of Building 3 were also executed with an alkaline pre-wash/acid after-wash system. The results shown here on the south elevation of Building 3 indicate that no cleaning was achieved by this method.

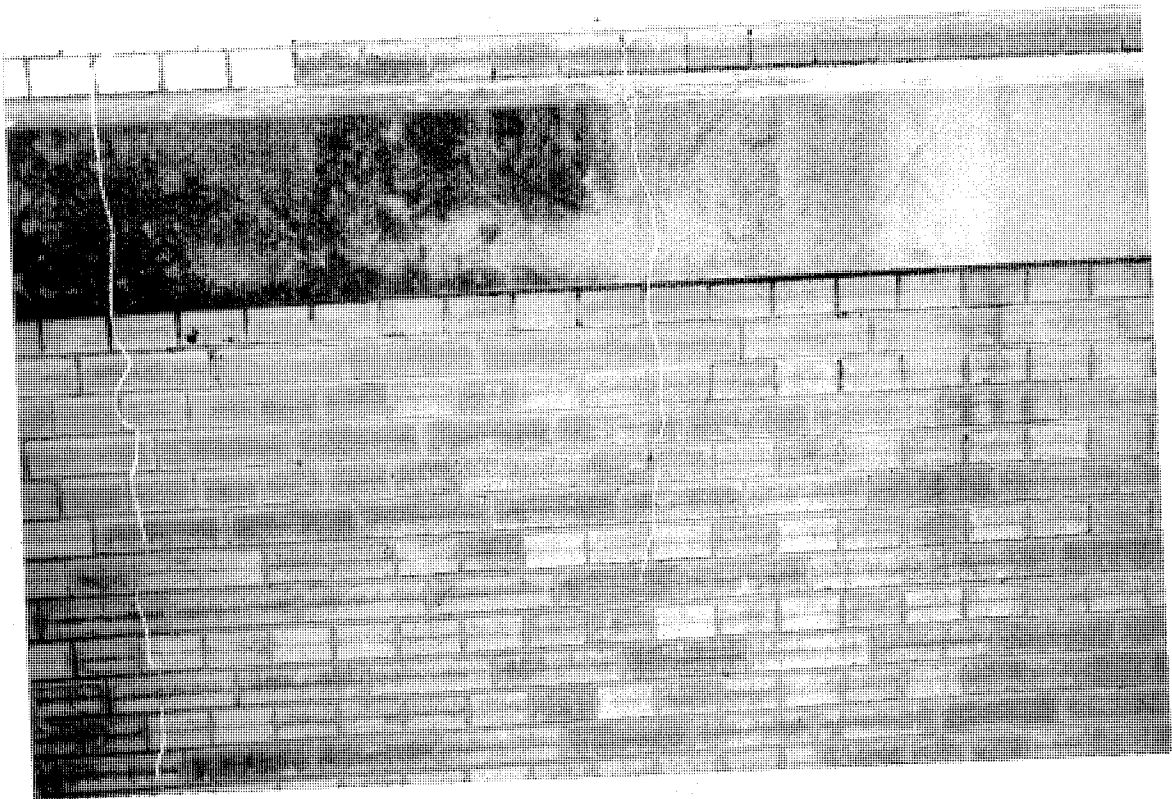
Figure 8-16

Cleaning tests were executed on the brick of Building 3 using increased concentrations in the alkaline pre-wash/acid after-wash system. Again, no cleaning was achieved as shown here on the south elevation of Building 3.

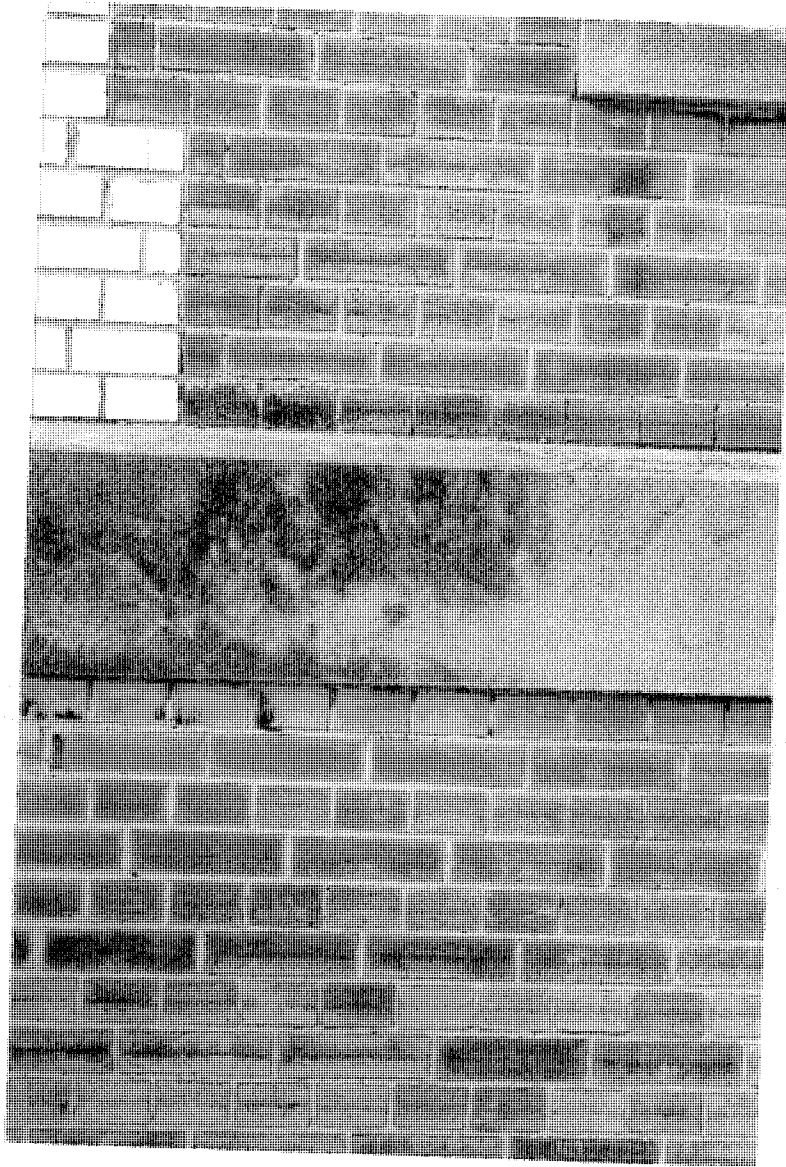
Figure 8-17

Figure 17 shows the brick before cleaning with method 4 (misting method) and Figure 18 result after 24 hours of misting. Little or no cleaning of the brick was achieved. For testing method 5, a representative area was chosen on the south elevation of Building. The poultice was applied as outlined above, and the result was poor, the poultice can be seen in Figure 19. The poor result of cleaning by Method 6 is seen in Figure 20.

A section of the brickwork on the east elevation of Building 4 was cleaned with the water misting method. On the lower left the brick (and the limestone water table) can be seen before cleaning.

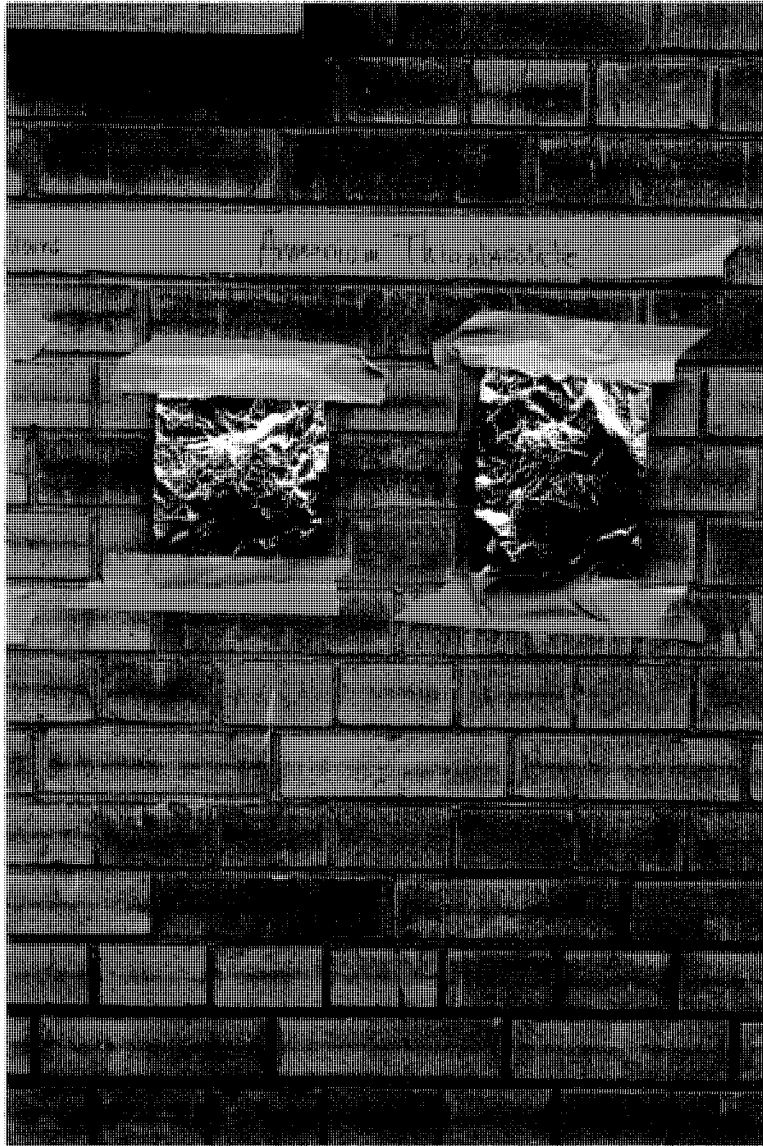
Figure 8-18

After 24 hours of water mist here on the east elevation of Building 4 the appearance of neither brick nor the limestone water table has altered significantly.

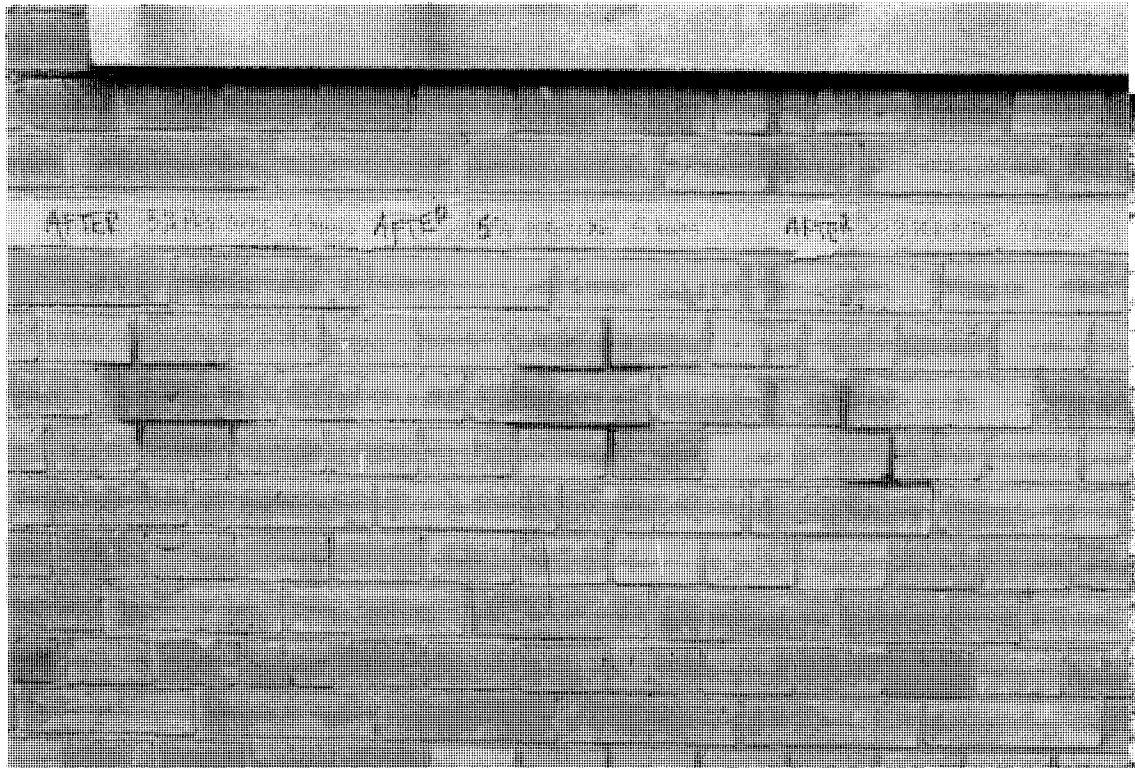
Figure 19

Application of ammonium thioglycolate poultice to brick to remove soiling from Buildings 3 & 4. Note the typical soiling conditions immediately adjacent to the poultices at Building 3.

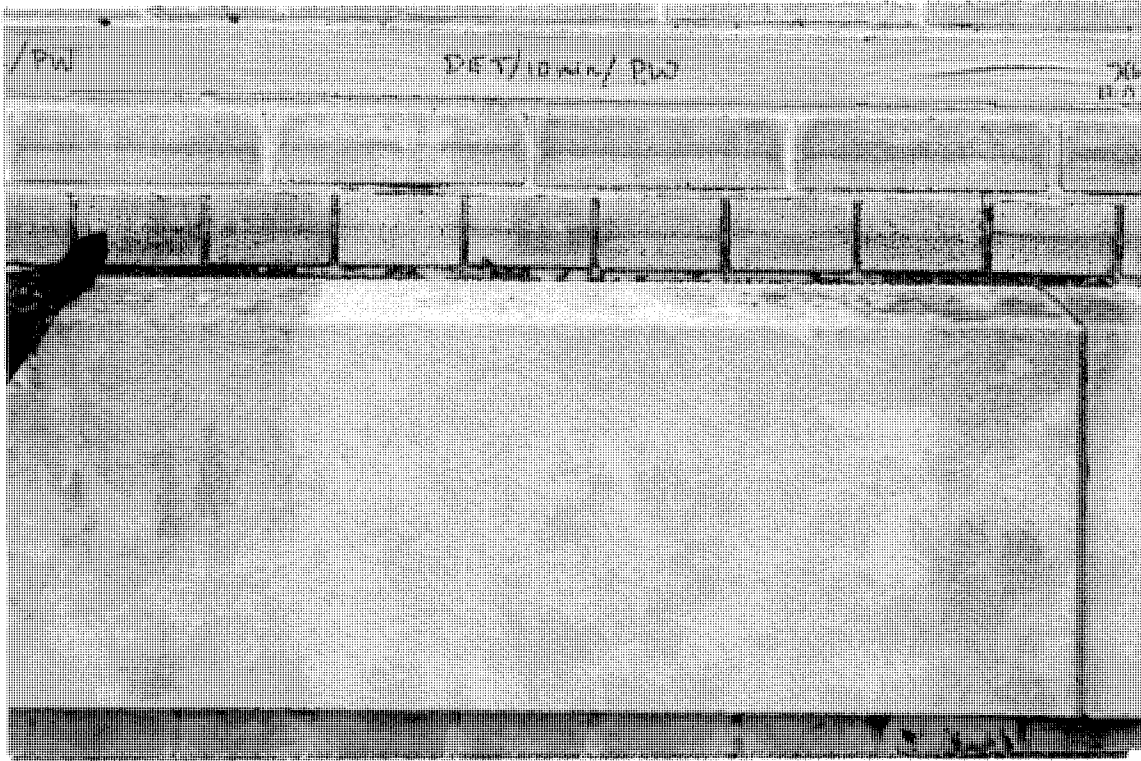
Figure 20

None of the examined cleaning methods proved to be a successful soilant removal technique. At this time, no recommendation can be made to adequately clean the surfaces of the brick without unduly and irreparably damaging the bricks' surfaces. Given that the numerous cleaning methods yielded either marginal or disappointing results, it appears likely that this soiling issue is inorrectable.

Unsuccessful results of the hydrogen peroxide cleaning tests; there was little or no change from "before" and "after" on Building 3.

Abrasive cleaning techniques should not be used since their application may likely damage the substrate beyond repair. Future testing, if it is deemed necessary, may consist of an application of PROSOCO's BIOKLEAN, which is specifically formulated for eliminating biological growth.

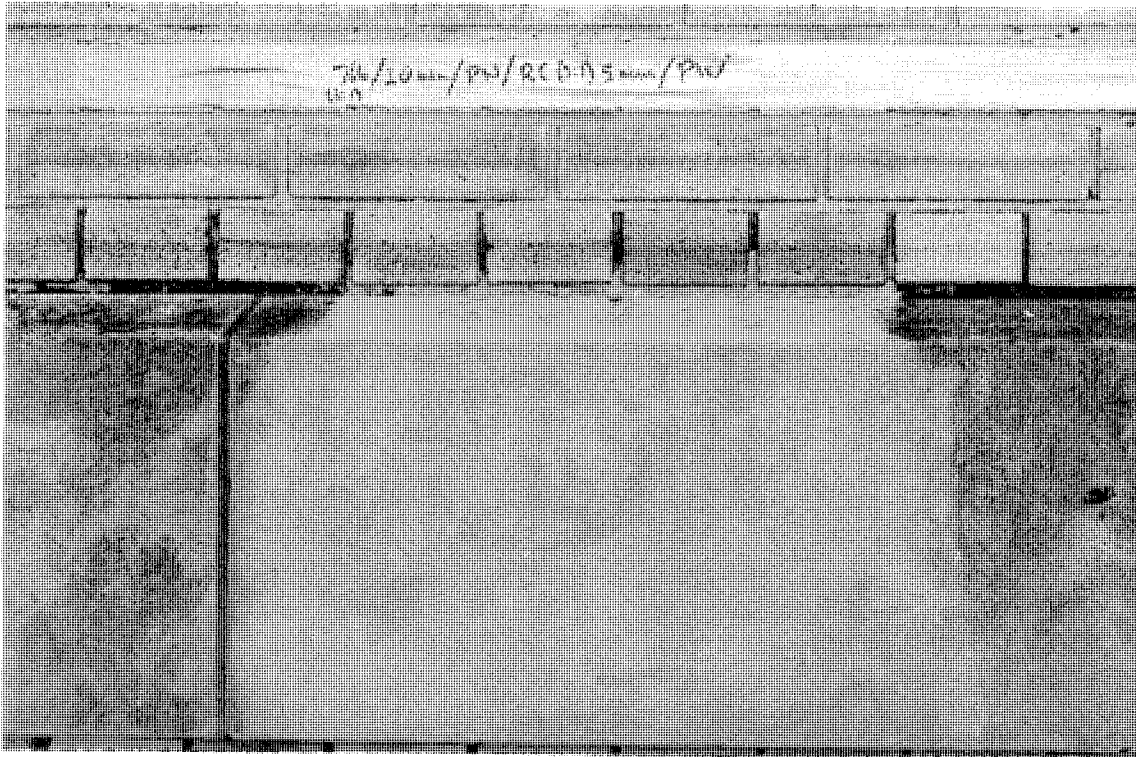
Figure 8-21

A section of the limestone water table on the north elevation of Building 4 was cleaned by several methods. Here can be seen the result when cleaning with a detergent followed by power washing. Good cleaning is achieved with little harm to the substrate. The before cleaning condition can be seen to the left and the to the right of the cleaned area.
