Potomac Annex: Buildings 1 & 3-7

Historic Structures Report, Corrected Final Submission
General Services Administration Project Control Number: 44007

September 9, 1997

BUILDING 1: EXTERIOR EXISTING CONDITIONS

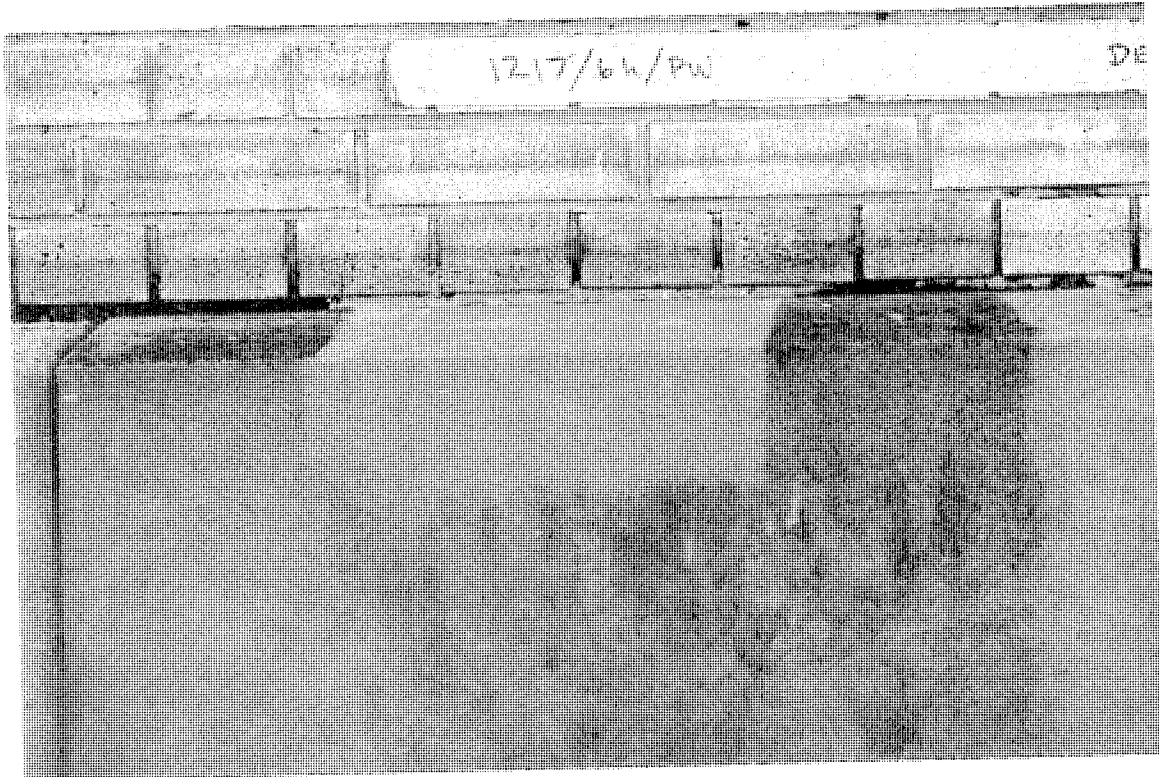
Figure 8-22

A section of the limestone water table on the north elevation of Building 4 was also cleaned by the alkaline pre-wash/acid after-wash method. Good cleaning is also achieved but the method is more aggressive on the substrate. The before cleaning condition can be seen to the left and the to the right of the cleaned area.
