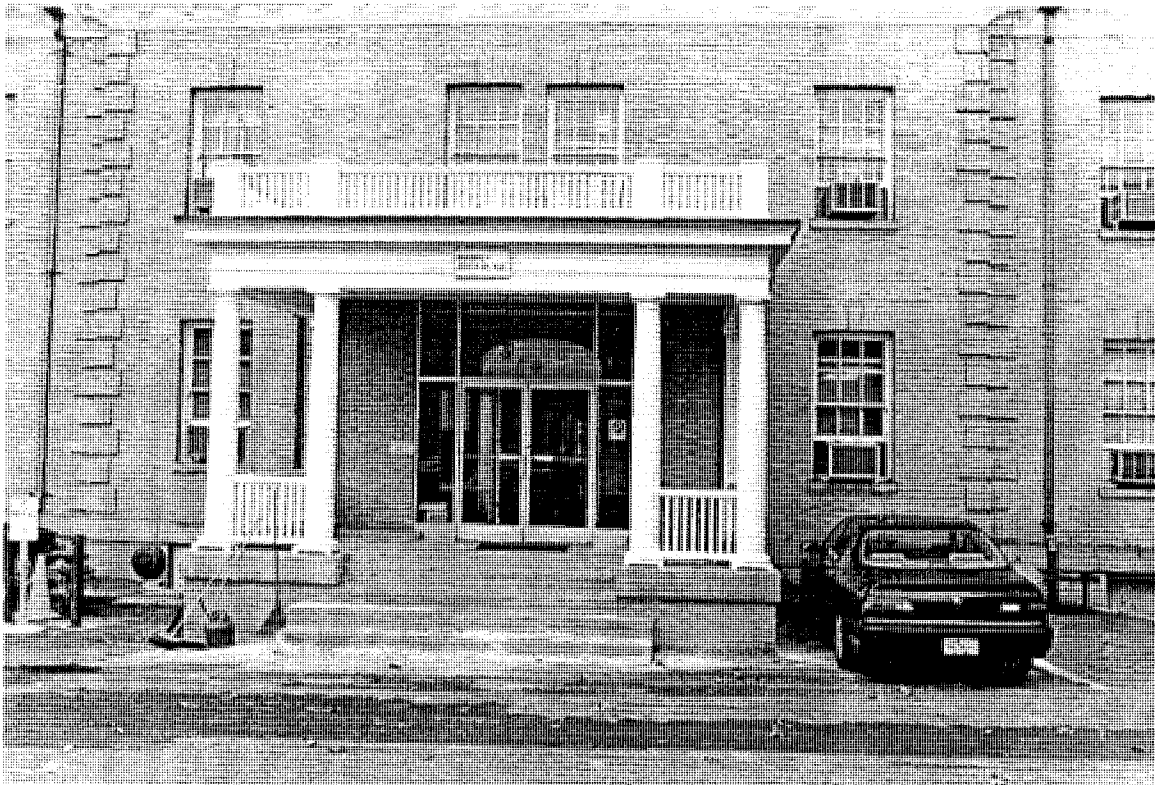
Figure 1-2.

Building 1. East elevation, entry portico. The aluminum framed glass doors infill what was originally a recessed entry. Presumably at that time, the original wood and glass doors, fanlight and sidelights were also replaced, creating an interior vestibule. The new infill detracts from the architectural character of the portico and the building. The balustrade on the roof of the portico was replaced, and the columns repaired during the summer of 1994.

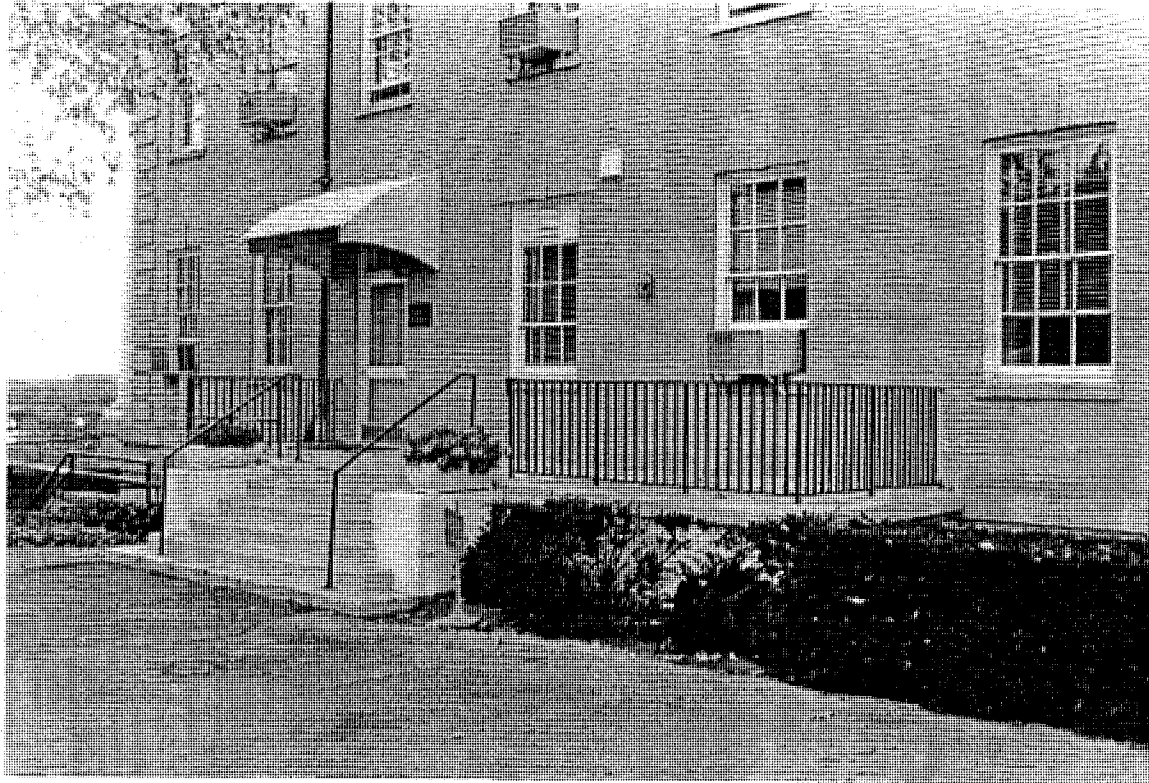
Figure 1-3.

Building 1. East elevation, south end. This entry to the Surgeon General's office was created from an original window opening. The brick infill in the window opening to the right, indicates that this is the original opening.

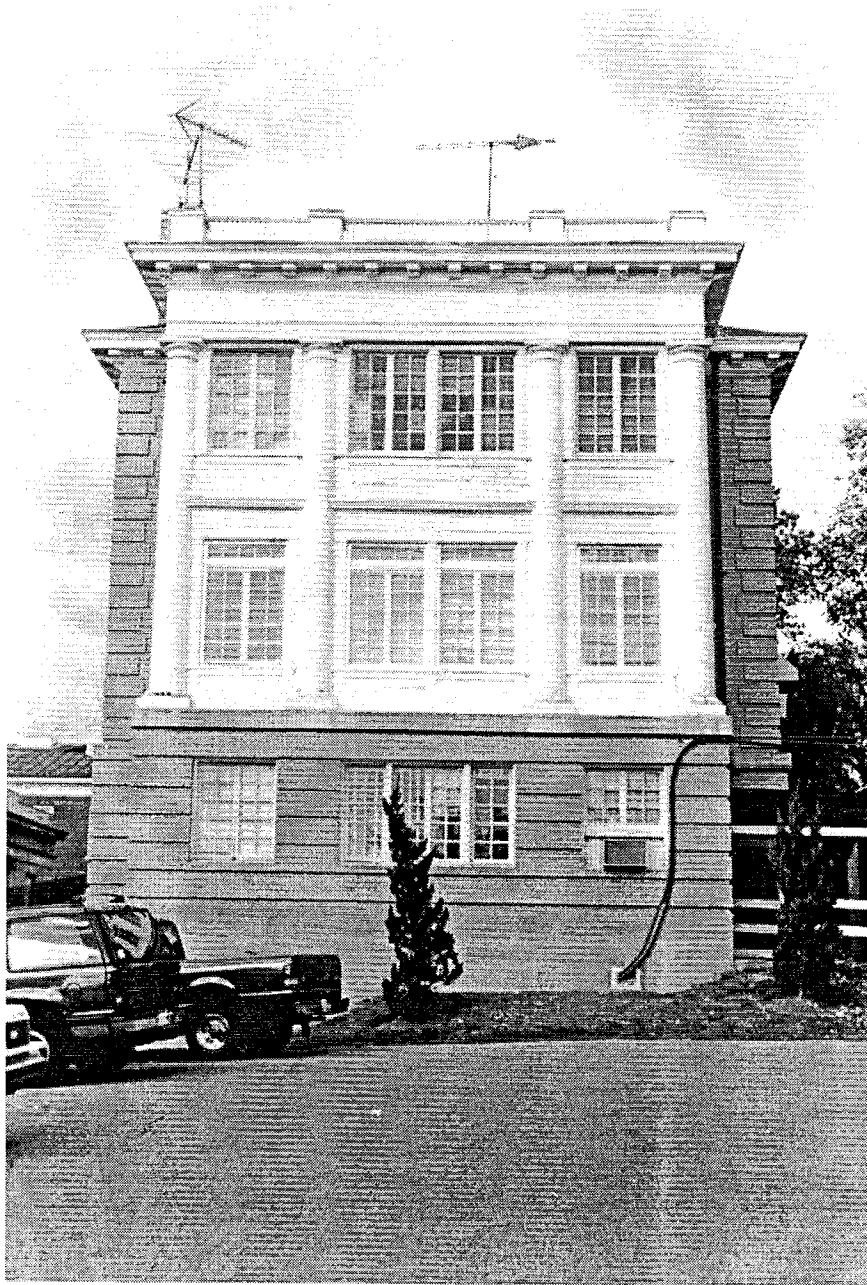
Figure 1-4.

Building 1. South elevation, sun porch. This sun porch was constructed as part of the 1926 addition. The structure, configuration and windows all probably date to that time. Paint failure is evident on the columns and spandrel panels under the windows.

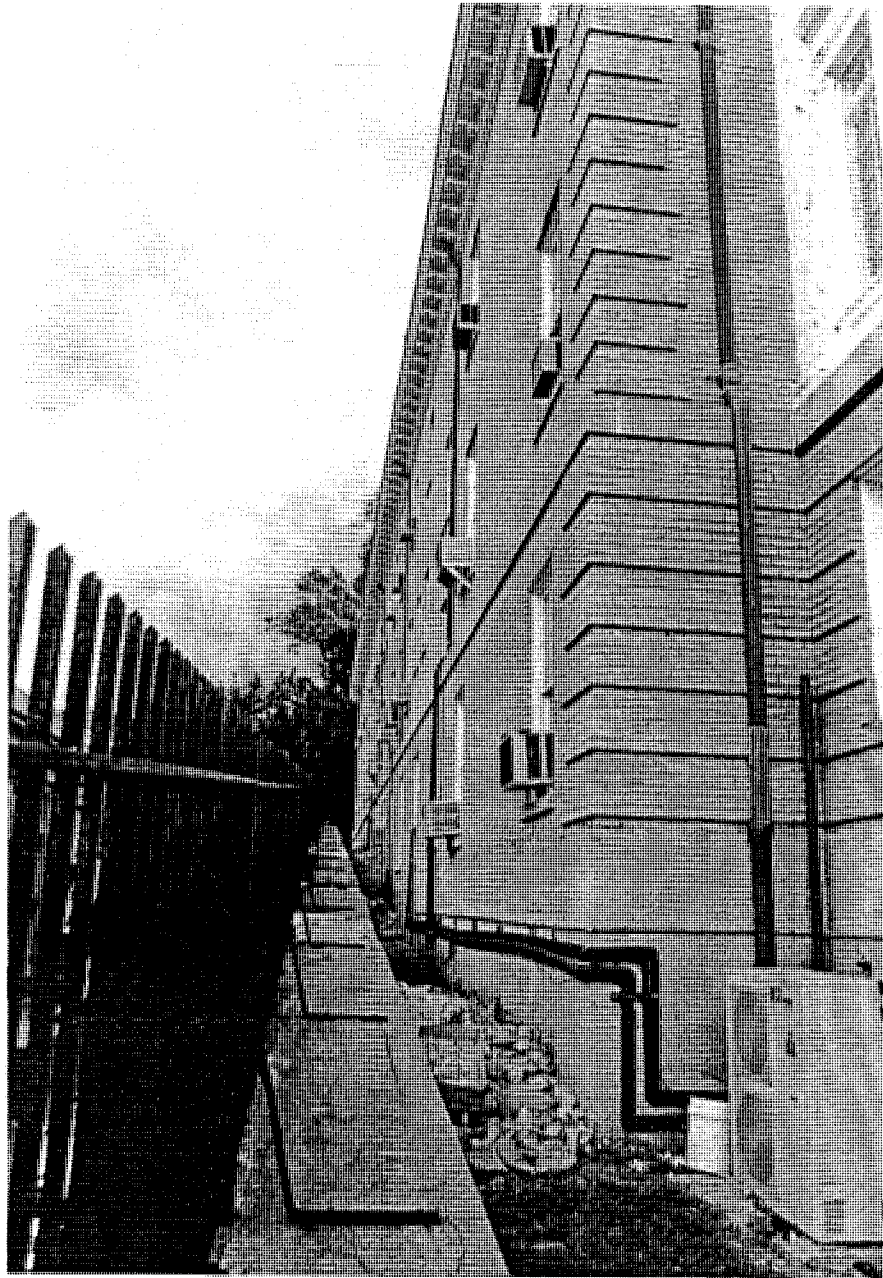
Figure 1-5.

Building 1. West elevation. The retaining wall and iron fence, represents the property line. Note electric cables running across and into building.

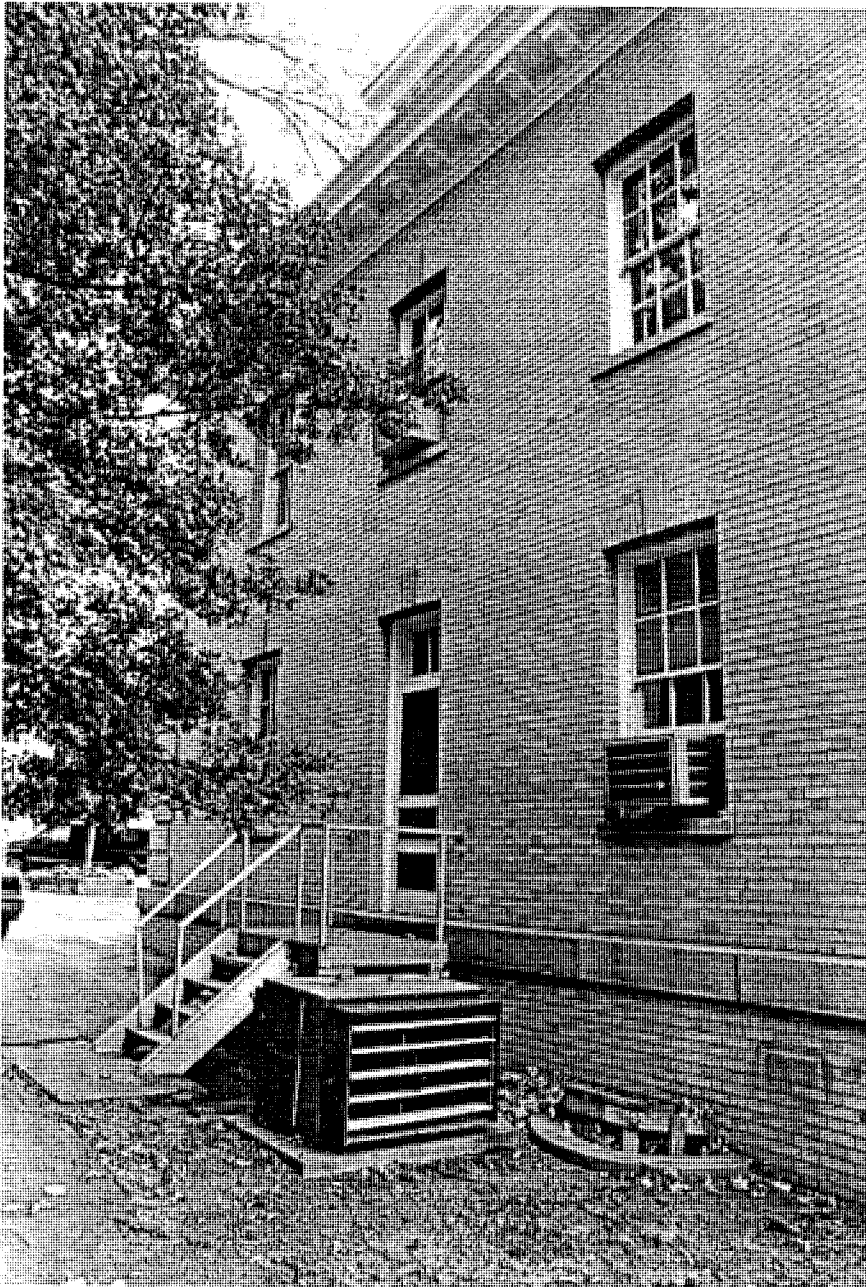
Figure 1-6.

Building 1. North elevation. This entry was created from an original window opening; ghosts of former railings and stoop are evident in the masonry. The opening is a sensitive addition; however, the existing stoop and railing are of poor quality and condition.

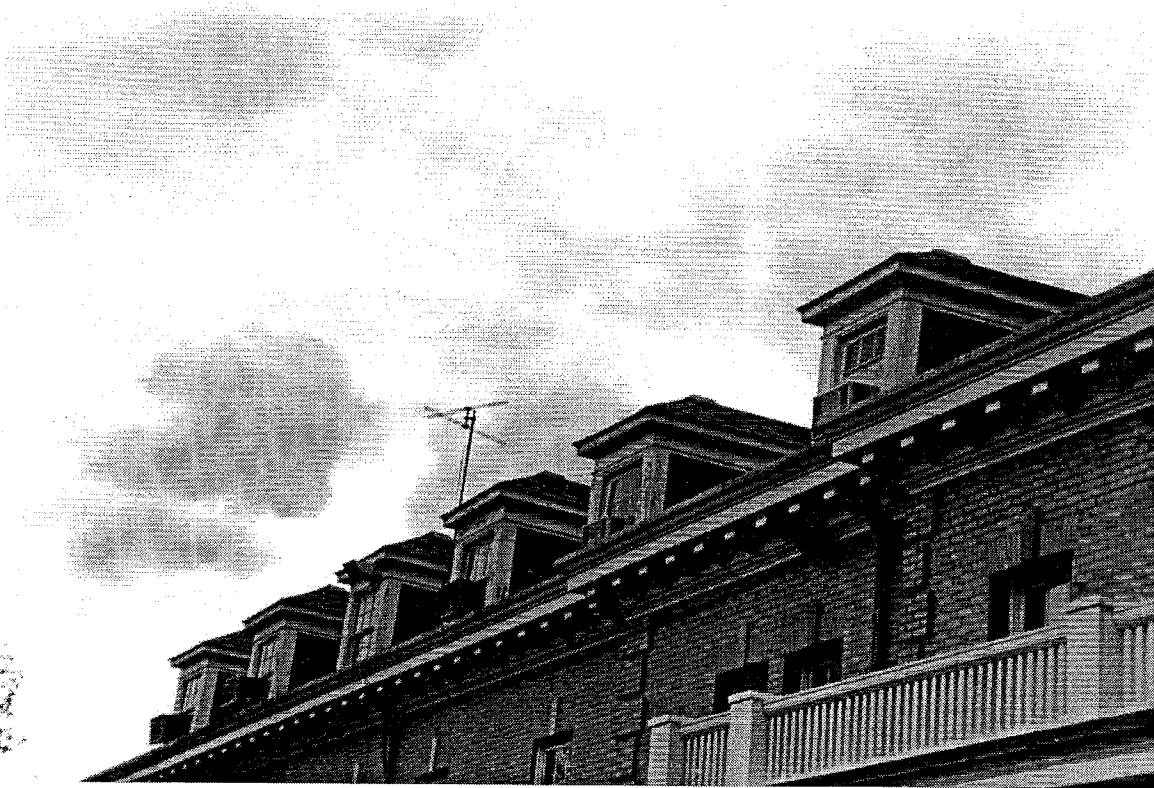
Figure 1-7.

Building 1. Cornice, roof and dormers. The painted wood cornice is generally in good condition. The dormers and roof are clad with slate, which is mismatched and in varying degrees of condition.

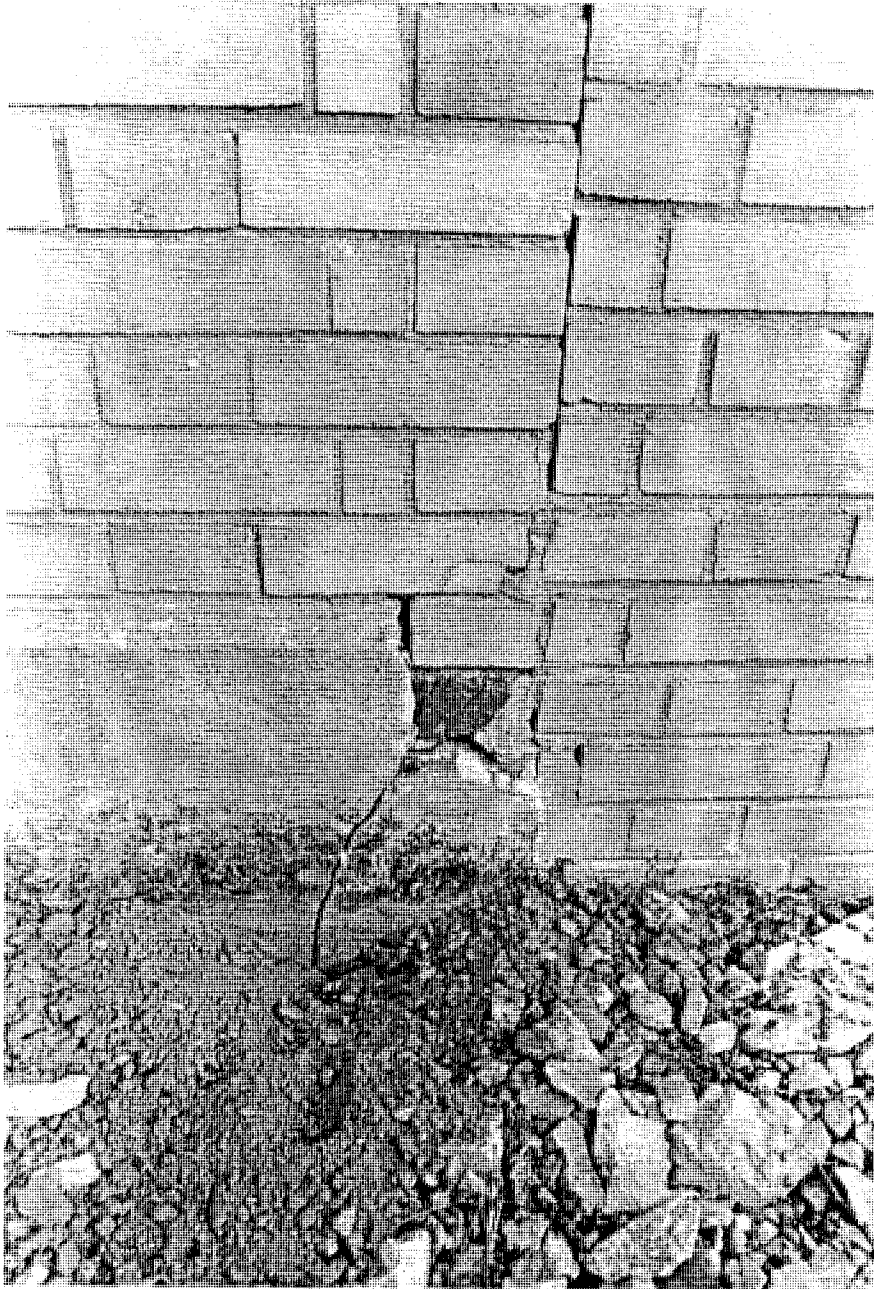
Figure 1-10.

Building 1. West elevation. The joint between the bricks in the original 1908 section and the 1925-26 addition on the rear is open. This occurs at the basement level only, no joint is evident above the belt course, or on the front of the building.

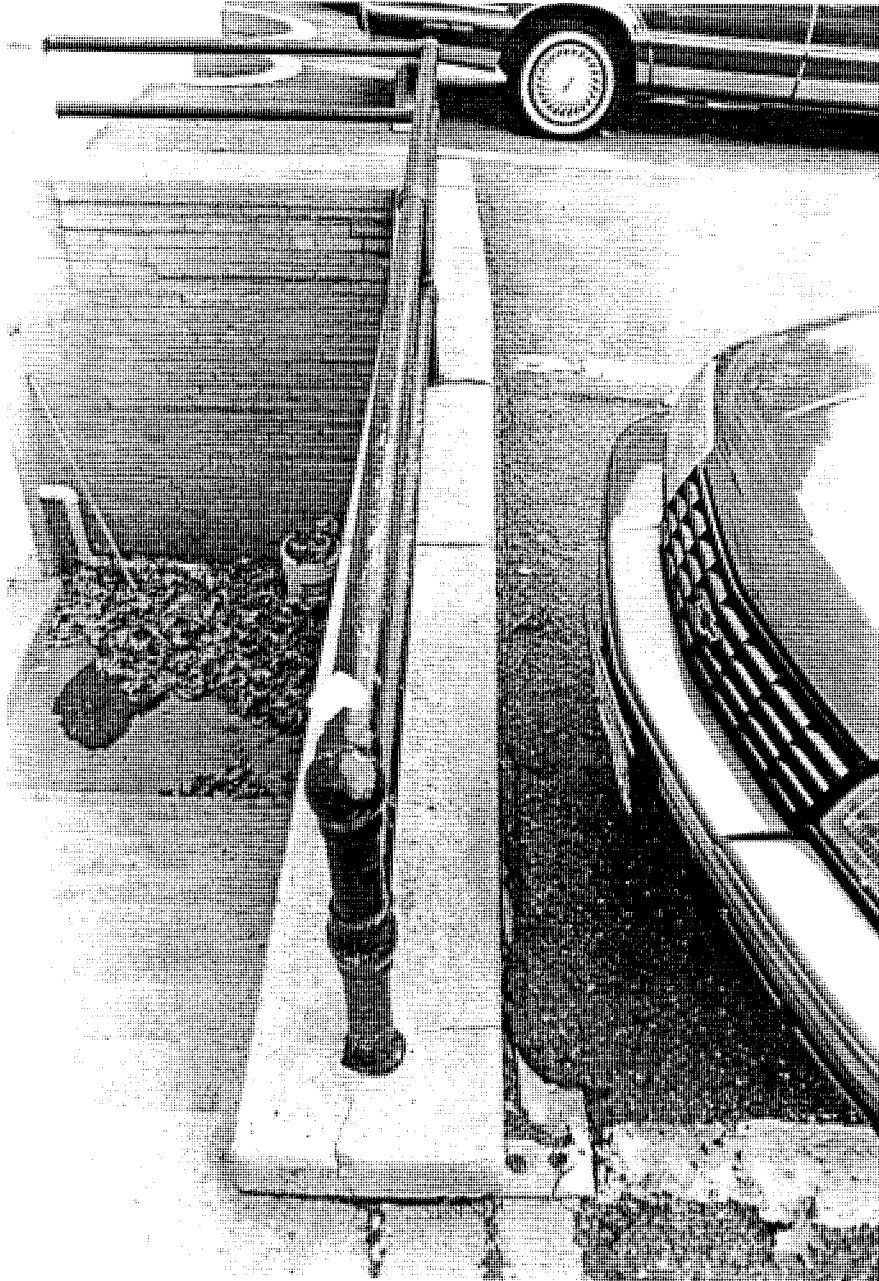
Figure 1-12.

Building 1. Concrete stairs leading to the areaway on the east side of building. Note cracks in the concrete curb in the foreground, and misalignment of the rear sections. Also note displacement of bricks at the rear.

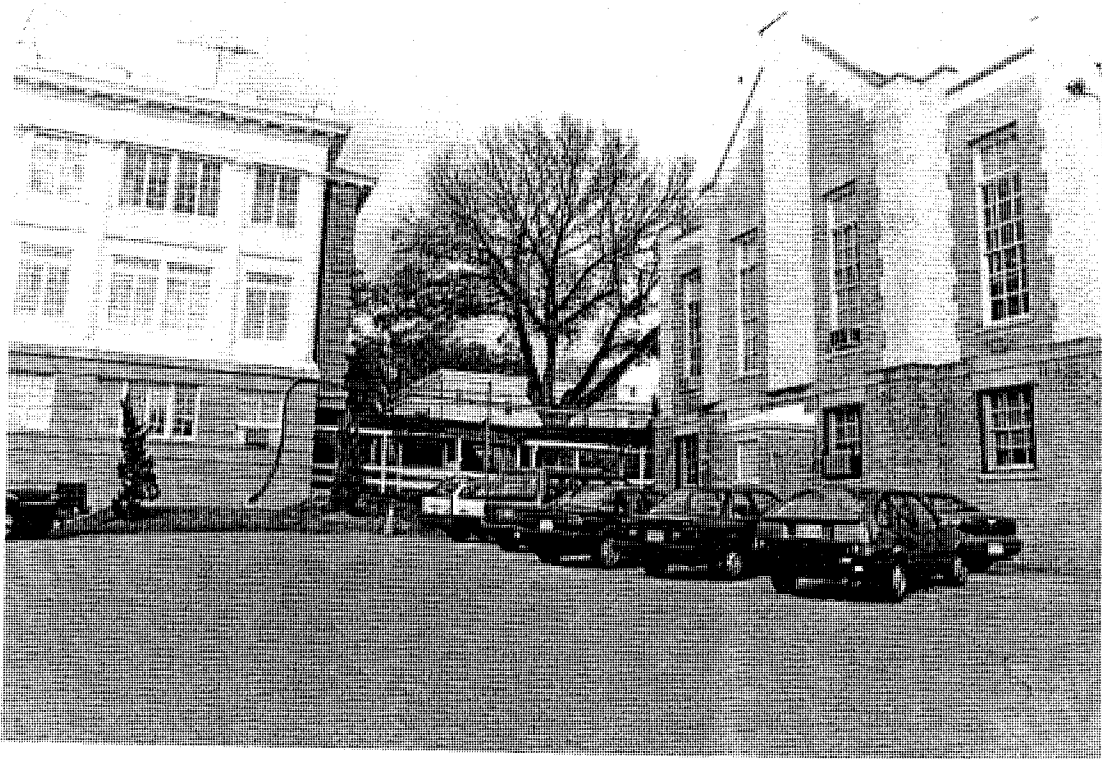
Figure 1-13.

Building 1. View of the south elevation of Building 1 and the west elevation of the northeast pavilion of Building 3. Note the covered walk between the two buildings, and wide expanse of parking. Asphalt parking covers a large percentage of the site and detracts from the overall appearance of the setting. Parking immediately adjacent to the buildings leads to impact damage.

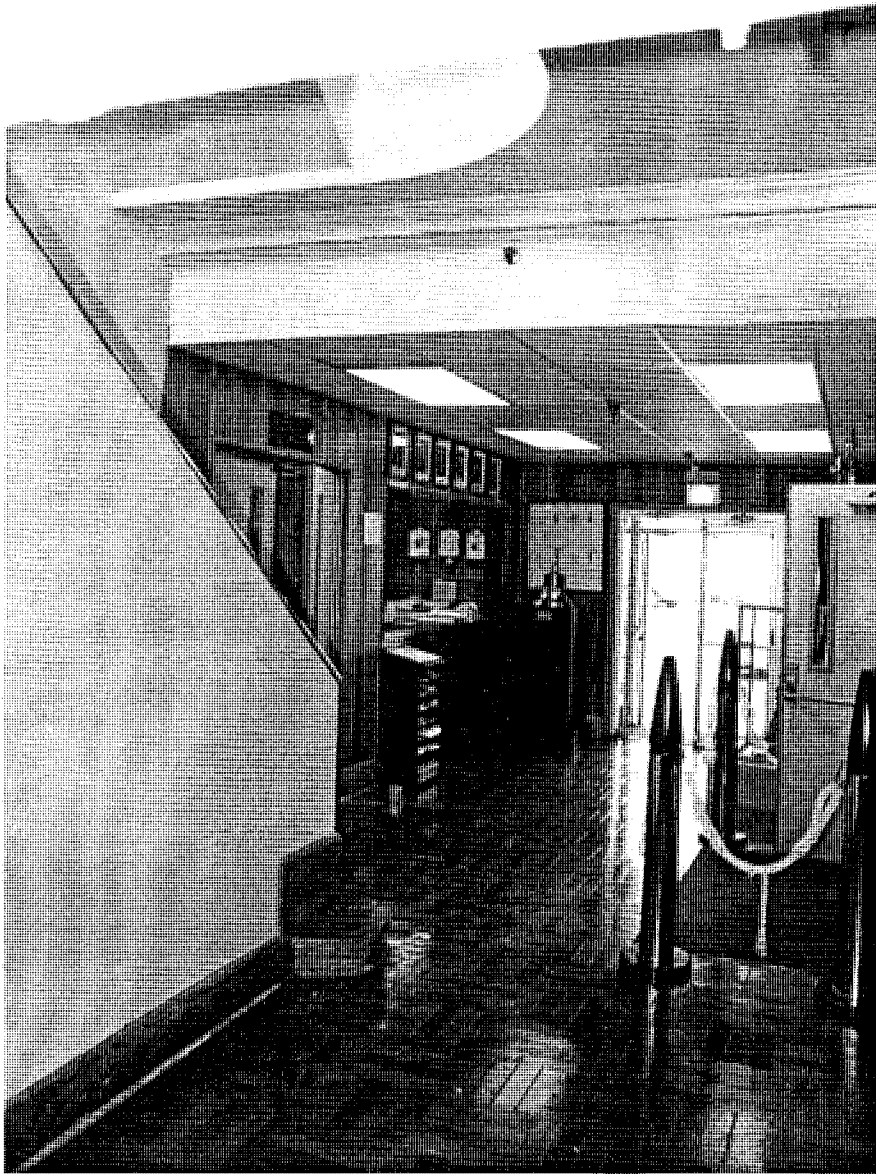
Figure 1-14.

Building 1. View of lobby looking toward main entry. Note how non-original materials and treatments have compromised the space. The suspended ceilings, flush varnished wood interior doors and aluminum entry doors, and stair banister infill, all obscure or replaced original materials and finishes.

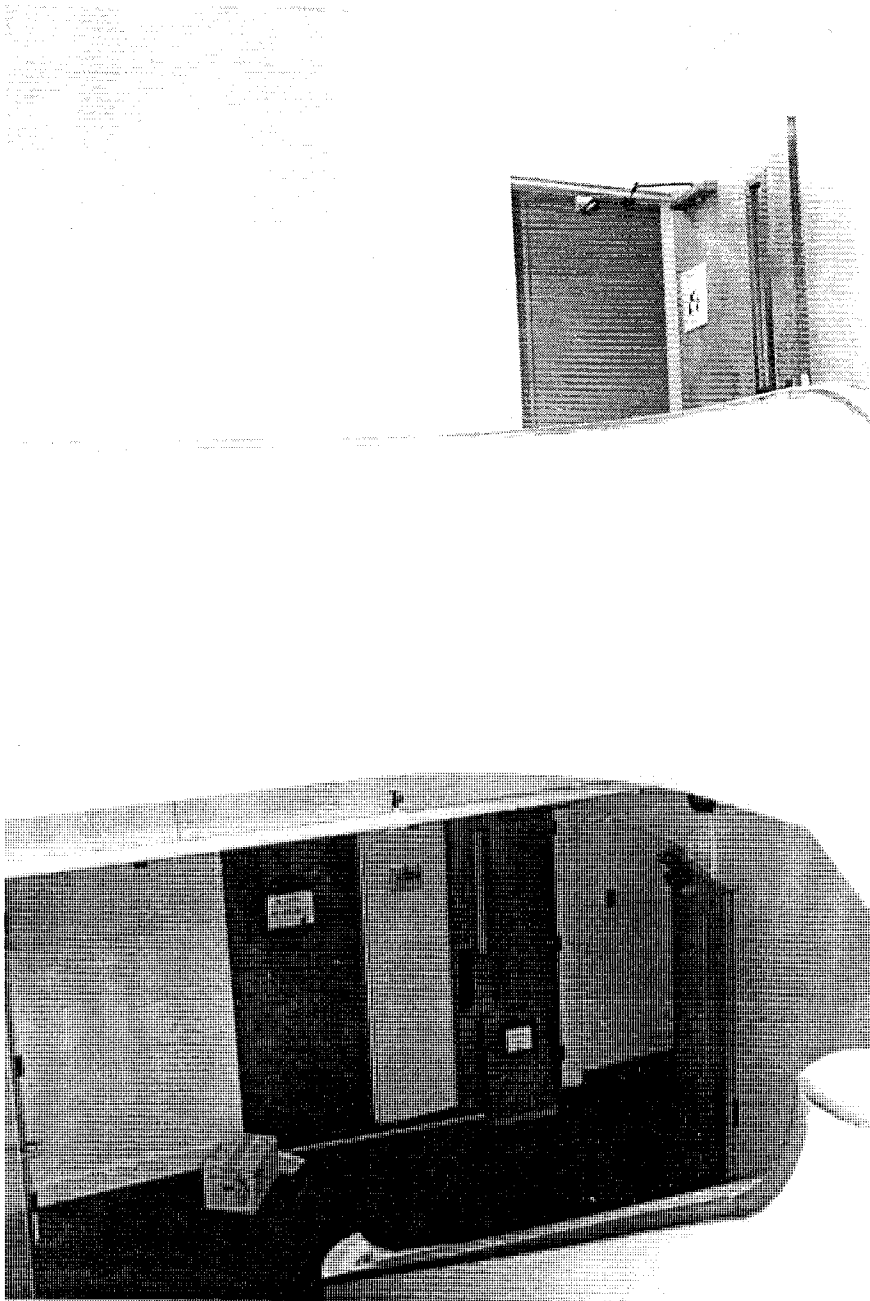
Figure 1-16

Building 1. View of the north stair from the landing between the second and third floors. Note how non-original partitions compromise the third-floor landing, and how non-original varnished wood doors impact the spaces.

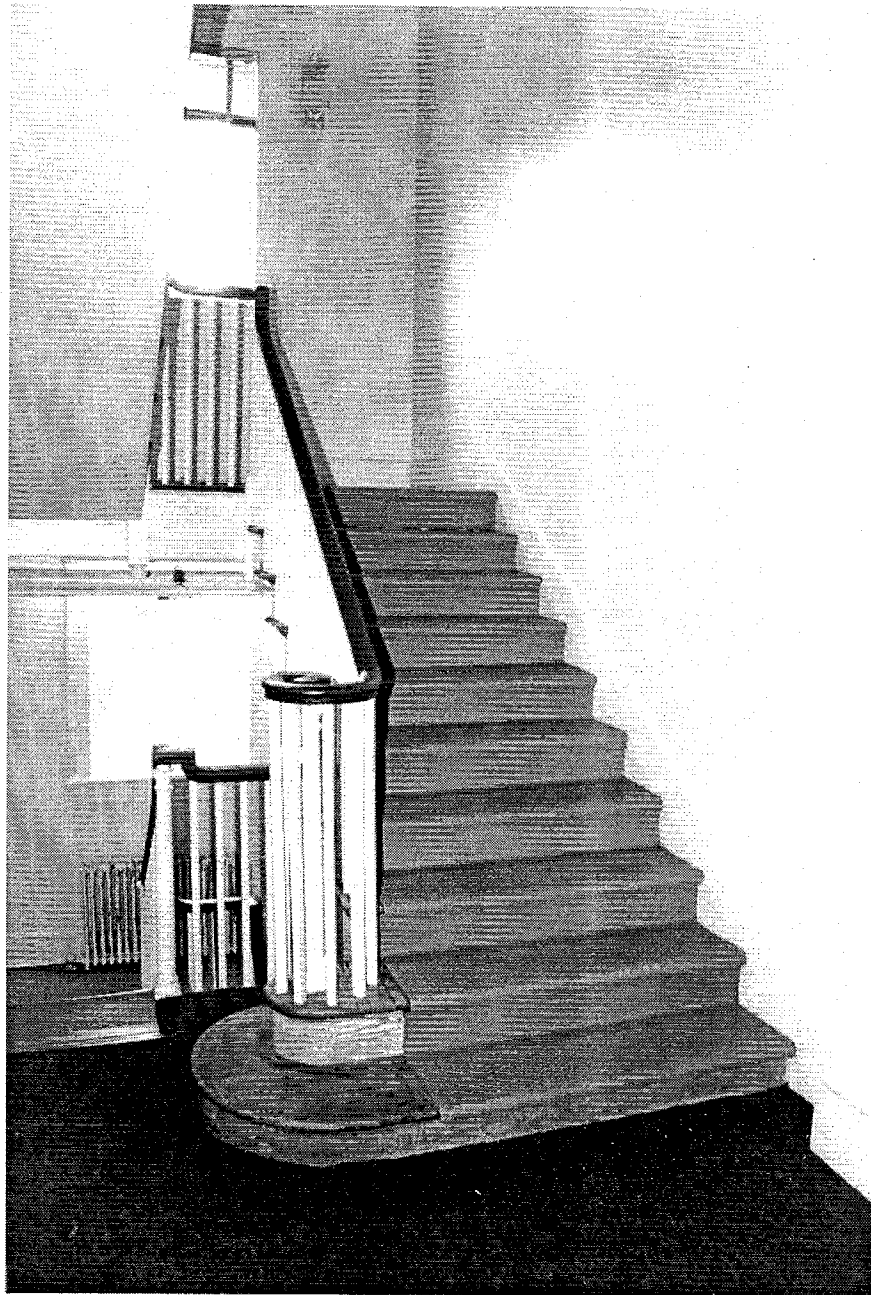
Figure 1-17

Building 1. View of the south stair from the first floor. Vinyl anti-skid flooring is a minor detraction, but the stair is generally intact and in good condition.

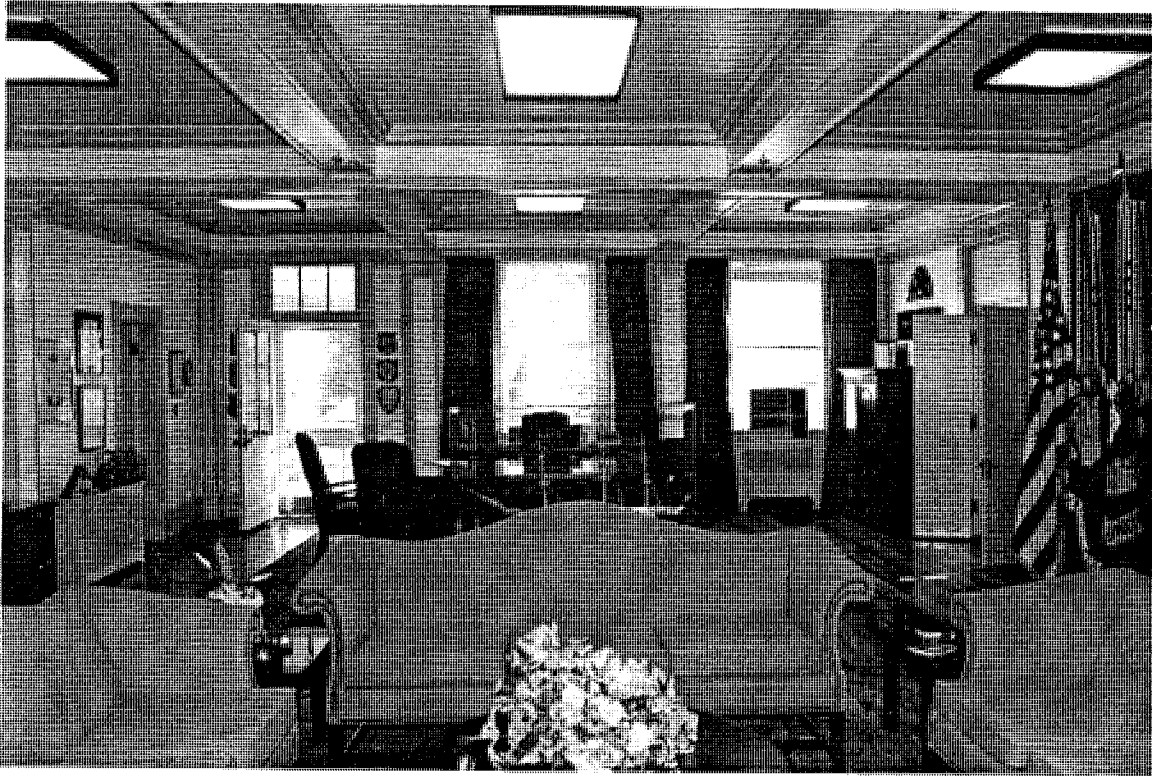
Figure 1-18

Building 1. Surgeon General's office (Rooms 1119, 1120, 1121) looking east. This room is the most intact and, therefore, most significant historic space in the building. The dropped beam ceiling is unique in the building. Fitting the original wood doors with flush panels (example at right) detracts from the quality of the space as do the fluorescent ceiling fixtures.

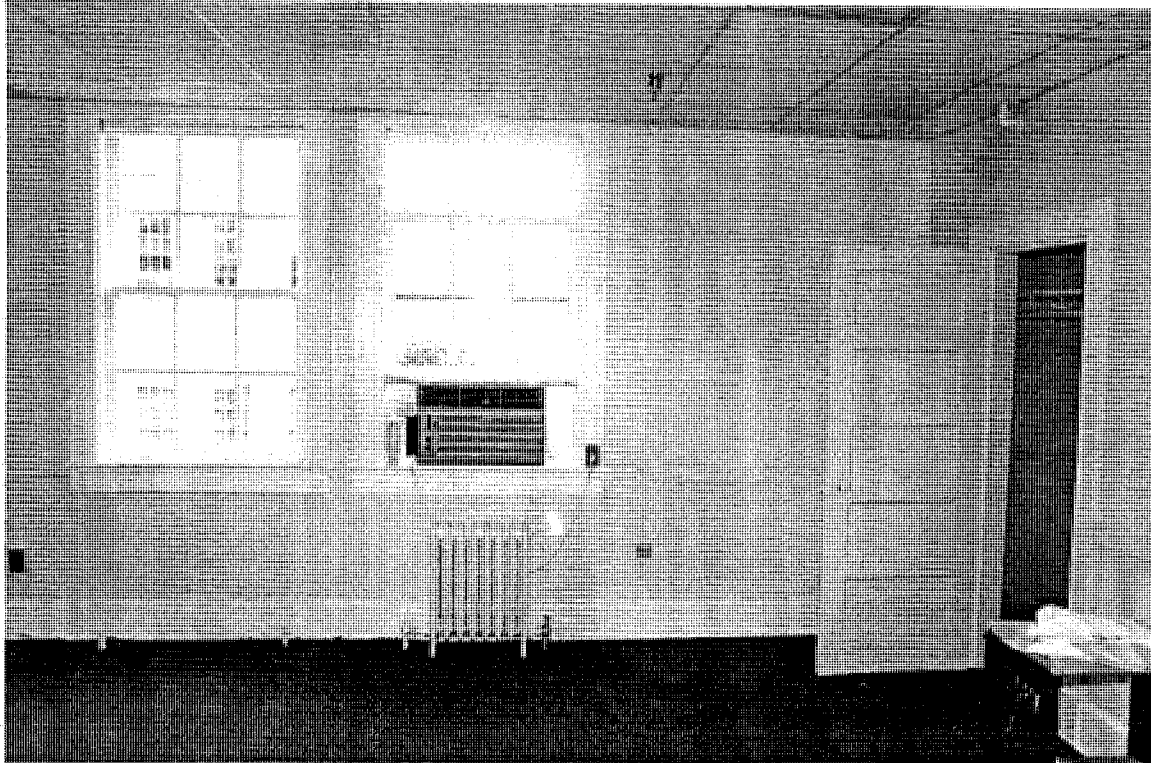
Figure 1-23

Building 1. Room 1202. The five-panel closet door, door frame, windows and window frame and base board are original. These details are typical throughout the building. The chair rail may be original. Note how suspended ceiling interferes with the top of the window frames and compromises the architectural character of the space.

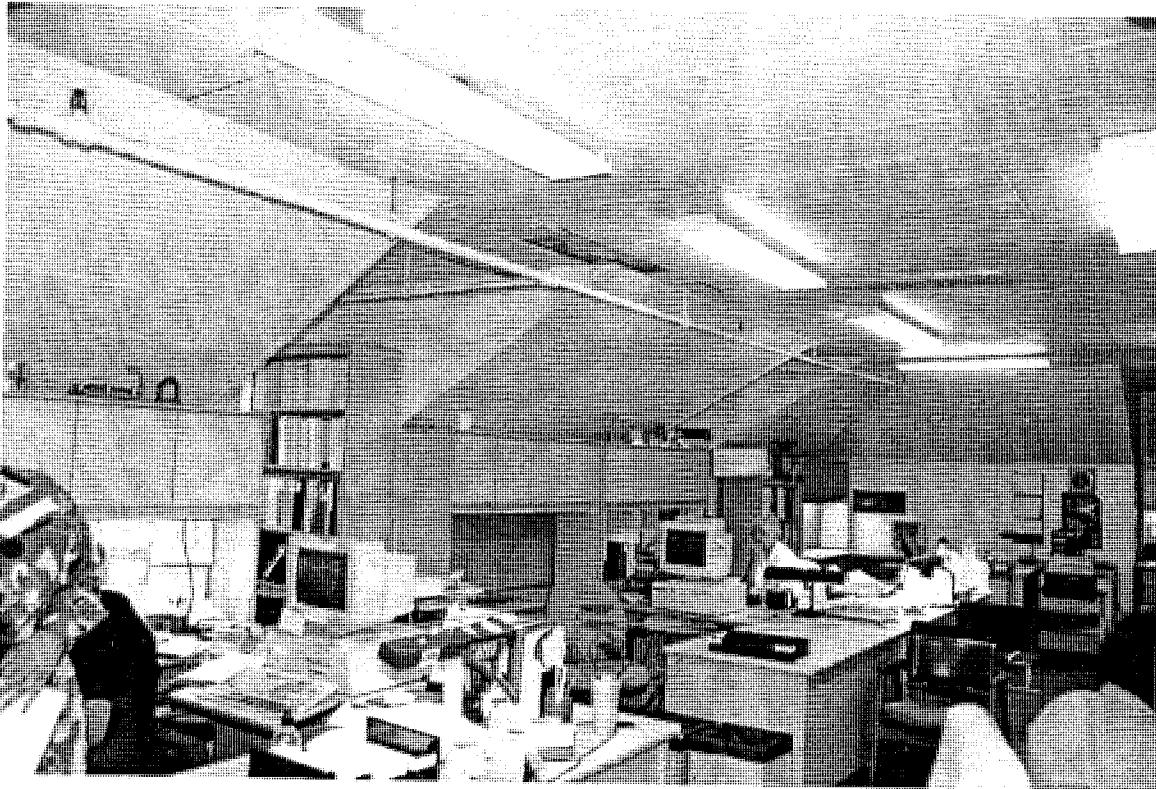
Figure 1-25

Building 1. Room 1318. This room was created by removing partitions from several smaller rooms. The space is negatively impacted by the fluorescent lights and the acoustic tile wall and ceiling treatment.

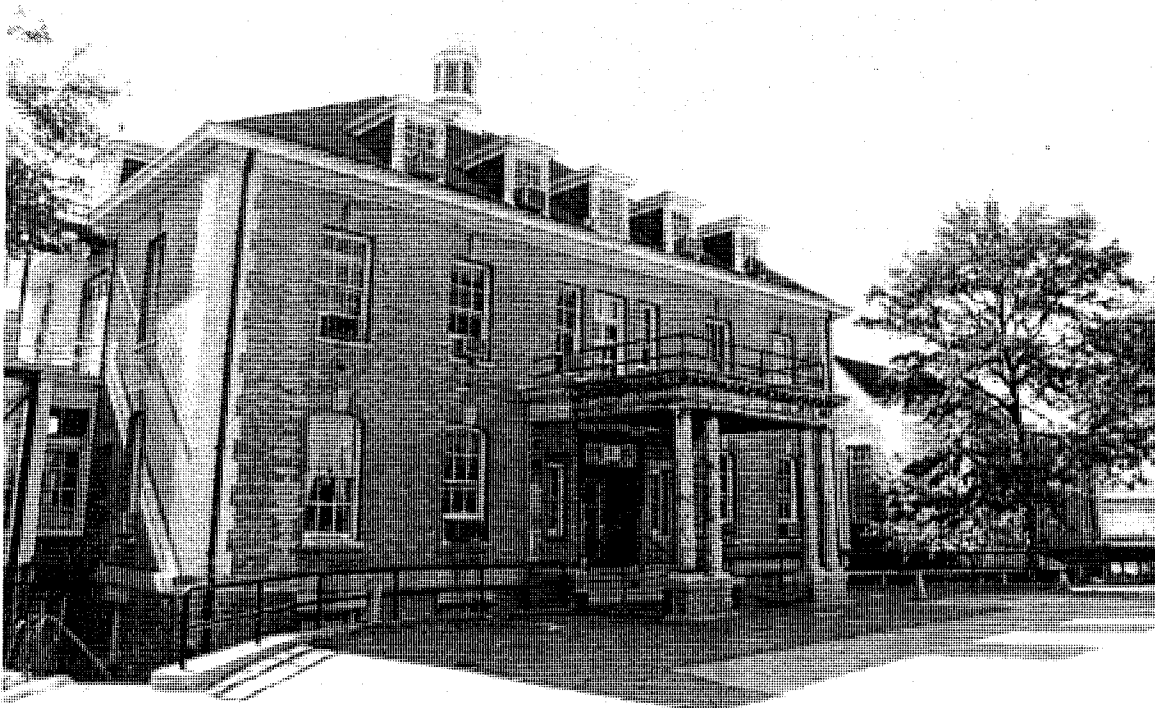
Figure 3-1.

Building 3. View of north elevation. The original roof slates were replaced with asphalt. The cupola is an important architectural feature of exterior. It also houses a fan, part of the original ventilating system for the hospital. Note that paint was removed from most of the porte cochere with an acetylene torch in the Summer of 1994.

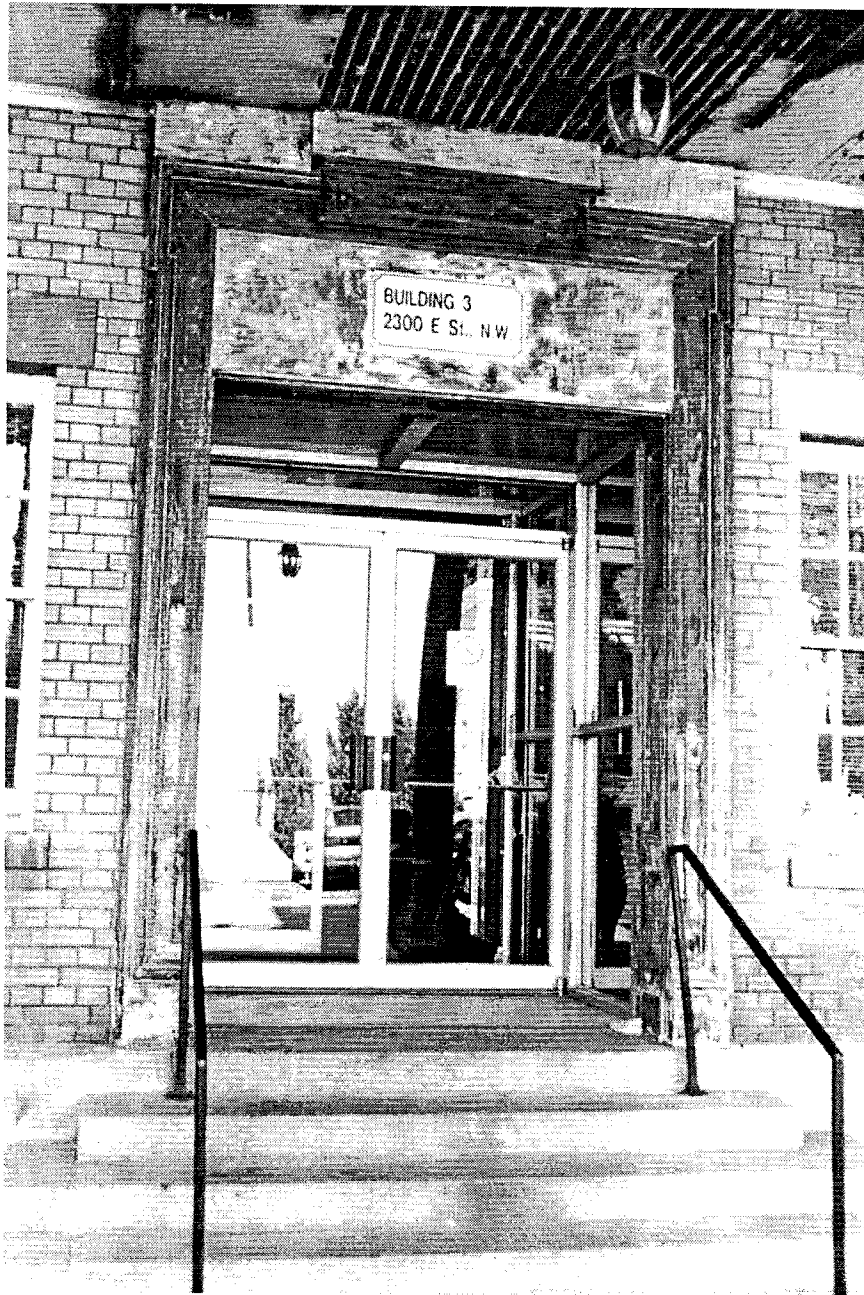
Figure 3-2.

Building 3. Detail of entry. Note scorch marks in the wood surface from the paint removal process. The aluminum and glass entry infill detracts from the architectural character of the porch and intrudes on the interior space. The lighting fixture above, is typical of those found on other buildings on the site. They are flimsy and do not maintain the scale of decorative elements on the buildings.

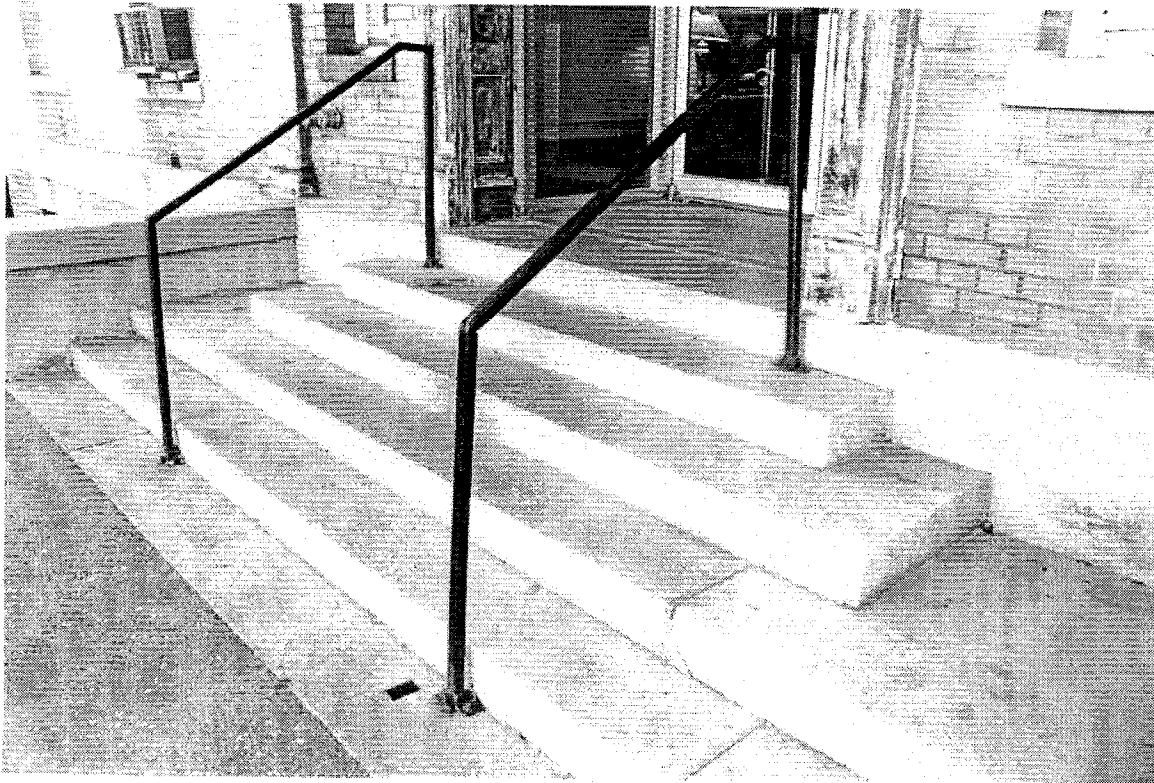
Figure 3-3.

Building 3. Detail of north entry stair. Note chiseled surface of center treads. This is probably an original treatment. The square-sectioned hand rail is not original.

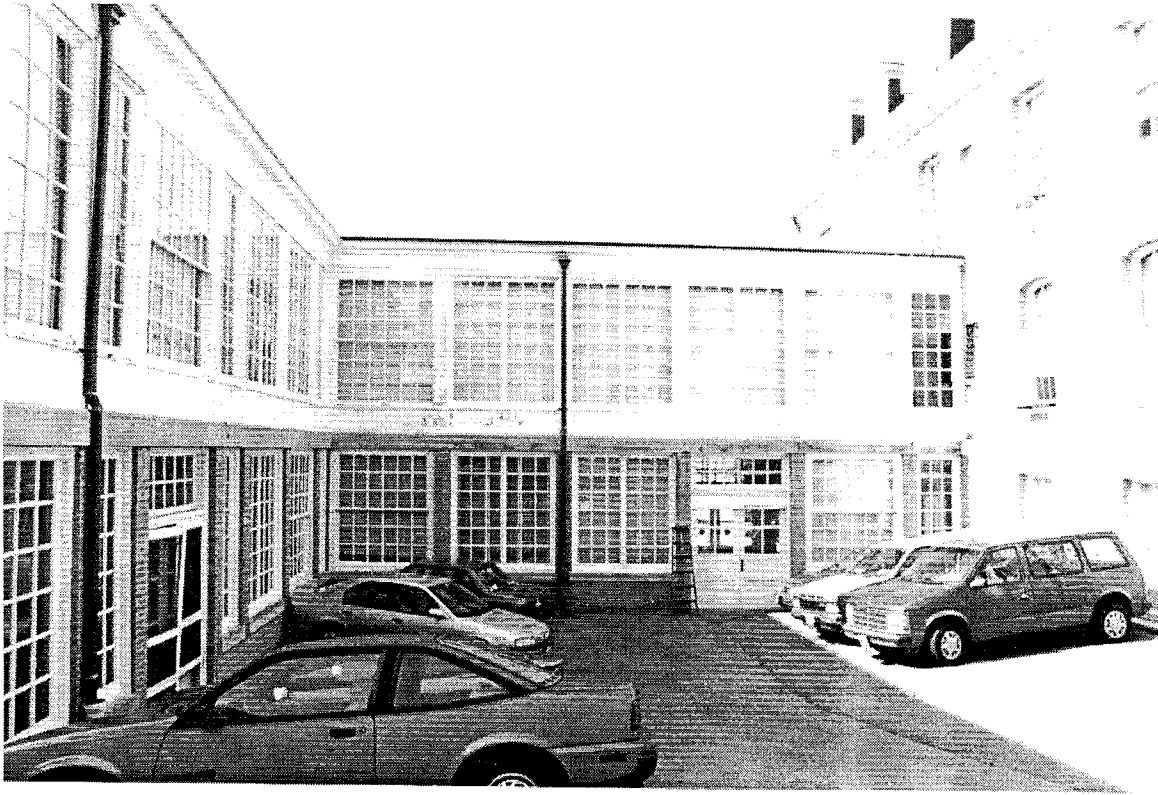
Figure 3-9.

Building 3. The junctures of the corridor to the hospital building and the pavilion at each end are recessed from the plane of the corridor facade. This condition exists on both the north and south facades of the north corridors only. The transom area over the recessed section adjacent to the main building is open and appears to have served as a plenum for the original ventilating system.

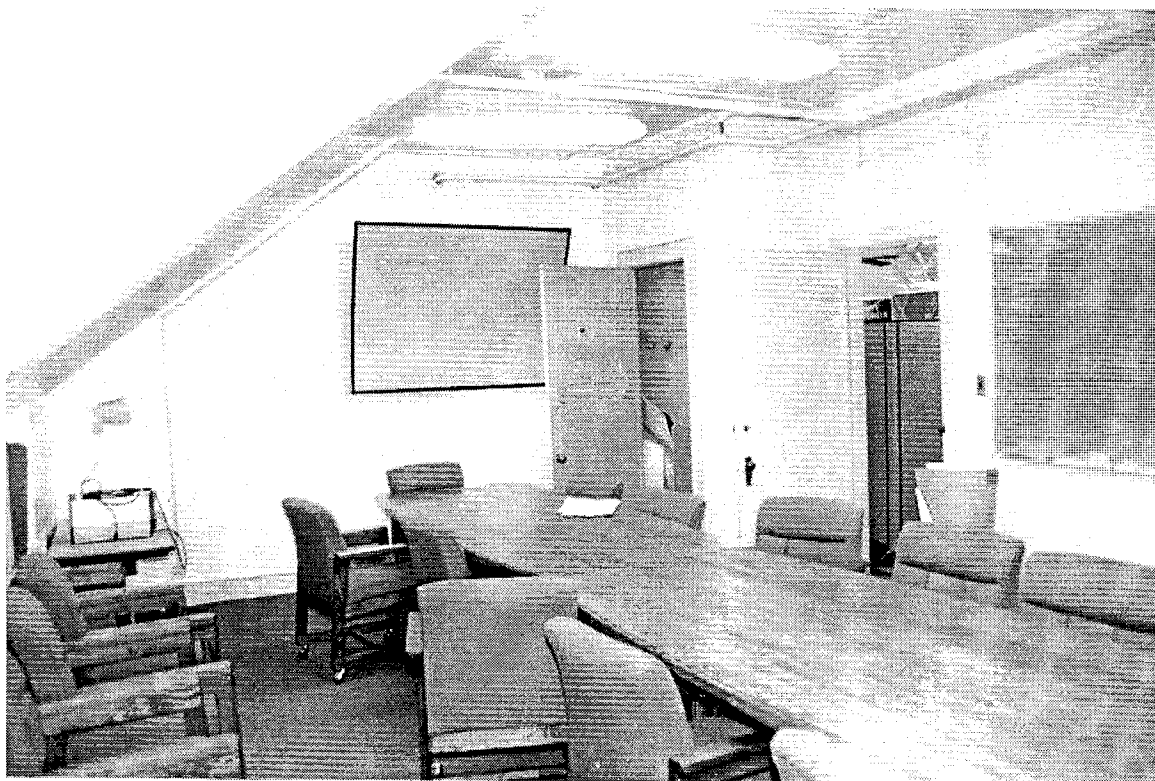
Figure 3-17.

Building 3. View of Room 3207. The condition of this office space is typical of spaces throughout the building. This room was created by combining two smaller room. The doors are five-panel doors, similar to those found throughout the site. They are original, or early replacement doors. Door and window frames are flat with no moldings.

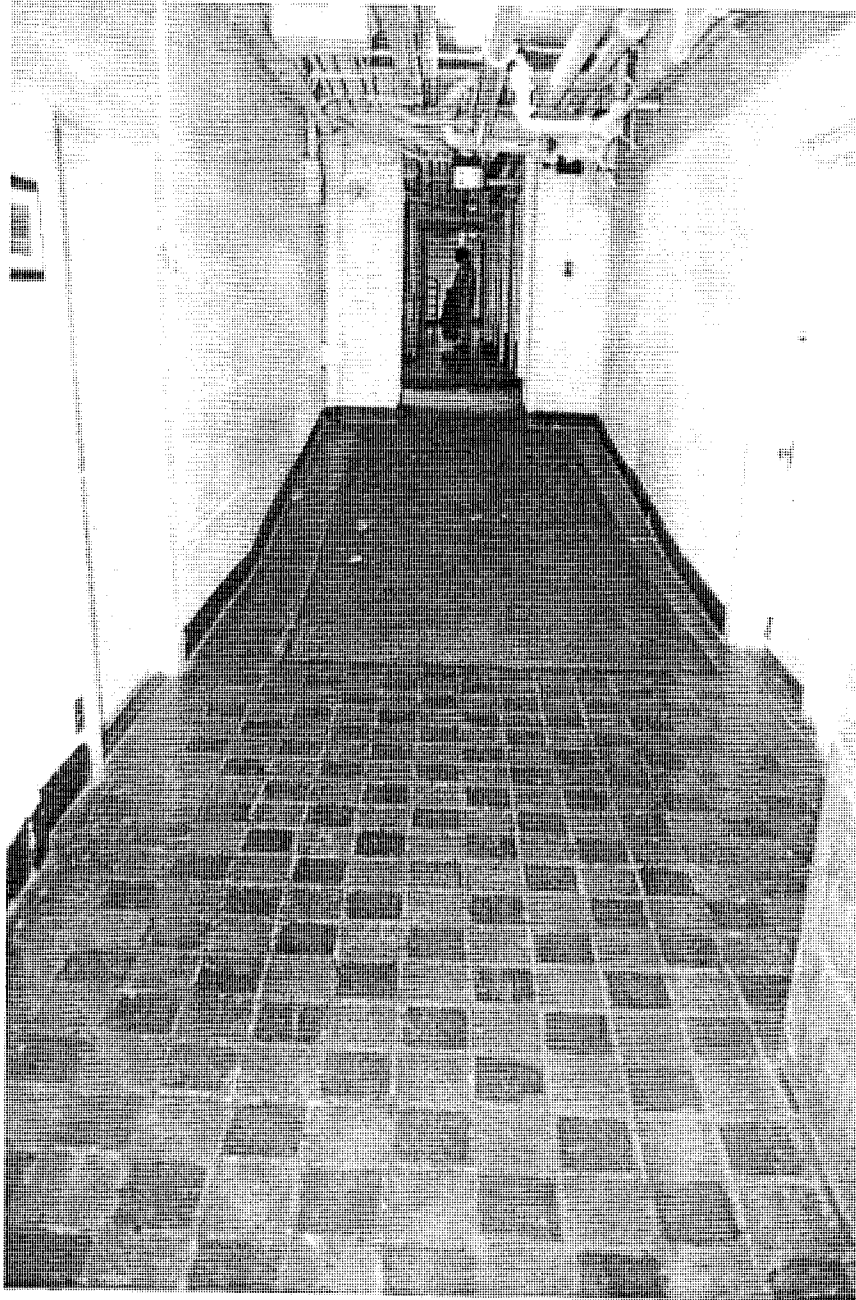
Figure 3-21.

Building 3. Basement. View of solarium corridor looking into the tunnel connecting Building 3 to Building 5. Note ghost of former door in brick wall.
