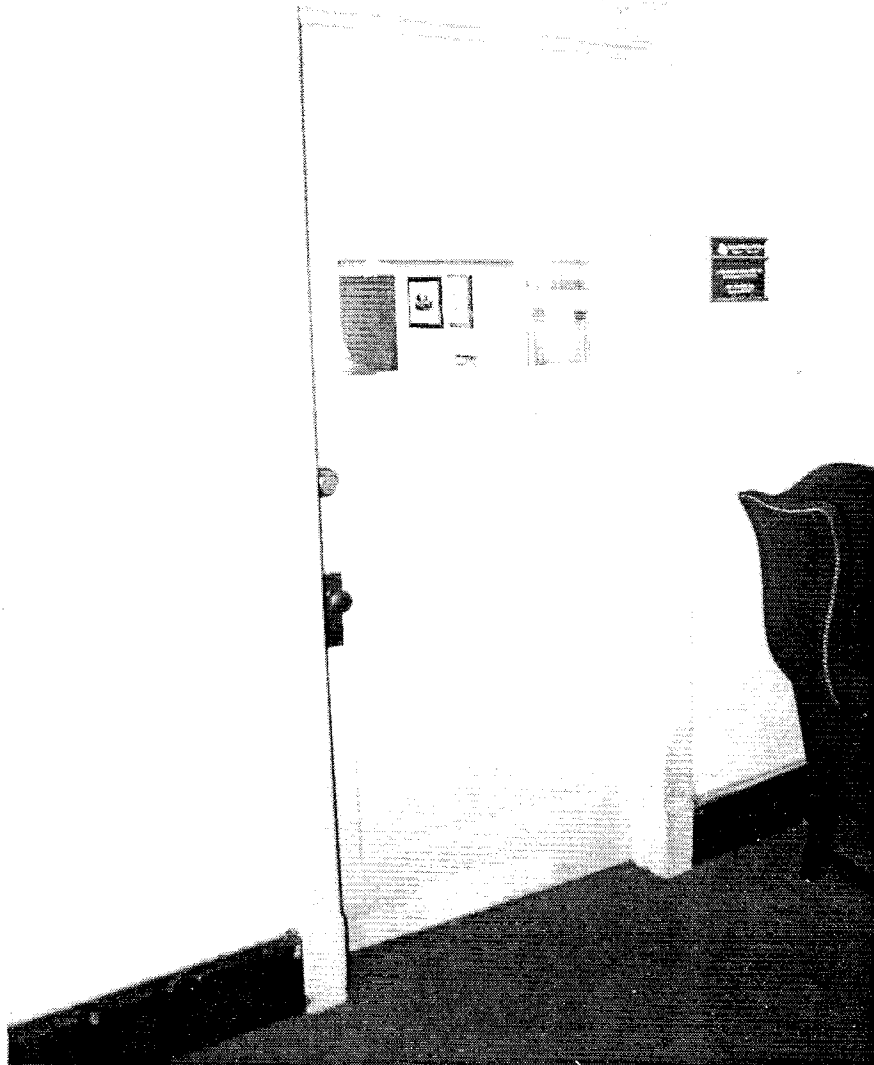
Figure 3-31.

Building 3. Original opening and early door in the east corridor. Unlike the door and window frames in other parts of the building, those on the first floor have raised moldings. The doors and frames in the first-floor corridor were originally varnished. The door has been altered by the addition of a glass panel.

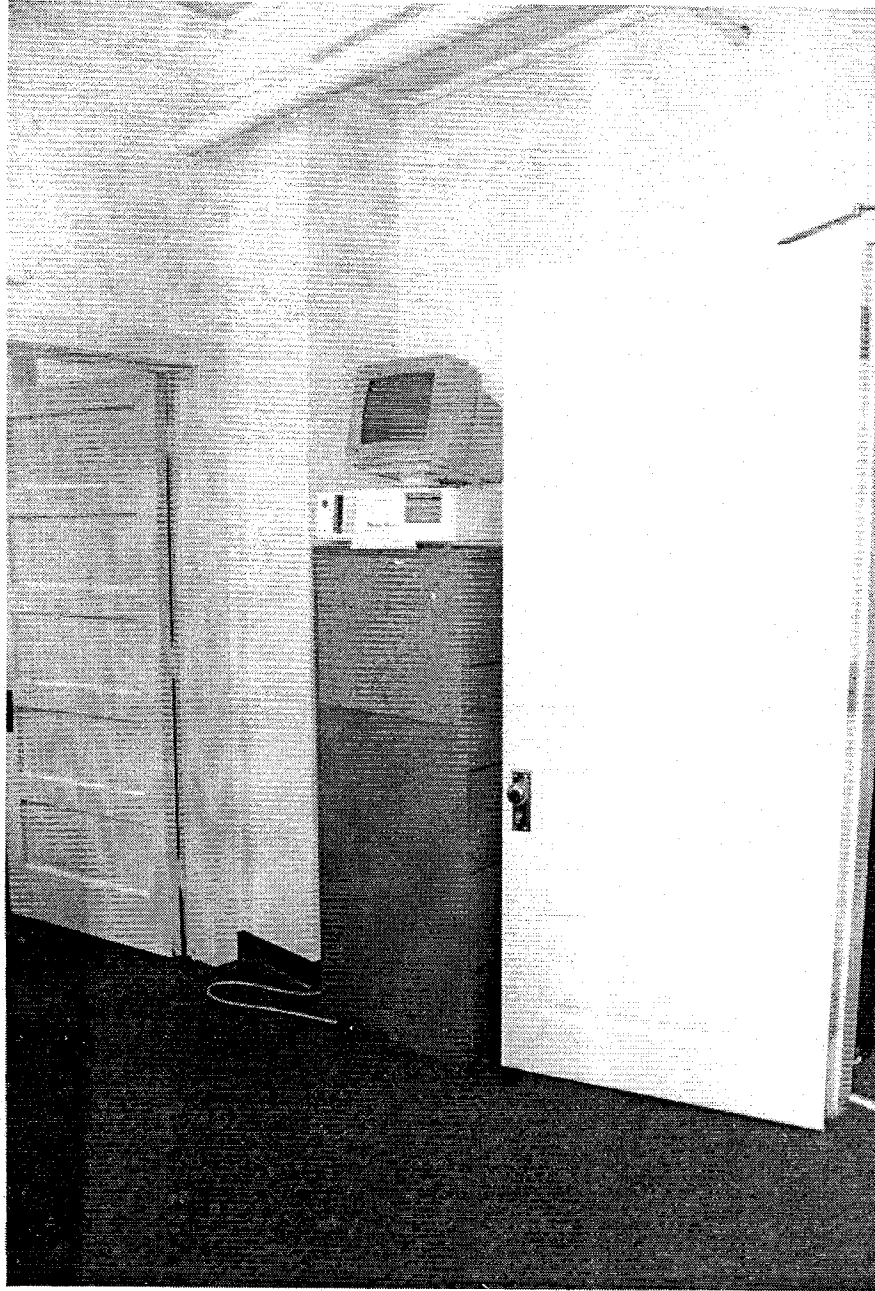
Figure 3-32.

Building 3. This door is located in the west corridor on the first floor. It is a five-panel door with a flat frame, similar to other early doors in the building and on the site. However, this is likely to be an early alteration. Most of the door frames on the first-floor corridor have transoms and a more articulated door frame. The doors also have a different panel configuration. The door has been altered by the installation of a glass panel.

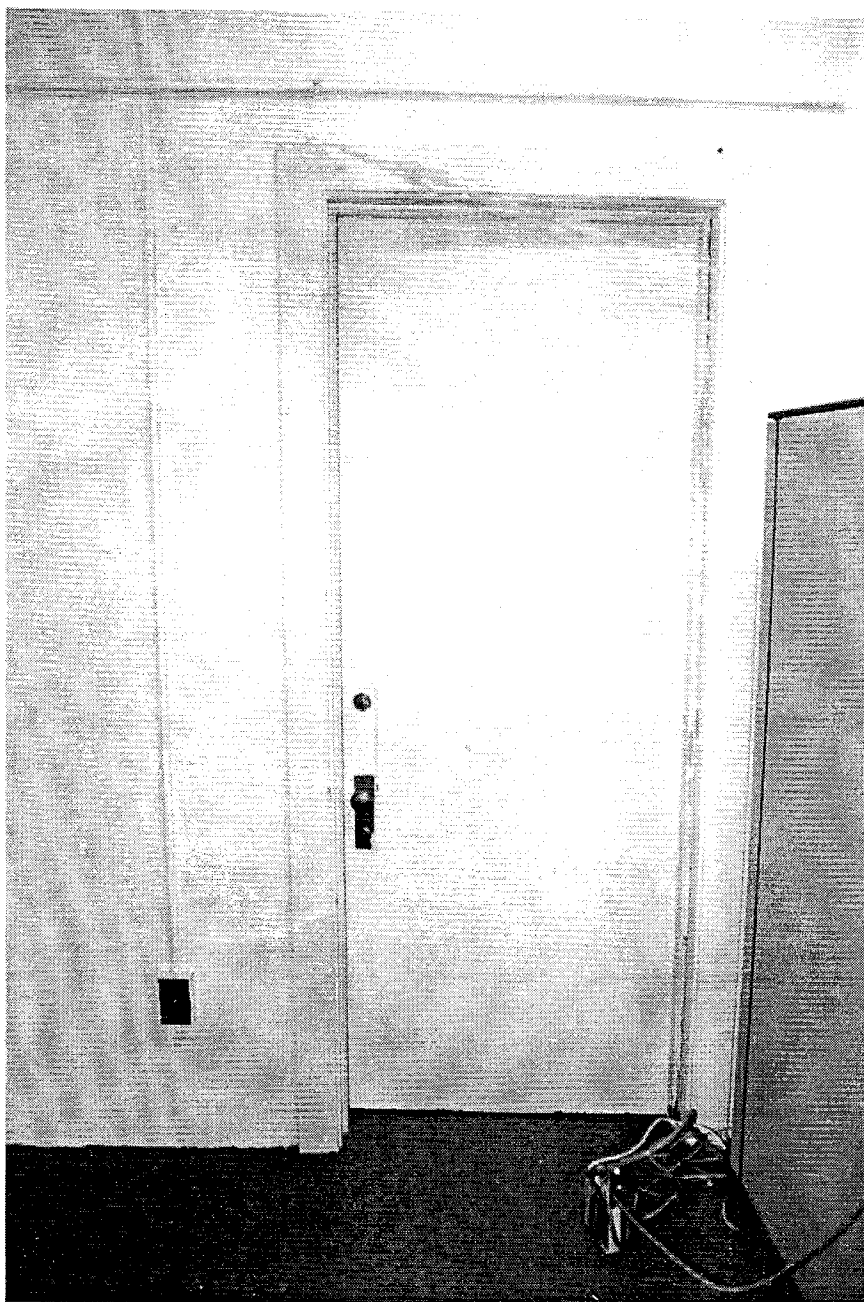
Figure 3-33.

Building 3. Typical doors on the second floor. Note that the door on the left is an original or early five-panel wood door; the one on the right is a recent replication.

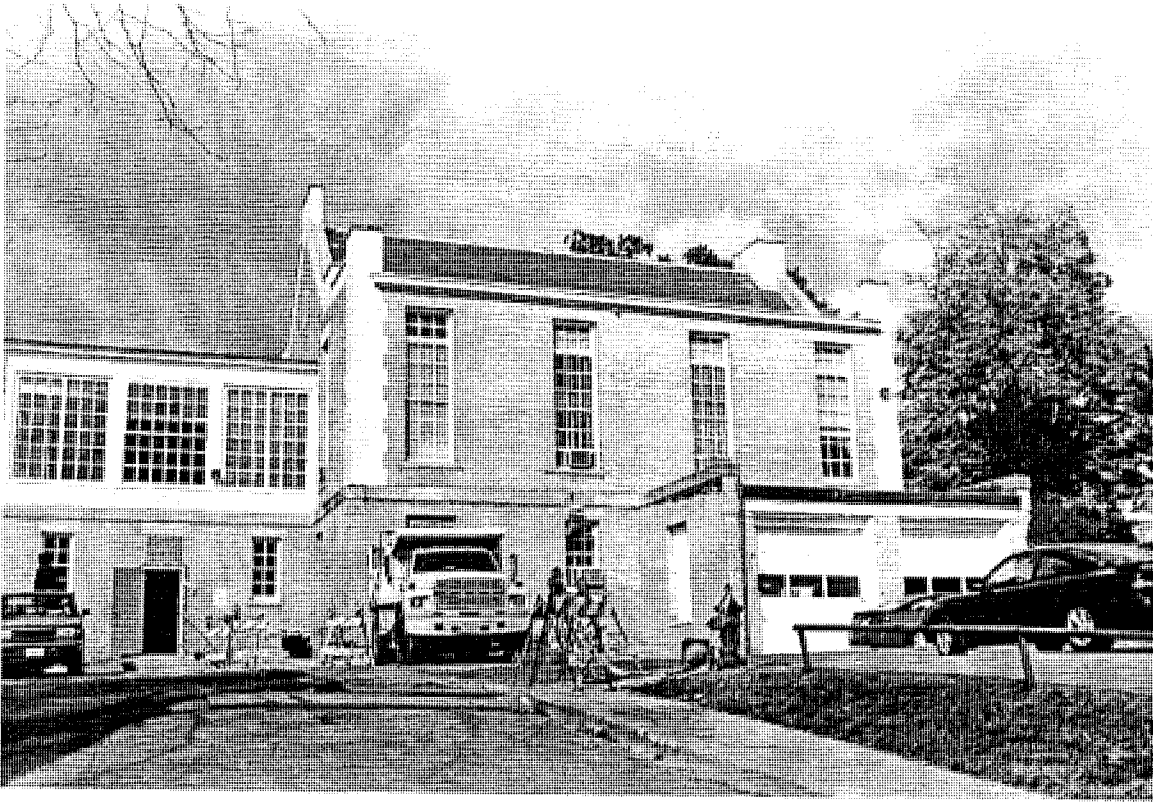
Figure 4-6.

Building 4. View of southeast side showing loading dock. This is part of the 1917 construction, although it has been altered. The double-leaf wood and glass door entering the loading dock is probably original.

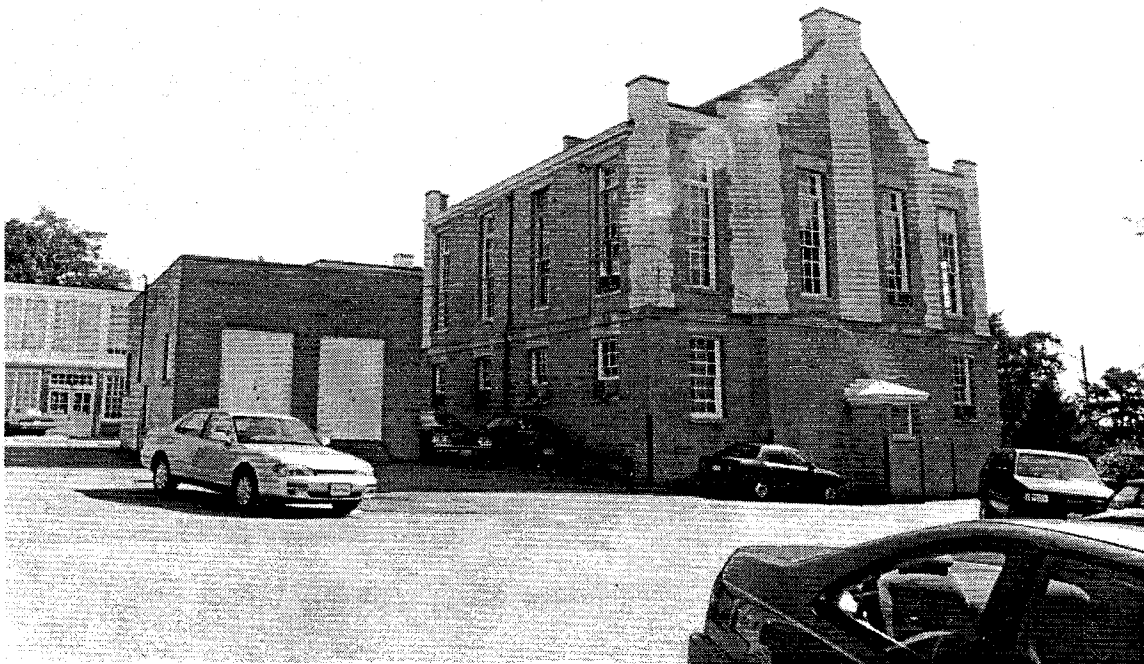
Figure 4-7.

Building 4. Southeast pavilion. The garage is a later addition. Note insertion of doors in original window openings were done crudely; brick infill is red.

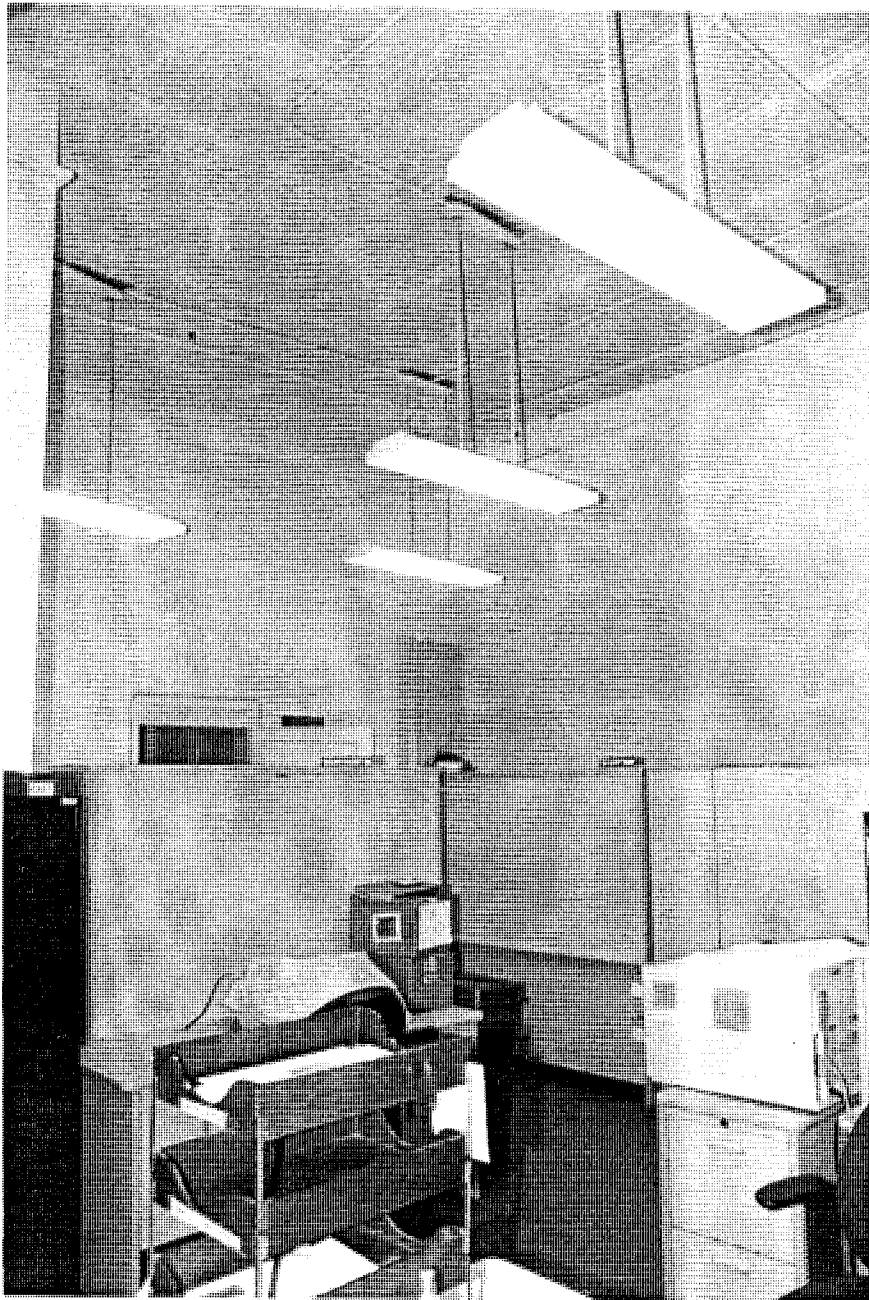
Figure 4-12.

Building 4. First floor. Operating Room ante room. Note ceramic tile wainscot. The door is similar to other 5-panel doors found throughout the site. However, the infill of the opening indicates that this door may have been salvaged from elsewhere.

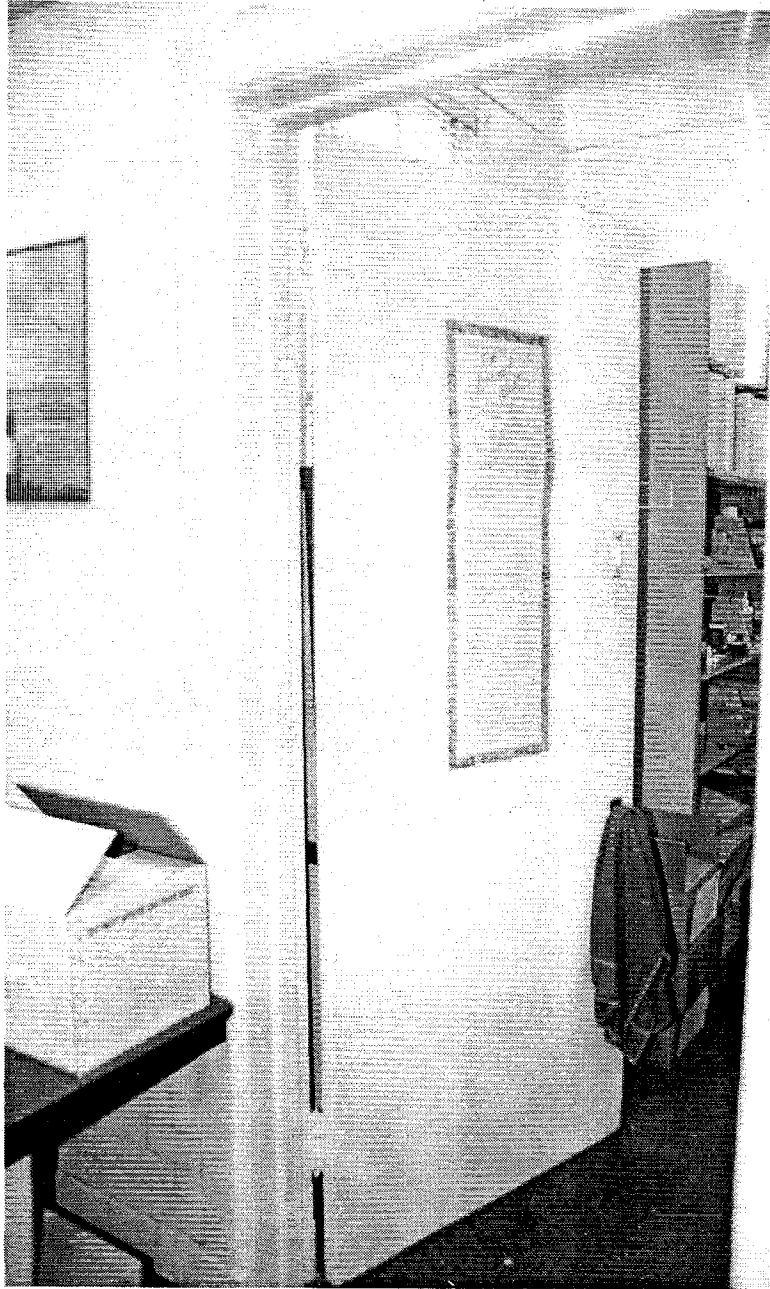
Figure 4-13.

Building 4. First floor. Original Operating Room. Note sloped wall at right; this is the original skylight, which has been covered with gypsum board. Metal ceiling is probably original.

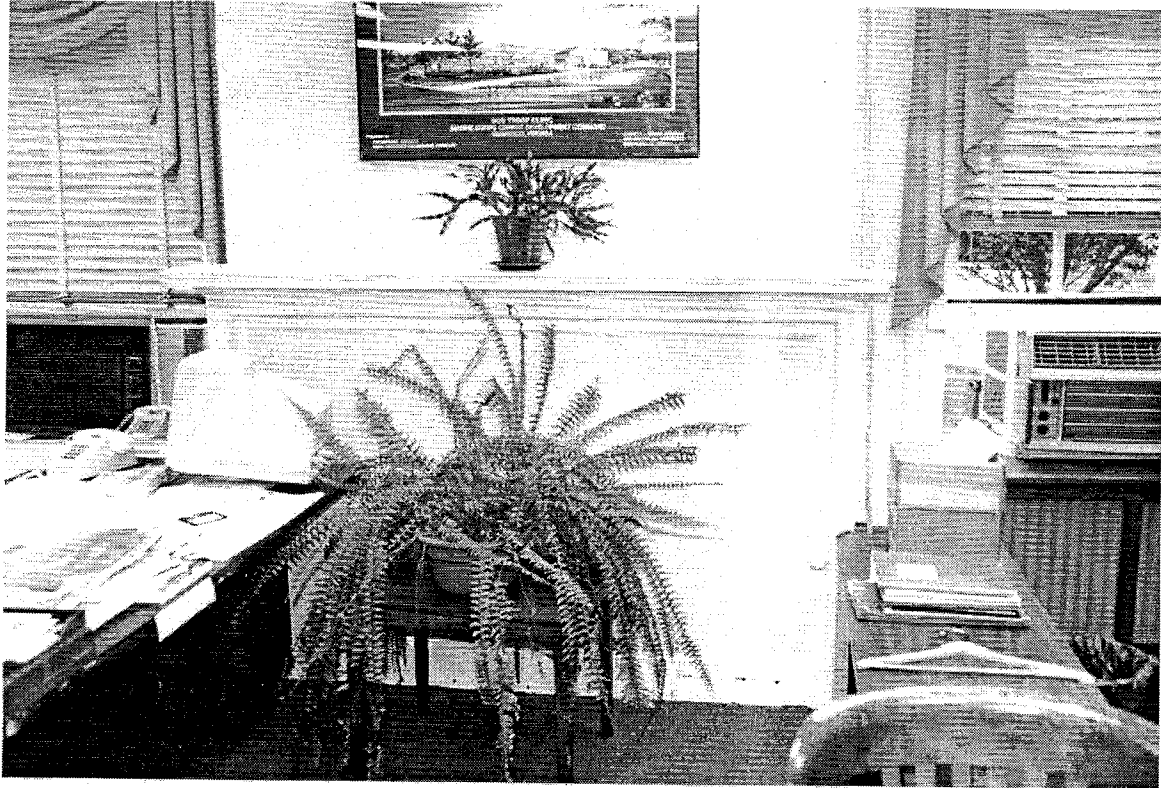
Figure 4-21.

Building 4. Southeast pavilion. View toward the fireplace on the east wall. As in all the pavilions, the suspended ceiling has a severe impact on the original height of the space and on the windows. The partition wall dividing the space is not original. Note that the room on the right retains some original ceramic wall tile. This room was originally designated a Quiet Room.

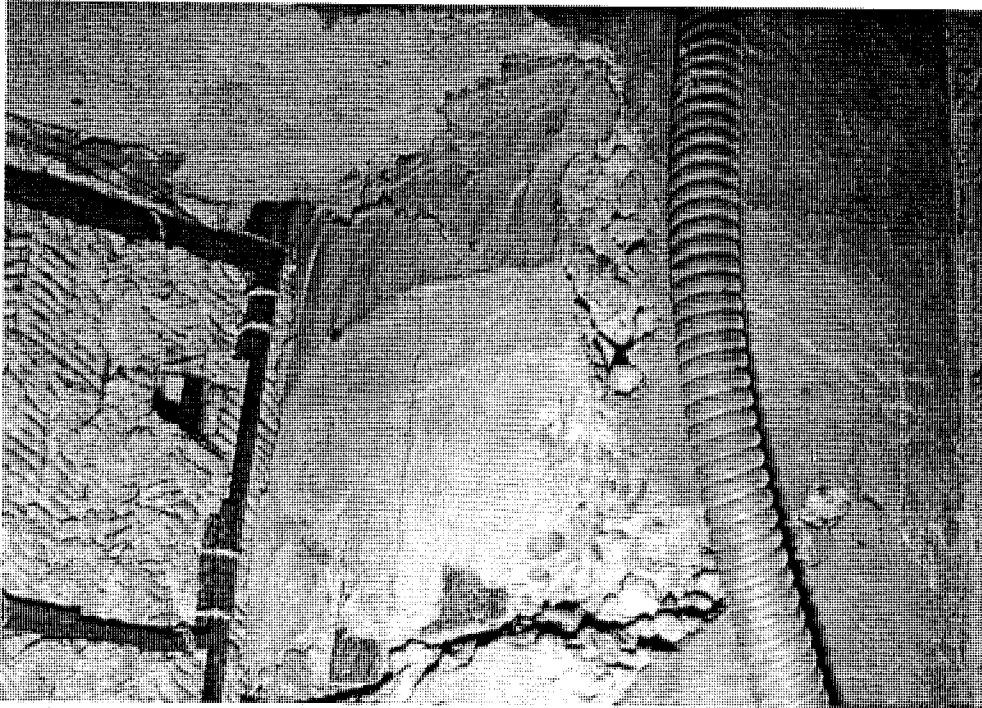
Figure 4-27.

Building 4. Structure. Fan Chamber in Building 4, showing the underside of the ribbed concrete roof slab with terra cotta tile infill between the ribs. The crack in the concrete beam is visible to the right of the column.

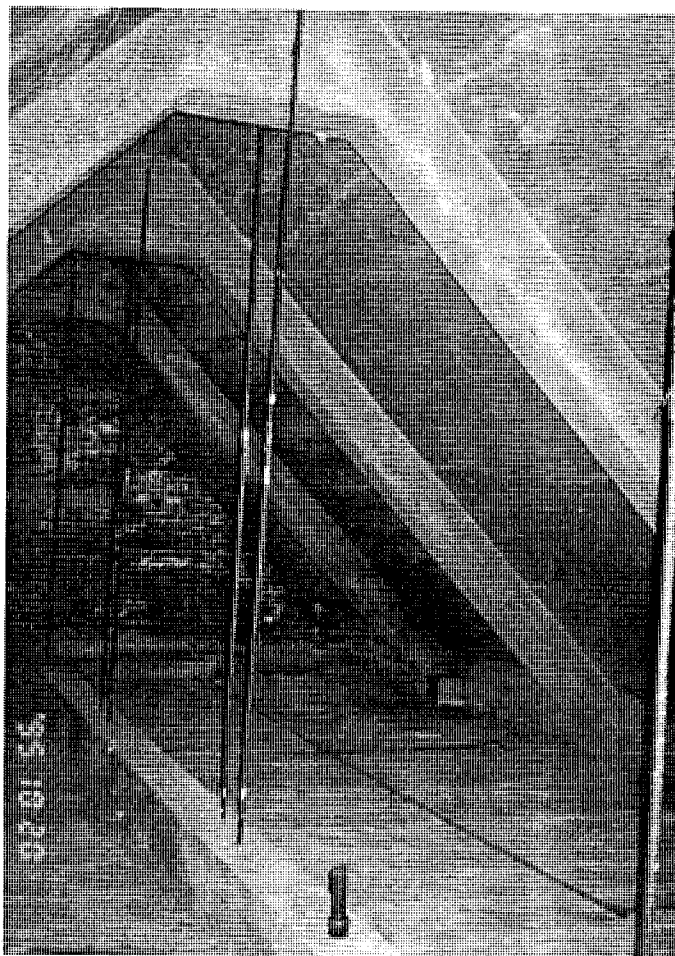
Figure 4-28.

Building 4. Structure. Detail of crack in reinforced concrete roof beam in the Fan Chamber.

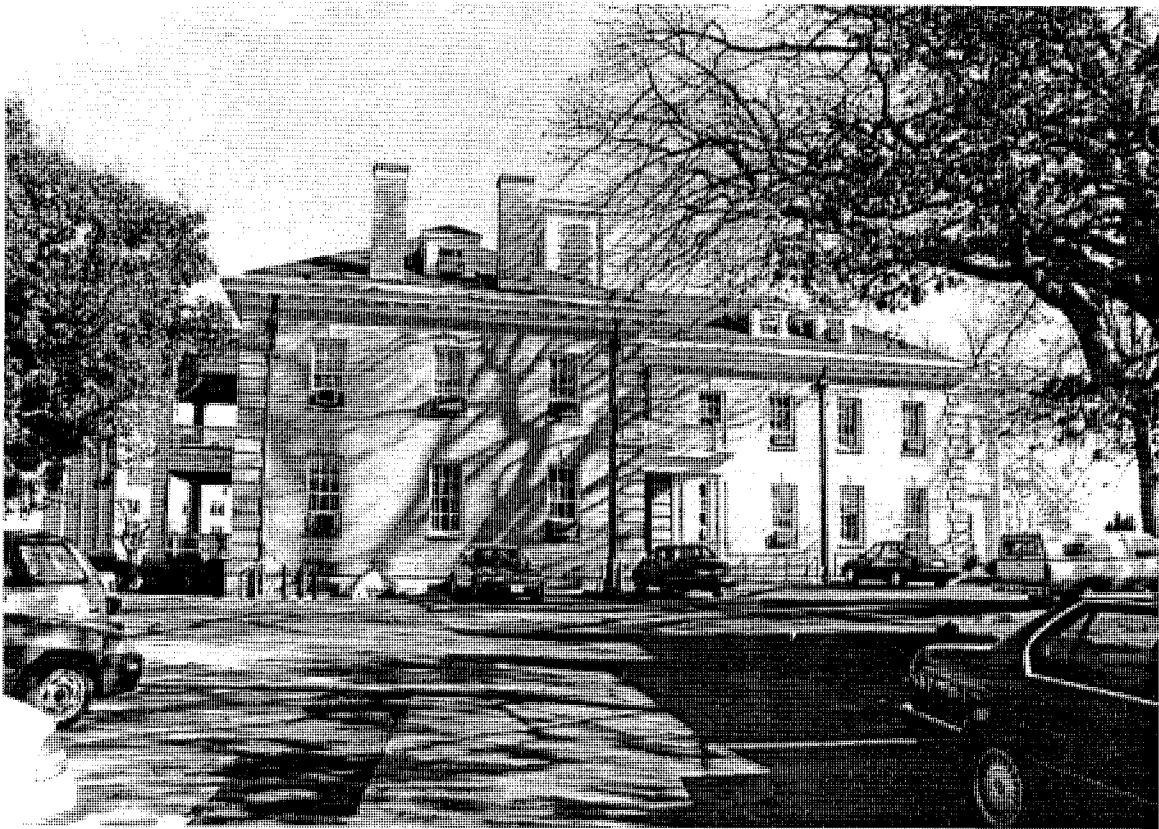
Figure 5-1.

Building 5. West elevation. The building originally functioned as the Sick Officers' Quarters. It was constructed 1908-1910. The building is similar in style and massing to the other buildings on the site. However, it is distinguished by a two-story porte cochere on the north elevation (at left in the photograph).

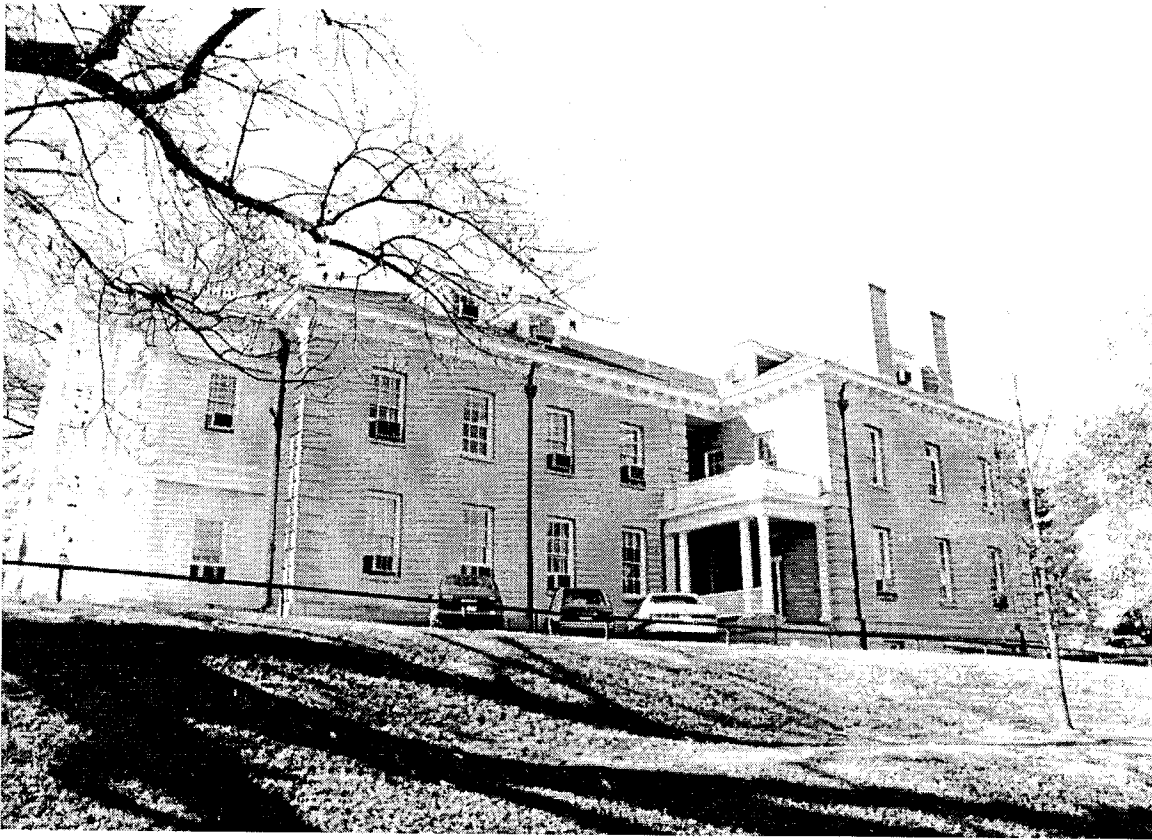
Figure 5-2.

Building 5. Oblique view from the southeast. The building's "T" shape accommodates a secondary entry porch on the east side, similar to that on the west. Note also the steep slope of the site down to 23rd Street and parking lot adjacent to the building.

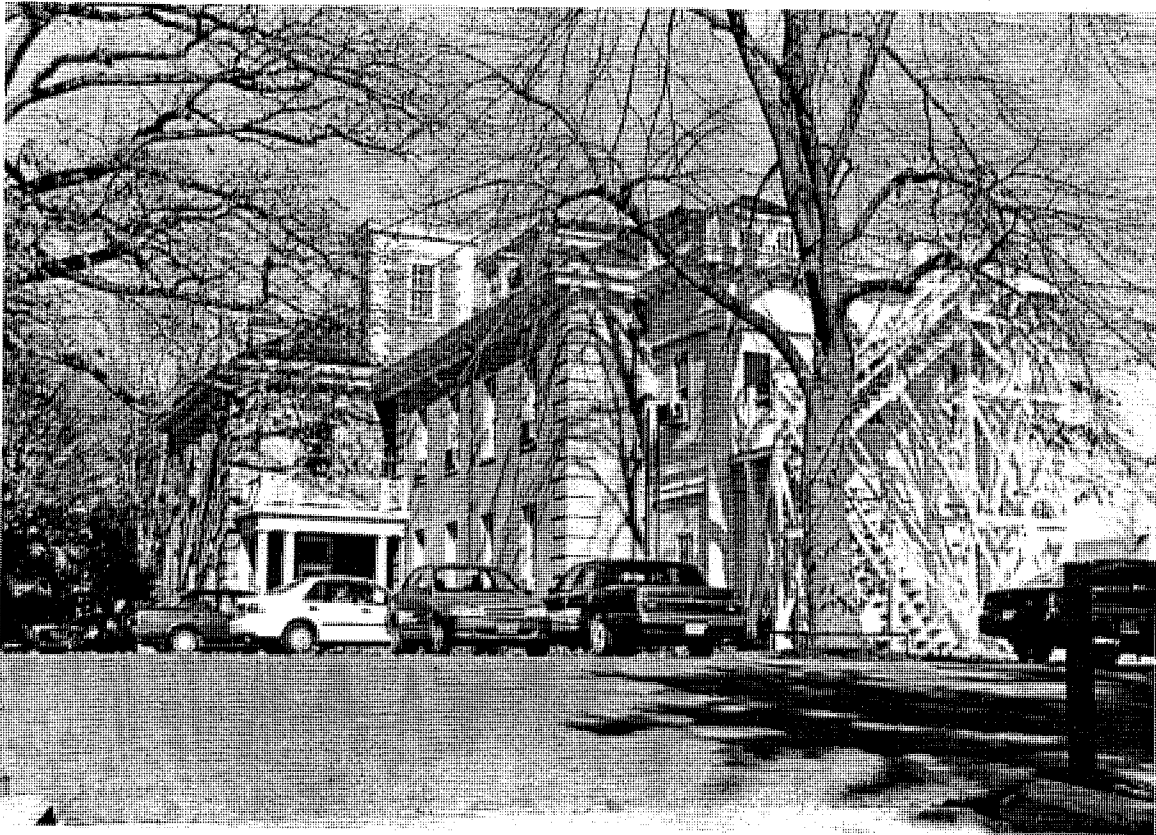
Figure 5-3.

Building 5. Oblique view from southwest. The building's "T" shape accommodates a secondary entry porch on the west side, similar to that on the east. The elevator bulkhead at the roof crossing is an original feature.

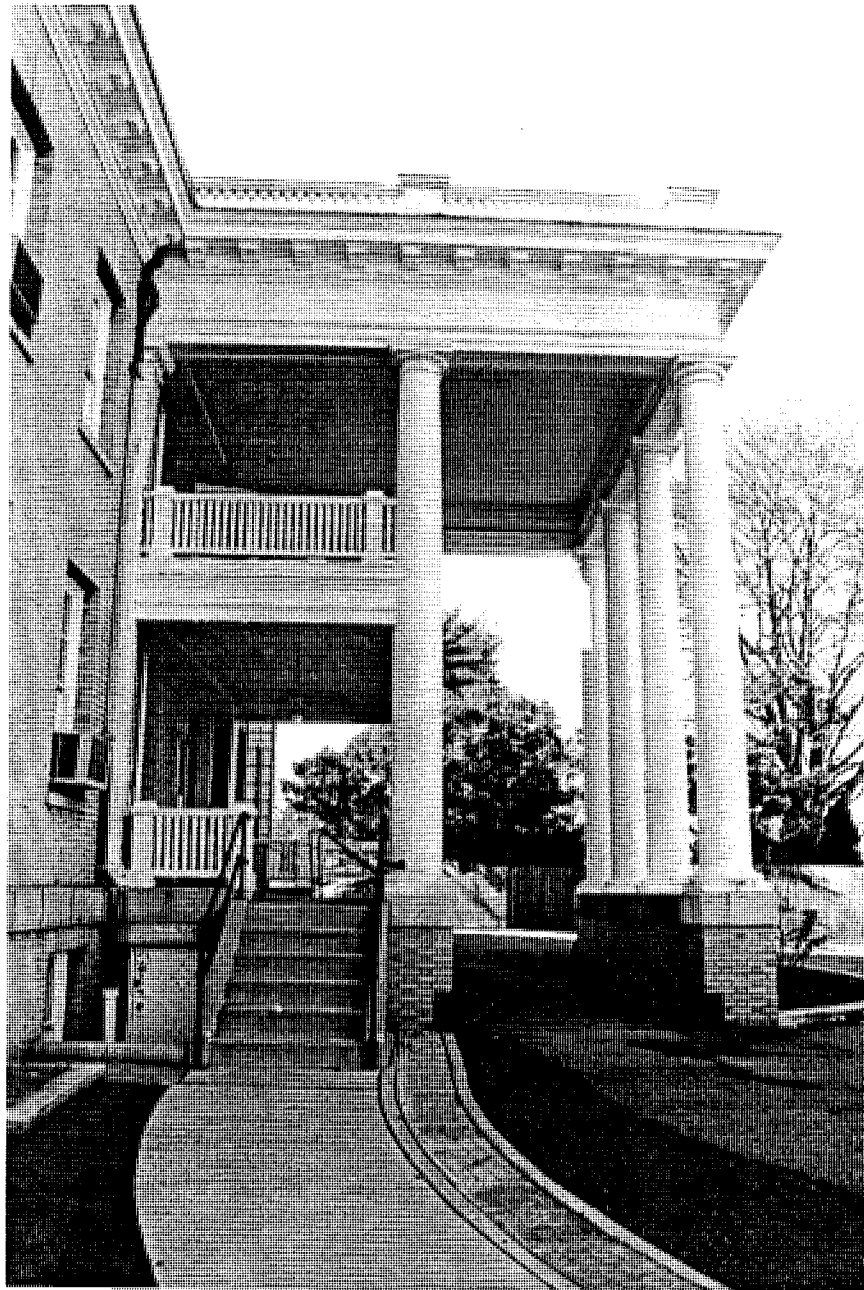
Figure 5-4.

Building 5. North elevation. Porte cochere, east side. The porte cochere is the most distinguished feature of the building; however, it is also the most compromised due to alterations and severe water damage. The concrete steps and covered swale next to the concrete sidewalk are not original features of this building. The wood fence in the background separates the asphalt driveway from the residence garden to the north.

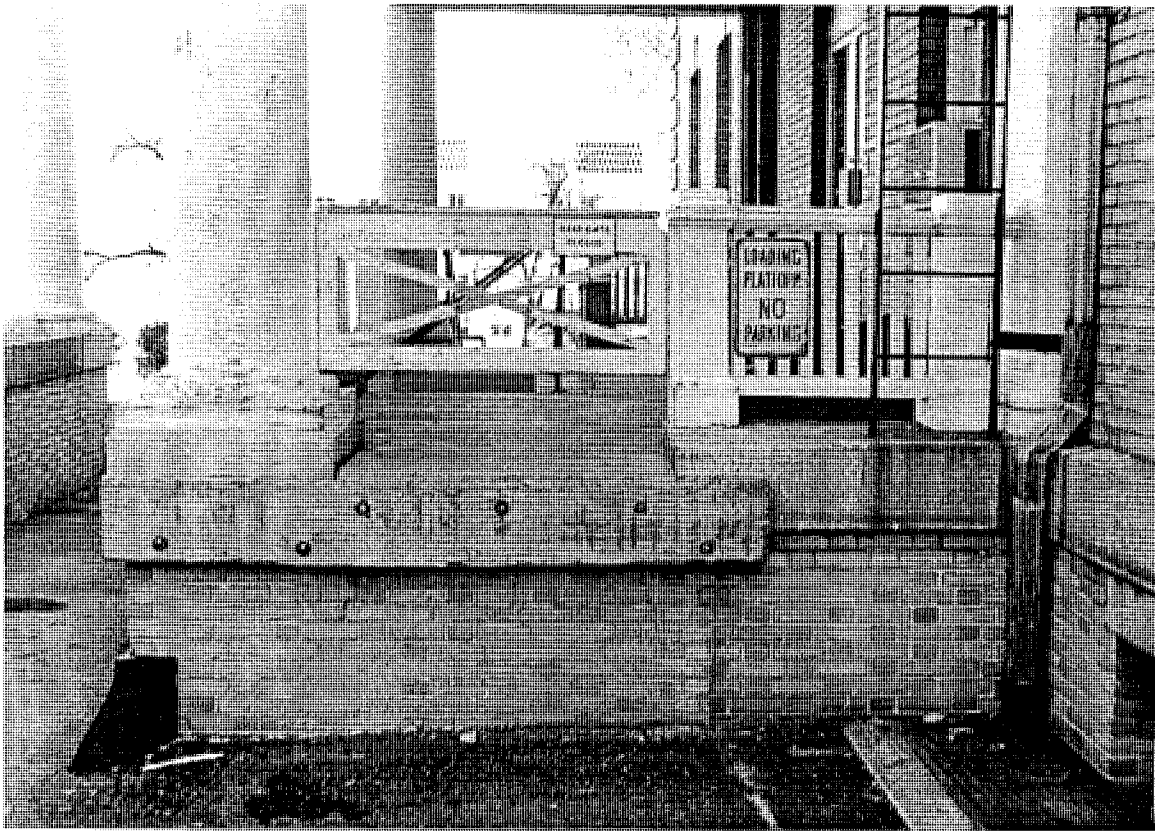
Figure 5-8.

Building 5. Porte cochere. Detail of west side. The date of the conversion of the porte cochere to a loading dock is not known. However, original drawings show a set of granite steps in this location. Infill brick under the platform is close to the original in color, but noticeably different. The installation of the wood gate and crude attachment of bumpers, corner guards and signs further detract from the architectural character of the building.

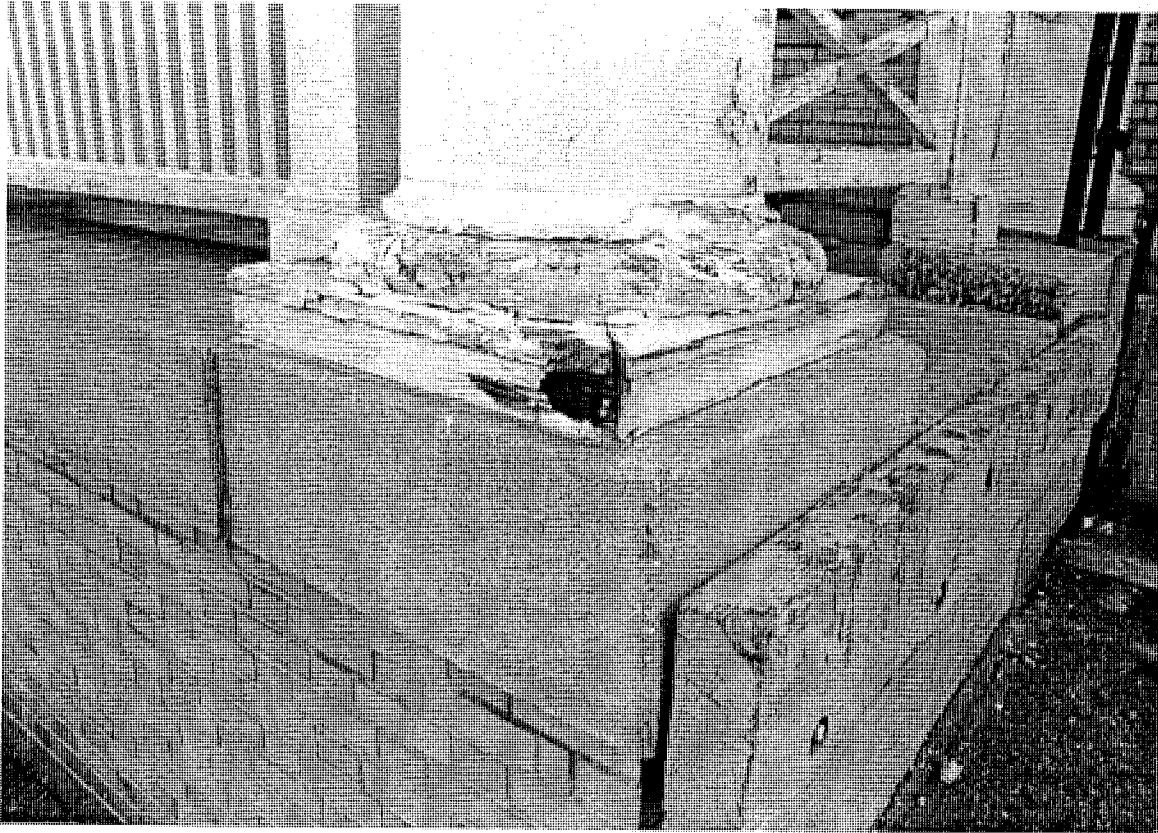
Figure 5-9.

Building 5. Porte cochere. Detail of column base and wood plinth on west side. Water damage is noted throughout the wood elements in the porte cochere. The bases on other columns have replacement steel plinths, which are rusting.

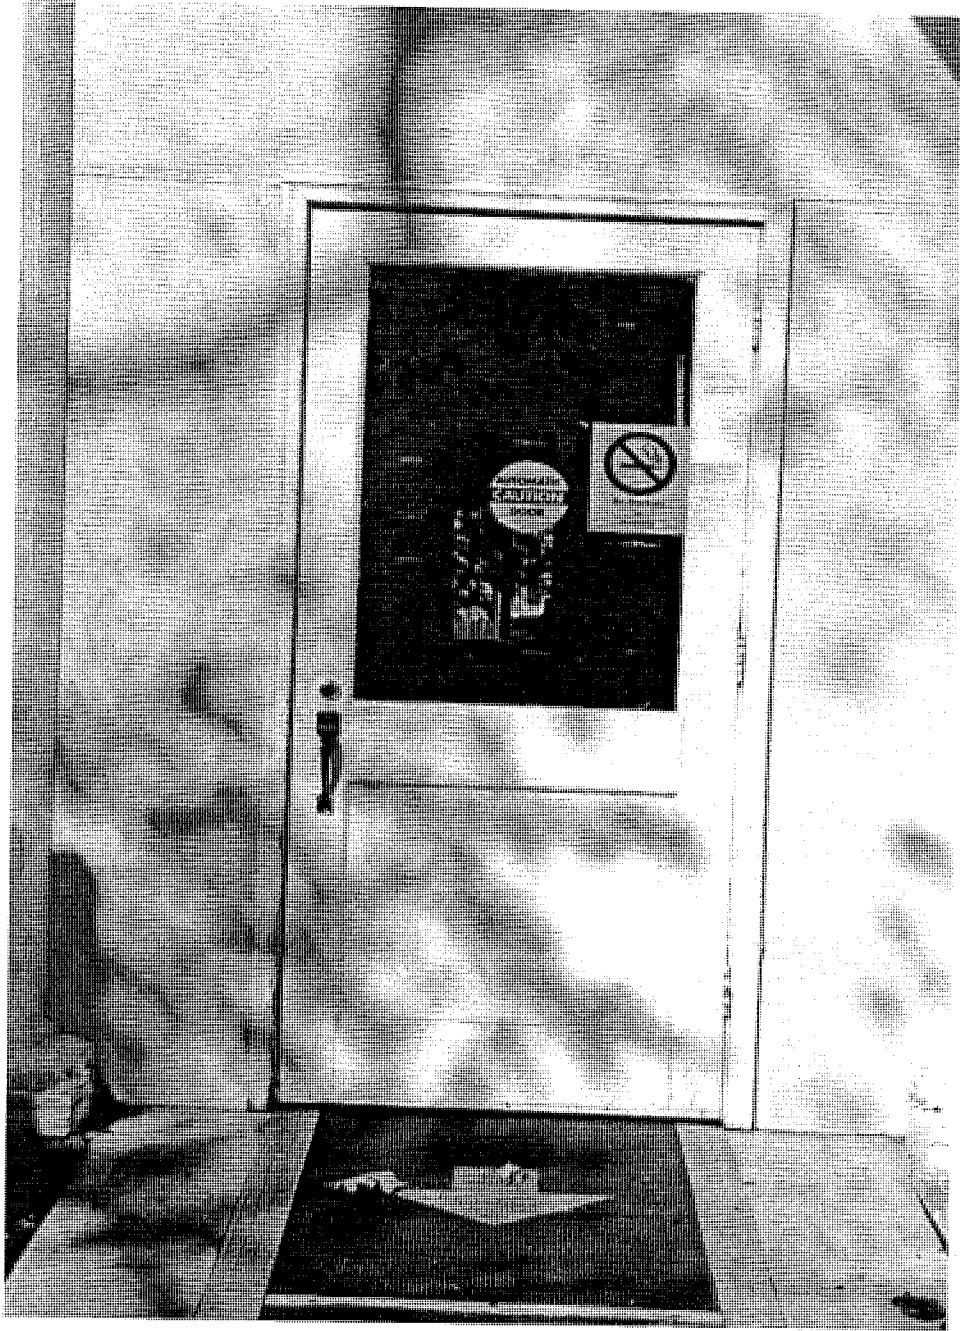
Figure 5-11.

Building 5. Sun porch detail. The wood and glass door entering the south side of the sun porch probably dates to the construction of the infill.

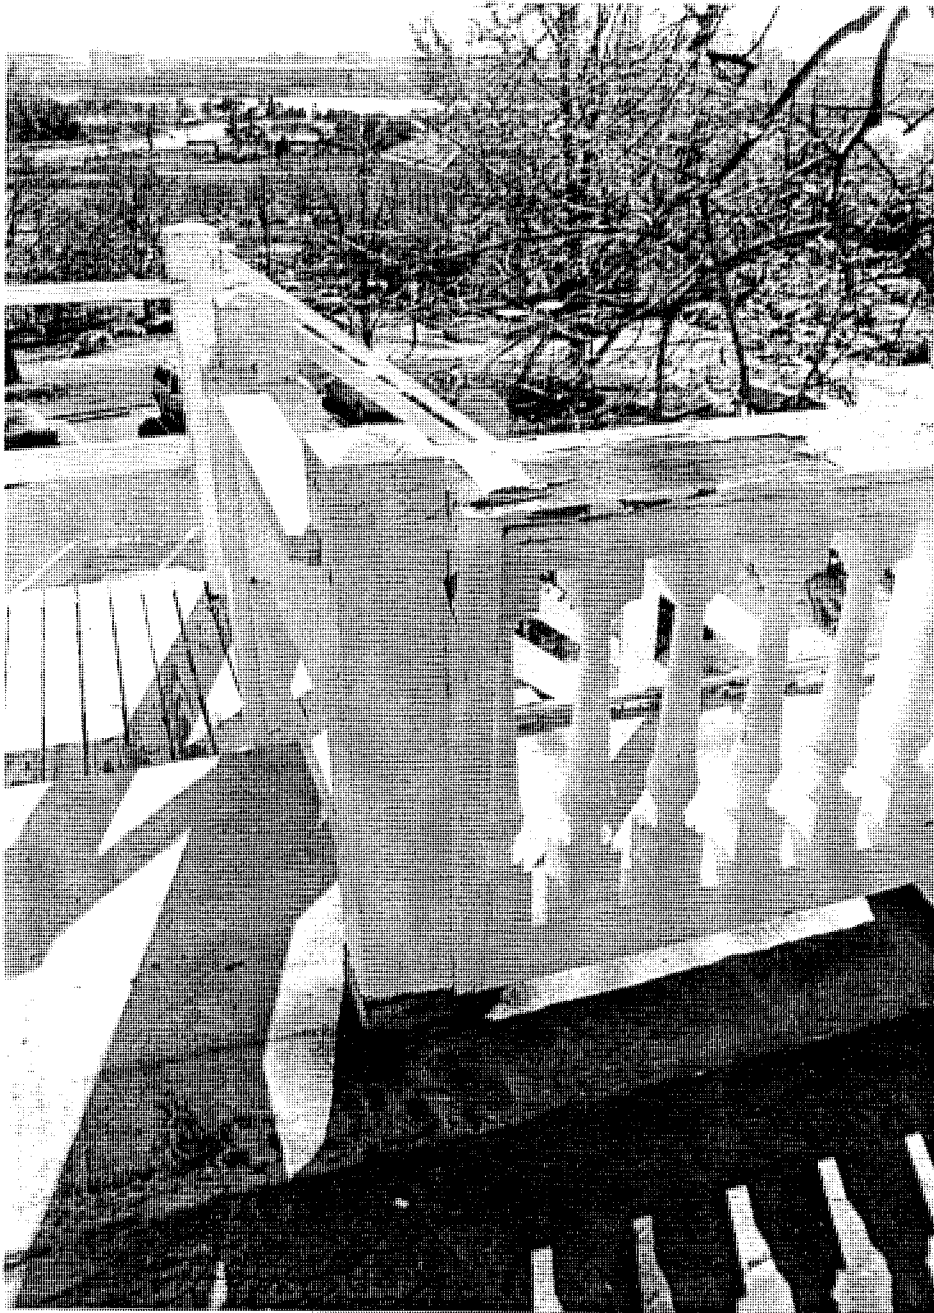
Figure 5-12.

Building 5. Sun porch detail. The balustrade at the top of sun porch opens onto the wood fire escape. Peeling paint, checked wood rail and replacement newel indicate water damage and lack of maintenance. Also note cracking in the roofing material (bottom center of the photograph).

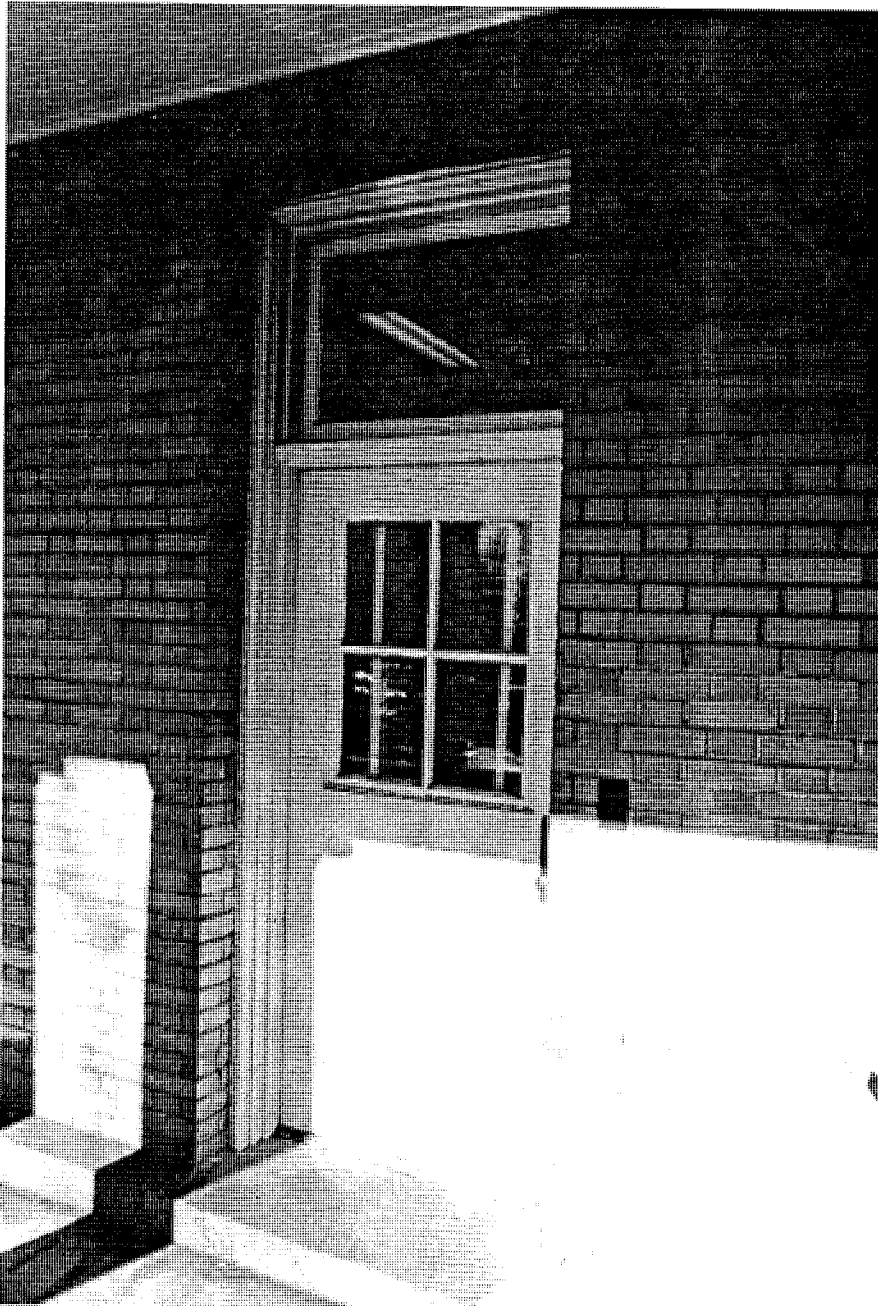
Figure 5-14.

Building 5. West entry porch detail. This door appears to be original.

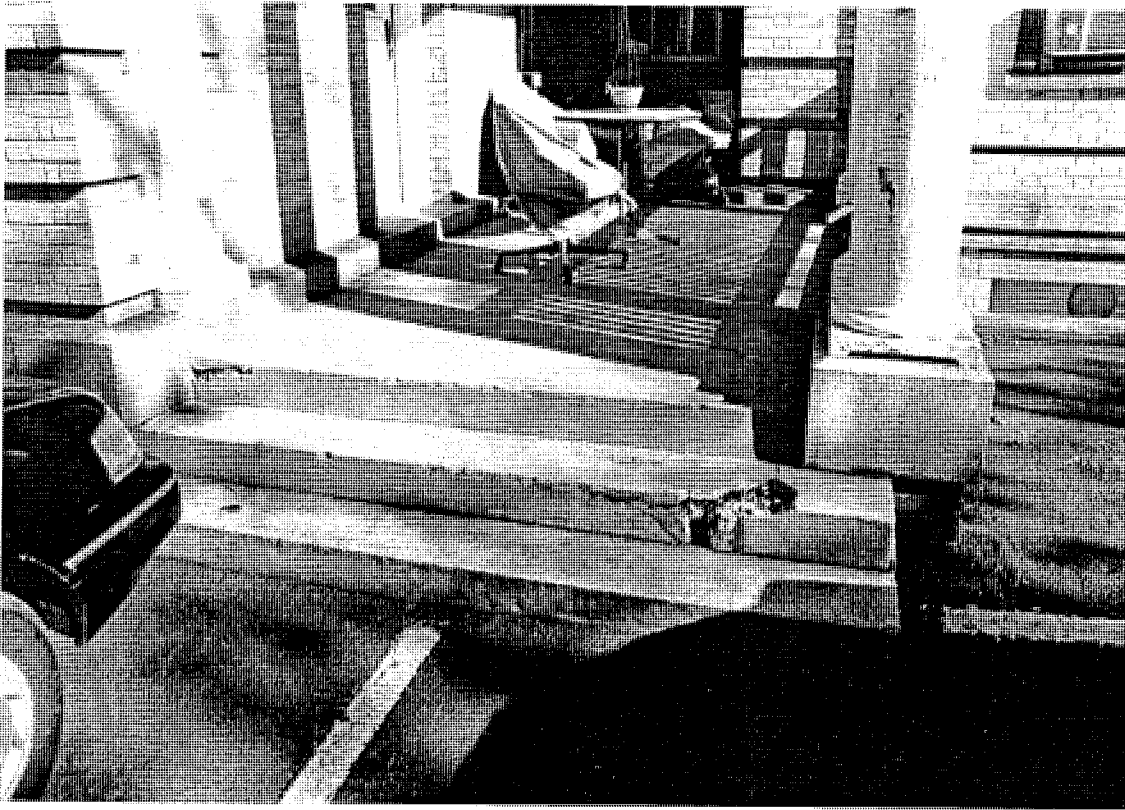
Figure 5-15.

Building 5. West entry porch detail. Note that the original granite step at the bottom is in good condition, while the concrete replacement above, and the porch slab, are cracked.

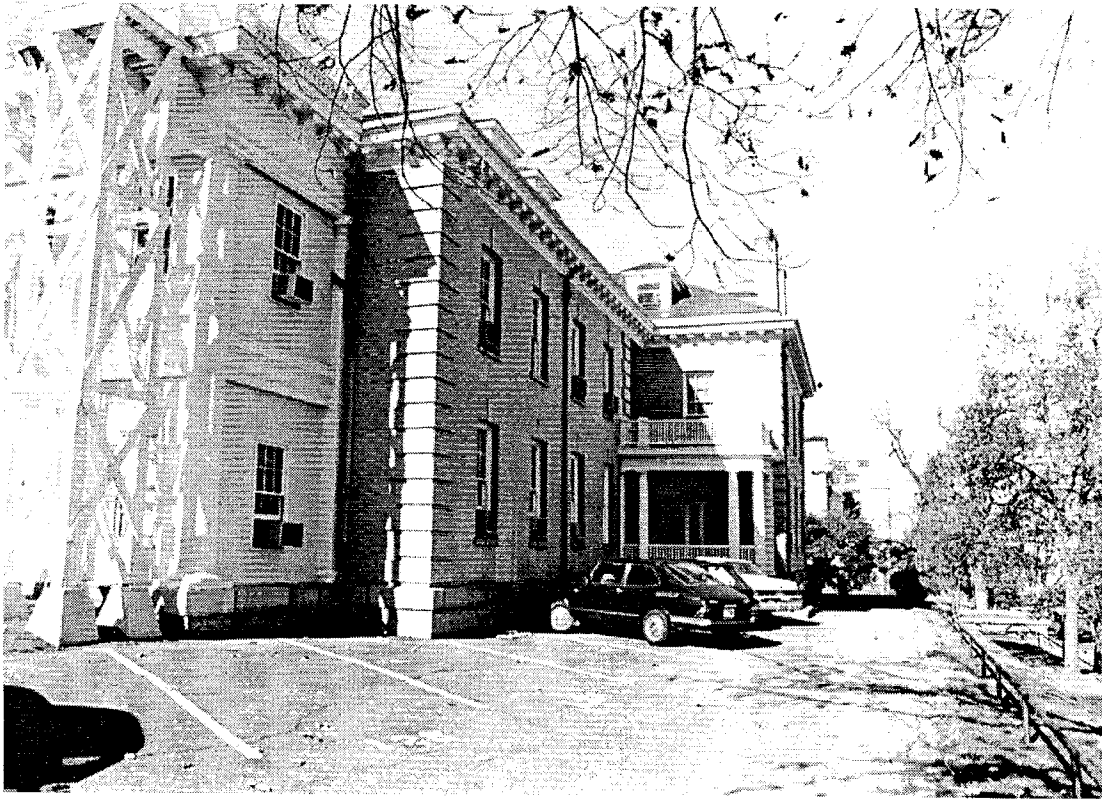
Figure 5-16.

Building 5. Oblique view from the southeast. Note that the asphalt parking abuts the building at grade, exposing it to impact damage. There is no curb on the east side of the parking lot (at right); the pipe railing serves as guard rail. The site slopes sharply to the east toward 23rd Street.
