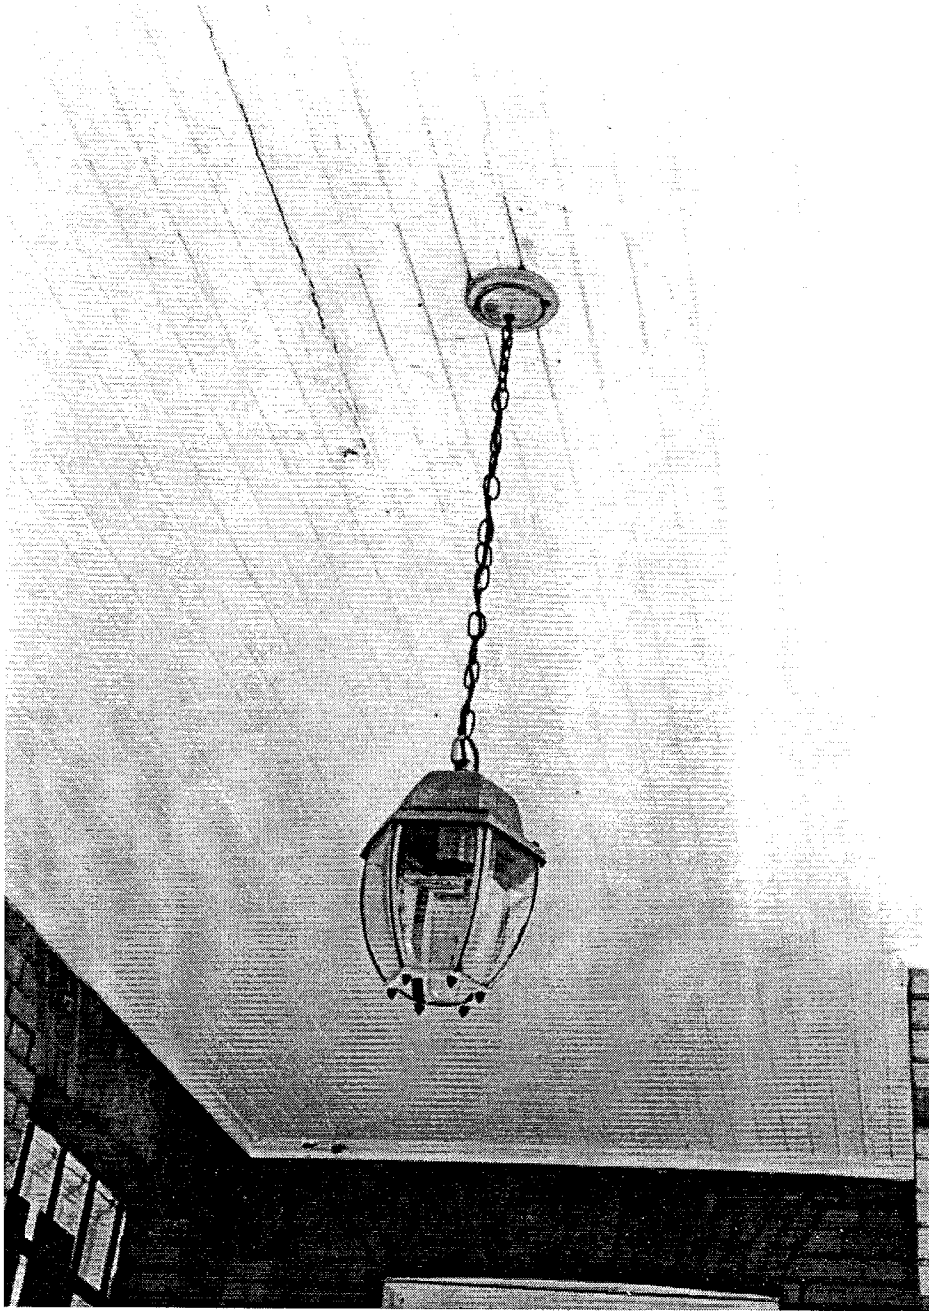
Figure 5-18.

Building 5. Typical exterior light fixture. This type of fixture is suspended from the ceilings of the porte cochere and the east and west entry porches. It is not original.

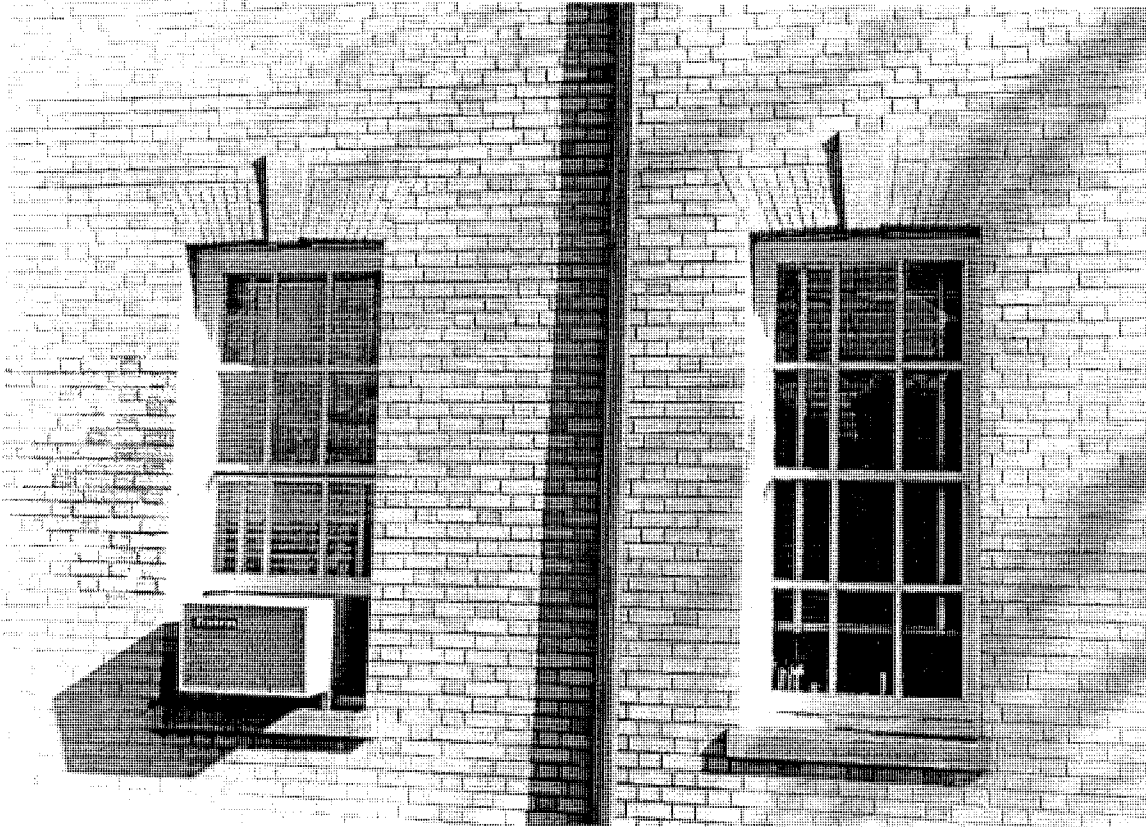
Figure 5-19.

Building 5. Most of the windows are the original six-over-six double-hung wood sash set into wood frames. While they have been over-painted, they appear to be in sound condition. Also note the brick and granite detail. The masonry, too, is in good condition.

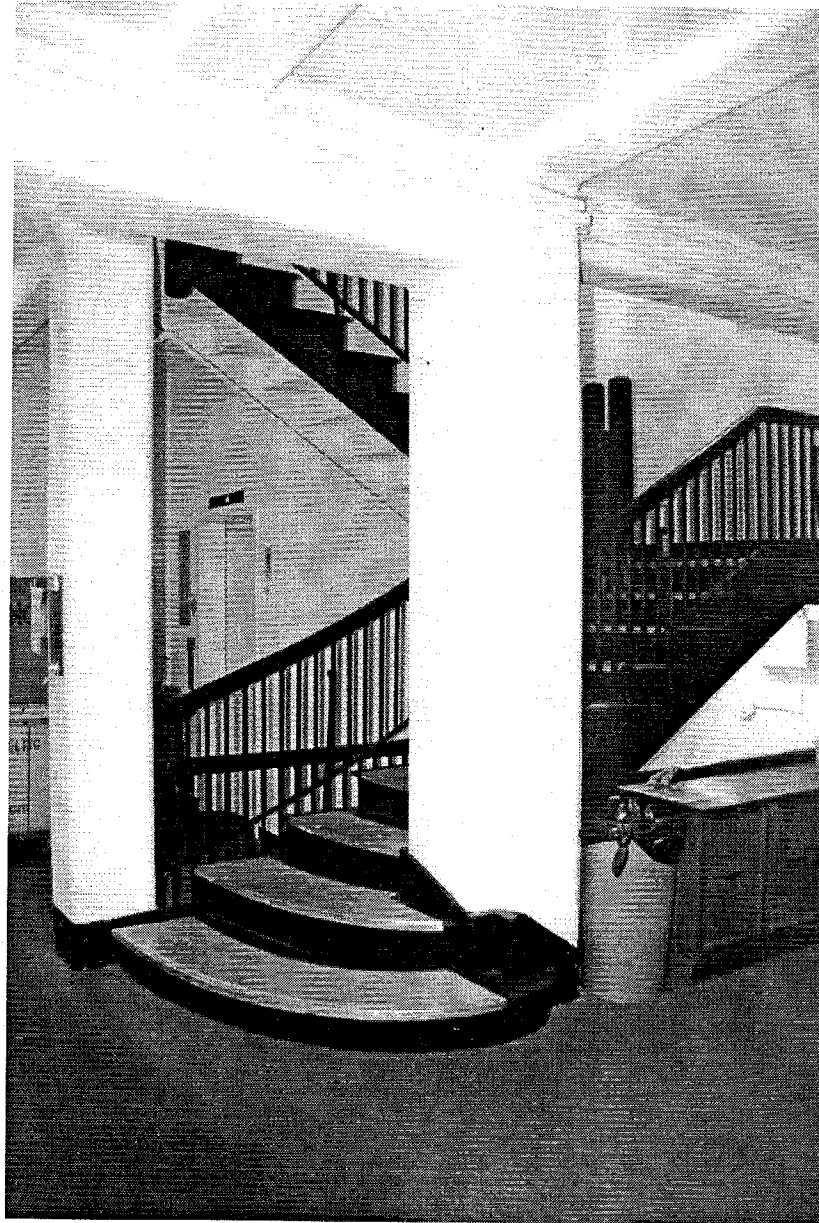
Figure 5-21.

Building 5. Main staircase. The first-floor level of the stair remains open and in its original configuration. Its design and detailing is similar, but not a replication of the stair in Building 3.

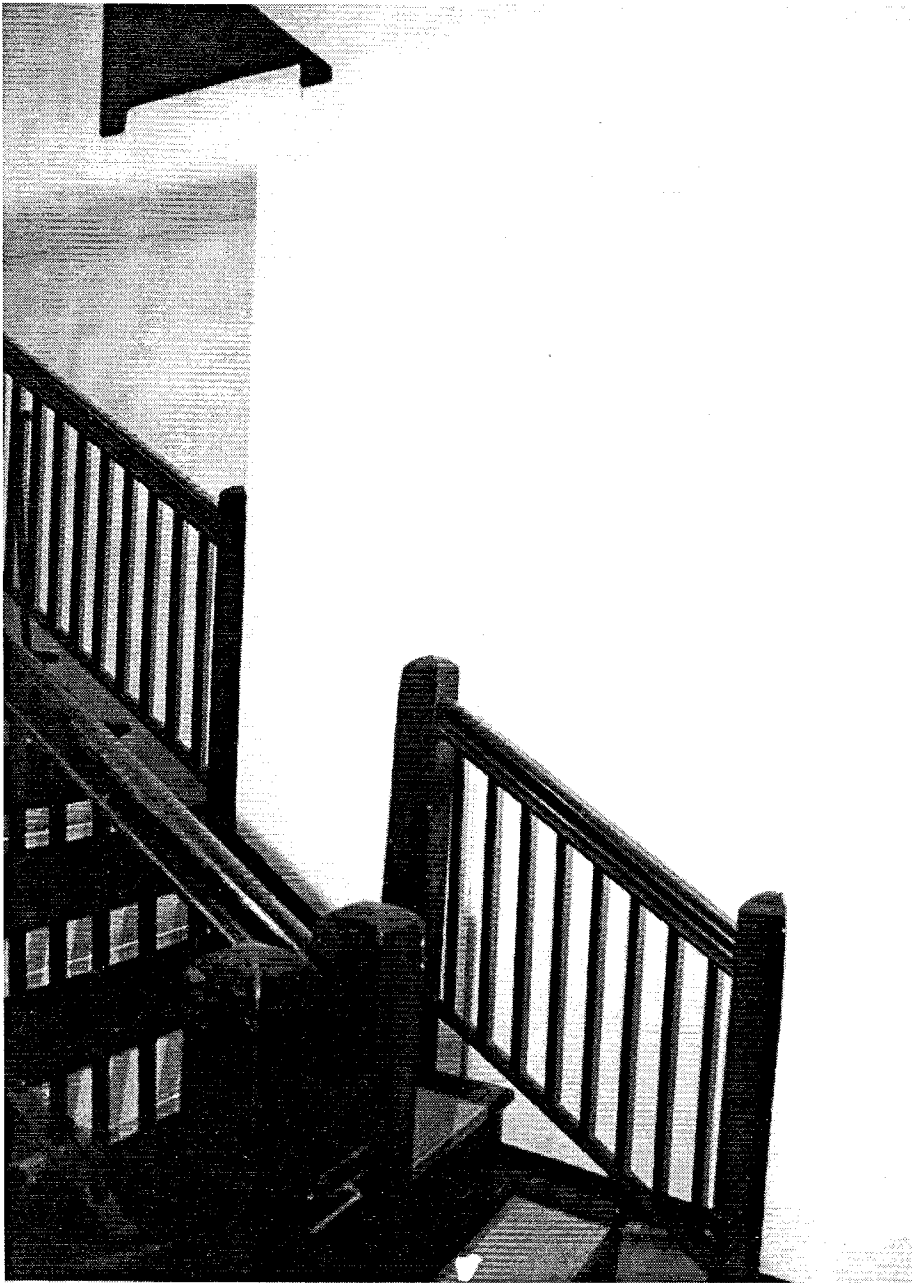
Figure 5-22.

Building 5. Main staircase, from the landing between the first and second floors. Unlike the treatments seen in other buildings, the fire enclosure of this stair left open the original hand rail. The enclosure does detract from the architectural character of the space, but it does leave the detail exposed. If it is necessary to enclose the stair for fire-rating purposes, this is a reasonable compromise.

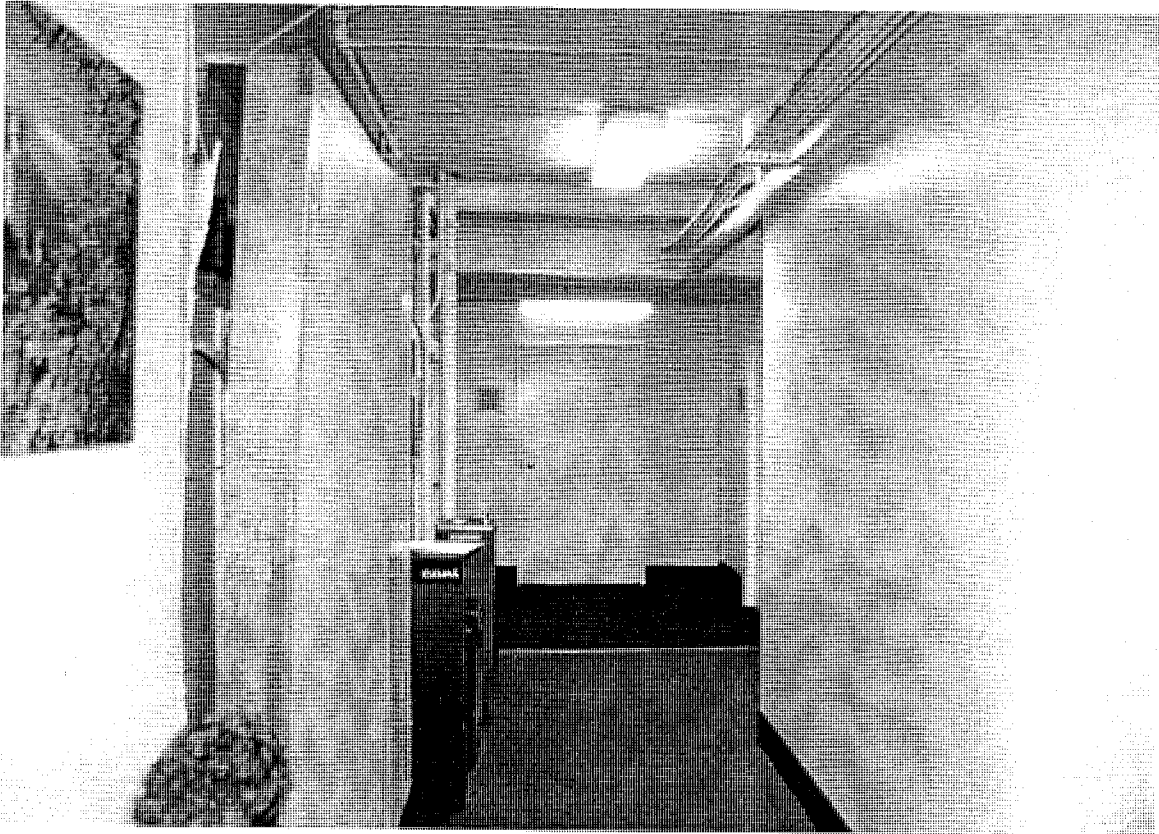
Figure 5-23.

Building 5. View of the second floor looking south. This space has been heavily altered. The gypsum board stair enclosure to the right, and the partition with door at the end of the space are not original. The electrical closet enclosure to the left is pulling away from the plaster wall.

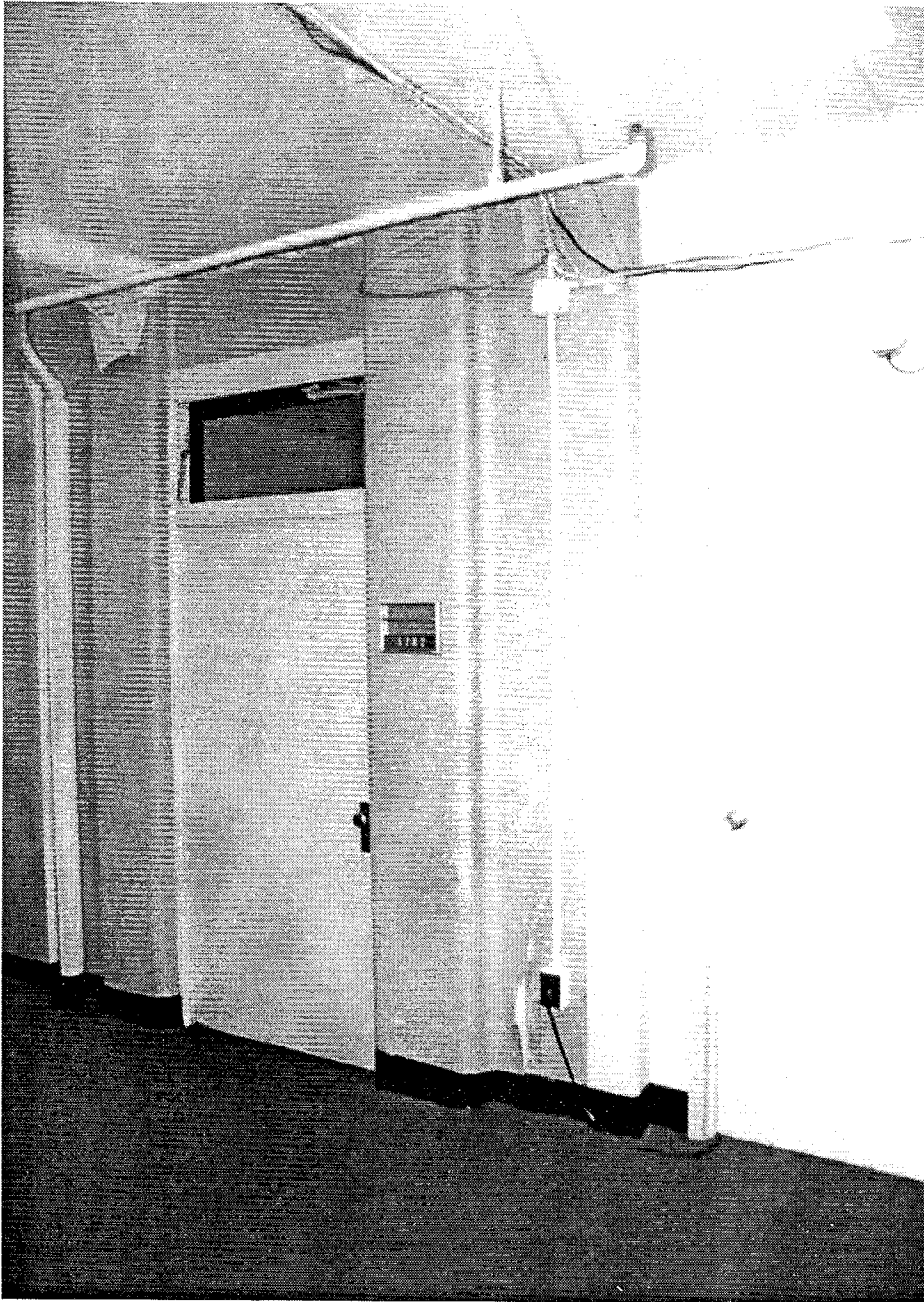
Figure 5-24.

Building 5. View of the second floor looking north. The door opening to the left is original, but the door is not. The infill and door to the right of the structural column are not original.

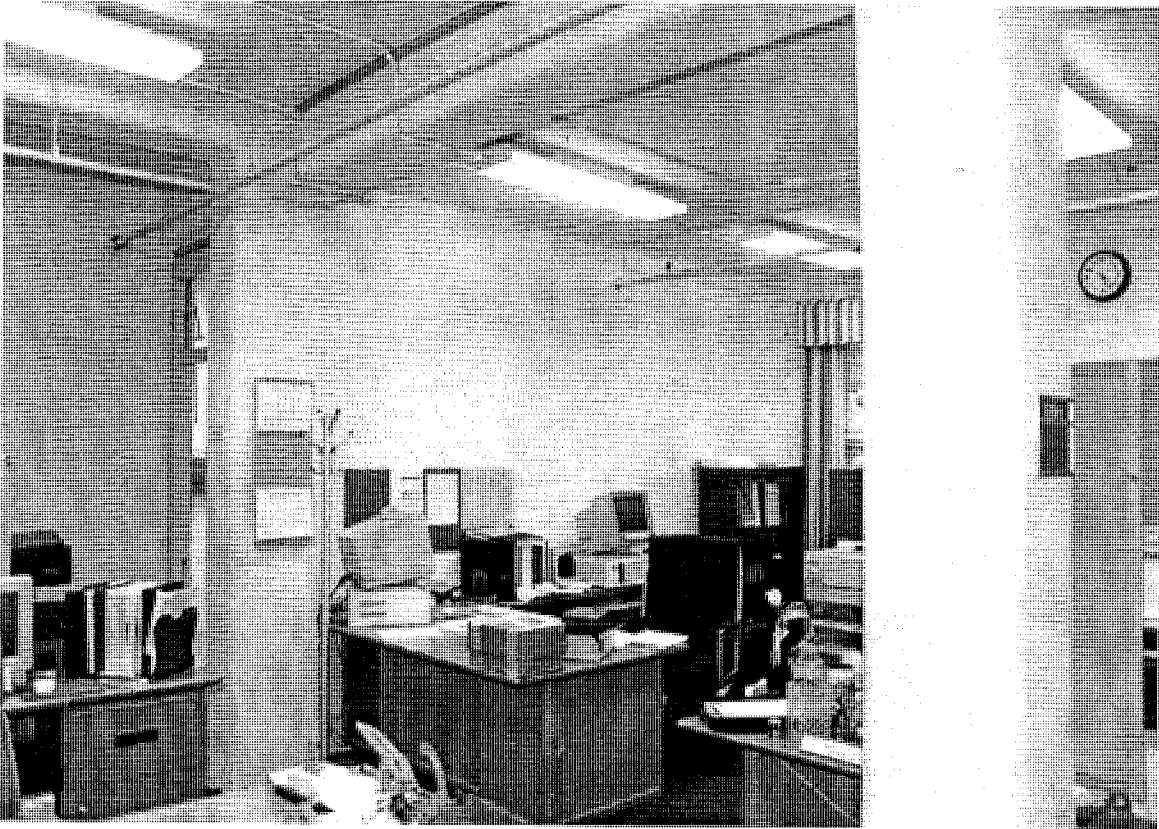
Figure 5-25.

Building 5. View of a typical office space on the second floor (Room 5207). The room configurations have been altered throughout the building.

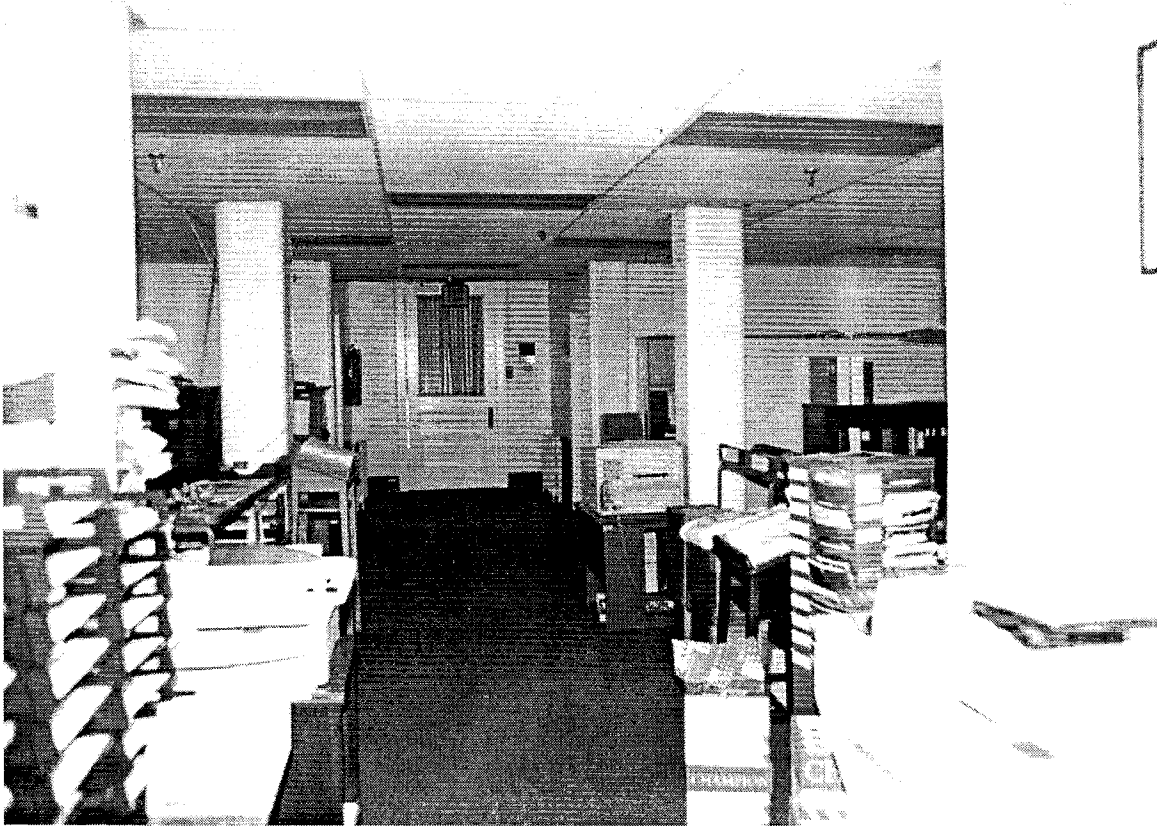
Figure 5-26.

Building 5. View of Room 5213. Like many rooms in the building, this has been altered by the removal of interior partitions. The suspended ceilings reduce the room height and cover the tops of door and window frames.

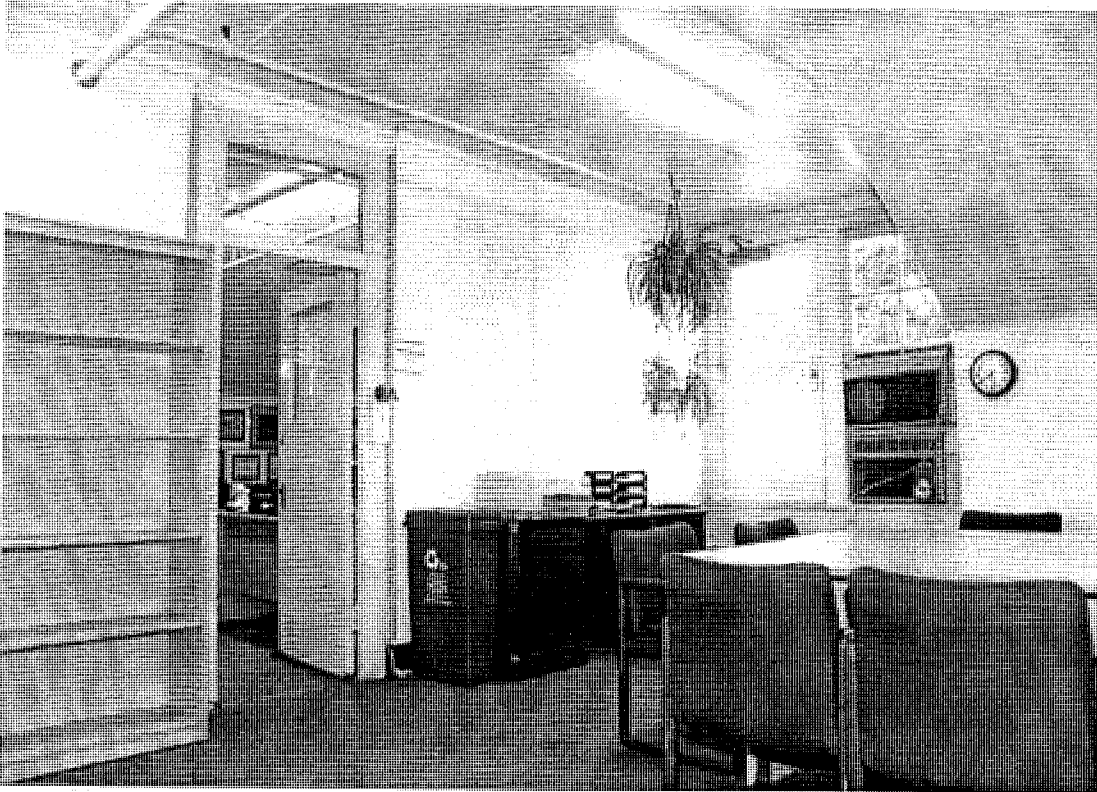
Figure 5-27.

Building 5. View of the third-floor corridor. This area is used as circulation and conference space. Floor plan changes have been made on this floor, as on the others.

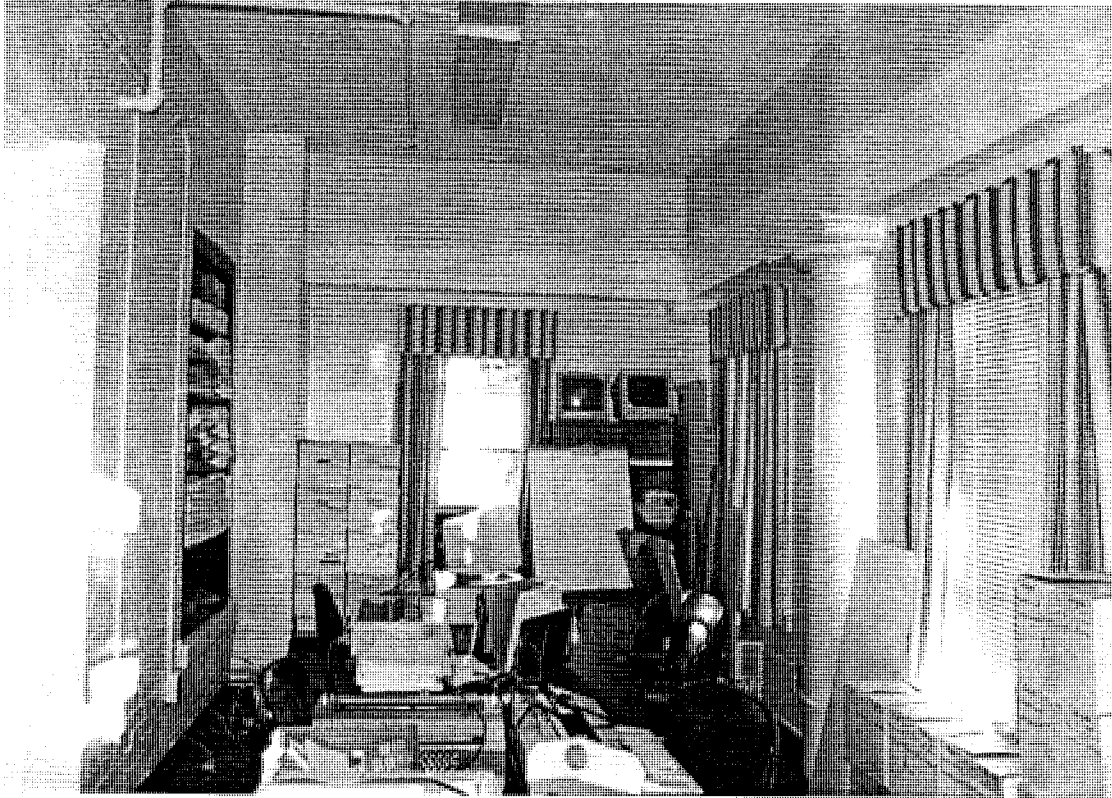
Figure 5-28.

Building 5. View of the second-floor sun porch. This space is used for storage. The door to the left appears to be original (see Figures 5-27, 5-33), but the window openings have been blocked in.

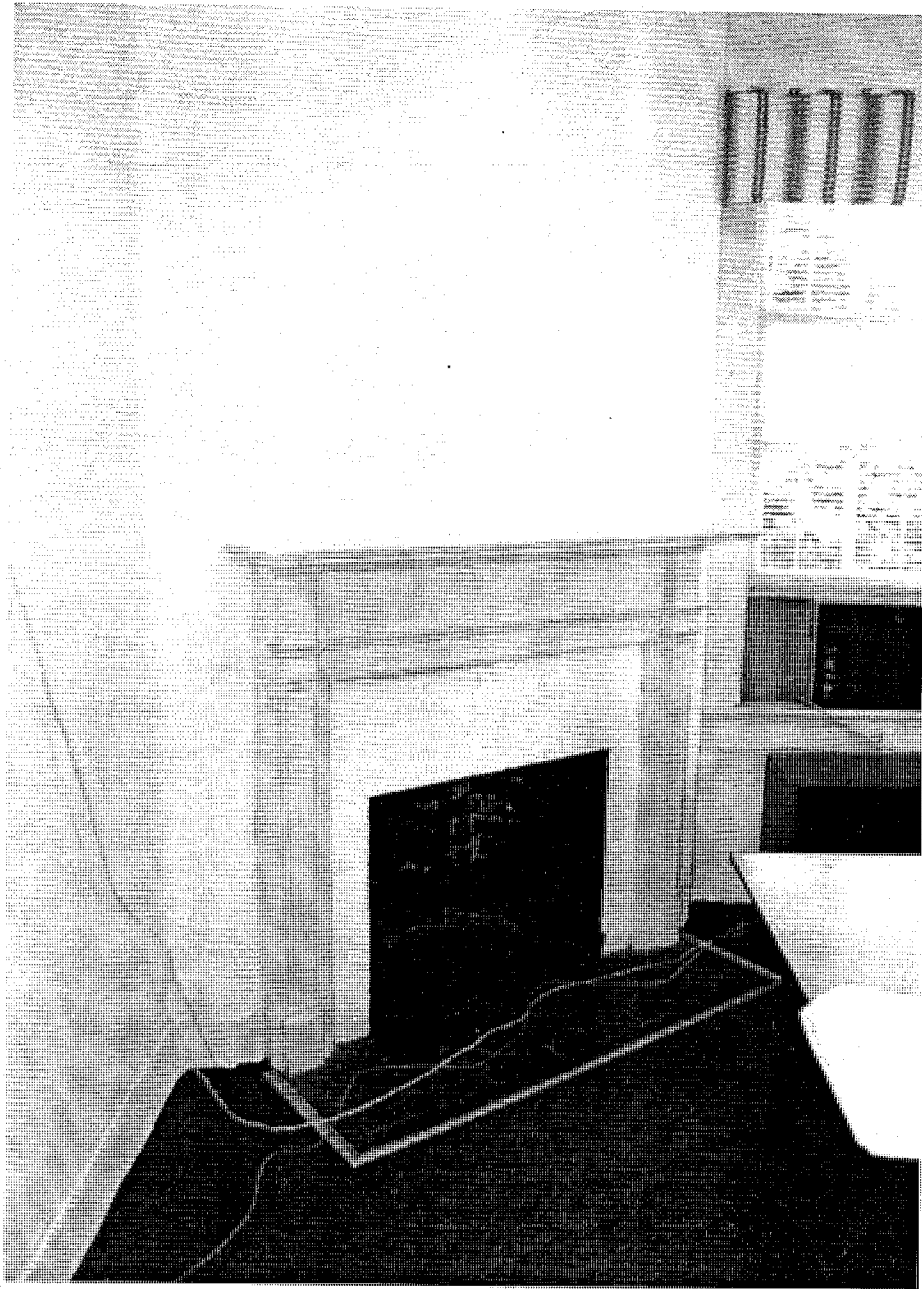
Figure 5-29.

Original brick fire places with painted wood mantels are extant in Rooms 5103, 5104, 5105, 5203, 5204 and 5205 (Figure 5-29). The fire place in 5105 has a brick hearth. A few of the fire boxes have been bricked in.

Building 5. Fireplace in Room 5205. Some of the fireplaces have had minor alterations; but they are all extant and mostly intact.

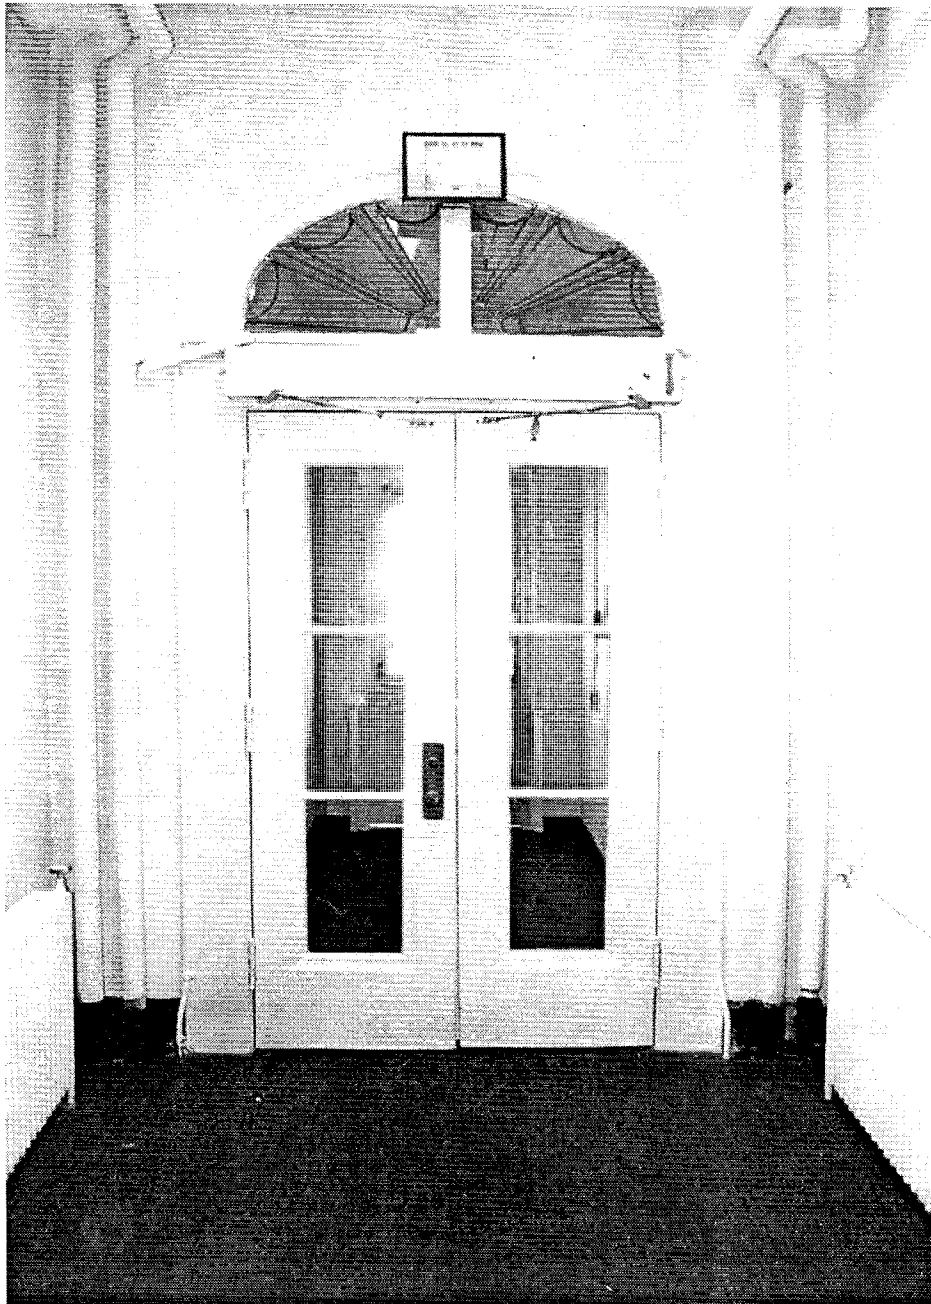
Figure 5-30.

Building 5. The doors and fan light at the south end of first-floor corridor are in their original location, although they are now enclosed by the sun porch corridor. The original north entry doors and fan light were identical to these.

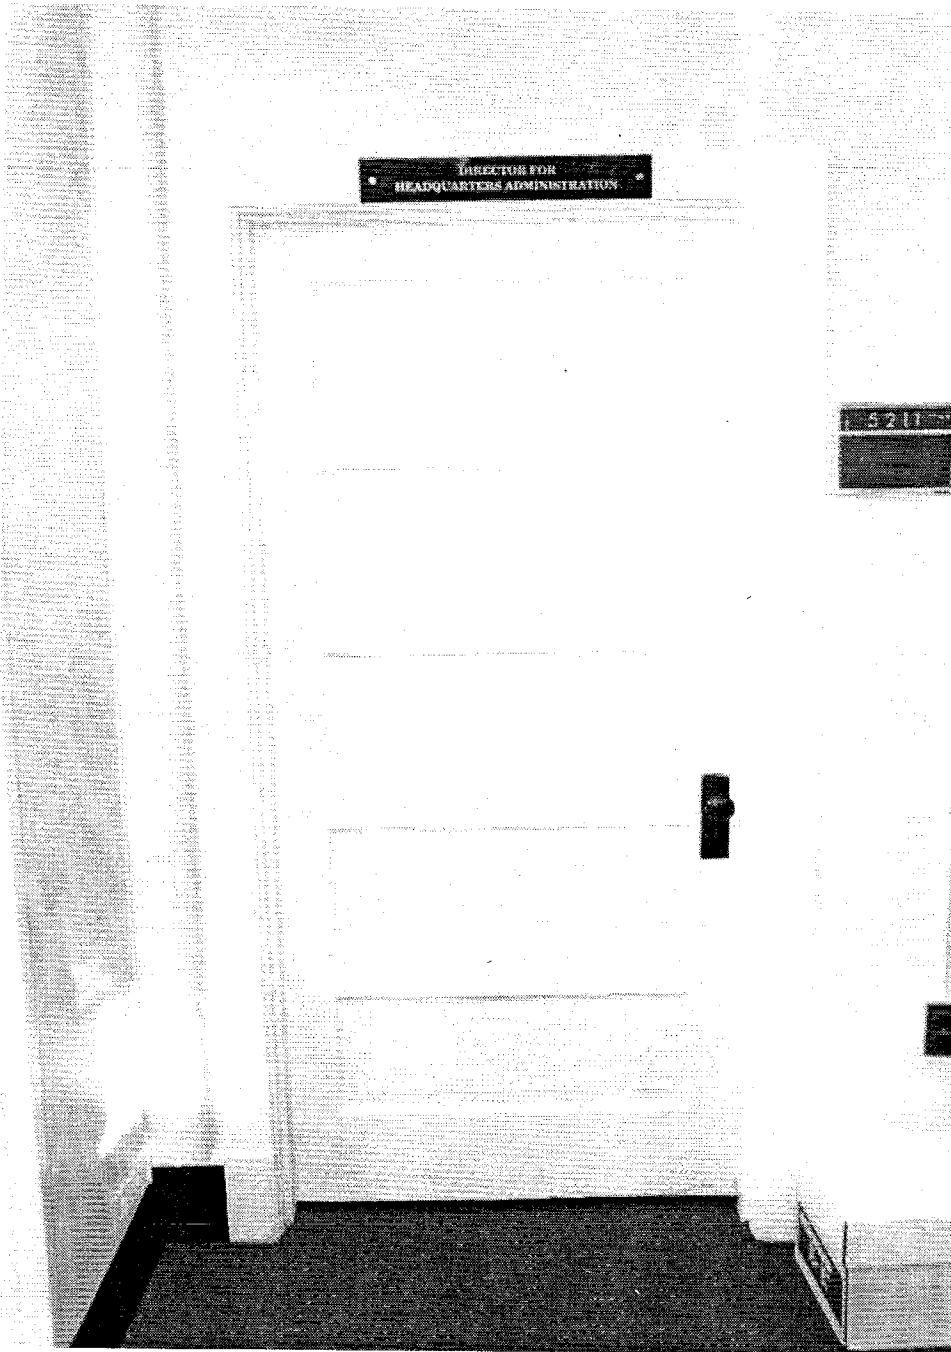
Figure 5-31.

Building 5. Typical five-panel wood door with original hardware. The panel moldings in these doors all have molded profiles. Rounded profiles on doors in other buildings on the site seem to denote that the doors are original; molded profiles seem to signify early replacements. The fact that there are no rounded moldings on the doors in this building may signify that they are early replacements, as well.

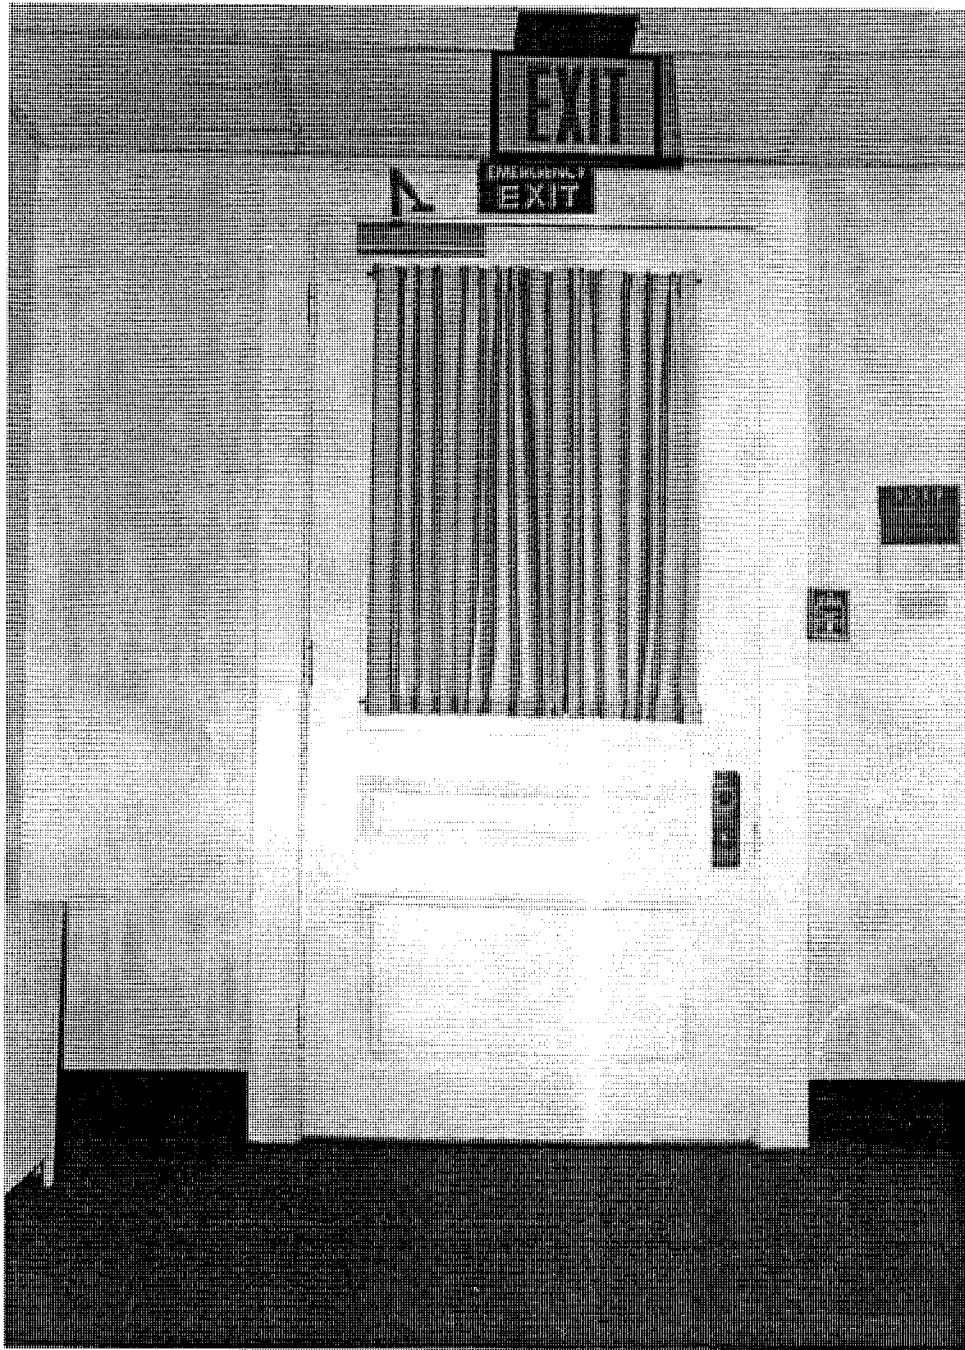
Figure 5-33.

Building 5. The entry door to the second-floor sun porch appears to be original.

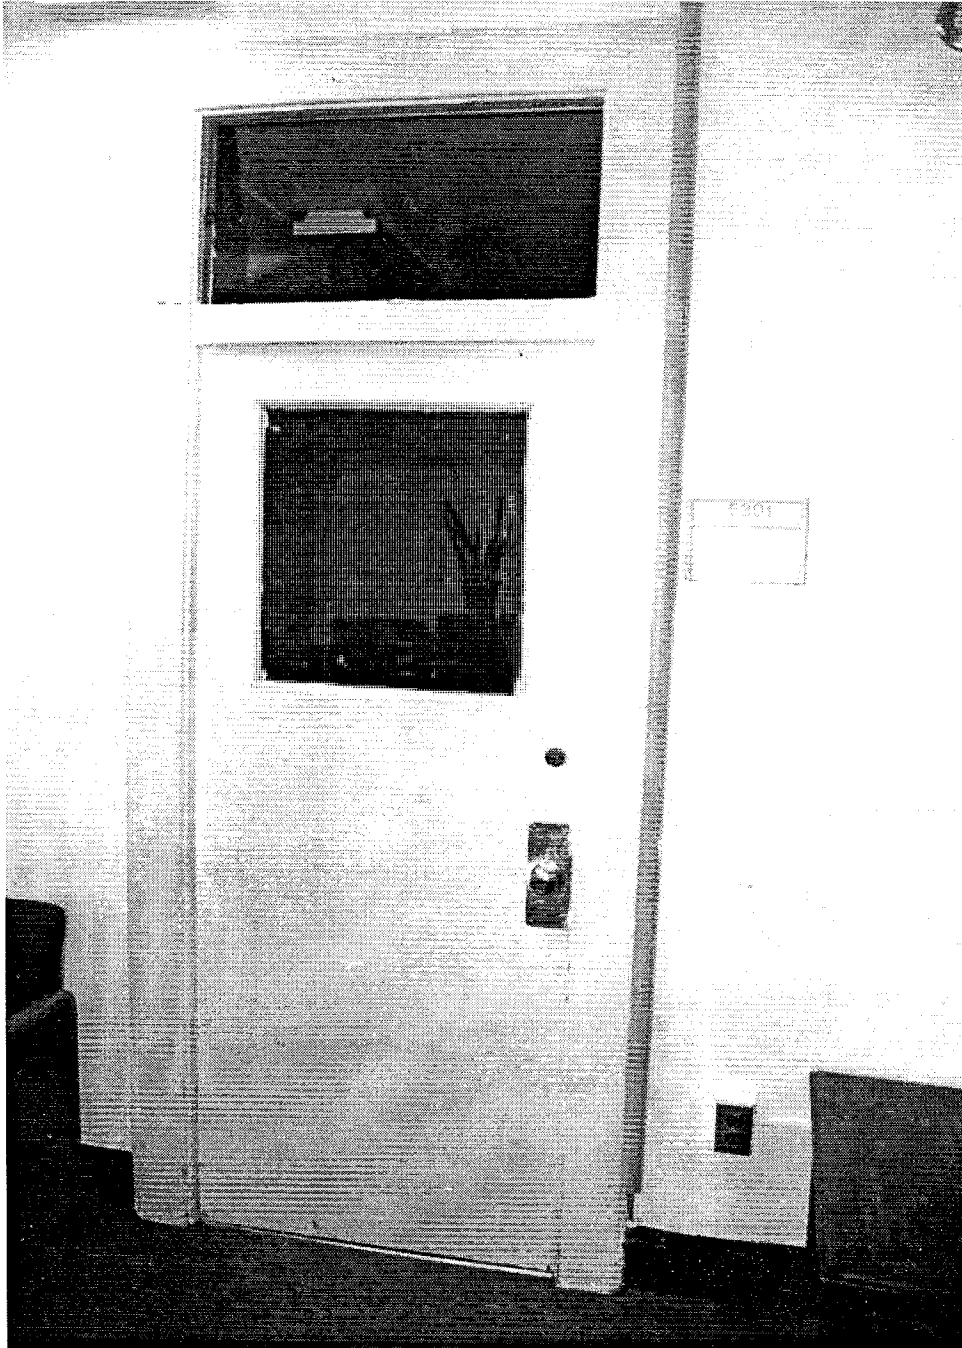
Figure 5-34.

Building 5. Typical third-floor door. These flush doors with window panels are probably early replacements.

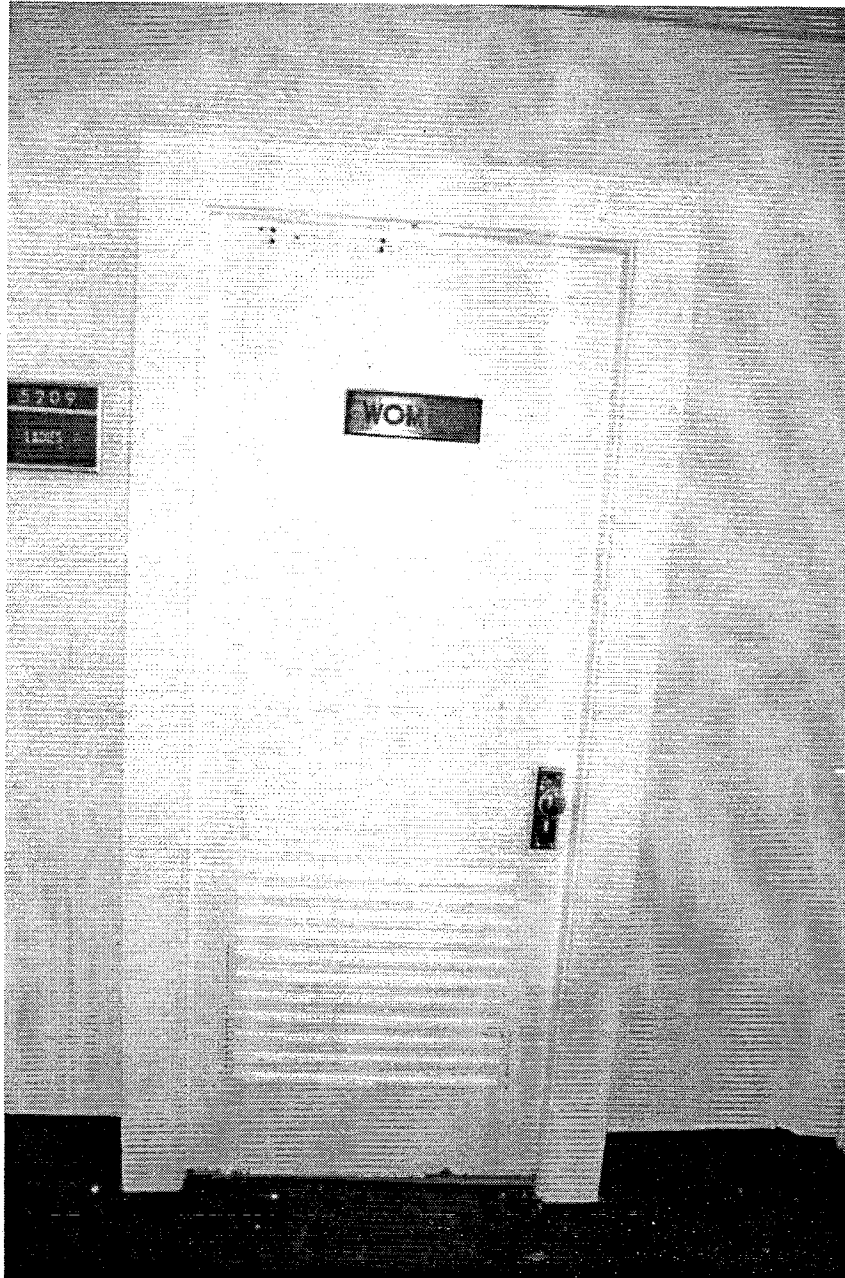
Figure 5-35.

Building 5. Typical toilet door and sign. These are probably early replacements.

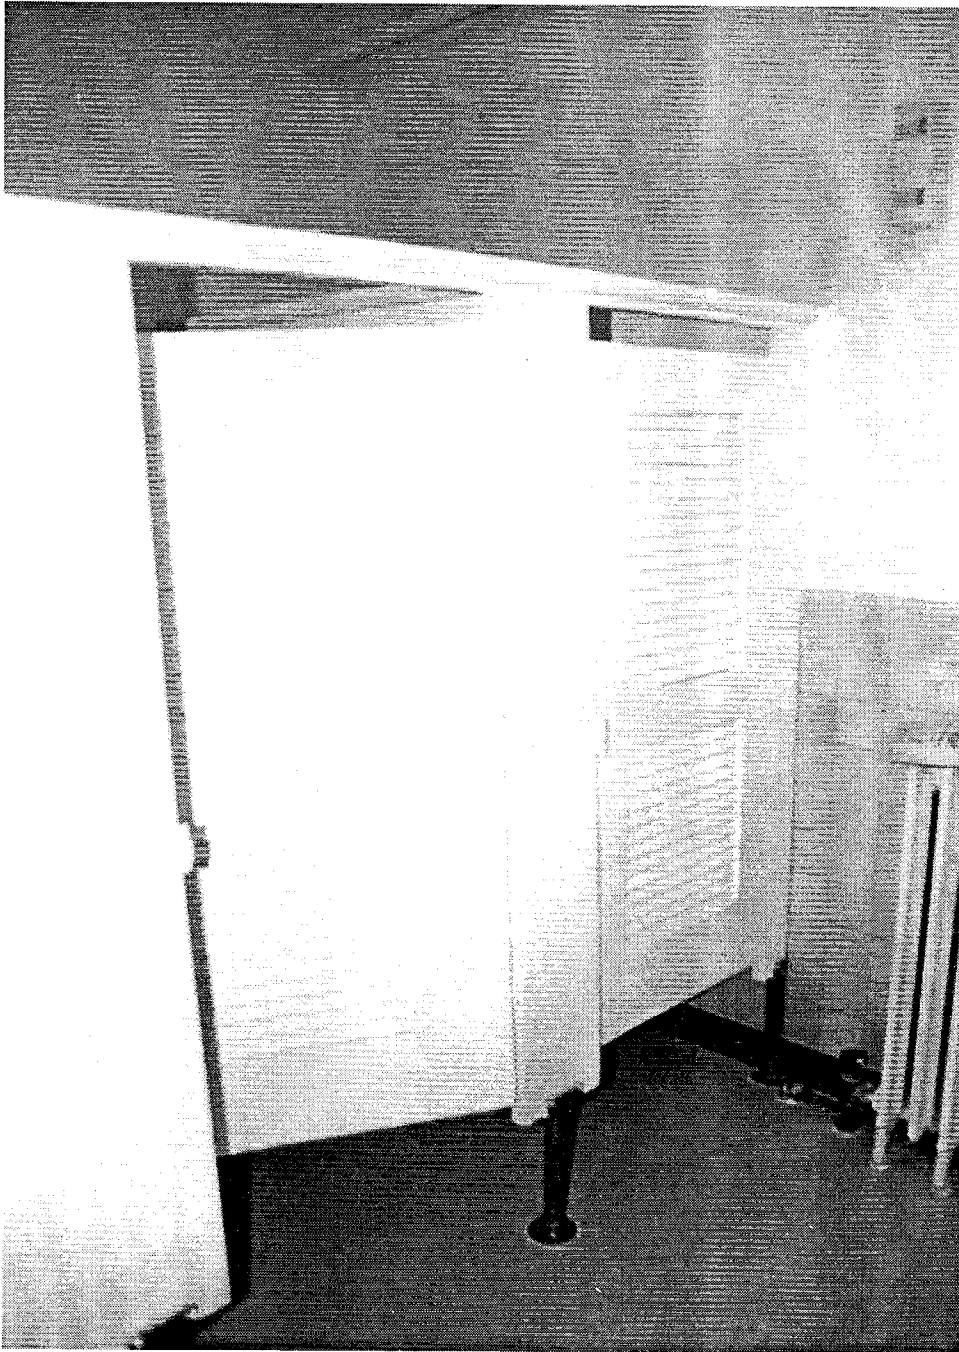
Figure 5-36.

Building 5. Typical toilet enclosure (Room 5209). These wood partitions with louvered or paneled doors probably represent early alterations. Most of the toilets were originally smaller bathrooms outfitted with tubs.

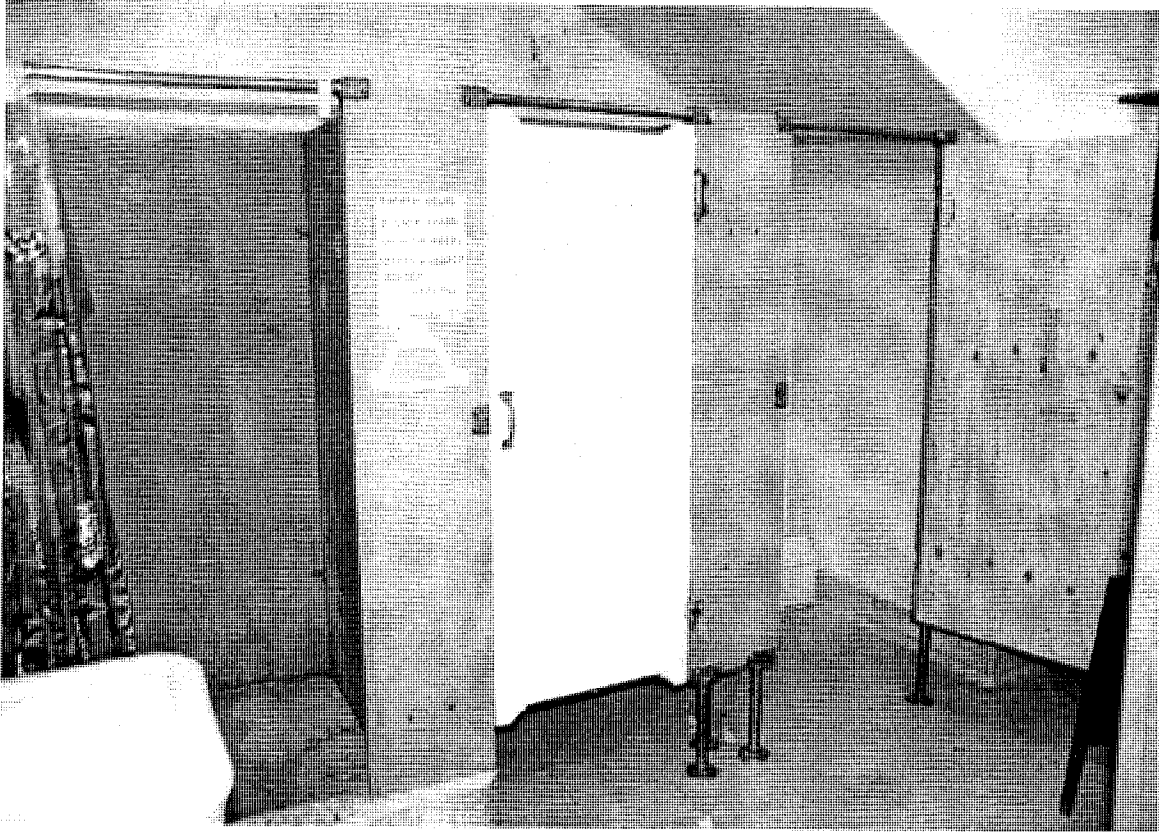
Figure 5-37.

Building 5. Typical toilet enclosure (Room 5306). Marble partitions may be original or early alterations.

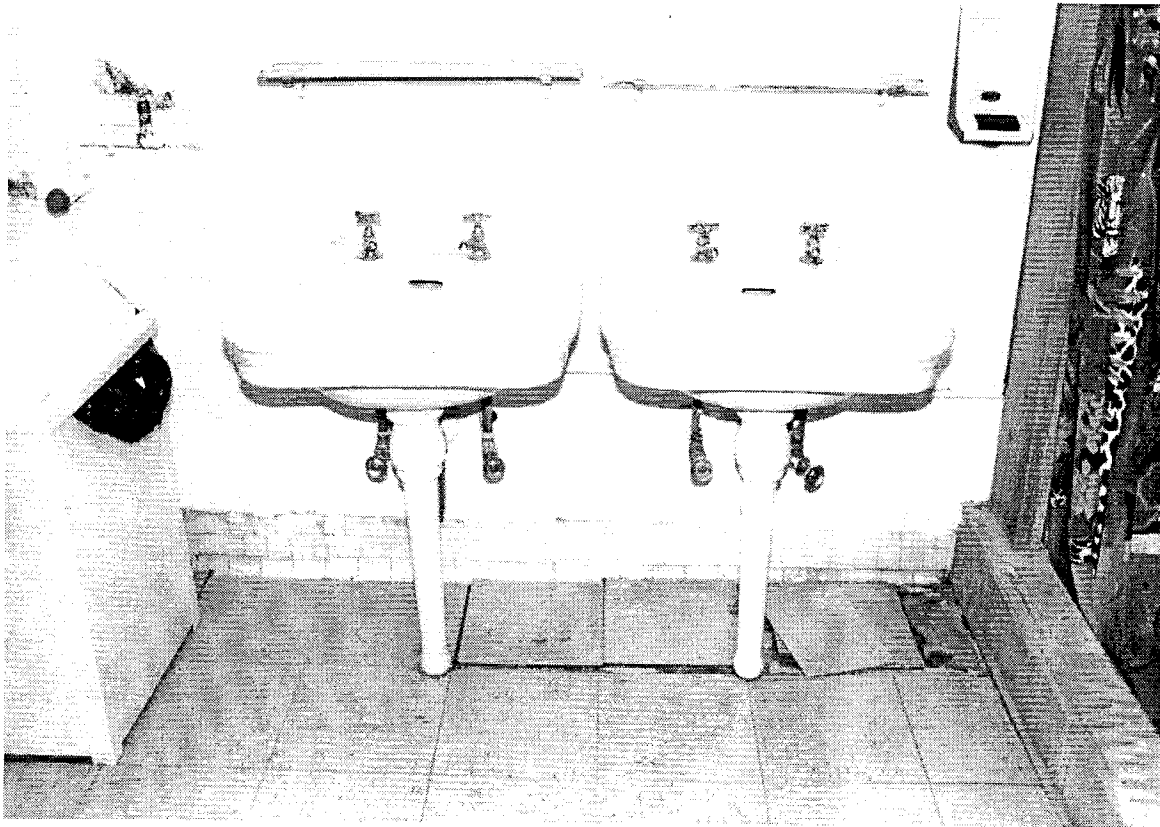
Figure 5-38.

Building 5. Original pedestal sinks. Several original sinks exist in this building.
