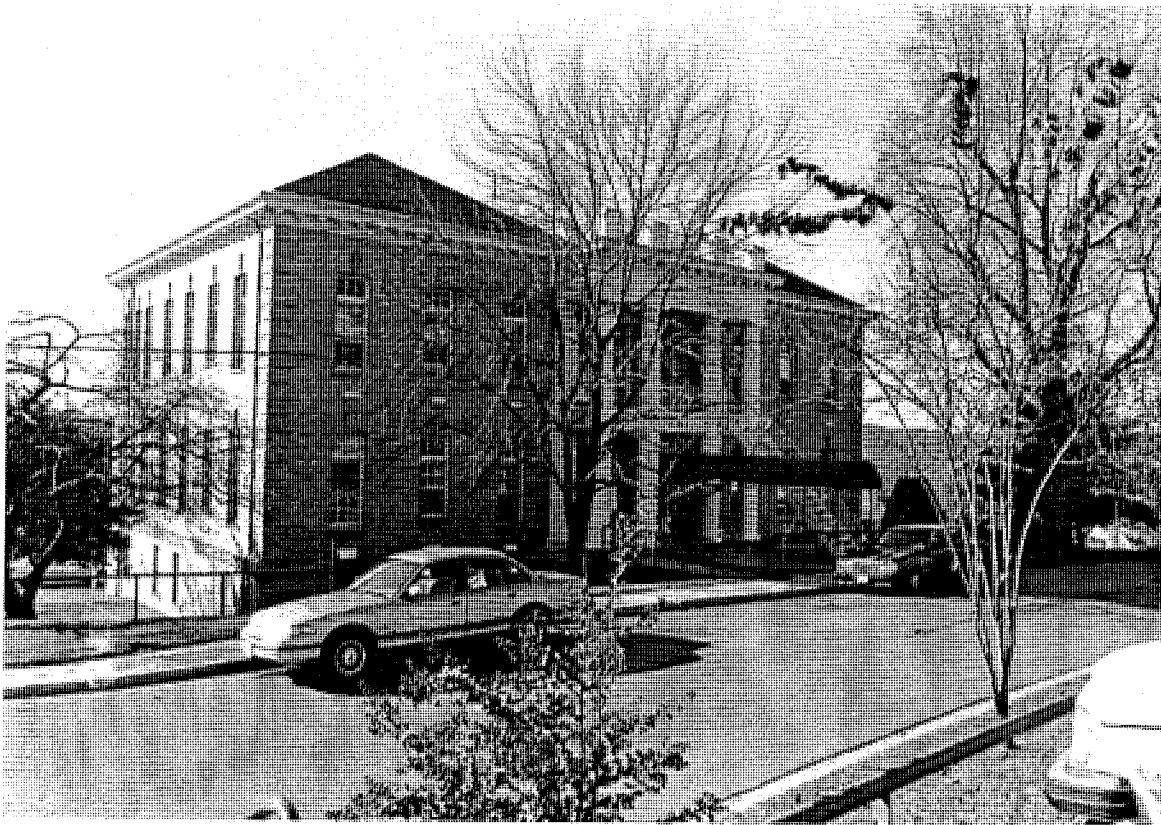
Figure 6-1.

The front elevation (Figure 6-1) is oriented to the north. A two-story classically-inspired entry portico with Tuscan columns is the central feature of the facade; this is flanked by three window bays on either side. The portico projects from the facade plane and the entry is recessed slightly. While the historic elevations do not represent the original entry in any detail, the existing aluminum and glass entry infill is most certainly a later alteration, which detracts from the architectural integrity of the facade. The second-floor balcony has been treated in a similar manner. A metal stair (a highly obtrusive later alteration) makes a straight run up to the second-floor balcony on the west side. A canvas canopy extends from the entry to the sidewalk.

The hipped roofs (Figure 6-1) are covered with grey slate tiles. They appear to be in good condition. Roof and dormer ridges, and edges are flashed with copper. The gutters and down spouts are also copper. The entire roof is finished by a wood modillioned cornice with an integral copper-lined gutter. A brick chimney is located at the west end of the roof. There is a skylight situated over the stair; and an elevator bulkhead pierces the central section. The roof of the porte cochere on the south side is built up asphalt roofing with gravel and the covered walkway is roofed with asphalt shingles. Air-conditioning equipment and ducts are located on the roof of the porte cochere and the south side of the main roof. The latter is highly visible from the south.

The roof is finished with a painted wood modillioned cornice (Figures 6-1, 6-4). The cornice is generally in good condition. The cornice is painted white, which is consistent with the historic trim noted on the building.

The north facade is dominated by a two-story balustraded classical portico with Tuscan columns (Figures 6-1, 6-2, 6-3). The two-story wood columns support an entablature with a blank frieze and modillioned cornice. The entablature is surmounted by a balustrade with turned balusters. This is all in good condition, although there are some separations between wood members on the columns, and some paint failure.

A highly obtrusive metal stair (Figures 6-1, 6-2, 6-10) makes a straight run from grade to the second-floor level. It serves as an emergency egress, but it is frequently used by occupants as convenient access to the second floor. It is rusting in some areas and needs paint.

The landscaping around this building is spare. As indicated above, the lawn slopes sharply into the foundation on the north side (Figures 6-1, 6-4, 6-8, 6-9, 6-10). The area is unattractive and neither utilitarian nor ornamental. It has been utilized for the installation of A/C condensers on concrete pads. The east side of the slope is badly eroded and a drainage pipe protrudes near the top. The area near the foundation is damp, but no cracks or moisture-related problems were noted. A concrete sidewalk borders the west side of the north elevation. Concrete steps leading to the entry on the west side are cracked. A simple concrete path leads around the northwest corner; this is bordered by recent retaining walls made of treated wood timbers. Low plantings have been installed on the slope presumably to assist in stalling erosion. The east, south and west sides are bordered by parking lot and asphalt (or sidewalk concrete) meets the building at grade.

Building 6. Oblique view from northeast. Building 6 was constructed as the Contagious Hospital, and was constructed 1908-1910.

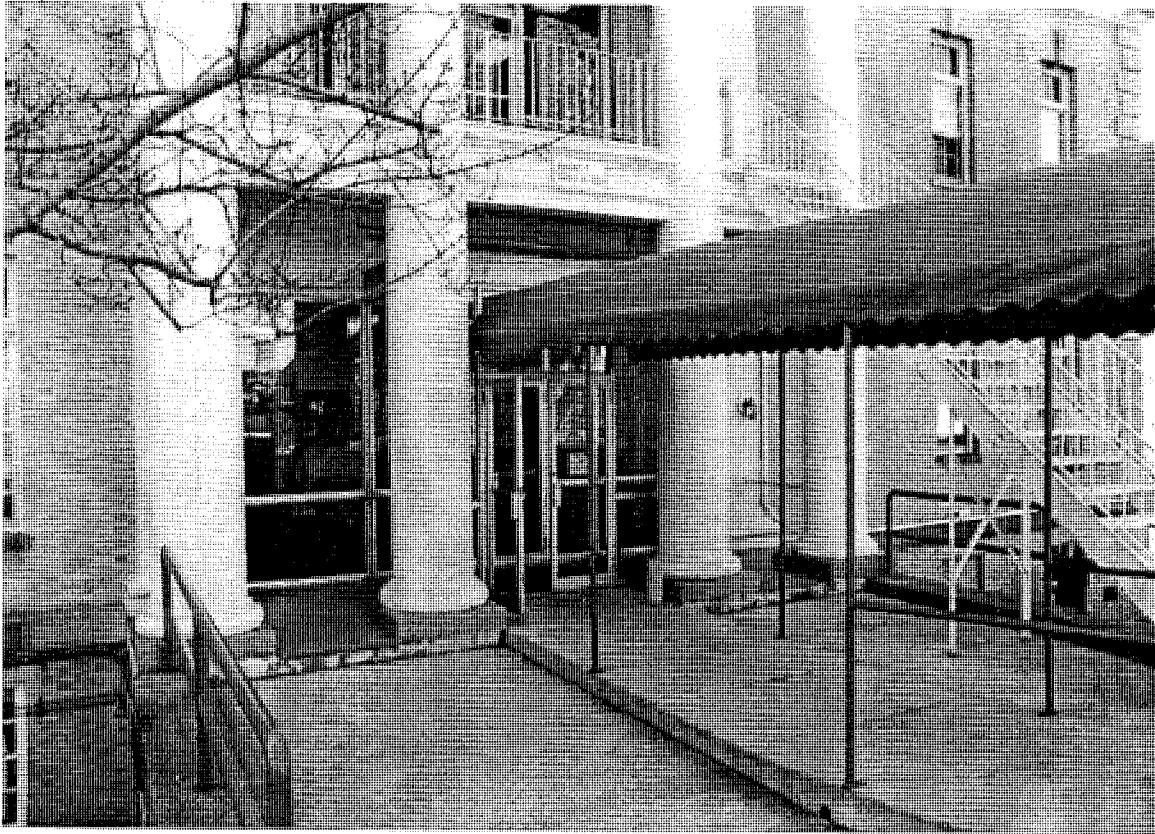
Figure 6-2.

The existing aluminum and glass entry infill (Figure 6-2) is most certainly an obtrusive later alteration. The second-floor balcony (Figure 6-3) has been treated in a similar manner. The original balustrades on both porch levels have been removed. On the first floor, they were replaced by a simple pipe rail; on the second floor, they were replaced by a thin metal railing.

There is no original lighting on the building. There are flood lights and brass light fixtures in a vaguely classical style mounted on the porch (Figures 6-2, 6-3). These could be replaced by more compatible fixtures.

Building 6. North elevation, entry portico. The aluminum and glass entry infill replaces a folding partition arrangement noted on original drawings. A glazed partition could be an appropriate solution to enclosing the building; but the heavy, mill-finish aluminum members of this system detract from the architectural integrity of the building. The steel stair (to the right of the canopy) and the metal railing along the second-floor balcony replace a wood balustrade; both elements detract from the building's design.

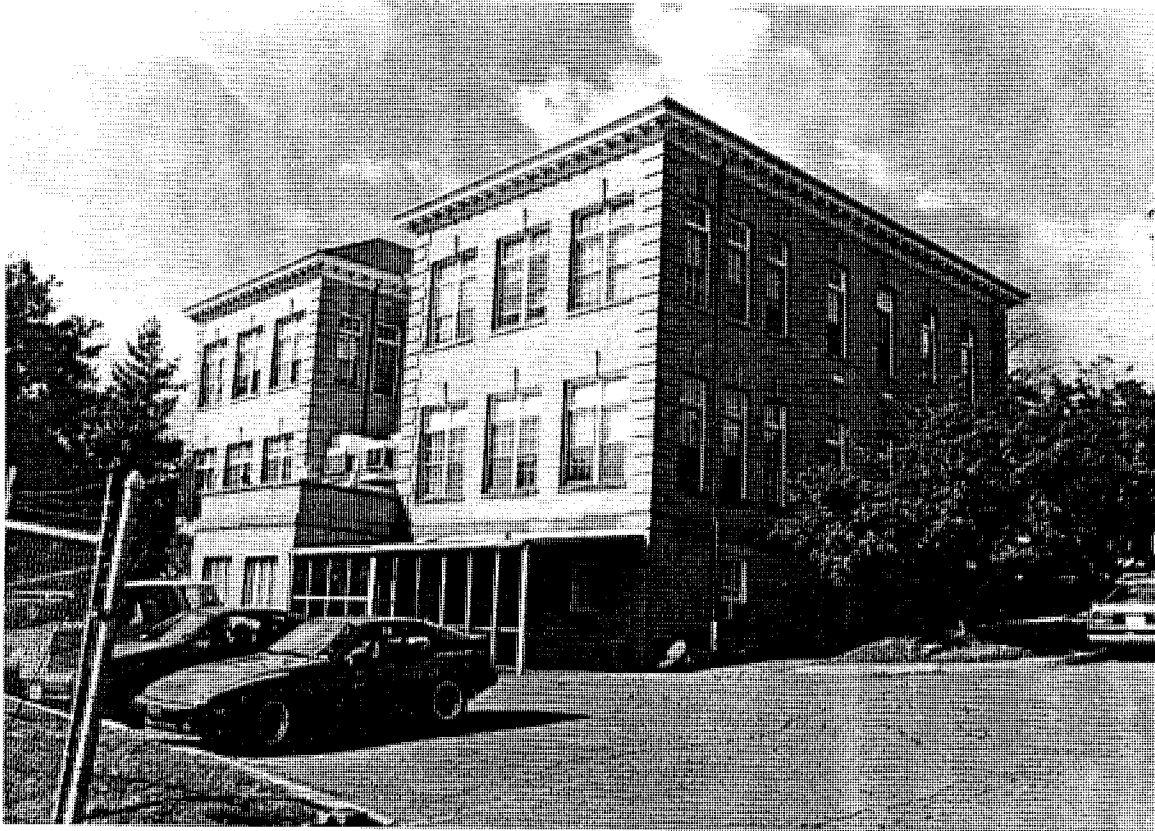
Figure 6-4.

Building 6. Oblique view from the southeast. The south elevation of this building, and the HVAC equipment on top of the porte cochere, are highly visible from off-site. Note also that the windows are original 6-over-6 wood sashes. On the north, east and west they are single units with transoms. On the south elevation, the windows are paired in wider masonry openings.

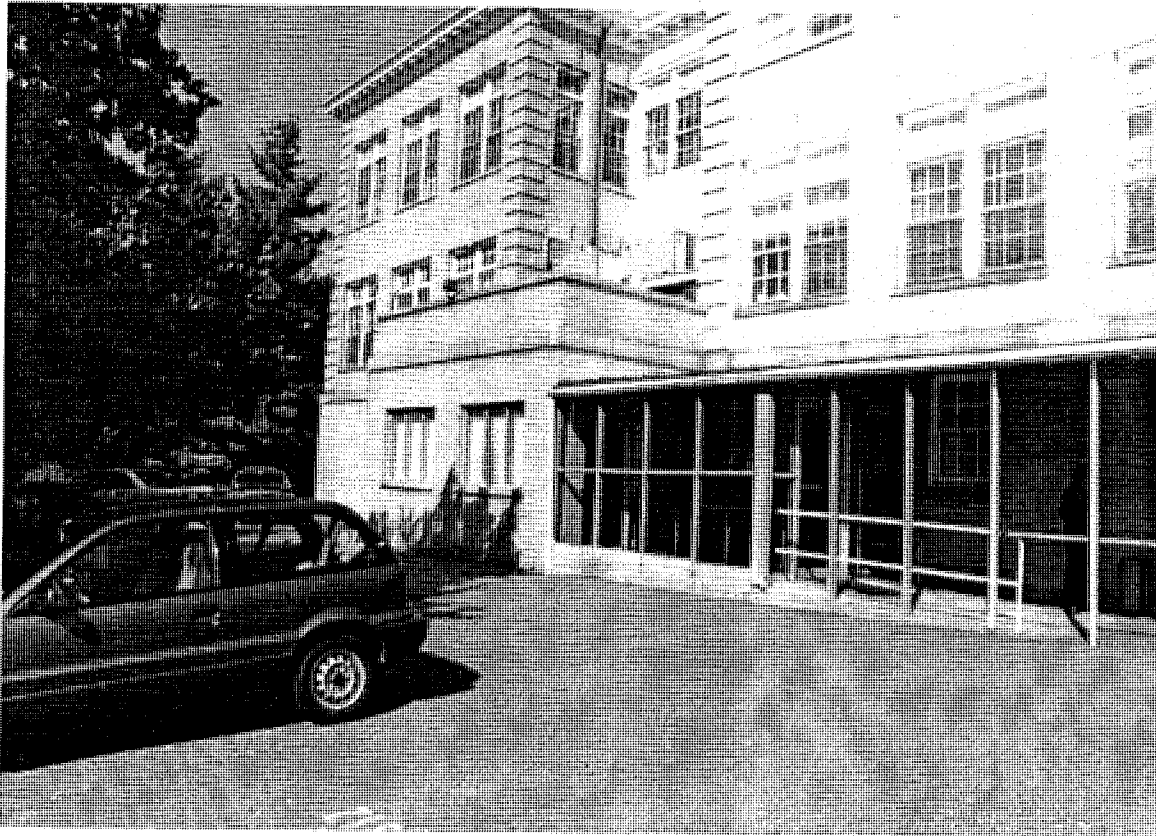
Figure 6-5.

Building 6. South elevation, detail of former porte cochere. The aluminum and glass infill, and the covered walk detract from the building's architectural character. Glazed systems could be an appropriate solution, but the heavy, mill-finished aluminum members of the infill and heavy posts of the walkway do not enhance the quality of this design.

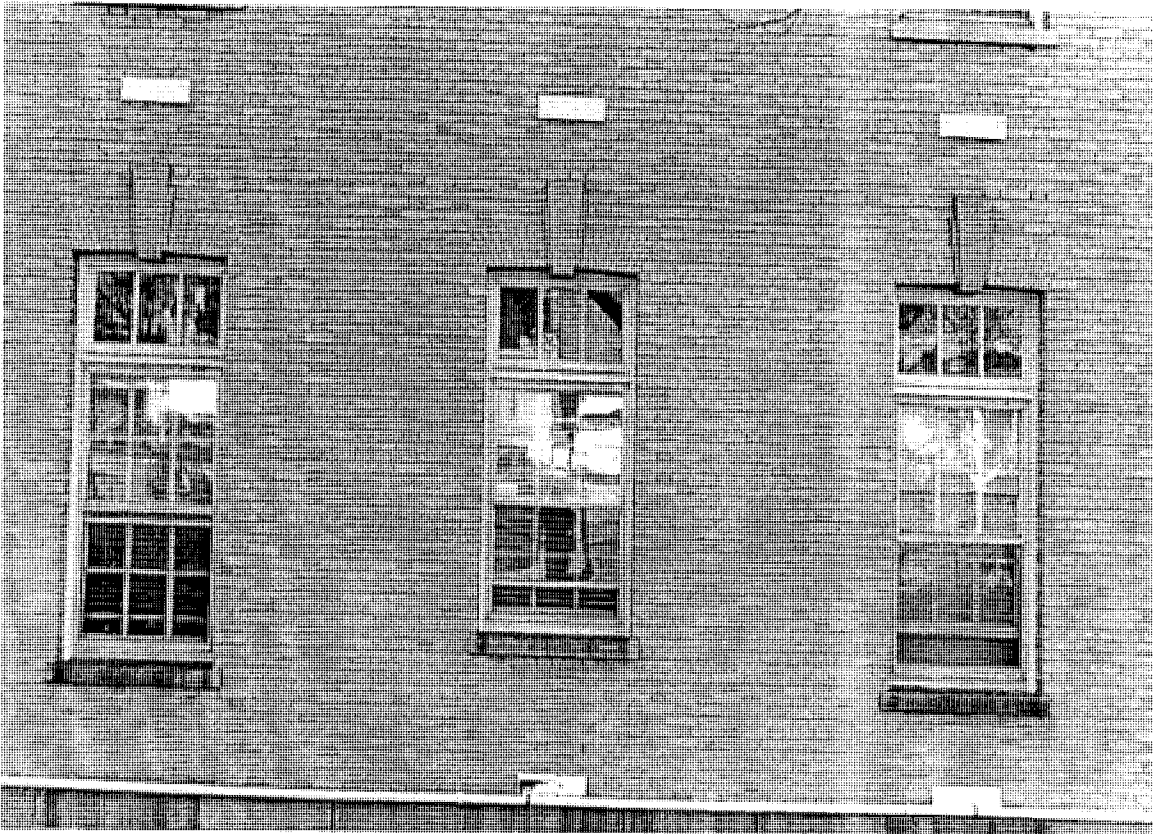
Figure 6-6.

Building 6. North elevation. Six-over-six wood double-hung sash windows set under three-light transoms are typical of north, east and west elevations. The white panels under the windows are vestiges of the ventilating system designed for the original hospital use of this building. Also note obtrusive conduit running across the top of the water table belt course.

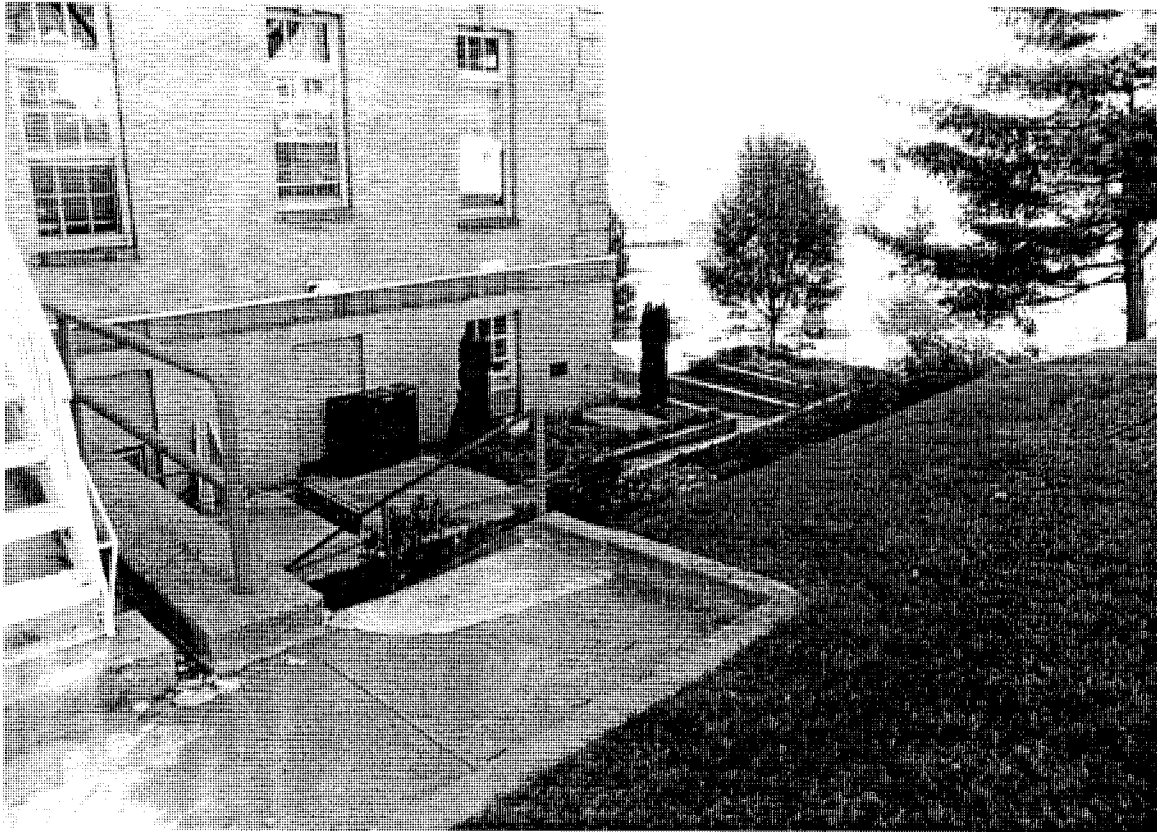
Figure 6-8.

Building 6. Landscape, view looking down the slope toward the southwest. Note the recent retaining walls and plantings; the pressure-treated lumber is not a sympathetic material in the landscape on this site, which is typified by masonry paths and retaining walls.

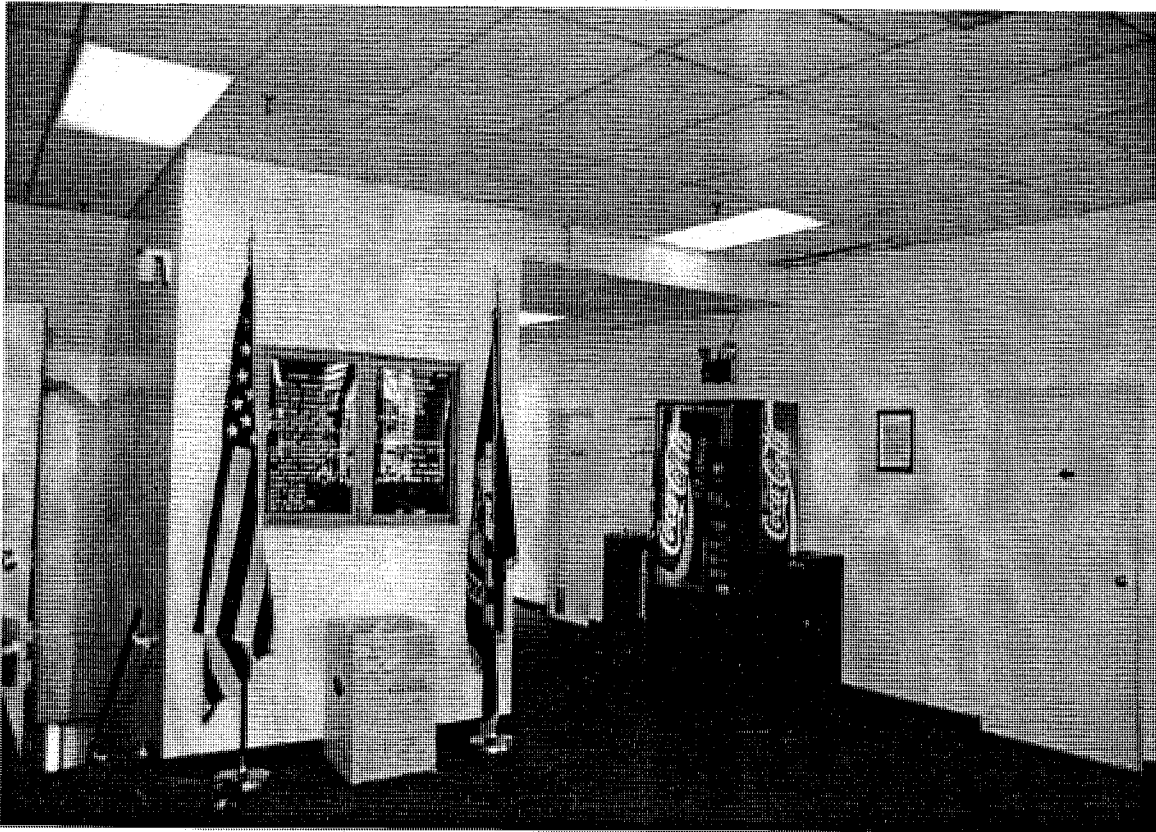
Figure 6-11.

The existing doors are a combination of flush wood or metal (Figures 6-11, 6-16) set into metal bucks. Some doors have a glazed viewing panel.

Building 6. View of the first-floor lobby space. Note elevator shaft in the foreground (behind the flags). The elevator doors open to the area to the right, which is a deviation from the original design intent. The interior of this building has been altered more heavily than any other building on the site. Of particular note are dropped ceilings, new partitions and flush wood doors throughout.

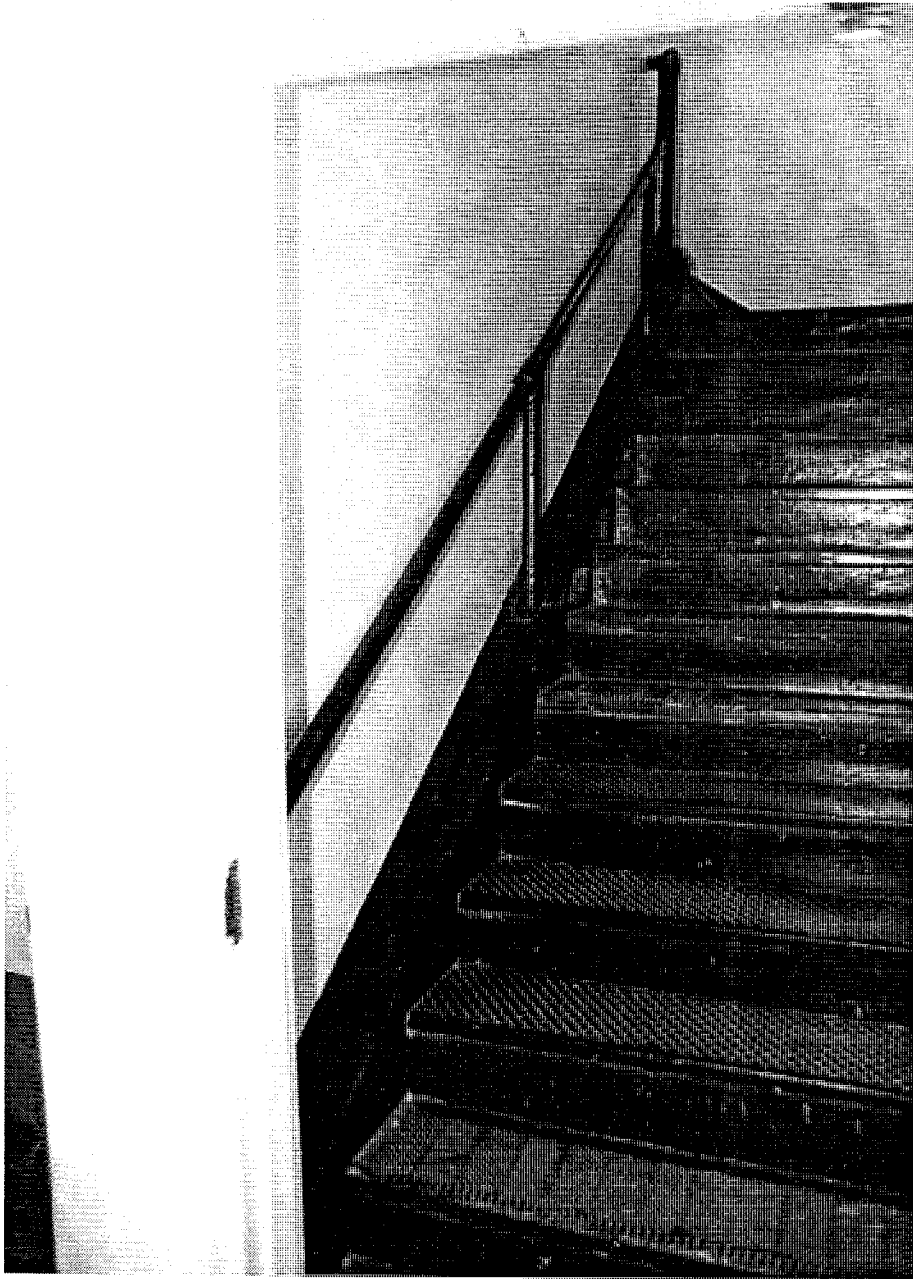
Figure 6-12.

Building 6. View of stair leading from first-floor lobby to second floor. The gypsum board enclosing the stair is a later alteration.

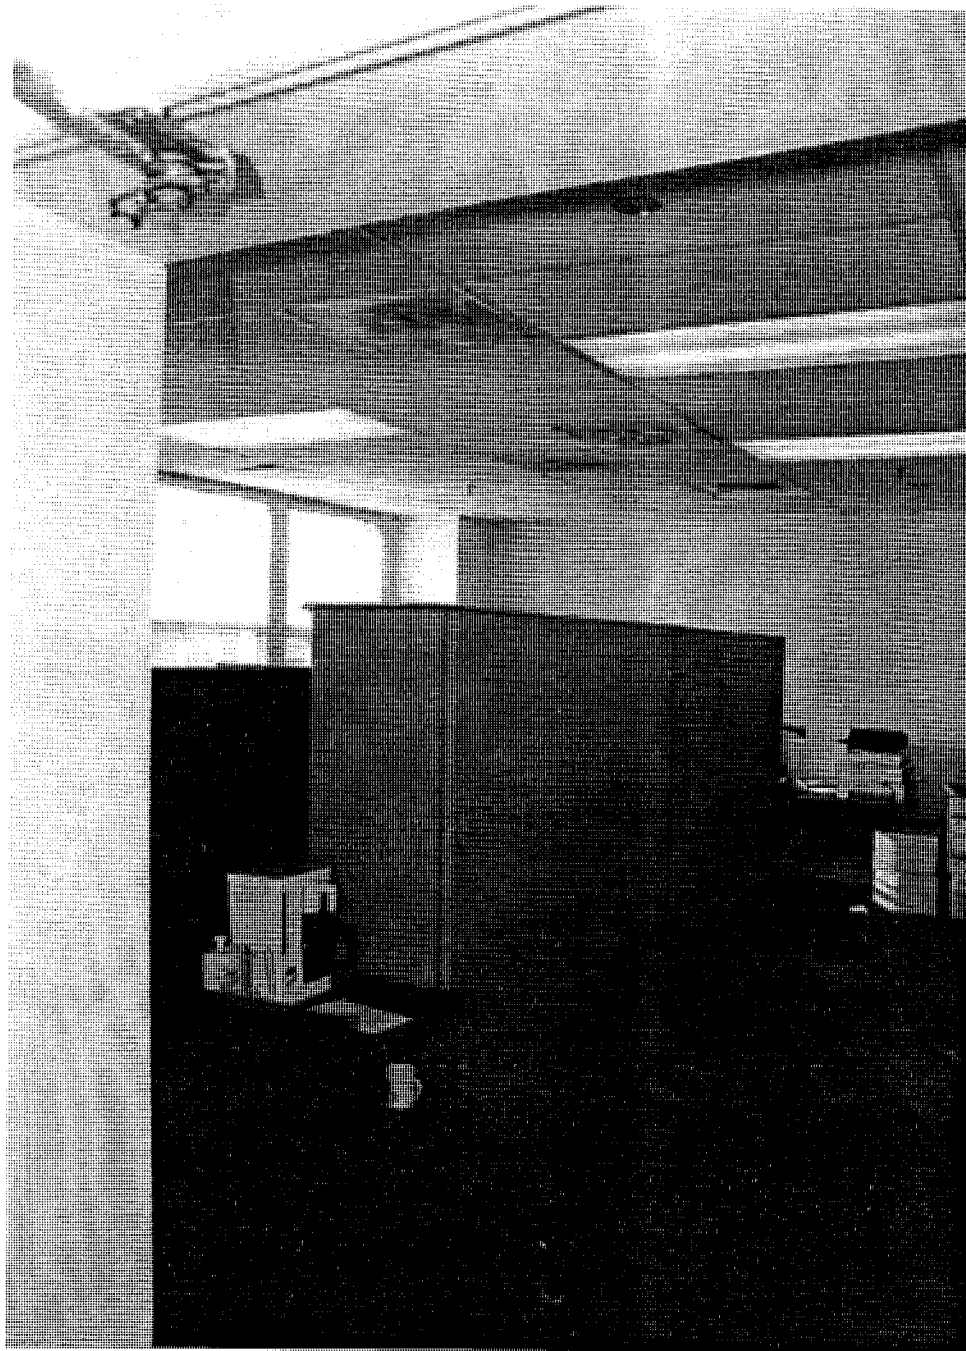
Figure 6-13.

Building 6. Room 6113. Note that hung ceilings butt into the window at the transom level. This detracts from the original height of the room and is also visible from the exterior.

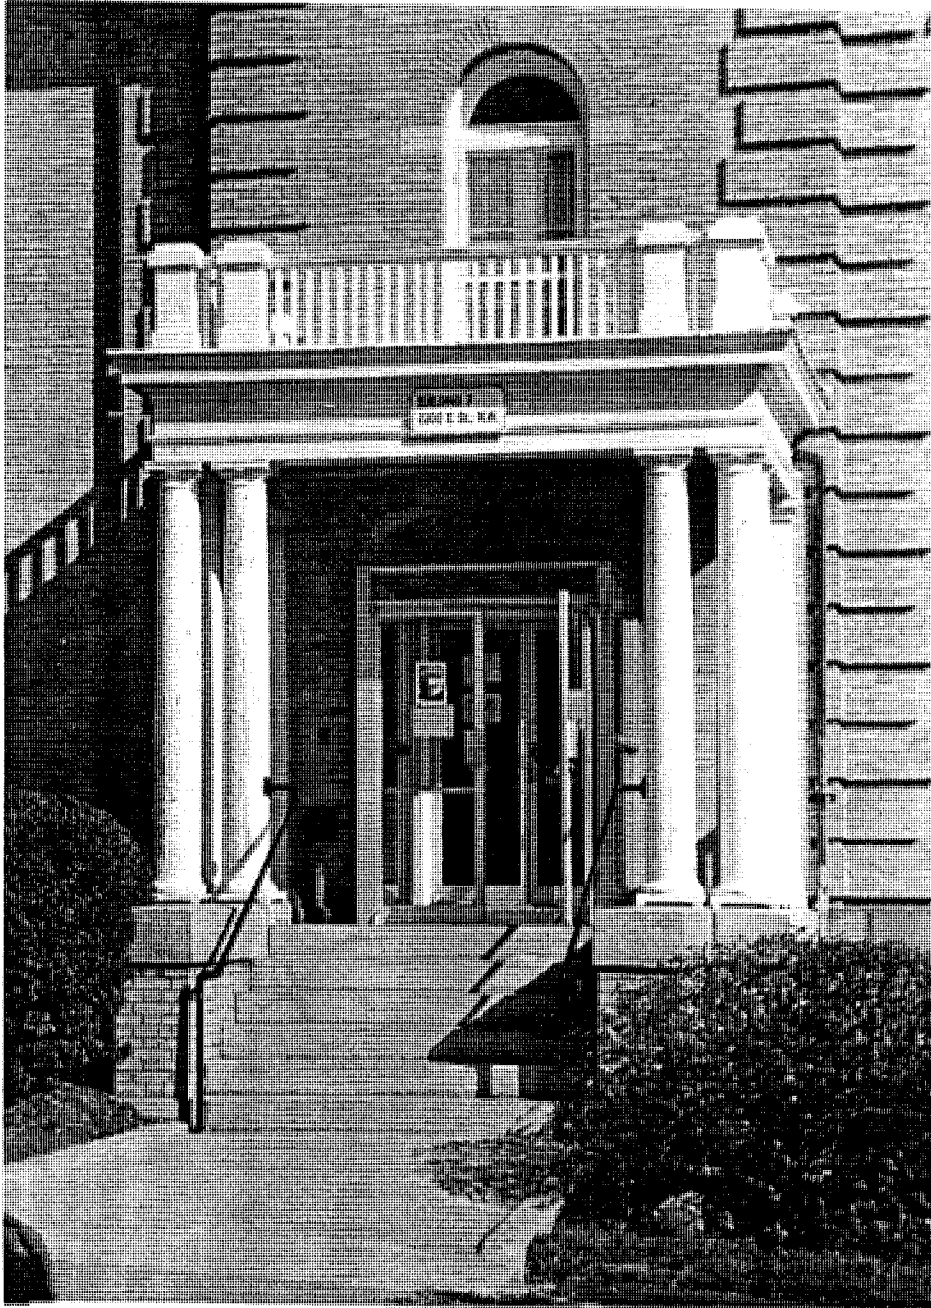
Figure 7-2.

Building 7. West elevation, entry portico. The portico is in its original configuration. The fanlight transom and side panels of the original entry remain, but they were damaged by the installation of the aluminum and glass vestibule. The original door no longer exists. In addition to damaging the fabric of the building, the vestibule detracts from the architectural character of the building. Also note paint failure on the columns.

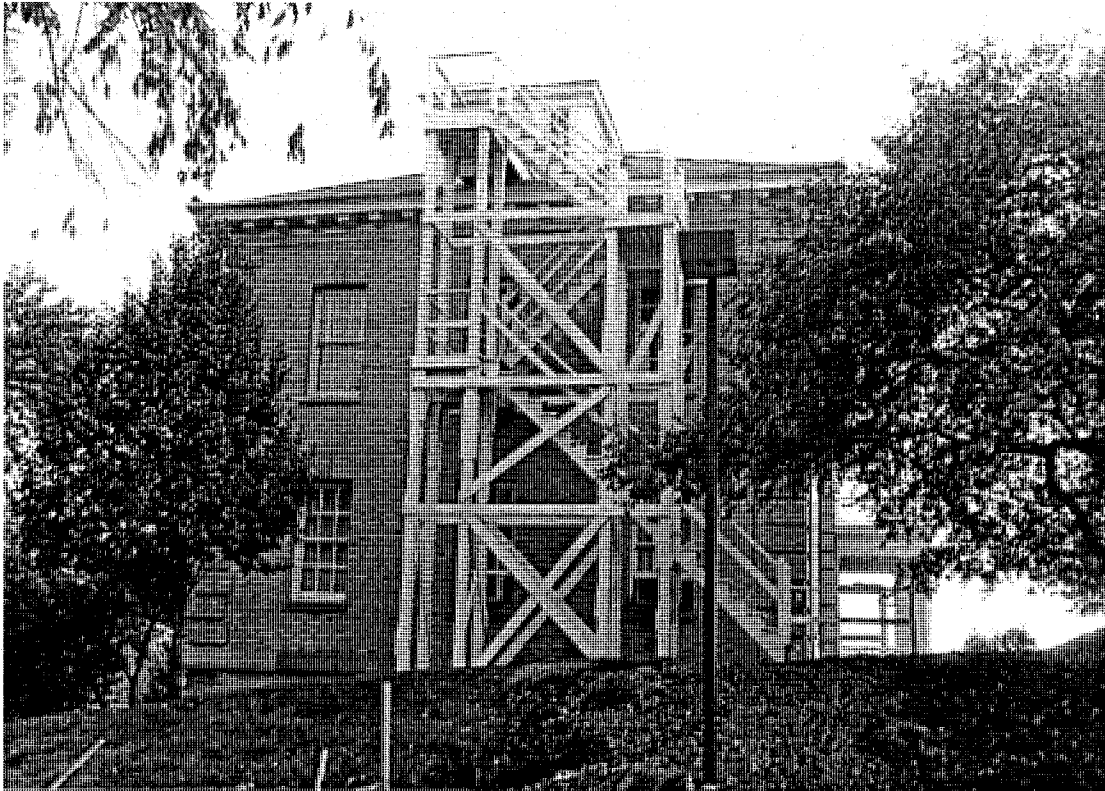
Figure 7-5.

Building 7. North elevation. The fire escape dominates and obscures most of the north elevation; it is a highly obtrusive alteration. The third-floor dormer provides access to the escape by a wood platform projecting over the roof cornice (see Figure 7-21). The second-floor access to the fire escape is through the center bay window (see Figure 7-20).

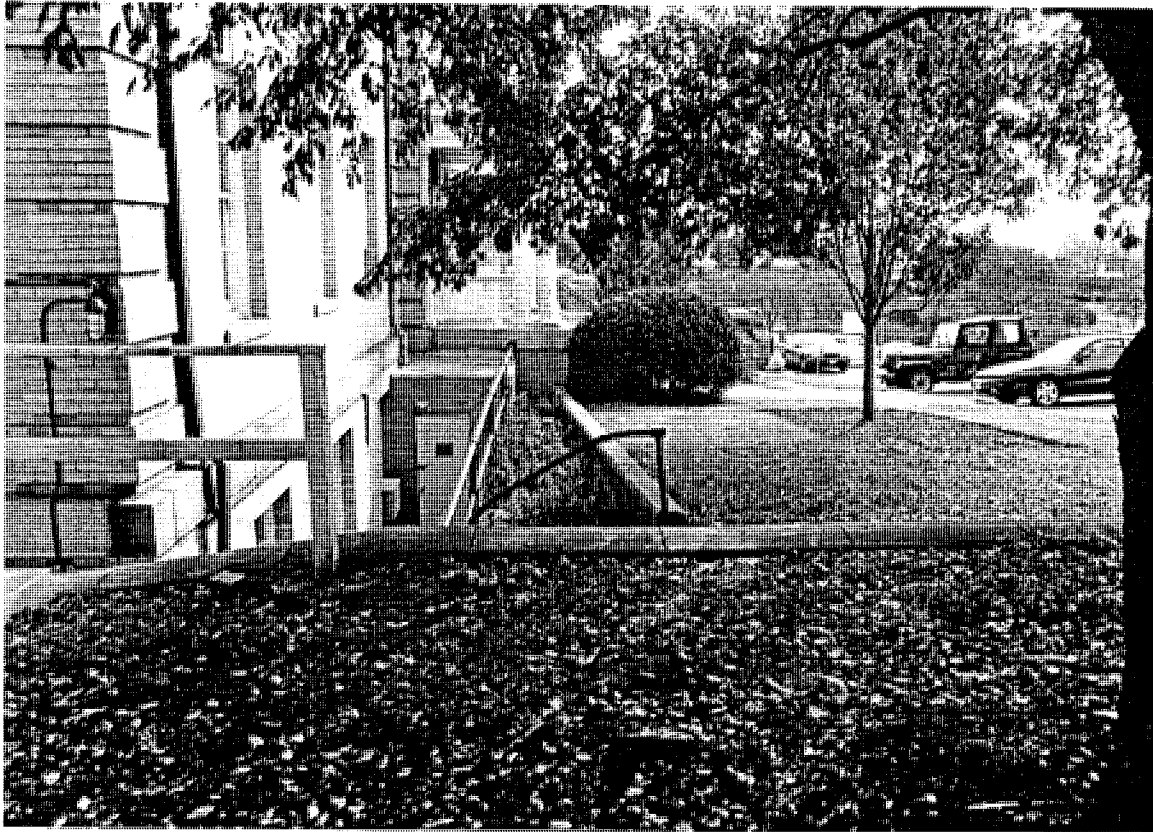
Figure 7-6.

Due to the eastward slope of the site, the west and north basement levels are served by a concrete areaway, which gives access, light and air to the basement spaces (Figure 7-6). The areaways are entered from grade behind a retaining wall at the southwest corner of the building, and by way of concrete steps leading down from grade on the northwest and northeast corners (Figures 7-6, 7-7). The areaway retaining walls are bowing and several cracks are evident. Simple iron pipe rails surmount the retaining walls; they appear to be original and in good condition. On the other sides, the basement level is mostly above grade. The exterior of the foundation walls are clad in brick.

Building 7. Landscape at northeast corner of site. The areaways are accessed from grade behind a retaining wall at the southwest corner of the building, and by way of concrete steps leading down from grade on the northwest and northeast corners (see Figure 7-7). The areaway retaining walls are bowing and several cracks are evident. Simple iron pipe rails surmount the retaining walls; they appear to be original and in good condition.

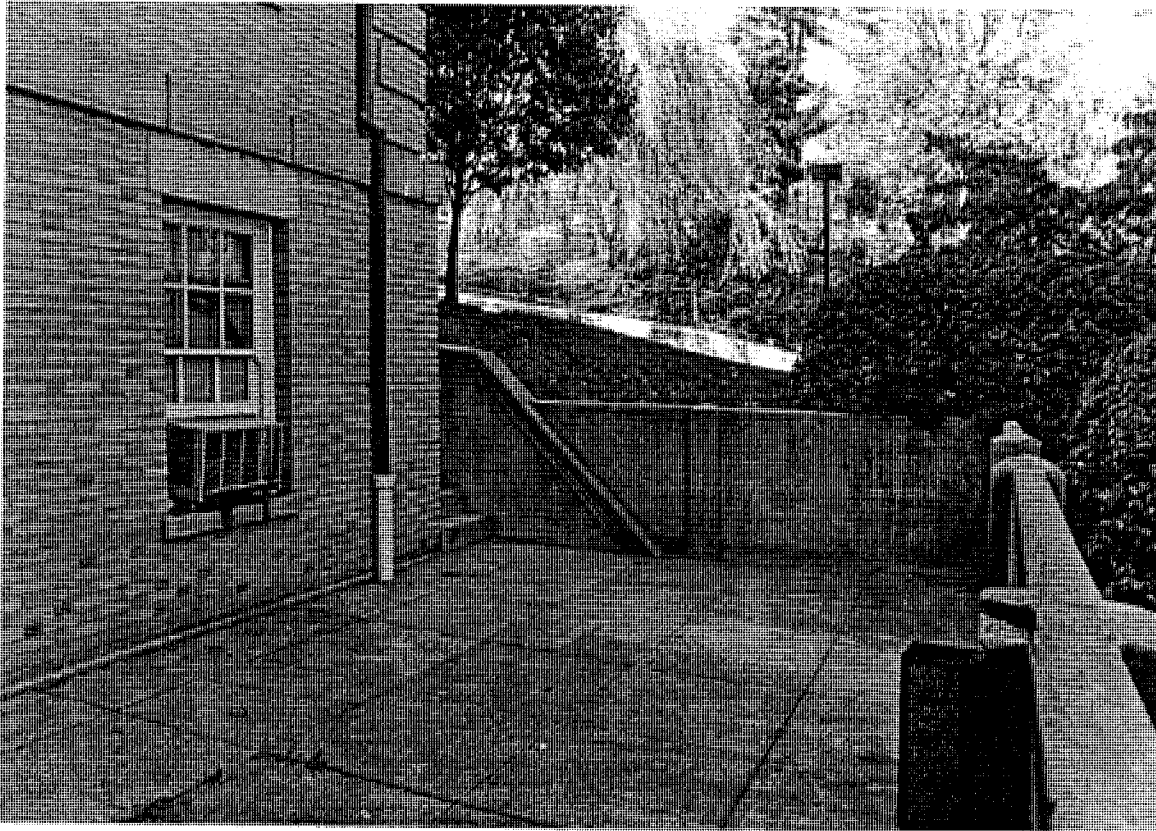
Figure 7-7.

Building 7. Concrete patio at north end of east elevation. Concrete steps, at the edge of the building accommodate the change in grade from the front to the rear of the building. Generally, the concrete paving, steps, retaining walls and coping stones are in poor condition.

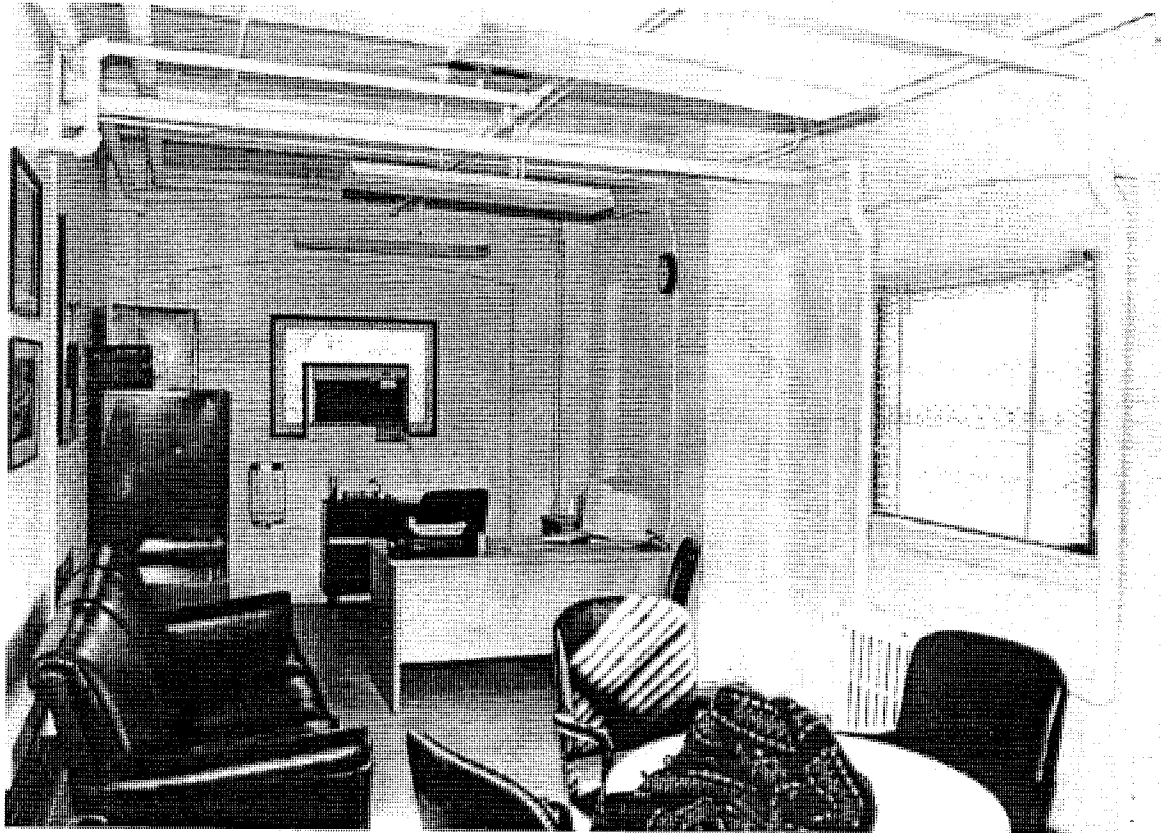
Figure 7-9.

Room 7001A (the garage) is now used as an office and for storage (Figure 7-9). Its walls are painted brick. Arched brick openings with non-original brick infill characterize the east, west and south walls. A doorway on the north wall has been plastered in. The ceiling consists of the exposed concrete floor slabs and beams, which have been painted. The flooring is vinyl tile, which probably covers a concrete slab.

Building 7. Basement room 7001A, room under the sun porch. The brick infill in the arches is not original, but it is close to the original in color. The infill also is set back from the plane of the original brick on the interior and the exterior. Unfortunately, the installation of the windows and air conditioning units does not enhance what would otherwise be a sympathetic alteration.

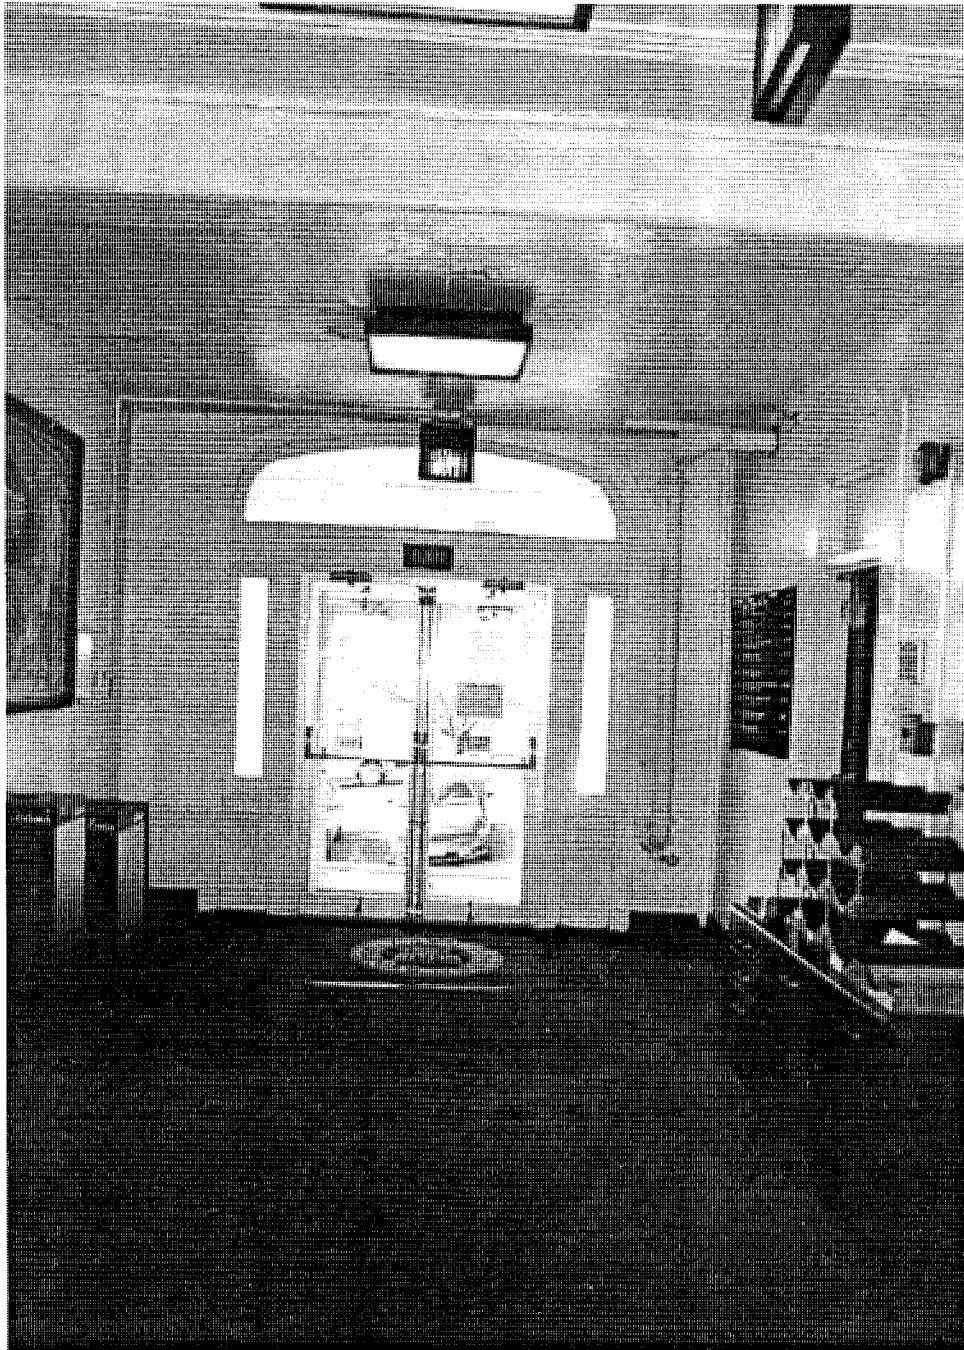
Figure 7-12

Building 7. View of the first-floor lobby space toward the entry. The original transom and sidelight panels are original. However, the original configuration of the glazing was altered by the installation of undivided glazing, and the original doors have been removed. The installation of the aluminum and glass doors and vestibule damaged the original millwork on the exterior. In addition, the design and detailing detract from the architectural character of both the interior and exterior of the building.

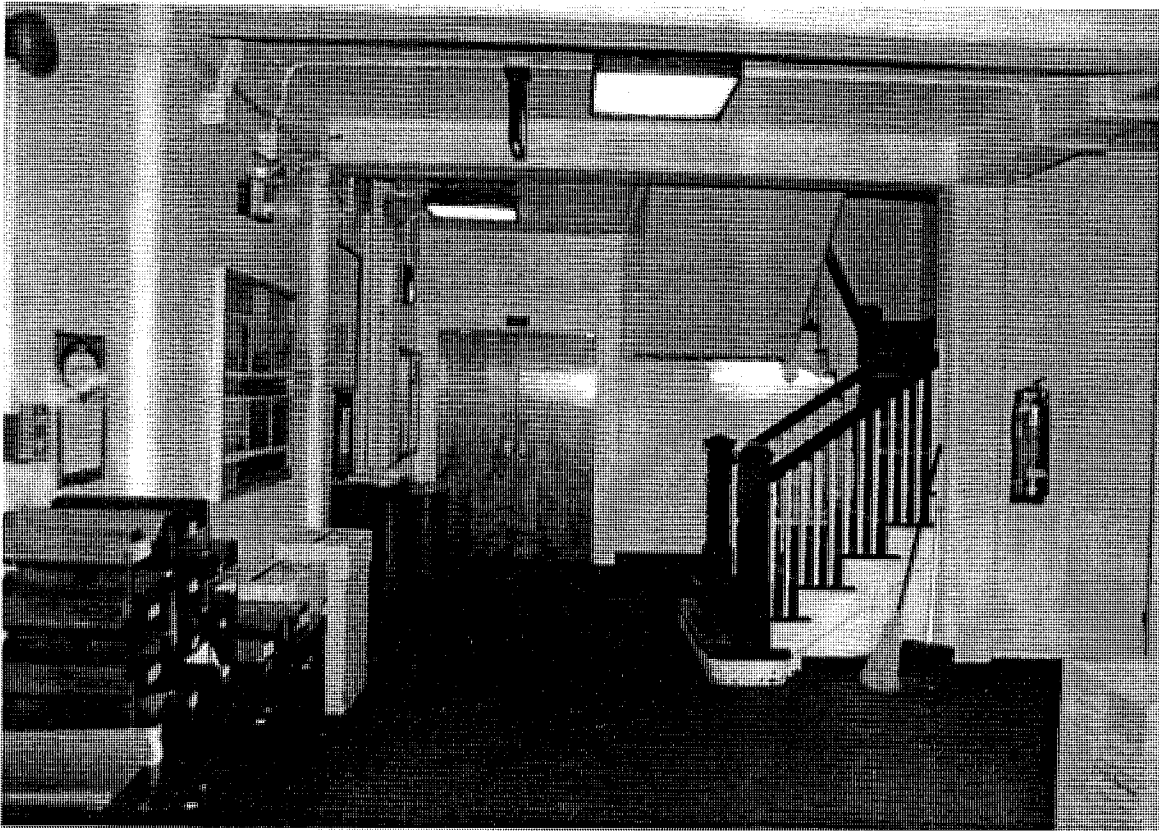
Figure 7-13

Building 7. View of the first-floor lobby space toward the stair. The flush wood doors beyond the stair are not original, but they are set into the original door frame with transom. These doors do not conform to the appearance of the original five-panel wood doors seen in other parts of the building, and they detract from the appearance of this space.

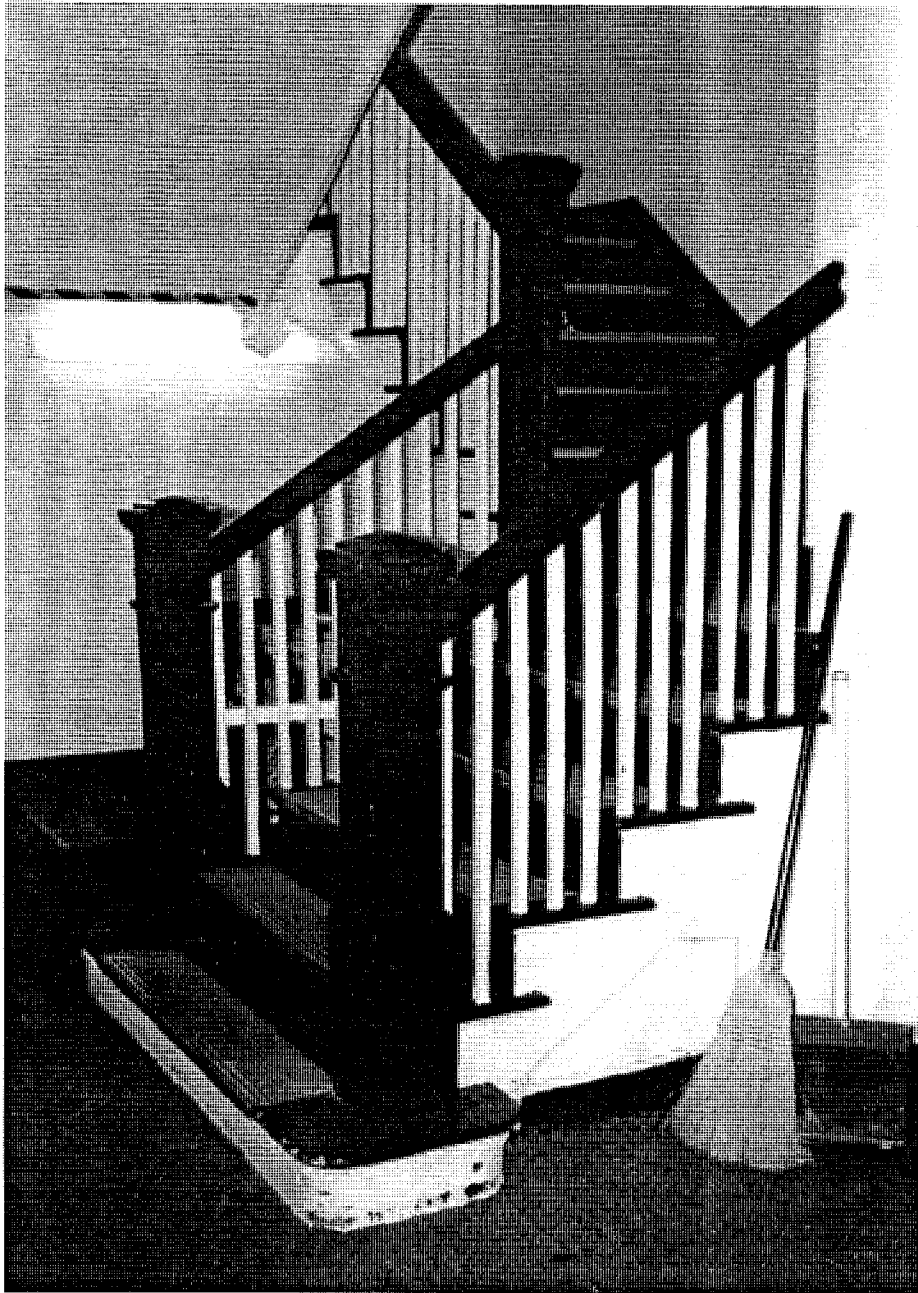
Figure 7-14

Building 7. Detail of the stairs in first-floor lobby space. The stair surfaces are scuffed and worn, but generally in good condition.

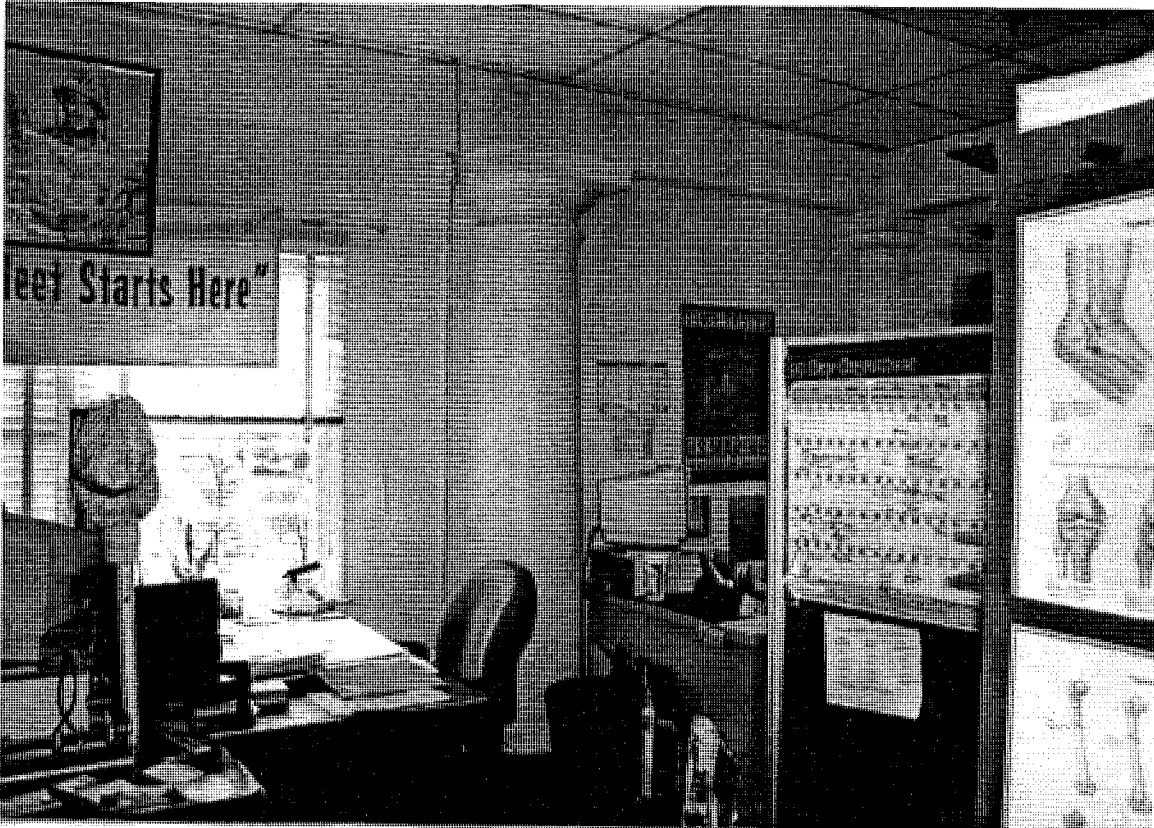
Figure 7-17

Rooms 7101A and 7201A (the sun porch rooms on the first and second floors) are used as office spaces (Figure 7-17). In each case, the north wall is painted brick (originally the exterior wall). Although many of the openings leading to the porches from the interior have been infilled, and the french doors removed, the voussoirs and keystones are still visible. The other wall surfaces are non-original gypsum board with wood sash windows set between original Tuscan columns. Wood baseboards correspond with the column plinth height in room 7101A, and some vinyl baseboard has been installed in 7201A. In both rooms, the ceilings are covered with non-original acoustic or fiberboard tiles, and the floors are covered with blue wall-to-wall carpeting.

Building 7. Room 7201A, sun porch. View toward Tucson columns, which were part of original sun porch configuration. The infill with windows is not original. While an infill system could be compatibly designed, the design and installation of this system is not sympathetic to the architectural character of the building.
