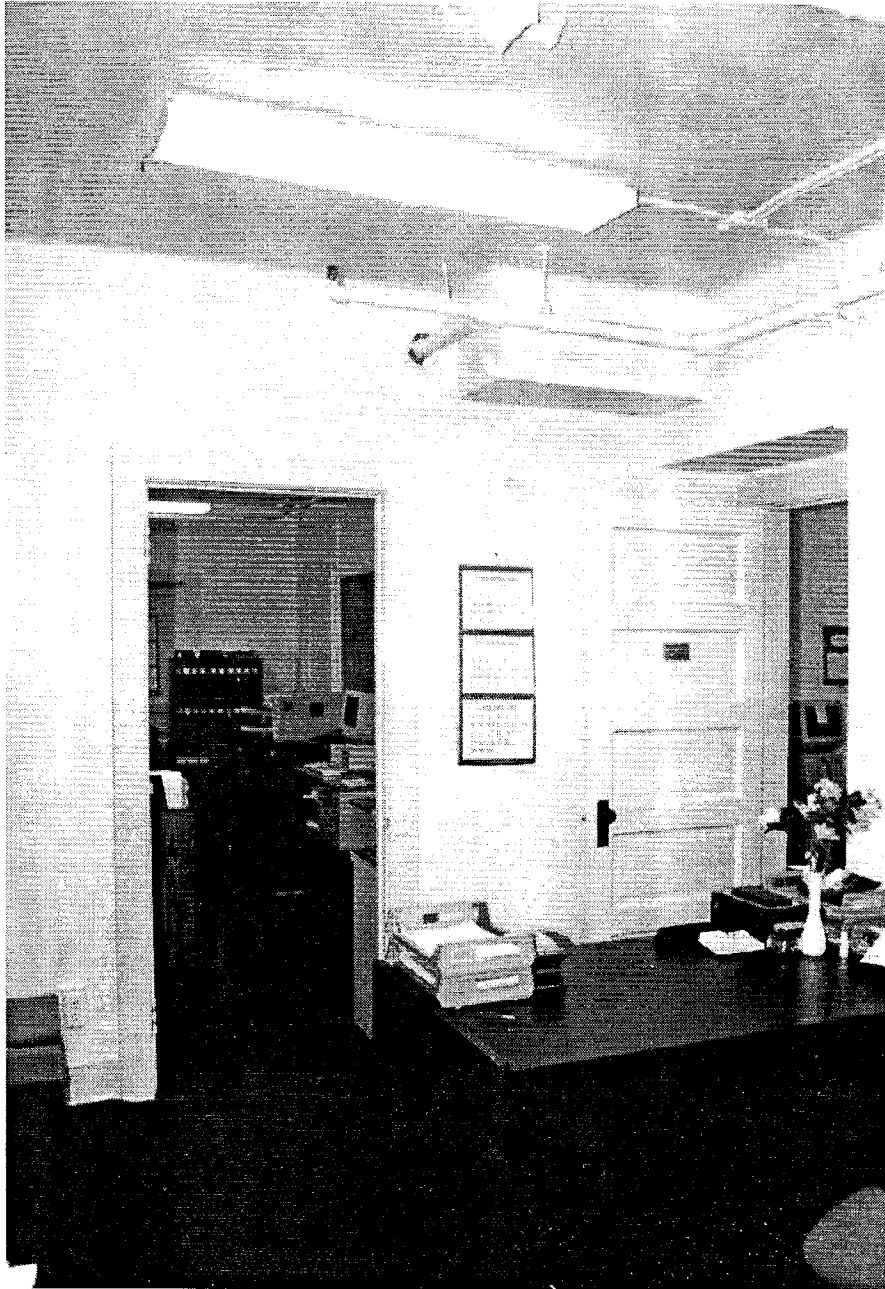
Figure 7-18.

Building 7. Room 7205. The door opening in the foreground appears to be original, although the door has been removed from its hinges. The door and opening to the corridor (on the right) are probably early alterations; they do not correspond to any door opening on the original floor plans. In addition, the door, very similar to other five-panel doors in the building, has molded profiles rather than rounded, which are noted on original doors. Pipes, conduits and lighting detract from the space. Note water damage in the ceiling and wall.

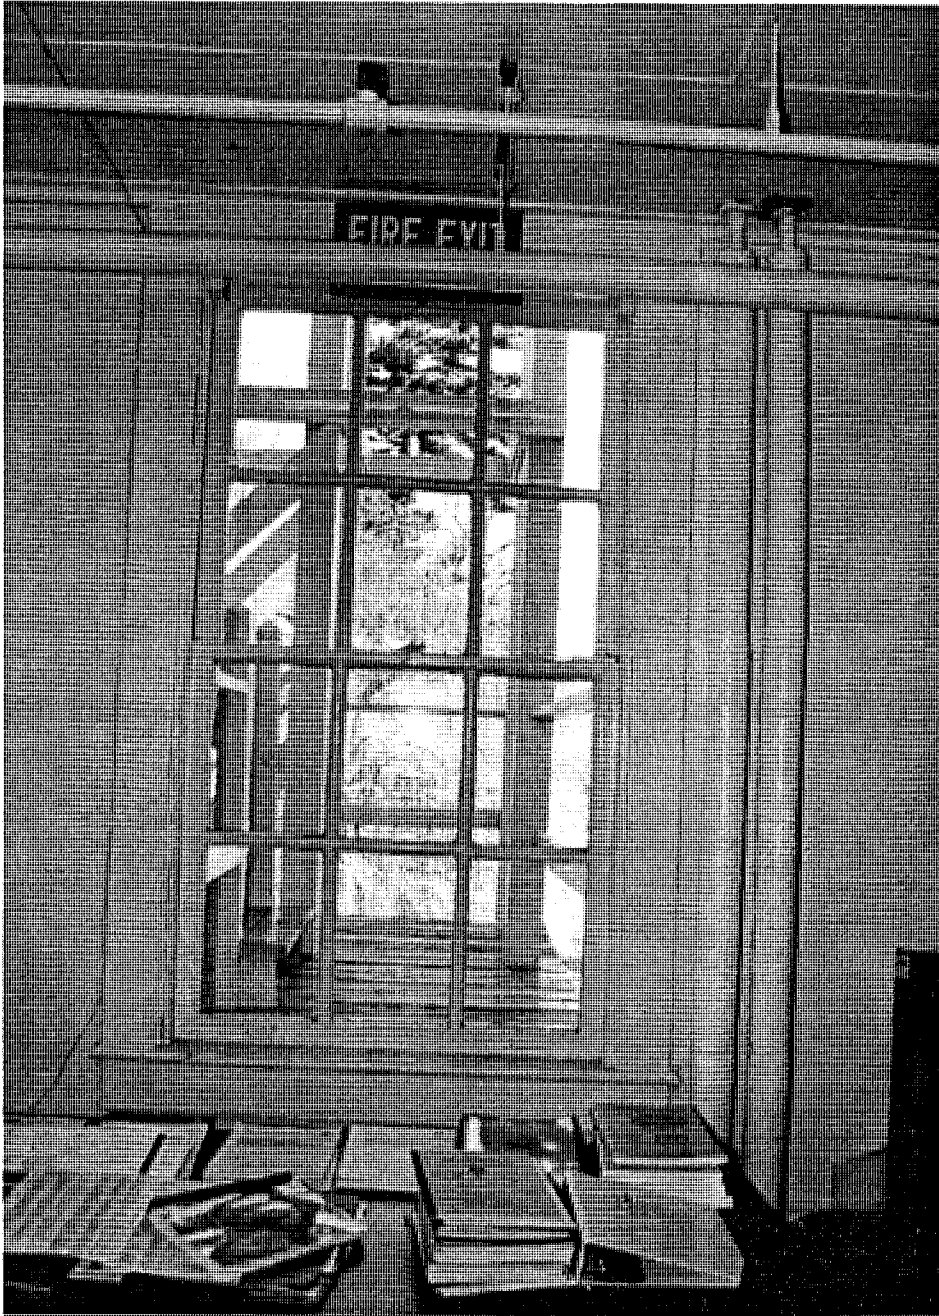
Figure 7-20.

Building 7. Rooms 7209-7210. View shows window opening onto the wood fire escape on the north side. Note that furniture blocks access to the window.

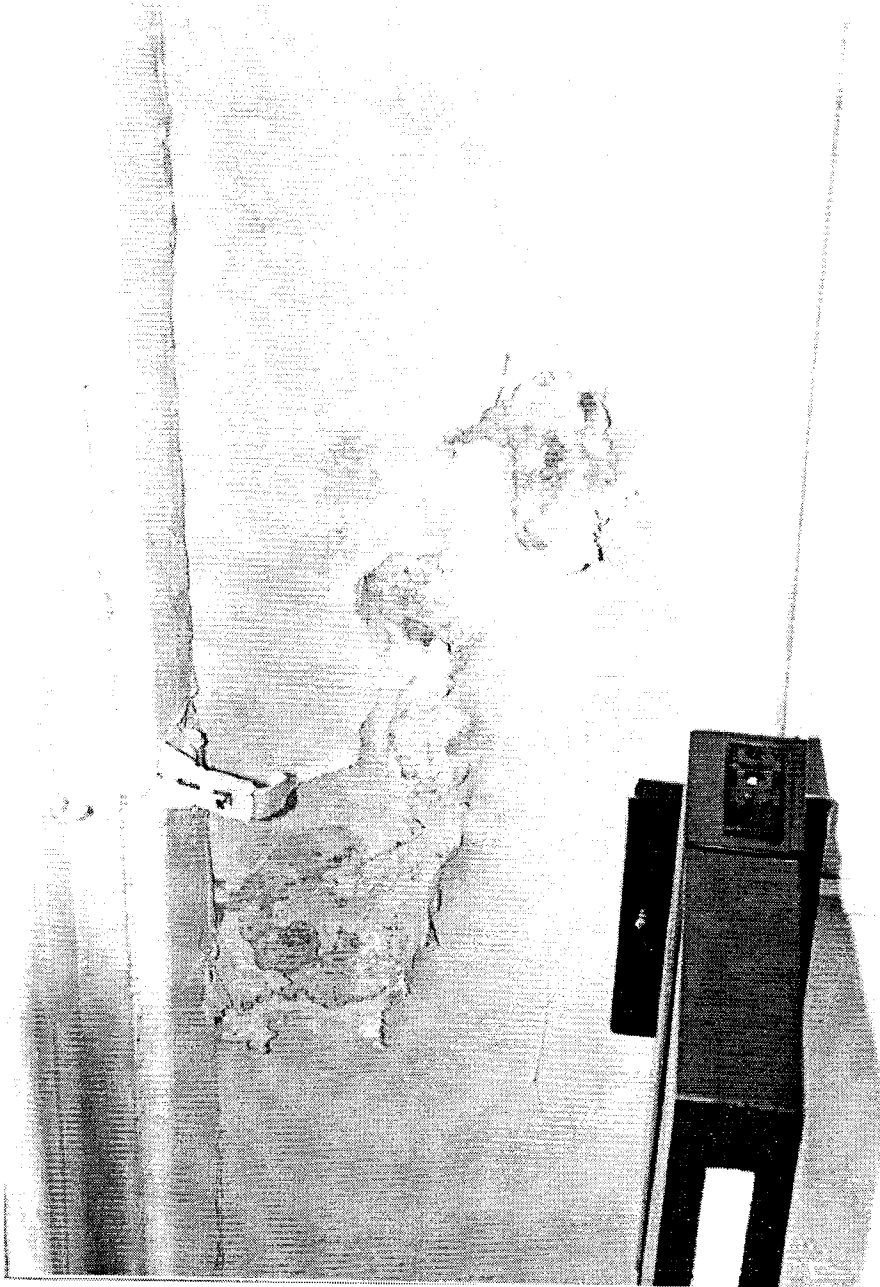
Figure 7-22

Main lobby: Severe water penetration is noted on the west wall and ceiling, adjacent to a vertical riser in Room 7105, most likely caused by plumbing failures. Water damage above entry (Figure 7-22) is probably due to faulty flashing on the portico.

Building 7. First-floor lobby. Detail of water damage in plaster over the entry. This is probably due to poor flashing and roof drainage. Other water damage noted on the west wall and ceiling in this room may be due to faulty plumbing above.

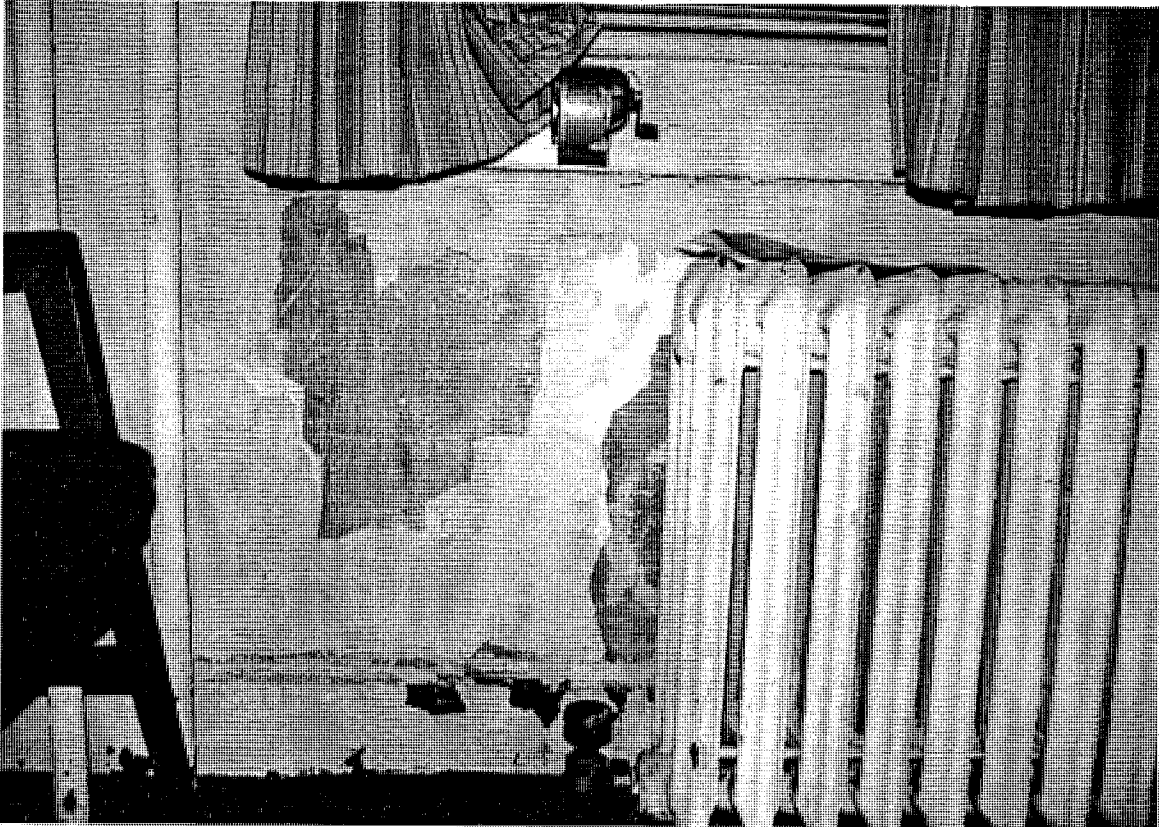
Figure 7-23

Room 7106: Seriously deteriorated plaster on the north wall is noted below the window and behind the radiator (Figure 7-23). This is probably due to prolonged poor radiator performance.

Building 7. Room 7106. Detail of damaged plaster on north wall. This may be due to water infiltration from the exterior wall, but it is more likely to be associated with prolonged poor performance of the radiator.

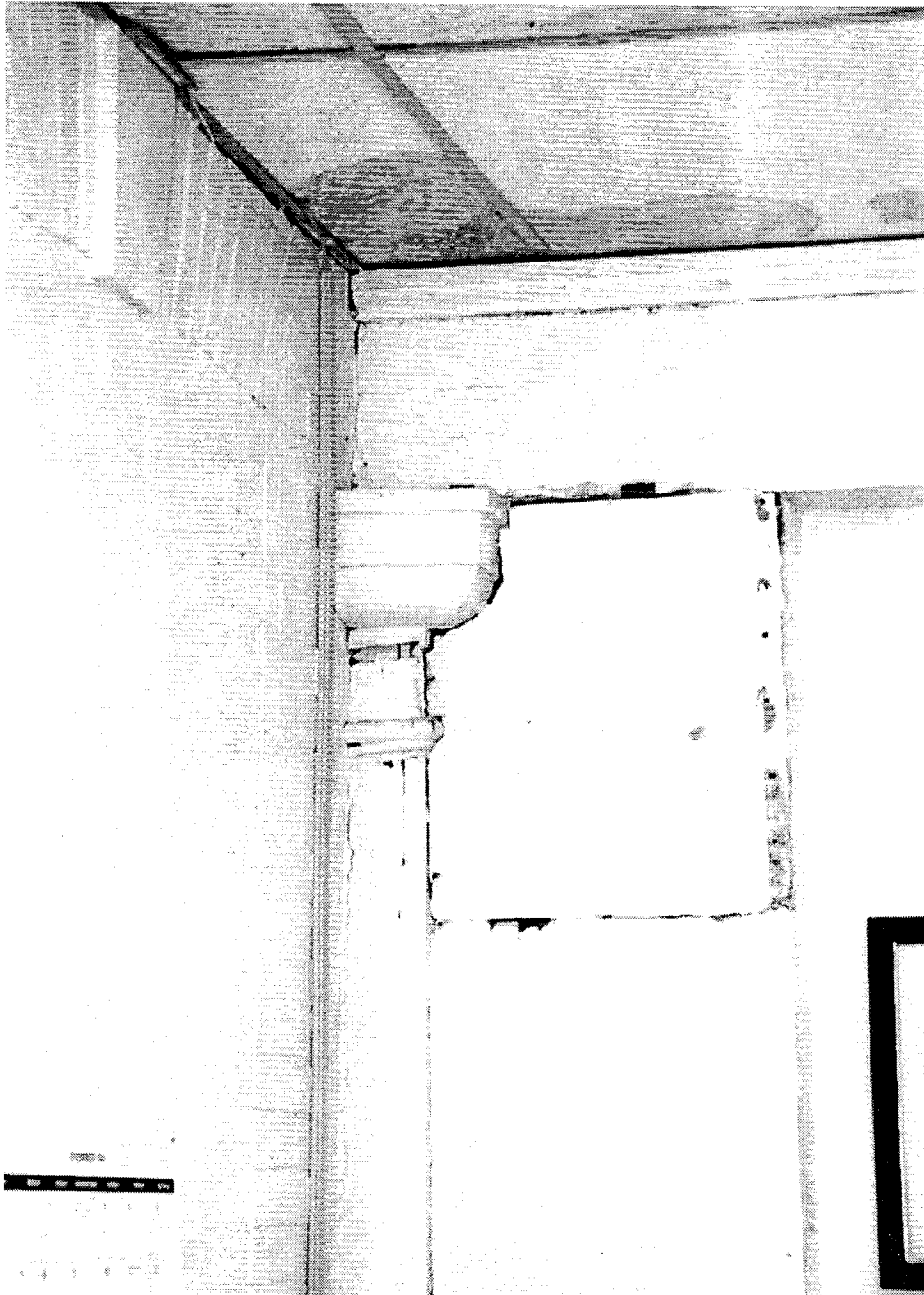
Figure 7-24

Rooms 7101A and 7201A: Moisture staining on the south walls is noted, particularly at the corners, resulting in peeling paint and probable deterioration of the wood (Figure 7-24).

Building 7. Room 7201A, sun porch, east corner. Detail of the juncture between the sun porch and the main structure of building. Water penetration has caused wood rot and displacement. Note that original masonry (to left) opening has been infilled with gypsum board, replacing original french doors. This is a typical condition on every floor of the sun porch.

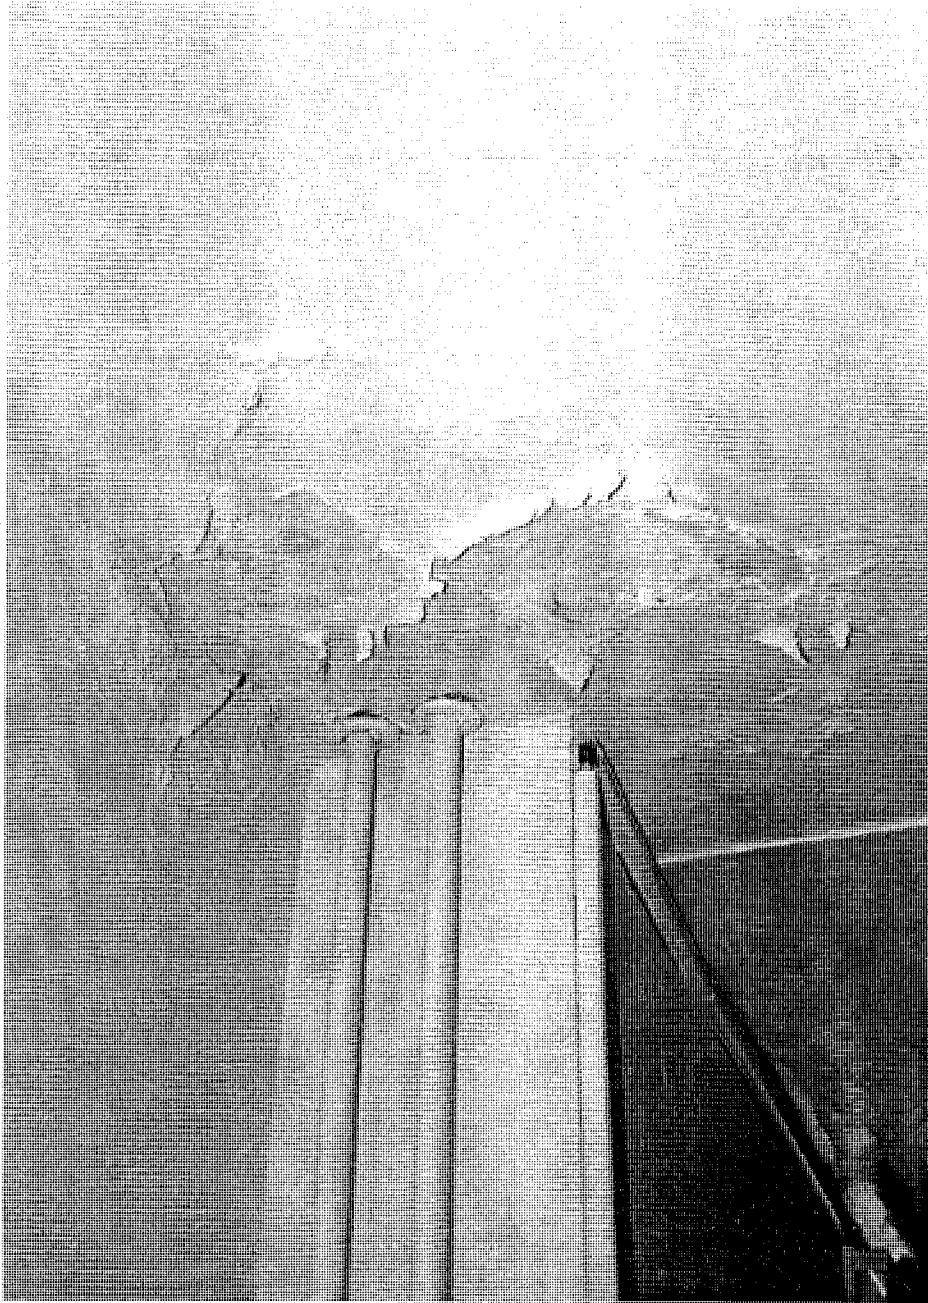
Figure 7-25

Rooms 7205 and 7207: Moisture stains and peeling paint (Figure 7-25) are probably related to leaks from the third-floor toilet.

Building 7. Room 7207. Detail of water damage in the ceiling, which is probably related to leaks from the third-floor toilet.

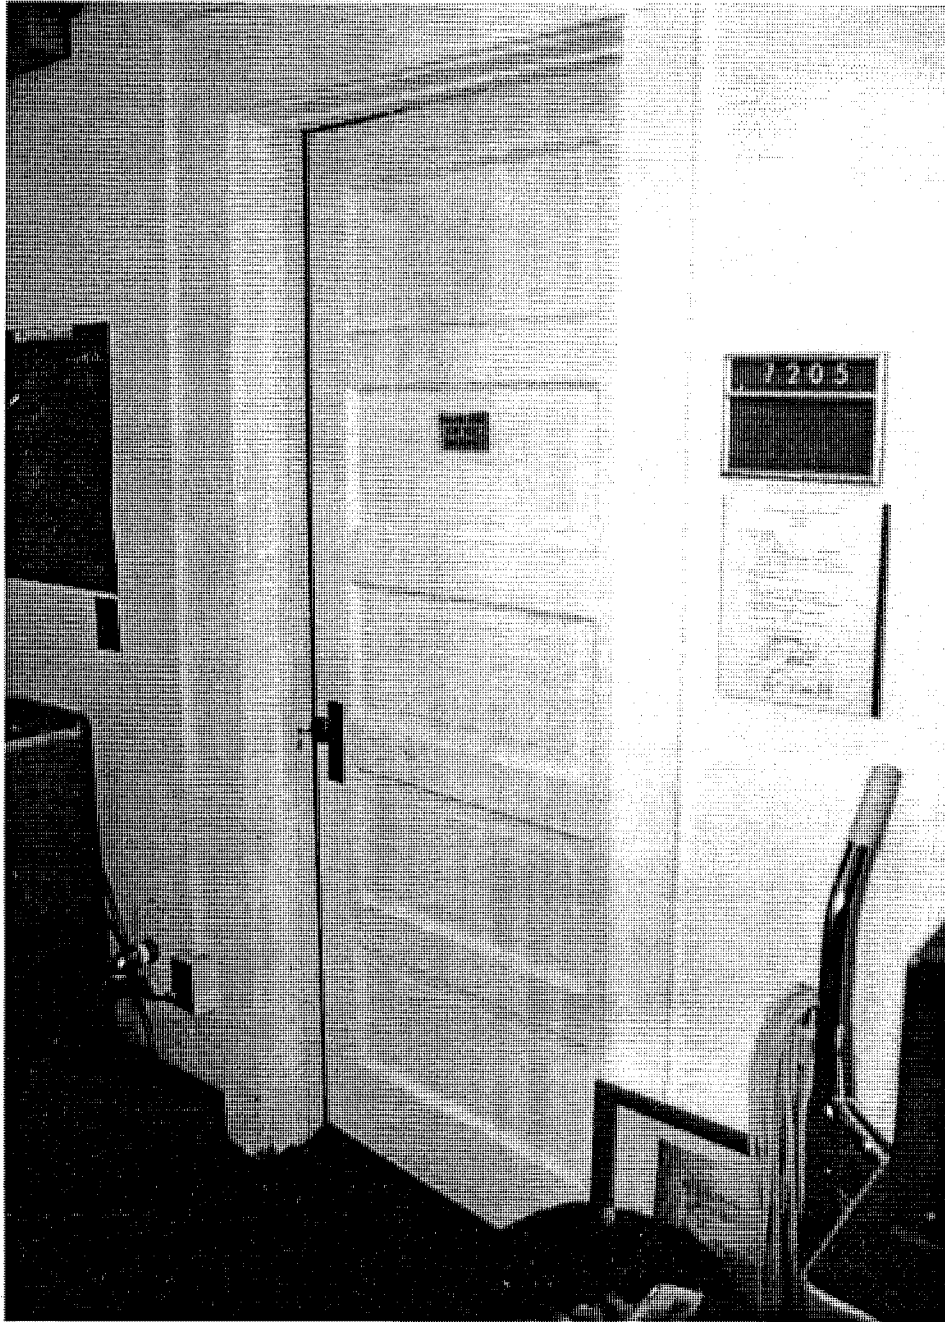
Figure 7-26

Building 7. Typical original five-panel wood door with original brass knobs and lockset. Note the rounded panel moldings, which differentiate the original doors from the early replacements. The simple, flat frames are typical throughout the building.

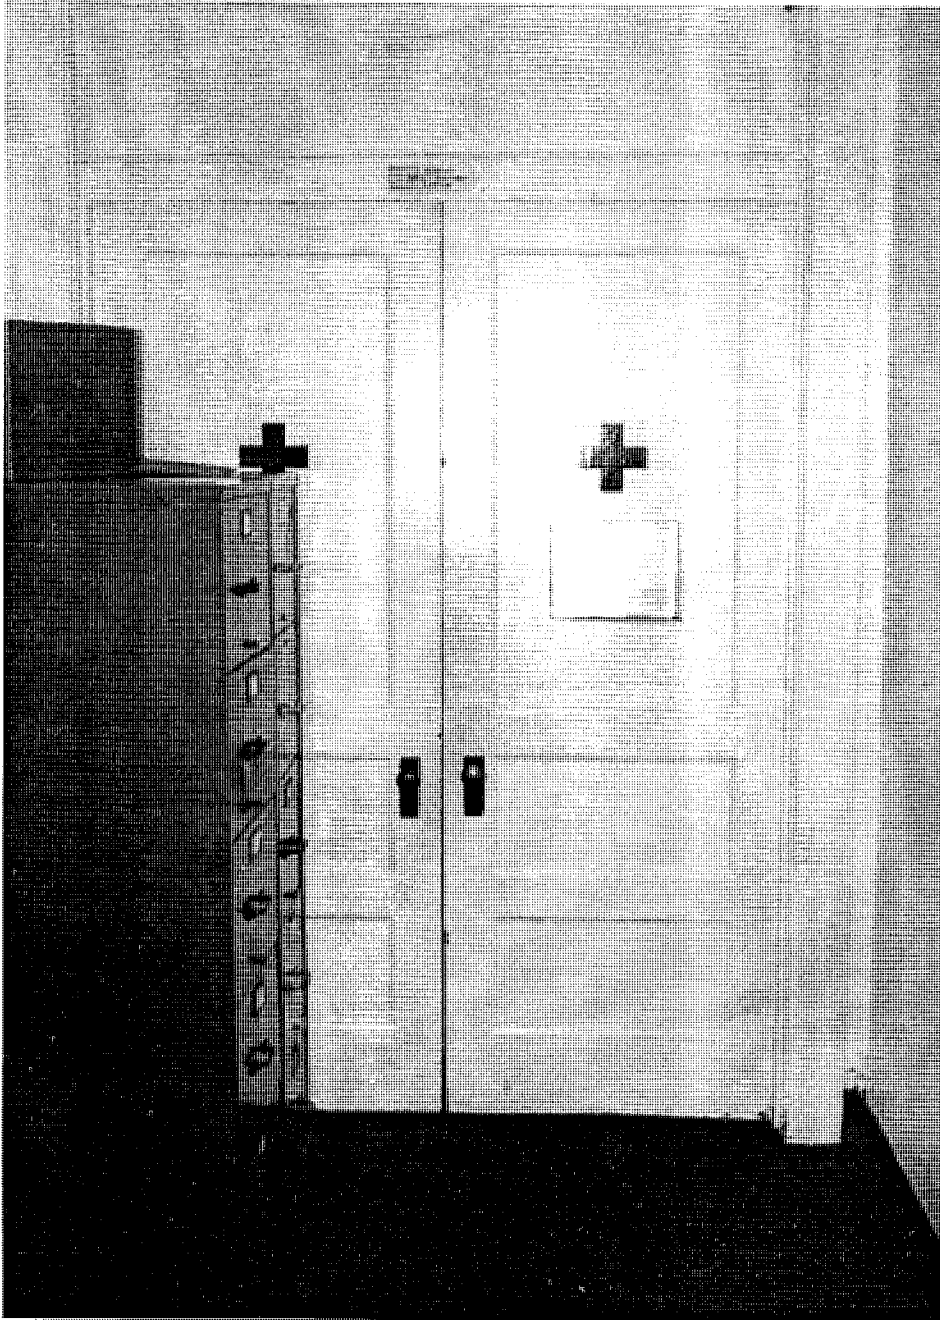
Figure 7-26a

Building 7. Typical early replacement five-panel wood door with original brass knobs and lockset. Note the molded profile of the panel moldings, which differentiate the early replacement doors from the originals.

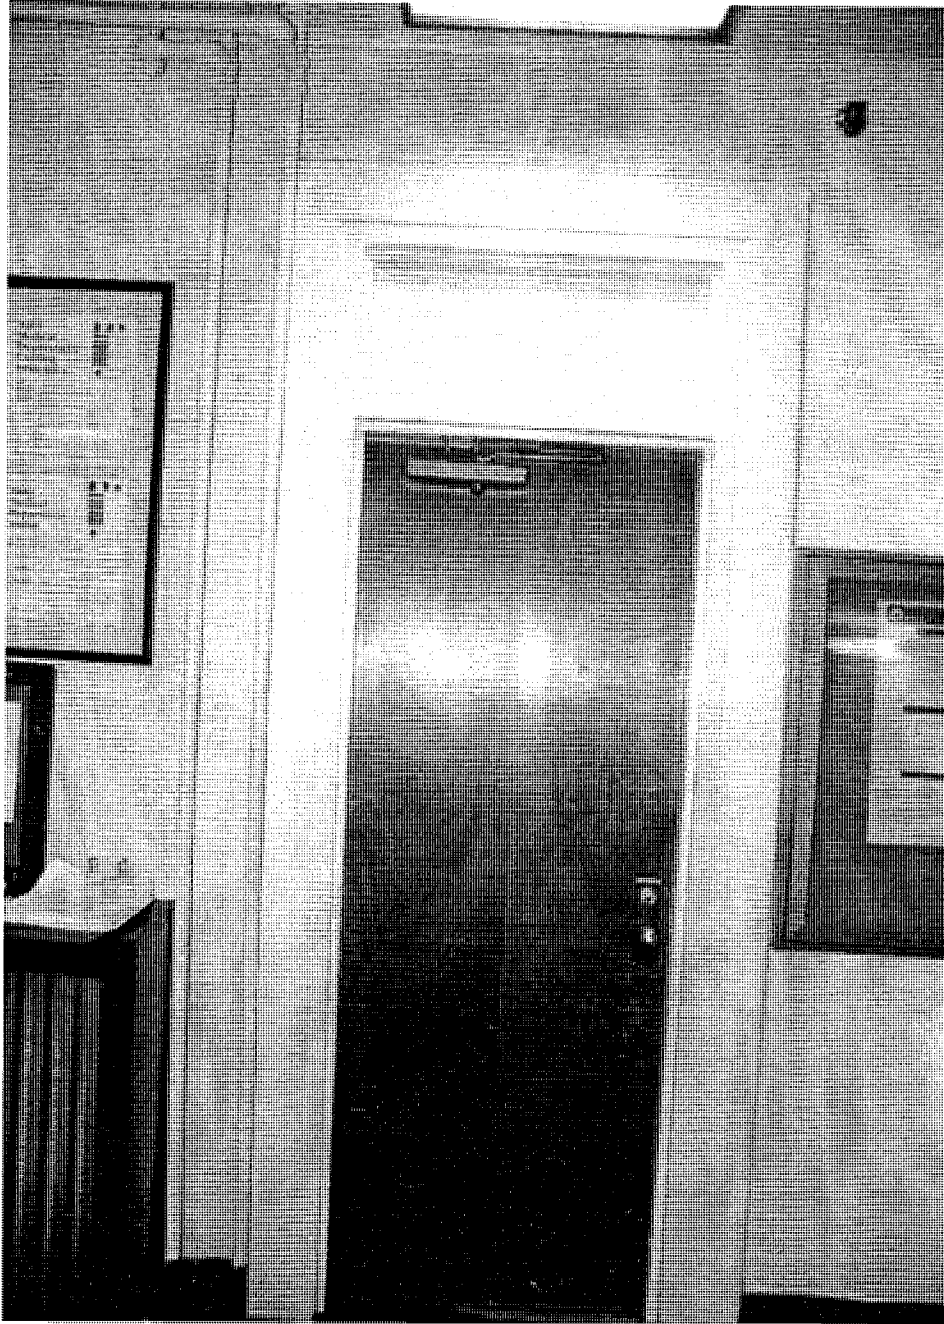
Figure 7-29

Building 7. This wood paneled door does not match the configuration of original five-panel doors. It is similar to doors found in Building 2, and it may have been salvaged from there.
