Potomac Annex: Buildings 1 & 3-7

Historic Structures Report, Corrected Final Submission
 General Services Administration Project Control Number: 44007
 September 9, 1997
 VOLUME 1 OF 2

HISTORIC STRUCTURE REPORT

**POTOMAC ANNEX
BUILDINGS 1, 3-7**

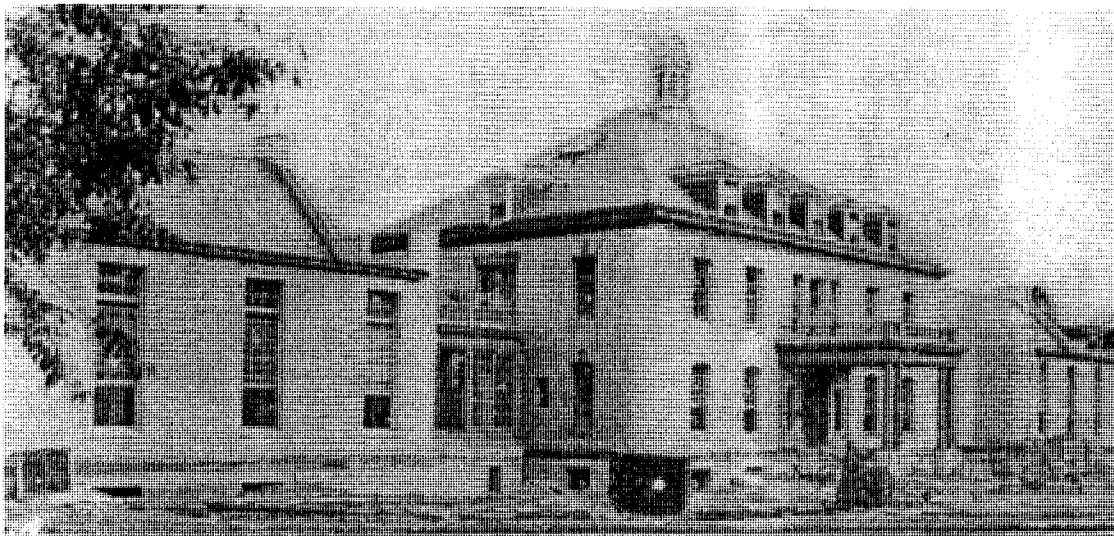
Figure 2-1
The New Naval Hospital Adjoining the Medical School
BUILDINGS 3 & 4
BUMED Archives

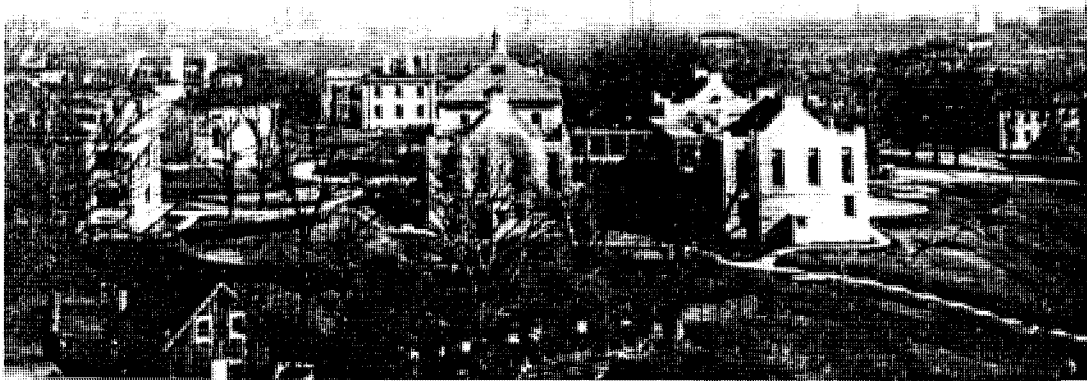
Figure 2-2

HOSPITAL COMPLEX

“Portion of hospital reservation, viewed from the west”, 1912.

It is noted that while some planning was given to circulation on the site, little attention was paid to landscaping around the buildings. A bird's eye view of the site dated 1912 (Figure 2-2, Chap. 2) shows the land around the hospital building to have been severely sloped and probably covered with grass. A few meandering paths, probably concrete, connect the buildings to each other and to the other buildings on the site. Mature trees seem to be located in a haphazard fashion; it is likely that they are survivors from the earlier landscape. A photograph from the 1940s (Figure 2-3, Chap. 2) shows a brick path cutting across the drive in front of Building 3. A brick swale with a pipe rail runs parallel to the drive.

A bird's eye view of the site dated 1912 (Figure 2-2, Chap. 2) shows the land around this building to have been severely sloped and probably covered with grass. Mature trees seem to be located in a haphazard fashion; it is likely that they are much earlier than the construction of the buildings.

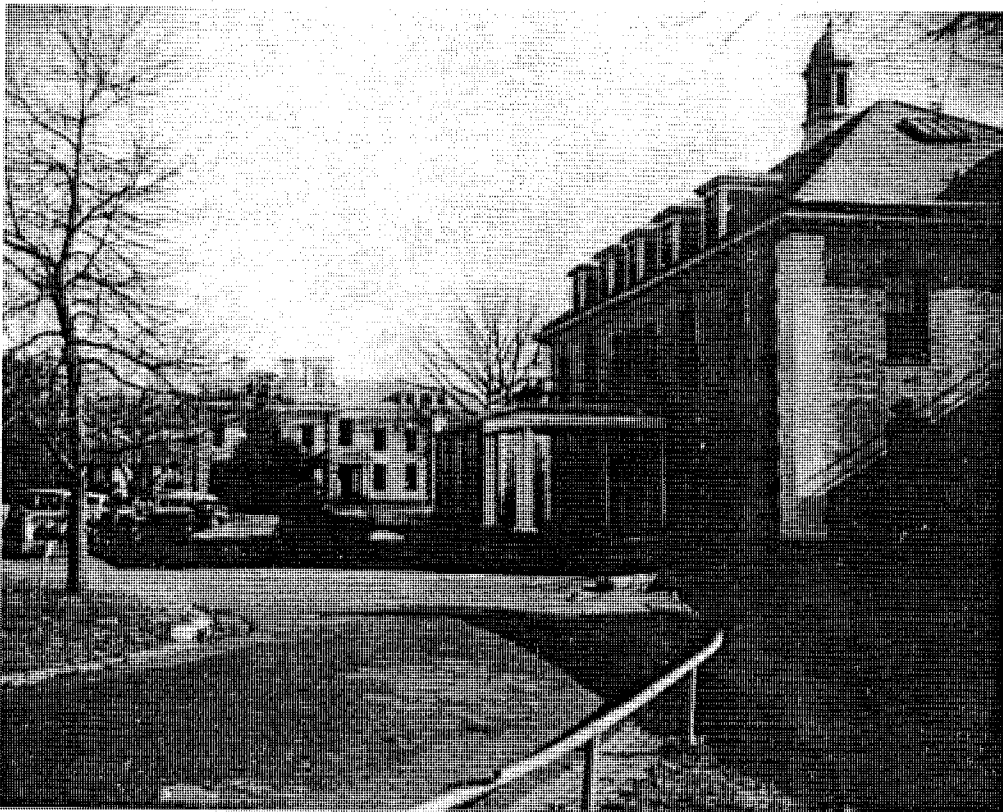
Figure 2-3
HOSPITAL (BUILDING 3)
North and west elevations of administrative building, ca., early 1940's
BUMED Archives

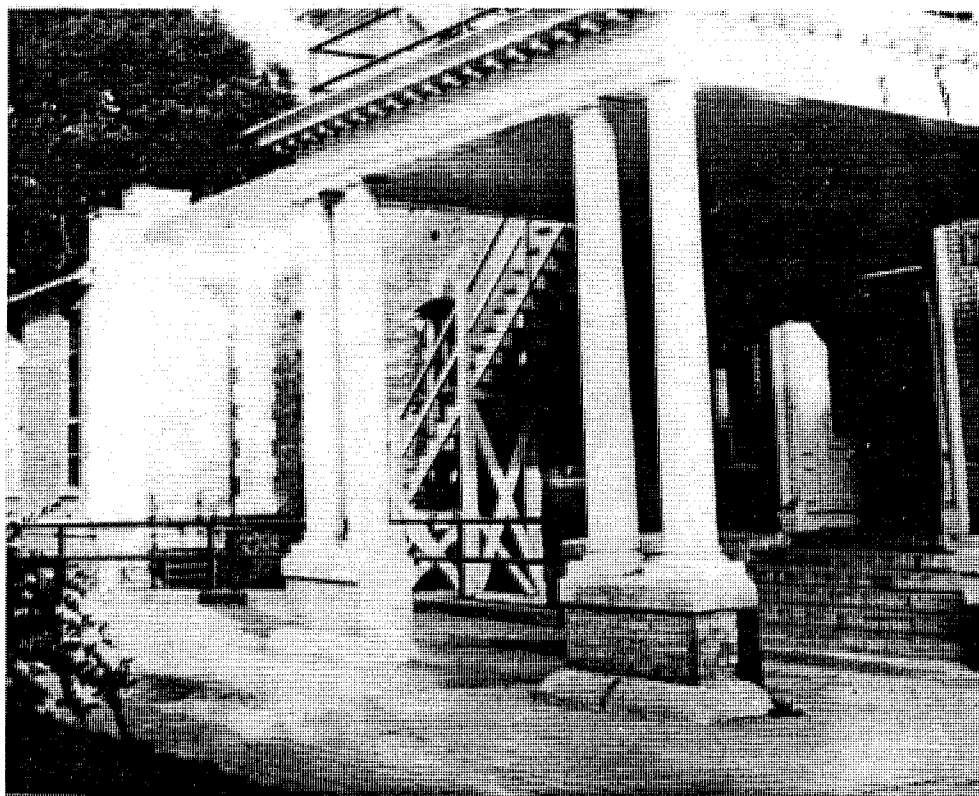
Figure 2-4
HOSPITAL (BUILDING 3)
Detail of ambulatory porch of hospital, north elevation (no date).
BUMED Archives

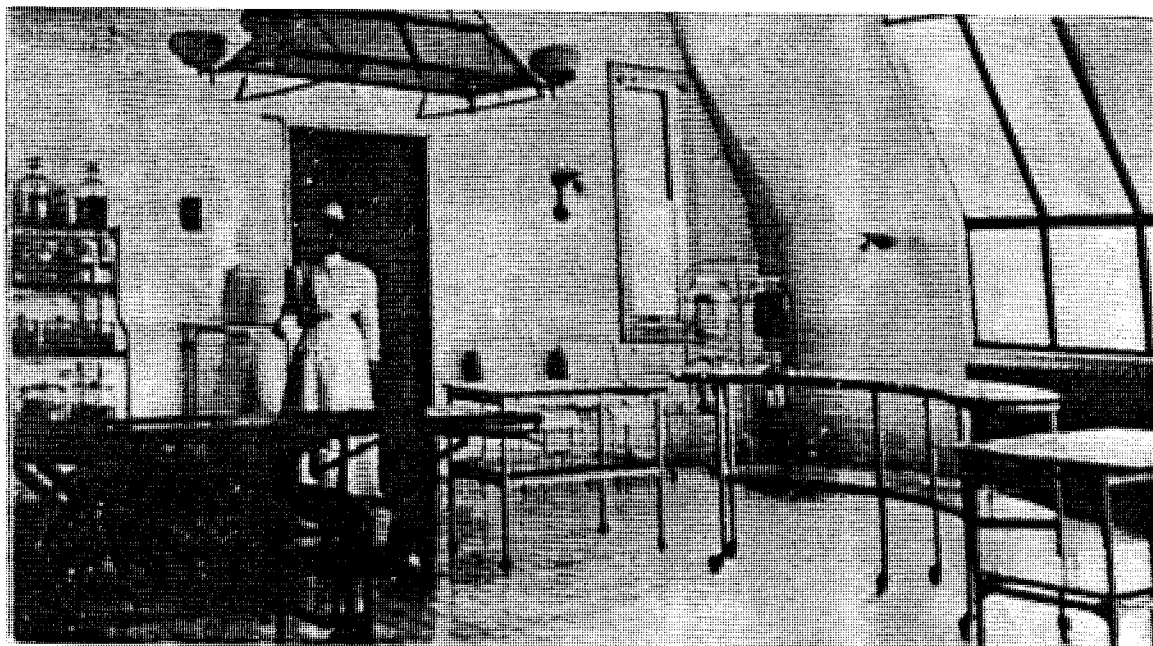
Figure 2-6

HOSPITAL (BUILDING 4)

Interior, Operating Room, 1912.

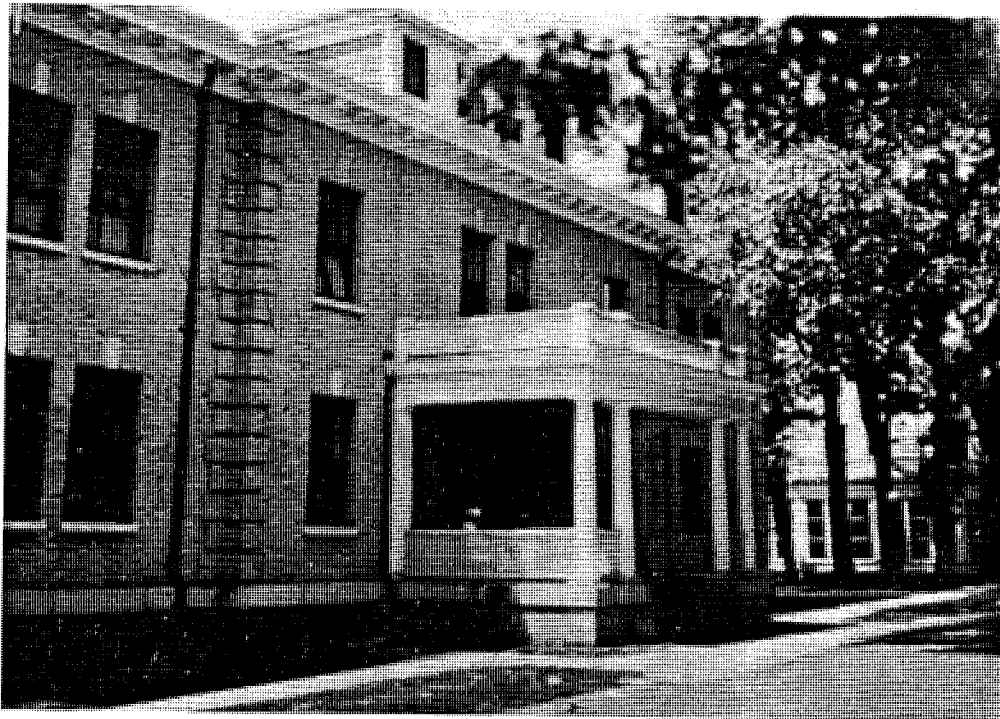
Figure 2-9
NURSES' QUARTERS (BUILDING 1)
East elevation, ca. 1921
BUMED Archives

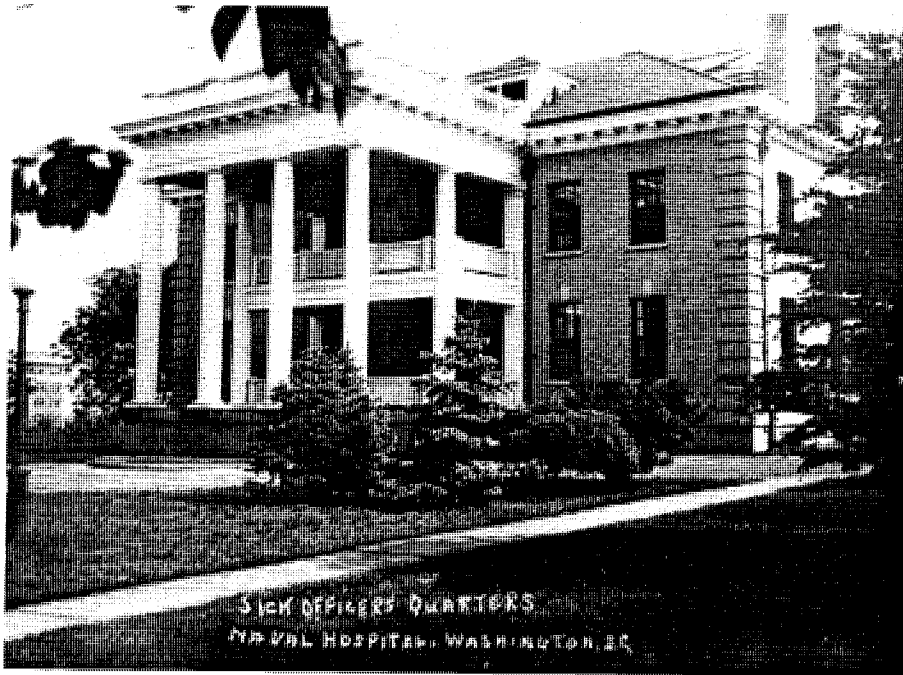
Figure 2-7

SICK OFFICERS' QUARTERS (BUILDING 5)

North elevation, 1912.

Historic photographs show that the landscaping around the Sick Officers' Quarters was marginally better than that around the other buildings. Possibly, this was planned to reflect the hierarchy of rank within the Navy. The 1912 photograph of this building (Figure 2-7, Chap. 2) shows the drive in front of the building with a small lawn buffer curving in front of the porte cochere. A larger lawn planted with a few low shrubs probably separated the site of the Sick Officers' Quarters from the residence to the north. A cast iron light pole with a globe lamp had also been installed at the edge of the lawn. A path, probably concrete, bordered the lawn to the west. Larger trees are noted at the edges of the photograph; these must pre-date construction of this building.

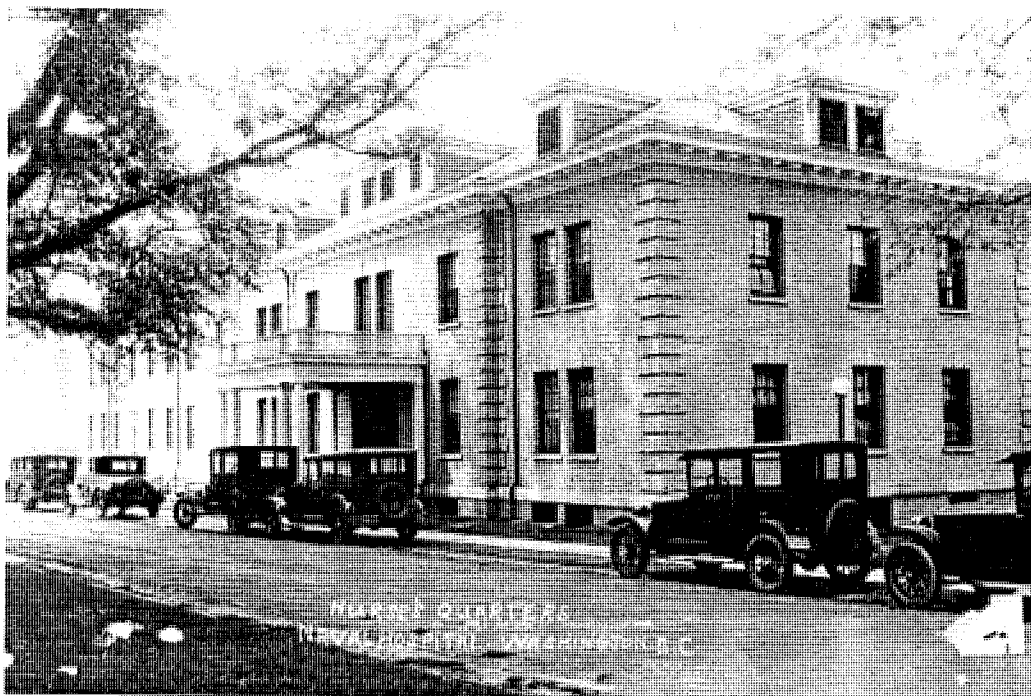
Figure 2-8
NURSES' QUARTERS (BUILDING 1)
East and North elevations, ca. 1929.
BUMED Archives

A general discussion of the historic landscape is located at the end of this chapter, however, a few site specific details regarding this building are noted here. The plot plan for this building dated 1925 indicates concrete and gravel walks at the front (west) of the building. The 1929 historic photograph of this building (Figure 2- 8) shows a drive and sidewalk running parallel to the building. It appears that a small lawn acted as a buffer between the drive and the building foundations. No other plantings are apparent. This represents a change from the conditions shown in the 1921 photograph (Figure2- 9), which shows paths, but no drive. Also, more mature trees are evident in the 1921 photograph. One cast iron light pole with a globe lamp appears at the north end of the building in 1929.

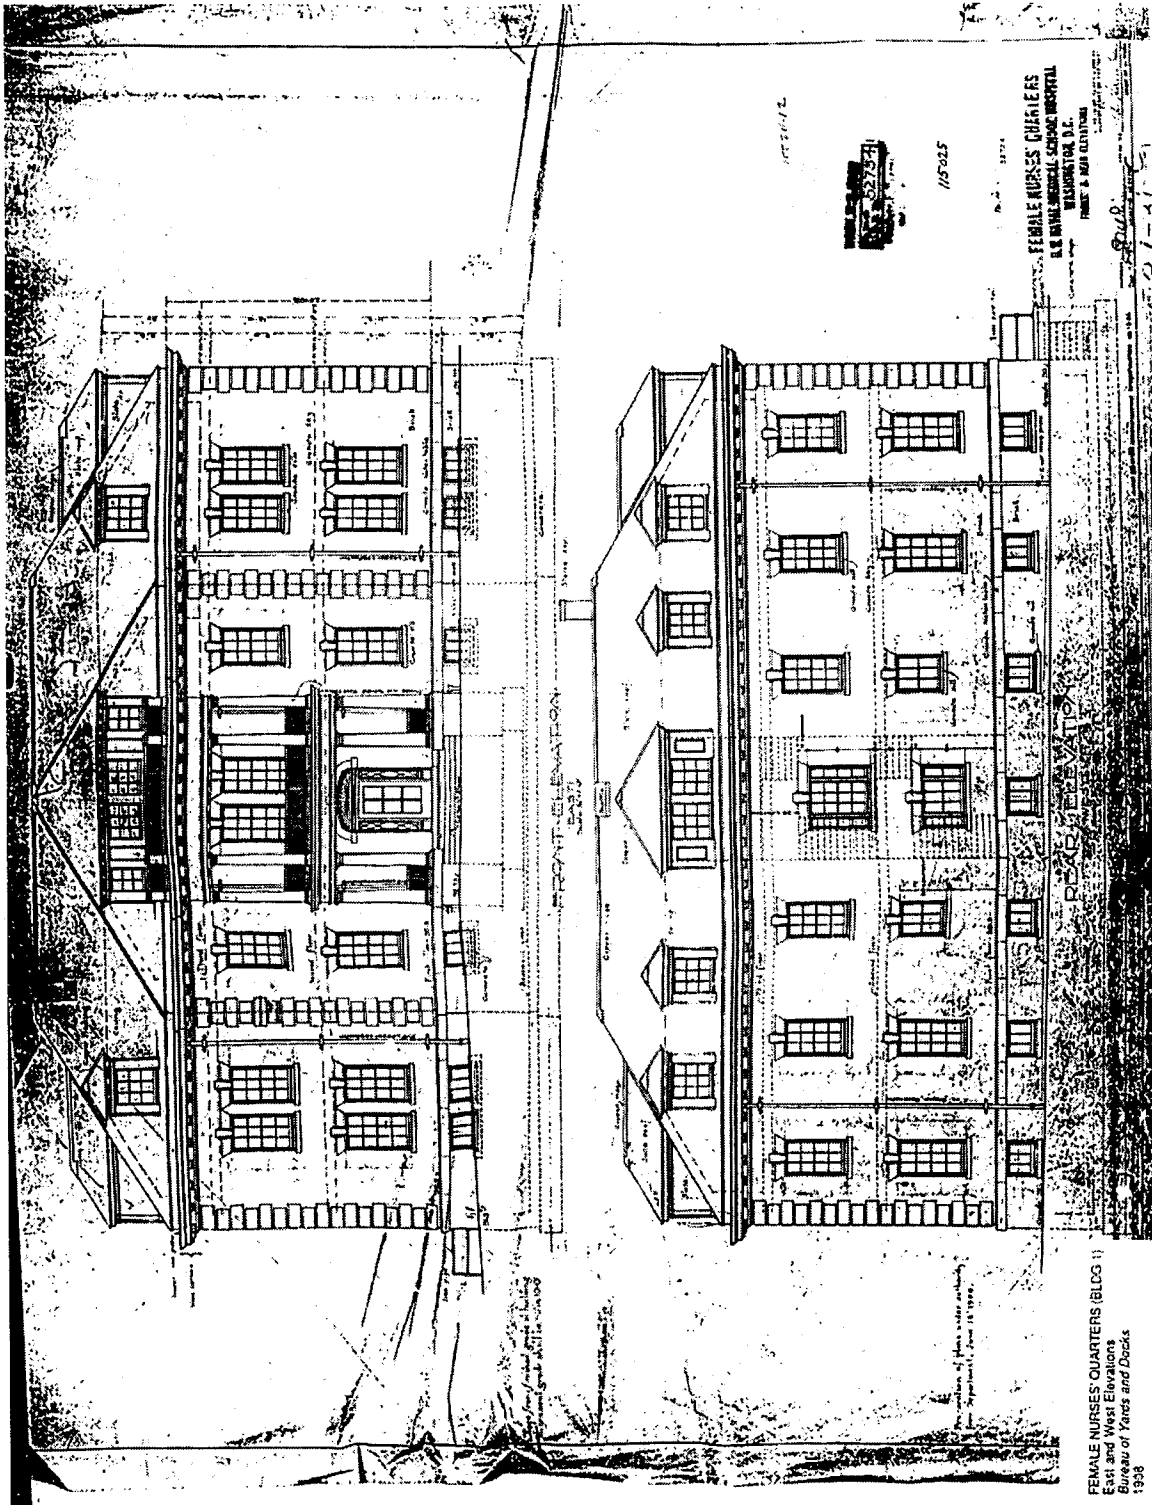
Figure III-1: Female Nurses' Quarters (BLDG 1), East and West Elevations
Bureau of Yards and Docks, 1908

Building 1 was originally constructed as the Female Nurses' Quarters, and was used as a dormitory (Figures III-1 – III-6) & III-18—III-19). It was located on the west side of the site. Like most of the buildings on the site, it was a two-and-one-half story brick Georgian Revival structure. It had a hipped roof and a classical balustraded portico, supported by Tuscan columns. The massing was symmetrical except for the sun porch on the south end. The body of the building was constructed of yellow brick laid up in Flemish bond with granite keystones, window sills, and water table. The windows were painted dark green and the other wood trim was white.

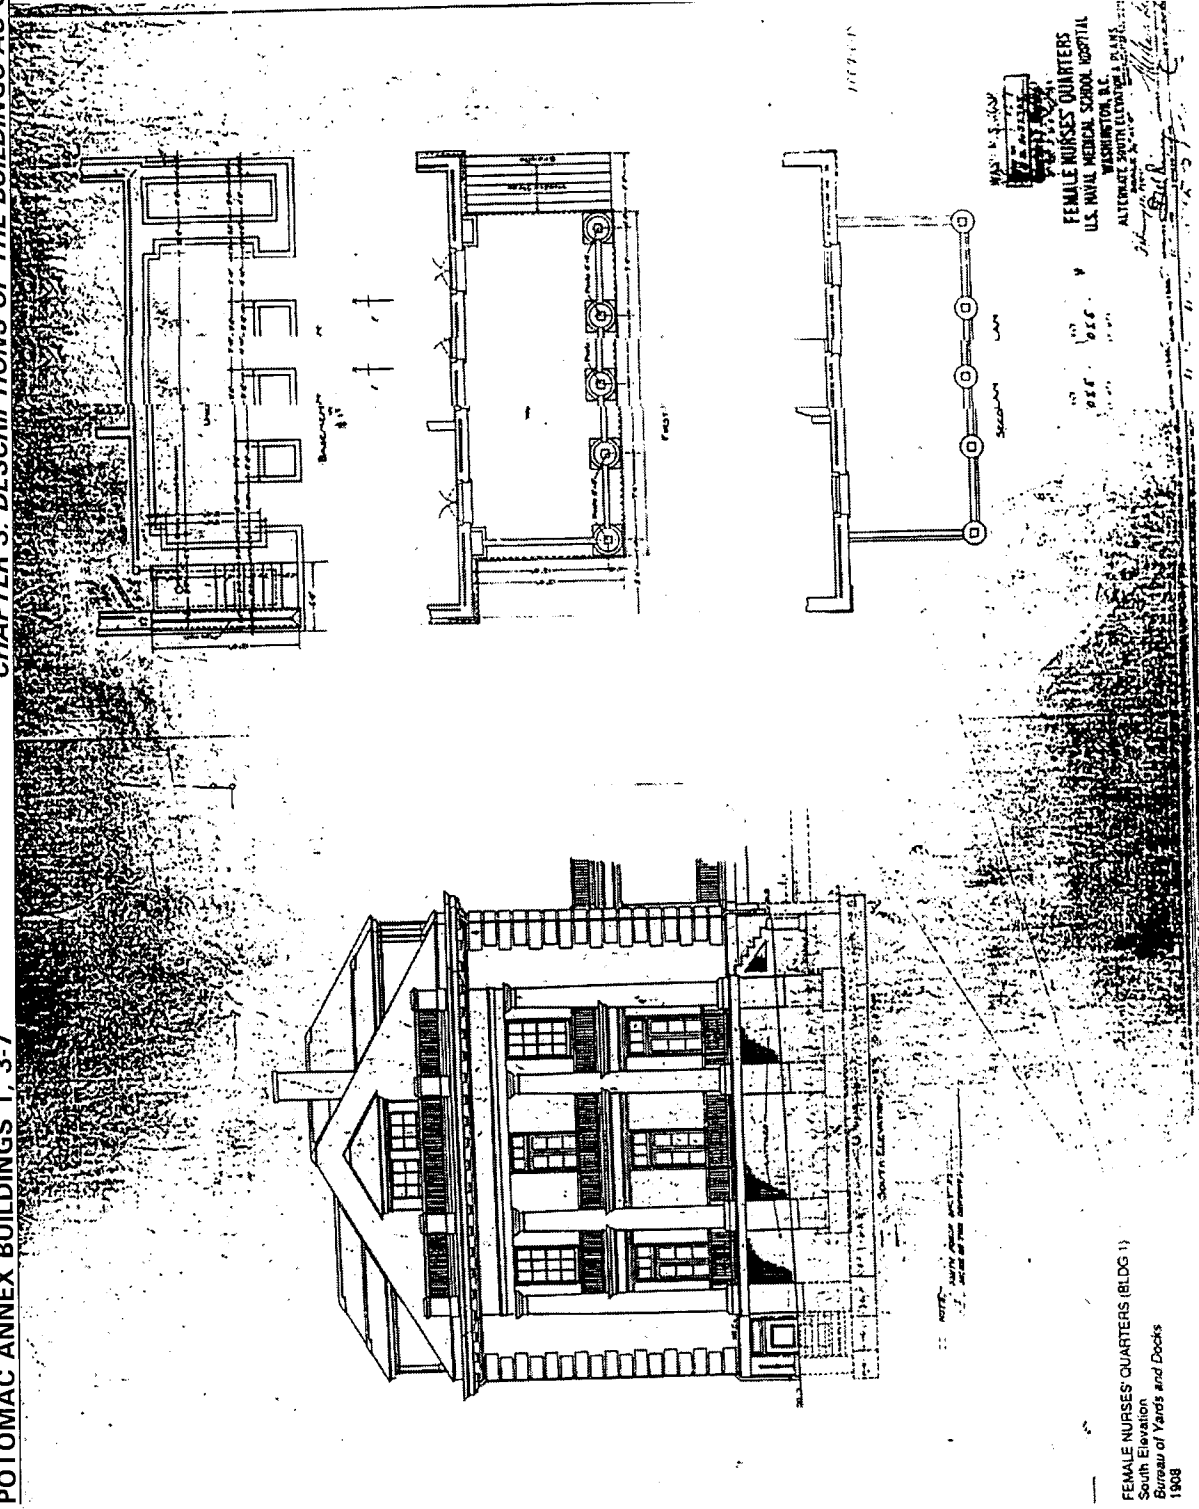
Figure III-2: Female Nurses' Quarters (BLDG 1), South Elevation
Bureau of Yards and Docks, 1908

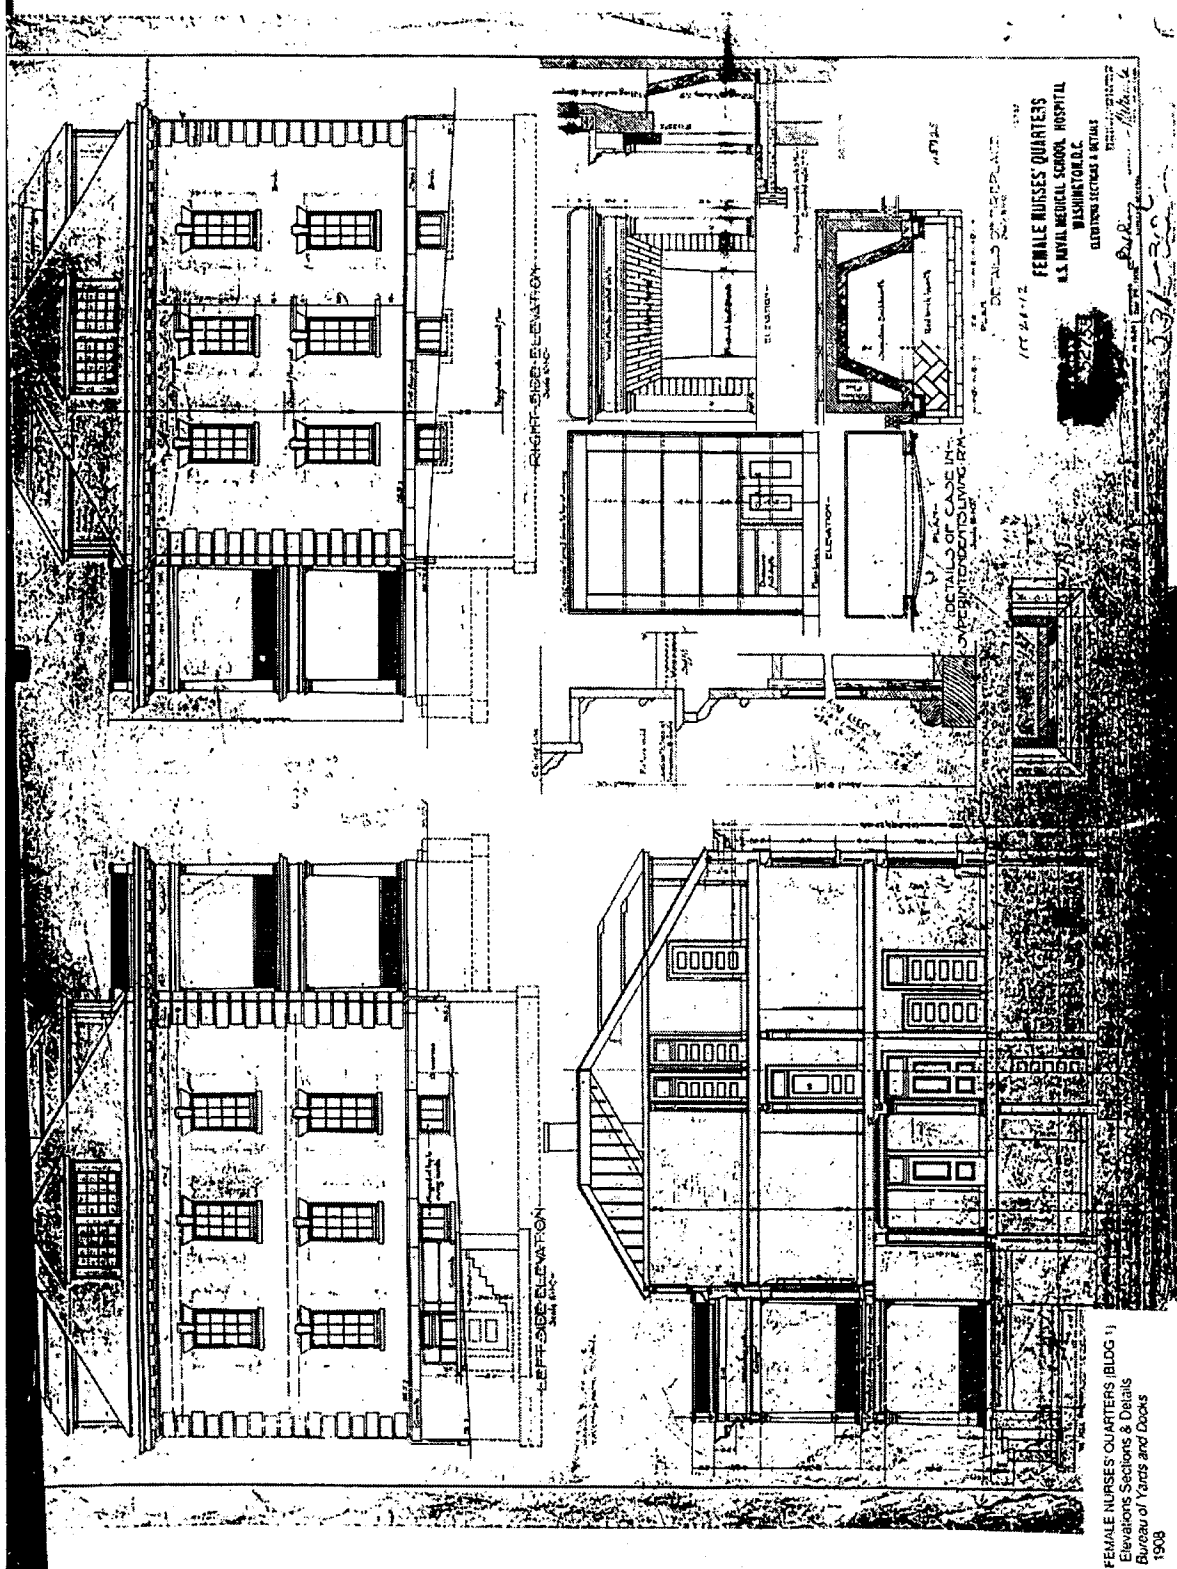
Figure III-3: Female Nurses' Quarters (BLDG 1), Elevations, Sections, and Details Bureau of Yards and Docks, 1908

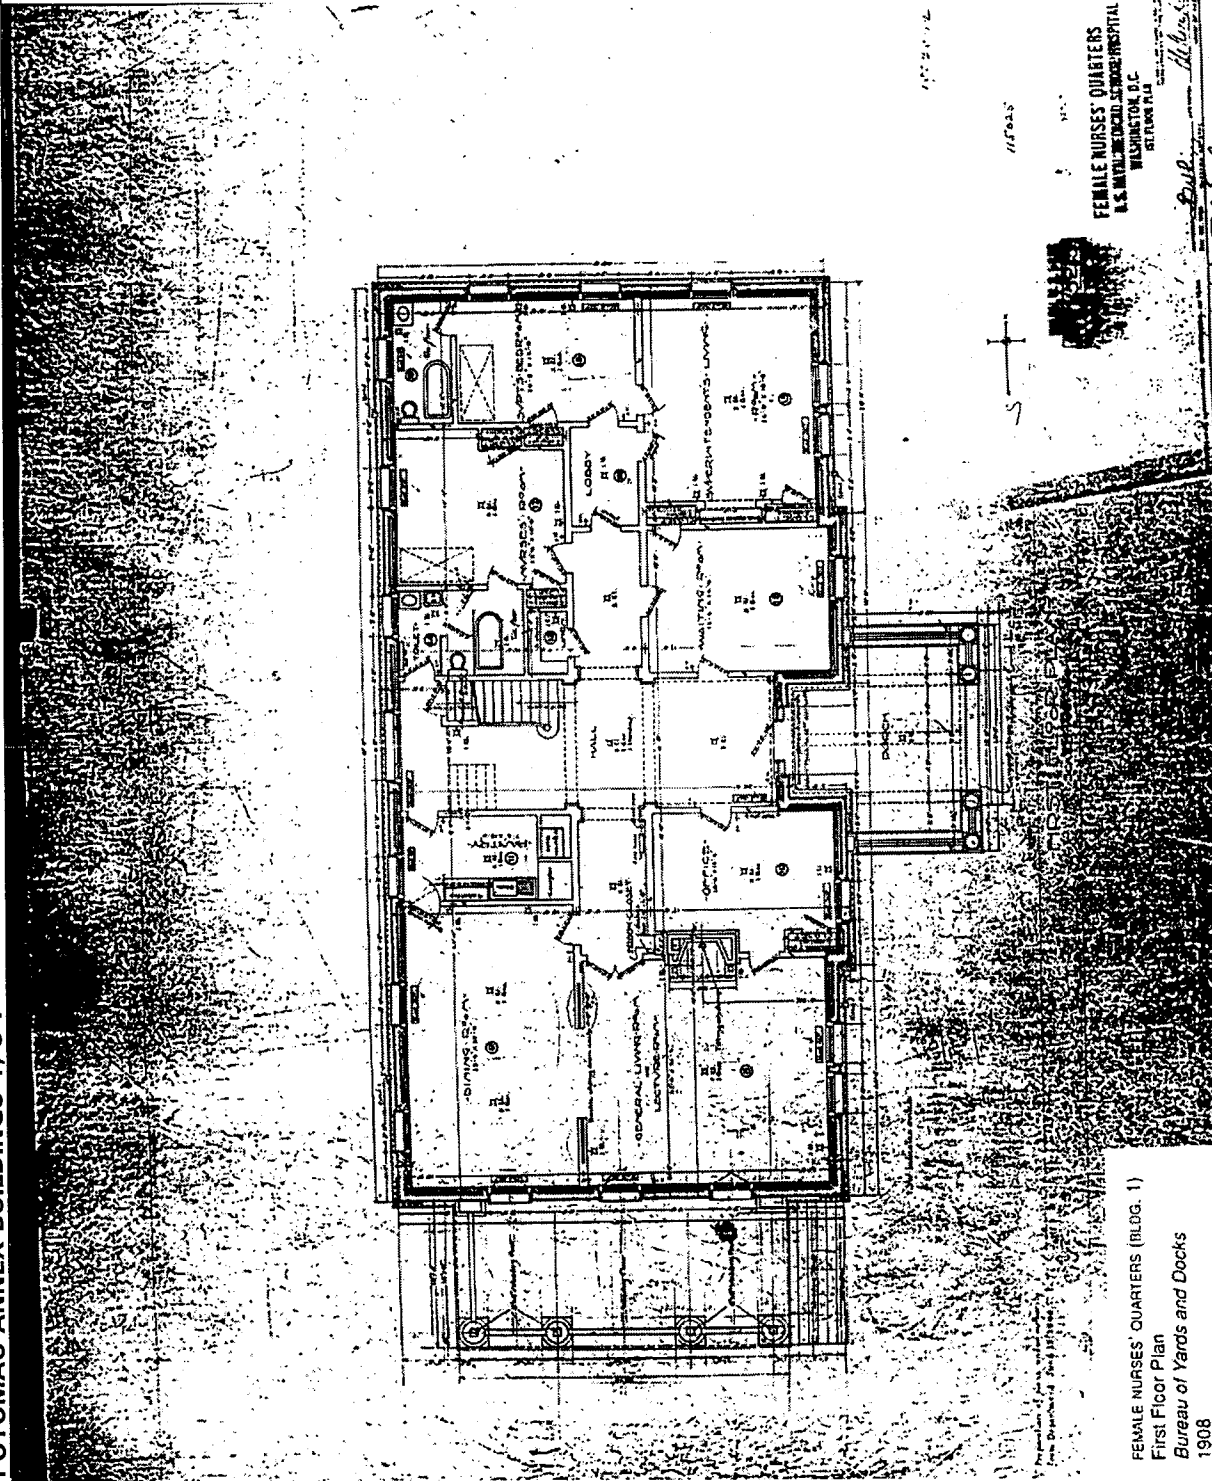
FEMALE NURSES' QUARTERS (BLDG. 1)
 First Floor Plan
 Bureau of Yards and Docks
 1908

Figure III-5: Female Nurses' Quarters (BLDG 1), First Floor Plan
 Bureau of Yards and Docks, 1908

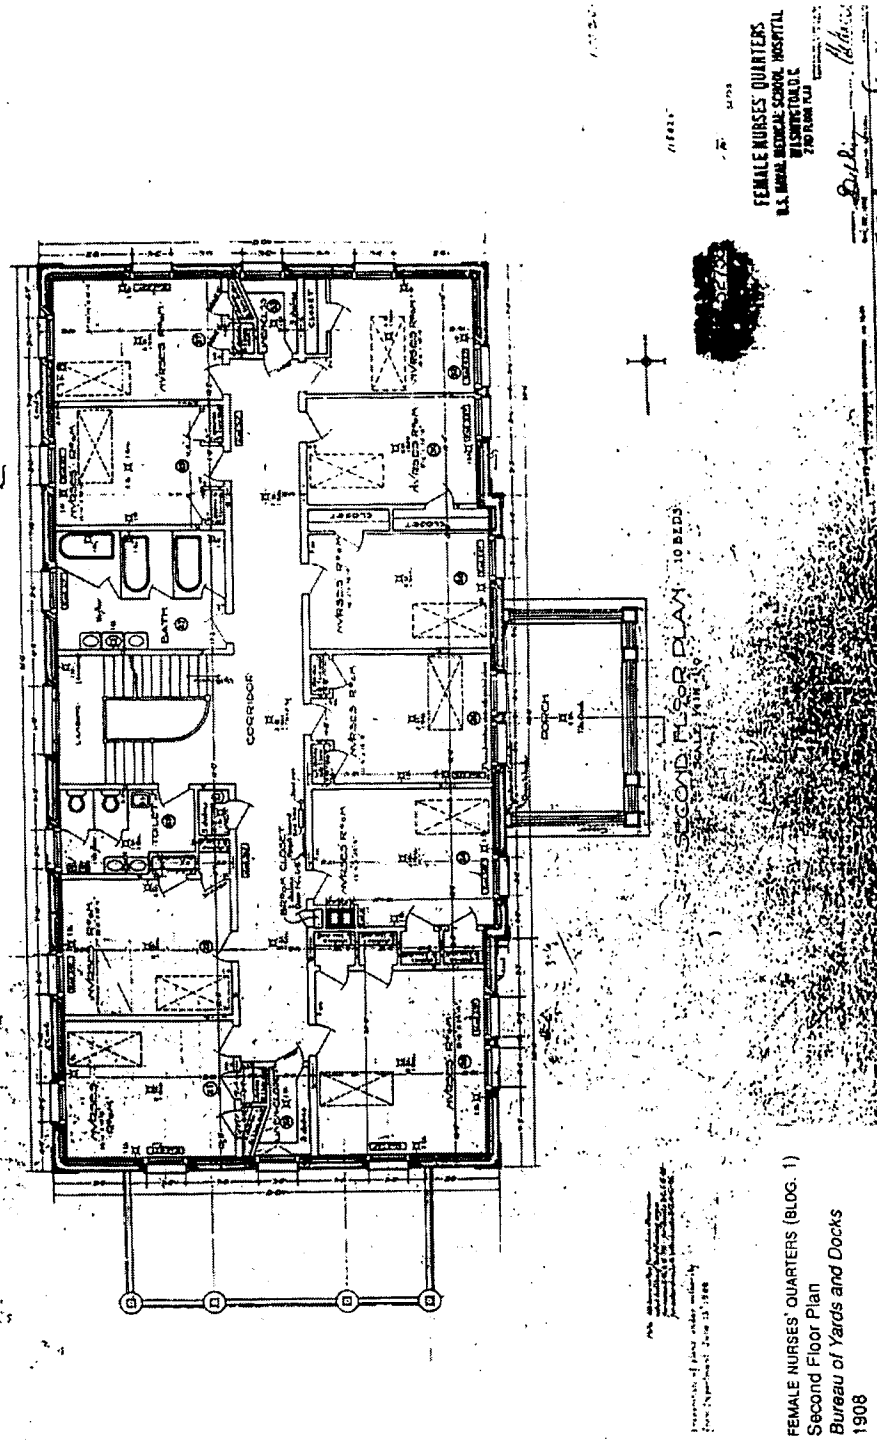
FEMALE NURSES' QUARTERS (BLDG. 1)
Second Floor Plan
Bureau of Yards and Docks
1908

Figure III-6: Female Nurses' Quarters (BLDG 1), Second Floor Plan
Bureau of Yards and Docks, 1908

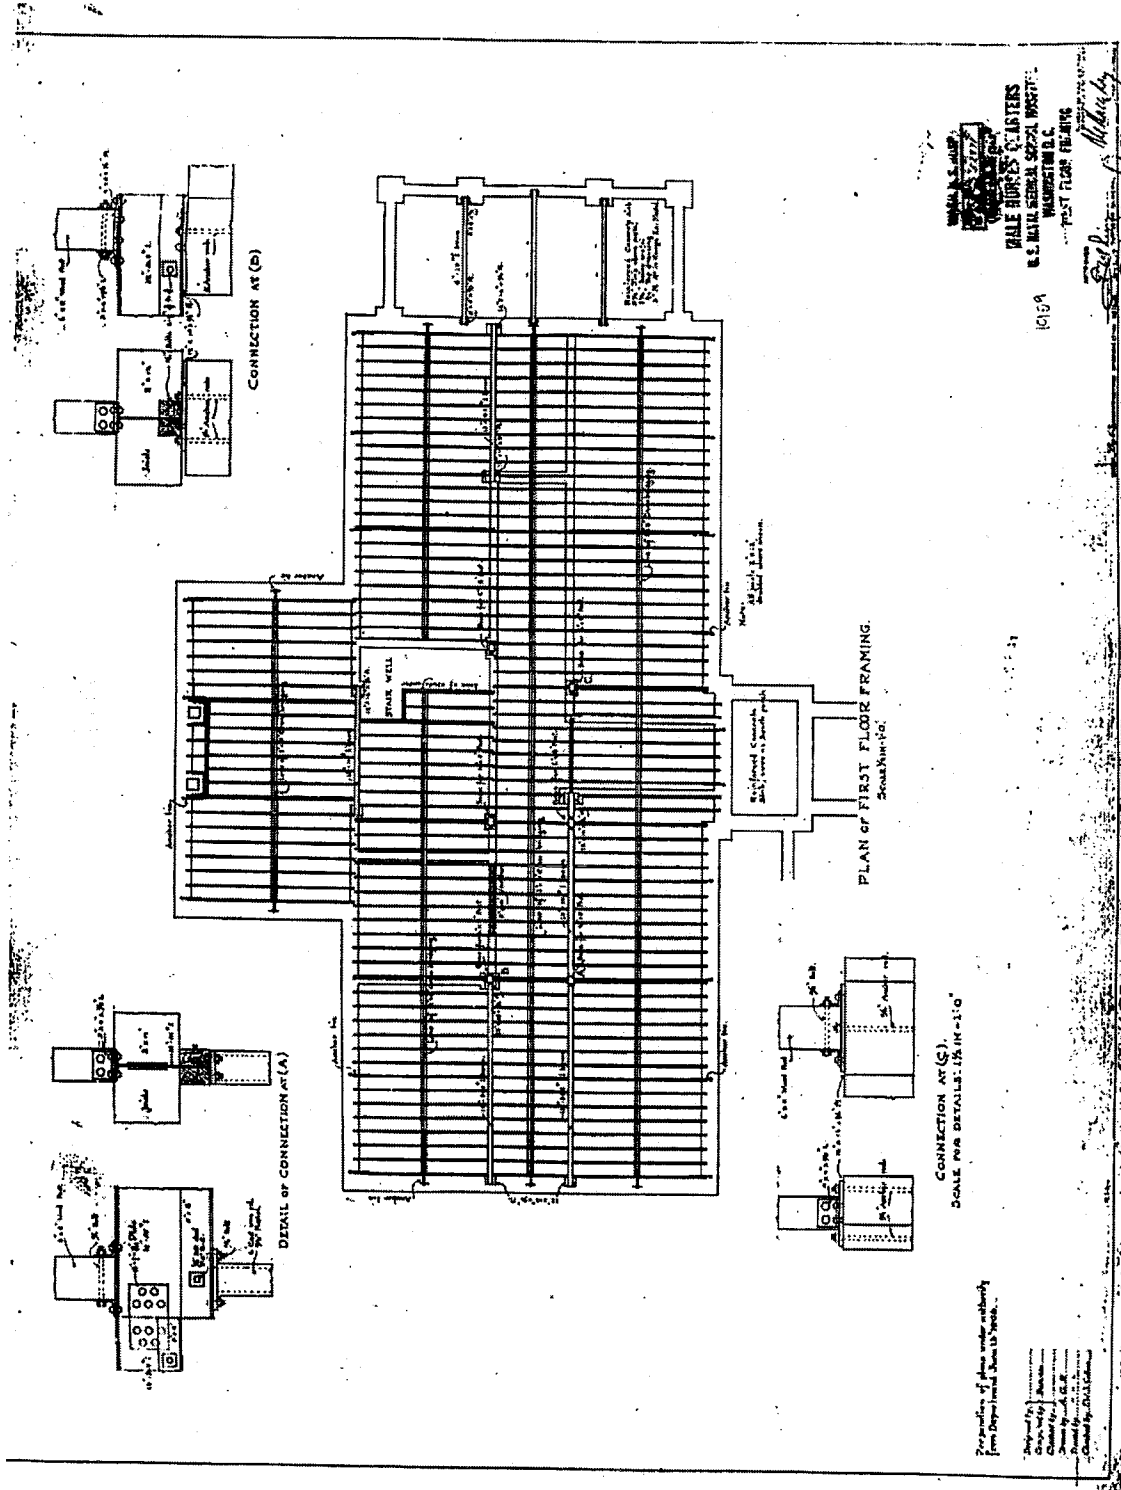
Figure III-61: Hospital Corp's Quarters (BLDG 7), 1st Floor Framing Plan
Bureau of Yards and Docks, 1909

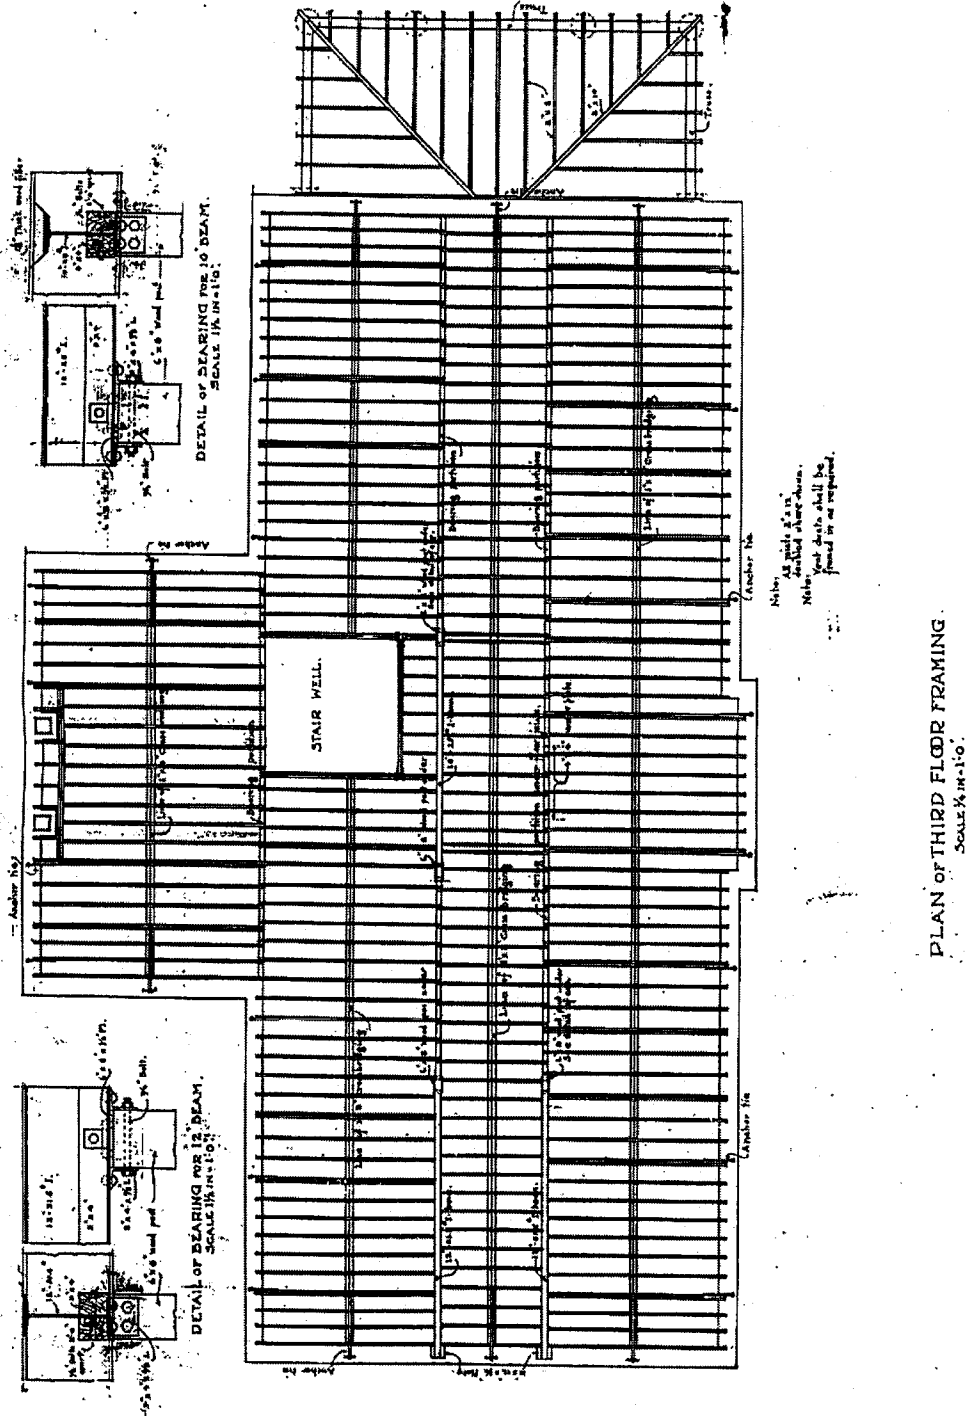
Figure III-63: Hospital Corp's Quarters (BLDG 7), 3rd Floor Framing Plan
Bureau of Yards and Docks, 1909

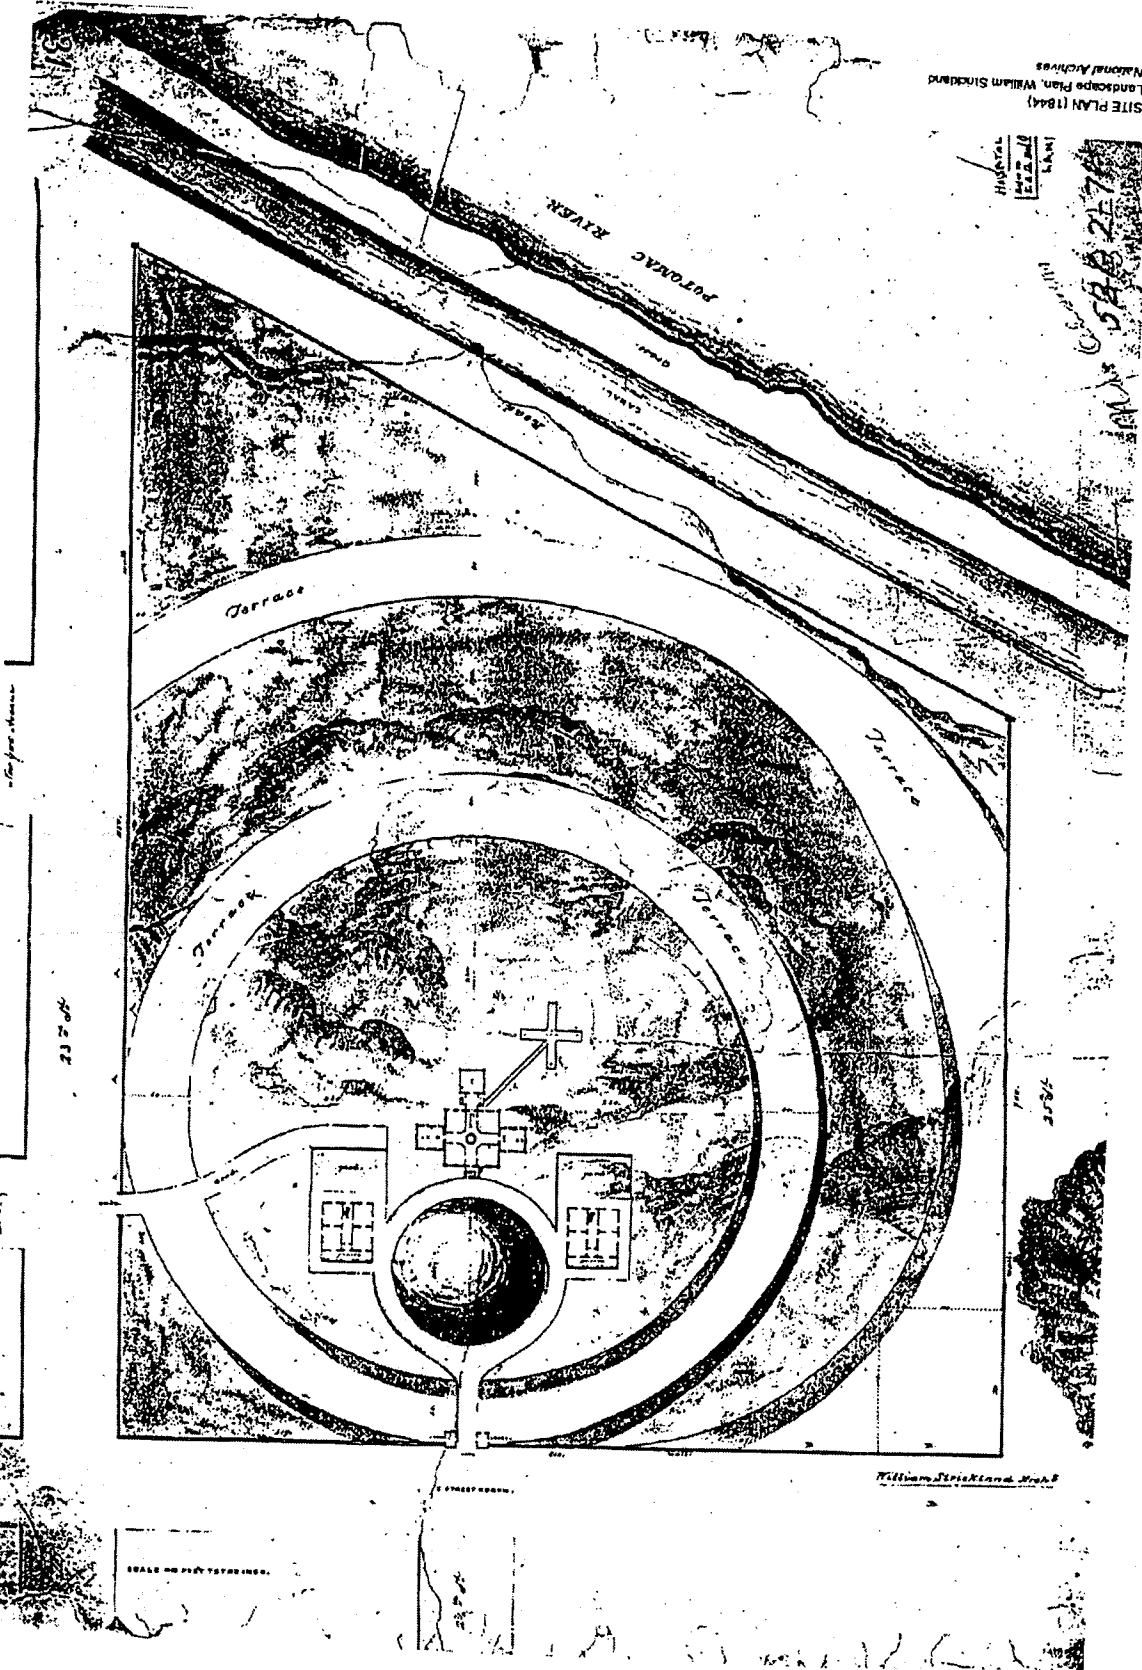
Figure III-65: Site Plan (1844), Landscape Plan
William Strickland, *National Archives*

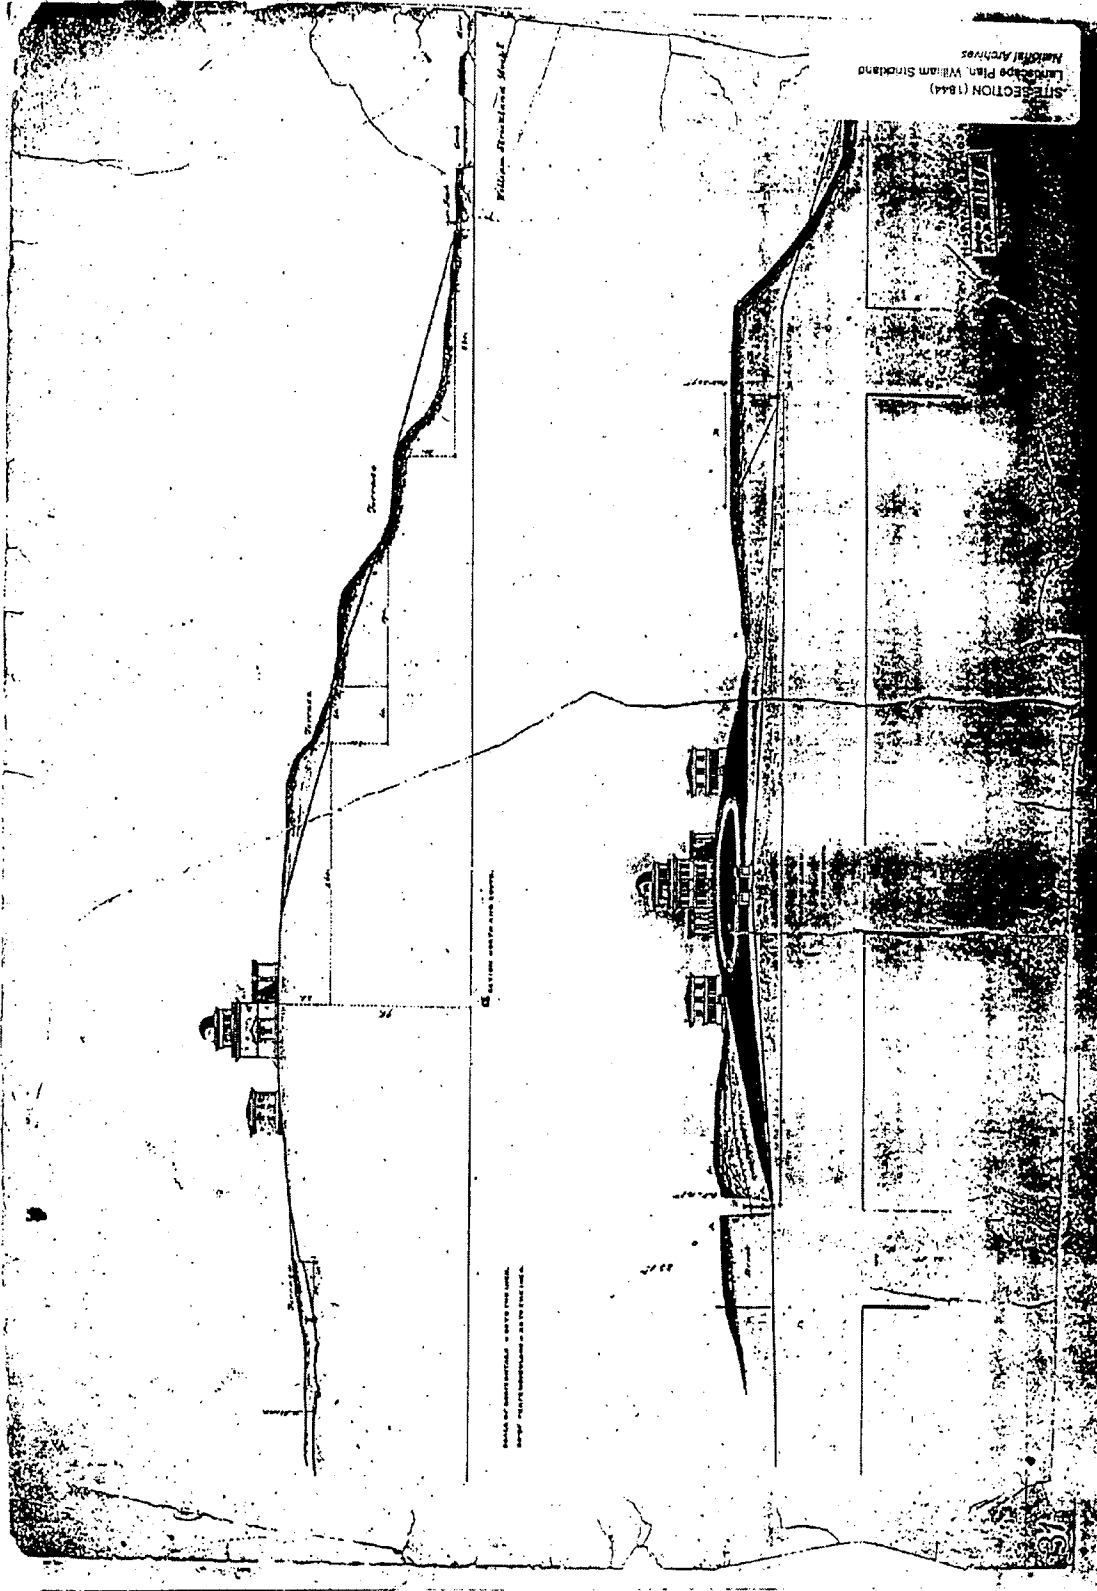
Figure III-66: Site Plan (1844), Landscape Plan, William Strickland National Archives

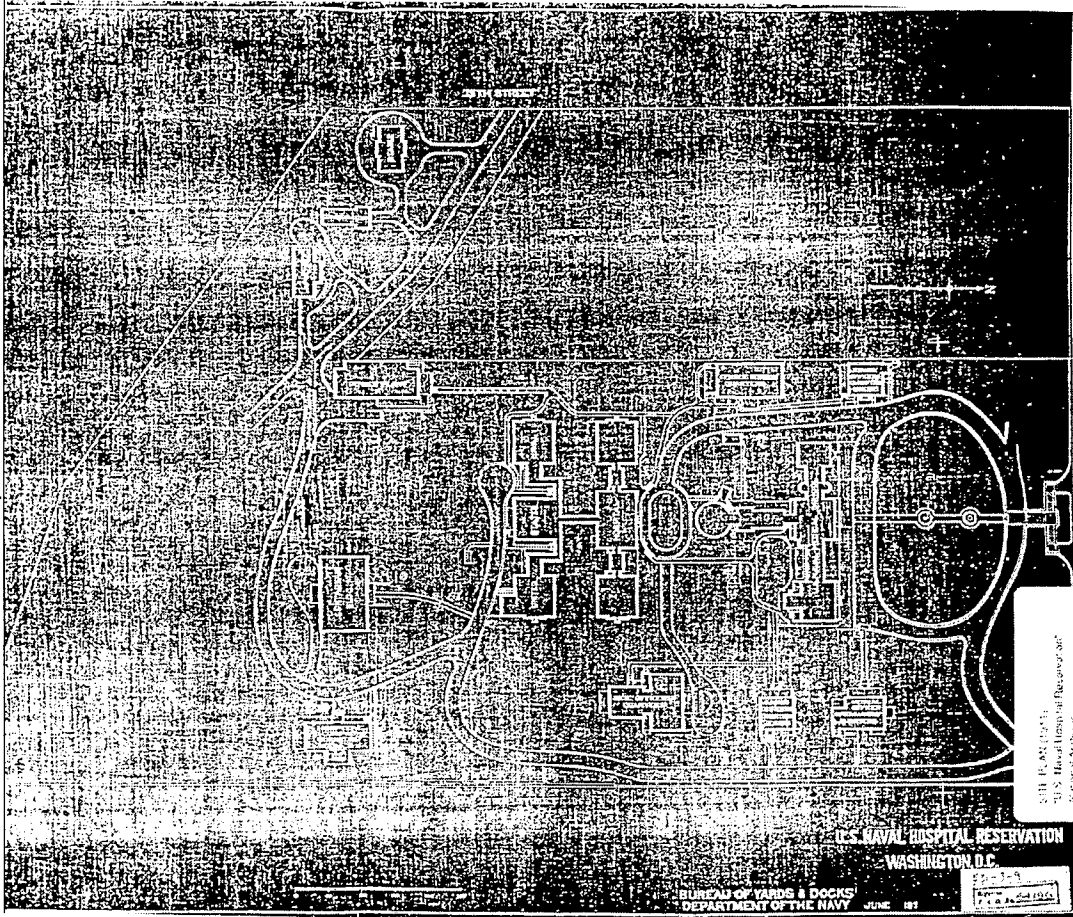
Figure III-68: Site Plan (1911), "U.S. Naval Hospital Reservation"
National Archives
