Potomac Annex: Buildings 1 & 3-7

Historic Structures Report, Corrected Final Submission
 General Services Administration Project Control Number: 44007
 September 9, 1997
 VOLUME 1 OF 2

HISTORIC STRUCTURE REPORT

**POTOMAC ANNEX
BUILDINGS 1, 3-7**

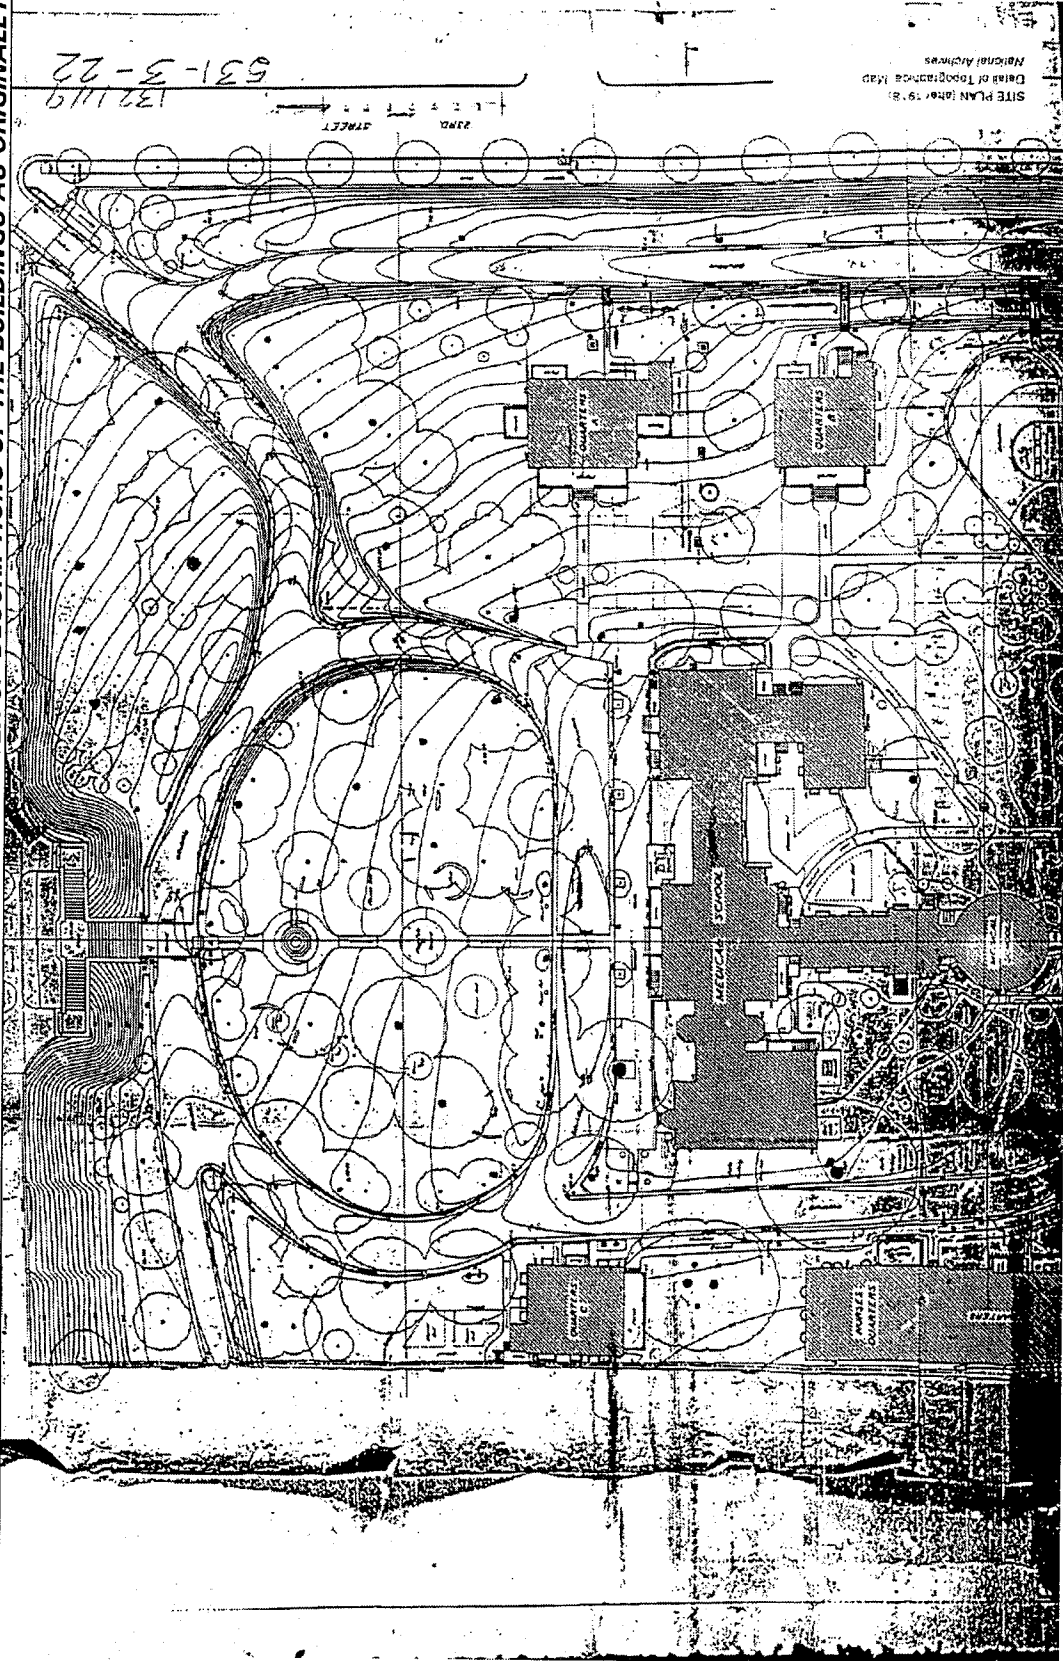
Figure III-69: Site Plan (after 1918), Detail of Topographical Map
National Archives

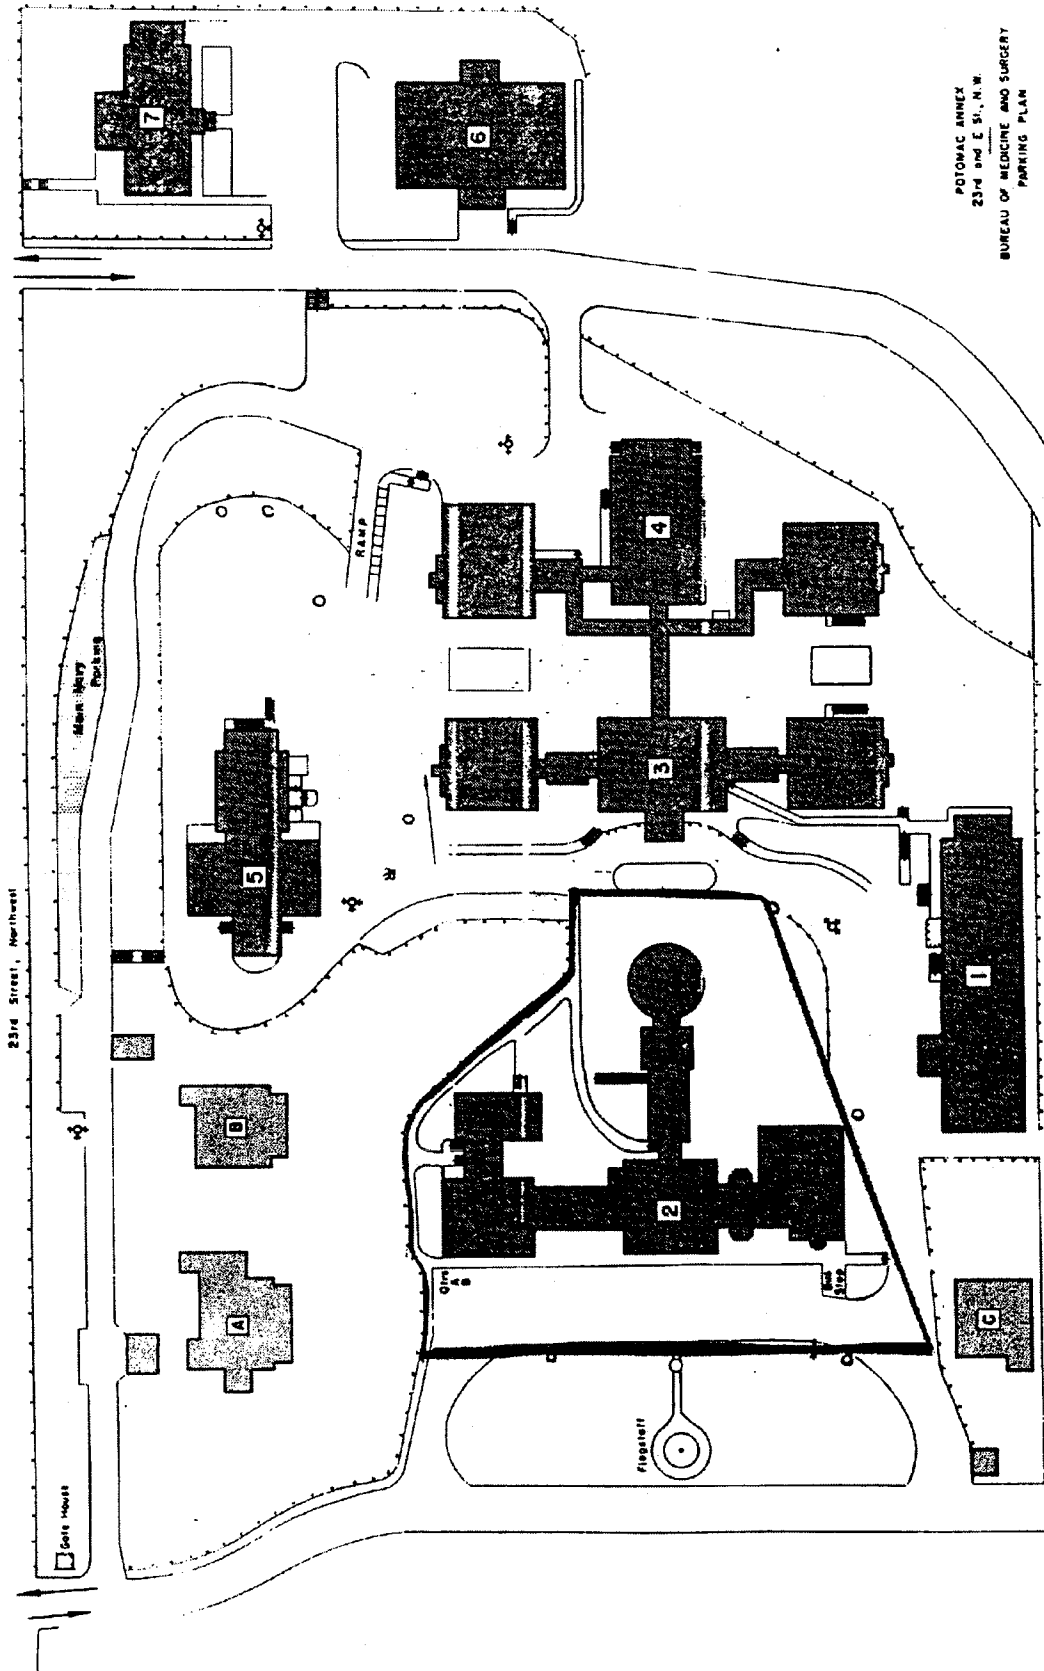
Figure III-73: Site Plan (1964)
Bureau of Medicine and Surgery
