Evaluation of Structures Army Reserves, New Jersey 79th Army Reserve Command

Sievers-Sandberg USARC
Pedricktown
Salem County
New Jersey

# 77th REGIONAL SUPPORT COMMAND NEW JERSEY, CULTURAL RESOURCE MANAGEMENT PLAN FACILITY DATA FORM

FACILITY: SIEVERS-SANDBERG U.S. ARMY RESERVE CENTER

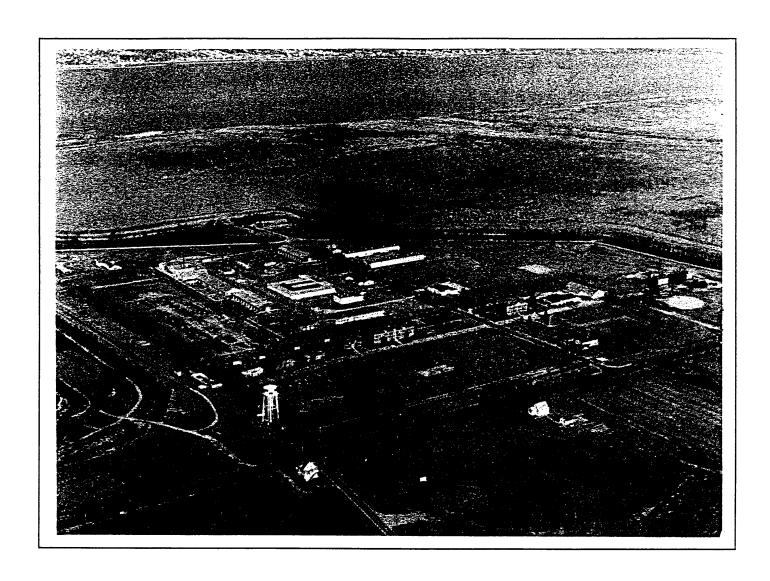
Figure 2

Aerial View of Site and Vicinity
Sievers-Sandberg USARC
Pedricktown, Salem County, NJ

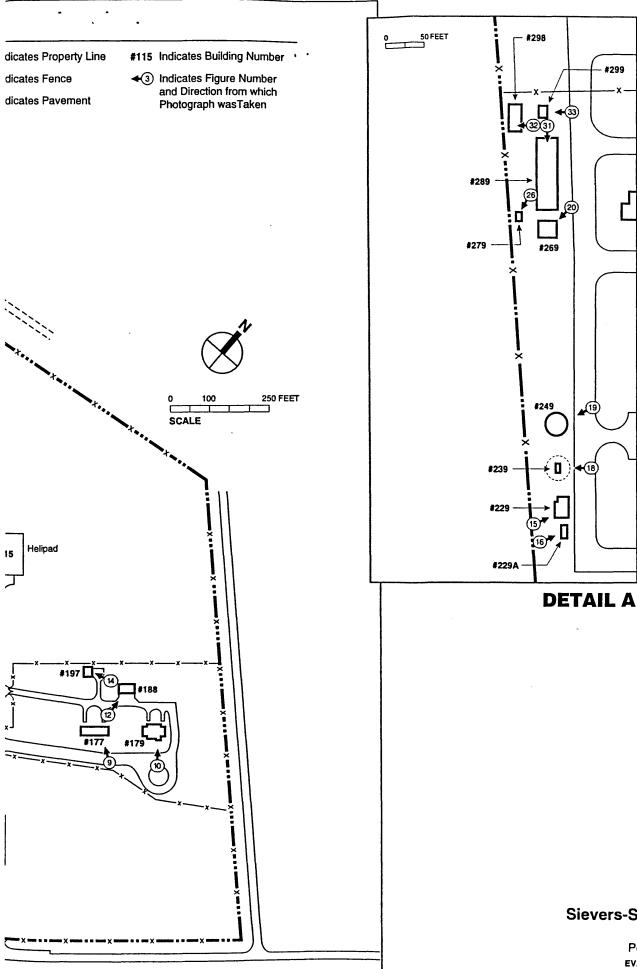
> Figure 3 Site Plan Sievers-Sandberg USARC

The Pedricktown Support Facility's 56 structures are grouped according to building type, as a result of its planned development over time—i.e., a housing area is placed at the front of the site, and a shop/maintenance area and a missile-related area share the rear of the site. There is a network of named streets and some sidewalks connecting the areas and buildings, small paved parking areas throughout, and a large unpaved vehicle storage area at the southwest border. Much of the land is grassy lawn and/or field. A few trees are found in the shop/missile area; the housing area has a number of large trees and remnants of original landscaping. (See Figure 2: Aerial View of Site and Vicinity; Figure 3: Site Plan.)
