985 Michigan Federal Building

FACT SHEET

Water Quality Investigation

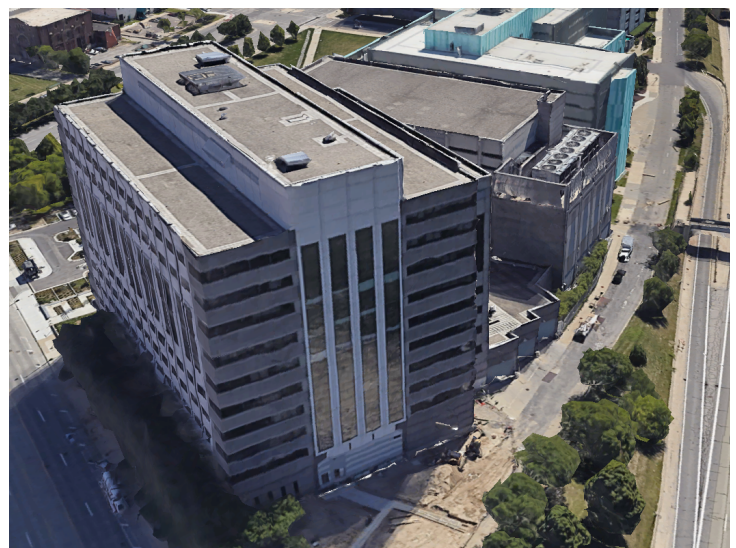
Aerial view of 985 Michigan showing the main building and parking garage. Cooling towers are adjacent to the parking garage.
